Fire Hazard and Risk Assessment

Thomastown Terminal Station Battery Energy Storage System

Project Name: TTS BESS

Report Name: Fire Hazard and Risk Assessment

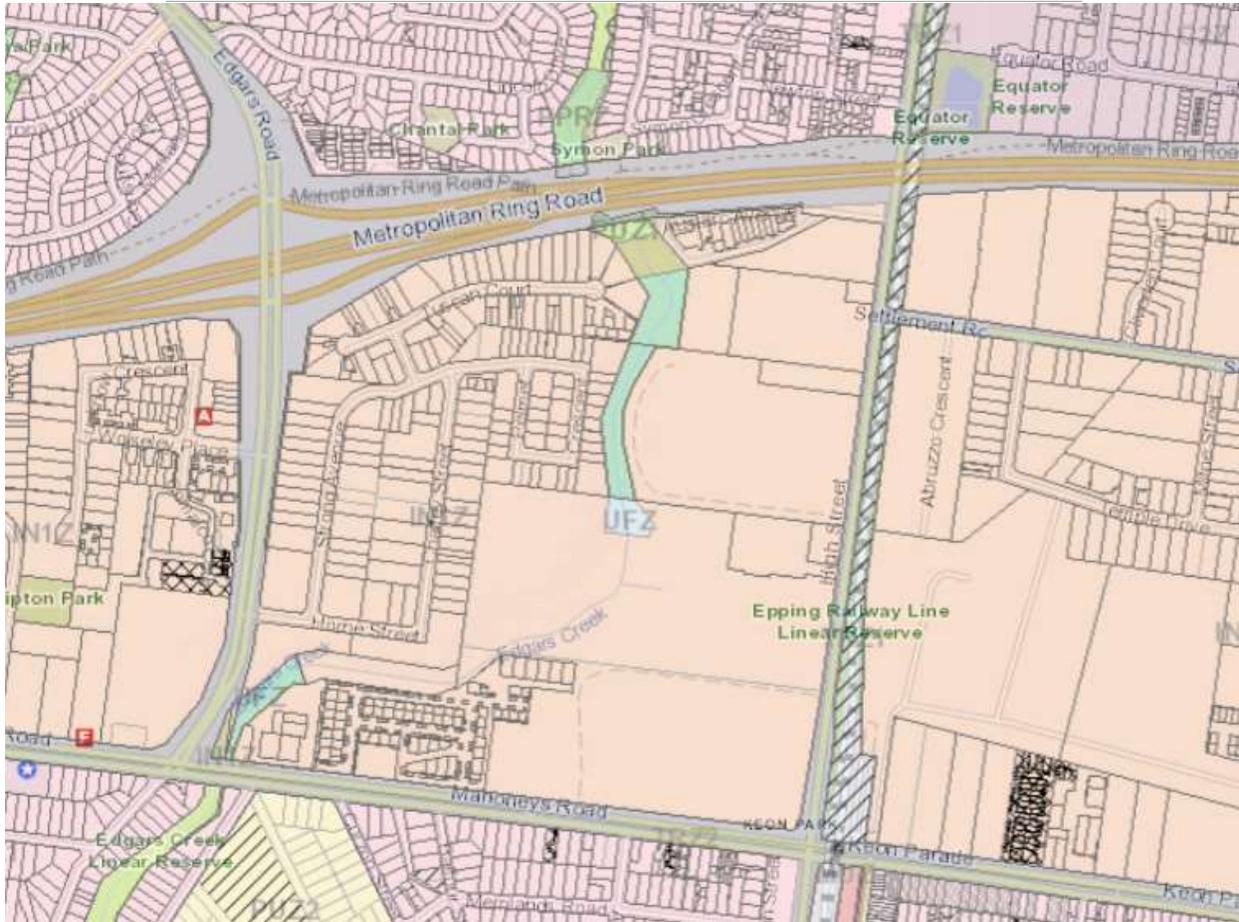
Figure 3: Site Zoning (UFZ – Urban Floodway Zone, IN1Z – Industrial Zone 1.)

Edgars creek runs to the South and East of the site. An urban floodway is located in the Northeast corner of the site and to the southwest of Edgars Creek.

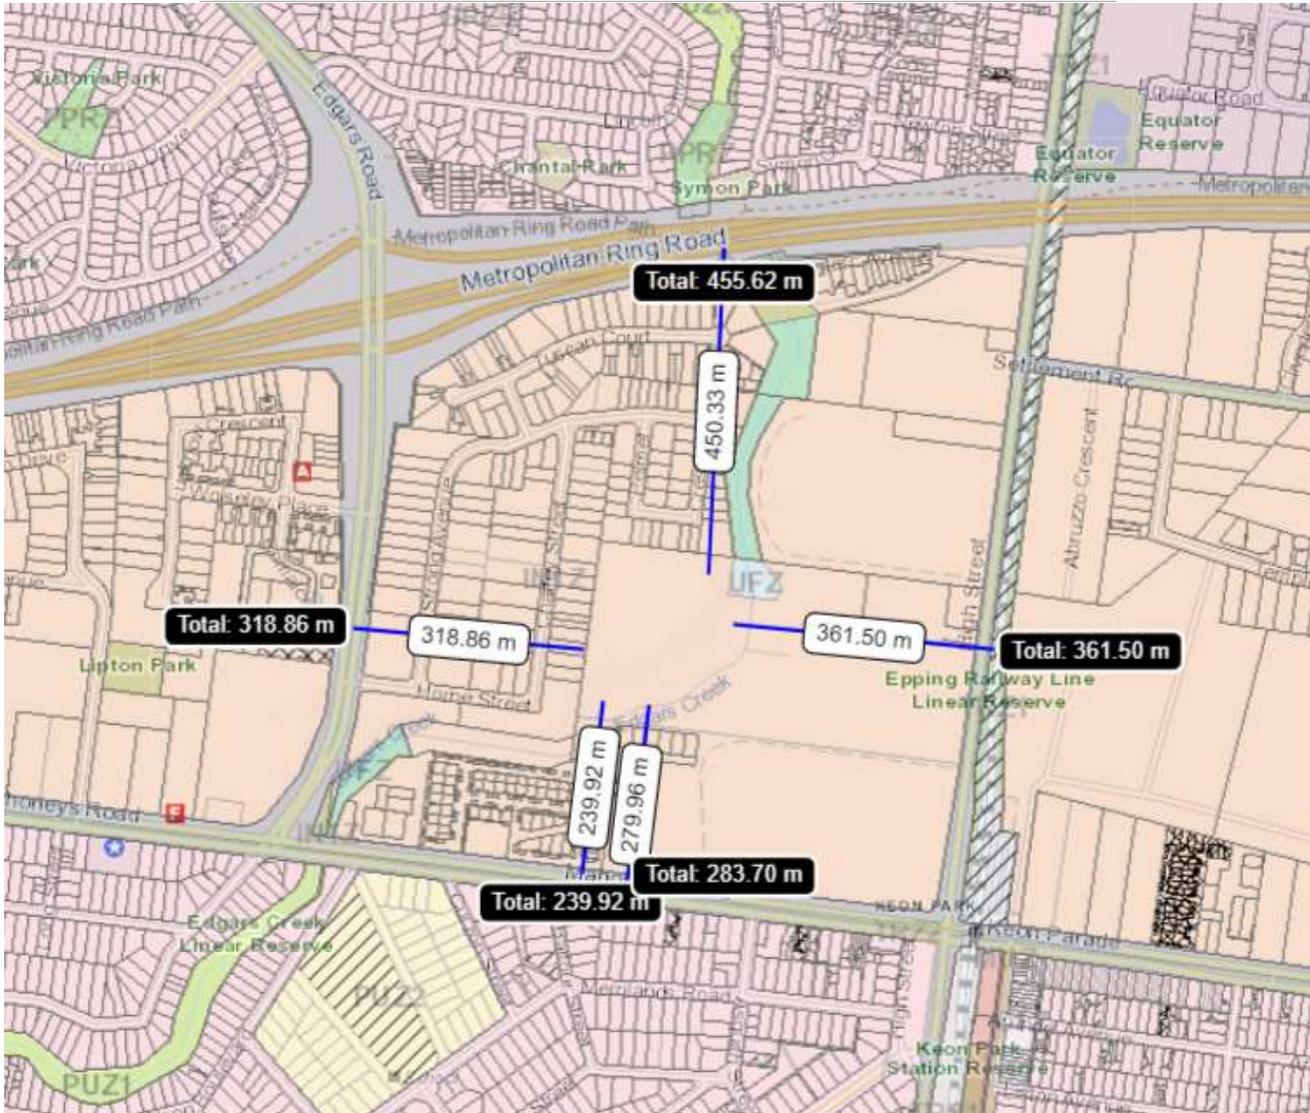
Figure 4 Separation Distances to other land uses

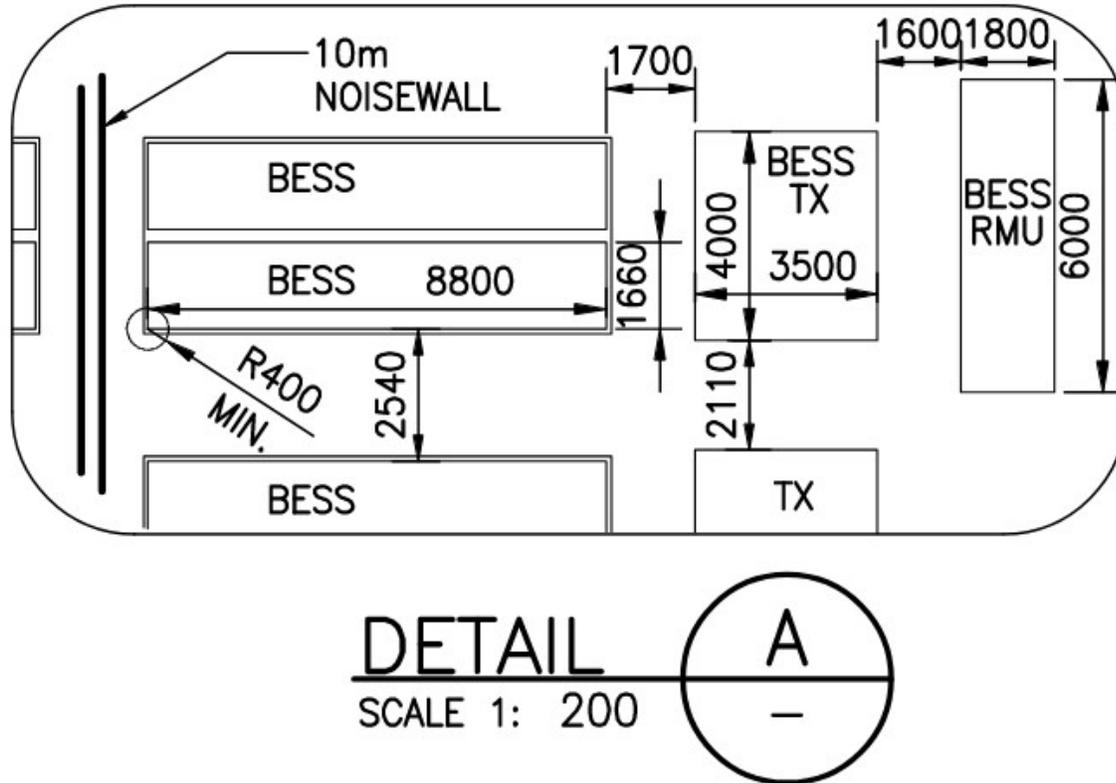
Figure 7 BESS unit layout

The noise wall is proposed to be constructed from an acoustic panel material consisting of steel sheets and a mineral wool interlayer similar to Flex shield Sonic system modular panel (Appendix C). The wall system has been tested to AS1530.4 and has achieved a fire rating of -/120/-. Accordingly, when supported by steel posts each side the sound walls would serve as a fire rated separation between the main rows of battery units in each island.

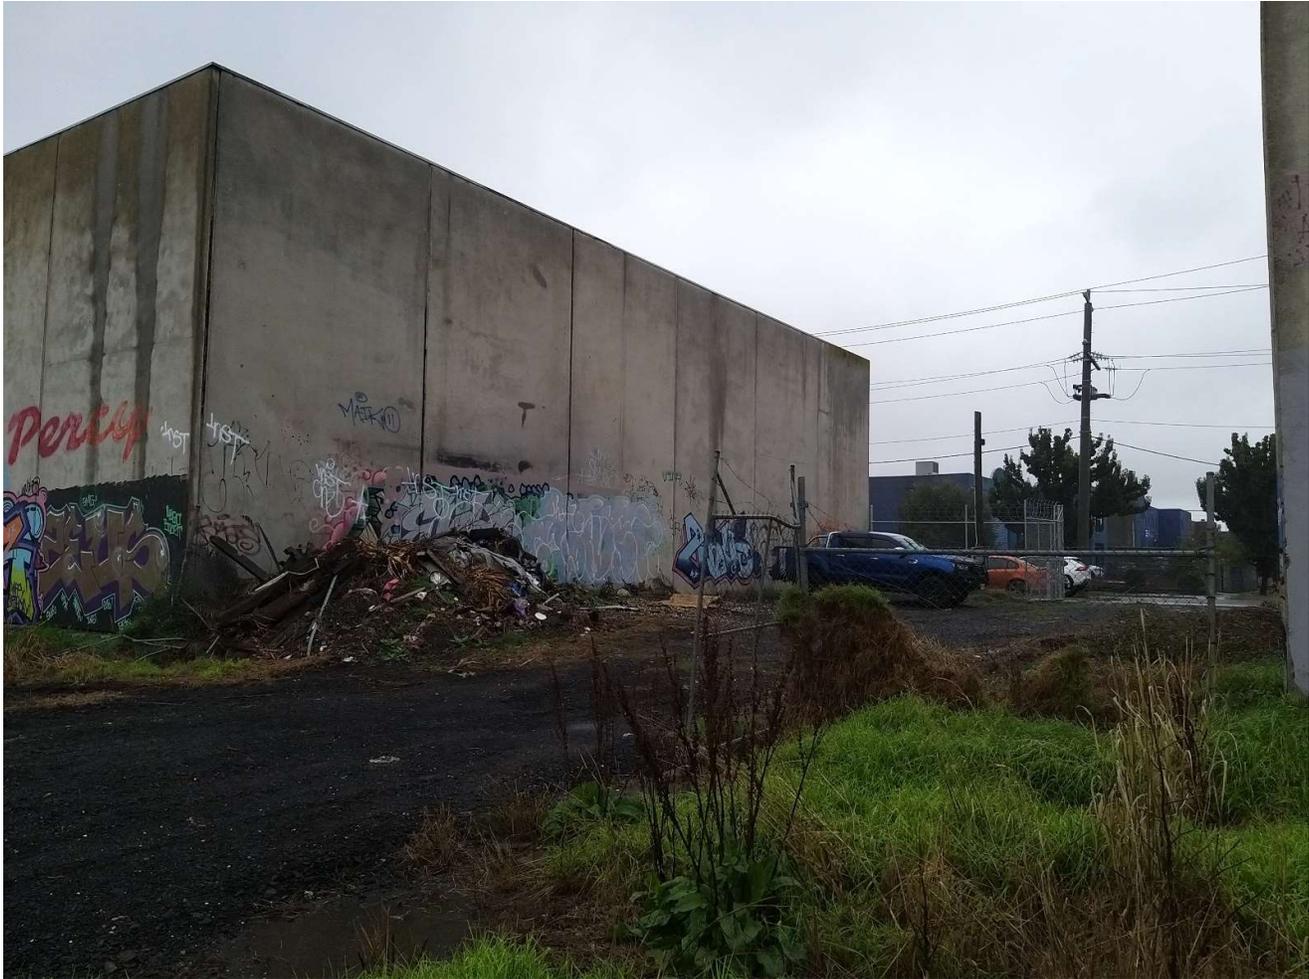
Figure 8 Site access

The fire tanks and booster are to be located adjacent to the access driveway that serves as the start of the fire brigade access track that is continuous around the entire facility as a 6m wide road. The 6m wide fire brigade track extends around and within the facility and separates the battery units into smaller areas. Attack fire hydrants are to be located around the fire track such that all areas can be covered by at least two hydrants.

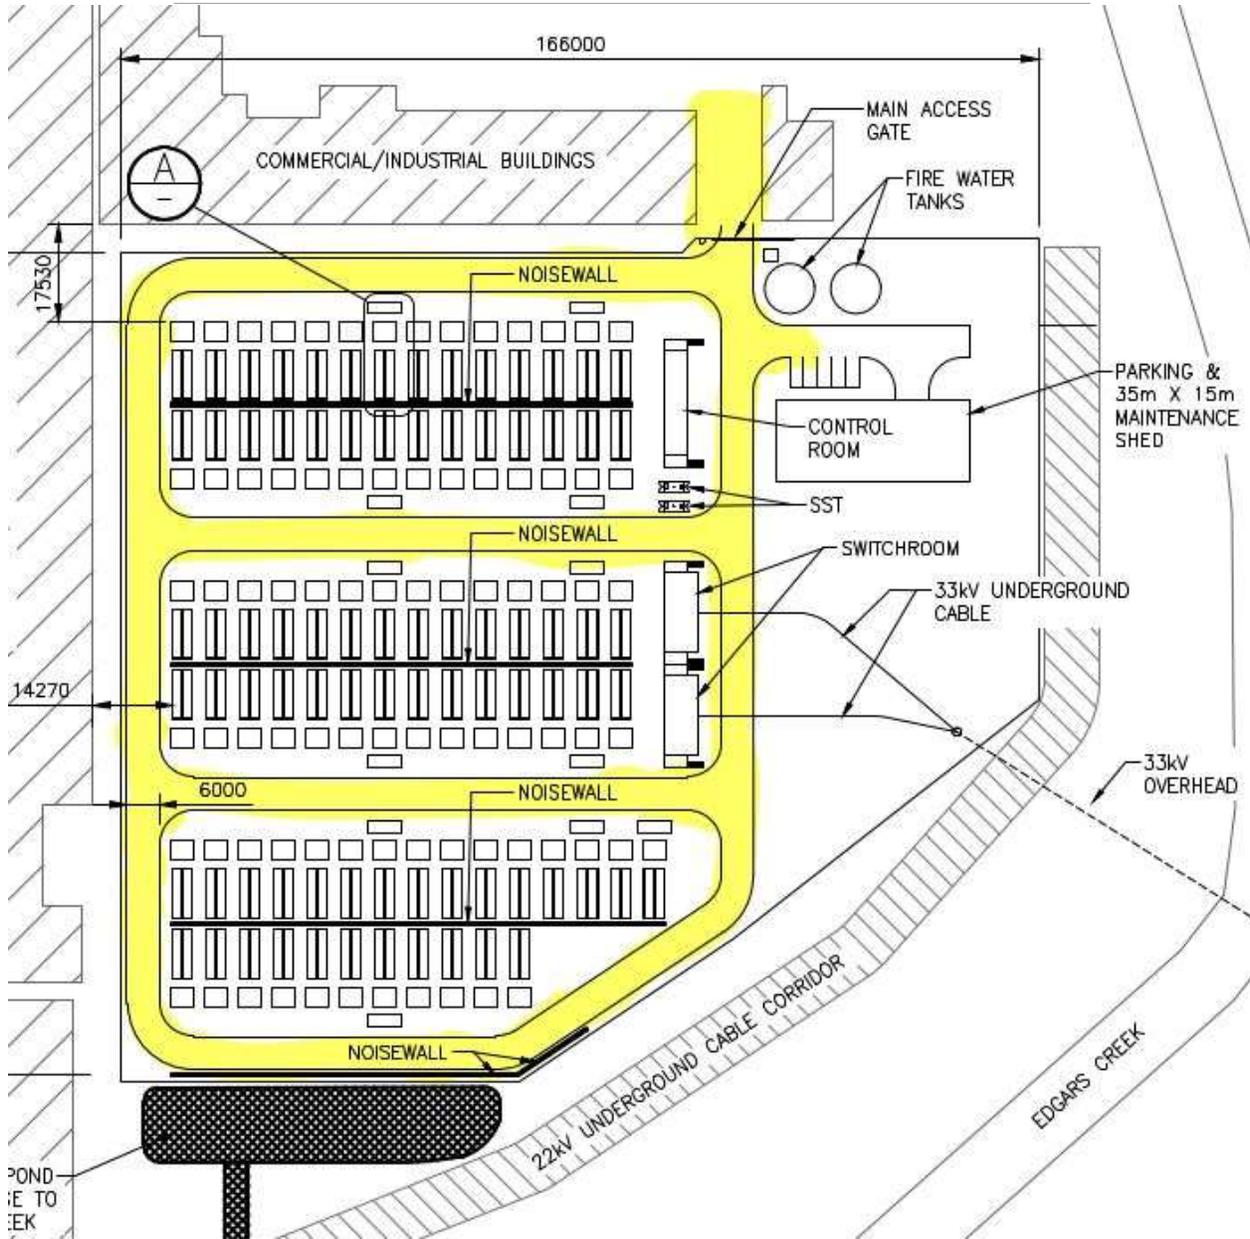
Figure 9 Site plan showing the fire track around and through the site

A control room (500m^2) and switch rooms are located to the East of the batteries. A laydown parking and future expansion area is to be located to the East of the site.

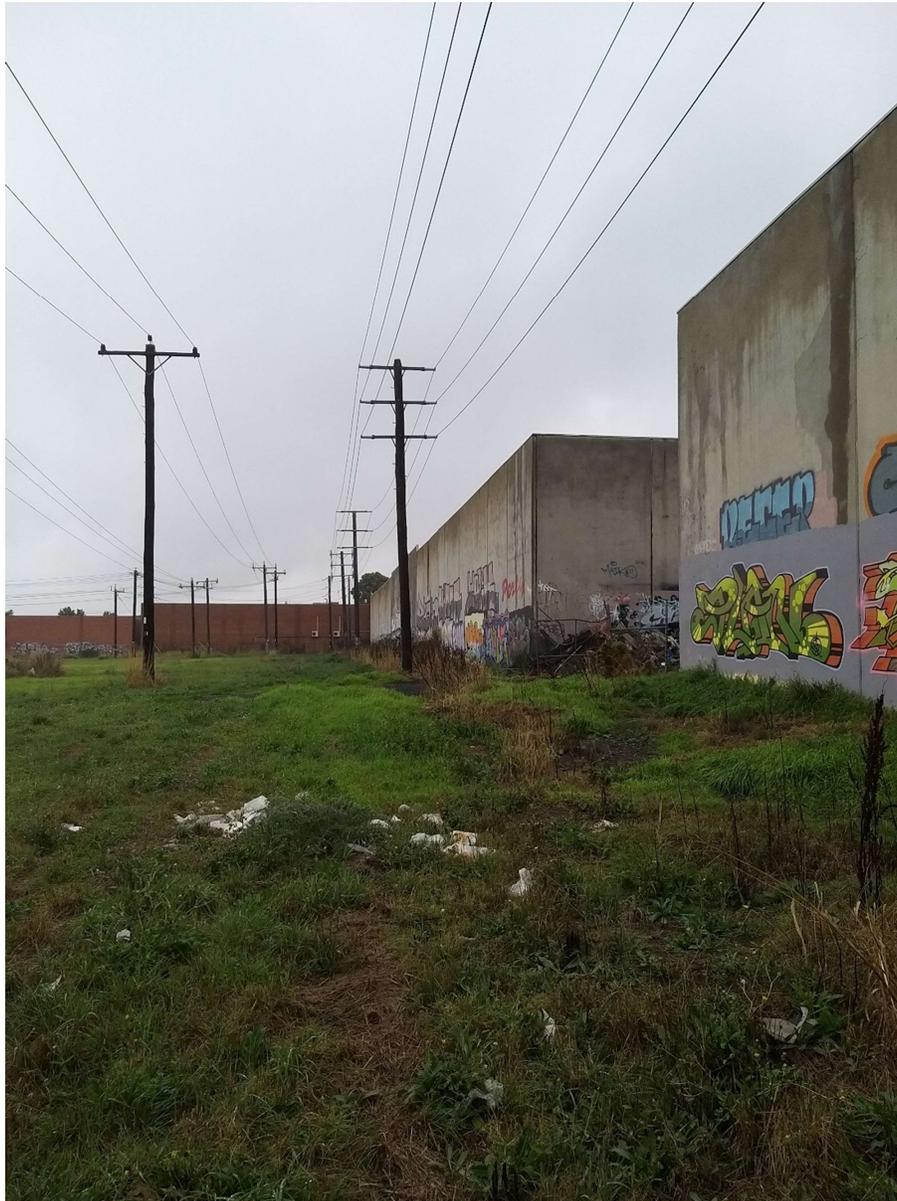
The buildings to the North are constructed to the boundary line and have a concrete panel wall on the boundary.

Figure 10 Building to the north of the property boundary. Note access driveway located between the buildings.

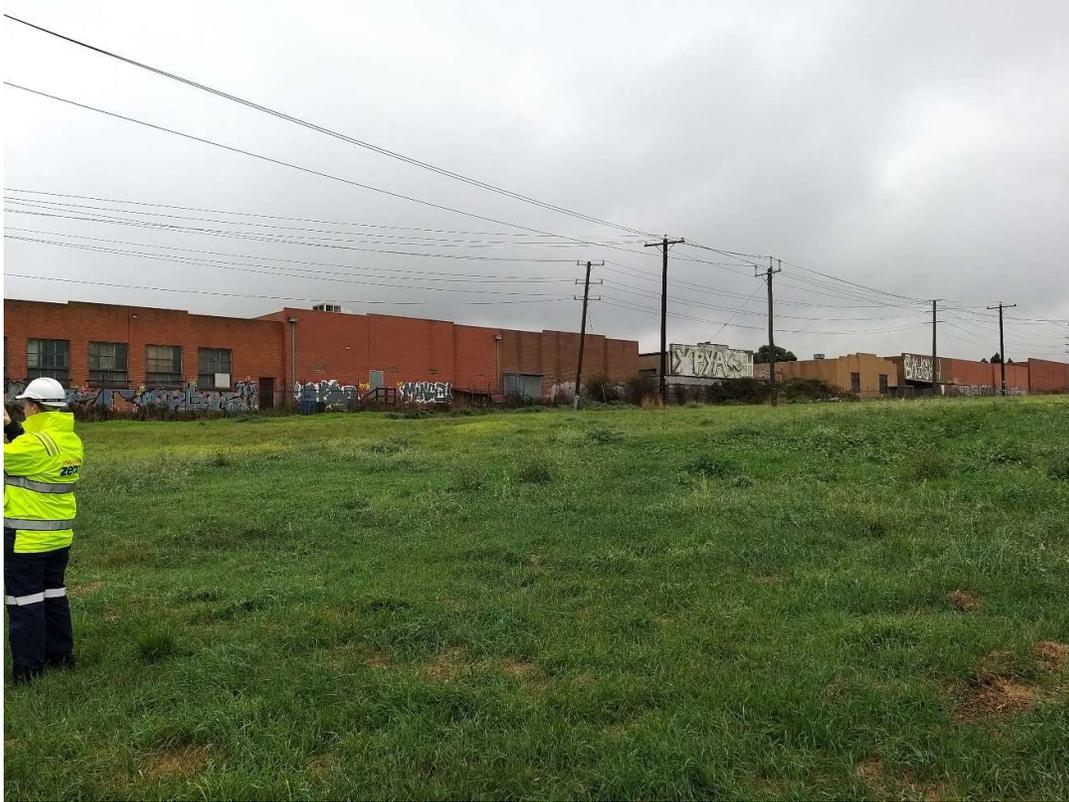
The buildings to the west are constructed from masonry and are generally located 3m off the property boundary although some veranda and the like have been constructed up to the boundary. The buildings contain window openings to the East elevations i.e., facing the subject property.

Figure 11 Properties to the West

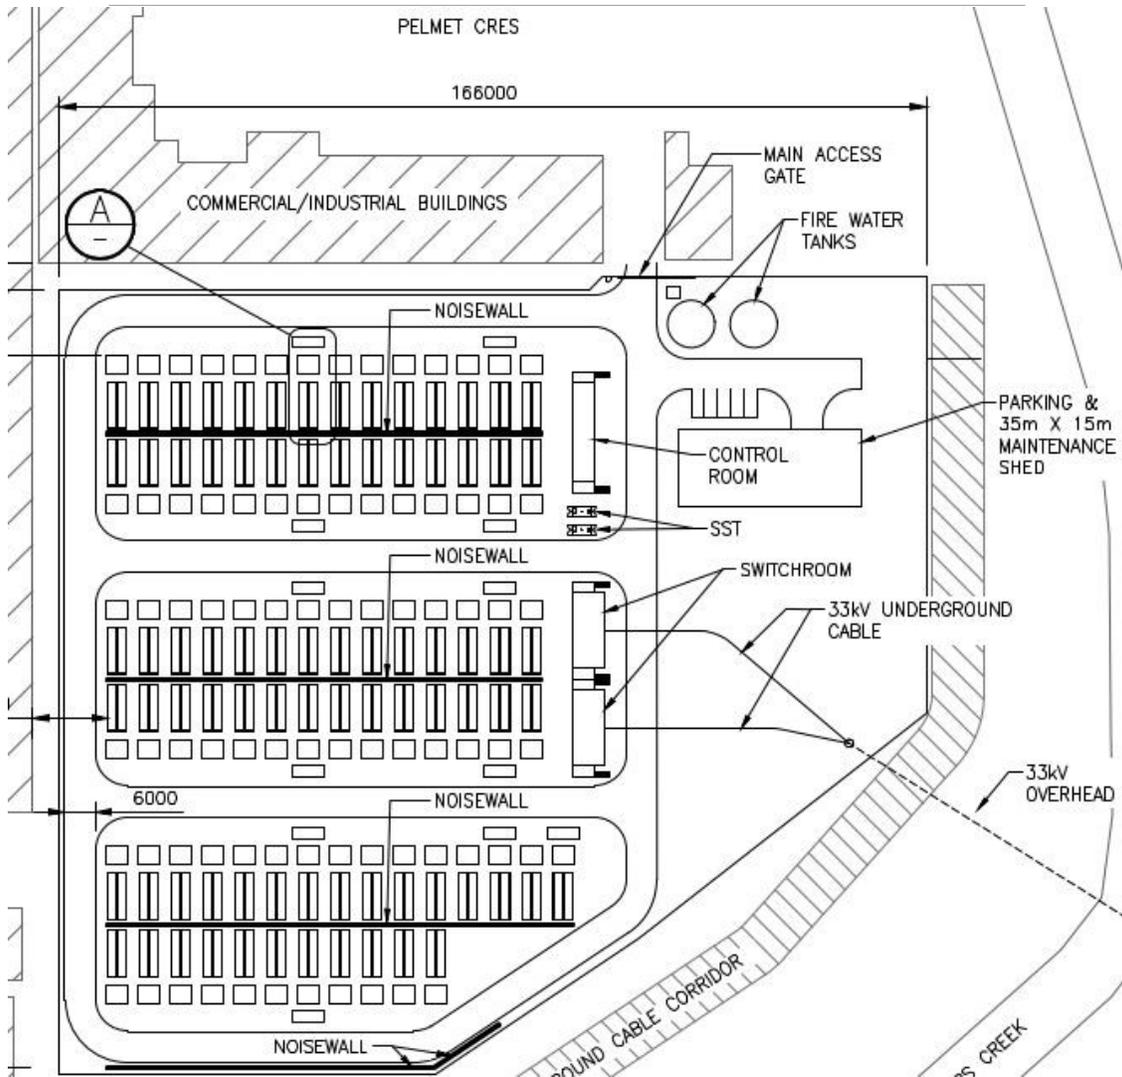
Figure 13 Location of the battery Units to the fire booster and tanks

The presence of the fire rated noise wall means the fire tanks and hardstand means they are protected from the main area of the facility and the level of exposure is significantly reduced.

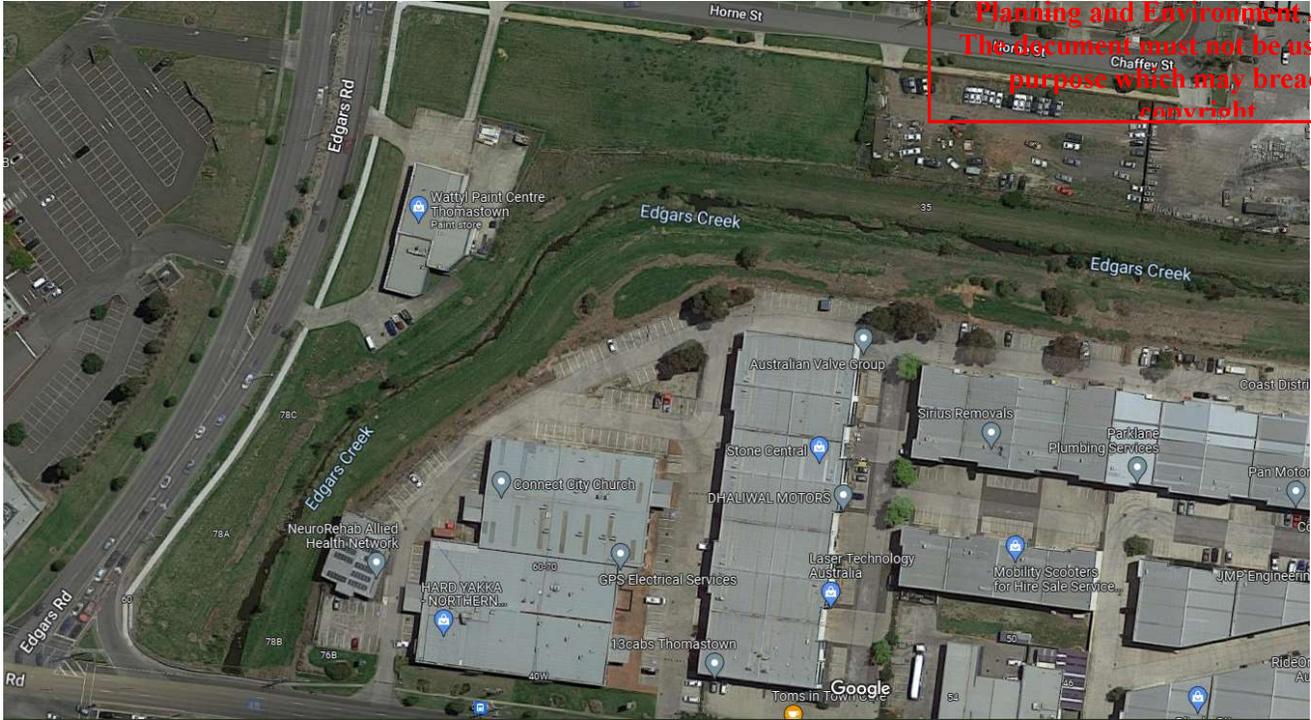
Figure 14 Southwest end of Edgars creek

This track is between an earth berm that is approximately 1.5m high to the north along the adjacent property boundary and a 2m drop to the creek to the south. The track is within the inundation overlay of the creek. The entrance from Edgars Road and the rear of the Watty Paint Centre carpark is approximately 350m from the southwest corner of the site.

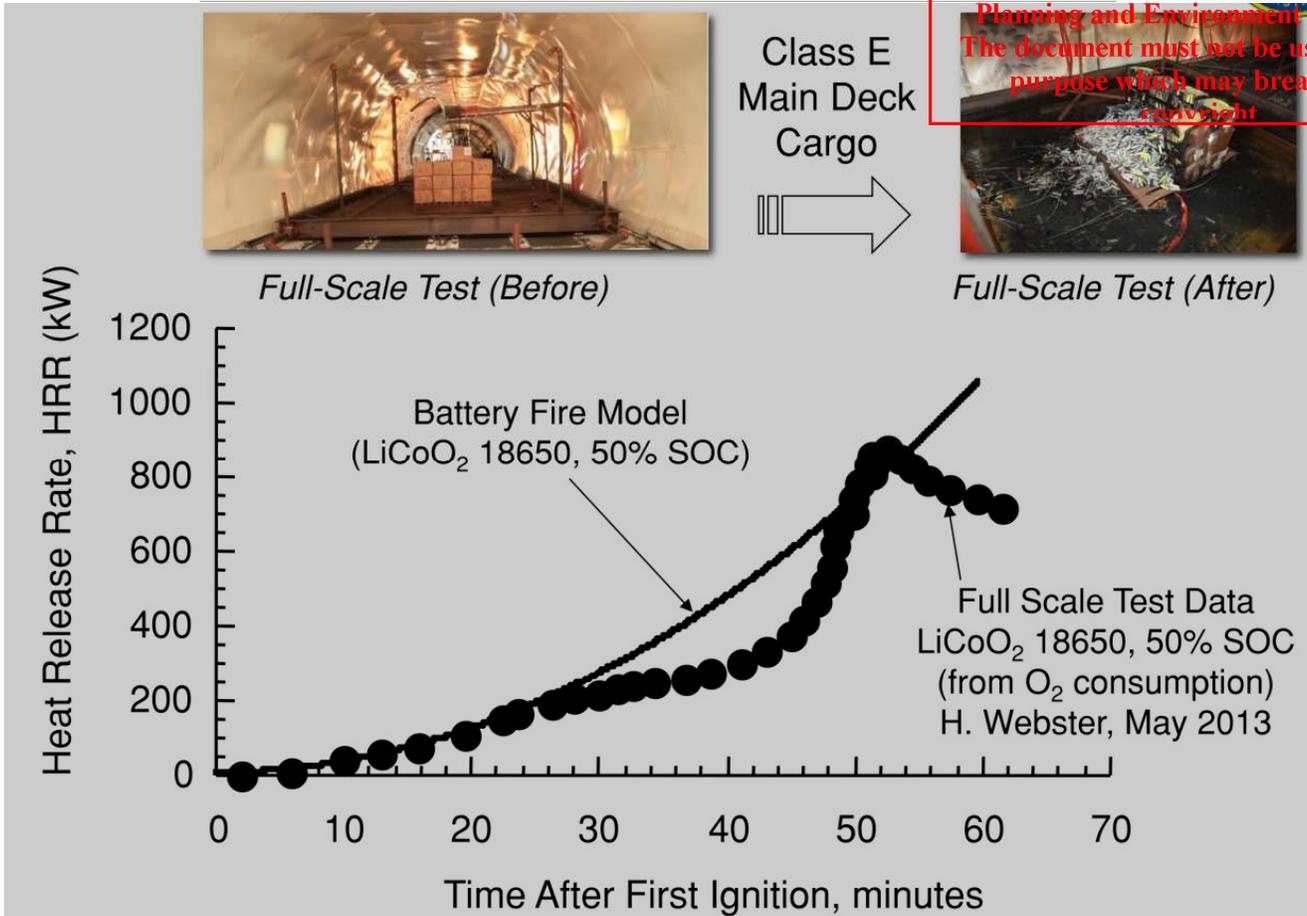
Figure 16 Results of full-scale tests on 18650 batteries

The peak heat release rate is approximately 1MW.

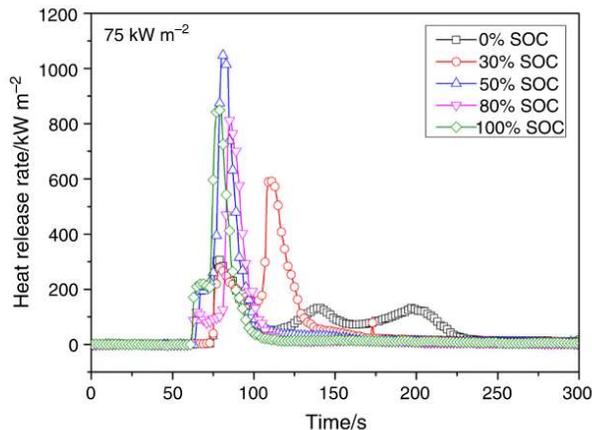
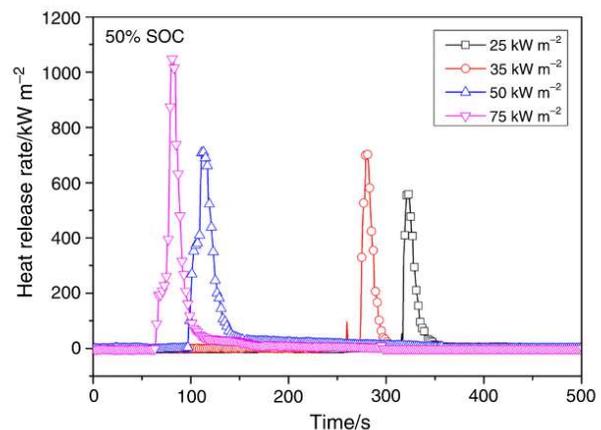
Figure 17 Tested heat release rates for Lithium-ion batteries

It was reported in “Fire behaviour of lithium-ion battery with different states of charge induced by high incident heat fluxes”, by Zhi Wang that the peak heat release rate of a battery unit is approximately 700kW/m² to 1050kW/m² and an average of approximately 150 – 200kW/m².

Note these are individual small batteries and not part of a BESS unit and the area is the surface area of the batteries. Based on the size of the units in the VBB fire as reported by the ESV investigation 7.5m x 1.6m x 2.5m) and assuming the front and the top of the unit (are burning based on the location of the ventilation the heat release rate is predicted to be 4.5MW to 6MW.

Fig. 7 Heat release rate of batteries at different SOC's under an incident heat flux of 75 kW m⁻²

Fig. 8 Heat release rate of batteries with 50% SOC under different incident heat fluxes

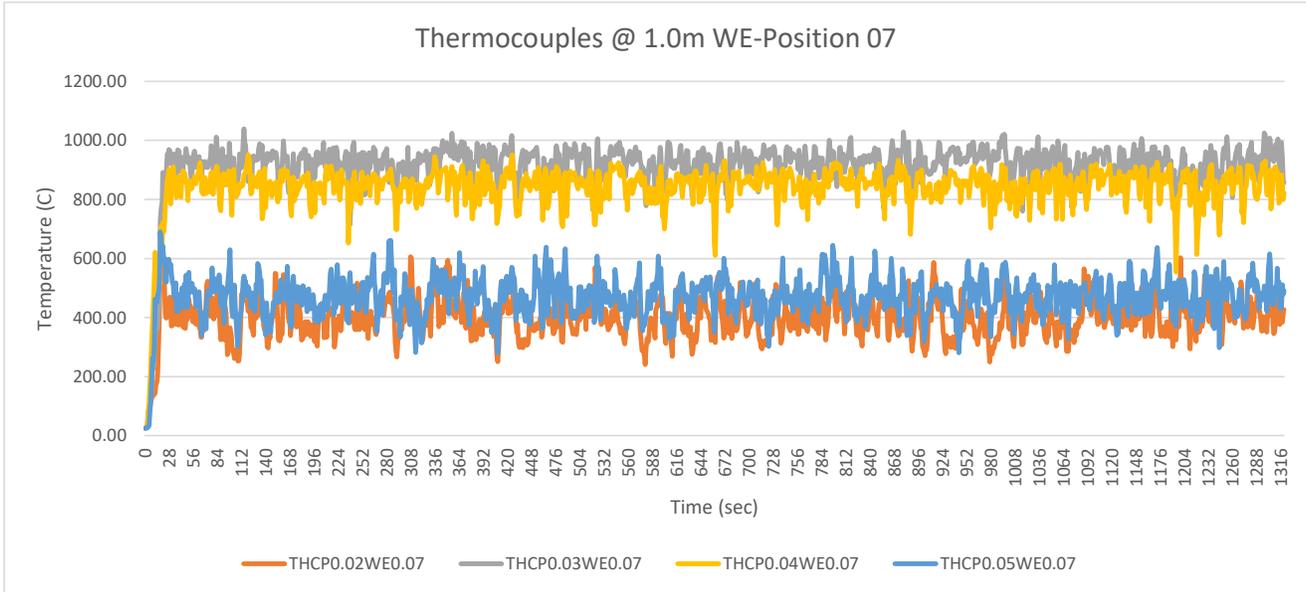
Figure 23 Temperatures with south wind, i.e., along the unit

Temperature peaks above 550°C are reached between 1.0m and 4.0m high to the west side of the model within 1.0m from the unit.

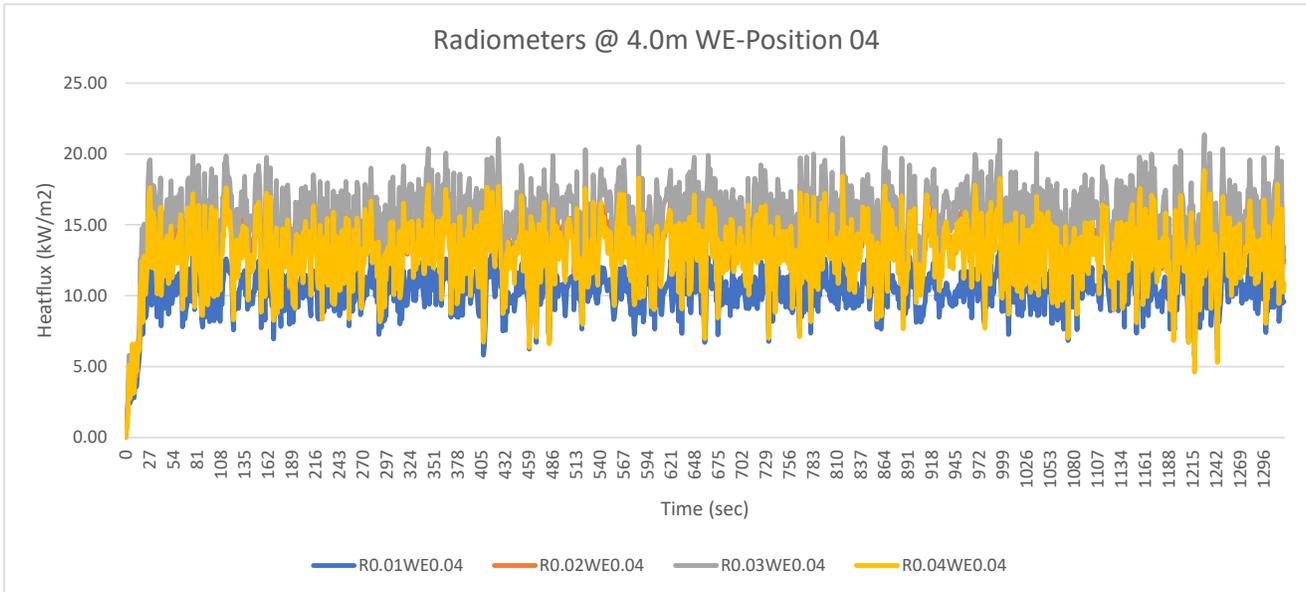
Figure 24 Radiation with south wind, i.e., along the unit

Heat flux above 12.5 kW/m² are reached within 4m from the unit, between 0m and 4m high to the west side. After 3m high or at greater distances the heat flux decreases significantly.

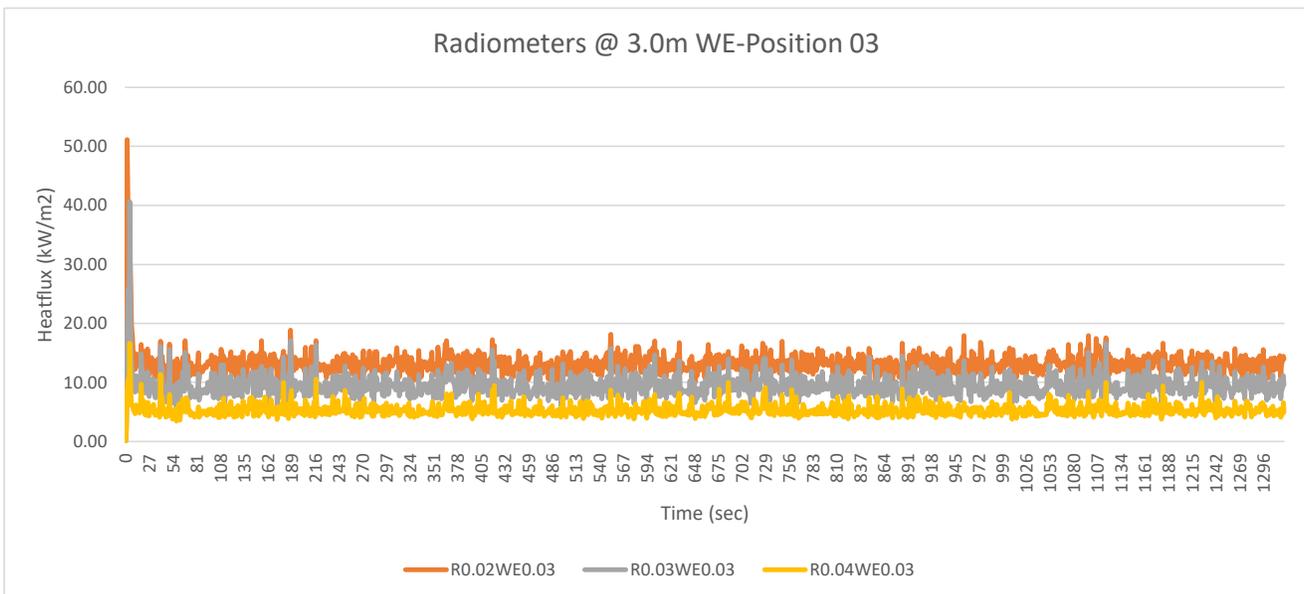
Figure 26 Heat flux

Heat flux above 12.5 kW/m² are reached within 3m from the unit, between 0m and 2m high to the west side. After 2m high the heat flux decreases.

It is expected the same result on the opposite side if the wind flows in the opposite direction.

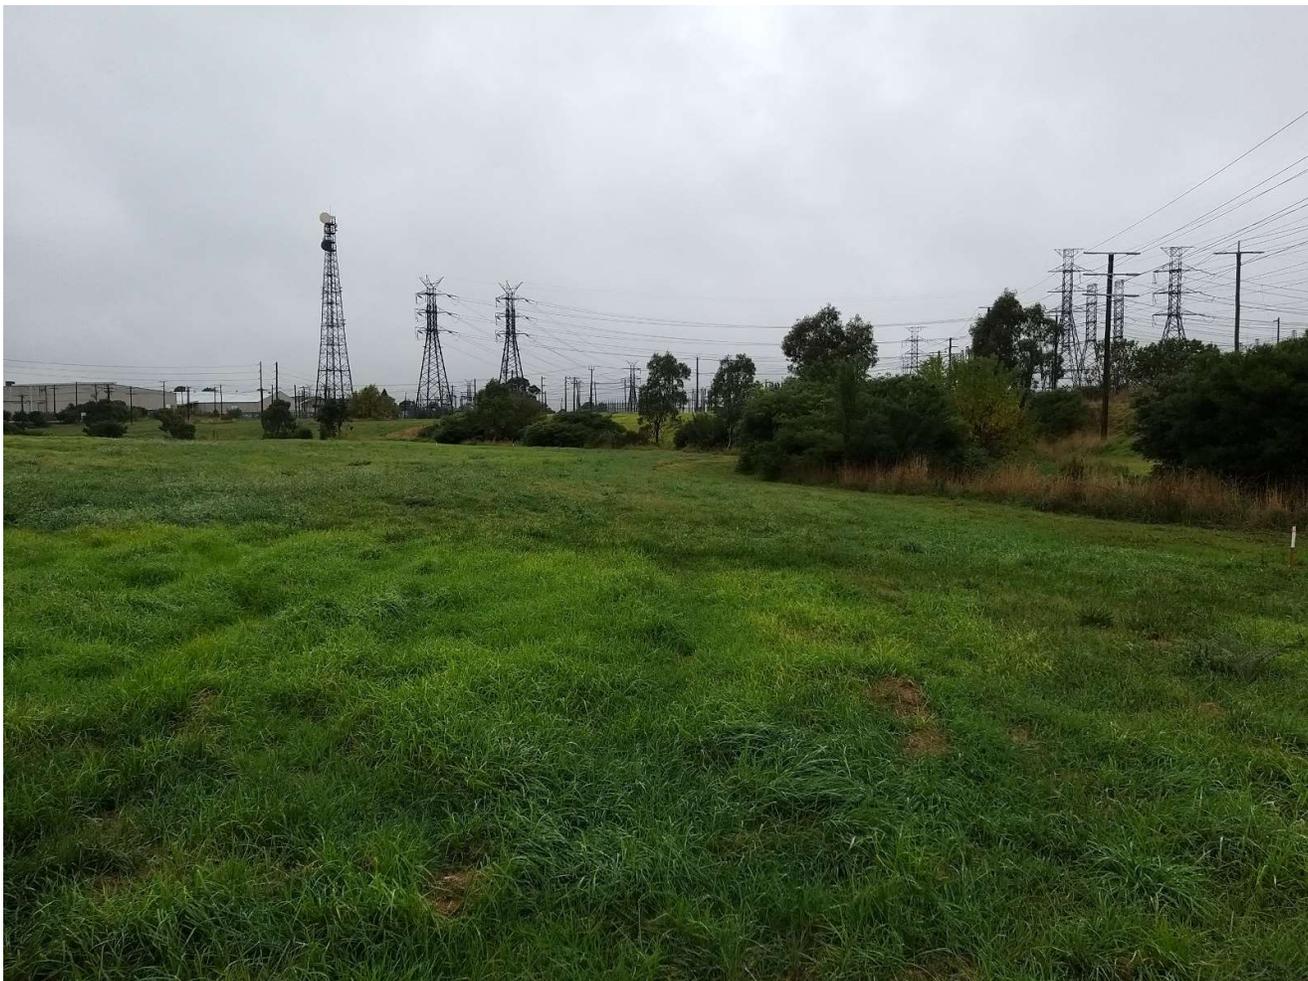
Figure 27 Minor vegetation along the creek

These areas are separated by the access road and security fence such that if a fire did occur it is unlikely to actually reach the battery units.

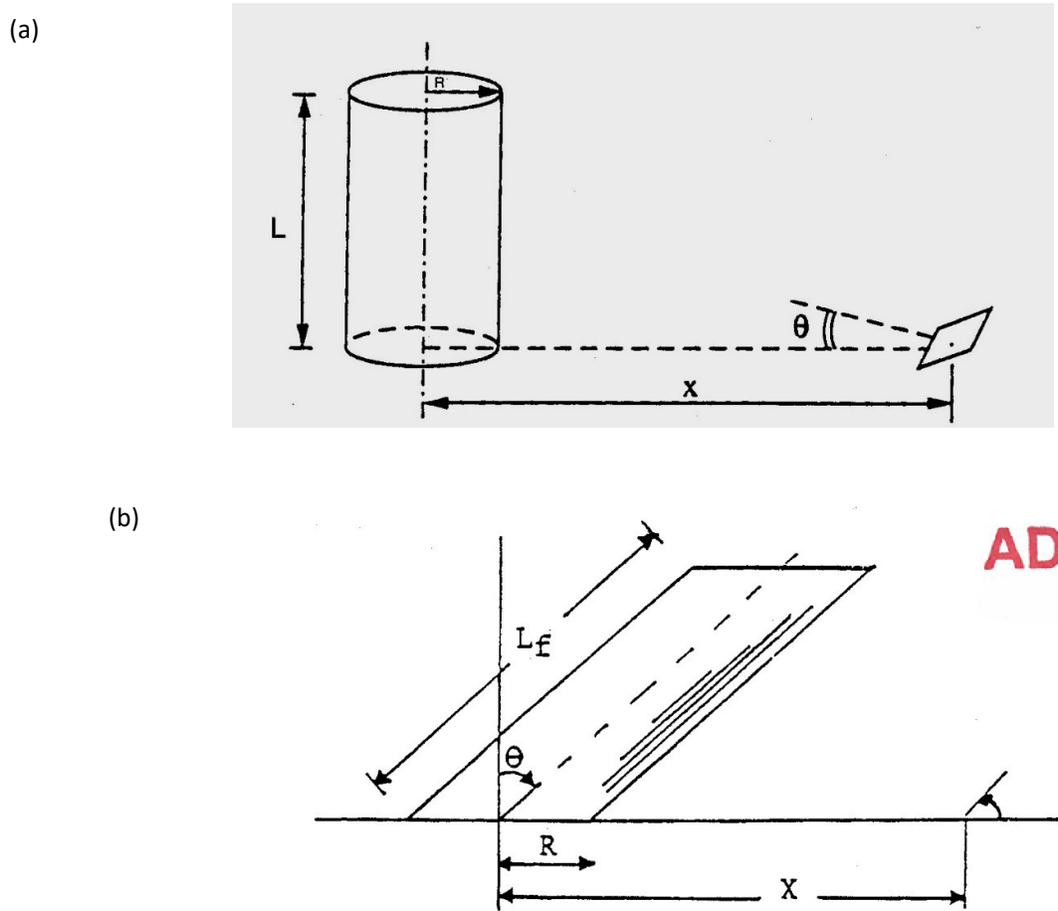
Figure 29: (a) Target and flame geometry of vertical cylindrical radiator. (b) Target and flame geometry of tilted cylindrical radiator

For the former conditions, the geometry of the pool fire is best approximated as an upright cylinder while for the latter conditions, a tilted cylinder geometry is best (Figure 29).

Thus, two flame height correlations were used in order to calculate the flame height at still conditions and at windy conditions.

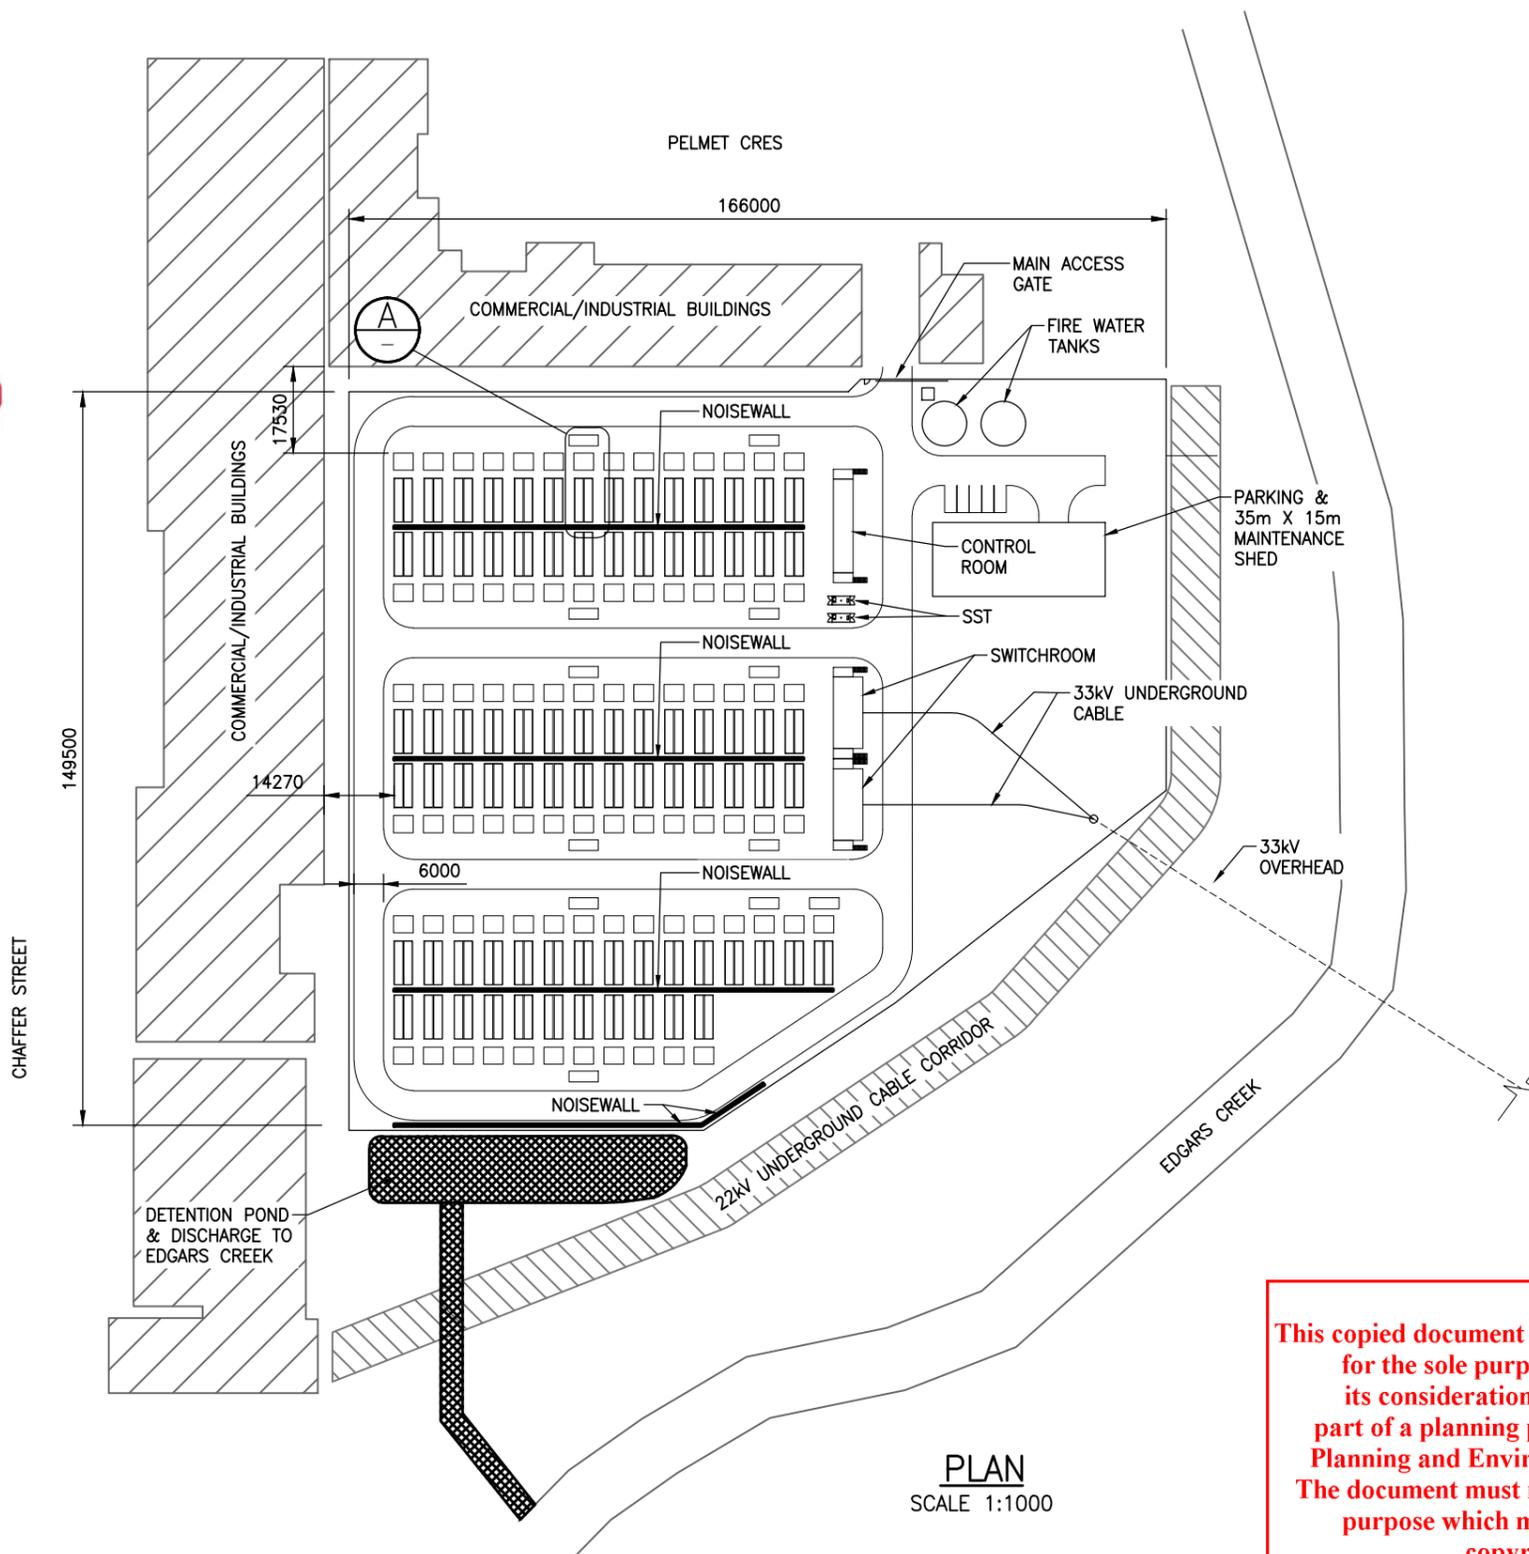
PLAN
SCALE 1:1000

REFERENCE DRAWINGS									THOMASTOWN BESS GENERAL ARRANGEMENT OVERALL		
	DRAWING TITLE	DRAWING No.	DATE	REV	DESCRIPTION	BY	CONTRACTOR		ISSUED	Spec No.	Order No.
								ENDORSED DATE	Contractors No.		
								ENDORSED			
								WCS			
								JACOBS			
								REV 0.3			
											TTBESS-P01-001 0.3

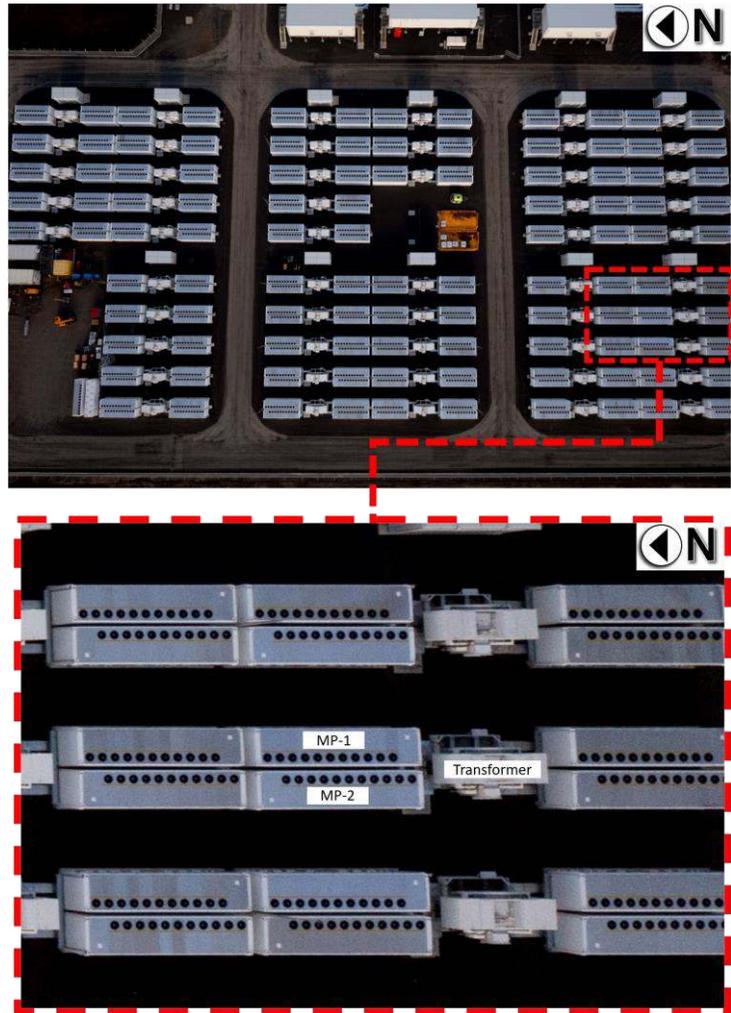
Figure 1 VBB Megapack layout (top) and area of fire origin (bottom)

The VBB fire investigation process involved analyzing not only the root cause of the initial fire in MP-1 but also the root cause of the fire propagation into MP-2. The Megapack has been designed to be installed in close proximity to each other without fire propagating to adjacent units. The design objective of the Megapack in terms of limiting fire propagation was mainly reliant on the thermal insulation of the Megapack’s exterior vertical steel panels and the sheer mass of the battery modules acting as a heat sink (i.e., they are difficult to heat up). With this thermal insulation, the Megapack spacing can be as close as 15 cm (6 in) to the sides and back of each unit with 2.4 m (8 ft) aisles in front of each Megapack, as shown in Figure 1. This product spacing has been validated in UL9540A unit level tests.⁸ Similar to the fire origin and cause investigation, the on-site inspections were supported simultaneously with an analysis of telemetry data (such as internal temperatures) from MP-2 and fire testing. The on-site investigation findings, the telemetry data analysis and fire tests, when combined, identified a scenario where Megapack to Megapack fire propagation can occur.

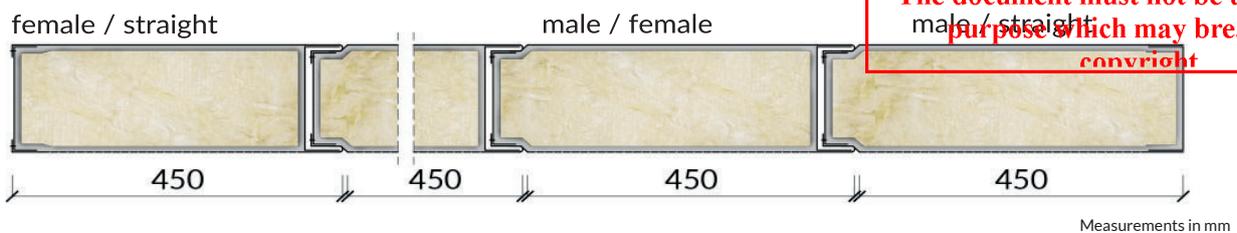
The Sonic System Acoustic Modular Panel has different types of joints: the traditional male/female and the two female/straight and male/straight joints. For specific projects, Flexshield can produce panels with customised dimensions to prevent subsequent cuts and adjustments.
