# Fire Safety Study (FSS)

Project Name:	Murchs Corner BESS – Stony Point, 2977 Hamilton Highway, Darlington VIC 3271
Job Number:	9708
Date:	11 December 2025
Client:	Ebare Pty Ltd. ATF Stony Point Trust
Revision	02

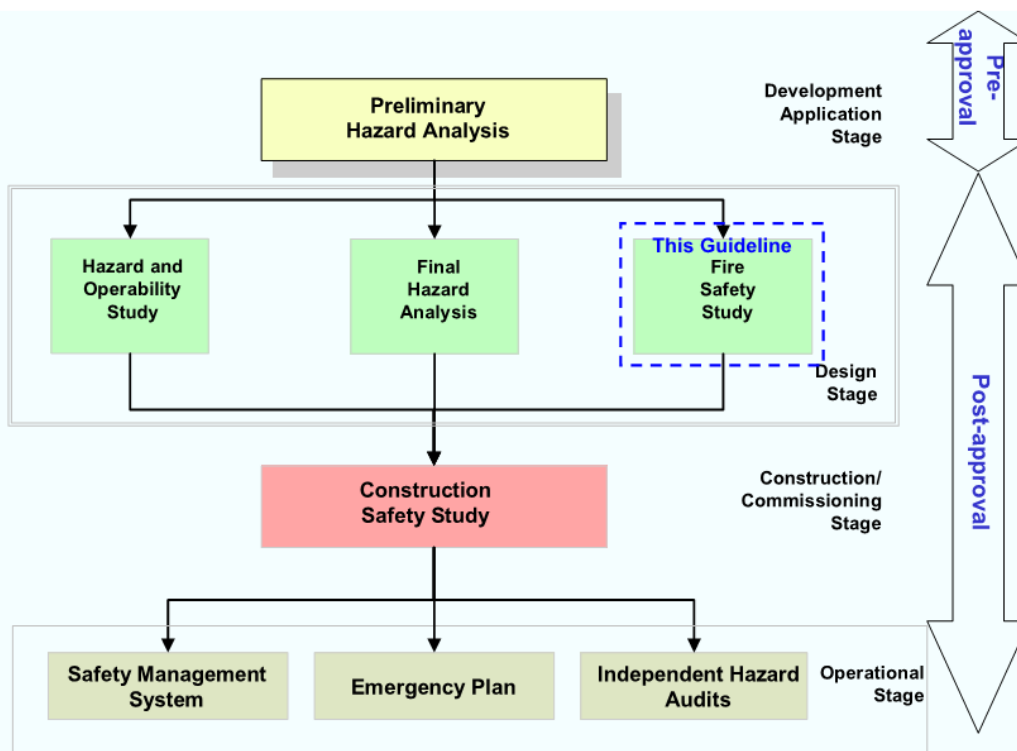
**Figure 2: The Hazards-Related Assessment Process**

The process is shown diagrammatically in Figure 2.

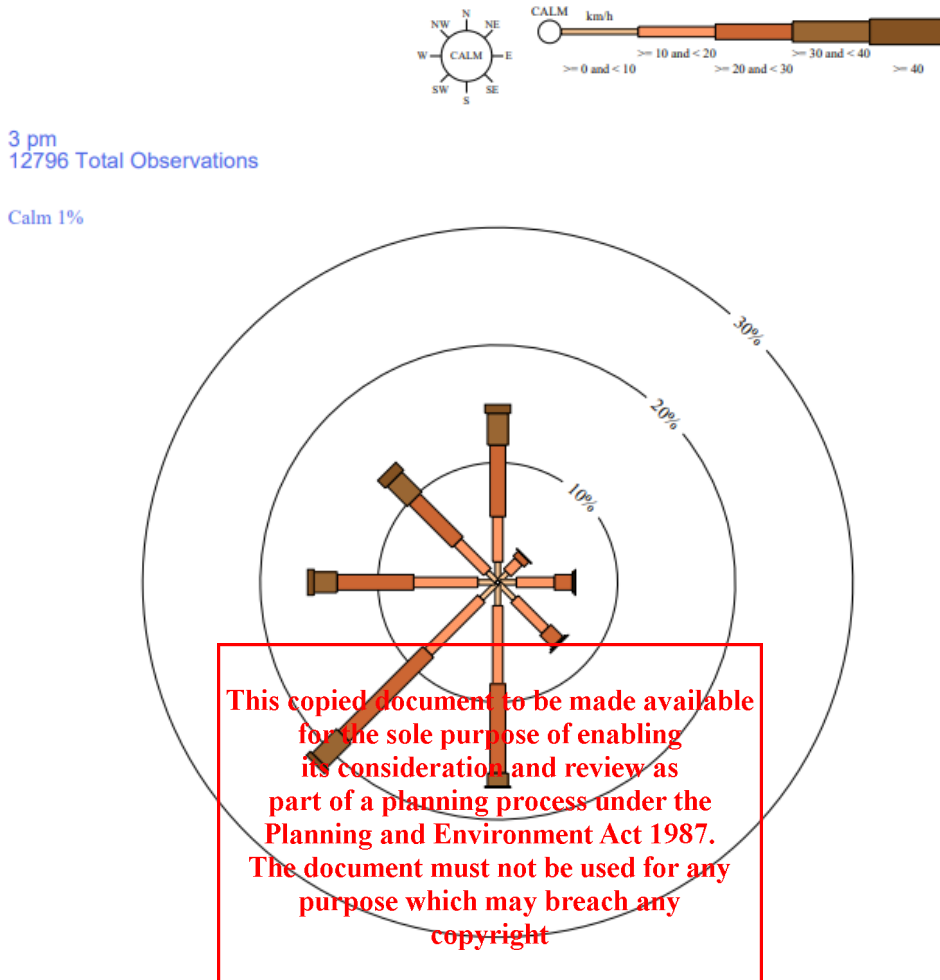
Figure 9 – Wind Rose from Mortlake Racecourse Station.

The closest weather station to Murch's Corner BESS development is at the Mortlake Racecourse. In accordance with the available data at the Bureau of Meteorology, the average weather conditions are the following (Figure 8 Figure 9) [10]:

- The average temperature is 19.4°C and the highest temperature can reach up to 26.3°C in January.
- The mean relative humidity is 83% in the morning, and 45% in the afternoon.
- Wind statistics (Figure 9):
  - Wind is calm 1% of the time.
  - The strongest wind comes from the south-east with a speed of more than 40 km/hr (11.1m/s), approximately 0.5% of the time.
  - Maximum average speed of the wind is 22.0km/hr (6.1m/s).

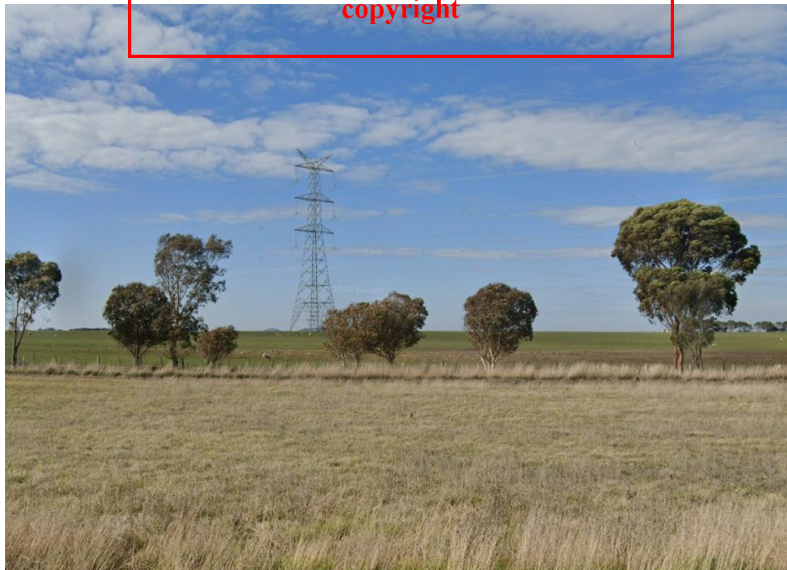
Figure 17 – Dominant vegetation at the Murch's Corner BESS site (Google Maps).

Although the subject site is located within a bushfire prone area, the figure below shows that the predominant vegetation is grassland and isolated trees, therefore a further assessment is not required in accordance with the AS3959-2018.

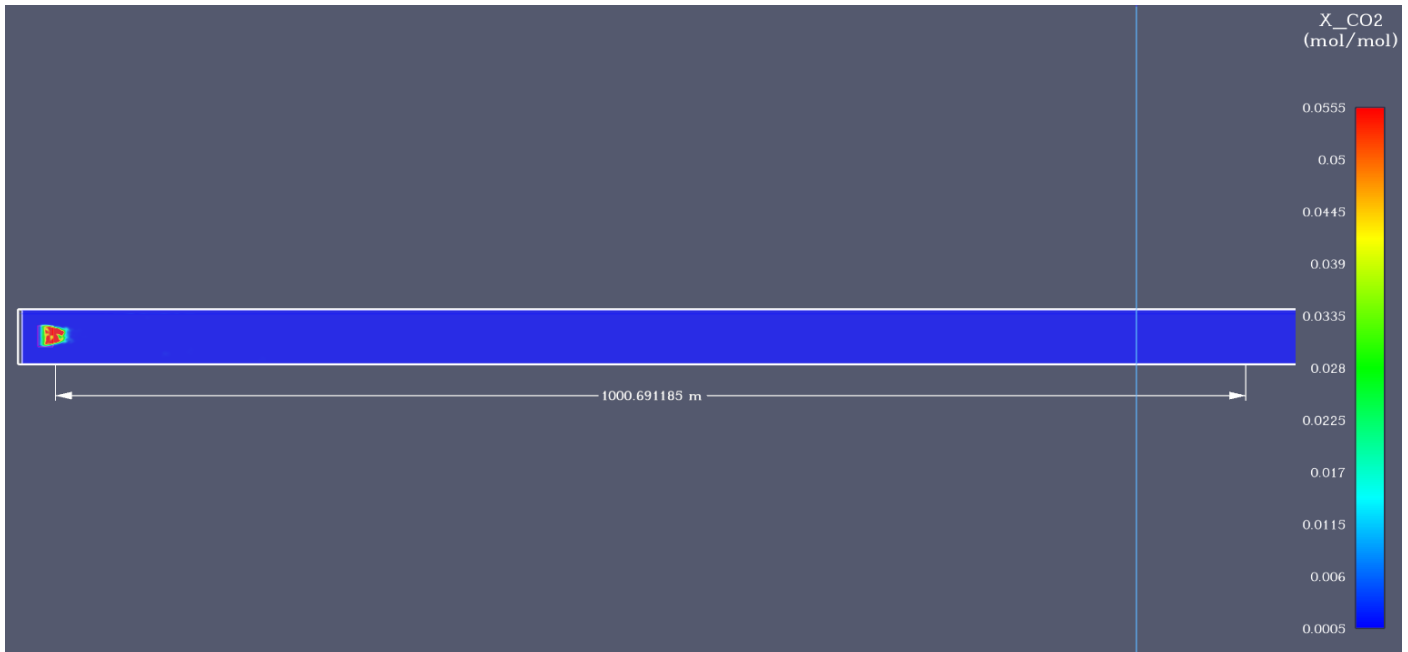
**Figure 19 – CO<sub>2</sub> Concentrations at residential communities.**

Assuming a fire of an average transformer that uses mineral oil with a capacity of 60,000 litres (60.0 m<sup>3</sup>), with a bund of 19m x 13m, the figures below demonstrate that concentration of pollutants to more than 1.0km away from the subject site are not expected to surpass the human thresholds.

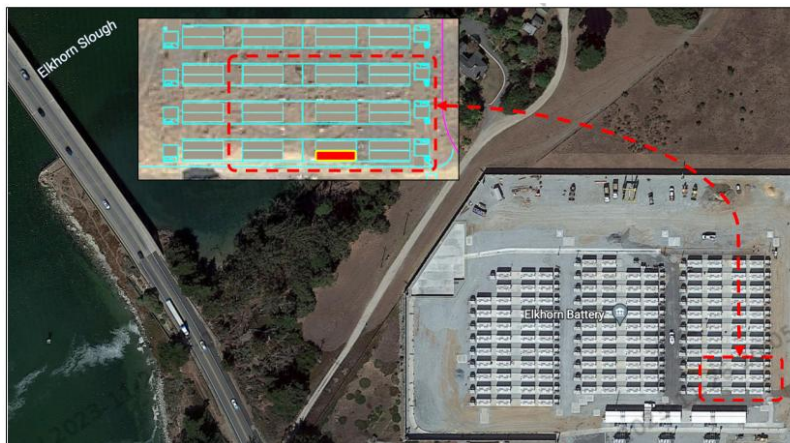
**Figure 28: Overview of Elkhorn BESS and Megapack on fire.**

In September 2022, a fire occurred to a single Megapack as shown in the picture below (Figure 28). In summary, "The fire proceeded in accordance with its design and consumed itself. It burned as a flaming fire for about 6 hours, and then generated visible smoke and off-gas for another 12 hours. As per the instructions in Tesla's Lithium-Ion Battery Emergency Response Guide (ERG), which were incorporated into the PG&E Pre-Fire Plan, the Megapack was allowed to burn and consume itself while being monitored by first responders at a safe distance".

The above demonstrated that where a Megapack is on fire, fire is not expected to spread to adjacent Megapacks or adjoining structures, and fire will be limited to the affected Megapack.
