**OLDMEADOW
ARBORICULTURE**

Arboricultural Impact Report

Oldmeadow Arboriculture has been engaged to undertake an objective assessment of any trees within the vicinity of the proposed construction of a 2-story dwelling located at 130 Great Alpine Road, Hotham Heights, Vic 3741.

The proposal involves the addition of a basement garage to the existing dwelling as well as other renovations including a deck to the north.

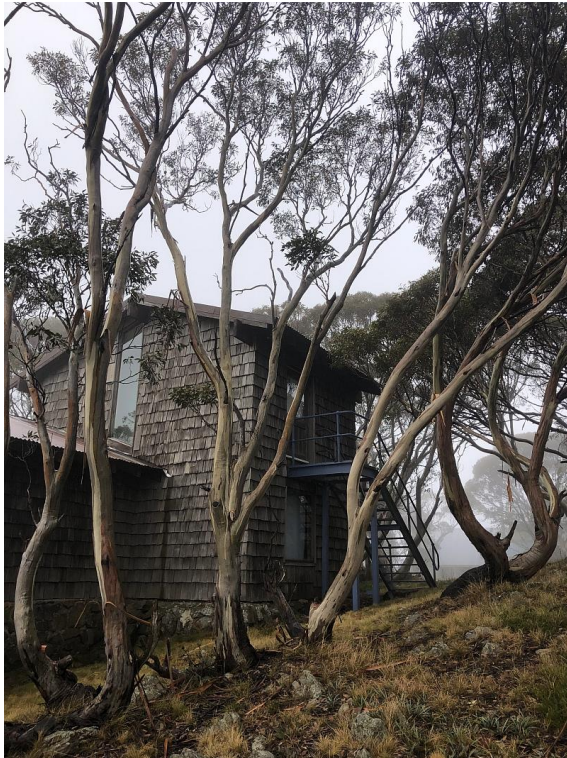
Plate 1 Photo is looking toward the north west corner of the existing building

The 1307sqm property supports an existing 2 story dwelling with stone foundations and shingle walls. The property is surrounded on 3 sides by indigenous *Eucalyptus pauciflora*, snow gums.

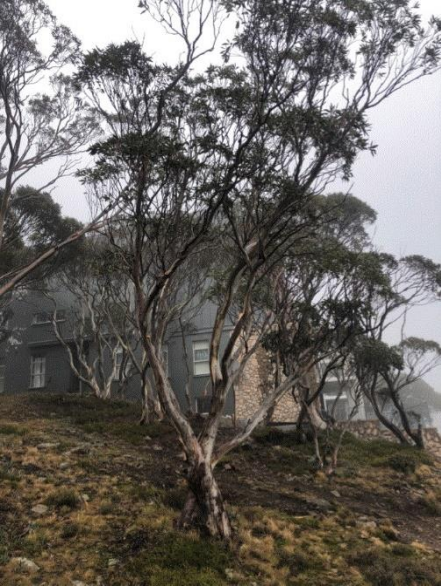
TREE #	1

NUM OF TREES	1	
SPECIES	<i>Eucalyptus pauciflora</i>	
COMMON NAME	Snow Gum	
DBH (CM)	33	
TPZ (M)	4	
HEIGHT (M)	5	
SPREAD (M)	6	
STRUCTURE	Good	
HEALTH	Good	
AGE	Mature	
AMENITY VALUE	Medium	
ULE (YRS)	>40	
NOTES	4m to existing decking	
IMPACT	Moderate ~24% encroachment from proposed driveway upgrade and underground basement excavation. Prune any exposed roots during excavation to Australian standard 4373.	
RECOMMENDATIONS	Install new driveway on grade. Erect TPZ fencing surrounding the TPZ to protect from development related impacts.	
TREE #	2

Tree 1 - Install new driveway on grade. Erect TPZ fencing surrounding the TPZ to protect from development related impacts

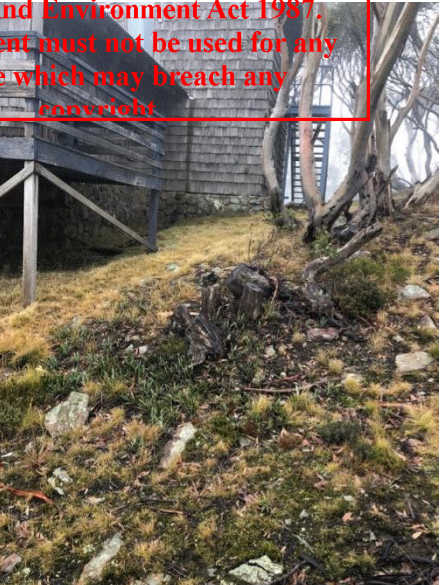
NUM OF TREES		
SPECIES	<i>Eucalyptus pauciflora</i>	
COMMON NAME	Snow Gum	
DBH (CM)		
TPZ (M)	2	
HEIGHT (M)	0	
SPREAD (M)	0	
STRUCTURE	N/A	
HEALTH	N/A	
AGE	N/A	
AMENITY VALUE	Nil	
ULE (YRS)	0	
NOTES	Stump	
IMPACT	High. Proposed to be removed	
RECOMMENDATIONS	Remove stump to ground level or grind out carefully to prevent damage to adjacent tree roots.

Tree 2, 10 - Remove tree/stump fully to prevent damage to adjacent tree roots.

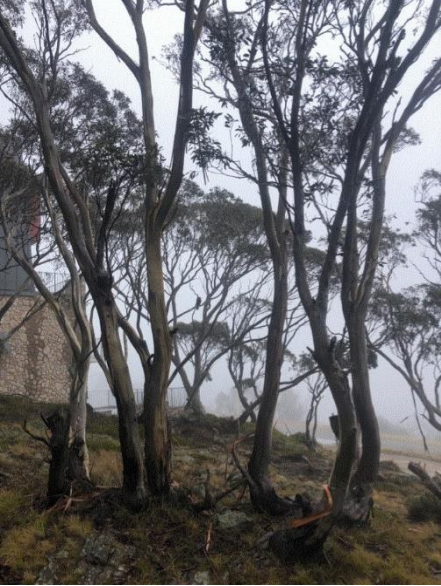
TREE #	3

NUM OF TREES	3	
SPECIES	<i>Eucalyptus pauciflora</i>	
COMMON NAME	Snow Gum	
DBH (CM)	25	
TPZ (M)	3	
HEIGHT (M)	6	
SPREAD (M)	4	
STRUCTURE	Good	
HEALTH	Good	
AGE	Mature	
AMENITY VALUE	Medium	
ULE (YRS)	>40	
NOTES	Average DBH of tree group. Several trees with multiple stems.	
IMPACT	Moderate ~15% encroachment from basement excavation. The trees will likely tolerate this degree of incursion; however, they may have some minor adverse impacts.	
RECOMMENDATIONS	Erect TPZ fencing surrounding the TPZ to protect from development related impacts. Prune any exposed roots during excavation to Australian standard 4373.

Tree 3-4 - Erect TPZ fencing surrounding the TPZ to protect from development related impacts. Prune any exposed roots during excavation to Australian standard 4373.

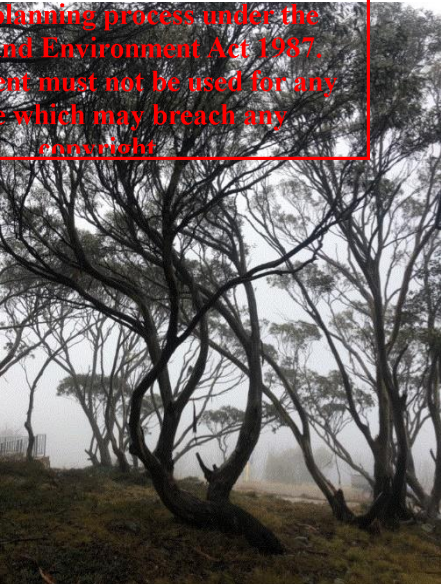
TREE #	4

NUM OF TREES	1	
SPECIES	<i>Eucalyptus pauciflora</i>	
COMMON NAME	Snow Gum	
DBH (CM)	35	
TPZ (M)	4.2	
HEIGHT (M)	6	
SPREAD (M)	5	
STRUCTURE	Good	
HEALTH	Good	
AGE	Mature	
AMENITY VALUE	Medium	
ULE (YRS)	>40	
NOTES	Single tree with leaning form.	
IMPACT	Moderate ~16% encroachment from basement excavation. This tree will likely tolerate this degree of incursion; however, it may have some minor adverse impacts.	
RECOMMENDATIONS	Erect TPZ fencing surrounding the TPZ to protect from development related impacts. Prune any exposed roots during excavation to Australian standard 4373.

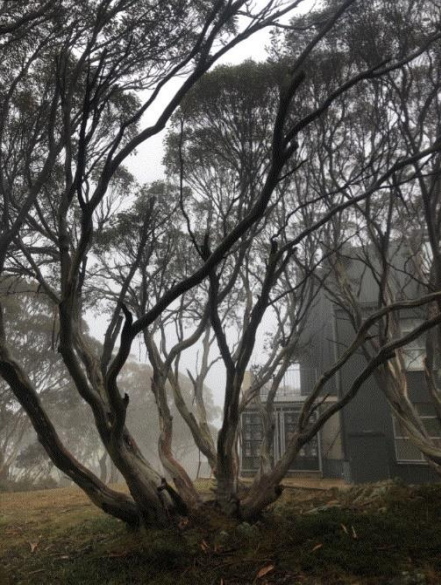
TREE #	5

NUM OF TREES	1	
SPECIES	<i>Eucalyptus pauciflora</i>	
COMMON NAME	Snow Gum	
DBH (CM)	49	
TPZ (M)	5.9	
HEIGHT (M)	6	
SPREAD (M)	9	
STRUCTURE	Good	
HEALTH	Good	
AGE	Mature	
AMENITY VALUE	Medium	
ULE (YRS)	>40	
NOTES	DBH estimated from multiple stem calculation.	
IMPACT	Low – All works should be outside of the TPZ. May be impacted by construction related activities.	
RECOMMENDATIONS	Erect TPZ fencing surrounding the TPZ to protect from development related impacts.

Tree 5-8, 11 - Erect TPZ fencing surrounding the TPZ to protect from development related impacts. Prune any exposed roots during excavation to Australian standard 4373.

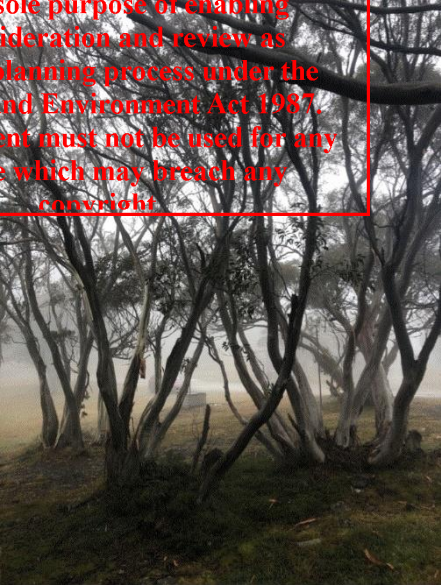
TREE #	6

NUM OF TREES	3	
SPECIES	<i>Eucalyptus pauciflora</i>	
COMMON NAME	Snow Gum	
DBH (CM)	49	
TPZ (M)	5.9	
HEIGHT (M)	6	
SPREAD (M)	9	
STRUCTURE	Good	
HEALTH	Good	
AGE	Mature	
AMENITY VALUE	Medium	
ULE (YRS)	>40	
NOTES	Average DBH of tree group estimated. 4m from existing dwelling.	
IMPACT	Low – No ground works are proposed within the TPZ of these trees. Could be impacted by construction related activities.	
RECOMMENDATIONS	Erect TPZ fencing surrounding the TPZ to protect from development related impacts

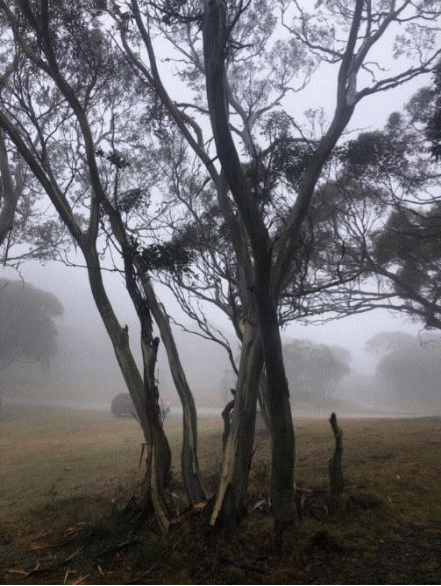
TREE #	7

NUM OF TREES	4	
SPECIES	<i>Eucalyptus pauciflora</i>	
COMMON NAME	Snow Gum	
DBH (CM)	45	
TPZ (M)	5.4	
HEIGHT (M)	6	
SPREAD (M)	4	
STRUCTURE	Good	
HEALTH	Good	
AGE	Mature	
AMENITY VALUE	Medium	
ULE (YRS)	>40	
NOTES	Average DBH of tree group estimated. 5m from existing dwelling	
IMPACT	Low – No ground works are proposed within the TPZ of these trees. Could be impacted by construction related activities.	
RECOMMENDATIONS	Erect TPZ fencing surrounding the TPZ to protect from development related impacts

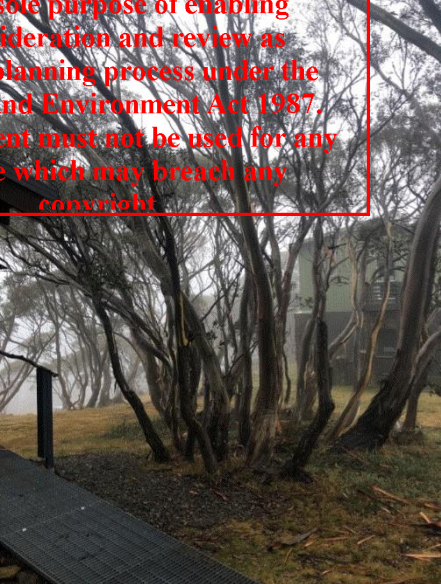
TREE #	8

NUM OF TREES	15	
SPECIES	<i>Eucalyptus pauciflora</i>	
COMMON NAME	Snow Gum	
DBH (CM)	22	
TPZ (M)	2.6	
HEIGHT (M)	6	
SPREAD (M)	4	
STRUCTURE	Good	
HEALTH	Good	
AGE	Mature	
AMENITY VALUE	Medium	
ULE (YRS)	>40	
NOTES	Average DBH of tree group estimated. 4m from existing dwelling. Large group of trees	
IMPACT	Low – No ground works are proposed within the TPZ of these trees. Could be impacted by construction related activities.	
RECOMMENDATIONS	Erect TPZ fencing surrounding the TPZ to protect from development related impacts

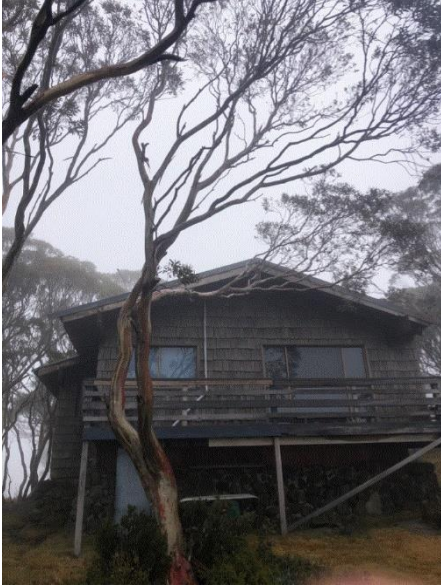
TREE #	9

NUM OF TREES		
SPECIES	<i>Eucalyptus pauciflora</i>	
COMMON NAME	Snow Gum	
DBH (CM)	37	
TPZ (M)	4.4	
HEIGHT (M)	5	
SPREAD (M)	5	
STRUCTURE	Good	
HEALTH	Fair	
AGE	Mature	
AMENITY VALUE	Medium	
ULE (YRS)	15 > 40	
NOTES	Thin canopy. 4m to existing dwelling.	
IMPACT	High ~39% encroachment from basement car park excavation and concrete slab excavation. Depth of excavation unknown. May be further impact by proposed deck depending on height, may require canopy pruning.	
RECOMMENDATIONS	Redesign plans to remove car space 3 to reduce impact. Or minimise excavation as far as practicable and undertaken in the presence of a qualified arborist. Prune any exposed roots during excavation to Australian Standard 4373.

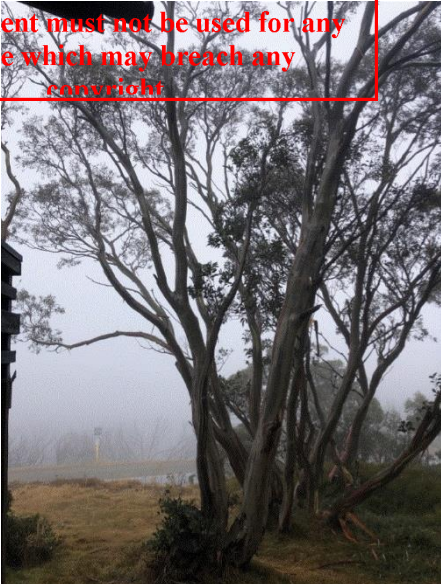
TREE #	10

NUM OF TREES		
SPECIES	<i>Eucalyptus pauciflora</i>	
COMMON NAME	Snow Gum	
DBH (CM)	35	
TPZ (M)	4.2	
HEIGHT (M)	6	
SPREAD (M)	7	
STRUCTURE	Good	
HEALTH	Good	
AGE	Mature	
AMENITY VALUE	Medium	
ULE (YRS)	>40	
NOTES	2 of 4 stems removed already.	
IMPACT	High. Proposed for removal	
RECOMMENDATIONS	Proposed for removal

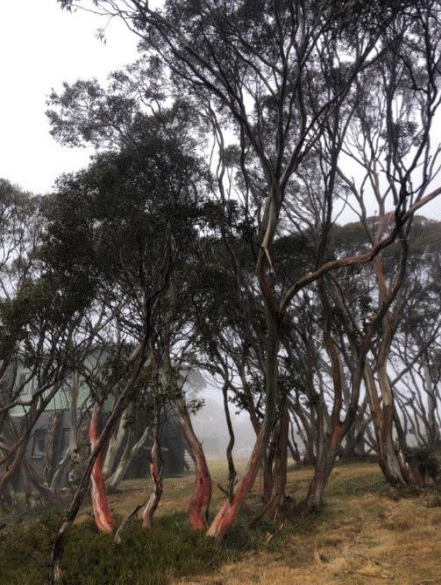
TREE #	11

NUM OF TREES	6	
SPECIES	<i>Eucalyptus pauciflora</i>	
COMMON NAME	Snow Gum	
DBH (CM)	21	
TPZ (M)	2.5	
HEIGHT (M)	6	
SPREAD (M)	3	
STRUCTURE	Good	
HEALTH	Good	
AGE	Mature	
AMENITY VALUE	Medium	
ULE (YRS)	>40	
NOTES	Average DBH of tree group thin canopy	
IMPACT	Moderate ~14% encroachment. Impact could be less than calculated if the stone wall is built on grade without excavation. These trees will likely tolerate this degree of encroachment with some minor adverse impacts possible.	
RECOMMENDATIONS	Erect TPZ fencing surrounding the TPZ to protect from development related impacts.

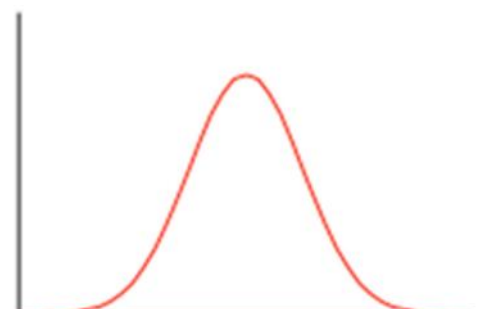
*Figure 1 Tree condition \ (Health & Structure)
Indicative normal distribution curve for tree condition*

Diagram 1, provides an indicative distribution curve for tree condition to illustrate that within a normal tree population the majority of specimens are centrally located within the condition range (normal distribution curve). Furthermore, that those individual trees with an assessed condition approaching the outer ends of the spectrum occur less often.

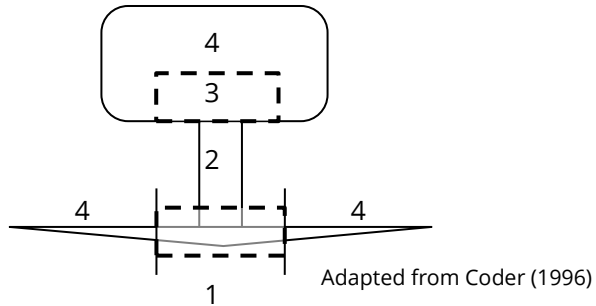
Diagram 2: Tree structure zones

1. Root plate & lower stem
2. Trunk
3. Primary branch support
4. Outer crown & roots

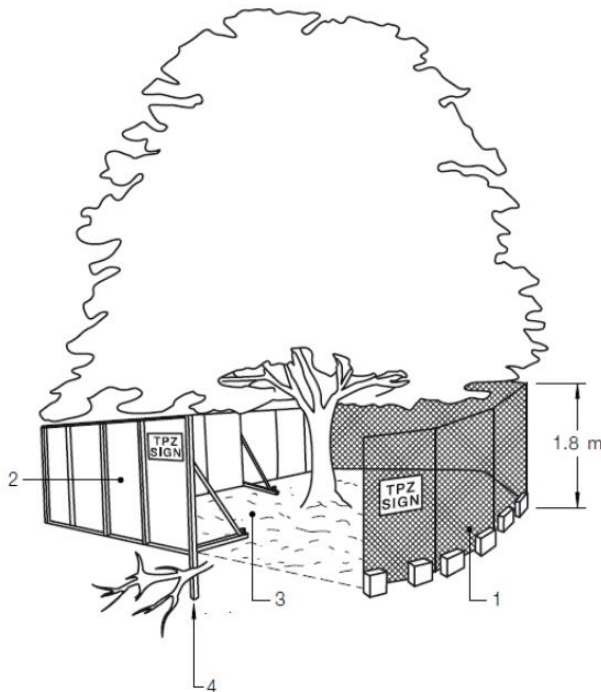
TREE PROTECTION ZONE SIGN EXAMPLE
(Informative)

TPZ sign provides clear and readily accessible information to indicate that a TPZ is established. Figure C1 provides an example of a suitable sign.

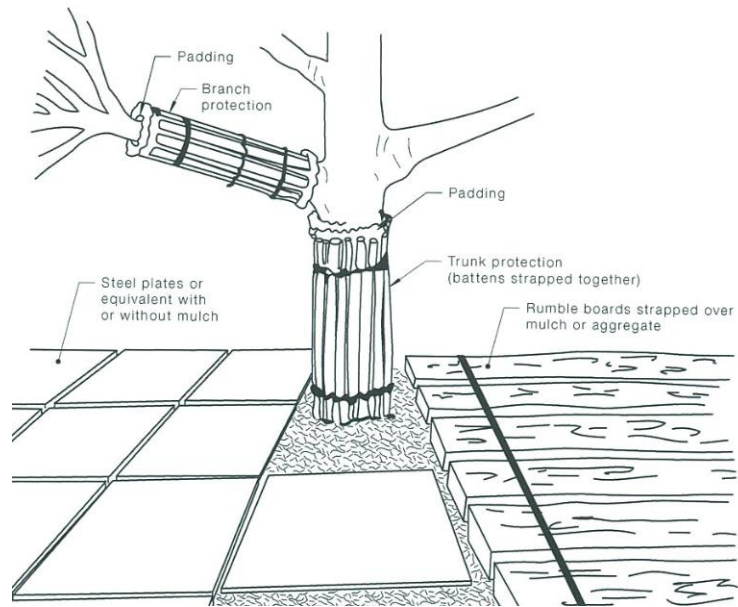
(Ground Protection)

If temporary access for machinery is required within the TPZ, ground protection measures will be required. The purpose of ground protection is to prevent root damage and soil compaction within the TPZ. Measures may include a permeable membrane such as geotextile fabric beneath a layer of mulch or crushed rock below rumble boards. These measures may also be applied to root zones beyond the TPZ (see image).
