Preliminary Geotechnical Assessment

Preliminary Geotechnical Assessments
130 Great Alpine Rd., Hotham Heights

23 March 2018

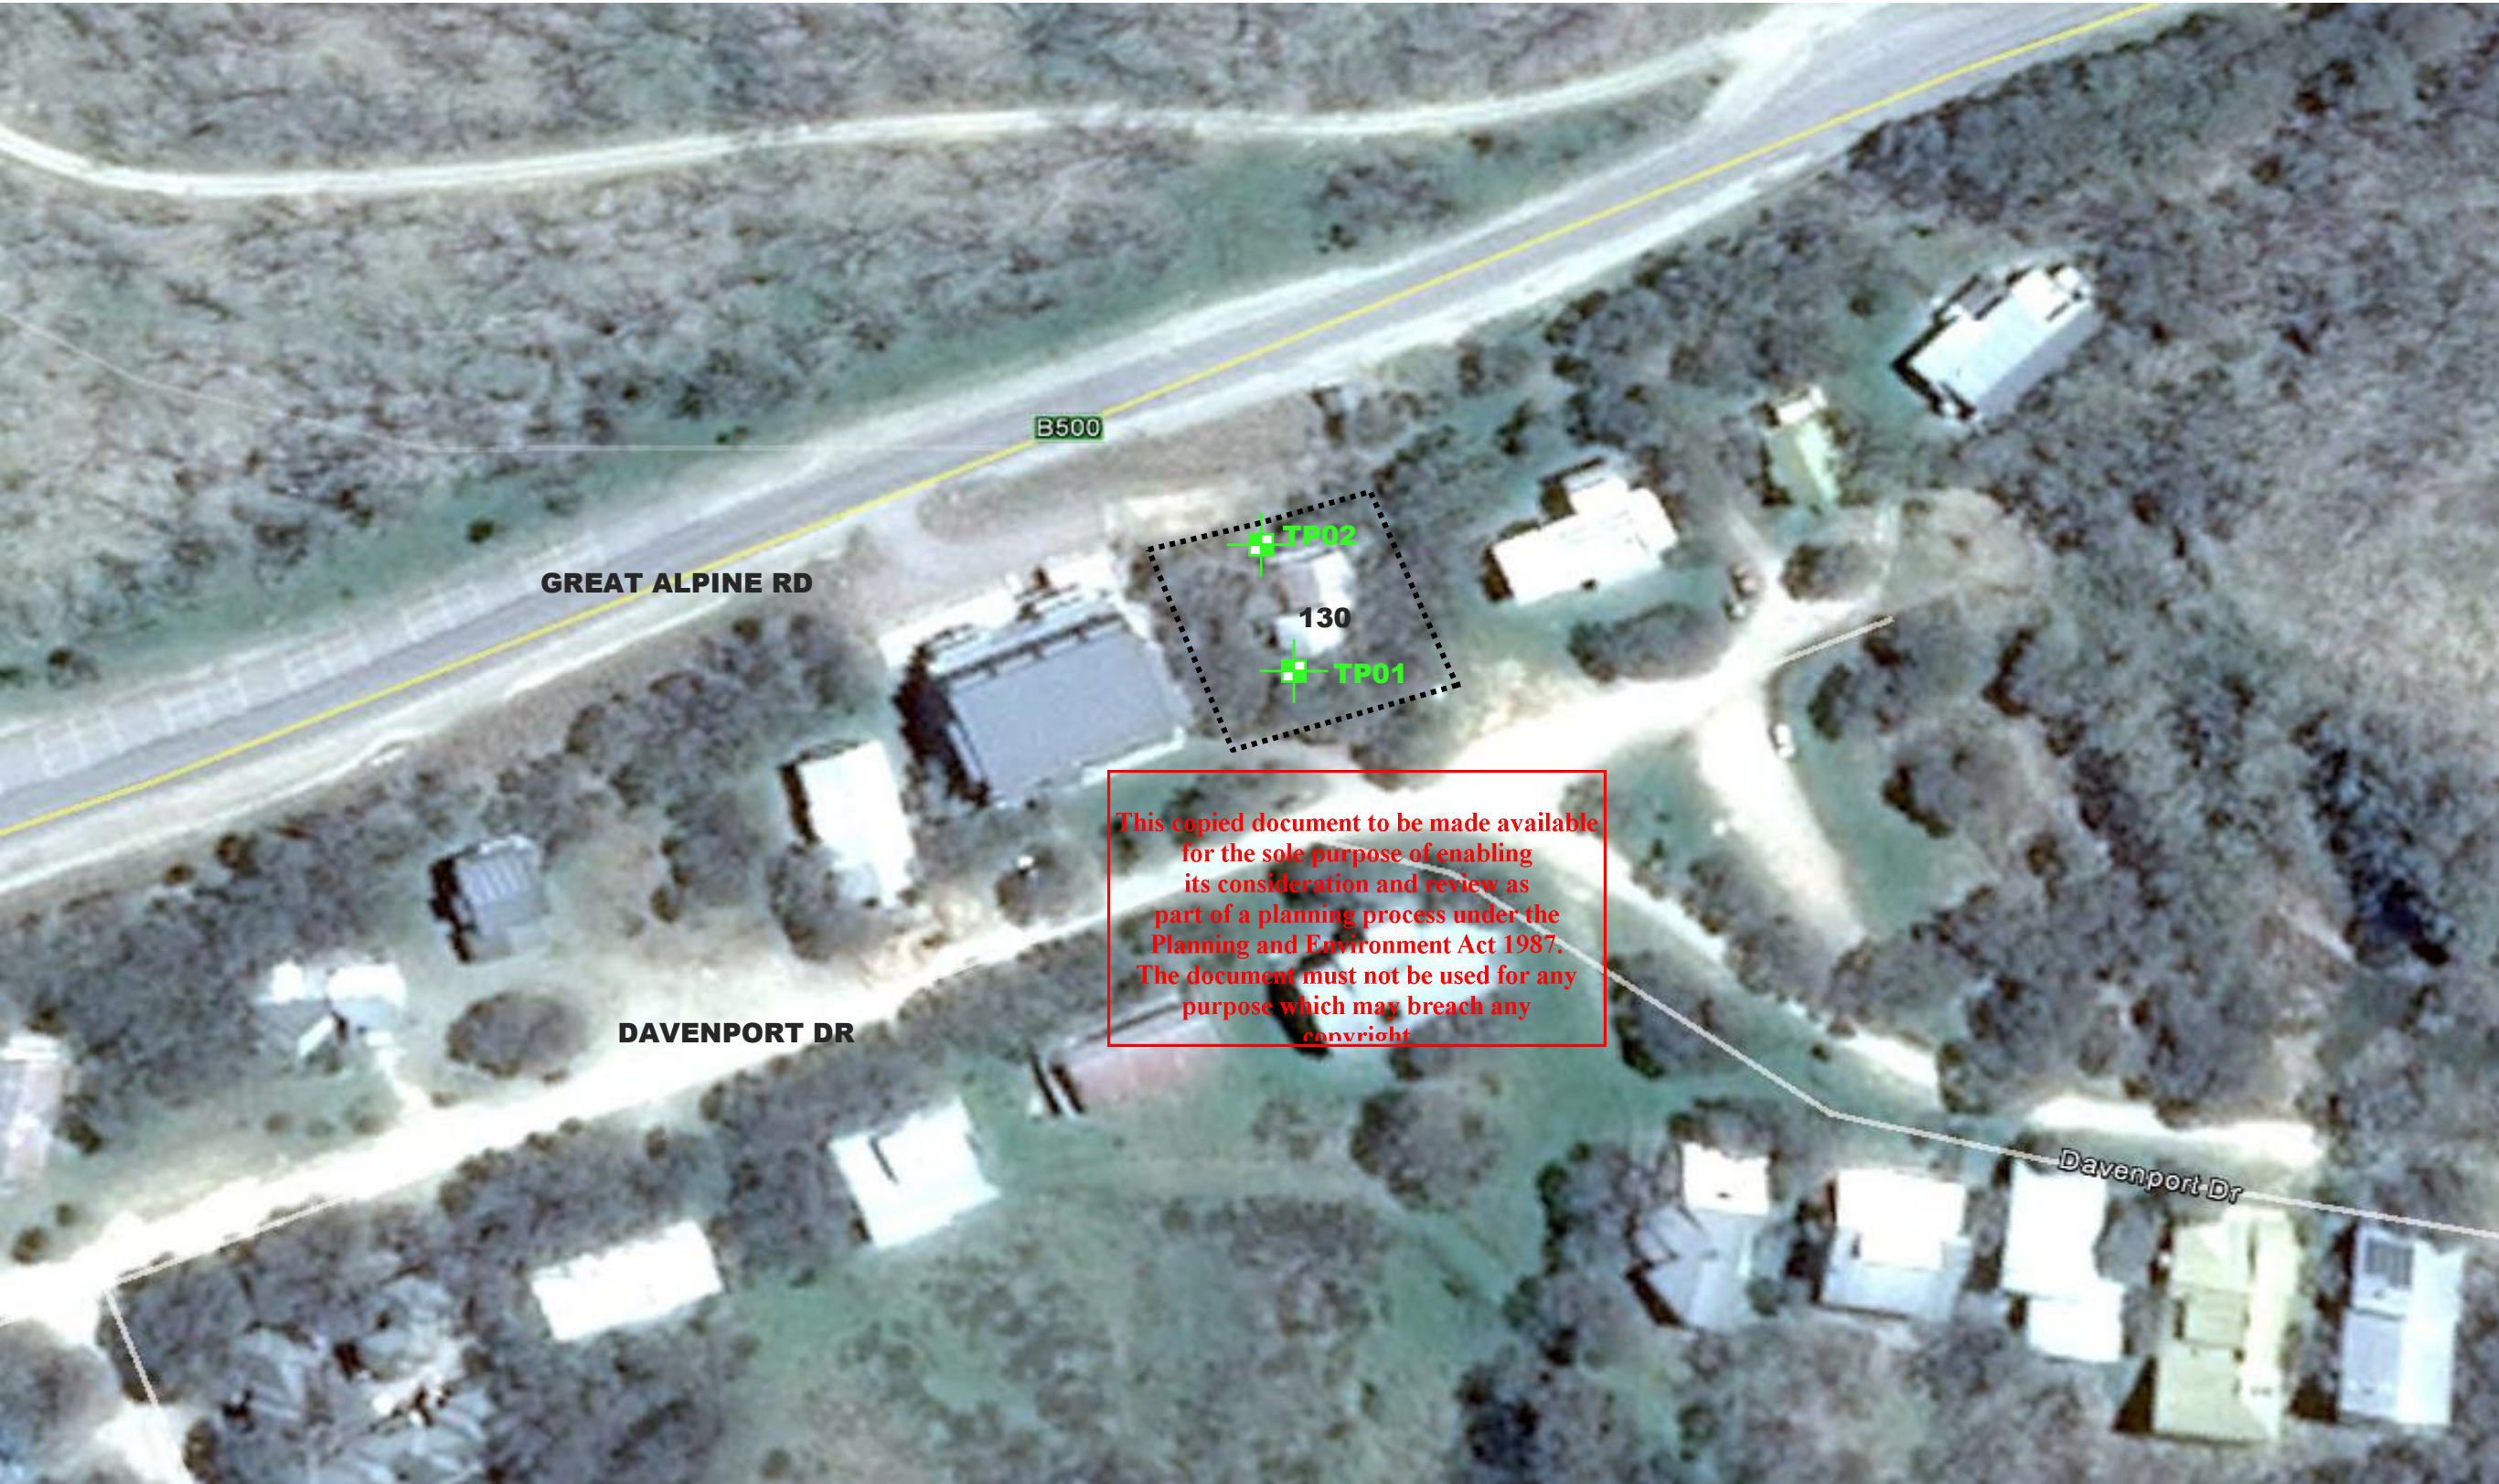
| revision | description | drawn | approved | date | <div><div><div></div></div><div>Test Pit Location</div></div> <div><div>....</div><div>Site Boundary</div></div> | drawn | FK | <div><div>coffey</div><div>A TETRA TECH COMPANY</div></div> | client: MANGO PROPERTY SERVICES | |

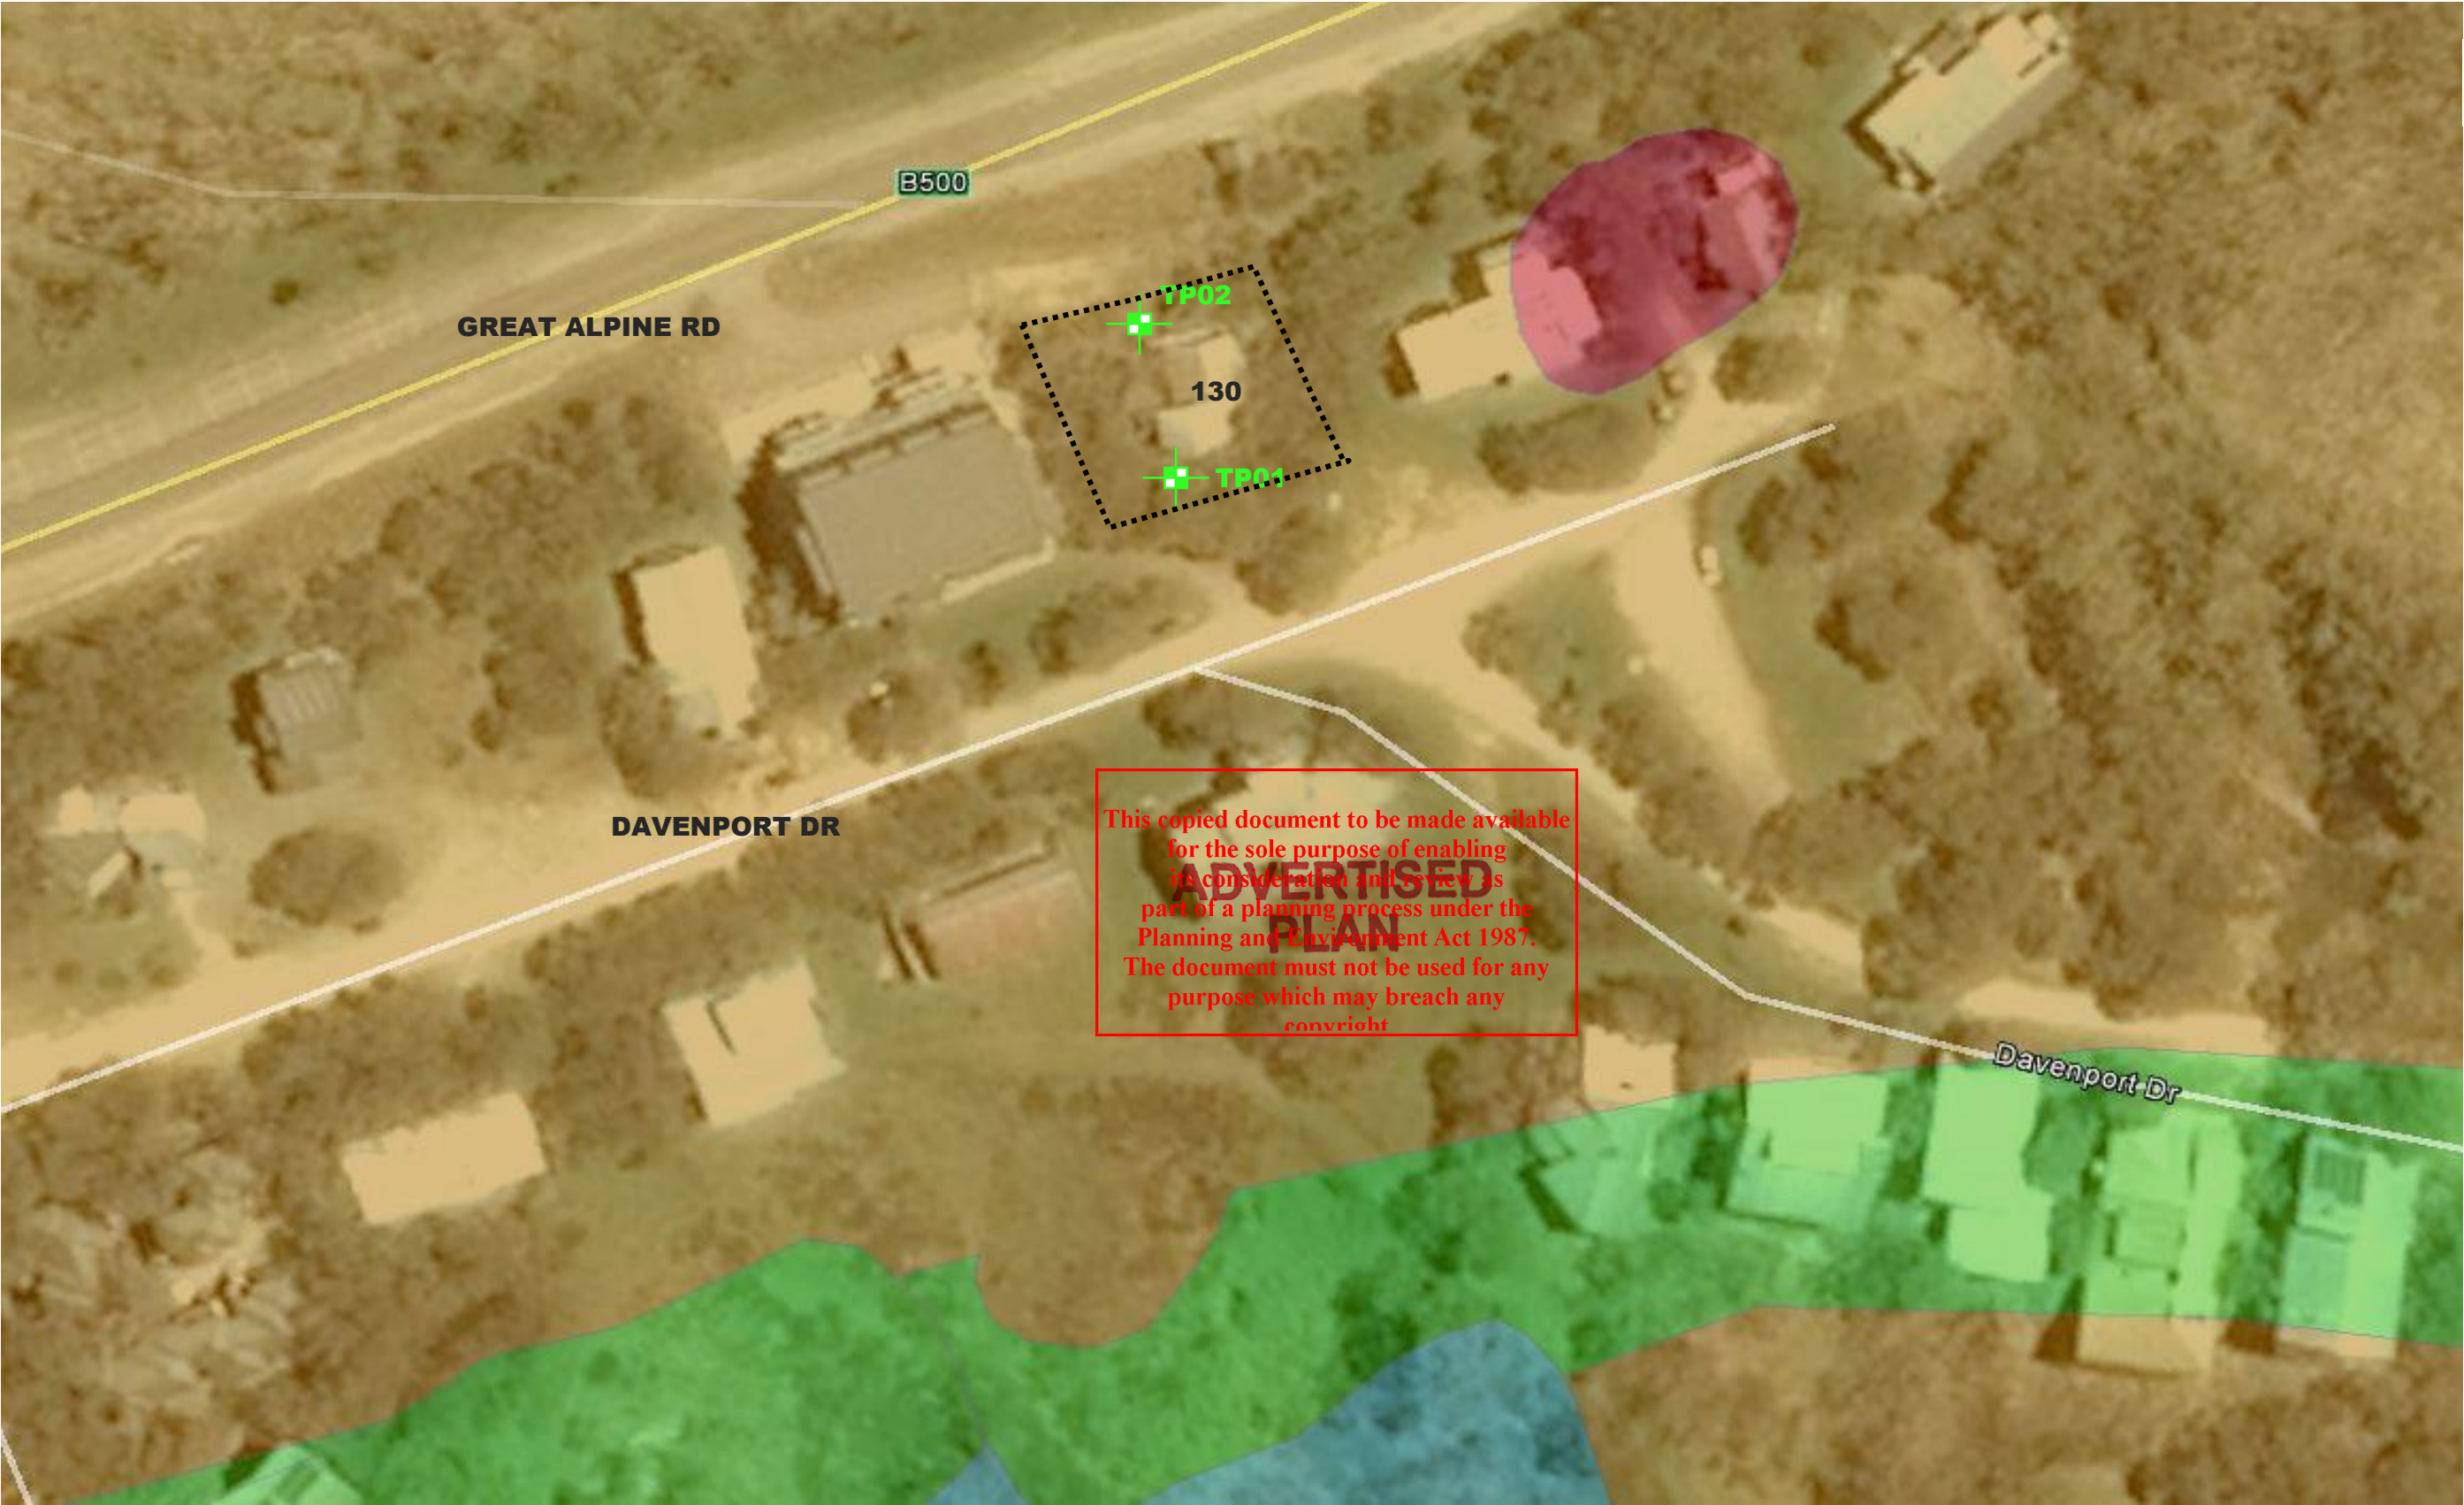
| | | | | | | date | 22/03/18 | | title: | LANDSLIDE HAZARD MAP | |

| revision | description | drawn | approved | date | <div><div></div>Test Pit Location</div> <div><div></div>Landslide Hazard Zoning</div> <div><div></div>Very High</div> <div><div></div>High</div> <div><div></div>Medium</div> <div><div></div>Low</div> | drawn | FK | <div><div>coffey</div><div>A TETRA TECH COMPANY</div></div> | client: | MANGO PROPERTY SERVICES | |

SMEC completed a stability review and hazard assessment of the ski lodge sites along Davenport Dr and Alpine Rd in 1999. A summary of the assessment for this site is shown in Table 1. The assessed hazard rating for a shallow landslide, cut excavation and fill embankment ranged from 'Low' to 'Very Low'. There was no rock fall hazard at the site.

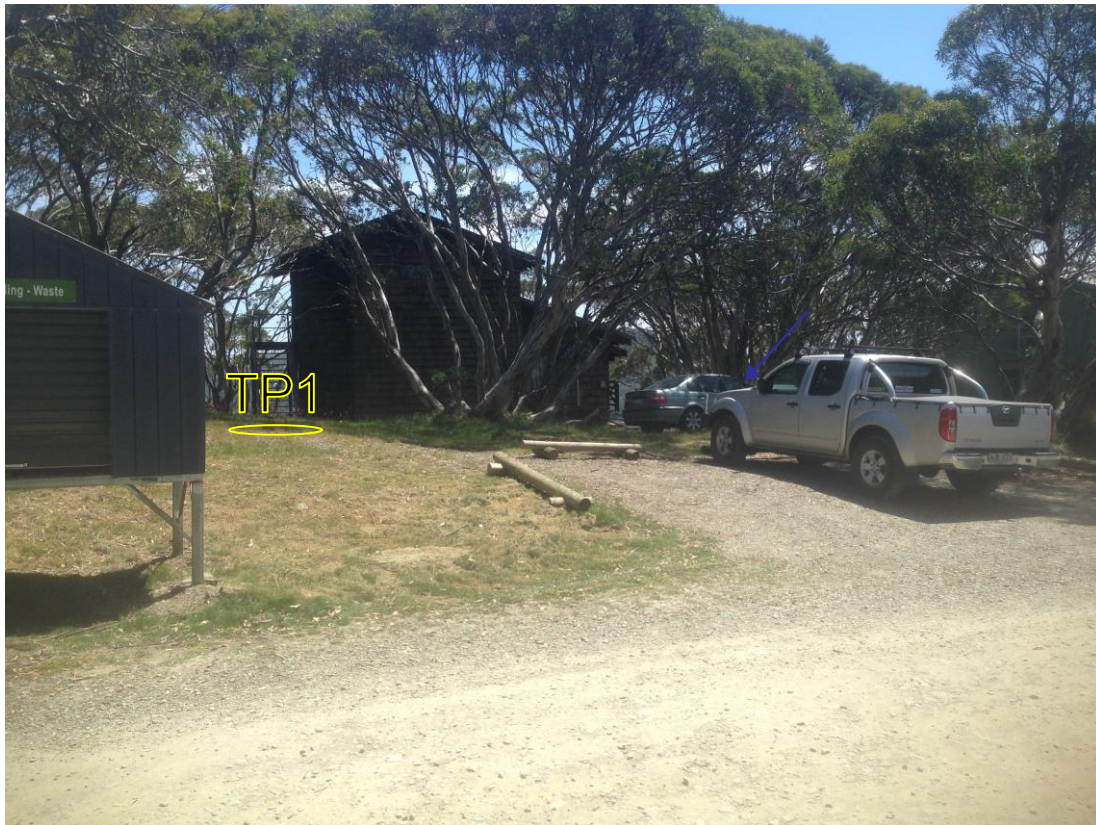
PHOTOGRAPH 1 - SITE LOOKING NORTH

- Sloping block;
- The existing building is a two-storey lodge constructed with timber shingles on exterior, stone wall between walls and foundations;
- Meta-siltstone outcropping at surface;
- Vegetation is grass, small shrubs, mature snow gums;
- Cut to Alpine Rd faced with basalt boulders (riprap revetment), approx. 4m high; and
- An access track exists between the crest of the cut to the Alpine Rd and the actual site.

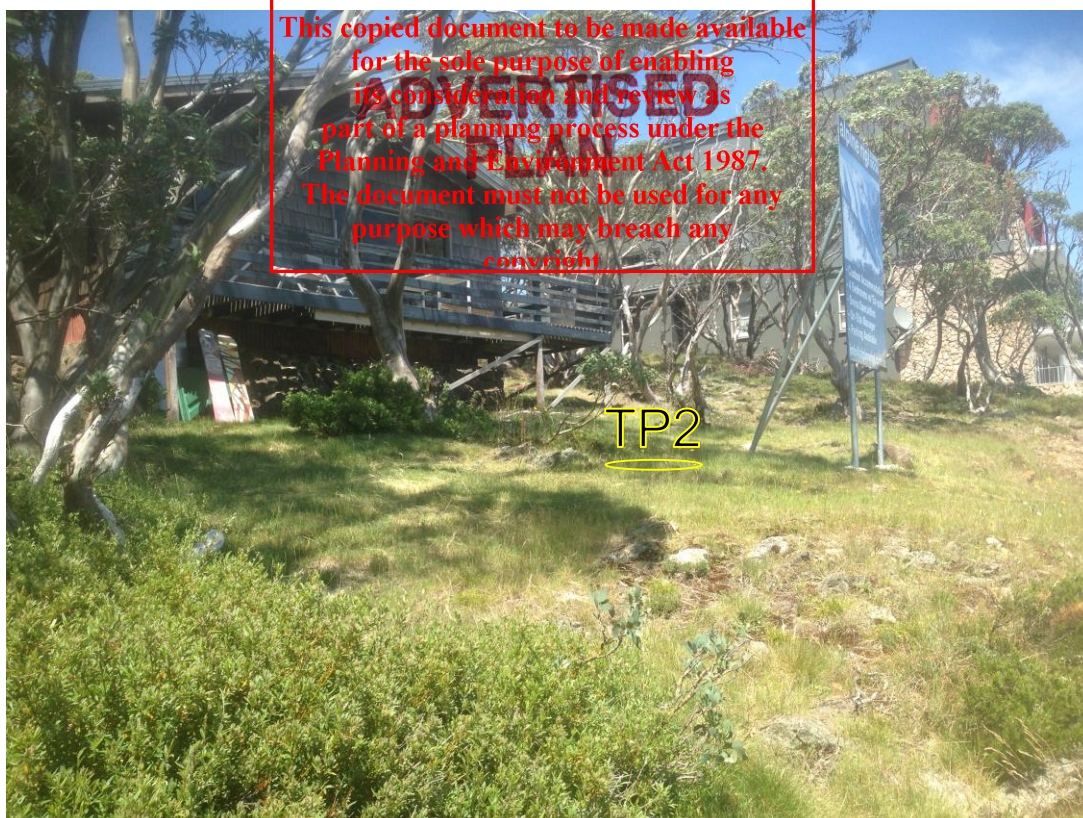
PHOTOGRAPH 2 - SITE LOOKING SOUTH-WEST

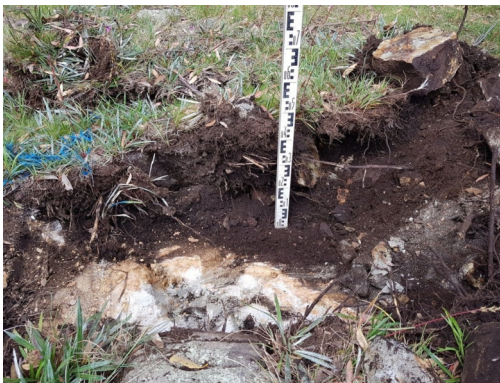
| excavation information | | | | | material substance | | | | |
|---|---|---|---|---|---|---|---|--|--|
| BH | N | 1 2 3 | D | | | | CL | TOPSOIL: Silty CLAY: medium plasticity, dark brown, with fine to medium grained sand (loam). CLAYEY SAND: fine to coarse grained, pale grey, mottled orange, with fine to coarse grained angular gravel. Test pit TP02 terminated at 0.1 m Refusal Refusal on Rock | TOPSOIL rootlets RESIDUAL SOIL rootlets HP 50 kPa HP 150 kPa HP 300 kPa HP >500 kPa |

The natural subsurface conditions encountered in TP01 and TP02 are consistent with the published geology.
