# CULTURAL HERITAGE MANAGEMENT PLAN

# Northern Highway and Wandong Road Intersection Upgrade

## **FP-SR MANAGEMENT PLAN NUMBER**

19003

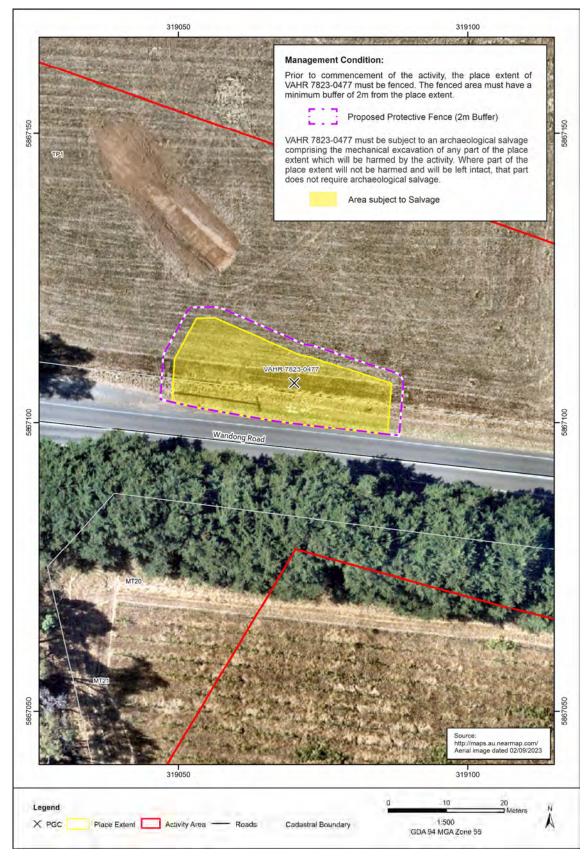
CONDITIONS MAP 1: SHOWING CONDITIONS PERTAINING TO VAHR 7823-0477

Conditions Map 1 shows the indicative location the impact area which is subject to salvage. The excavation methodology is detailed below.

Prior to commencement of the activity, the Place extent of VAHR 7823-0477 must be fenced (see Conditions Map 1):

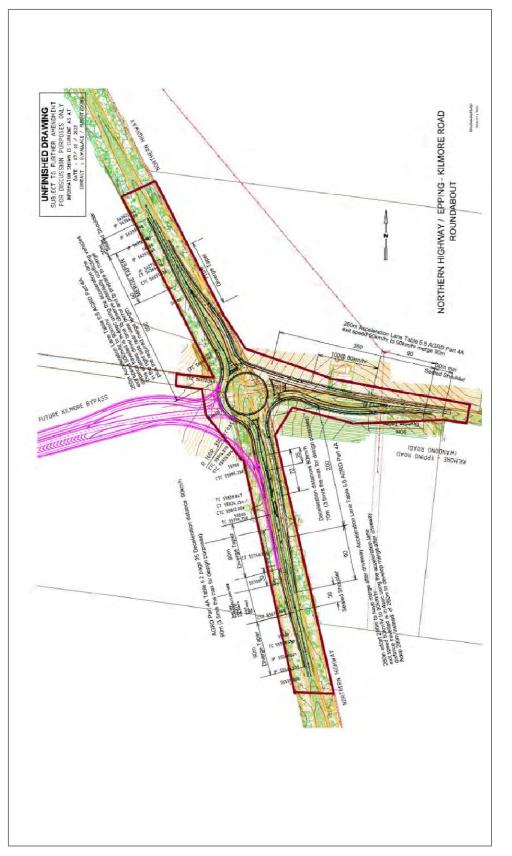
MAP 3: INDICATIVE DESIGN PLAN

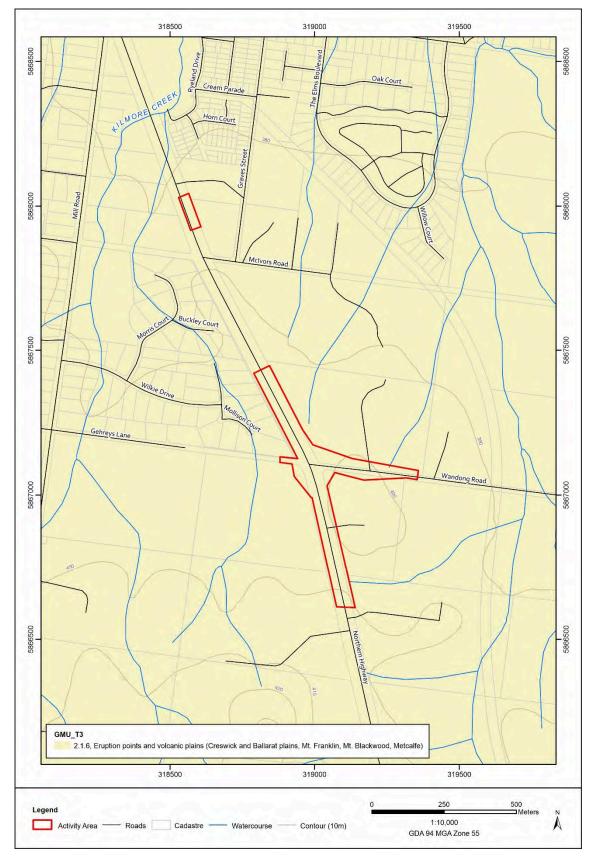
MAP 5: GEOMORPHIC UNITS IN THE ACTIVITY AREA

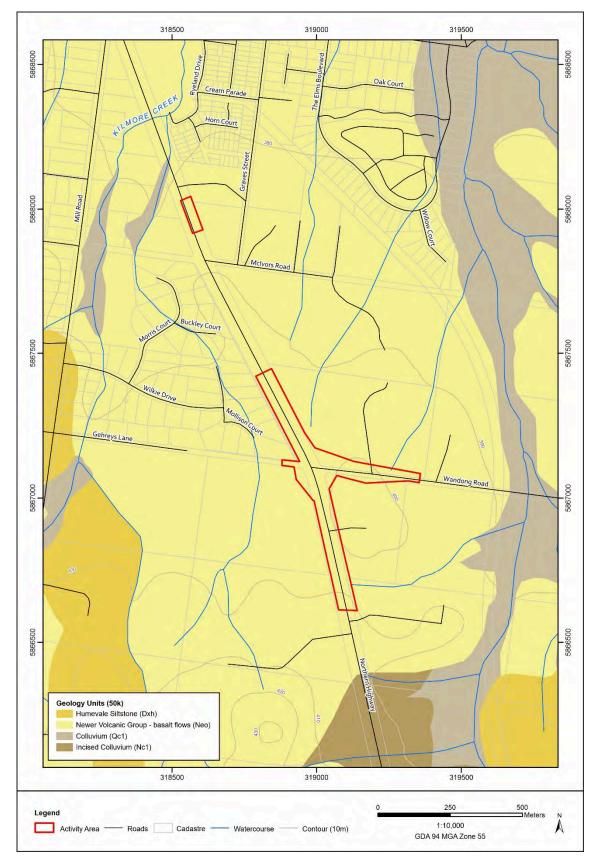
MAP 6: GEOLOGY OF THE ACTIVITY AREA

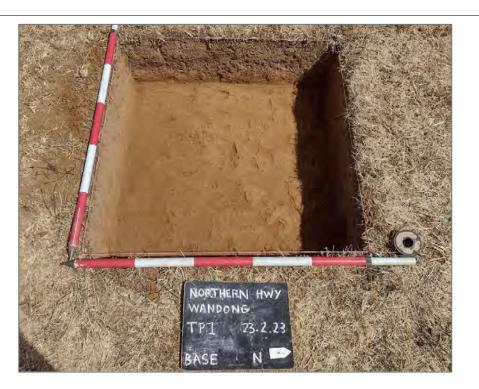
Test Pit 1 – End of excavation, facing north (A Hamdorf 23/2/23)

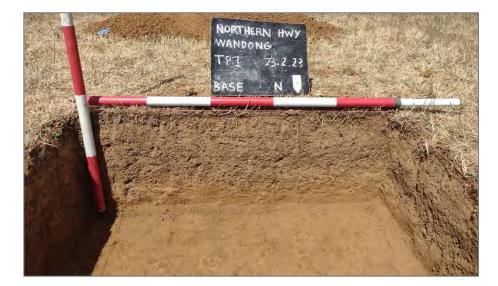
Test Pit 1 – Close-up of stratigraphic profile, facing north (A Hamdorf 23/2/23)

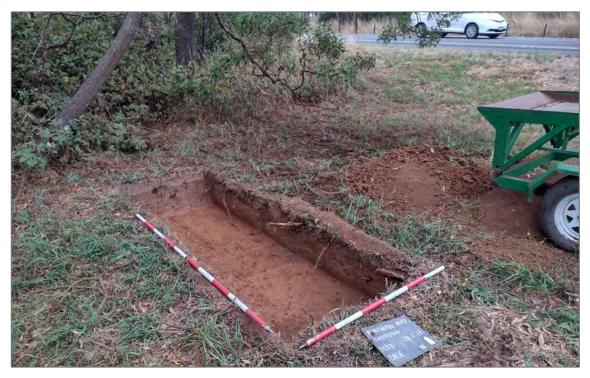
The stratigraphy of MTP 3 was broadly characteristic of the soils observed throughout the road reserve MTPs. The soil profile of MTP 3 displayed an A horizon of dark brown, disturbed silty clay to 100mm over an undisturbed, strong brown, clayey silt to 390mm with frequent buckshot. The B horizon comprised a dark reddish-brown clay from 390mm depth. The differences between these road reserve pits and the paddock pits is they typically have a clear disturbed horizon and an undisturbed horizon. Two artefacts were discovered within MTP 3 within the disturbed horizon. Full details of these artefacts is provided in Section 10 and Appendix 4.

PLATE 23: SHOWING LOCATION OF MTP 3 (VIEW NORTH EAST)

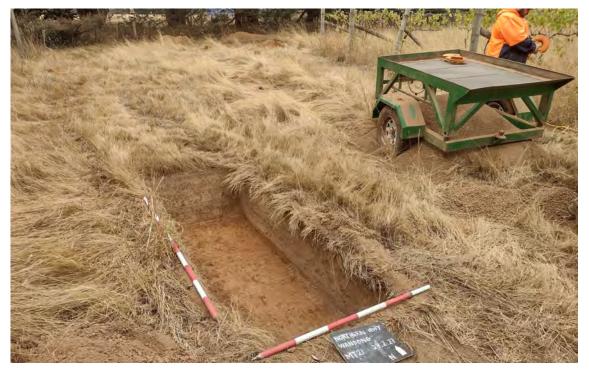
MTPs 20–21 were excavated within the **vineyard** paddock (Map 14, Plate 25). No artefacts were discovered in these MTPs and their soil profile was similar to MTPs 9 and 15, but with a deeper disturbed horizon, likely to historic deep ripping for the vineyard.

PLATE 25: SHOWING LOCATION OF MTP 21 IN PROXIMITY TO THE VINEYARD (VIEW NORTH)

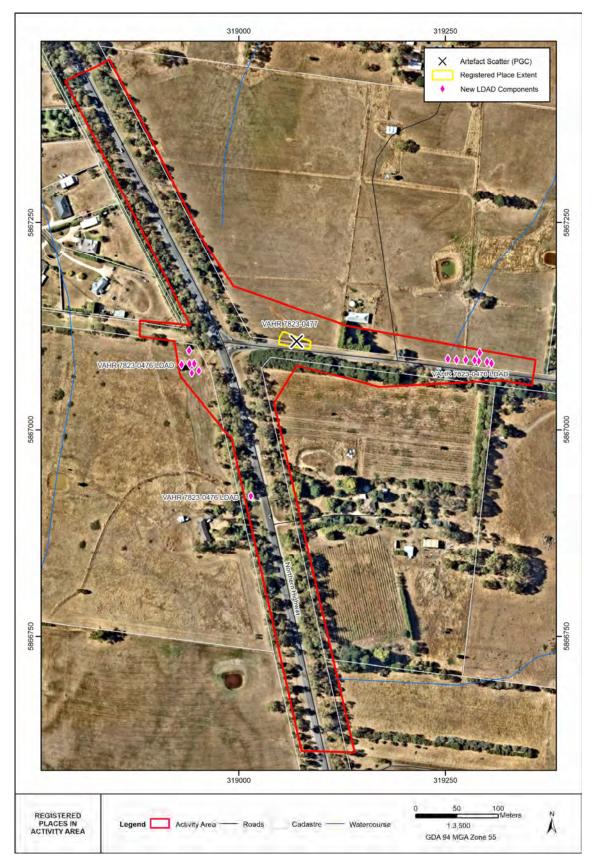
The artefacts trend to the crest of the broad rise in the north east paddock with 46 artefacts coming from MTP 15 and surrounds. Artefacts occur at much lower density on the lee side of the rise in the north east paddock with 16 artefacts coming from MTP 9 and surrounds. A further nine artefacts came from the south west paddock at the MTP 23–24 location. Two artefacts were discovered in the road reserve.

MAP 18: LOCATION OF ABORIGINAL CULTURAL HERITAGE WITHIN THE ACTIVITY AREA

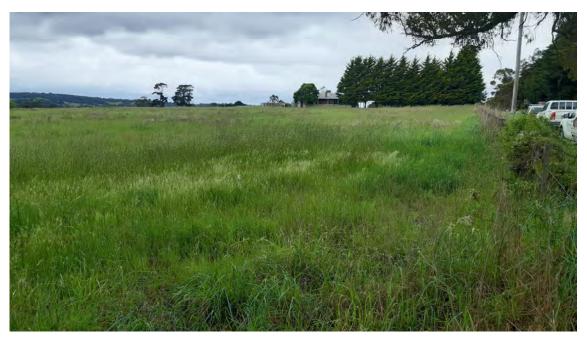
PLATE 26: VIEW EAST ACROSS VAHR 7823-0477 DURING THE STANDARD ASSESSMENT (PHOTO BY L FALVEY, 28/10/2022)

The Place is interpreted as representing a singular depositional event within a landscape characterised by low density discard.

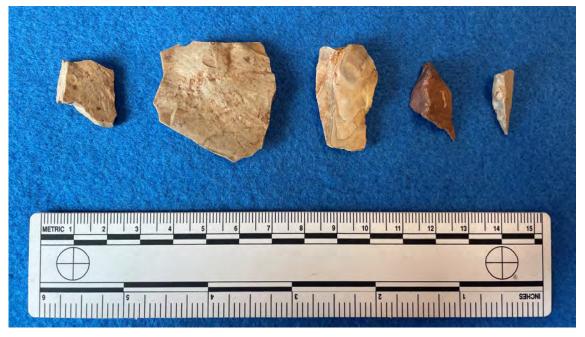
PLATE 27: SAMPLE OF ARTEFACTS FROM VAHR 7823-0477 (PHOTO BY Z LAY, 17/01/2023)

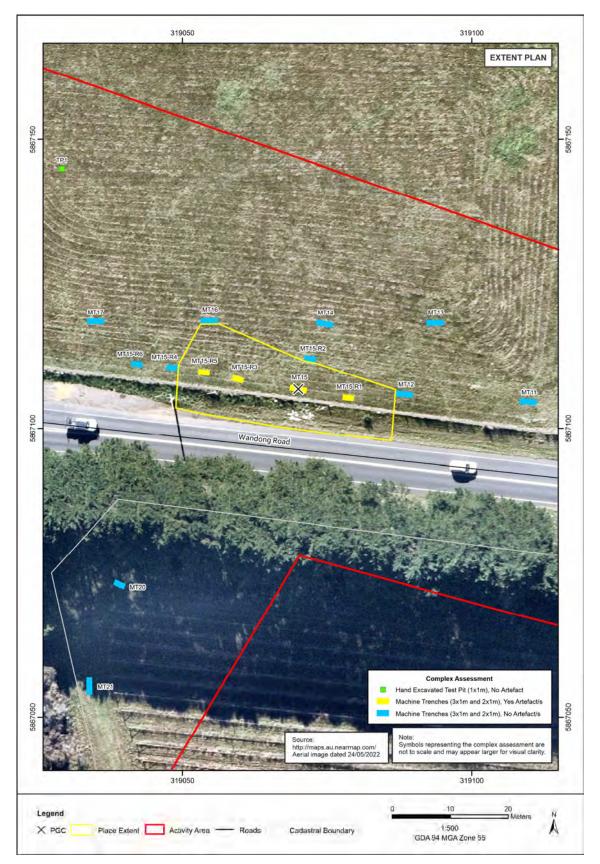
MAP 19: EXTENT OF VAHR 7823-0477

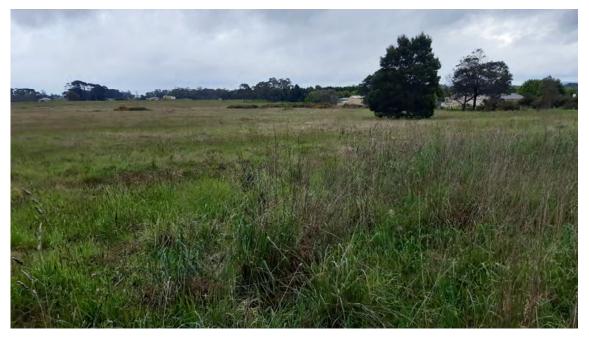
PLATE 28: VIEW WEST ACROSS MTP 23-24 PART OF VAHR 7823-0476 DURING THE STANDARD ASSESSMENT (PHOTO BY L FALVEY, 28/10/2022)

VAHR 7823-0476 comprises a low density scatter of 27 isolated silcrete, quartzite, quartz and tachylyte artefacts distributed across the activity area.

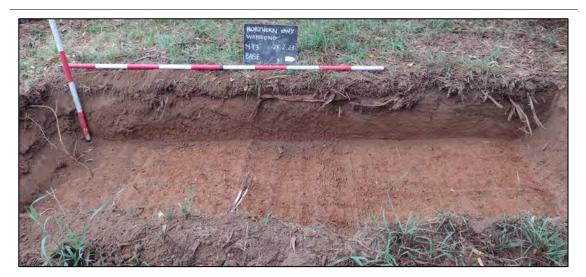
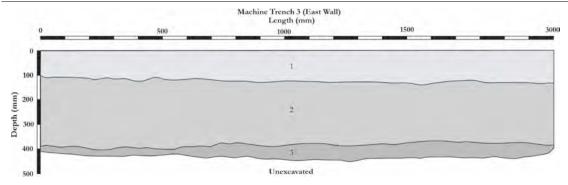
#### MACHINE TEST PIT 3

GDA94 COORDINATES	319014.788E / 5866921.169N	319014.437E / 5866918.016N
(ZONE 55)	319015.410E / 5866918.227N	319013.808E / 5866920.960N
CONTEXT 1	degrading wood organic inclusio roadstone, ceramic, paper, plastic	y clay with grass roots, onion weed and ons, occasional modern inclusions (glass, c and metal) and natural quartz, siltstone usions. Munsell: 7.5YR 3/3 (dark brown),
CONTEXT 2	100–390mm: Dry, compact clay Munsell: 7.5YR 4/6 (strong brow	rey silt with abundant ironstone gravels. 2n), pH: 6.
CONTEXT 3	390–410mm+: Dry, compact clay Munsell: 7.5YR 3/4 (dark reddisl	
ARTEFACTS	100–200mm: one silcrete proxin	nal flake and one quartz proximal flake.

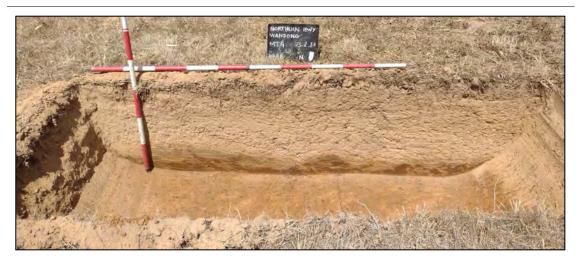
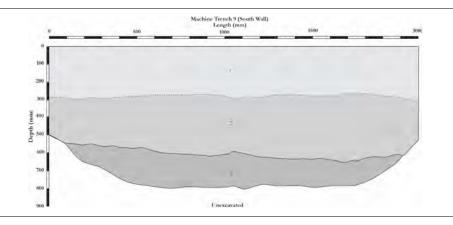
### MACHINE TEST PIT 9

GDA94 COORDINATES (ZONE 55)	319288.702E / 5867083.505N 319291.700E / 5867083.407N	319291.670E / 5867082.400N 319288.670E / 5867082.505N
CONTEXT 1	0–300mm: Dry, compact clayey grass roots. Gradual transition int <u>Munsell:</u> 10YR 4/3 (brown), pH:	
CONTEXT 2	300–550/610mm: Dry, compac gravels. <u>Munsell:</u> 10YR 5/4 (yellowish bro	et clayey silt with abundant ironstone
CONTEXT 3	550/610–800mm+: Dry, rigid cla <u>Munsell:</u> 5YR 4/4 (reddish brown	
ARTEFACTS	0–100mm: one silcrete medial fla 100–200mm: one silcrete comple 200–300mm: one silcrete proxim core.

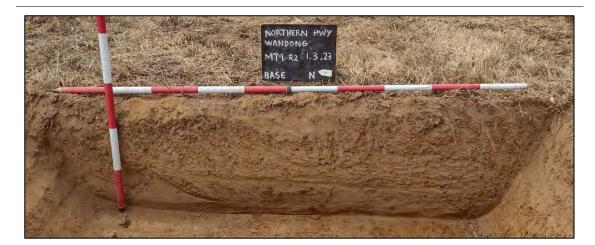
0–100mm: one silcrete proximal flake.

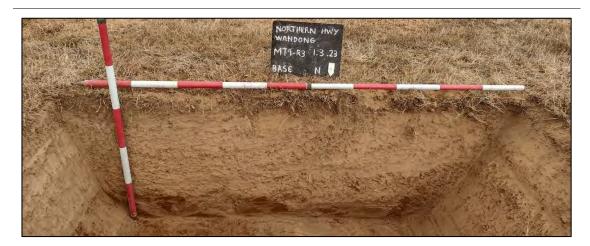
GDA94 COORDINATES	319290.438E/5867092.410N 319290.438E/5867093.410N	
(ZONE 55)	319292.438E/5867092.410N 319292.438E/5867093.410N	
CONTEXT 1	0–130mm: Dry, friable to firm silt with grass roots, insects, frequent ironstone gravels, occasional natural quartz gravels and occasional modern rubbish (glass, plastic and metal) inclusions. Munsell: 10YR 5/3 (brown), pH: 6.5.	
CONTEXT 2	130–510/590mm: Dry, firm clayey silt with abundant ironstone and natural quartz gravel inclusions.	
	Munsell: 10YR 5/6 (yellowish brown), pH: 6.5.	
CONTEXT 3	510/590–700mm+: Dry, strongly compacted clay. Munsell: 5YR 4/6 (yellowish red), pH: 7.	
ARTEFACTS	100–200mm: one silcrete medial flake (backed geometric microlith) and one silcrete proximal flake.

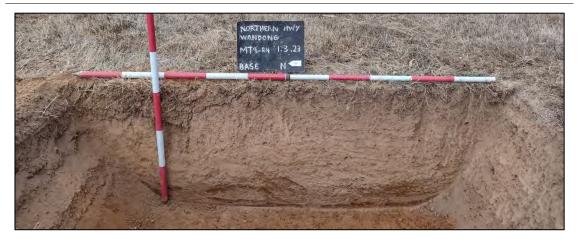
319299.613E/5867081.134N 319299.864E/5867083.118N		
319300.605E/5867081.008N 319300.857E/5867082.992N		
0–150mm: Dry, friable to firm silt with grass roots, insects, frequent ironstone gravels, occasional natural quartz gravels and occasional modern rubbish (glass, plastic and metal) inclusions. Munsell: 10YR 5/3 (brown), pH: 6.5.		
150–520mm: Dry, firm clayey silt with abundant ironstone and natural quartz gravel inclusions. Munsell: 10YR 5/6 (yellowish brown), pH: 6.5.		
520–690mm+: Dry, strongly compacted clay. Munsell: 5YR 4/6 (yellowish red), pH: 7.		
0–100mm: one silcrete proximal flake and one silcrete complete flake. 100–200mm: one silcrete proximal flake.

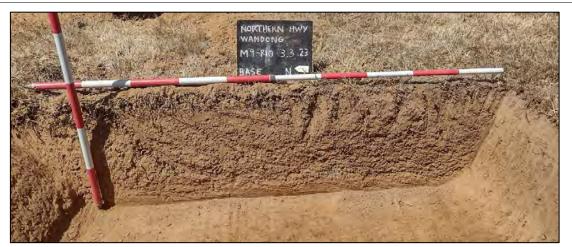
#### MACHINE TRENCH 9 RADIAL 10

GDA94 COORDINATES (ZONE 55)	319305.926E/5867079.196N 319306.395E/5867081.140N	319304.954E/5867079.430N 319305.423E/5867081.374N
CONTEXT 1		
CONTEXT 2	190–490mm: Dry, firm clayey sile gravel inclusions. Munsell: 10YR 5/6 (yellowish bro	t with abundant ironstone and natural quartz own), pH: 6.5.
CONTEXT 3	490–500/550mm+: Dry, strongl Munsell: 5YR 4/6 (yellowish red)	
ARTEFACTS	0–100mm: one silcrete distal flak 100–200mm: one silcrete proxim proximal flake.	e. al flake – backed Bondi point and one silcrete

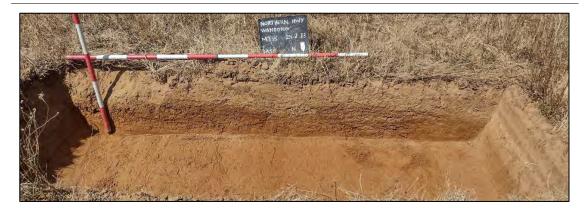
#### MACHINE TRENCH 15

GDA94 COORDINATES (ZONE 55)	319071.581E/5867106.961N 319068.630E/5867107.501N	319071.401E/5867105.977N 319068.450E/5867106.518N
CONTEXT 1		e clayey loam silt with grass roots, insects, ccasional modern rubbish (glass, ceramic, I: 6.5.
CONTEXT 2	-	7, firm clayey silt with abundant degrading o-angular) and rare modern rubbish (glass, H: 5.5.
CONTEXT 3	300/230/250–450mm+: Dry, cc Munsell: 5 YR 4/6 (yellowish rec	1 9
ARTEFACTS	100–200mm: one quartzite mul flake. 200–300mm: one silcrete angula	tidirectional core and one silcrete medial

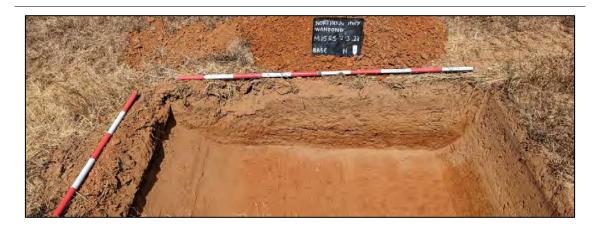
### MACHINE TRENCH 15 RADIAL 5

GDA94 COORDINATES	319052.737E/5867110.250N	319054.730E/5867110.082N
(ZONE 55)	319052.653E/5867109.254N	319054.645E/5867109.085N
(ZONE 55)		
CONTEXT 1	0–180/200mm: Dry, fine, friable	e clayey loam silt with grass roots, insects,
	moderate ironstone gravel and o	ccasional modern rubbish (glass, ceramic,
	metal and plastic) inclusions.	
	Munsell: 7.5 YR 5/3 (brown), pH	I: 6.5.
CONTEXT 2	180/200-460/420/400mm: I	Dry, firm clayey silt with abundant
	degrading ironstone gravels (co	urse and sub-angular) and rare modern
	rubbish (glass, ceramic and metal	) inclusions.
	Munsell: 7.5 YR 5/4 (brown), pH	I: 5.5.
CONTEXT 3	460/420/400-540/580/600mi	m+: Dry, compact clay.
CONTEXTS	Munsell: 5 YR 4/6 (yellowish red	l), pH: 6.5.
ARTEFACTS	0–100mm: one silcrete angular fi	ragment.

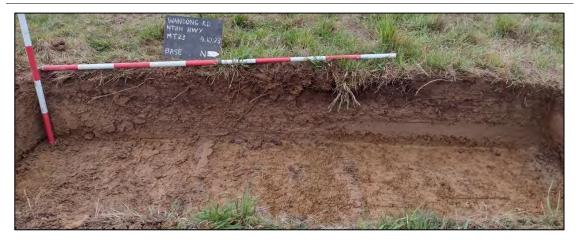
#### MACHINE TRENCH 23

318941.402E/5867078.287N 318940.758E/5867081.217N	318940.426E/5867078.072N 318939.782E/5867081.002N
	,,,
	silt with grass roots, worms, uncommor
	ents and uncommon buckshot gravels.
Munsell: 10 YR 3/3 (dark brown)	, pH: 6.
170–390mm: Moist, firm claye	y silt with grubs, worms and abundan
buckshot gravels.	
Munsell: 10 YR 5/3 (brown), pH:	: 6.
390–460mm+: Moist, compact o	lay.
Munsell: 10 YR 4/6 (dark yellow	ish brown), pH: 6.5.
0–100mm: One silcrete proxima	l flake.
	318940.758E/5867081.217N 0–170mm: Moist, friable clayey small tree roots, rare glass fragme Munsell: 10 YR 3/3 (dark brown) 170–390mm: Moist, firm claye buckshot gravels. Munsell: 10 YR 5/3 (brown), pH 390–460mm+: Moist, compact of Munsell: 10 YR 4/6 (dark yellow
