Preliminary Site Investigation

27-37 & 39 Kraft Court,
Broadmeadows, Victoria

Centre for Multicultural Youth
September 2023

Client No: M0310
Job No: 117975M

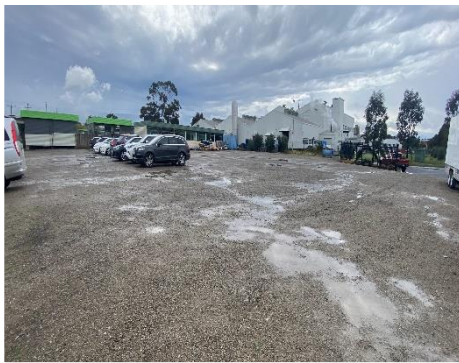
- The surface cover predominantly comprised gravel in fair condition;
 - A minor downwards slope was noted on the eastern and western boundaries towards the adjacent roads;

1. Northern portion of the Site

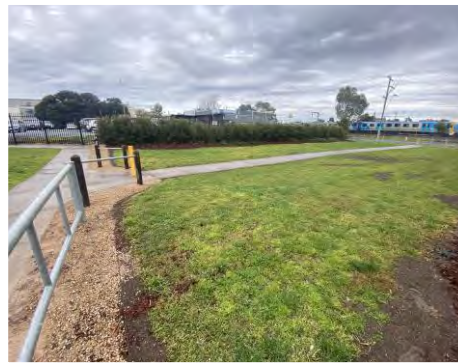
2. Central portion of the Site

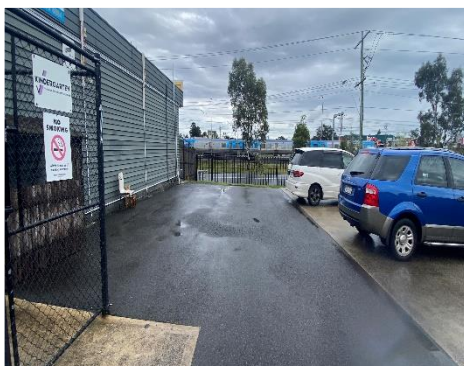
3. Carpark adjacent the southern portion of the Site

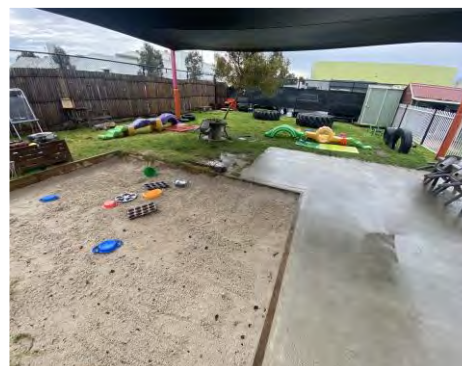
- The surface cover of the accessible outdoor areas comprised a combination of grass in fair condition, synthetic turf, paved pathways, sand/tanbark and bitumen;

4. Grassed, paved and sand covered areas in the southern portion of the Site.

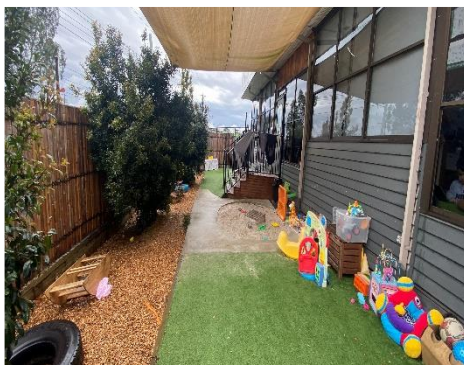
5. Tanbark and synthetic turf covered areas in the southern portion of the Site.

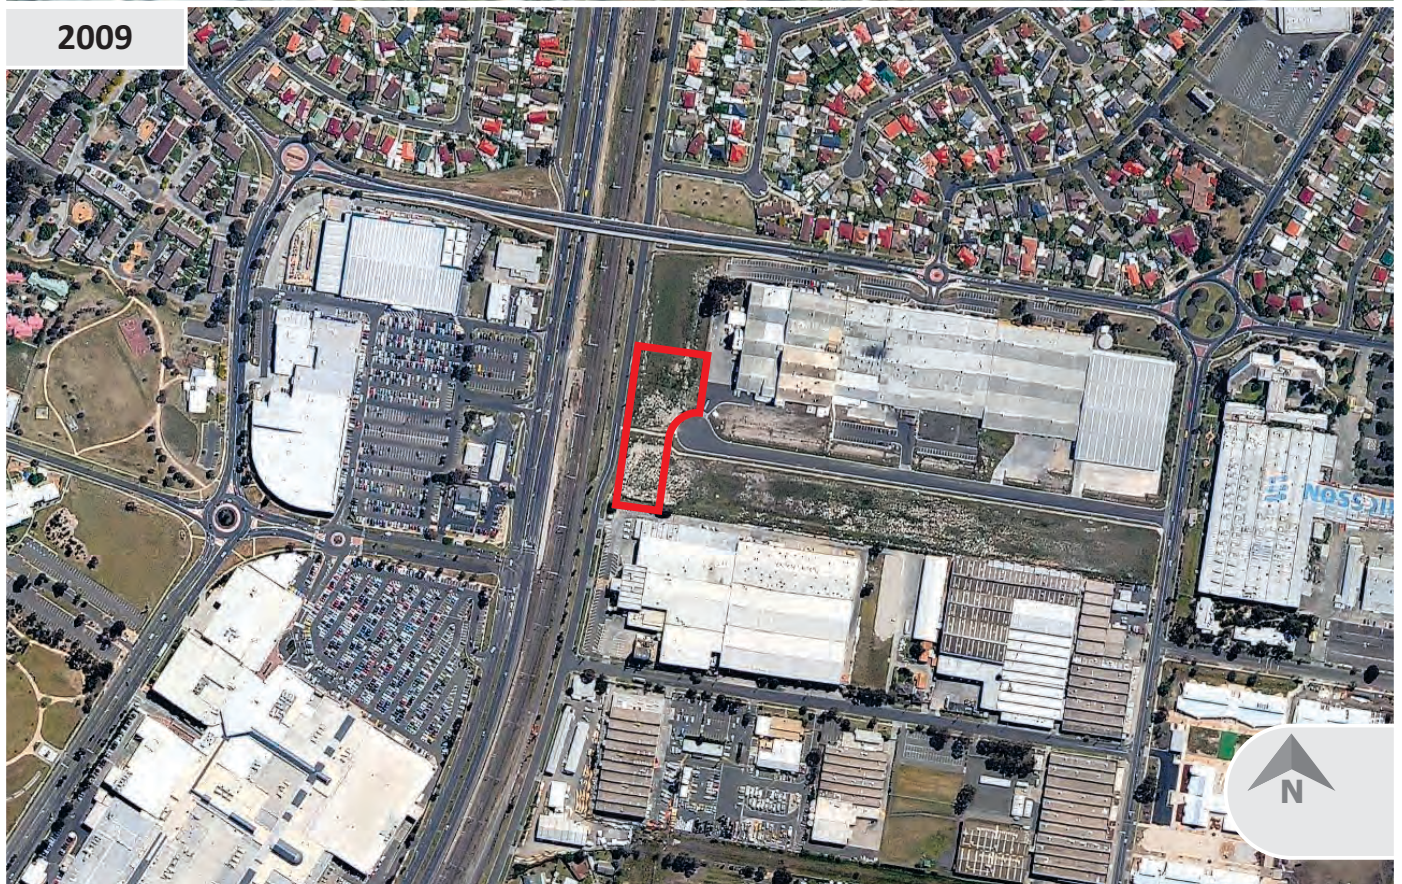
| Date | Observations On-Site | Observations Off-Site |
|---|---|---|
| 2009 | Ground disturbance is evident throughout the central and southern portions of the Site. The carpark in the northern portion of the Site has been removed and replaced with grass cover. A pathway has been established in the centre of the Site spanning from east to west. | The carpark directly north of the Site has been removed and replaced with what appears to be grass cover. The remaining open space to the east of the Site has been replaced with buildings. The structure to the west of the Site has been extended further. |
