Tree Consultants & Contractors

**re: 346-350 Macaulay Road, Kensington**

### **Introduction**

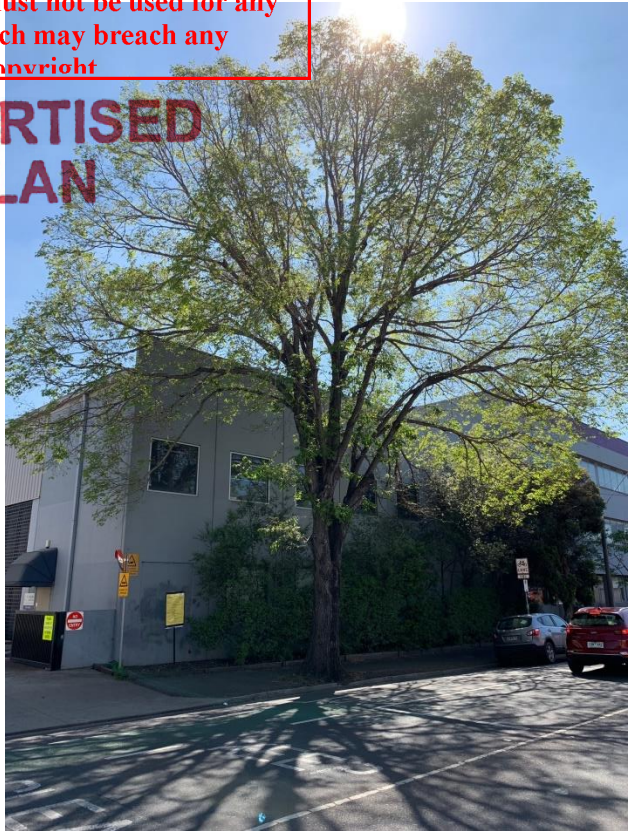
Tree 1

Tree No.	Species	DBH (cm)	HxS (m)	Comments, WOR, TPZ(m), SRZ(m)
1	Ulmus minor E Smooth-leaved Elm	72	20x20	Young mature vigorous healthy specimen. It is outgrowing its location as is evident by the damage the roots are causing to the kerb and channel, and the fact that the trunk is leaning over the kerb at beyond 2m height. The safe useful life expectancy is < 10 years, despite the good condition of the tree. TPZ 8.7m SRZ 3
2	Melaleuca linariifolia A Snow in Summer	41	7x6	Mature small tree in fair health. As is typical of the species, the trunk is very thick relative to the crown height and volume. The kerb is being damaged. The tree has little streetscape significance. TPZ 4.9 SRZ 2.3
3	Melia azedarach A White Cedar	14	5x5	Young small street tree in fair-good condition. Long SULE. TPZ 2 SRZ 1.5
4	Corymbia maculata V Spotted Gum	55	18x10	The tree has a prominent lean over Stubbs Street. Although healthy, it has become a traffic hazard, particularly trucks turning left into Stubbs Street from Macaulay Road. The trunk is being repeatedly bashed by trucks. SULE 0. TPZ 6.6 SRZ 2.7

With respect to tree 1, it cannot be retained under the current plans. Although the basement is set back sufficiently to the existing building line, beneath which there will be little or no root development, the protruding slab of the ground floor demands at least 600mm excavation. Given that the trunk centre is 3.8m from the edge of the building, the excavation for the slab will be well inside the SRZ. As discussed, the tree's SULE < 10 years, due to the very severe damage it will be causing to the kerb and channel by then, and the impedance over the road of the trafficable area, due to a combination of trunk girth increase and lean.

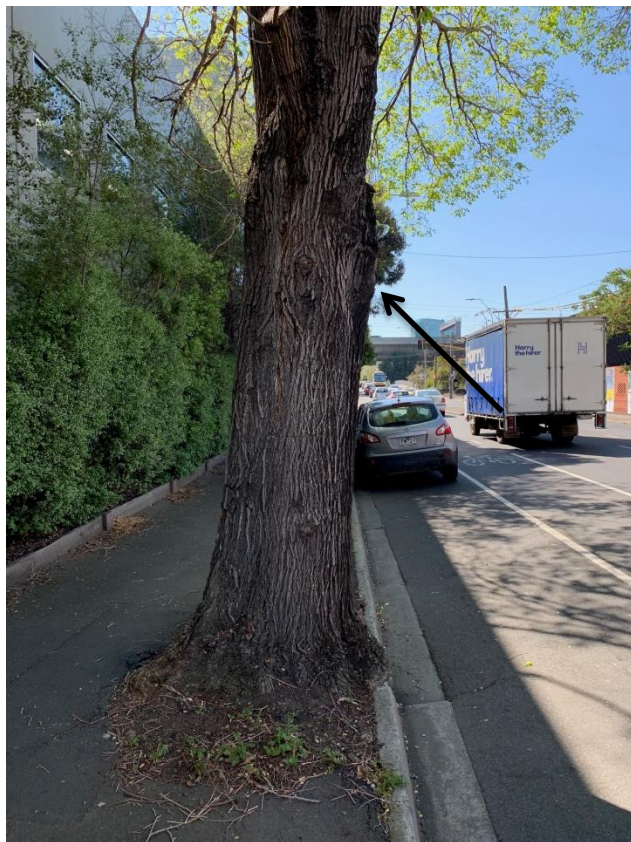
Damage to kerb and channel of tree 1 and encroachment of the trunk over the kerb, both problems which are likely to cause this tree to be untenable to be retained within 10 years as it keeps vigorously growing.

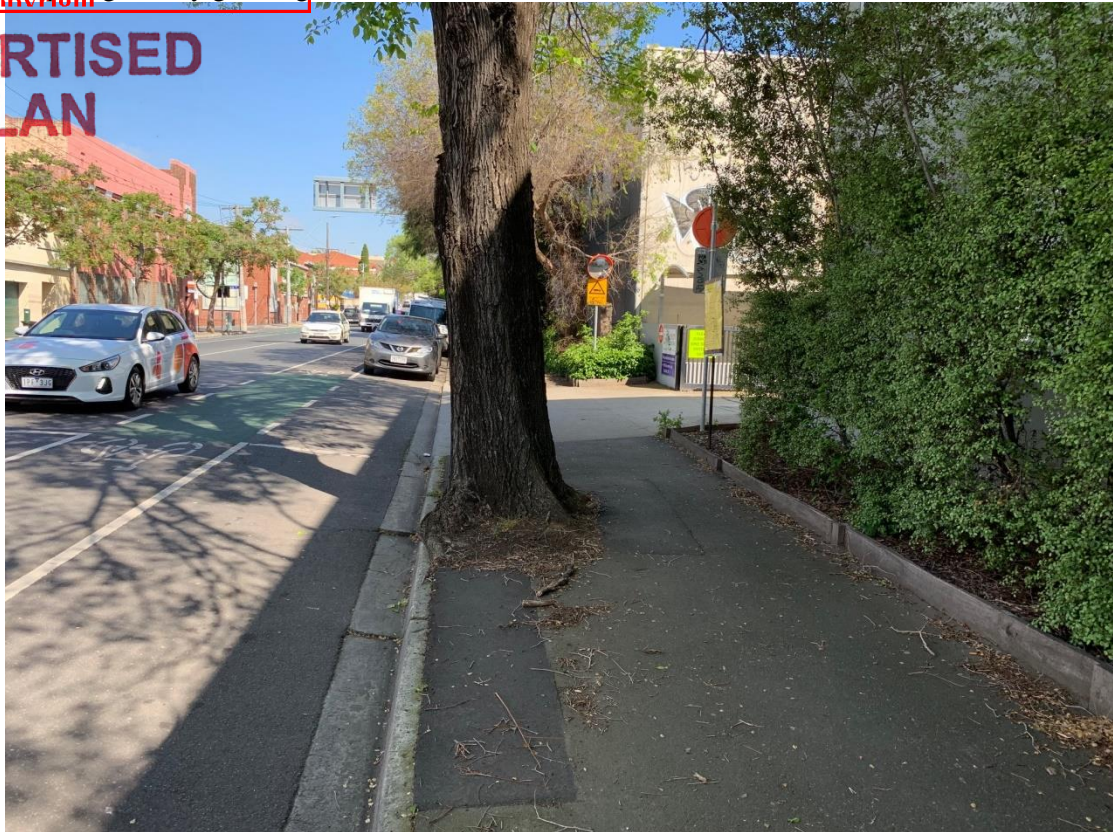
Tree 1, looking west – lean over the road is obvious.

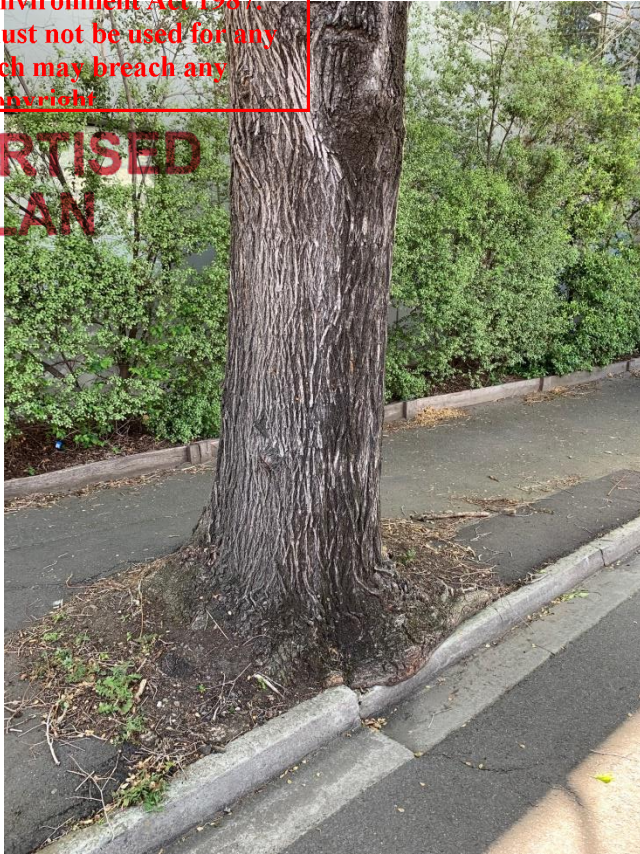
View of structural damage and encroachment of the trunk over the kerb.

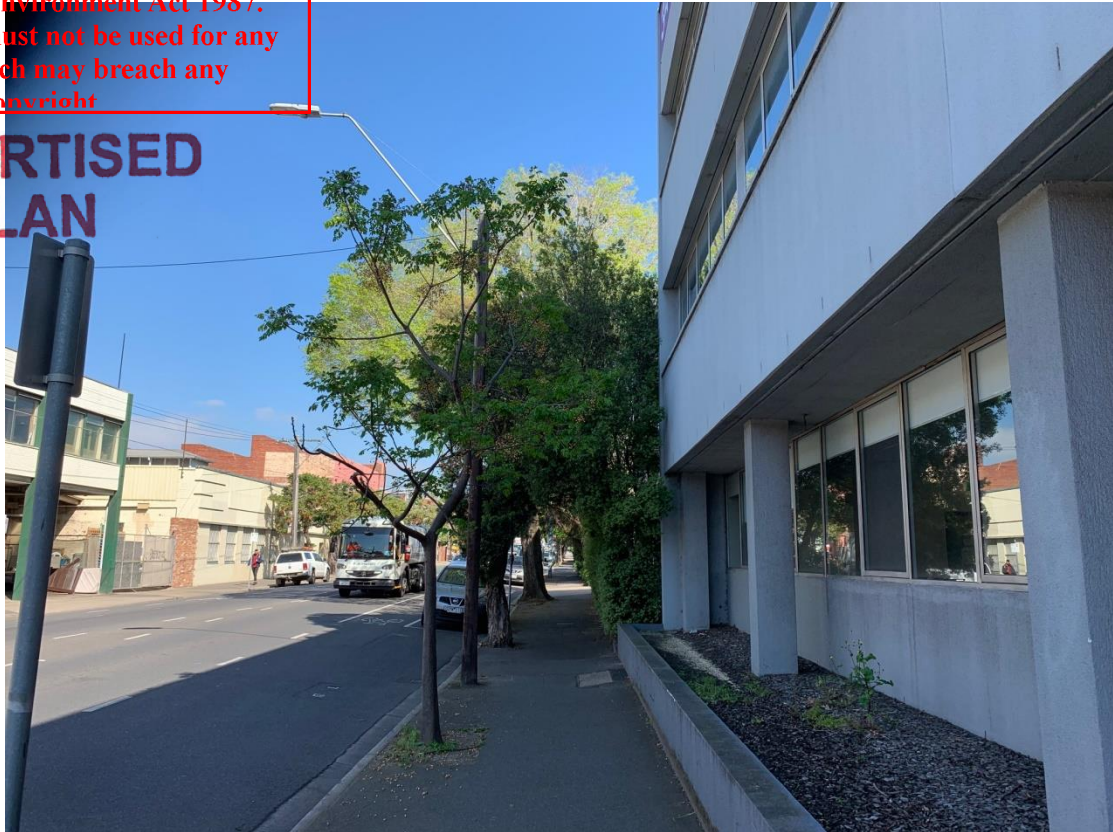
Trees 3-1 looking east to west.

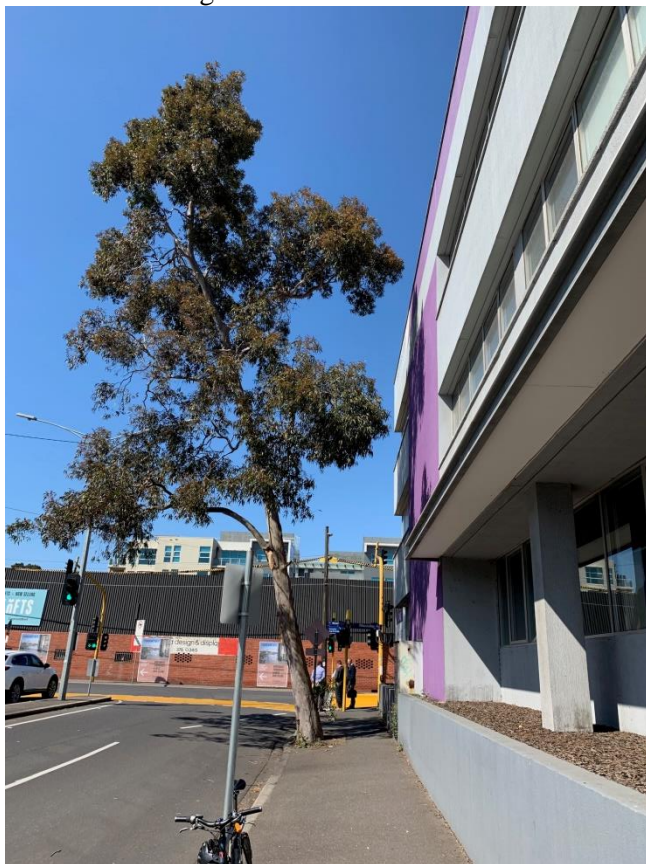
Tree 4 has a prominent lean over Stubbs Street.

Tree 4 cannot be retained, irrespective of whether there is any re-development of the site. It is a traffic hazard.

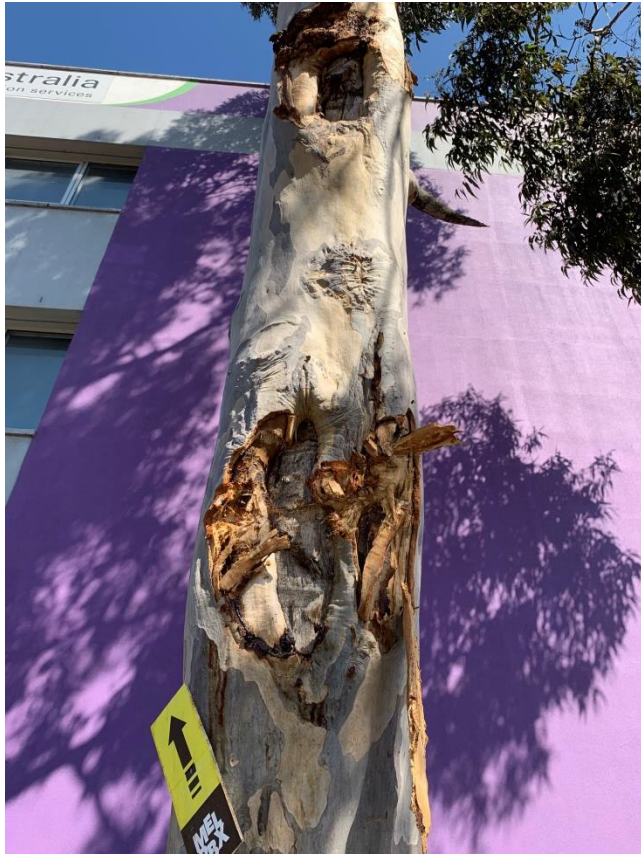
Close up of the repeated trunk vehicular impact wounds on tree 4.

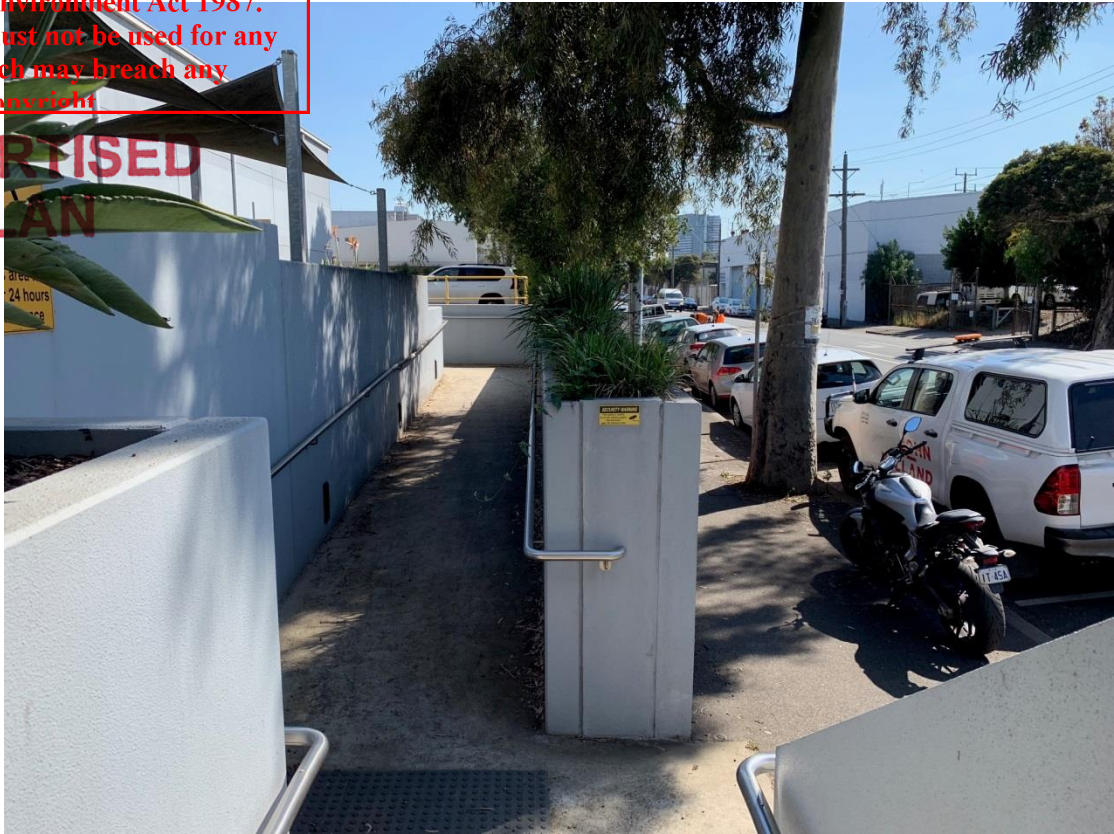
Significant root development is highly unlikely beneath the pedestrian concrete ramp opposite tree 5. Excavation to the left of the planter can take place without harming the tree.

With respect to tree 5, it is highly likely the tree can be successfully retained under this proposal. Its successful retention depends on whether there is any significant root development beneath the existing retaining walls making up the planter on the street frontage. My expectation is that there is not because of the height and solid nature of the walls of the planter, suggesting deep robust footings acting as root barriers. Furthermore conditions for root development west of the planter look poor – consisting of concrete and further retaining walls. The existing footings of the planter could be retained under this proposal so as to minimise disturbance of the root zone. Substantial pruning back of the west side of the crown will be required for the proposed building, however although this will affect the aesthetics of the tree, it is unlikely to impact on the SULE.
