## Application for Planning Permit

Cuckoo Lodge, 1 Beehive Lane (Lot 182B), Mount Buller

Alterations and additions to existing ski lodge (covered walkway and pedestrian entry)

February 2022

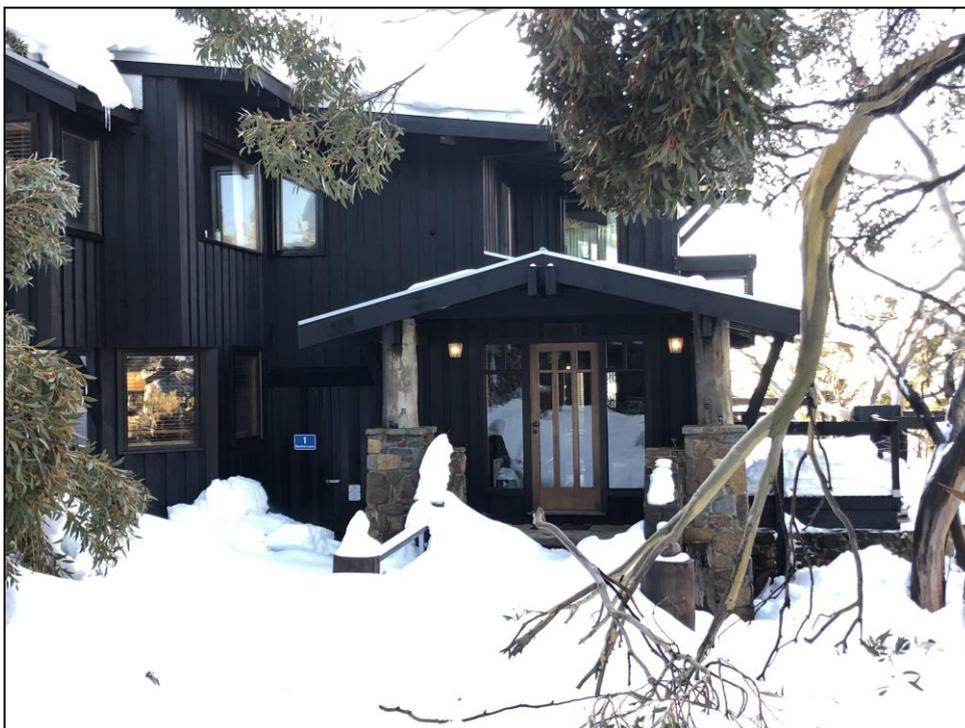
**Figure 3:** Entry to adjoining Wombat Lodge

The extent and type of materials are detailed in the accompanying architectural drawings and as mentioned above, its overall appearance complements the existing entry to Wombat Lodge (see below).

Although the new entrance to Wombat Lodge was subsequently built (as shown at Figure 3), the owners did not proceed with the more extensive underground works and entrance to Cuckoo Lodge.

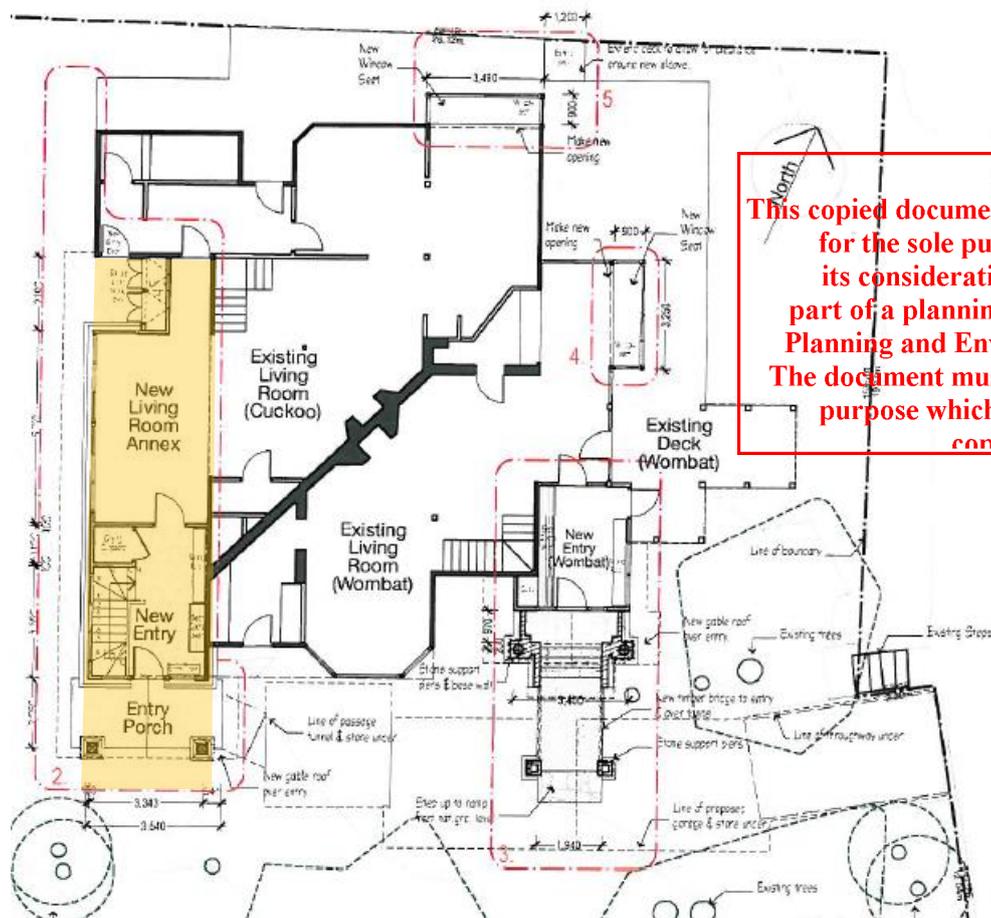
**Figure 4:** Portion of endorsed plans – Ground Floor Plan (with existing accessway shaded)

Planning Permit No. 2013/007709 was issued on 26 November 2013 allowing “buildings and works associated with an extension to existing buildings” at Lot 182 Beehive Lane, Mt. Buller. In summary, this earlier approval included the construction of two cellars and tandem basement garage within the front setback, accessed from a curved rampway from Beehive Lane, and a new pedestrian entry to Wombat Lodge. It also approved a ground and first floor extension to Cuckoo Lodge and new porch. Relevantly, the endorsed plans show an entry which is similar in appearance to the current request and the new living room annex extended over the current pedestrian accessway, as shaded at Figure 4 below. A copy of the permit and endorsed plan is included at **Attachment 2** of this report.

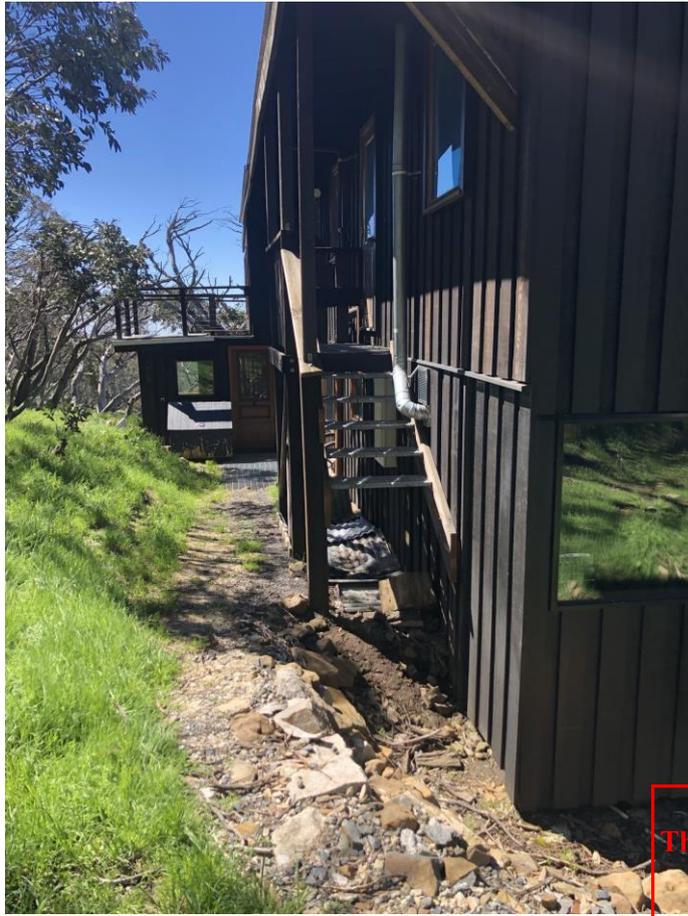
**Photo 1:**

Existing pedestrian walkway  
(summer)

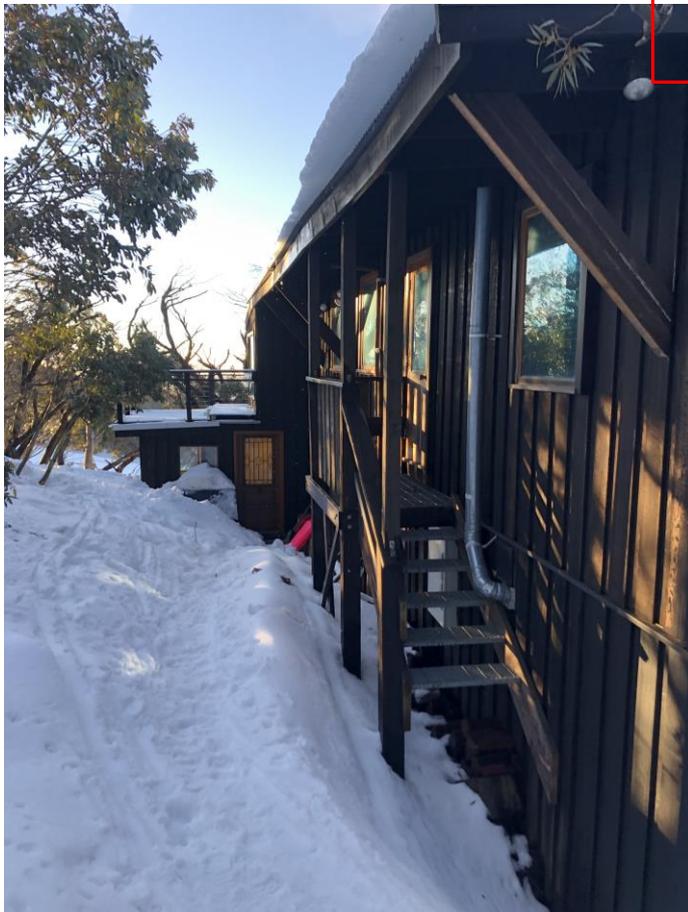
**Photo 2:**

Existing pedestrian walkway  
(winter – note snowshed)

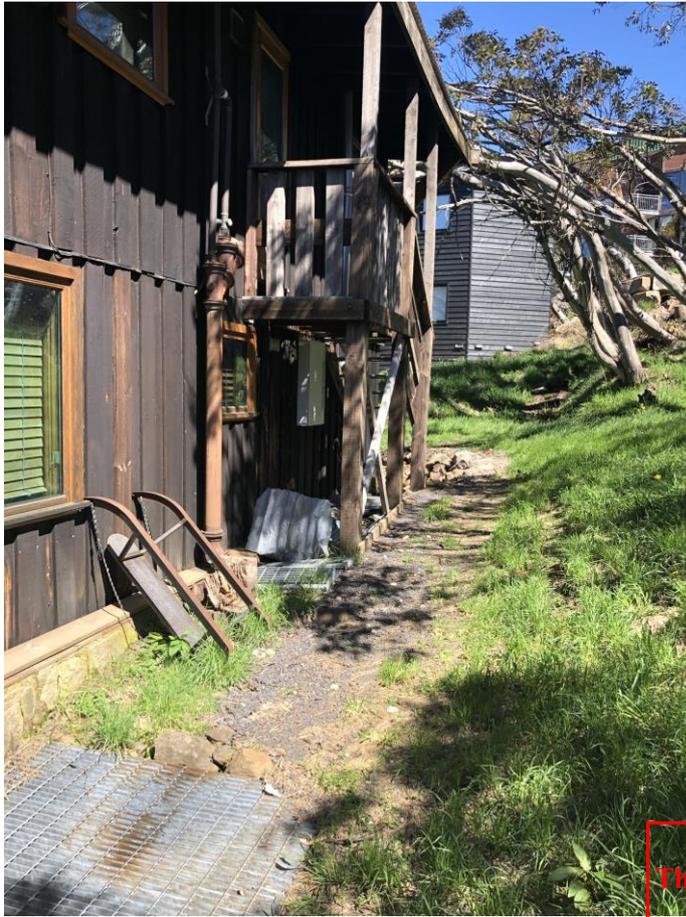
**Photo 3:**  
Stairway to be removed

- Demolition of existing external timber stairs and removal of doorway;
- Installation of stone pathway;
- Addition of a lean-to roof (with 10° fall) over the existing pedestrian accessway, with associated stone plinth and vertical timber supports;
- Alterations to doorway and adjoining windows within the southern façade; and
- Construction of a new gable roof over pedestrian entry, with low stone wall and timber supports.

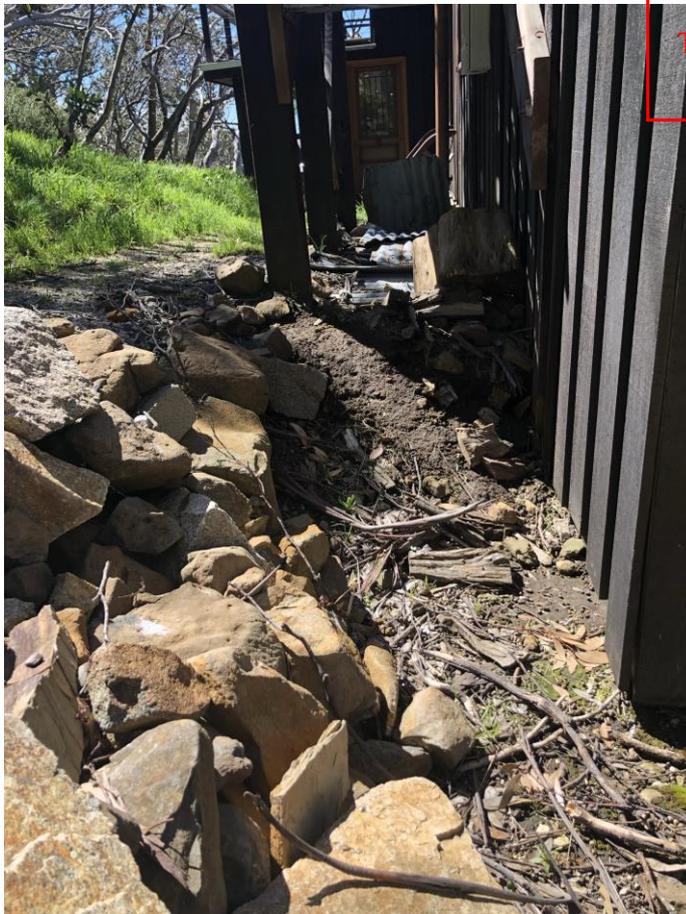
**Photo 4:**  
Rock wall and existing excavation

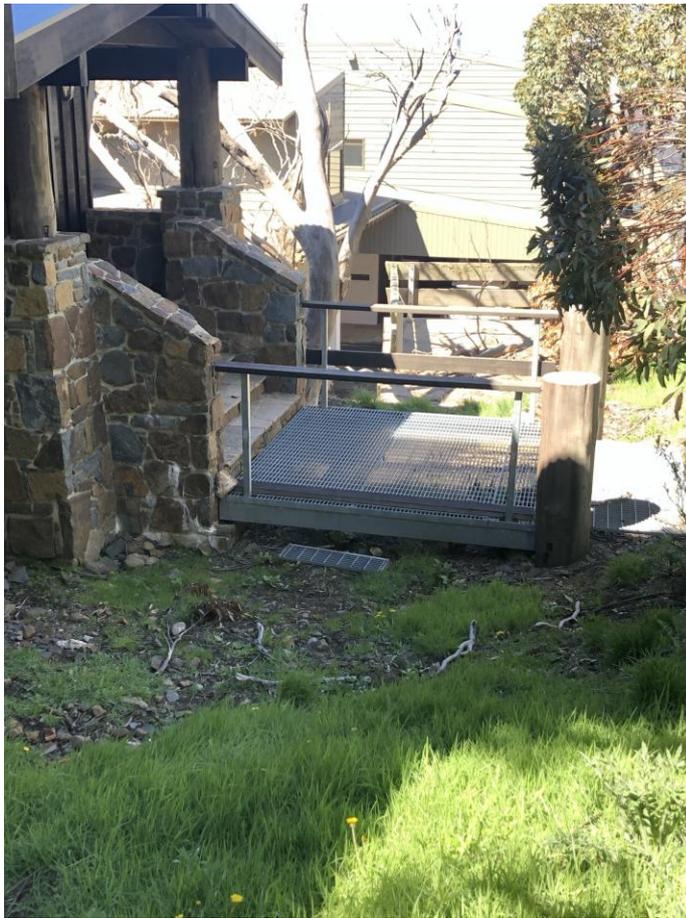
**Photo 5:**

Raised walkway to Wombat Lodge

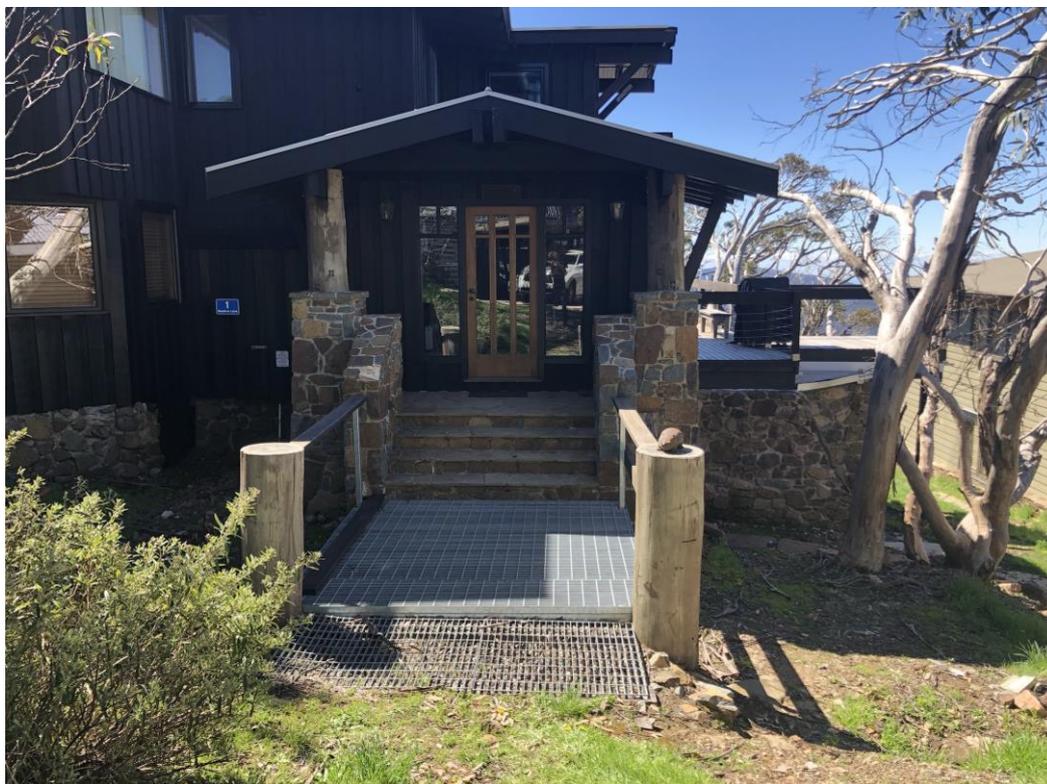
**Photo 6:** Gabled porch and stone/timber entry to Wombat Lodge

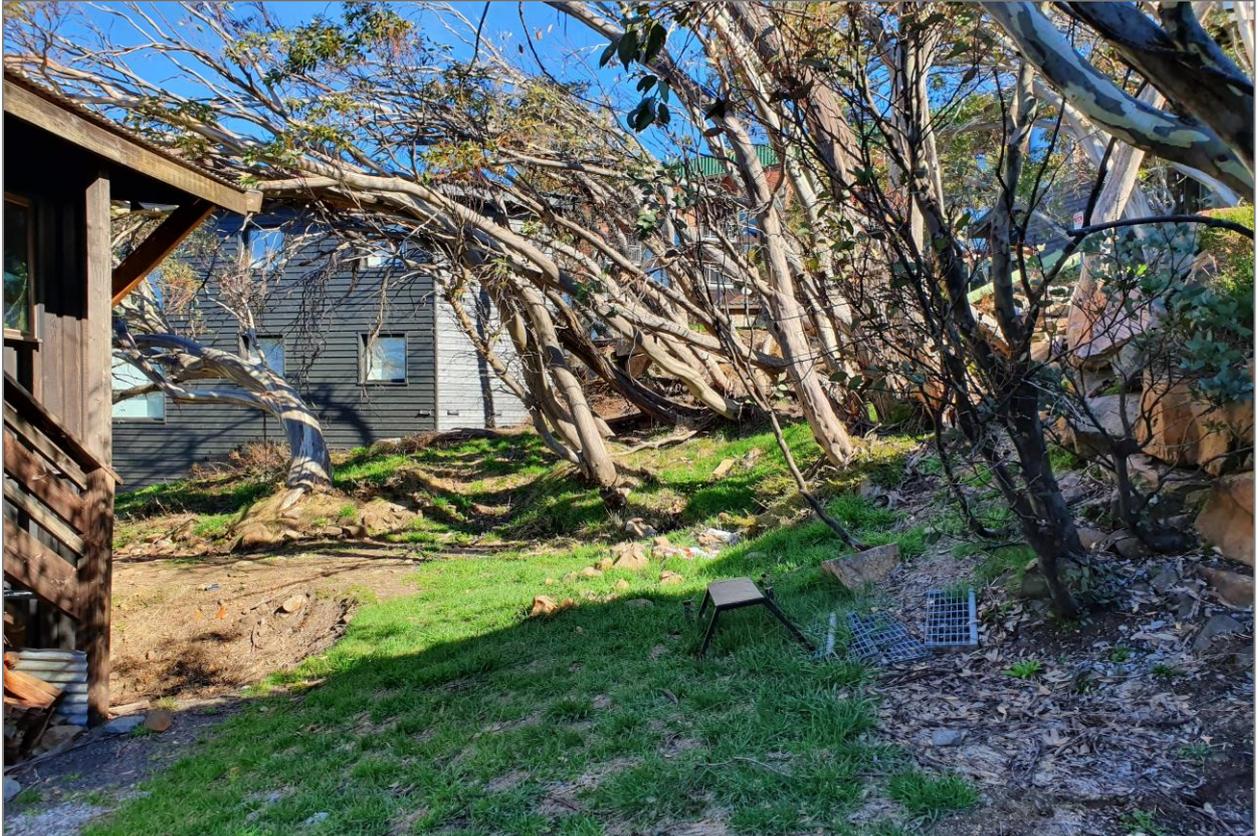
*West aspect, showing boulder fill*
