Heritage advice, former Kongwak Butter & Cheese Factory

Heritage impact assessment

Kongwak Butter & Cheese Factory

Final – 14 June 2023

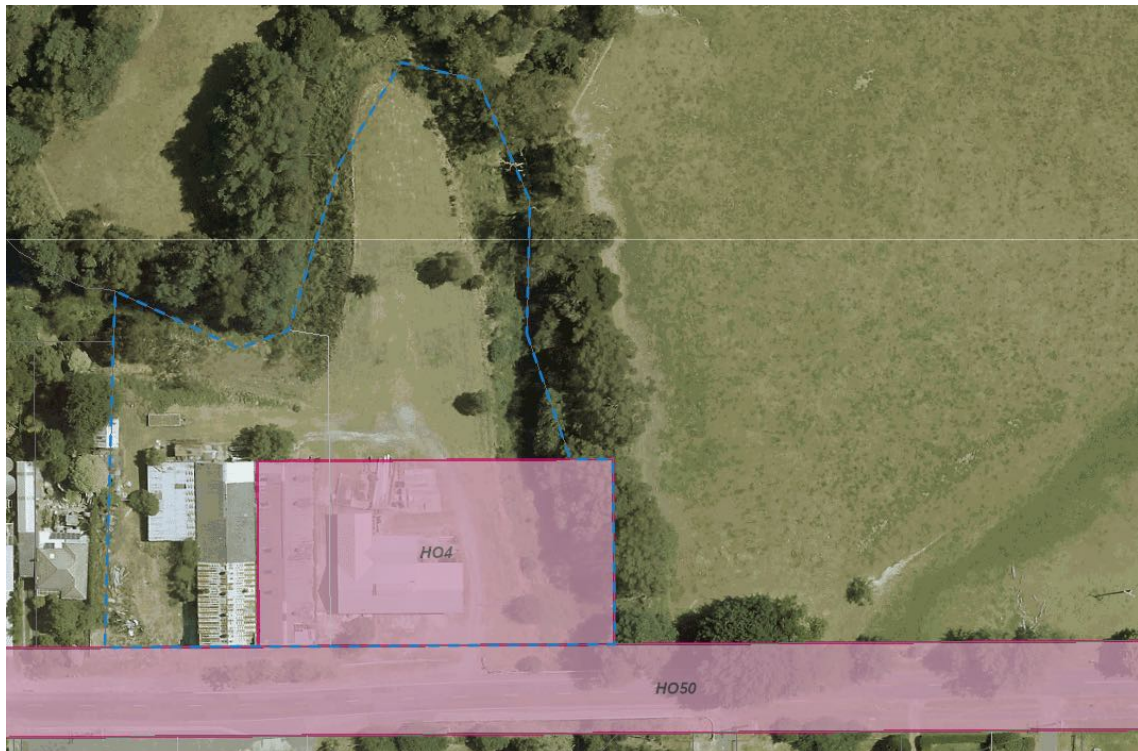
Figure 1: Extent of heritage overlays (Source: Vicplan)

Figure 1 shows that HO4 only applies to part of the subject site including the whole of the former butter factory (and the land to the east extending to Foster Creek), but only the eastern bay of the former cheese factory. The balance of the site (outlined in blue) is not within the HO.

The exclusion of the western bay of the former cheese factory is clearly an error and for the purposes of this HIS the whole of the building is assessed as being within the HO.

Figure 1 also shows part of the extent of HO50, which applies to the road reserve.

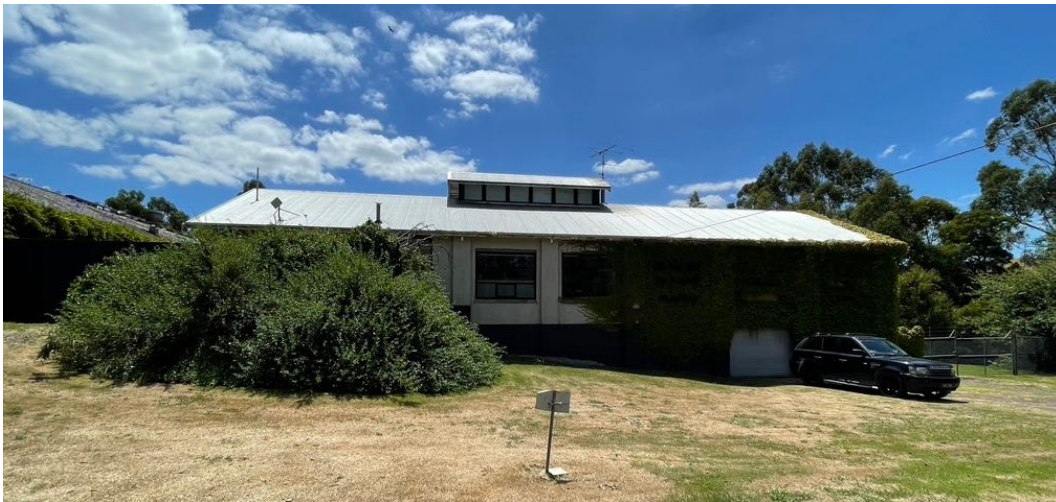
The former butter factory (Source: David Helms, 2023)

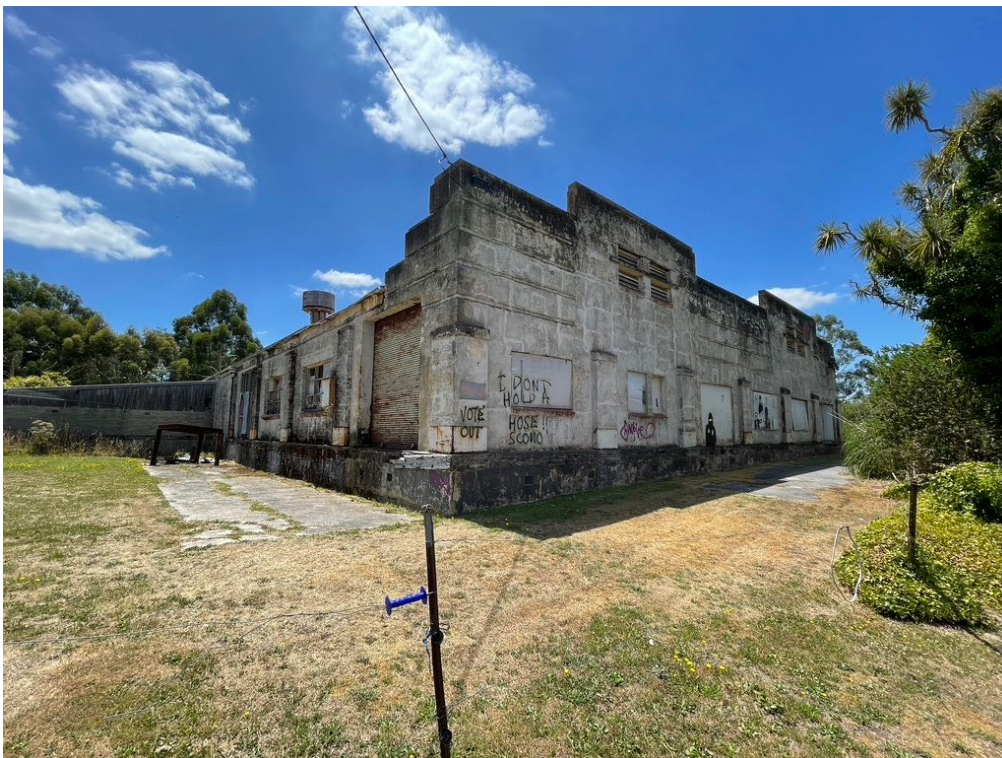
The former cheese factory (Source: David Helms, 2023)

During my site inspection I observed the current issues with the condition of the former cheese factory that have resulted in the need for the approved Stage 1 works. By comparison, the former butter factory has been renovated and is generally in good condition.

This inspection highlighted the urgent need to undertake repairs and other conservation works to ensure the former cheese factory can be retained and adaptively re-used. Without these works, the building is in potential danger of deteriorating to the point where demolition would be the only feasible outcome.

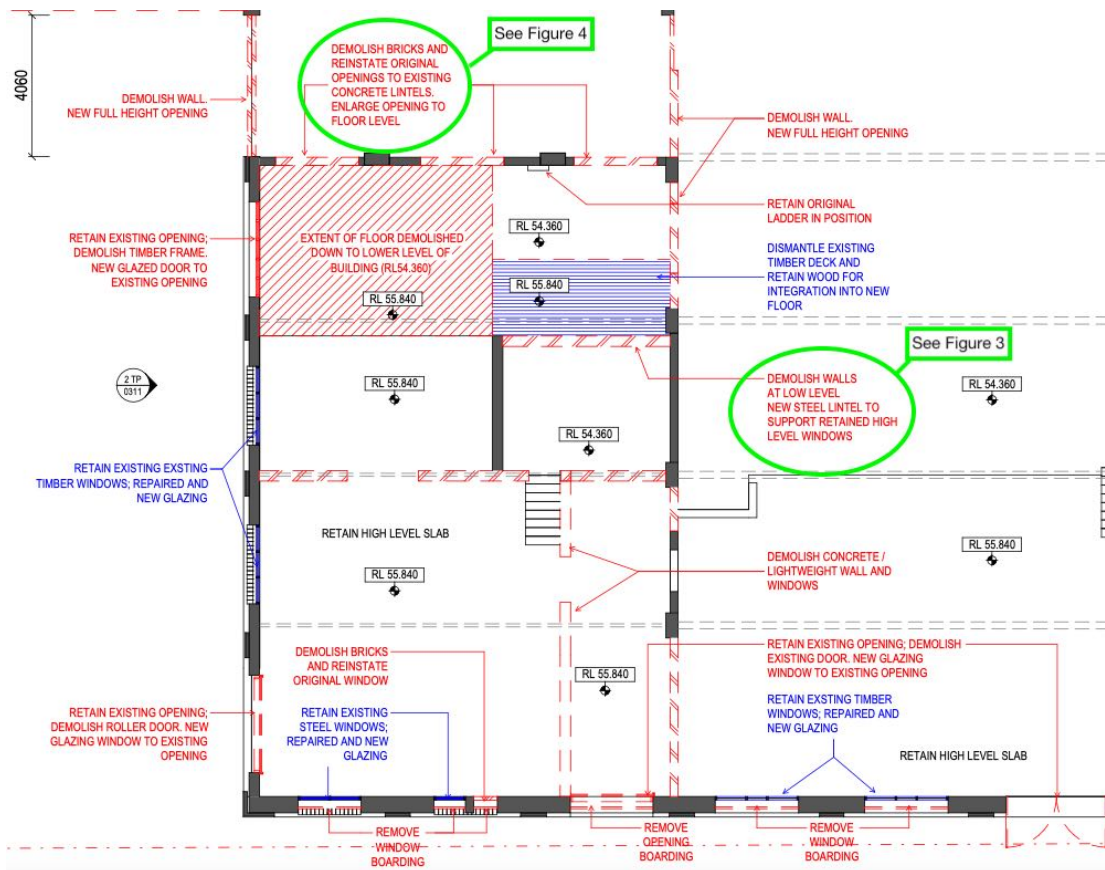
Figure 2 – Extract of demolition plan showing the proposed internal changes to the former cheese factory. The changes outlined in green are illustrated in Figures 3 and 4.

Some of the demolition will result in a positive change by removing intrusive features and/or allowing original features to be revealed, reinstated, or reconstructed. This includes:

- The removal of the lean-to addition, and the non-original boarding over the windows in the façade of the former cheese factory.
- The removal of brickwork to enable the reconstruction of original windows to both buildings.
- The removal of the non-original floor to the eastern section of the former butter factory, which will restore the original double-height volume of this space.

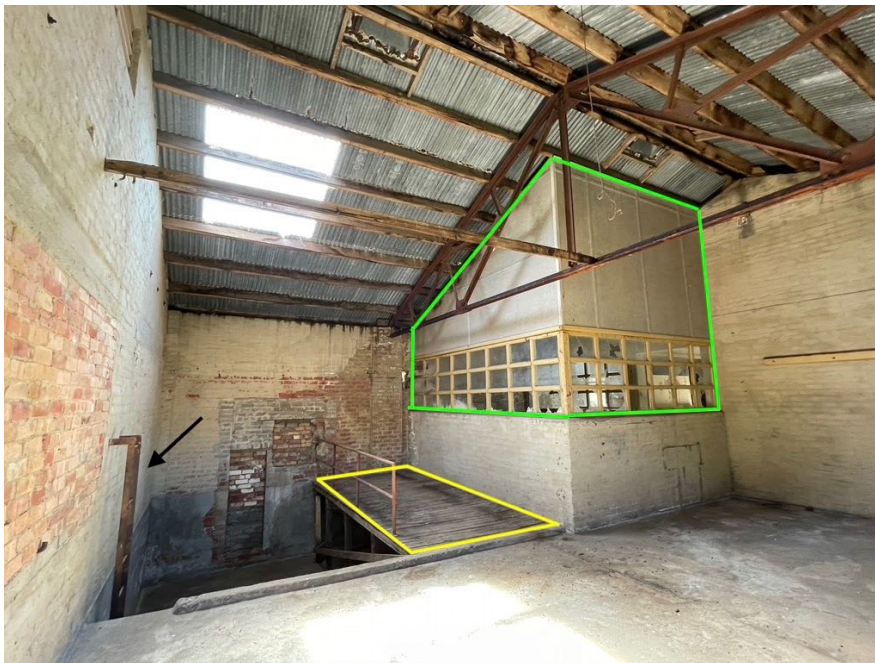
Figure 3: As shown in Figure 2, the section of original wall and glazing outlined in green will be retained as evidence of the original detailing within this space, the timber deck materials will be retained and reinstated in the floor below and the ladder at left will be retained.

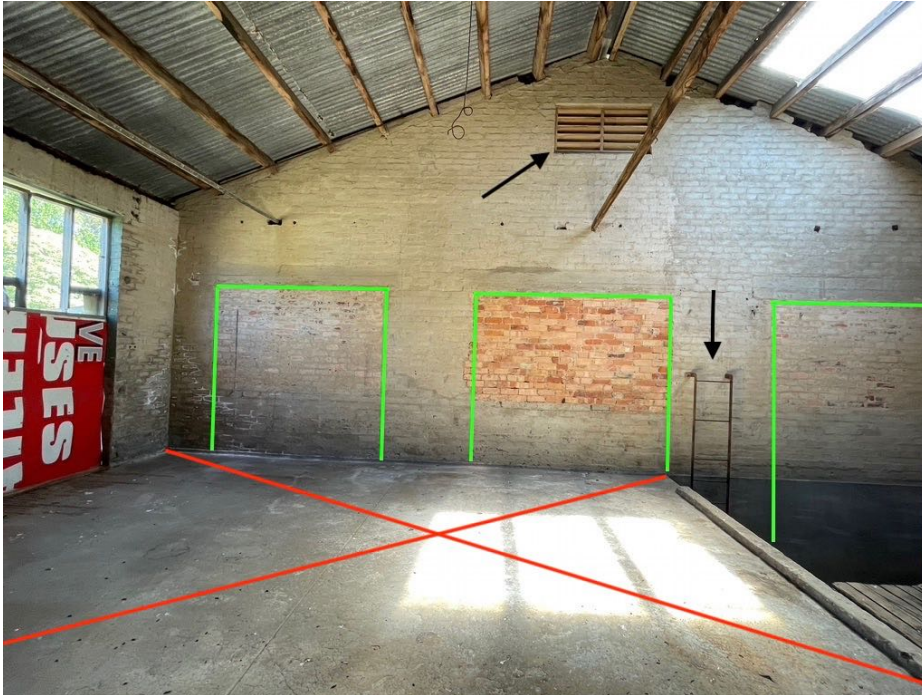
Figure 4: The three original window openings (bricked in later) outlined in green will be reopened and extended to floor level (the section of floor marked in red will be lowered to match the level of the lower floor at right). This will enable the staged development of the factory to be interpreted. Original features indicated by the arrows including the louvred vent and the ladder will be retained.

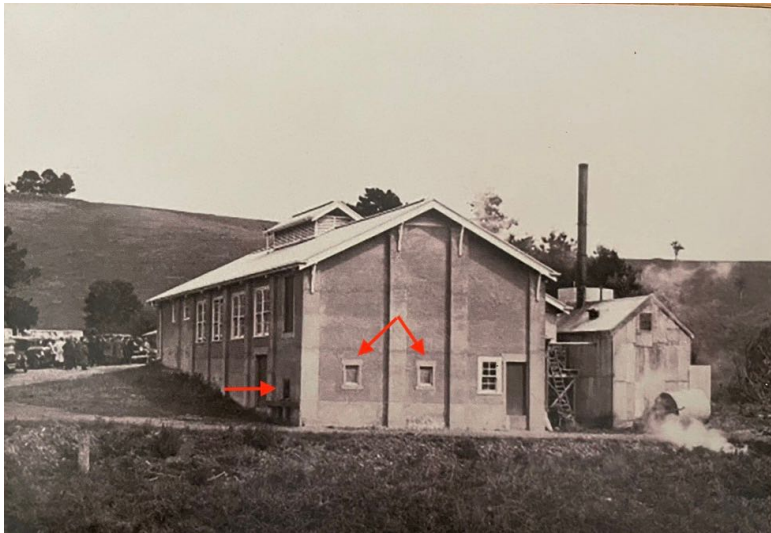
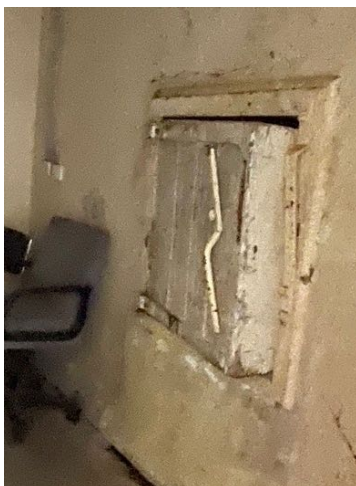
Figure 5: Top: c.1920s/30s image of the former butter factory showing the original openings in the east and front elevation (indicated by added red arrows) that will be reinstated. The lower image shows the original door to the front opening that survives and will be retained.

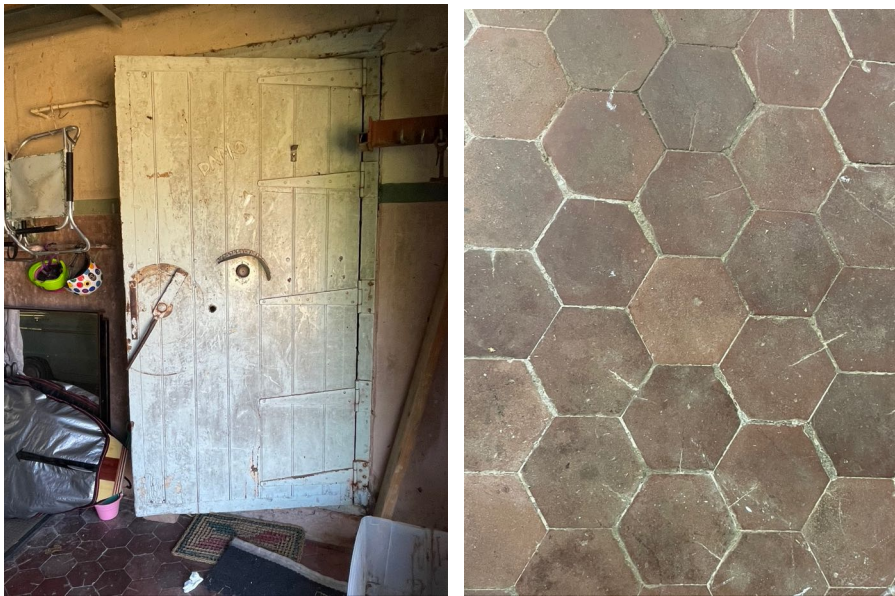
Figure 6: Original coolroom door at left and hexagonal tiles at right, which will be retained.

- While alterations are proposed to the layout of internal walls of the former cheese factory, enough fabric will remain to ensure the original spatial arrangement of this area as a series of discrete rooms can be interpreted. As illustrated in Figures 3 and 4, this includes the retention of an original wall ladder (enabling the original change in floor level to be understood), and reinstatement of timber deck materials in the same location, but at a lower height, to indicate the original location.
- In the former butter factory, the original double-height volume to the eastern half of the building will be restored. While one original wall in this space will be removed, this will be interpreted by the change in level and the retention of the original coolroom door. The important original hexagonal floor tiles will be retained within this space (Figure 6).

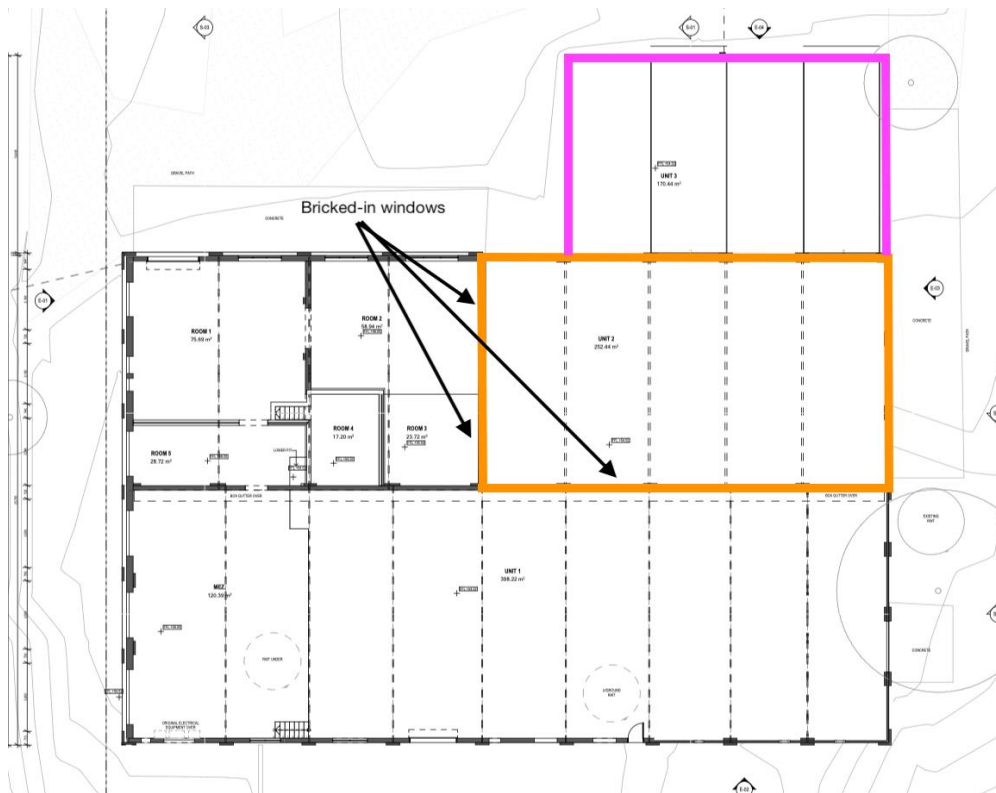
The rear section of the west bay outlined in orange is a later stage of the c.1941 factory, evidenced by bricked up windows in the walls as indicated. The section outlined in purple is a post-World War II addition.

- It appears the c.1941 building was constructed in at least two stages, as shown on the following plan. This is indicated by:
 - Evidence of bricked-in windows in a now internal walls in about the centre of the west bay and along the rear section of the central dividing wall.
 - Different construction materials (concrete block, timber trusses instead of metal, and asbestos cement roof cladding) of the rear section of the west bay.

There is also a post-World War II addition on the west side.

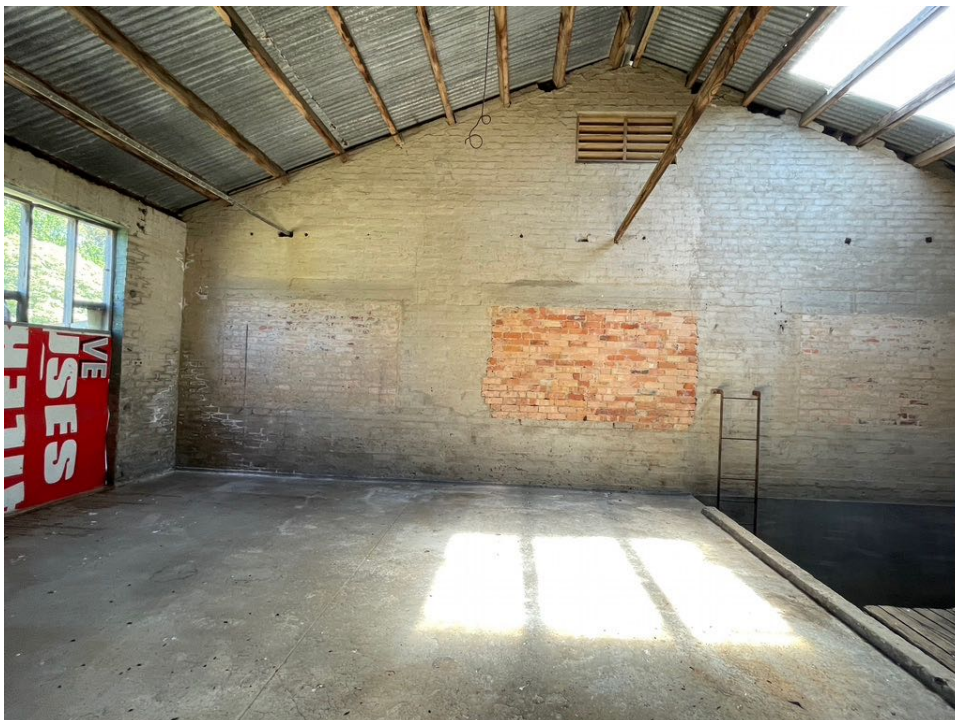
Evidence of bricked-in windows in central wall of western bay.

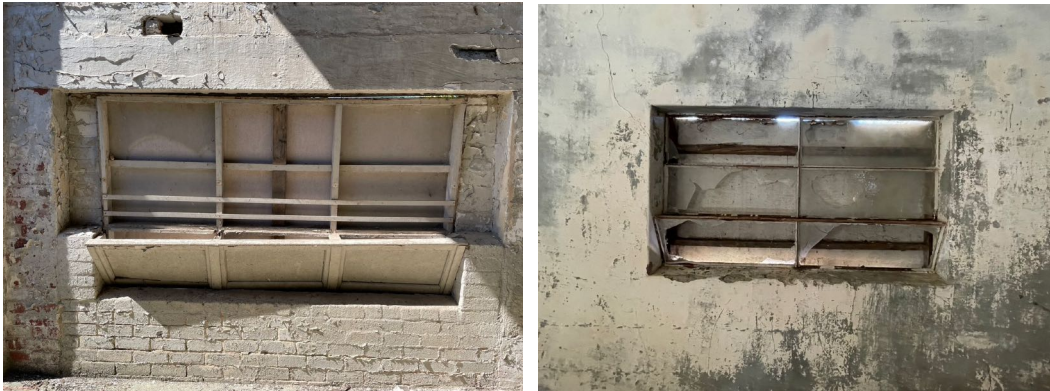
Façade windows in the east (left) and west (right) bays as viewed internally.

- The roof is a double gable structure, with the roof to the east bay (which is slightly wider) having a 26 degree pitch with a lower springing point, while the roof the narrower west bay has a 20 degree pitch that springs from a higher point on the side walls.
- Most of the roof is corrugated iron, except for the rear section of the west bay and there are large metal ventilators in the front section of the roof on the west bay.
- The windows in the front and west side elevations partially survive behind the external timber infill. These are multi-paned with inward opening 'hoppers' at the bottom. Those in the façade on the east side are timber framed. Those on the west side of the façade are metal framed – the one closest to the centre has been partially bricked in. Along the west side the windows are timber framed and are more intact.

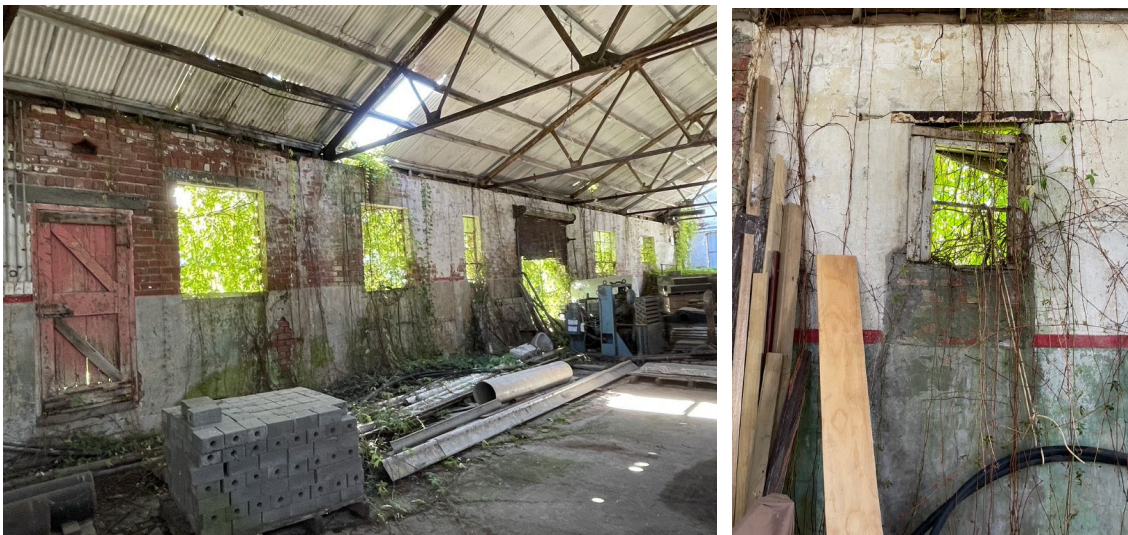
At left, Window openings along the east wall. At right, partially infilled timber window

- The east side wall originally contained a series of square metal and narrow timber framed windows. Several of these have been lost and in others only the metal frame survives. Most of the narrow timber windows toward the rear have been filled in with brick – one partially survives.

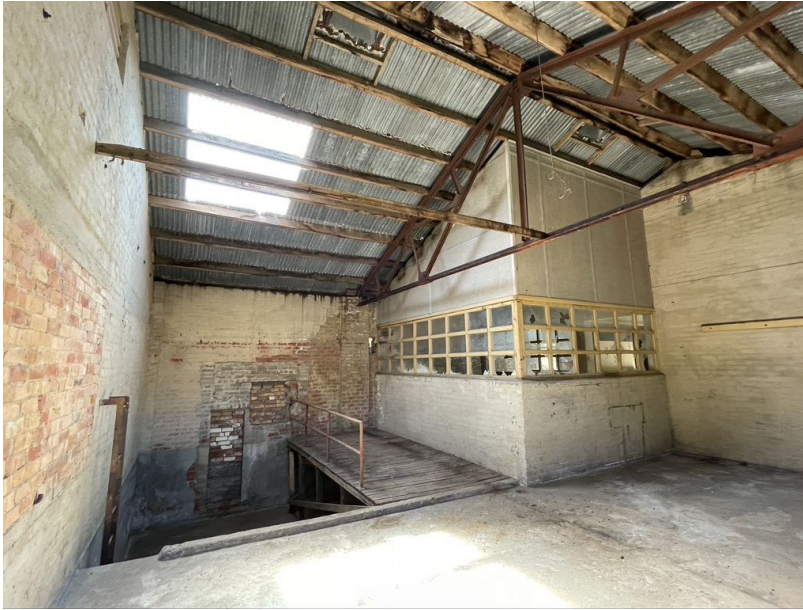
Part of the internal layout of the western bay showing timber framed glazing, ladders, and stairs etc

- Internally, the front section of the west bay retains some of the original room layout, and details such as timber framed glazing, ladders, and stairs etc. This is understood to have partly contained the administrative offices for the building.

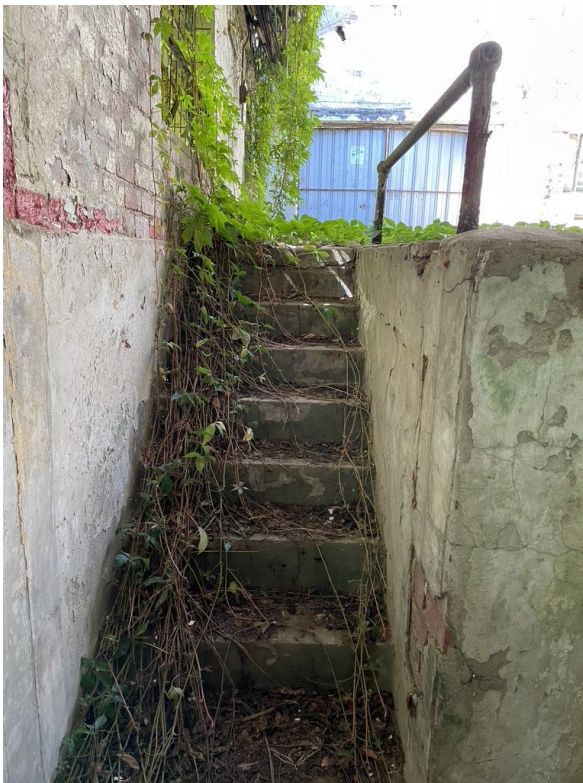
Stair and metal rail at one side of raised platform.

- On the east side the raised platform retains some original details including a stair with metal balustrade, and a crane device attached to one of the trusses.

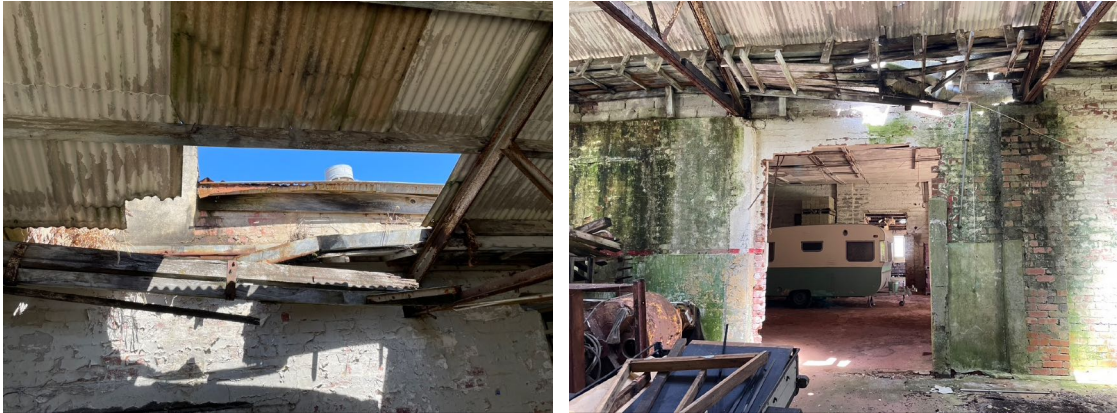
Missing sections of roof and failing sections of the central box gutter. Also note the lack of lintel to the added opening on the right.

- Sections of the roof are missing in places, and the central box gutter has failed, leading to water ingress and damage. Several openings added later to walls do not have lintels.

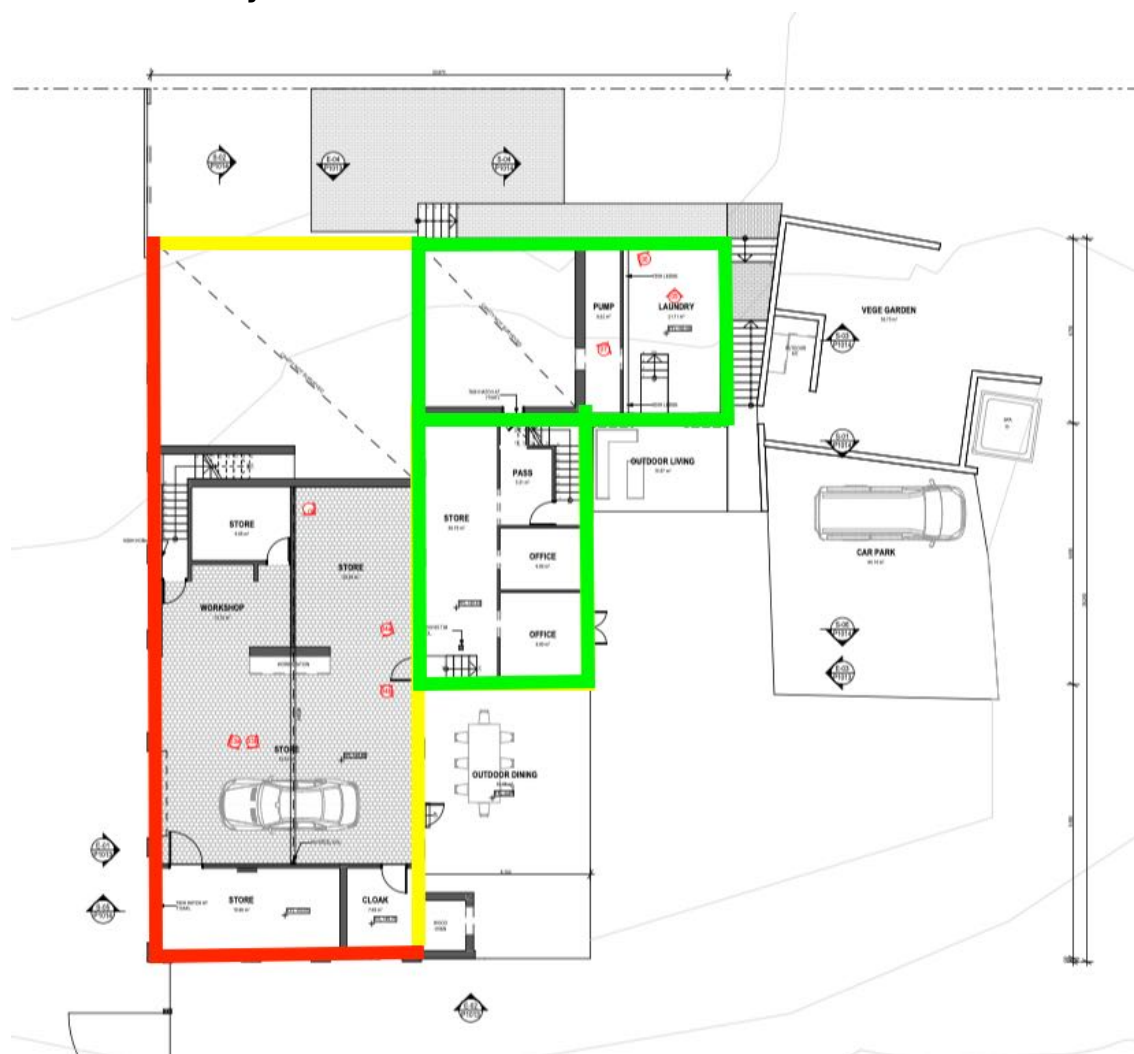
1925 Butter Factory

- Red – Primary significance
- Yellow – Secondary significance
- Green – Little or no significance

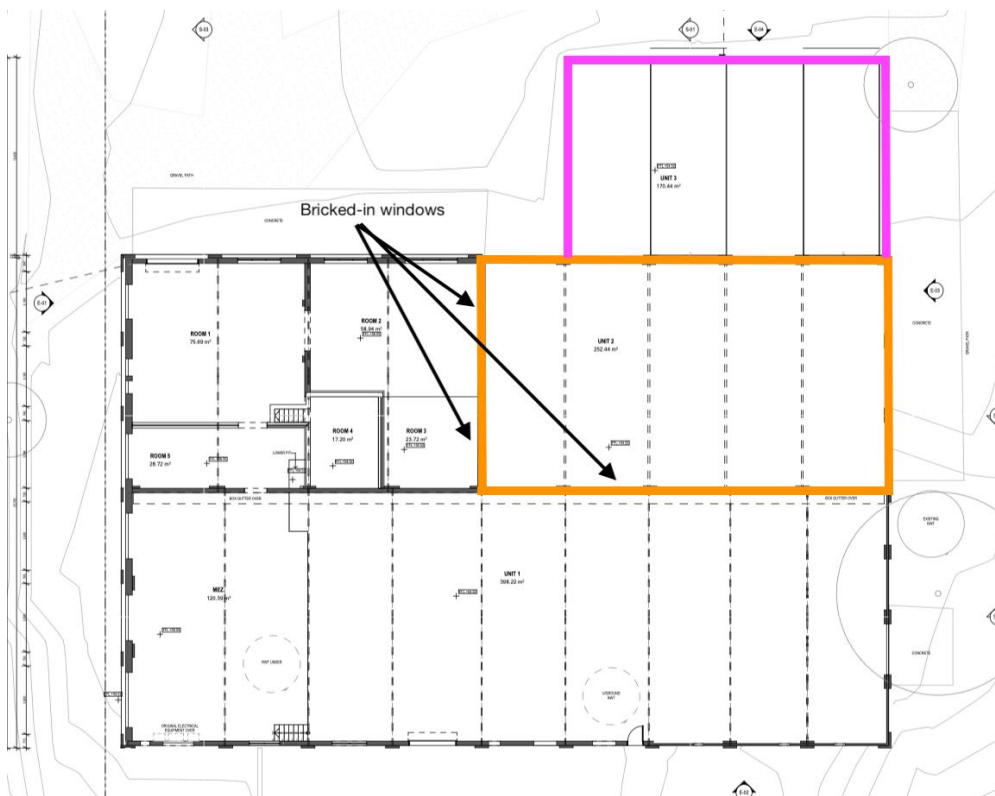
The rear section of the west bay outlined in orange is a later stage of the c.1941 factory, evidenced by bricked up windows in the walls as indicated. The section outlined in purple is a post-World War II addition.

- It appears the c.1941 building was constructed in at least two stages, as shown on the following plan. This is indicated by:
 - Evidence of bricked-in windows in a now internal walls in about the centre of the west bay and along the rear section of the central dividing wall.
 - Different construction materials (concrete block, timber trusses instead of metal, and asbestos cement roof cladding) of the rear section of the west bay.

There is also a post-World War II addition on the west side.

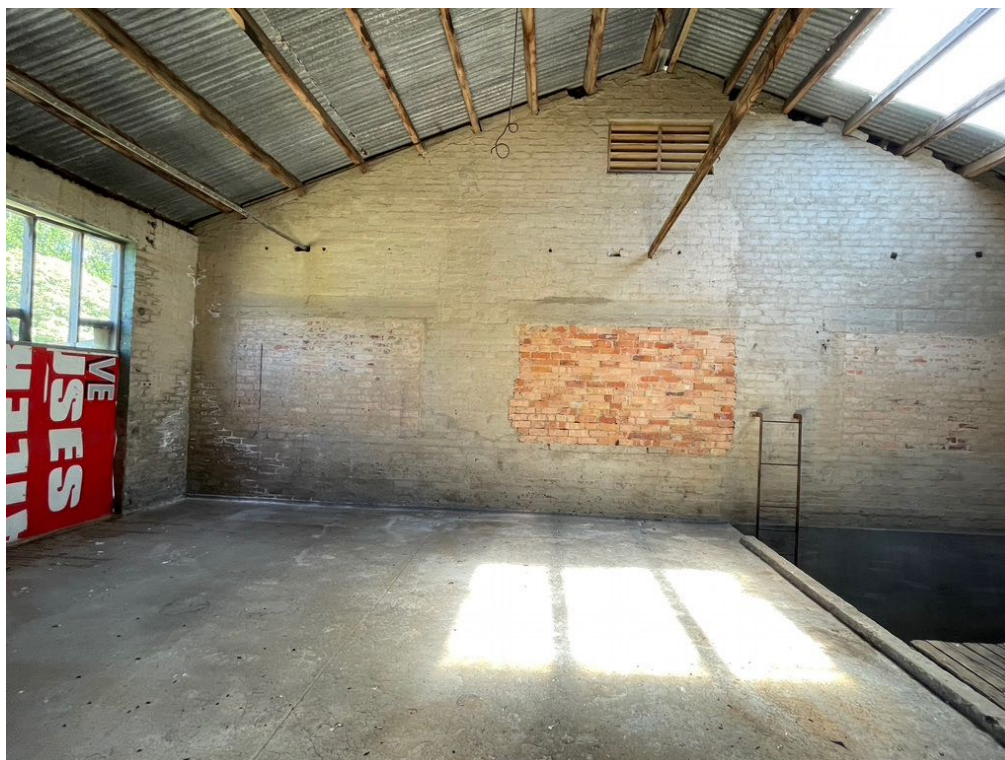
Evidence of bricked-in windows in central wall of western bay.

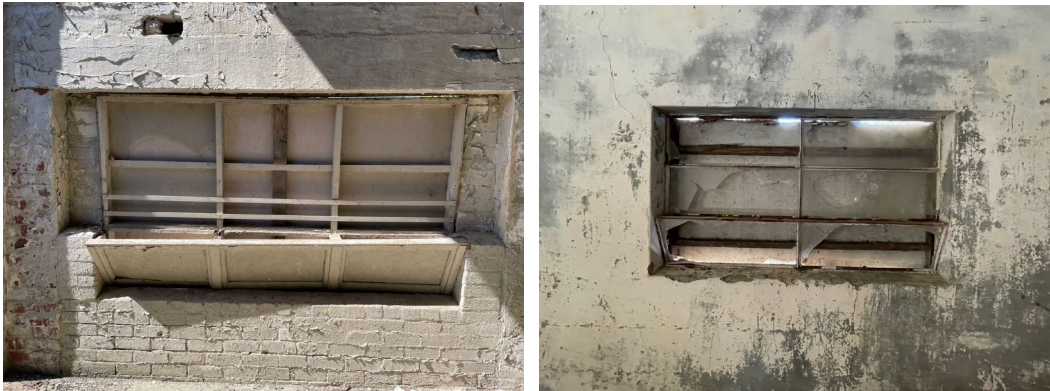
Façade windows in the east (left) and west (right) bays as viewed internally.

- The roof is a double gable structure, with the roof to the east bay (which is slightly wider) having a 26 degree pitch with a lower springing point, while the roof the narrower west bay has a 20 degree pitch that springs from a higher point on the side walls.
- Most of the roof is corrugated iron, except for the rear section of the west bay and there are large metal ventilators in the front section of the roof on the west bay.
- The windows in the front and west side elevations partially survive behind the external timber infill. These are multi-paned with inward opening 'hoppers' at the bottom. Those in the façade on the east side are timber framed. Those on the west side of the façade are metal framed – the one closest to the centre has been partially bricked in. Along the west side the windows are timber framed and are more intact.

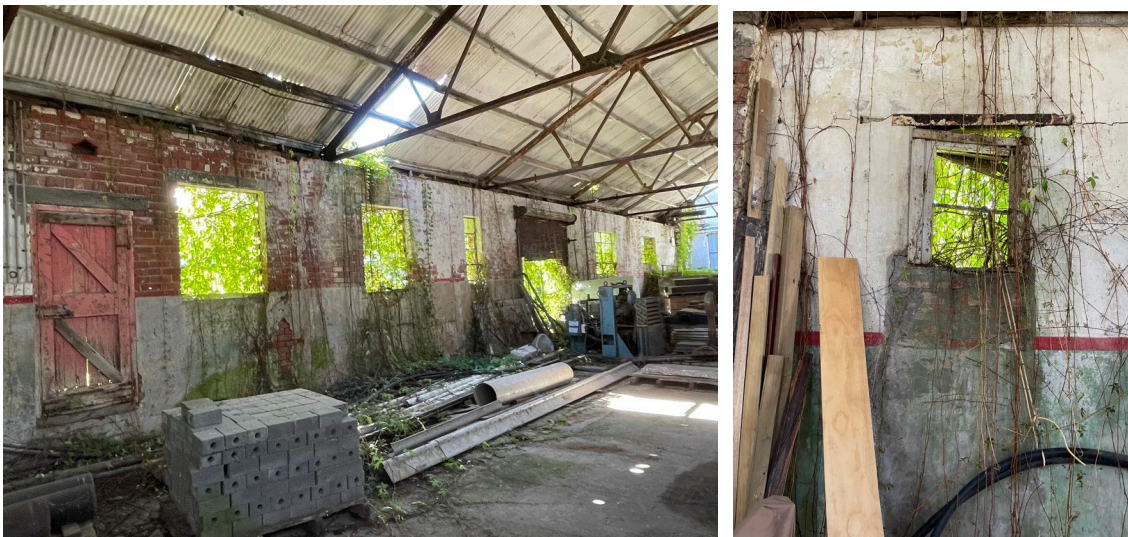
At left, Window openings along the east wall. At right, partially infilled timber window

- The east side wall originally contained a series of square metal and narrow timber framed windows. Several of these have been lost and in others only the metal frame survives. Most of the narrow timber windows toward the rear have been filled in with brick – one partially survives.

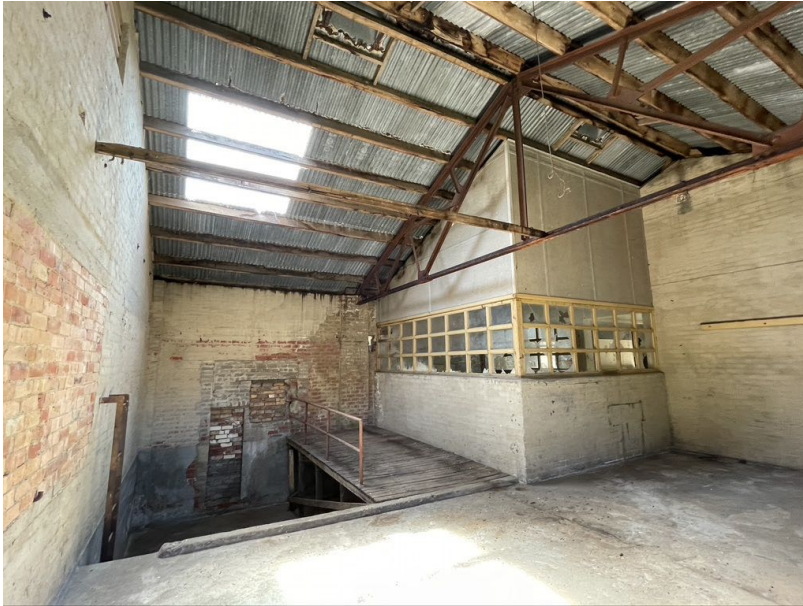
Part of the internal layout of the western bay showing timber framed glazing, ladders, and stairs etc

- Internally, the front section of the west bay retains some of the original room layout, and details such as timber framed glazing, ladders, and stairs etc. This is understood to have partly contained the administrative offices for the building.

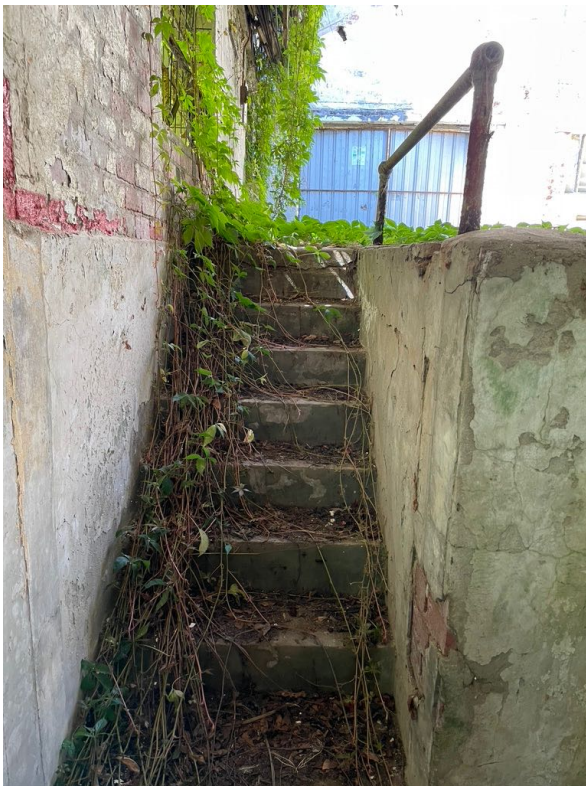
Stair and metal rail at one side of raised platform.

- On the east side the raised platform retains some original details including a stair with metal balustrade, and a crane device attached to one of the trusses.

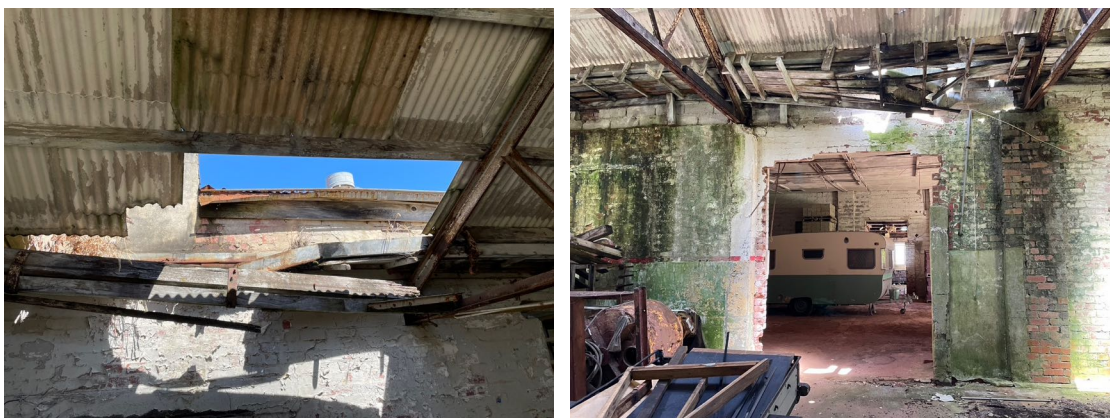
Missing sections of roof and failing sections of the central box gutter. Also note the lack of lintel to the added opening on the right.

- Sections of the roof are missing in places, and the central box gutter has failed, leading to water ingress and damage. Several openings added later to walls do not have lintels.
