MOUNT LILYDALE MERCY COLLEGE WATER SENSITIVE URBAN DESIGN ASSESSMENT

Stage 4 – Power Canteen & Staff offices

Document No.	b23203_CIV_WSUD_Assessment	Prepared By	Faslan Navavi
Revision No.	A2	Checked By	James Lee
Date	21.02.2024	Approved By	Faslan Navavi

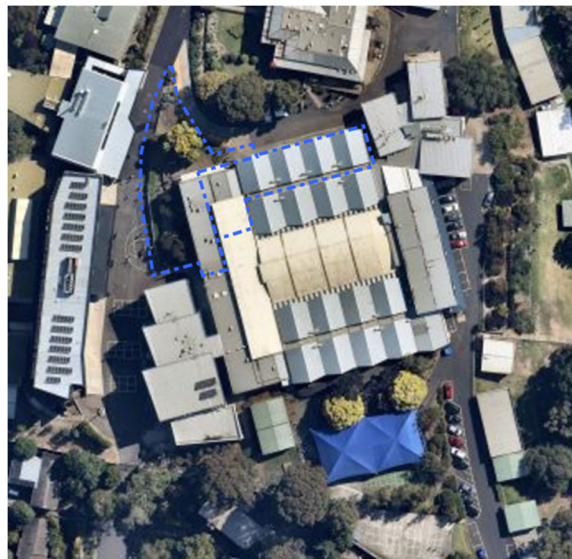
Figure 3.1 Aerial imagery

The new development is expected to be built over the existing landscaped batter next to the central driveway. The selected area of works is approximately 750sqm.

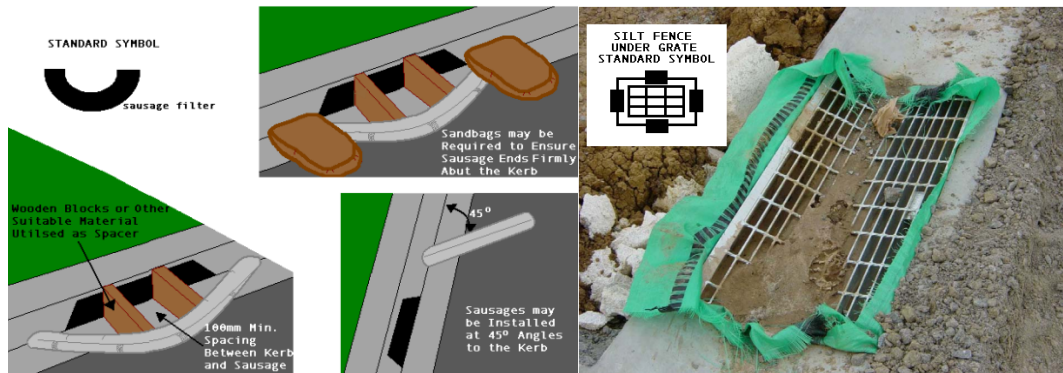
Figure 5.1A & 5.1B: Gravel sausage and under grate silt fence (EPA Victoria 2004, Publication 960 p.50/p.53)

Sediment traps to be installed on all pit inlets within the catchment area and any downstream pits that may reasonably be affected by construction works. Silt traps to be maintained weekly or after major or consistent rain falls.

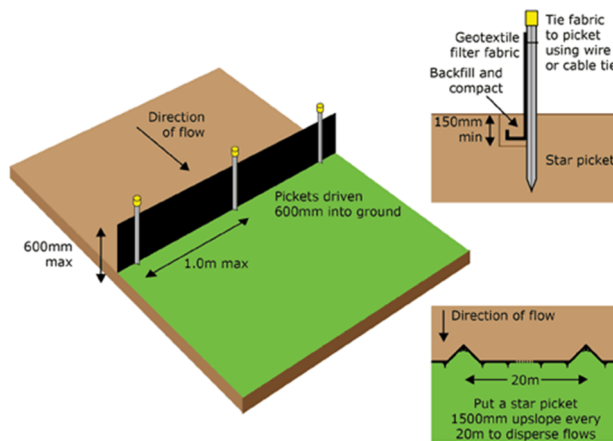
Figure 5.2: Silt fence (source: EPA Victoria 2004, Publication 960 p.30)

Geofabric lined silt fences are to be installed on the downhill side of the construction catchment. Refer to **Appendix 4** for silt fence layout.

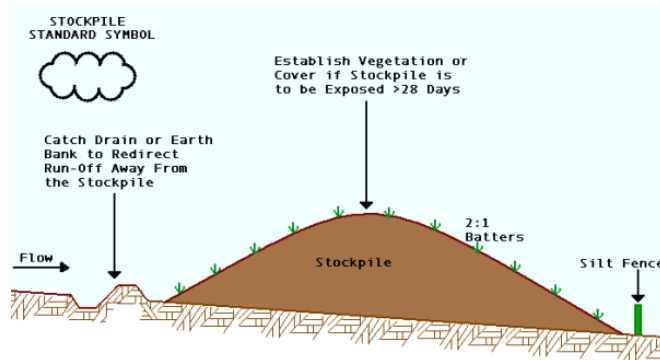
Figure 5.3: Stockpile protection (source: EPA Victoria 2004, Publication 960 p.25)

Long term material stockpiles or stockpiles on sloped land should be avoided where possible. Where stockpiles are necessary measures should be taken to ensure they are not within overland flow paths and silt fences should be installed on the downhill side to control sediment runoff. Long term stockpiles should be fitted with secured fabric or vegetated to prevent wind scouring.

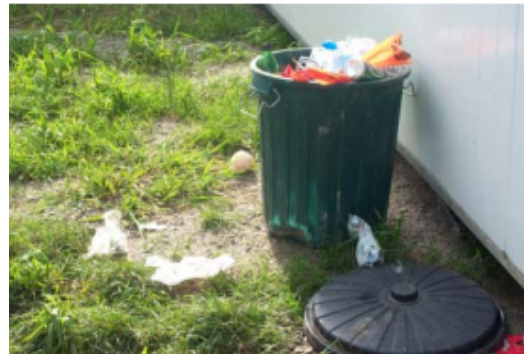
Figure 5.4: Site bin (source: EPA Victoria 2004, Publication 960 p.84)

Bins should be placed regularly around the site and next to site offices and dining areas to ensure appropriate litter controls. Site cleanup should be undertaken and bins emptied daily to reduce litter ingress into the drainage system.

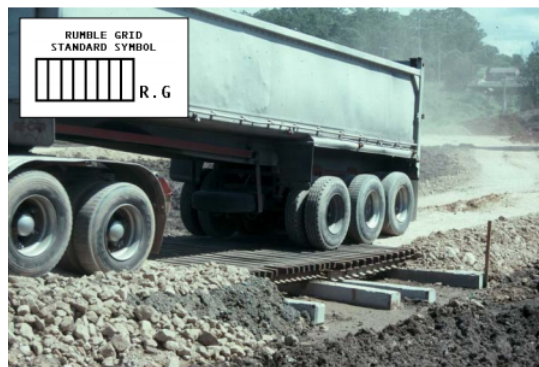
Figure 5.5: Rumble grid (source: EPA Victoria 2004, Publication 960 p.63)

Where excessive mud is present vehicle and pavement washdown should be undertaken regularly to reduce exporting sediment from the site. Gravel or rumble grids should be installed on vehicle access routes for additional sediment removal from exiting vehicles.

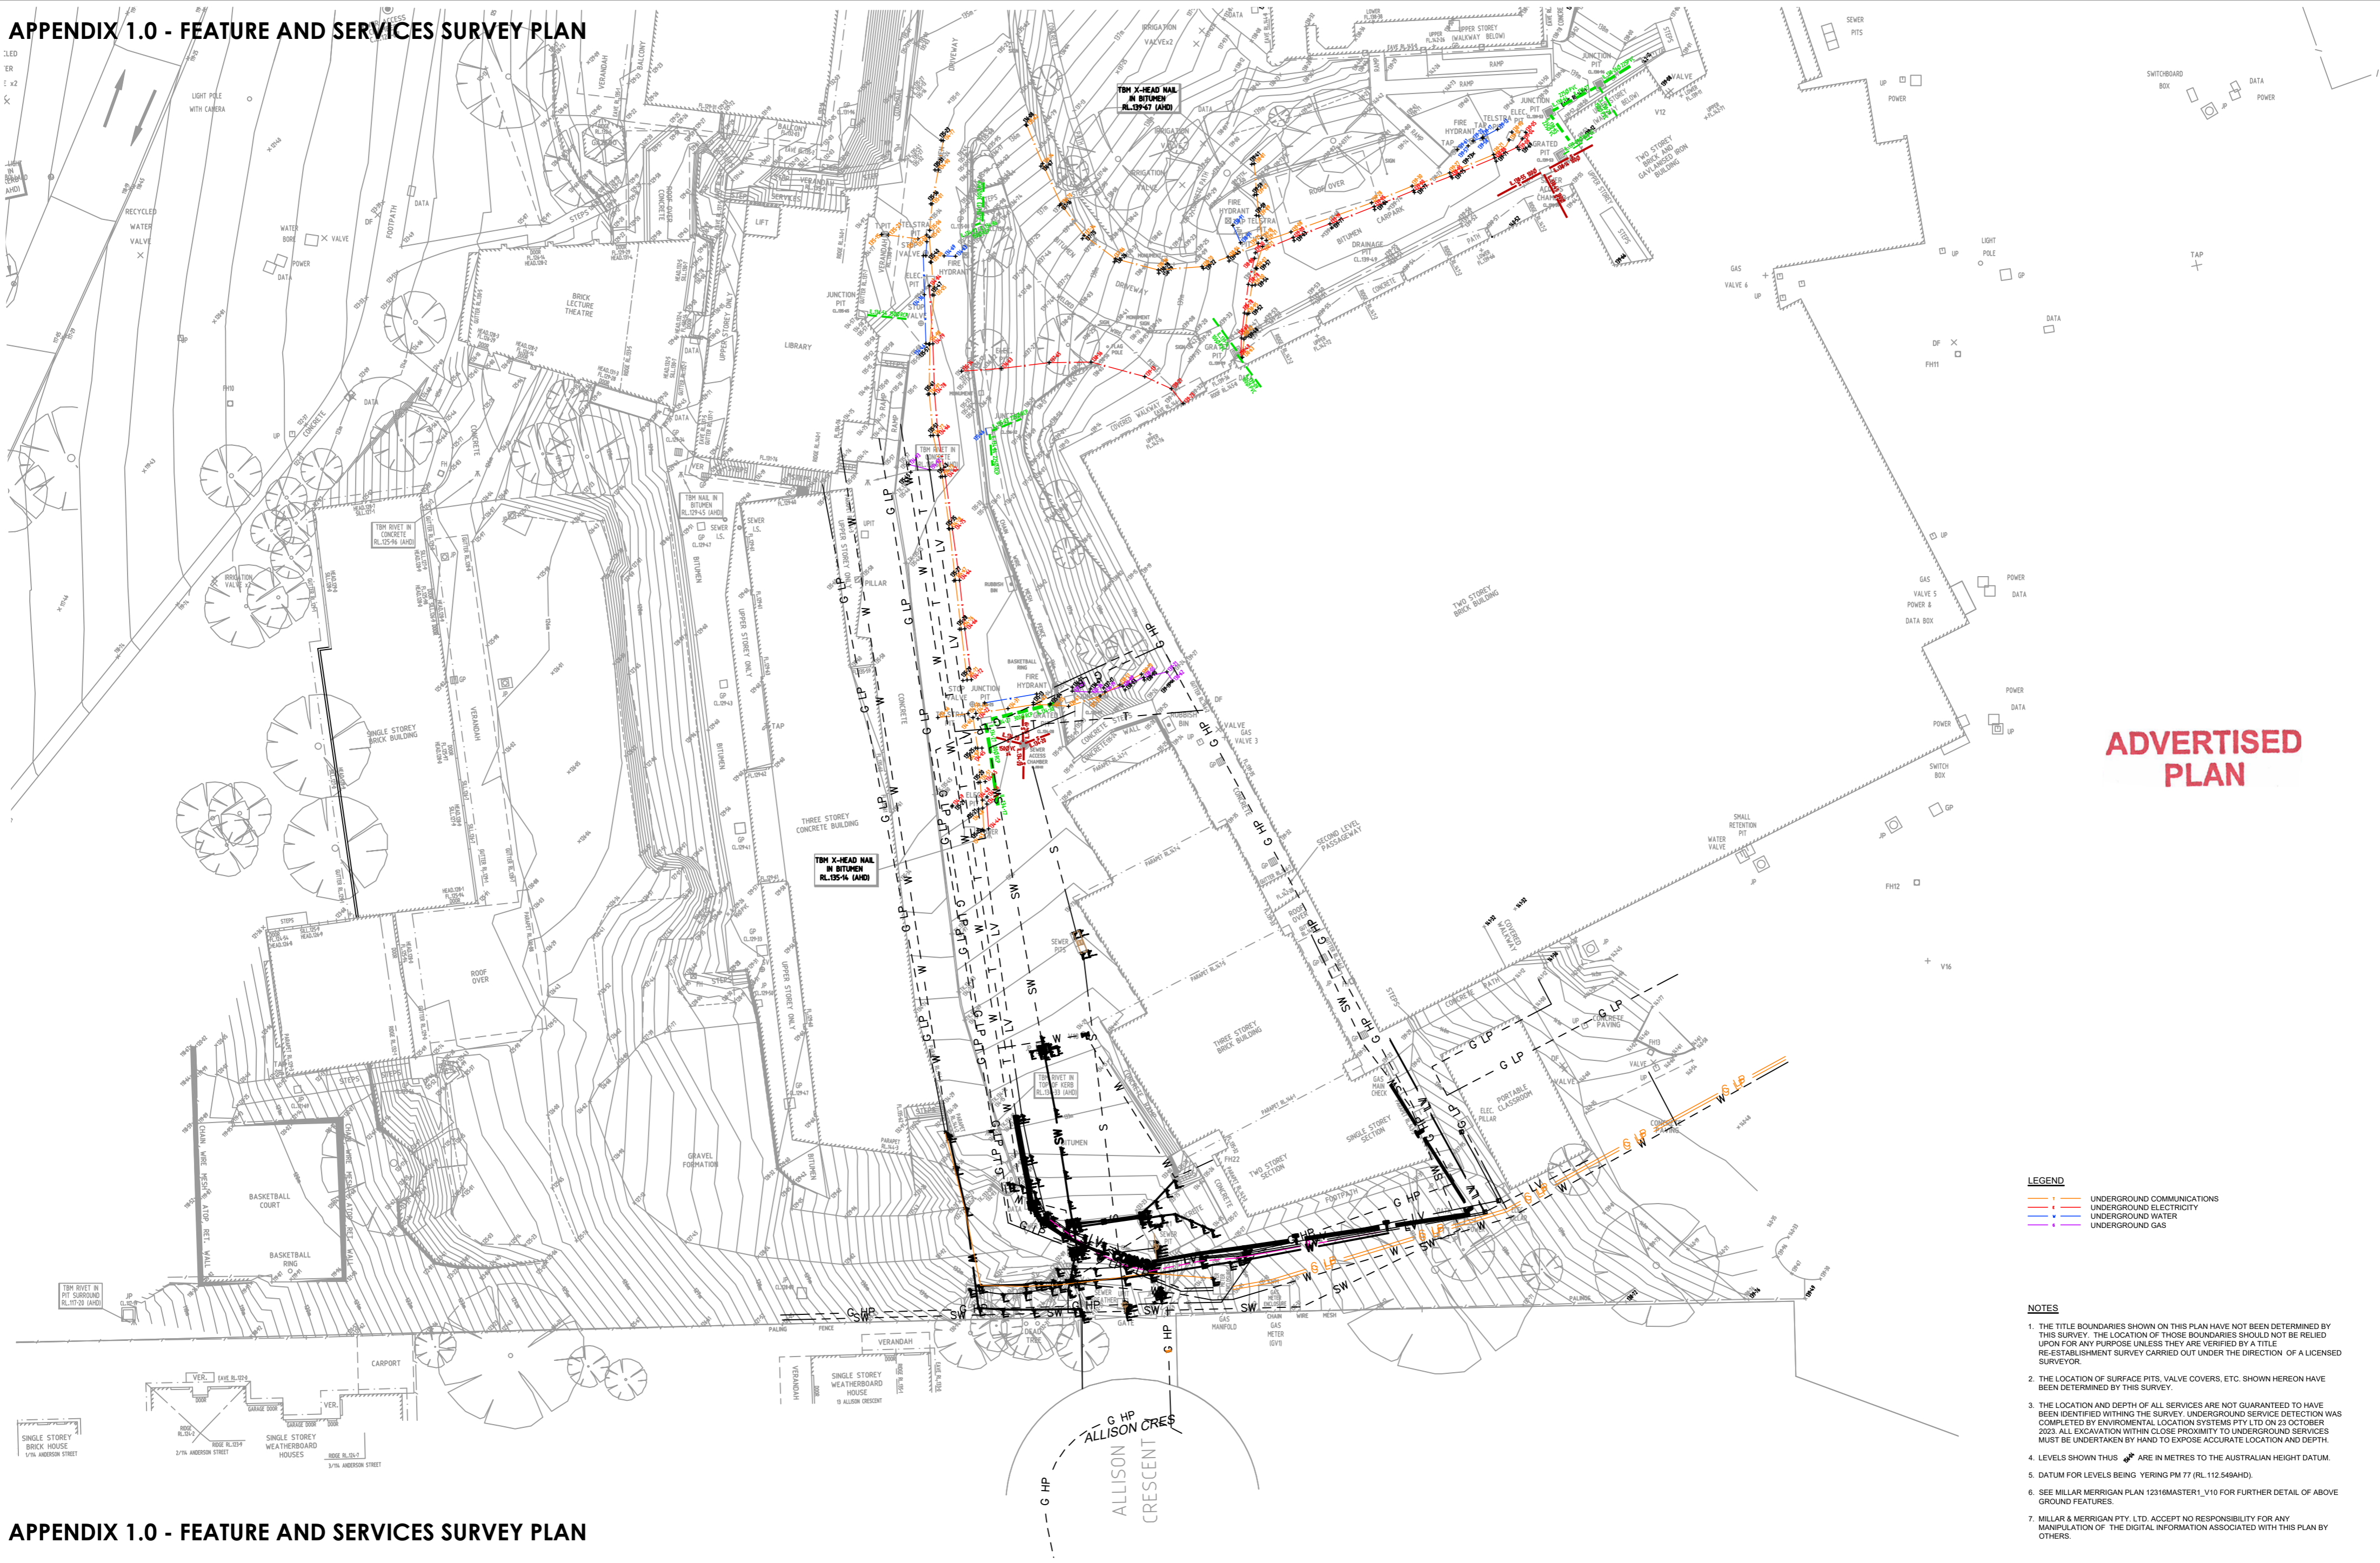
APPENDIX 1.0 - FEATURE AND SERVICES SURVEY PLAN

UNDERGROUND SERVICES PLAN
 MOUNT LILYDALE COLLEGE
 120 ANDERSON STREET, LILYDALE 3140
 YARRA RANGES COUNCIL

Refer to **Appendix 1** for site survey, layout and catchment.
