# AGRICULTURAL ASSESSMENT

# Battery Energy Storage System Tragowel, Victoria

Potentia Energy

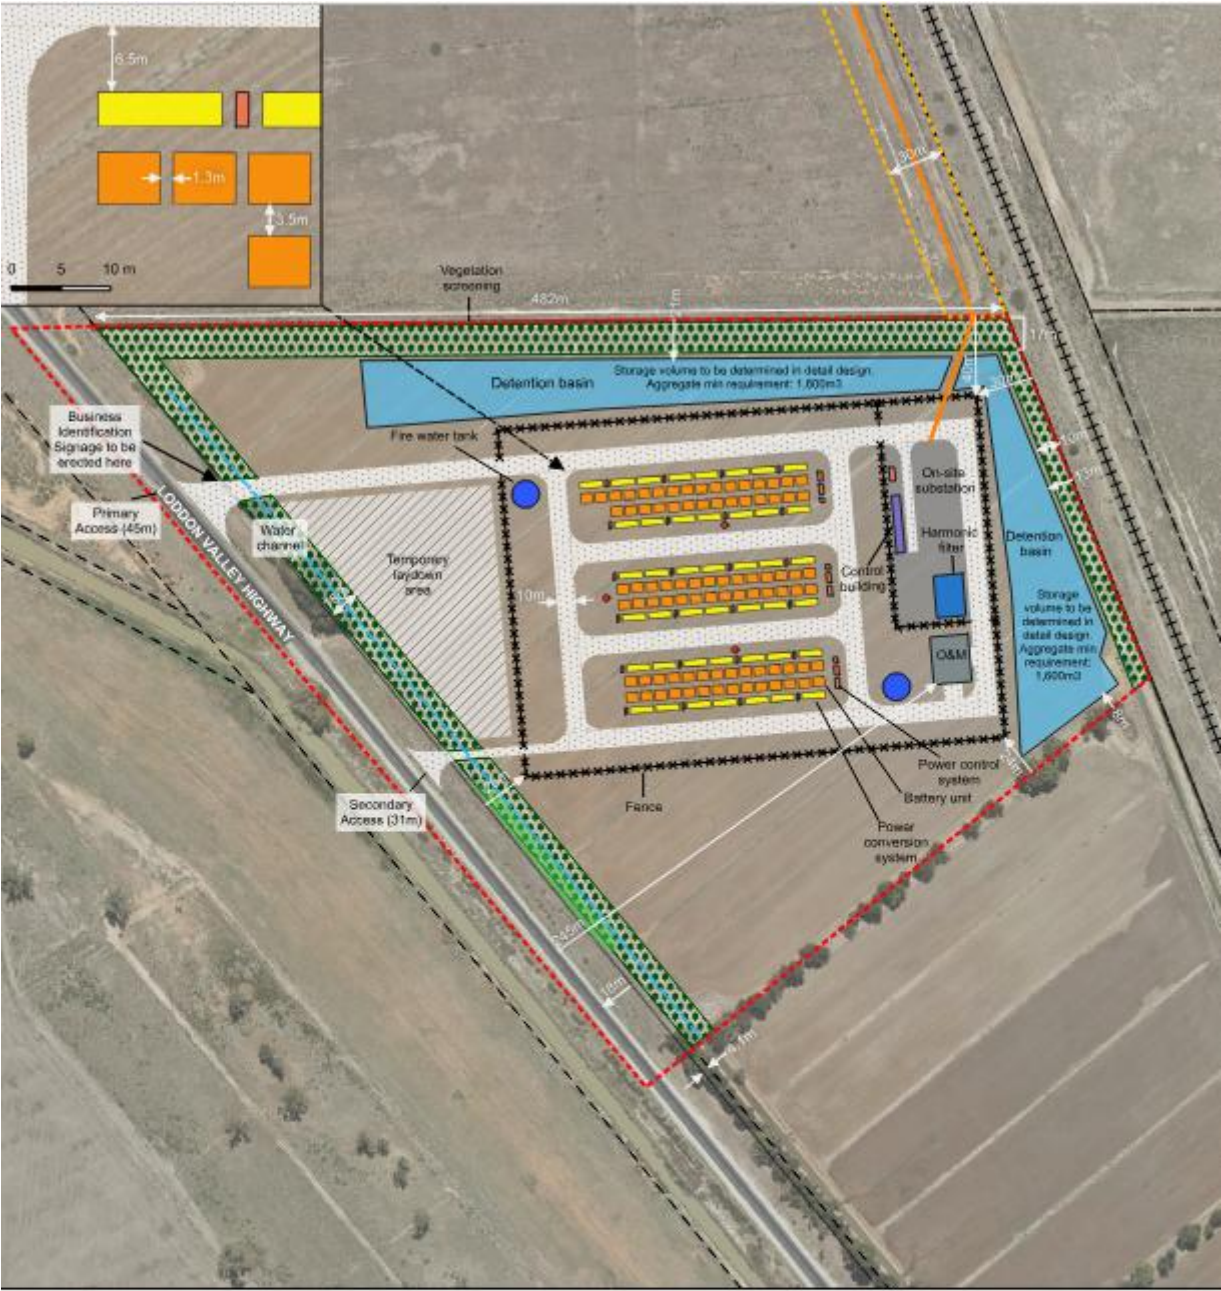
Figure 1. Bess Site and Project Site Concept Layout Plan

# BEES Concept Layout Plan

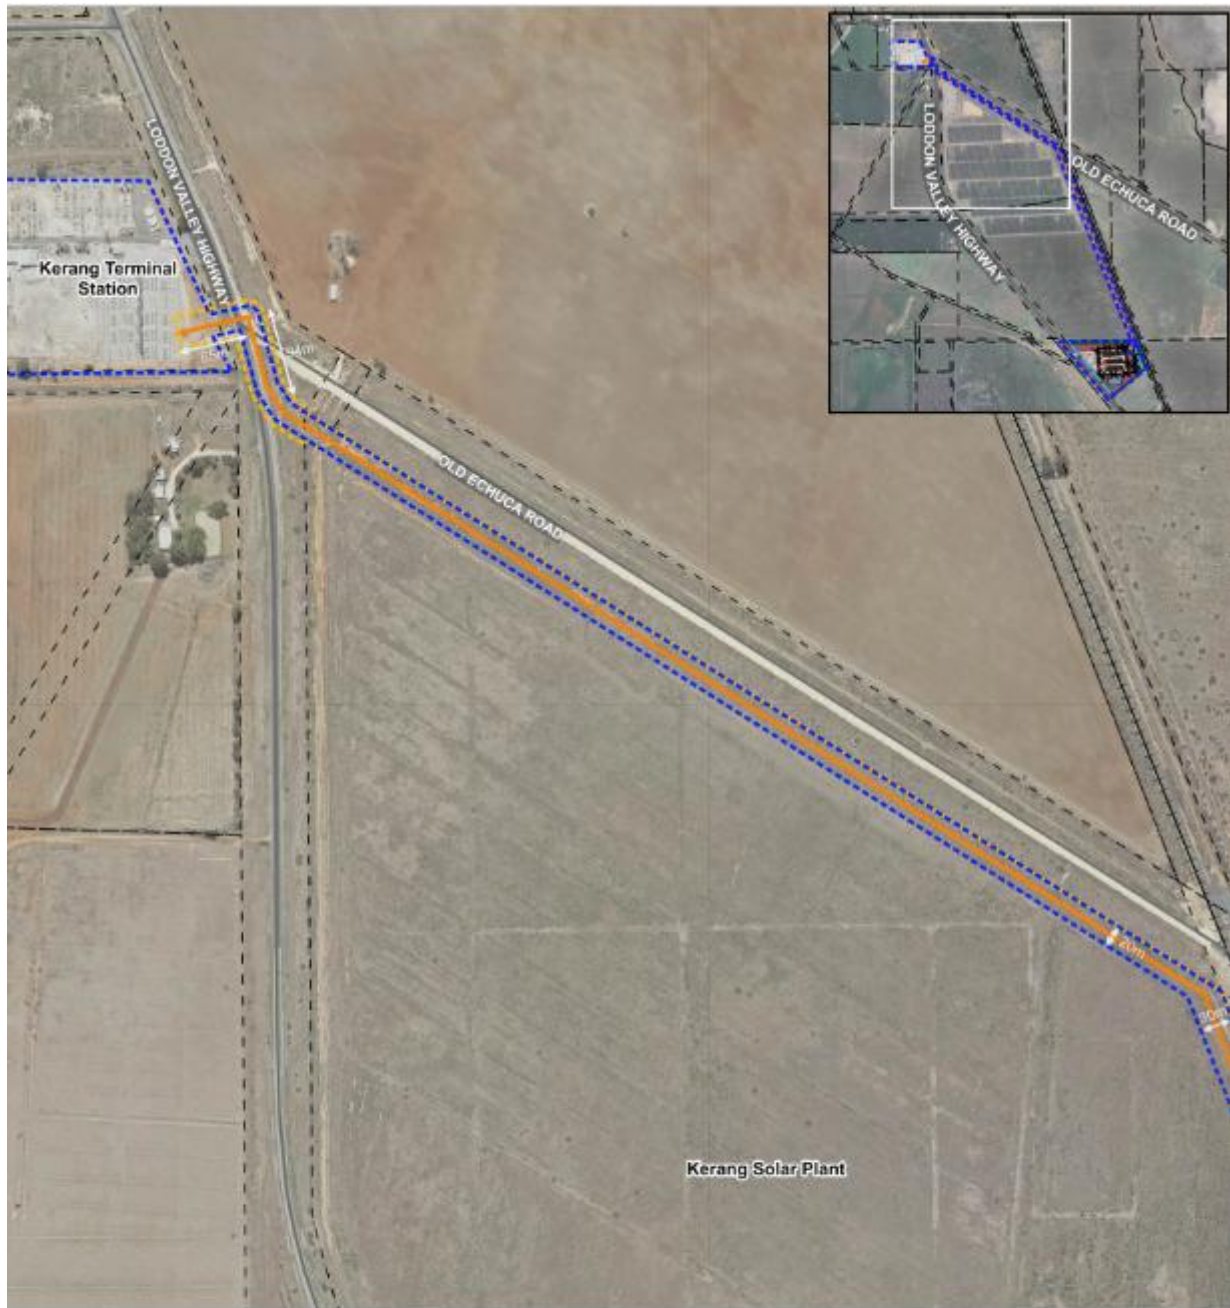
## Transmission route - northern extent

The proposed transmission line will be installed underground, beginning at the northeast corner of the proposed BESS area. It will run north across private land (including areas that host the Kerang Solar Farm) towards Old Echuca Road. At that point, the line will turn west, running underneath Loddon Valley Highway and north across Old Echuca Road, before turning west again to connect to the Kerang Terminal Station. The transmission corridor will occupy approximately 8 hectares and will extend about 2.5 kilometres in length and 30 meters in width.

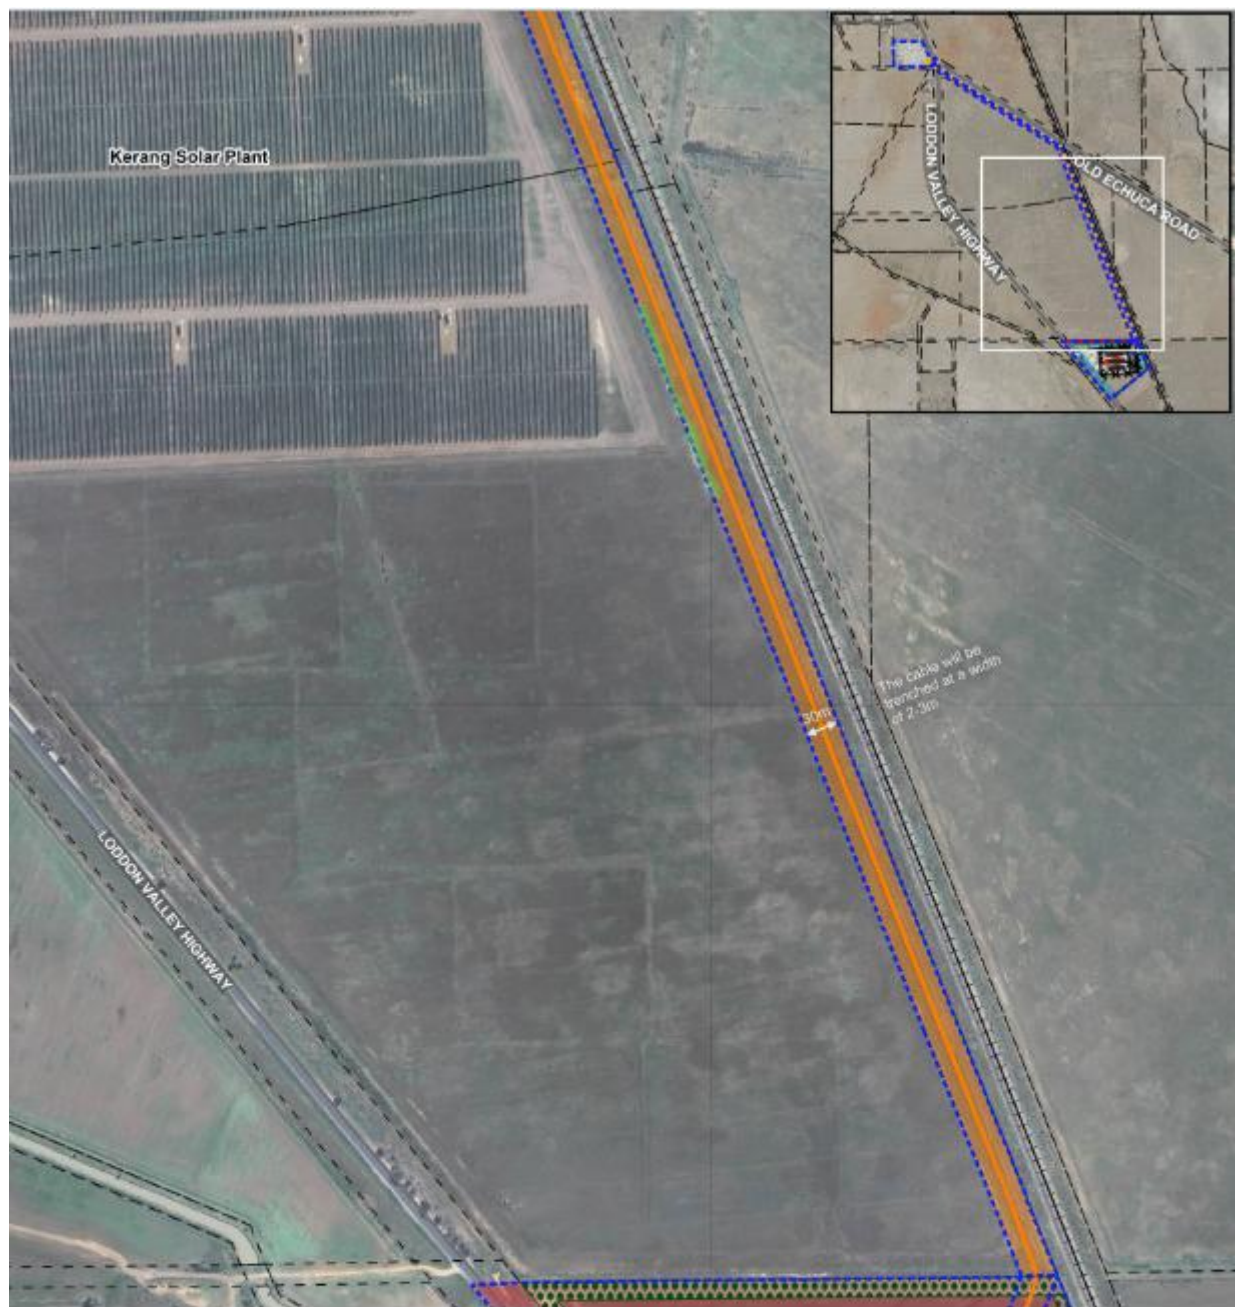
## Transmission route - southern extent

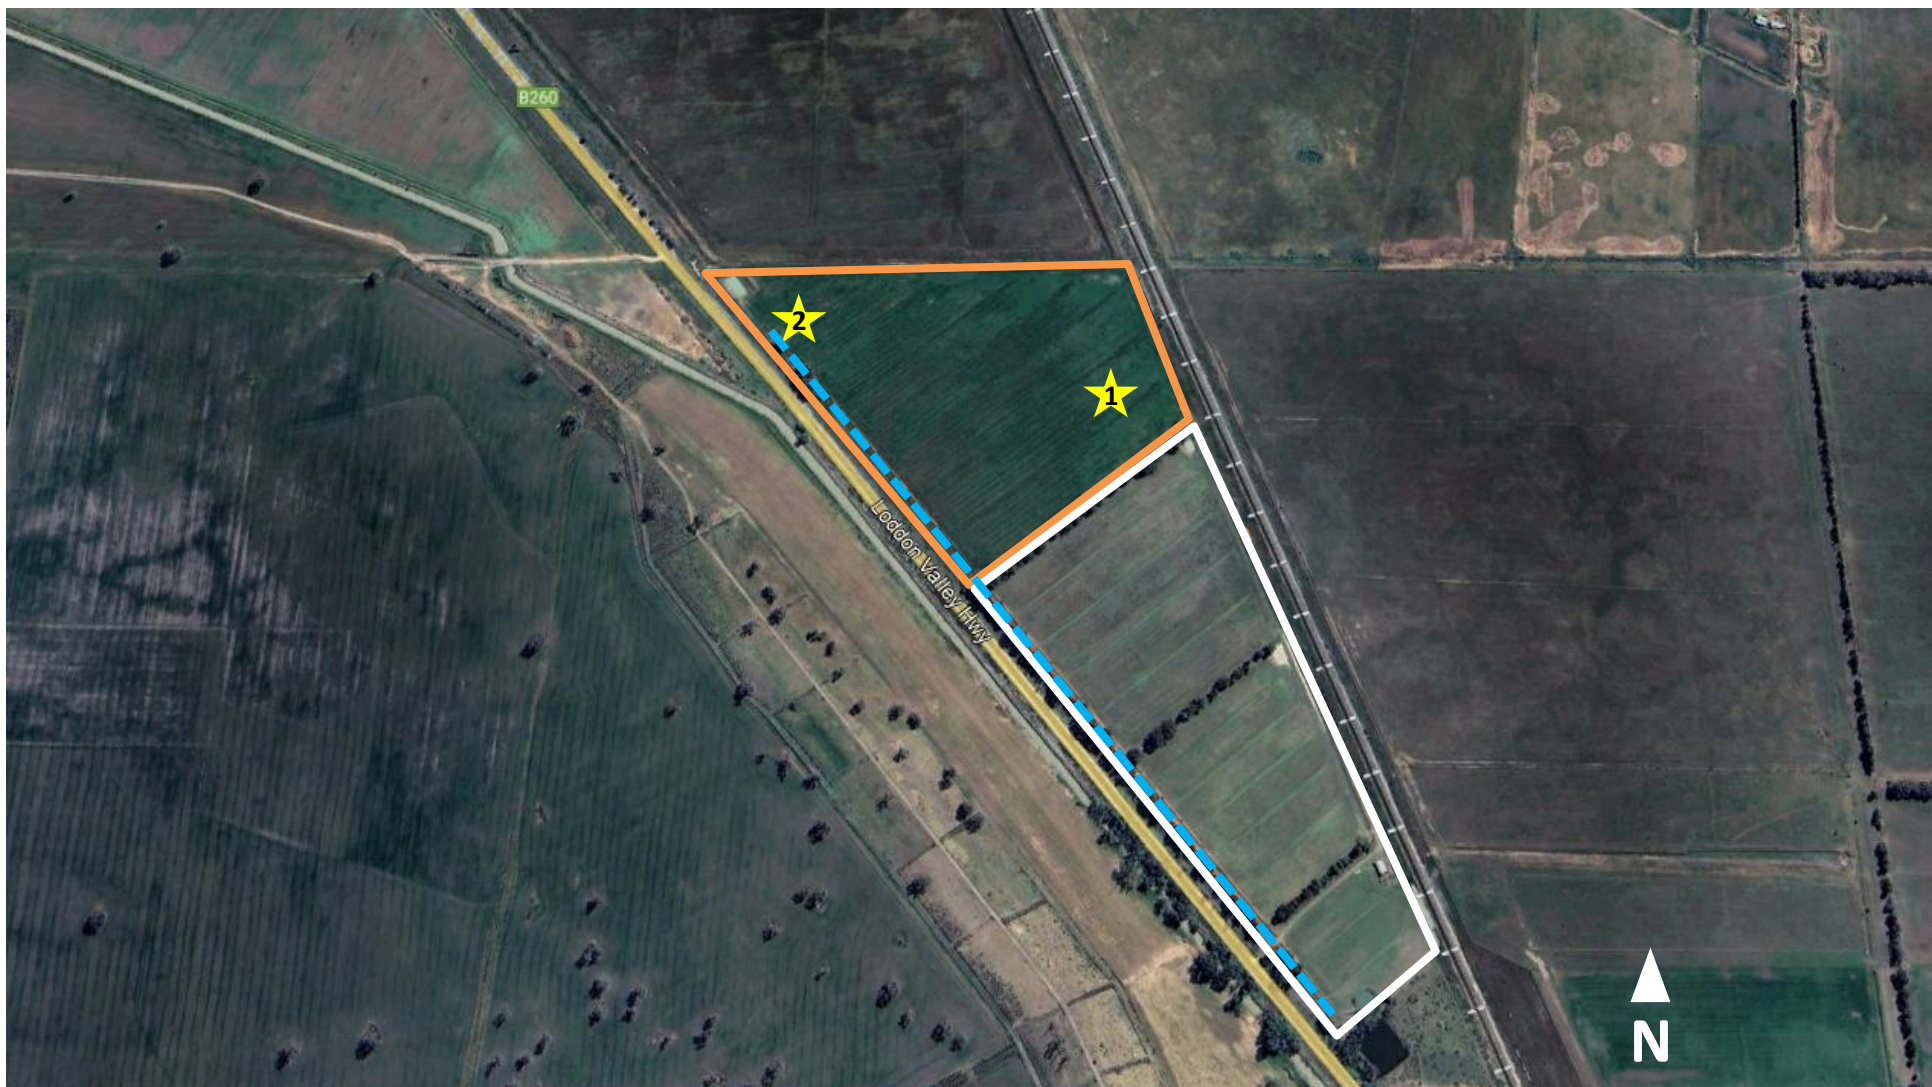
Figure 2. Aerial Image of property with Project site outlined in orange, balance of irrigation areas outlined in white and soil profile investigation locations denoted by yellow stars (Appendix 1). Irrigation channel shown as blue dashed lines.

Two soil profiles were examined across the Project site, with the locations shown in Figure 2 and described in Appendix I. Site 1 examined towards the eastern end of the Project Site was more consistent with the Macorna Clay, while Site 2 examined to the west of the site was more consistent with the Kerang Clay.

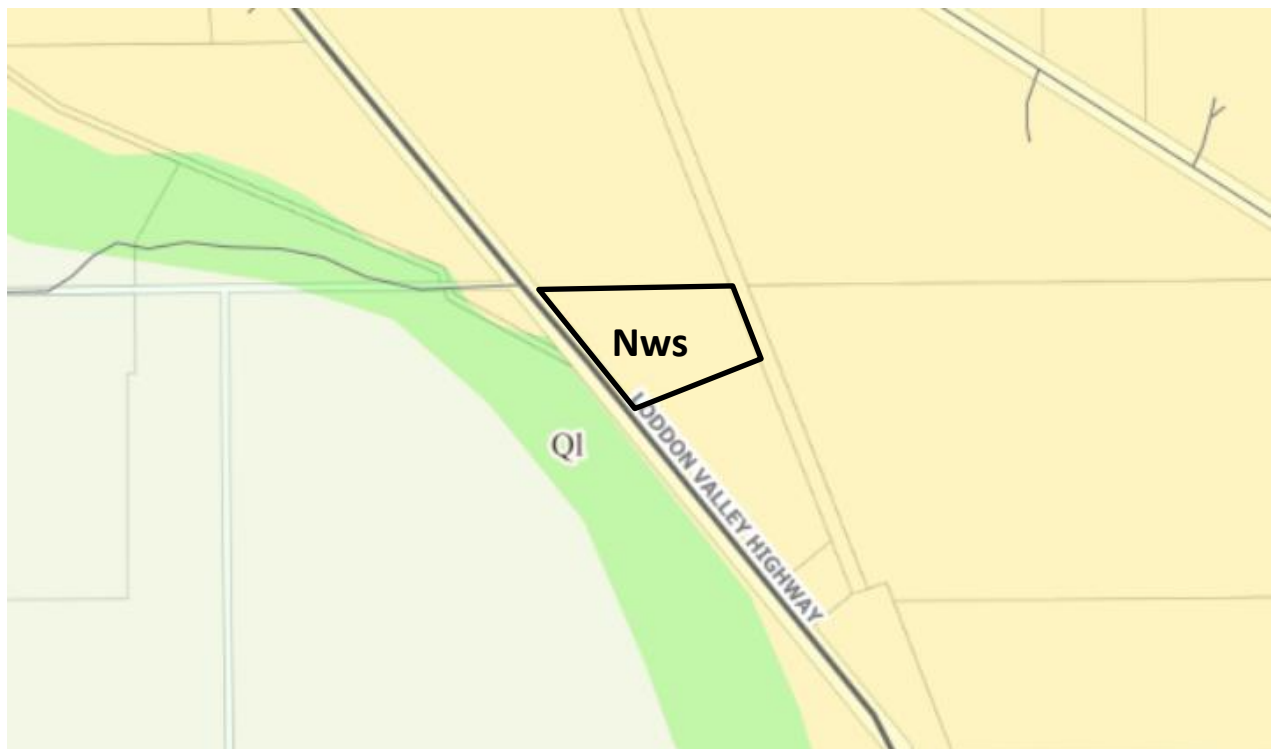
**Figure 3.** Geology – with Project Site in black – Accessed from Geovic<sup>6</sup>

The landscape is best understood in terms of the processes that formed it (Figure 3). The Project Site is an alluvial terrace (Nws) formed during the Quaternary Pleistocene period, from alluvial floodplain deposits of silt, sand and minor gravel. The abutting geological formation on the south western edge of the Project Site is a comprised of Lunette deposits (Qi) through aeolian processes, consisting of sand, silt and clay, deposited during the Quaternary Holocene to Pleistocene period.

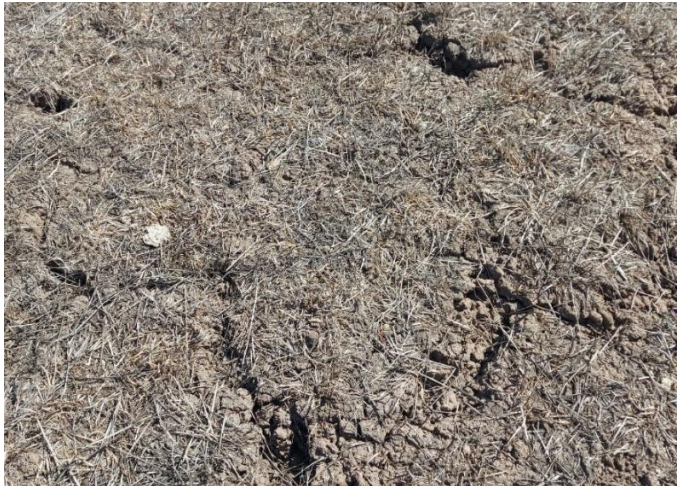
The surface soils are shallow, moderately structured cracking clays, generally leading to a medium clay at around 10 cm. See Figure 6 below for the cracks across the surface soils.

Figure 6. Image of surface soils cracking clays (West side of property – Kerang Clay)

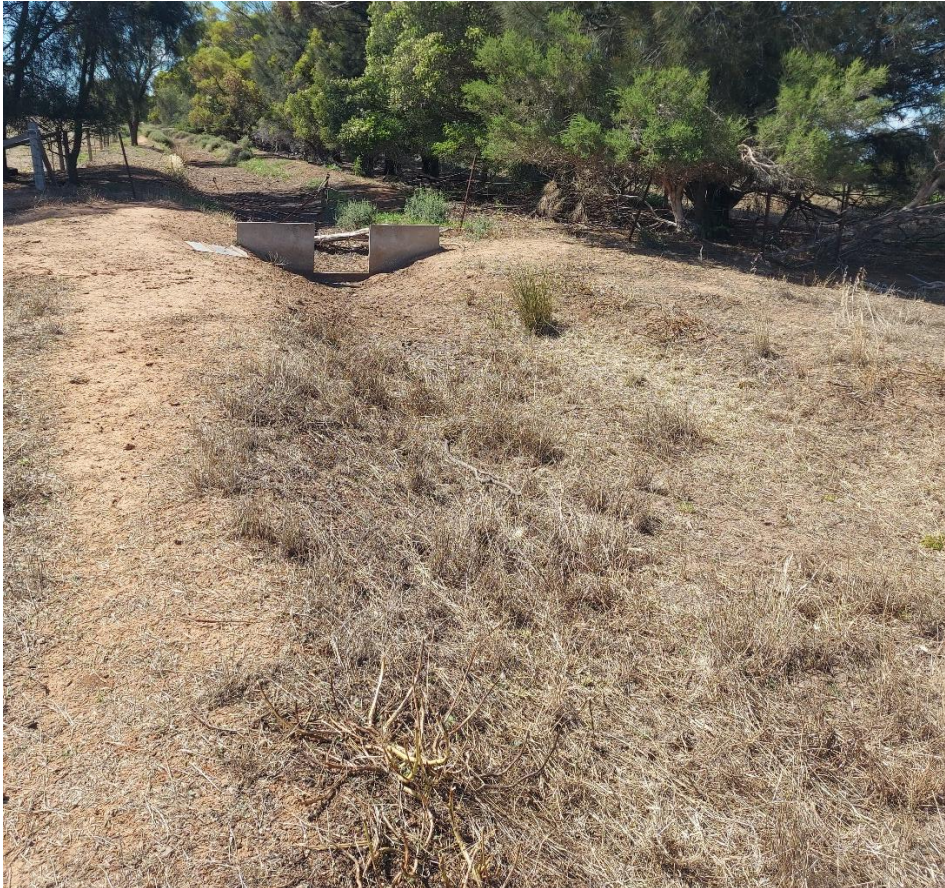
Figure 7. Image of Irrigation channel running south east to north west along the roadside boundary

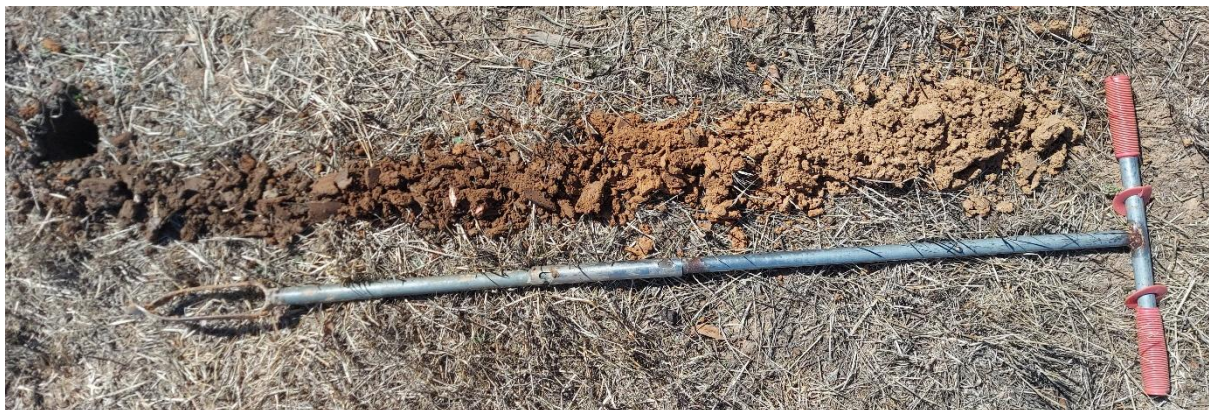
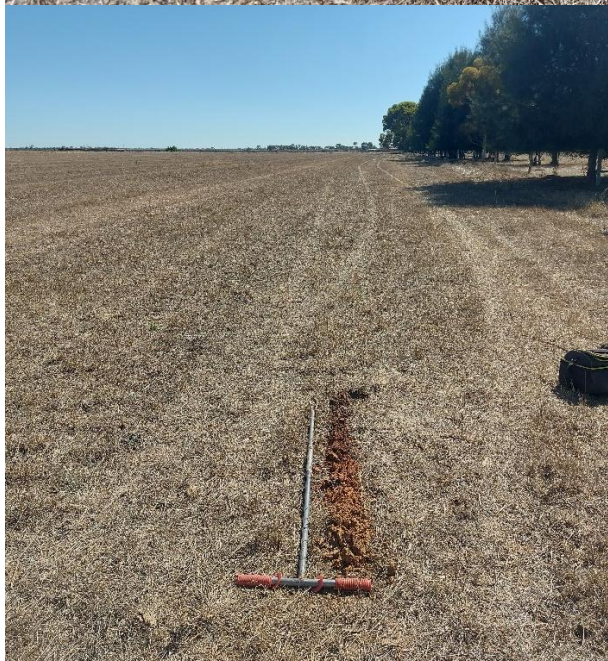
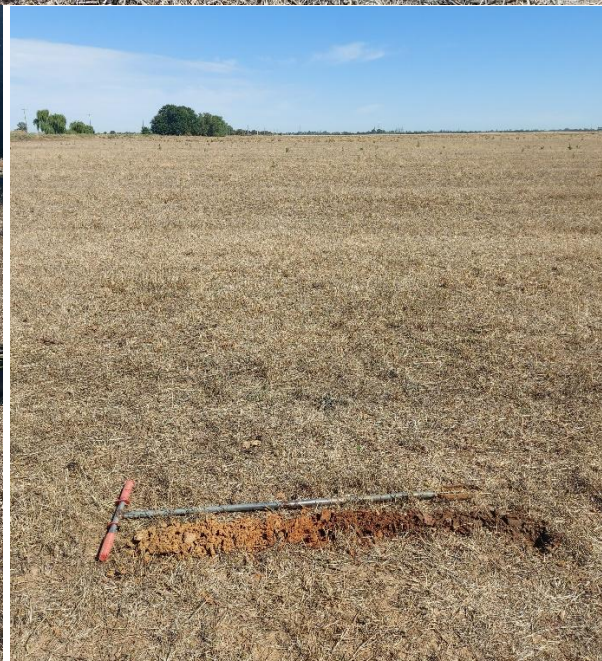
| Depth (cm) | Horizon | Description |
|---|---|---|
| 50 – 90 cm | B2 | Strong Brown 7.5 YR 5/6, poor structure<br><b>Heavy Clay</b><br><i>No Auger refusal hole terminated at 100 cm.</i> |

In dead pasture mix of shaftal clover, oats and ryegrass. Incident green artichoke thistle. Shelter belt of trees planted on the eastern fence line.

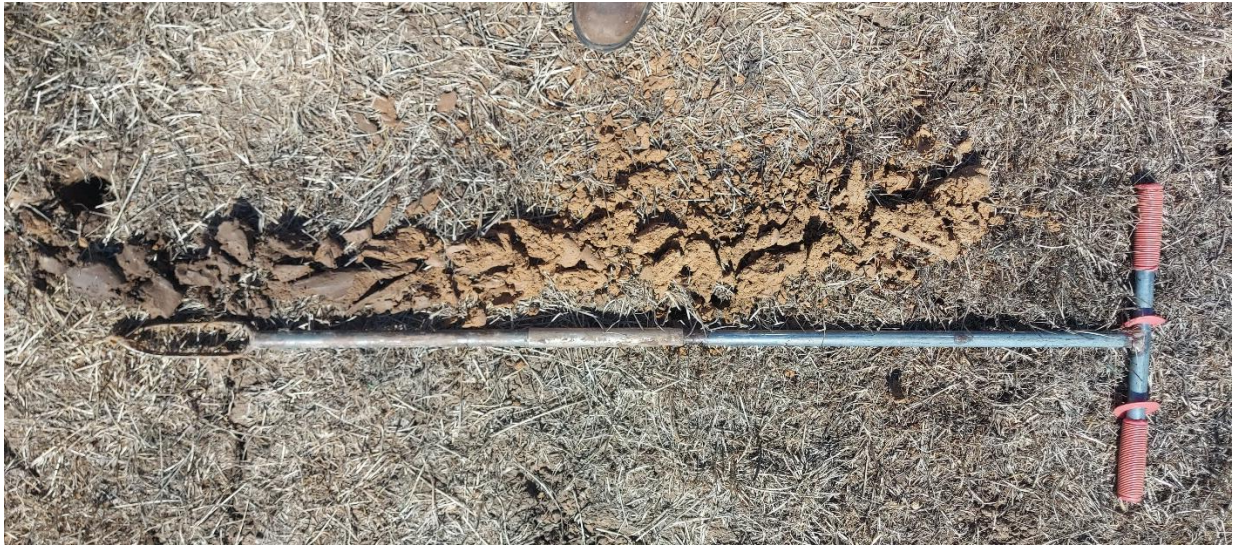
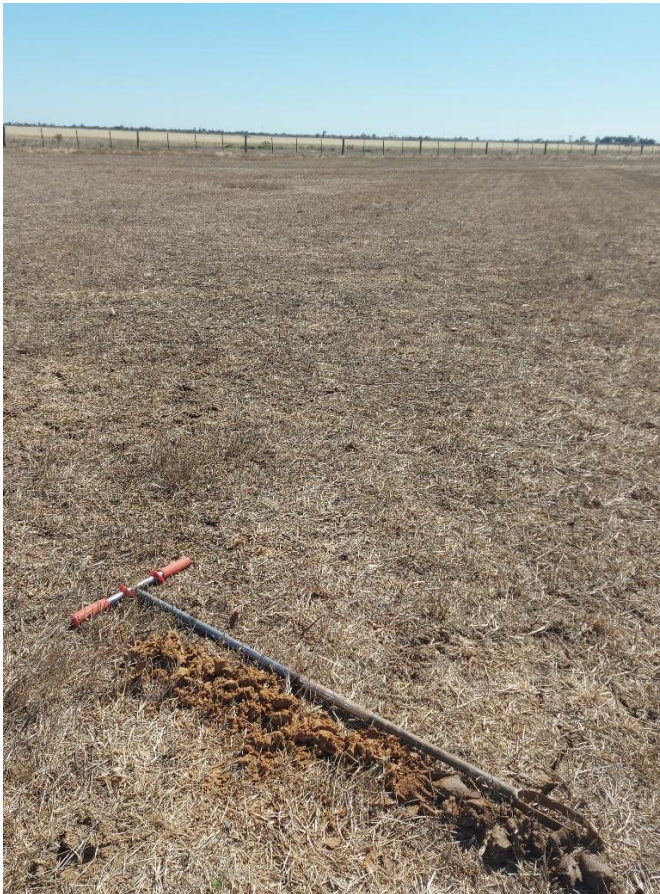
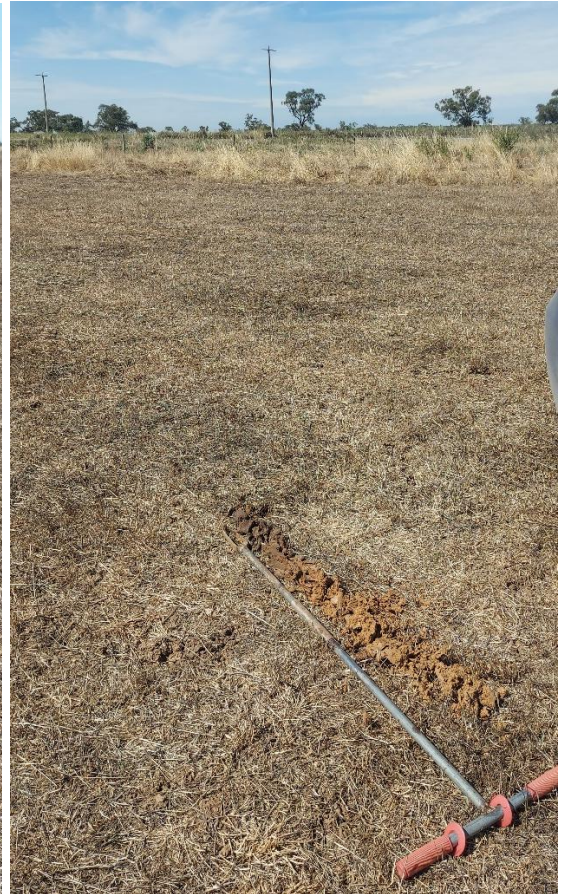
**Site. 2: Plateau near western boundary and south of dam.**

Similar soils to Site 1, however with yellowish brown mottles in place of reddish-brown mottles.
