ARBORICULTURAL ASSESSMENT/REPORT for *Krystal Rawnsen – Law Architects*

Report on Construction/Development on grounds
Catholic Ladies College, Eltham.

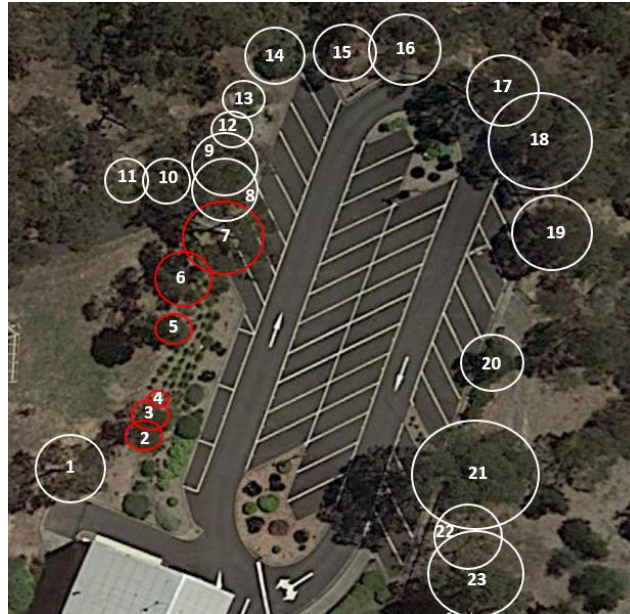
Figure 1 – Tree Population.

Trees that appear within the boundaries of proposed construction are seen in figure 1, in red and numbered 2,3,4,5,6,7 are potential trees for removal. The remaining trees numbered 1,8,9,10,11,12,13,14,15,16,17,18,19,20,21,22,23, and coloured white, are considered trees with retainable quality on the landscape.

Six of the Seven trees within the proposed planning zone (red icons in figure 1) are replaceable. The remaining (tree 1) poses a potential to provide optimum function and aesthetic to the building landscape. The potential loss of five trees that exhibit medium retention values might be considered fair when comparing to the preservation of the remaining eighteen. The result, in this scenario, can produce a landscape where construction ties neatly into a natural/native surrounding environment.

It is proposed that trees 2,3,4,5,6 and 7 are removed for construction.

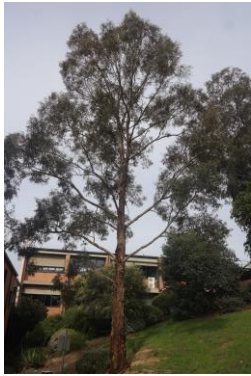
Tree 1. *E. melliodora*

One potentially naturally occurring tree (Tree 1) stands well within the boundary of proposed construction, this tree has a high retention value and requires protection. This tree is a *Eucalyptus melliodora* and has favourable characteristics and good genetic potential for longevity. All species identified as *E.melliodora* yielded high retention values due to numerous beneficial factors.

Retention of the remaining trees, particularly tree 1 is recommended.

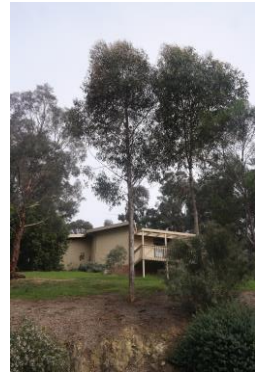
Tree 2. *E. cladocalyx*

Trees 2,3,4,5 appear insignificant to the endemic population surrounding them and present an underwhelming contribution to the landscape. These trees also appear to have endured previous structural failures and compromised health due to pest/insect invasion.

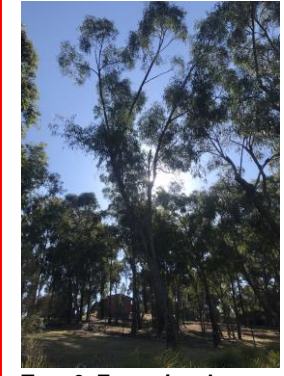
Tree 6. *E. goniocalyx*

Trees 2-7 feature low-medium retention value and appear to possess defective growth pattern and insect/pest damage. These trees have been planted in unfavourable positions, appear to have been introduced to the landscape and can be replaced through more effective species selection practices.
