## GEOTECHNICAL INVESTIGATION FOR CATHOLIC LADIES COLLEGE, ELTHAM

N1881  
24 September 2020

**RE: GEOTECHNICAL INVESTIGATION for CATHOLIC LADIES COLLEGE, ELTHAM**

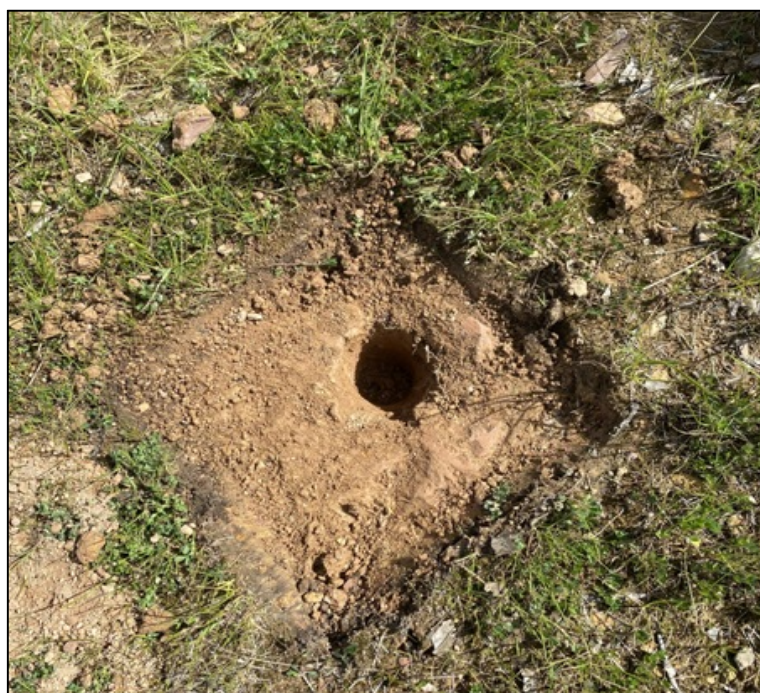
Photo: N1881 - BH5

Material Description	Depth (m)	Graphic log	Water	Moisture condition	Consistency density index	Structure, additional observations	Notes Samples Tests	Method	Support
FILL: CLAYEY GRAVEL, fine-coarse, brown			*	M	MD	FILL		D	-
SILTSTONE: Highly to Moderately Weathered medium to high strength, pale brown				D	H				
BH5 - Refusal @ 0.13 metres	0.50								
<b>ADVERTISED PLAN</b>	1.00								
	1.50

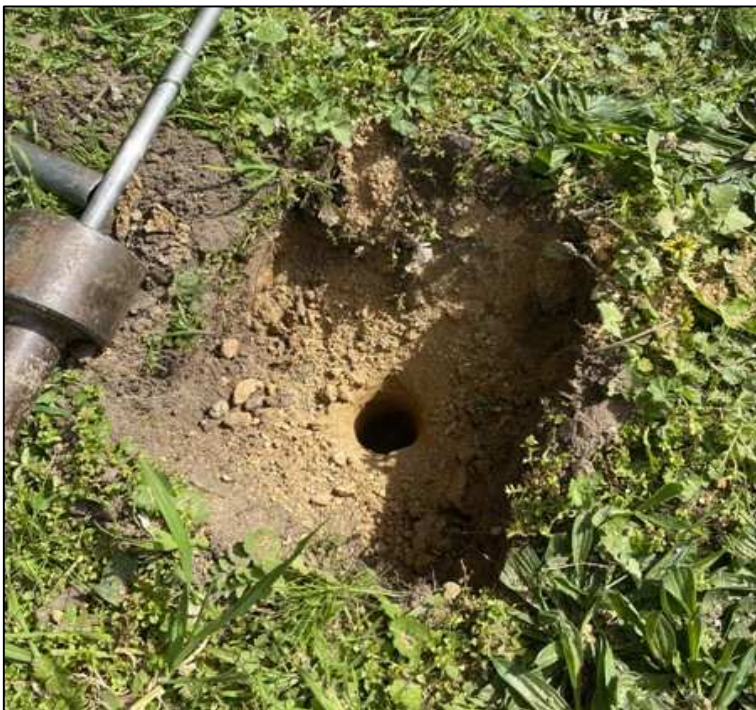
Photo: N1881 - BH6

Material Description	Depth (m)	Graphic log	Water	Moisture condition	Consistency density index	Structure, additional observations	Notes Samples Tests	Method	Support
FILL: SILTY SAND, fine to medium sands, grey	0.15m		*	M	MD	FILL		D	-
SILTSTONE: Highly Weathered, medium to high strength, pale brown	0.50			D	H				
BH6 - Refusal @ 0.30 metres	1.00								
	1.50

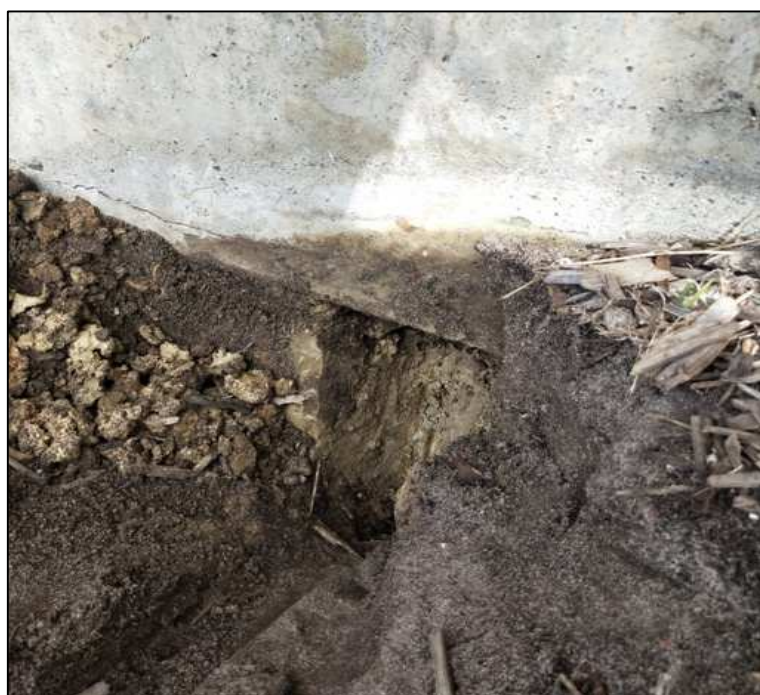
Photo: N1881 - FE1

Client :		CREO CONSULTANTS				Date :		16/09/2020		
Project :		CATHOLIC LADIES COLLEGE, ELTHAM				Logged By :		CS/BZ		
Location :		19 DIAMOND STREET, ELTHAM								
Drill model :		Handauger		Slope		90 deg		RL Surface : <i>Not measured</i>		
Hole diameter :		55mm		Bearing		- deg		Datum : -		
Material Description		Depth (m)	Graphic log	Water	Moisture condition	Consistency density index	Structure, additional observations		Method	Support
(EXPOSED)		0.00						Concrete Footing	D	-
FILL: MULCH and SILTY SAND, dark brown					M	L	FILL			
SILTSTONE: Highly to Moderately Weathered, medium to high strength, pale brown					D	H		Underside @ 0.1m		
FE1 - Refusal @ @ 0.40 metres		0.50								
		1.00

The exposure of the existing buildings foundations revealed that these footings are founded in the above mentioned EW/MW SILTSTONE materials at depths ranging from 0.1m to 0.8m+ below existing surface levels and may therefore be proportioned for allowable bearing pressures as recommended earlier. Full details of the existing footings dimensions are shown on the attached Footing Exposure logs.

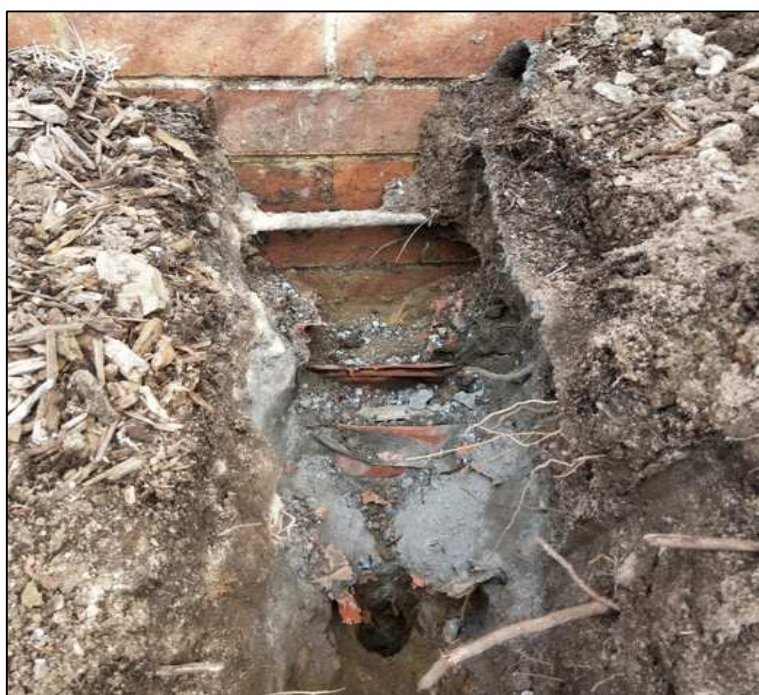
Photo: N1881 - FE2

Client :		CREO CONSULTANTS				Date :		16/09/2020		
Project :		CATHOLIC LADIES COLLEGE, ELTHAM				Logged By :		CS/BZ		
Location :		19 DIAMOND STREET, ELTHAM								
Drill model :		Handauger		Slope		90 deg		RL Surface : <i>Not measured</i>		
Hole diameter :		55mm		Bearing		- deg		Datum : -		
Material Description		Depth (m)	Graphic log	Water	Moisture condition	Consistency density index	Structure, additional observations		Method	Support
FILL: SILTY SAND, fine to medium sands, dark brown		0.50		*	M	L	FILL		D	-
FILL: SANDY GRAVEL, fine to medium sands and gravels, brown and grey					M	MD	FILL Outstands = 0.35m			
SILTY CLAY (CH), high plasticity, pale brown					M	VSt				
SILTSTONE: Extremely Weathered, brown										
FE2 - Refusal @ 0.80 metres		1.00
