Residential Redevelopment

Lot 10 LP8386 (11 Beach Street, Frankston)

Significant Ground Disturbance Assessment

Report to CAAMCo 11 Beach Street Pty Ltd

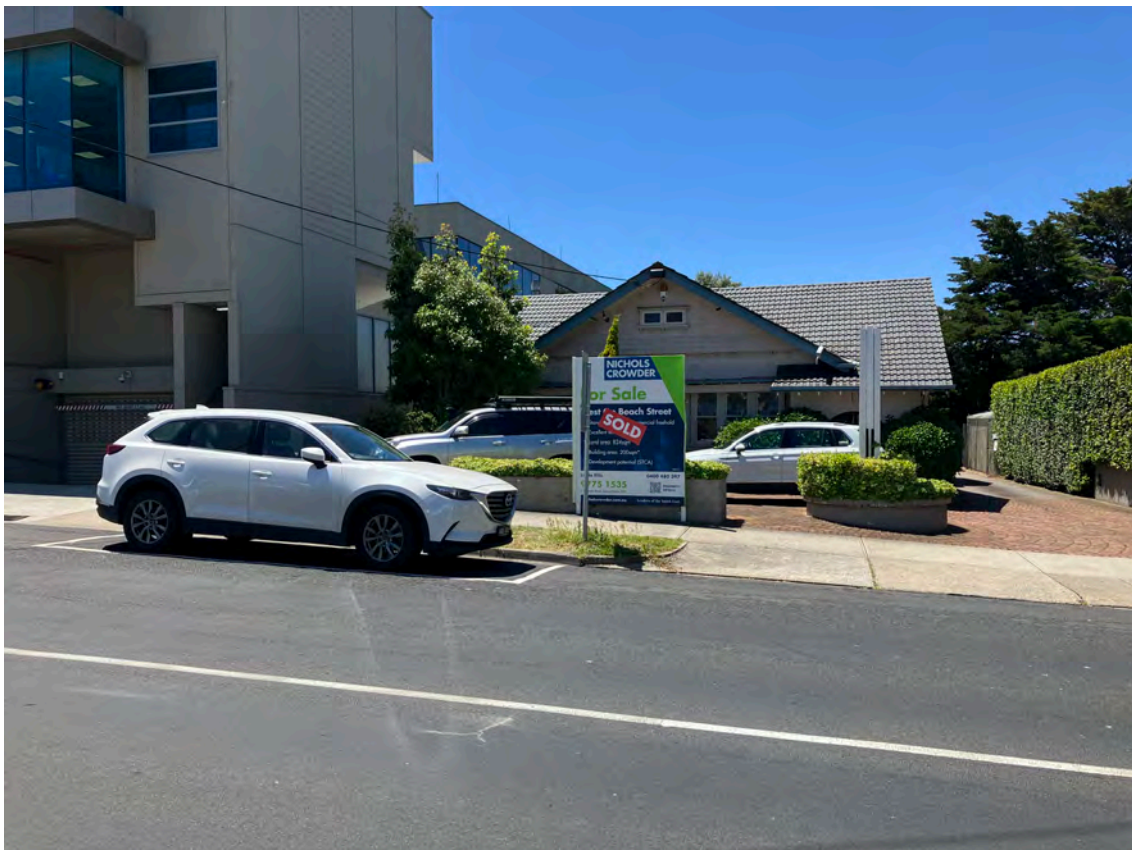
Figure 1. Existing dwelling at 11 Beach Street Frankston.

Lot 10 LP8386 (11 Beach Street, Frankston) has been extensively modified by past European land use practices. The original vegetation has been completely removed and the lot cut and levelled. The topsoil and subsoil within the lot has been substantially disturbed during past excavation of the foundations for the existing dwelling and associated carport and garden shed (Figures 1 and 2).

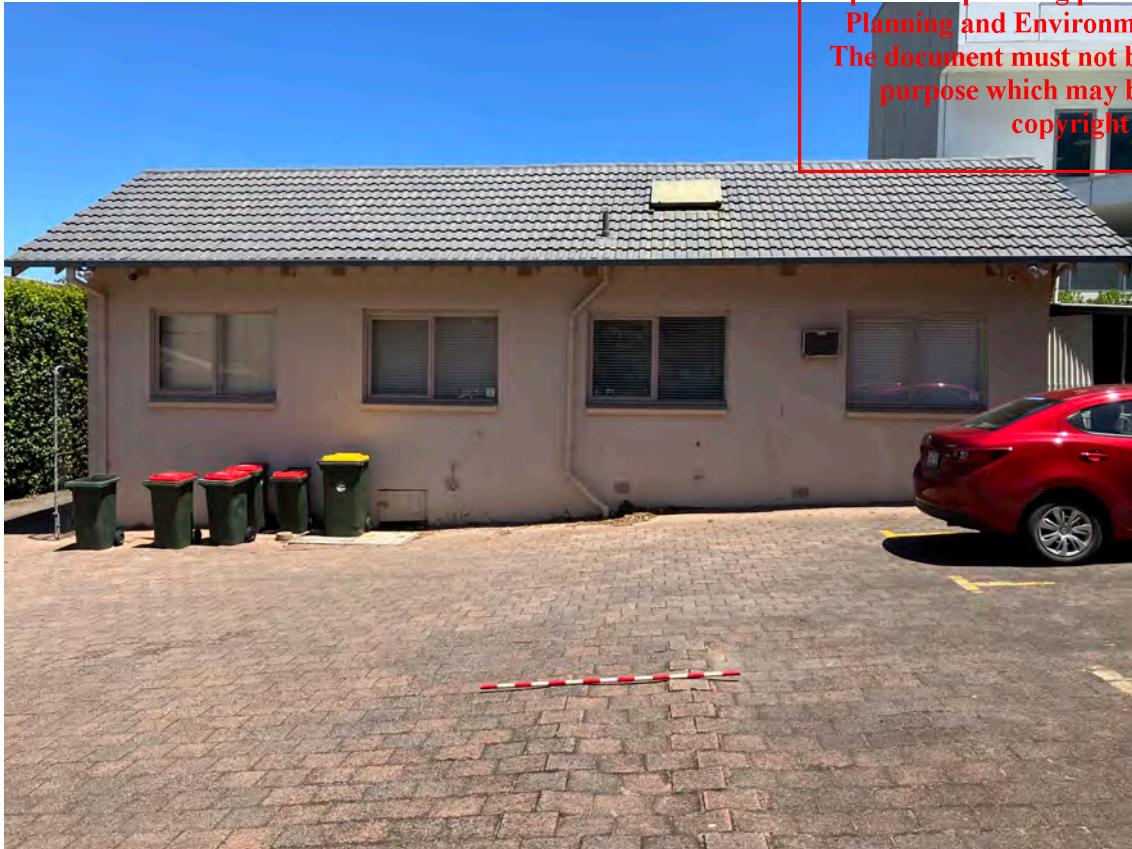
Lot 10 LP8386 (11 Beach Street, Frankston) has been extensively modified by past European land use practices. The original vegetation has been completely removed and the lot cut and levelled. The topsoil and subsoil within the lot has been substantially disturbed during past excavation of the foundations for the existing dwelling and associated carports and garden shed (Figures 1-3). The remainder of the topsoil and subsoil within the lot has also been heavily modified by earthworks during past excavations, terracing and levelling to construct concrete and paved driveways, concrete footpaths, brick and concrete retaining walls, footings for brick and timber property boundary fences and garden-beds, destroying all of the original land surface (Figures 5-8).

Figure 5. Rear of 11 Beach Street Frankston demonstrating the high levels of significant ground disturbance during concrete paving and dwelling construction.

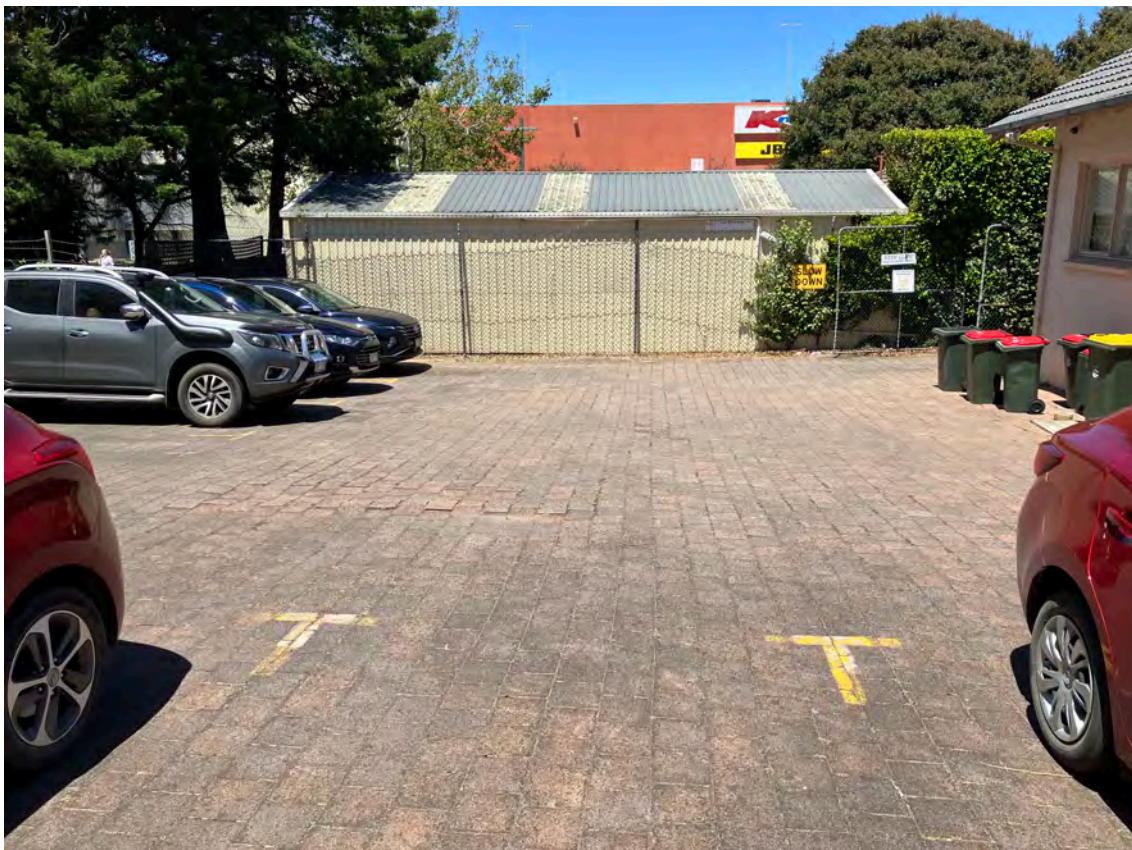
Figure 6. Rear of 11 Beach Street Frankston showing the significant ground disturbance by dwelling and concrete paving installation.

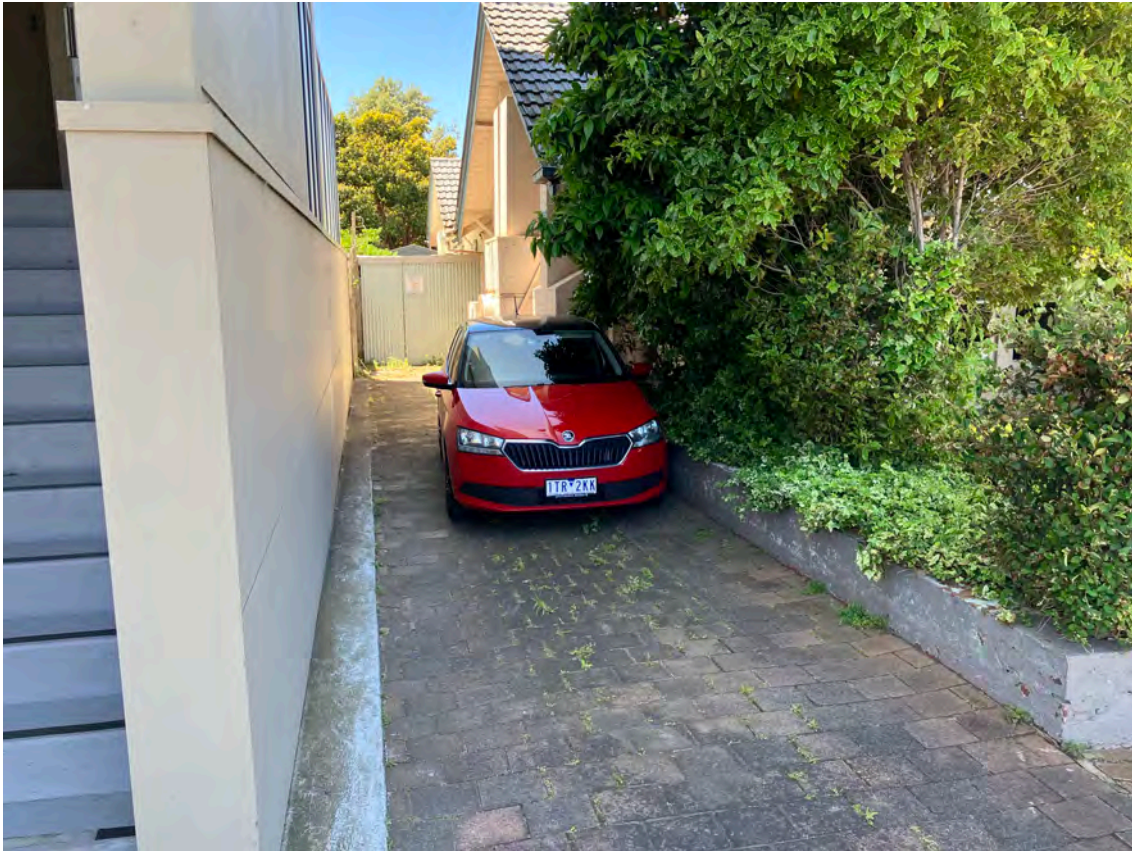
Figure 7. Western side of 11 Beach Street Frankston showing the significant ground disturbance.

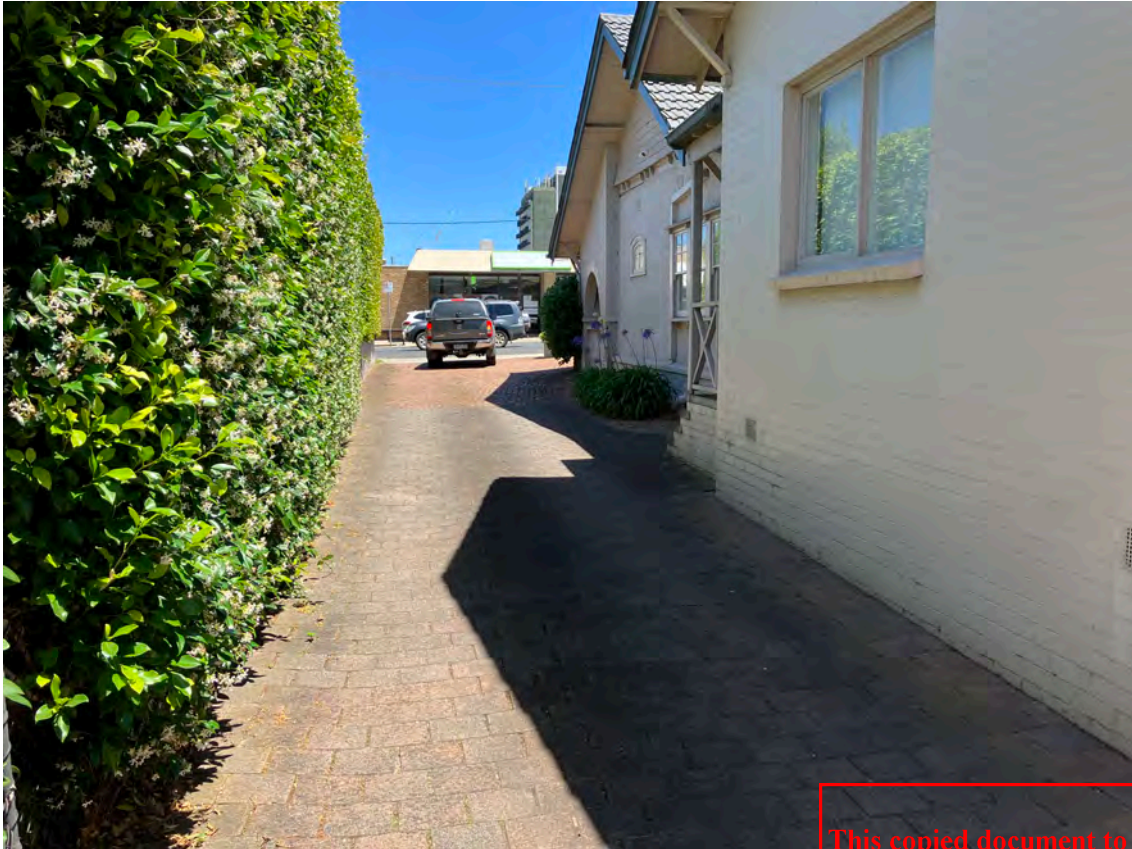
Figure 8. Eastern side of 11 Beach Street Frankston showing the significant ground disturbance.

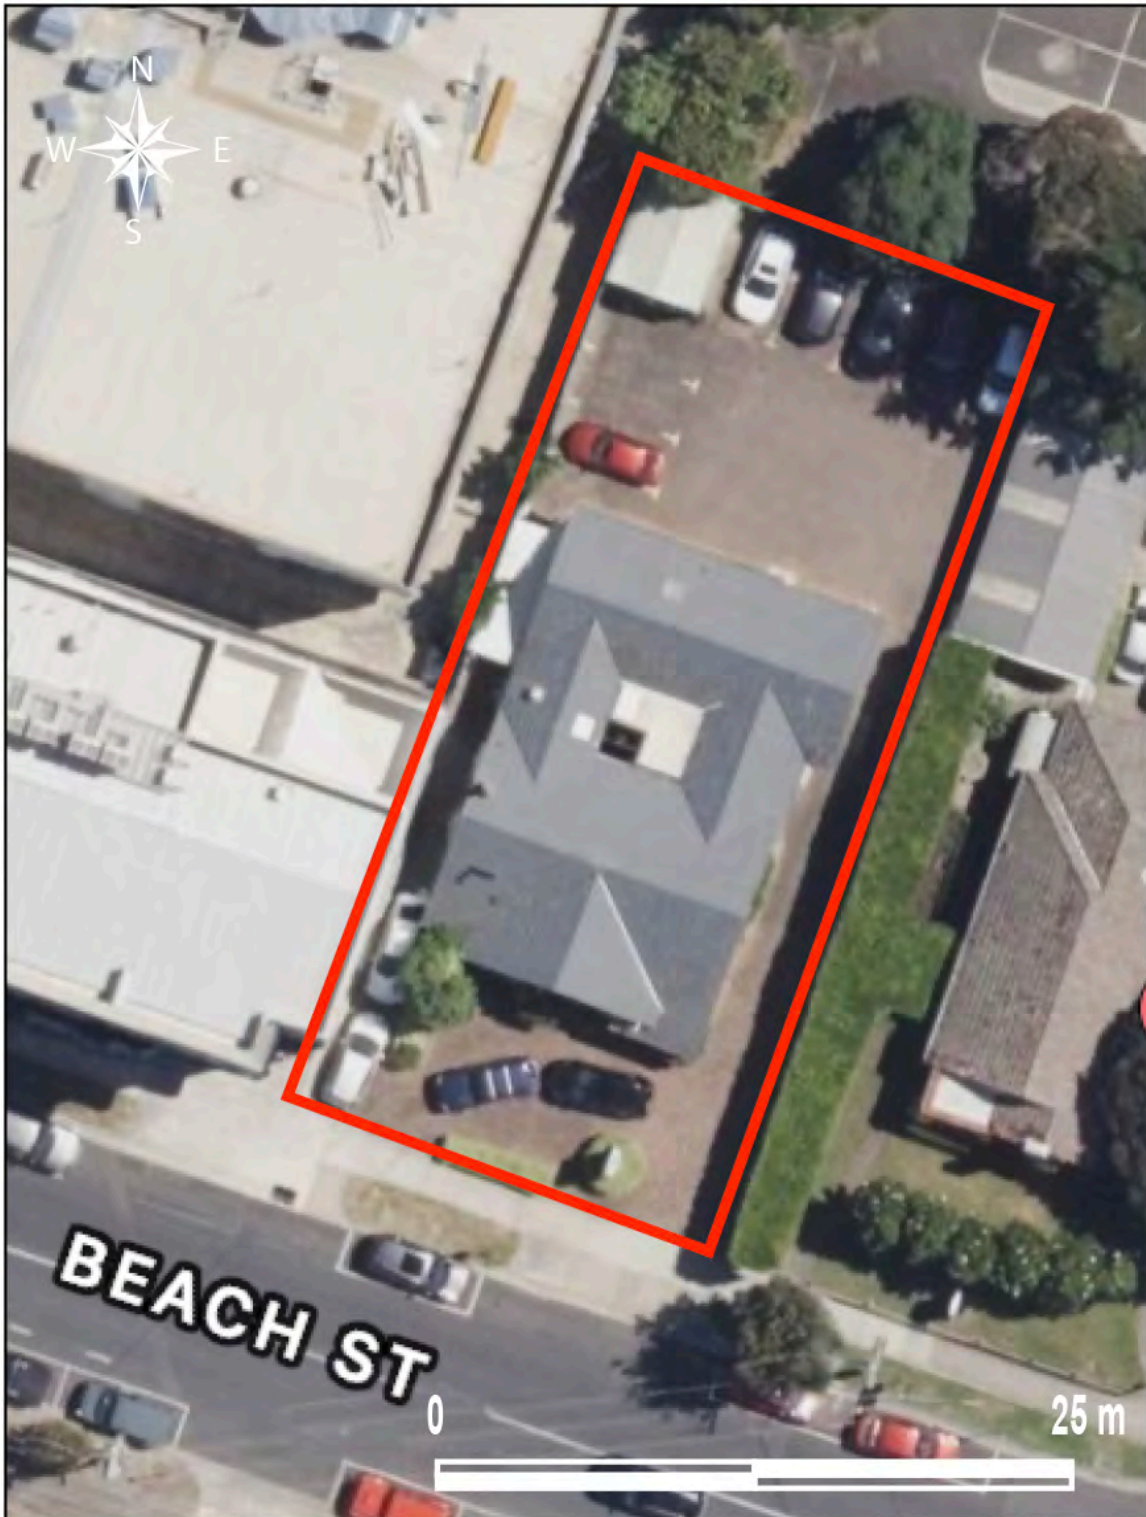
The aerial photograph in Figure 9 clearly shows the locations of the large existing dwelling and associated carport and garden shed on the lot and concrete paving. These surface features clearly visible on a publicly available aerial photograph show that the entire lot has been directly impacted by significant ground disturbance. Additionally, all land surrounding the lot has been significantly disturbed by heavy earthmoving machinery excavating the foundations for adjacent offices and dwellings, suburban streets (with kerbs and guttering), nature-strips and concrete footpaths.

Figure 9. Aerial photograph of Lot 10 LP8386 demonstrating the significant previous development of the lot.

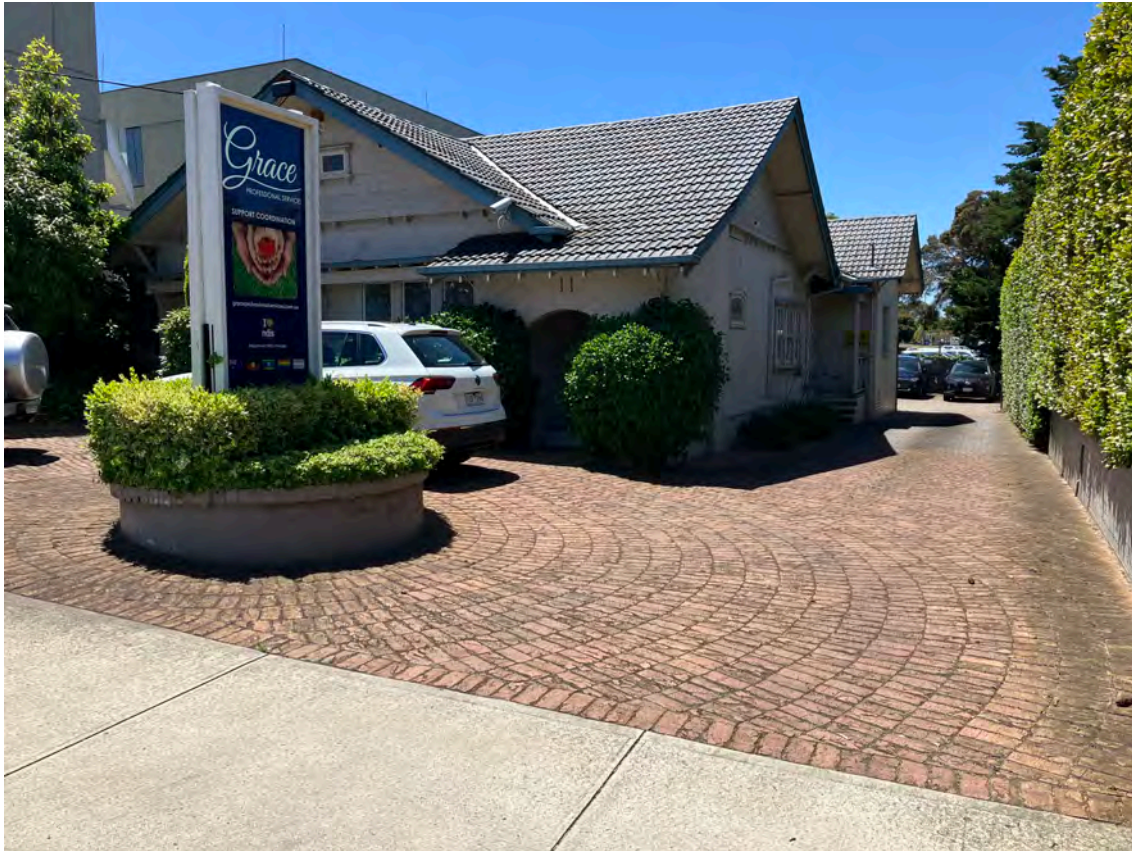
Figure 10. Front of 11 Beach Street Frankston demonstrating the high levels of significant ground disturbance.

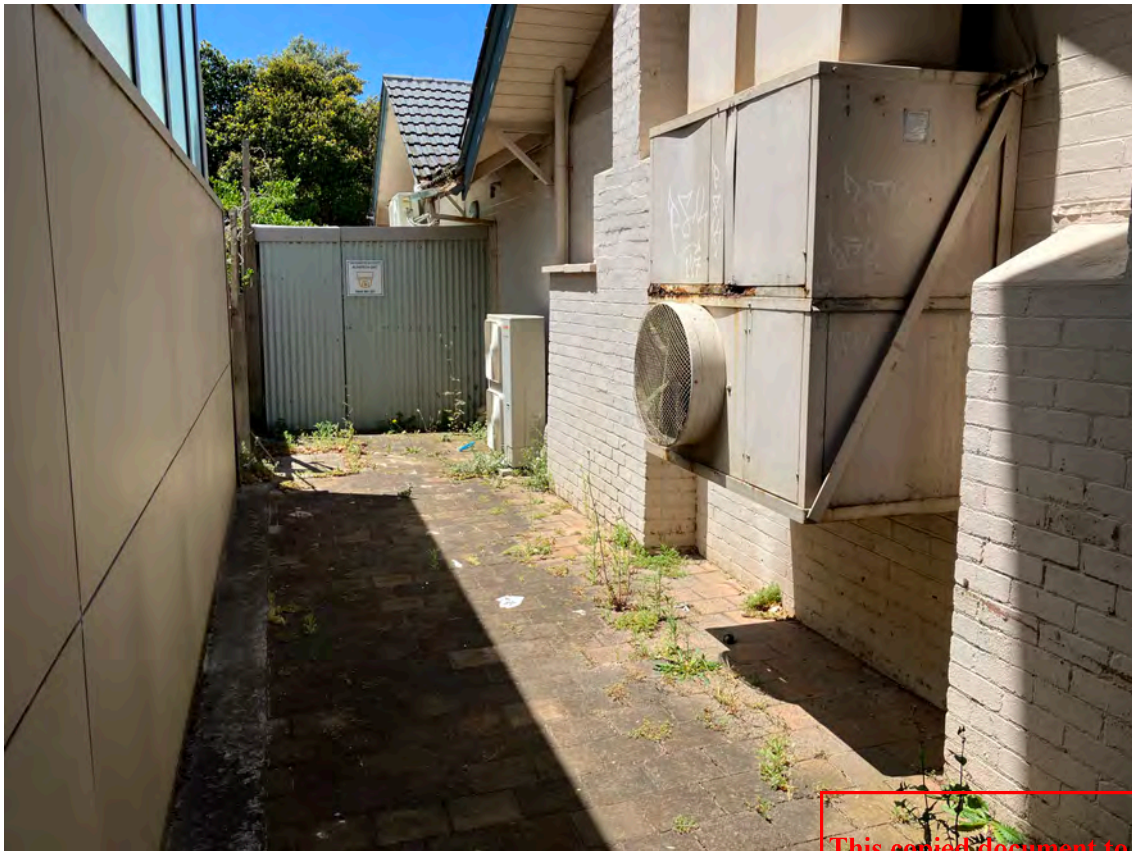
Figure 11. Western side of 11 Beach Street Frankston showing the significant ground disturbance.

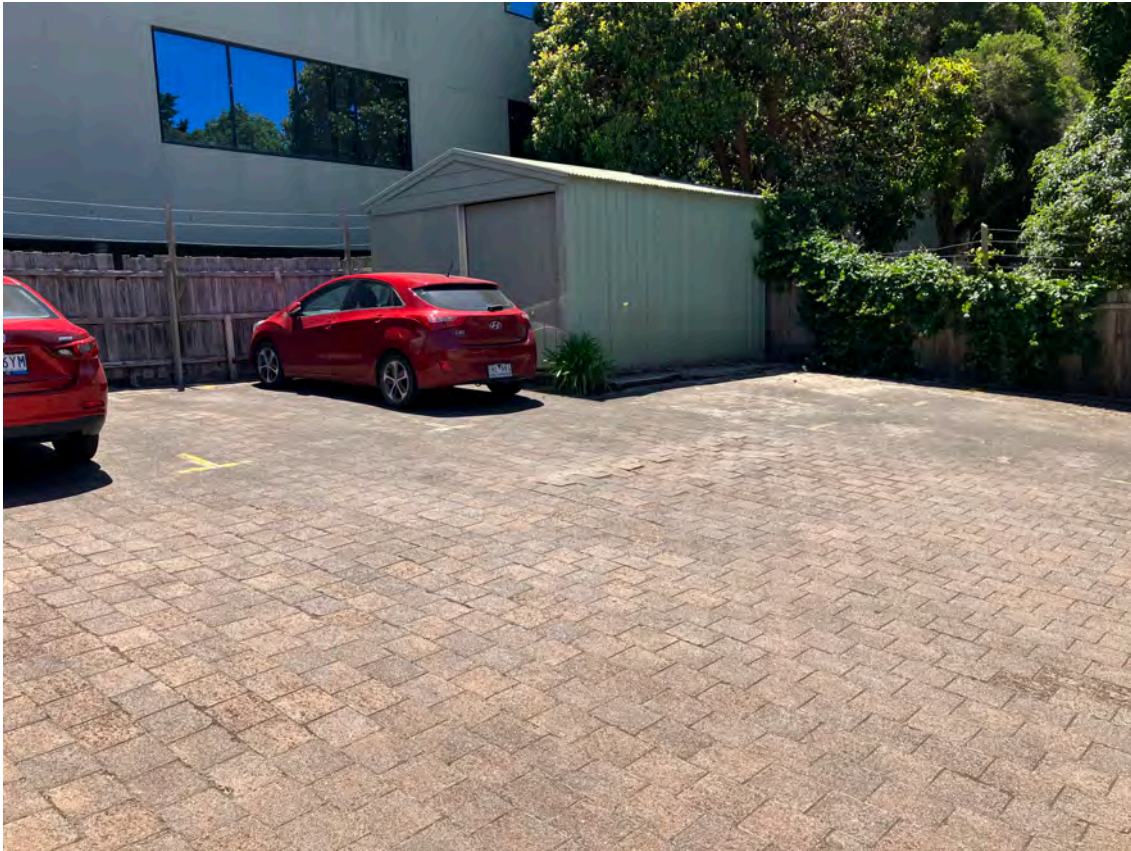
Figure 12. Rear of 11 Beach Street Frankston demonstrating the high levels of significant ground disturbance.

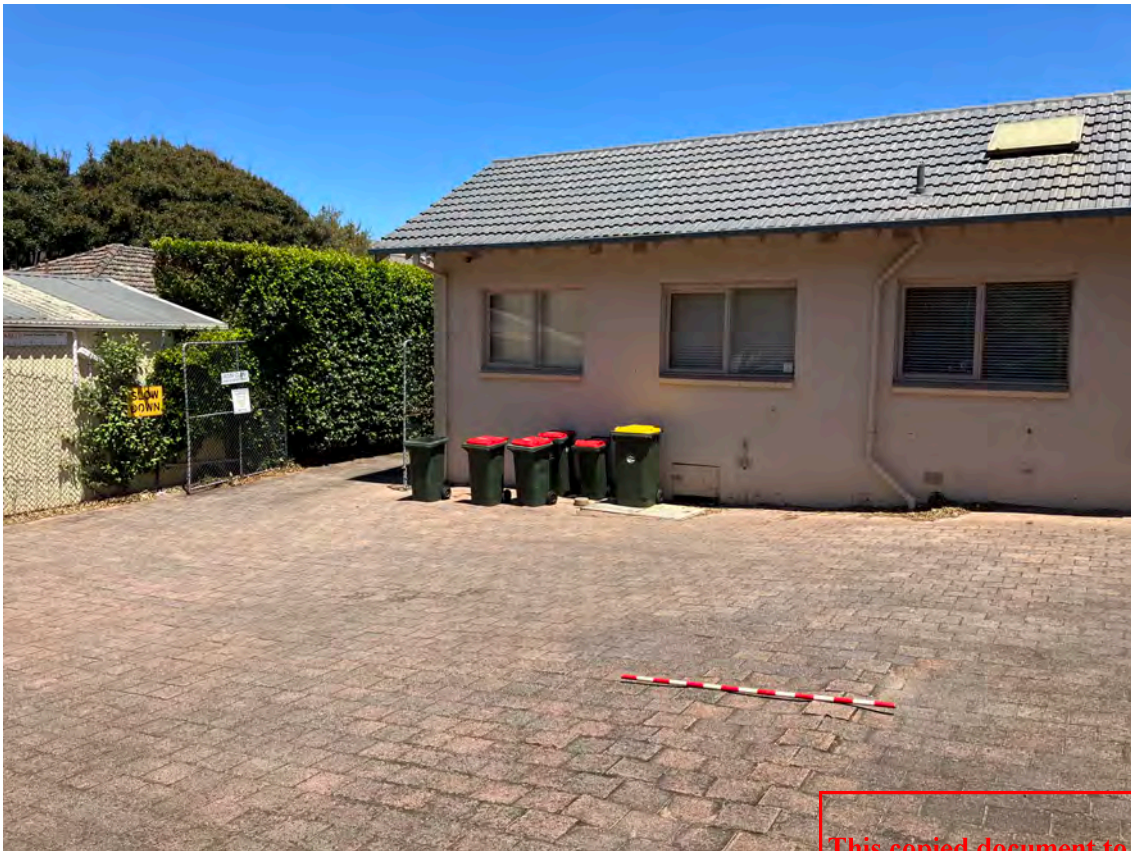
Figure 13. Rear of 11 Beach Street Frankston showing the significant ground disturbance. A large diameter sewer main has been trenching through this area.

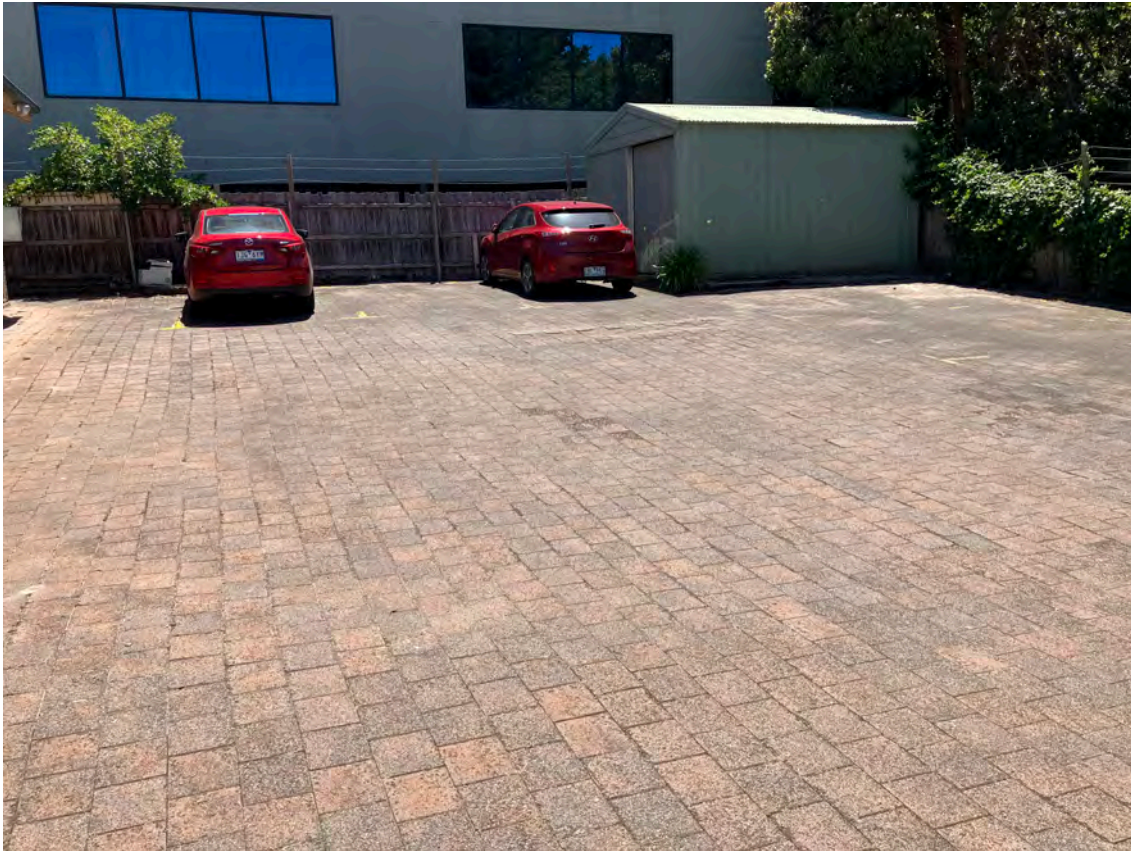
Figure 14. Rear of 11 Beach Street Frankston showing the significant ground disturbance including dwelling and shed construction and concrete paving.
