Lang Lang Sand Resources Pty Ltd

5575 South Gippsland Highway, Lang Lang
Geotechnical Assessment

September 2022

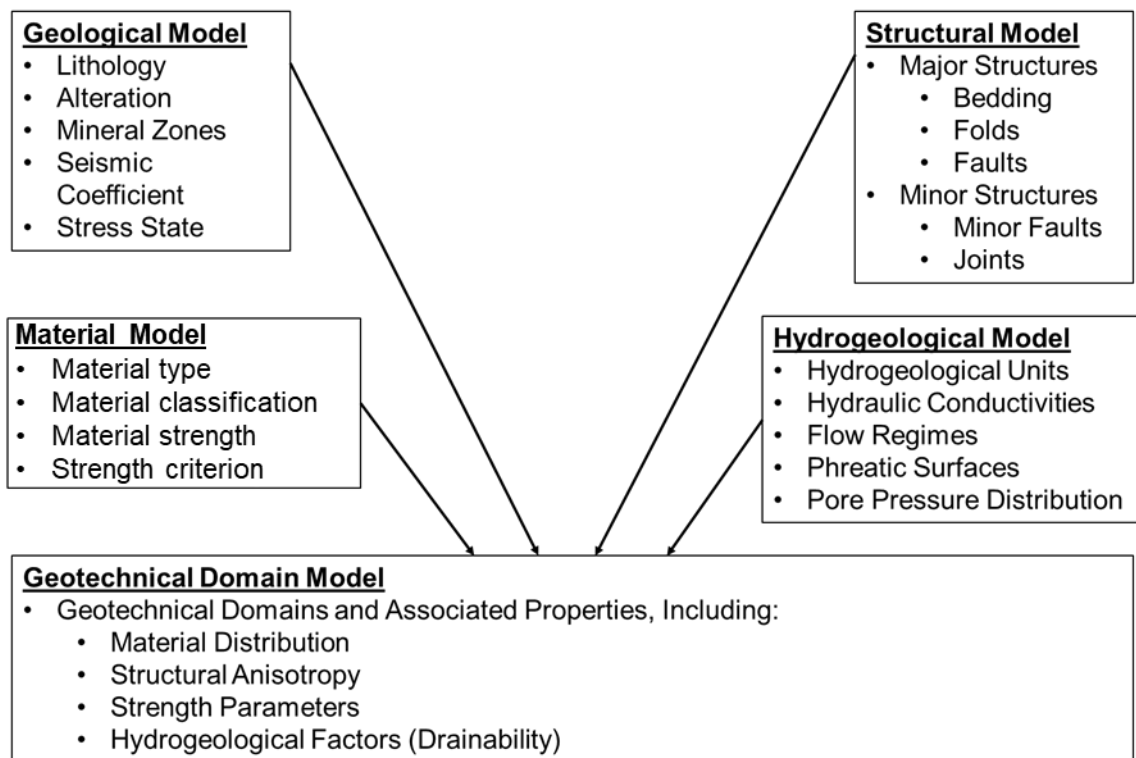
Figure 11 Development of Geotechnical Domain Model after Read and Stacey (2009)

Geotechnical domaining of the Client's site has relied upon the philosophy set out by Read and Stacey (2009). Outlined in the Figure 11 are the considerations that are taken into account when formulating site specific geotechnical domains.

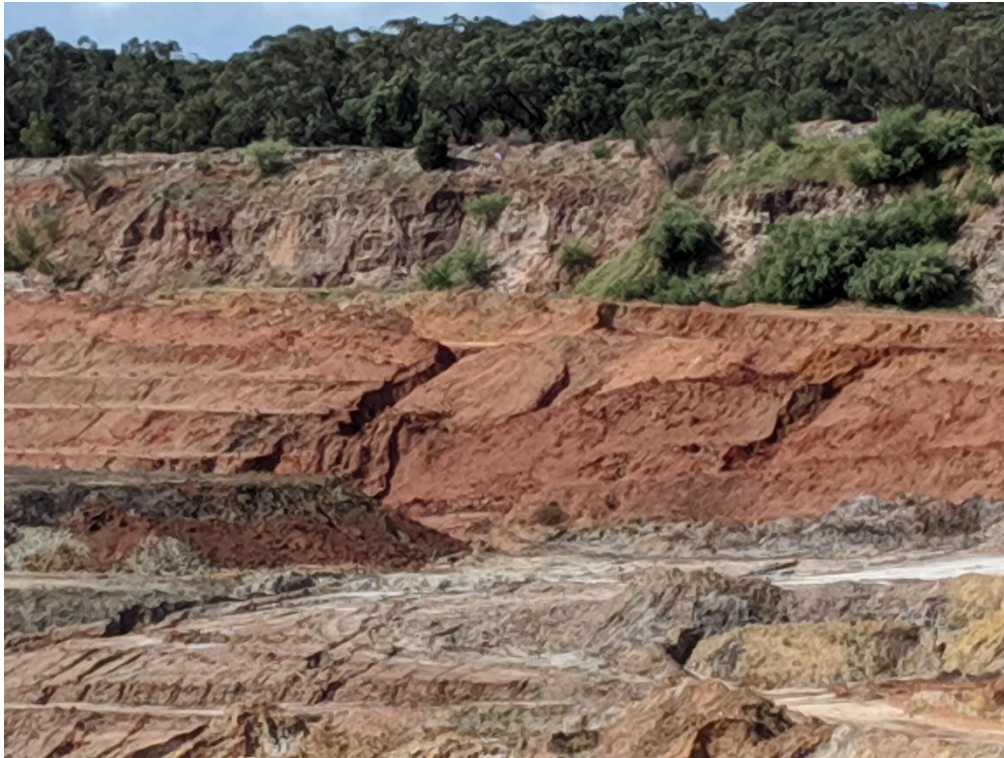
Figure 13 Example of Erosion of Exposed Sand Batters at Nearby Quarry

Piping can occur as water infiltration or perched water may drain via weak zones in the in-situ materials causing the soil to wash out and undercut overlying batters. This can potentially lead to batter instability if not suitably managed. Based on the encountered materials, it is likely that the primary mechanism of failure is circular failure. Circular failure can also result, particularly where the standing groundwater level interfaces with the exposed sand batters above pond level. Undercutting of the base/foundation could potentially increase the likelihood of circular failure of the overlying batter slope. This instability mechanism can be managed with suitable batter design (including offset from base of slope) and surface water management. The secondary mechanism of potential instability can occur from erosion of exposed batters, as the initiation of instabilities within exposed soil units are usually governed by build of pore water pressures as a result of uncontrolled / excessive surface water ingress. This can lead to a decrease in material strength and eventuate as slumping and / or sloughing of batters.

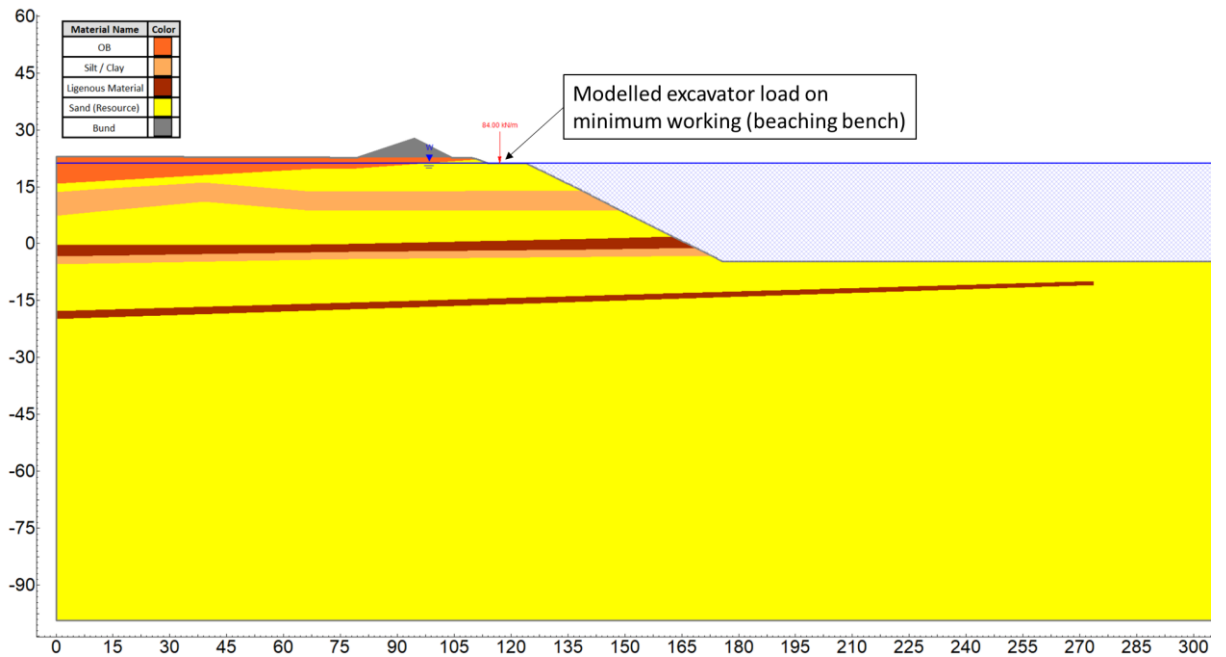
Figure 20 Schematic of Pit Geometry During Dredging

A stability assessment was undertaken to assess the minimum beaching bench width required during dredging to maintain stability of the underlying slope during excavation. For this assessment, based on the possible option of utilising a grab crane for excavation below water level, a potential load from a grab crane has been modelled. Conservatively, the loading from the grab crane has been modelled as a point load equal to 84 kN. A schematic of the loading

conditions assessed in this analysis is depicted in Figure 20 below. It is noted that should a different crane be utilised, the results of this assessments would need to be updated.

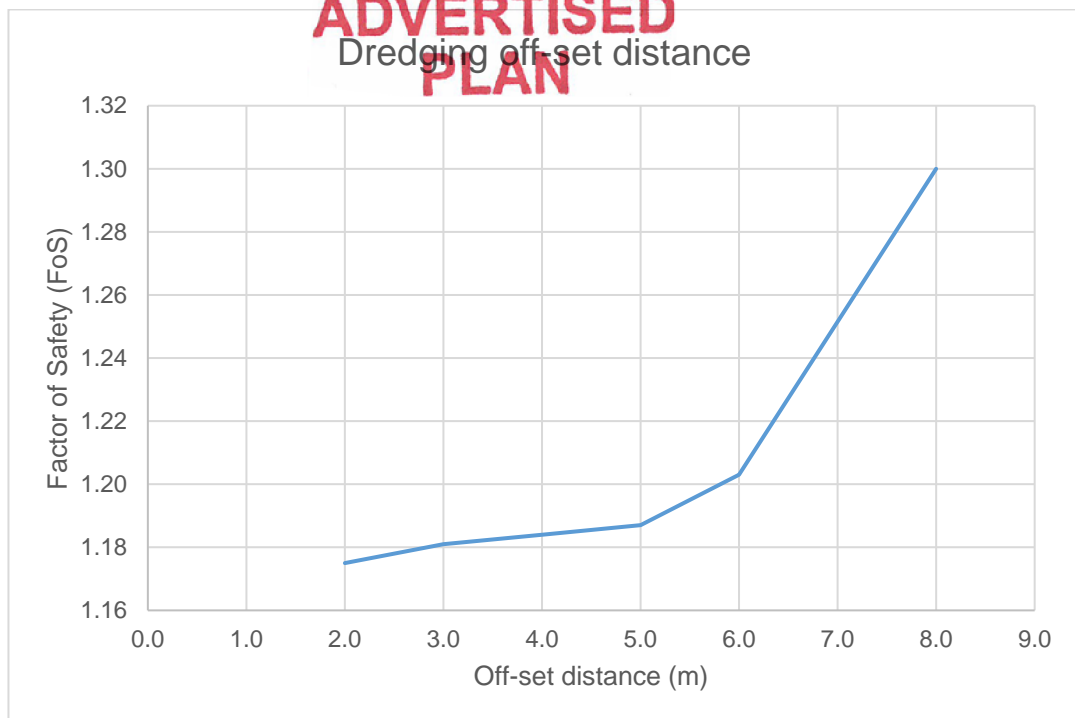
Figure 21 Crane Offset Distance

Figure 21 presents the results of the stability analyses undertaken to determine the minimum offset distance required from the crest to the nearest crawler. Based on the DAC adopted, a minimum FoS of 1.3 is required for the operating batters.

The results presented in Figure 21 indicate that a minimum offset distance of between 6 and 8 m from the crest is required to achieve the minimum operational FoS of between 1.2 to 1.3, respectively. It is considered that based on the duration of loading (e.g., short term: sustained crane loading for a duration of 1 month; a FoS of 1.2 can be adopted). This is depicted in Figure 22 for a FoS 1.3.

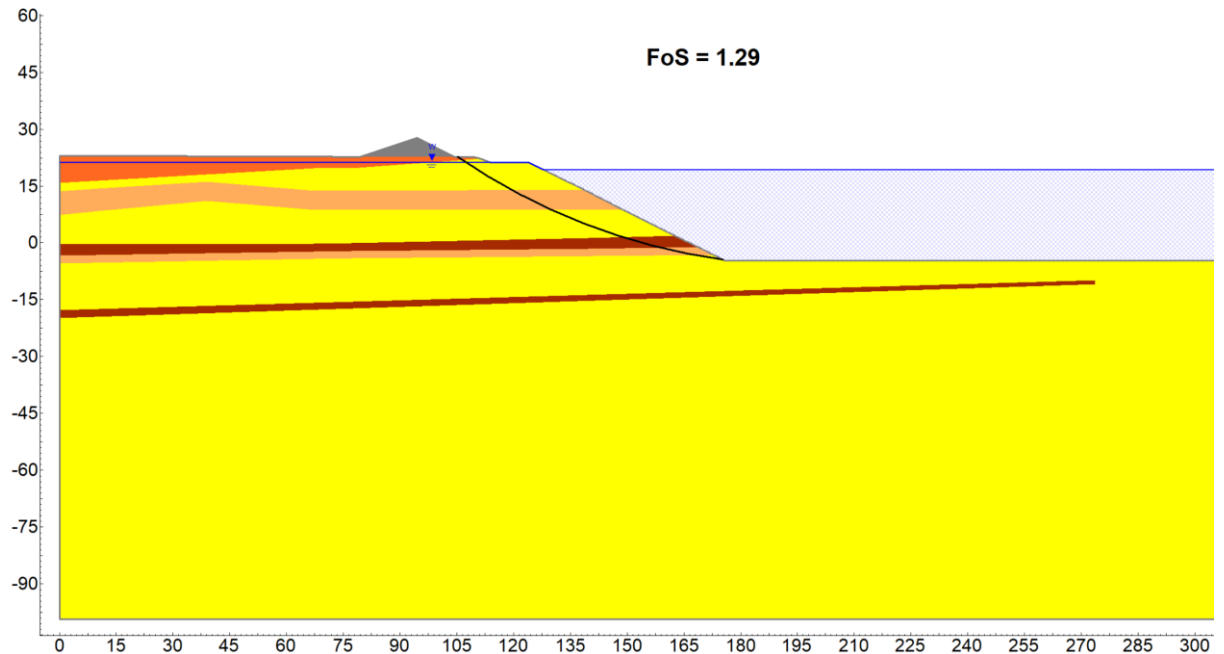
Figure 25 Section A-A' – Sensitivity Analyses – 2 m Reduction in External Water Level

As noted above, quarry lake forces provide a reinforcing effect and suitable ‘counterweight’ to the submerged batters. However, variance in water level may occur during and beyond dredging operations within the proposed quarry pit. Under extreme conditions, a rapid drawdown condition within the slope batters may occur. A sensitivity assessment has been undertaken to assess the stability implications as a result in the reduction of external water levels (i.e., by 1 to 2 m), this is presented in Table 5 and depicted in Figure 25. It should be noted that the calculated critical plane of instability is on a localised scale.

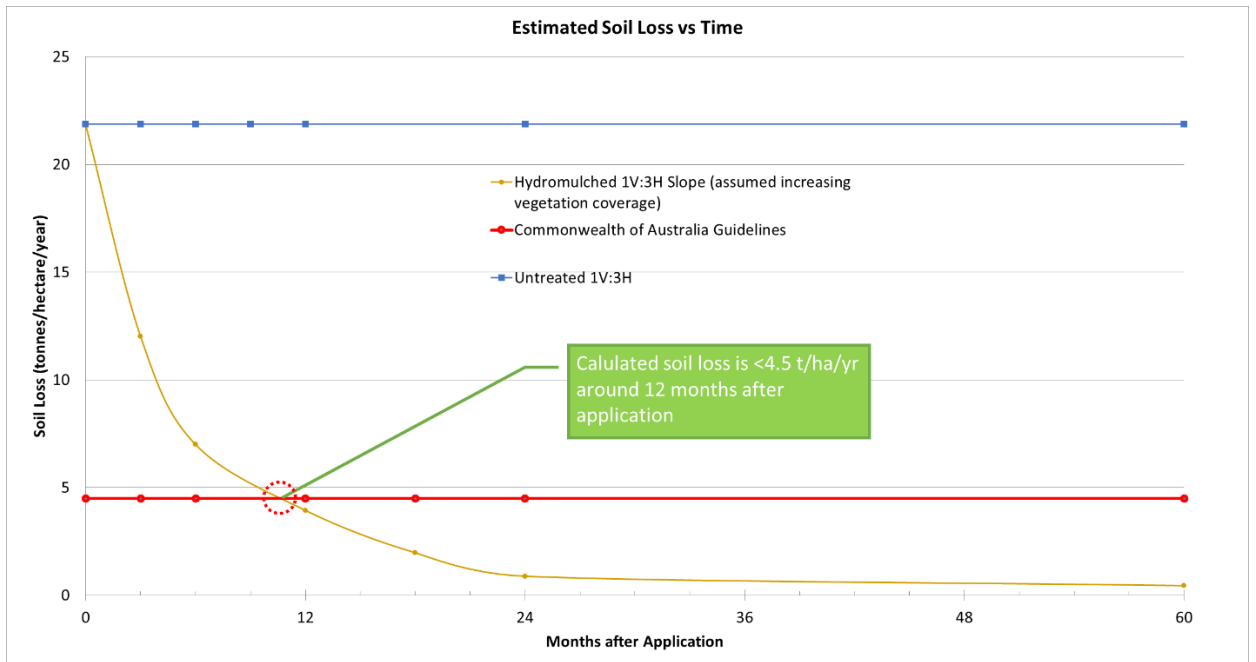
Figure 26 Results of Erosion Potential Analysis

The results of this erodibility potential analysis are based on the assumptions outlined above for the respective input factors. Figure 26 presents the calculated soil loss rate for both the proposed treatment option and an untreated scenario, relative to the 'Leading Practice Sustainable Development Program for the Mining Industry' (Commonwealth of Australia, 2016) guidelines.

Erosion Hazard categories after Morse and Rosewell (1966) and Landcom (2004) provide a metric for comparing the calculated soil loss rate with tolerable ranges (Table 6). The results of the erosion assessment are summarised in Table 12 with respect to the Erosion Hazard categories.

- After 12 months, the estimated soil loss for topsoiled, pre-vegetated batters is 'Very Low' based on the Erosion Hazard guidelines put forward by Morse and Rosewell (1996) and also satisfies the criteria set out by Commonwealth of Australia (2016) (i.e., less than 4.5 t/ha/yr.).
 - However, in accordance with section 89E of the Miner Resources (Sustainable Development) Act 1990, quarry owners are required (requirement no. 42) to rehabilitate the site to a state which is suitable for the planned final use, where vegetation is consistent with the final land use.
- The erosion assessment indicates that through the establishment of vegetation, the long-term erosion rate for rehabilitated batters satisfies the Commonwealth of Australia (2016) guidelines (i.e., <math><4.5\text{ t/ha/yr.}</math>) after 12 months.
