**Dwelling Analysis**

# Dwelling Analysis Locations Moreton Hill Wind Farm

Appendix A Dwelling Analysis locations (Map Source: ESRI, 2024)

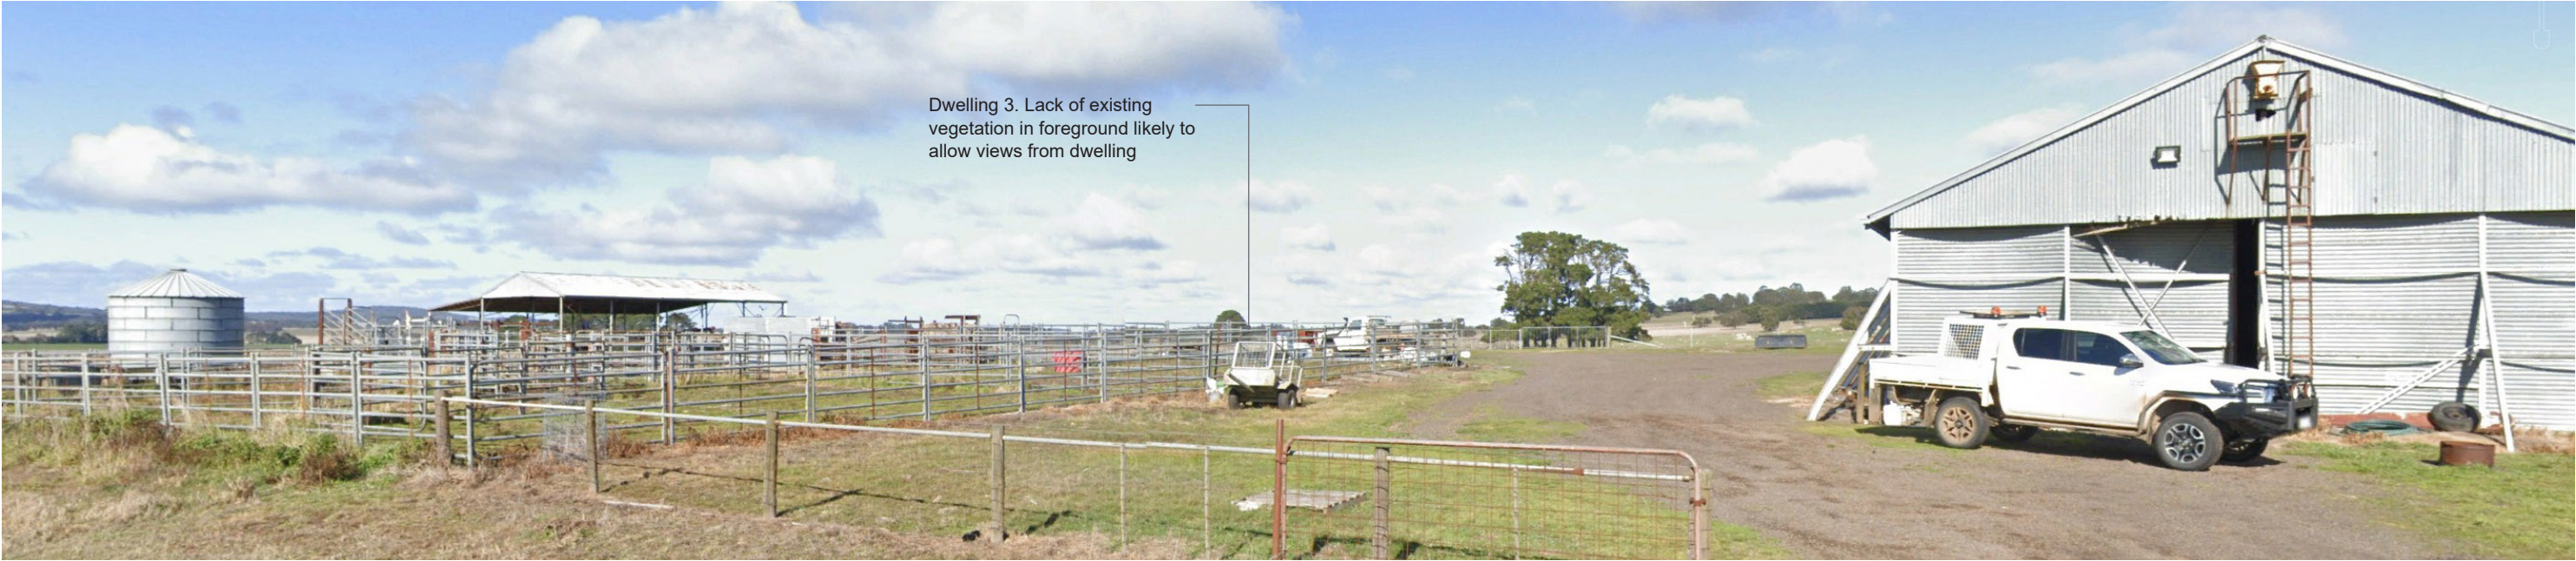
| Notes: |
|---|
| An assessment based on topography alone suggests that all turbines within 6 km are likely to be visible from Dwelling 3, however some are partially screened by intervening topography. Aerial imagery indicates scattered vegetation to the immediate south of the dwelling and an existing farm building to the south east. These are likely to assist in fragmenting views towards turbines, however some open views may be available from breaks in vegetation to the south. Due to the distance from the dwelling, the Project is unlikely to be a dominant element of the view in addition to the existing screening elements. |

Dwelling 3 - Existing View  
View from Mount Emu Settlement Road near mailbox of Dwelling 3 (Image Source: Google Street View 2024)

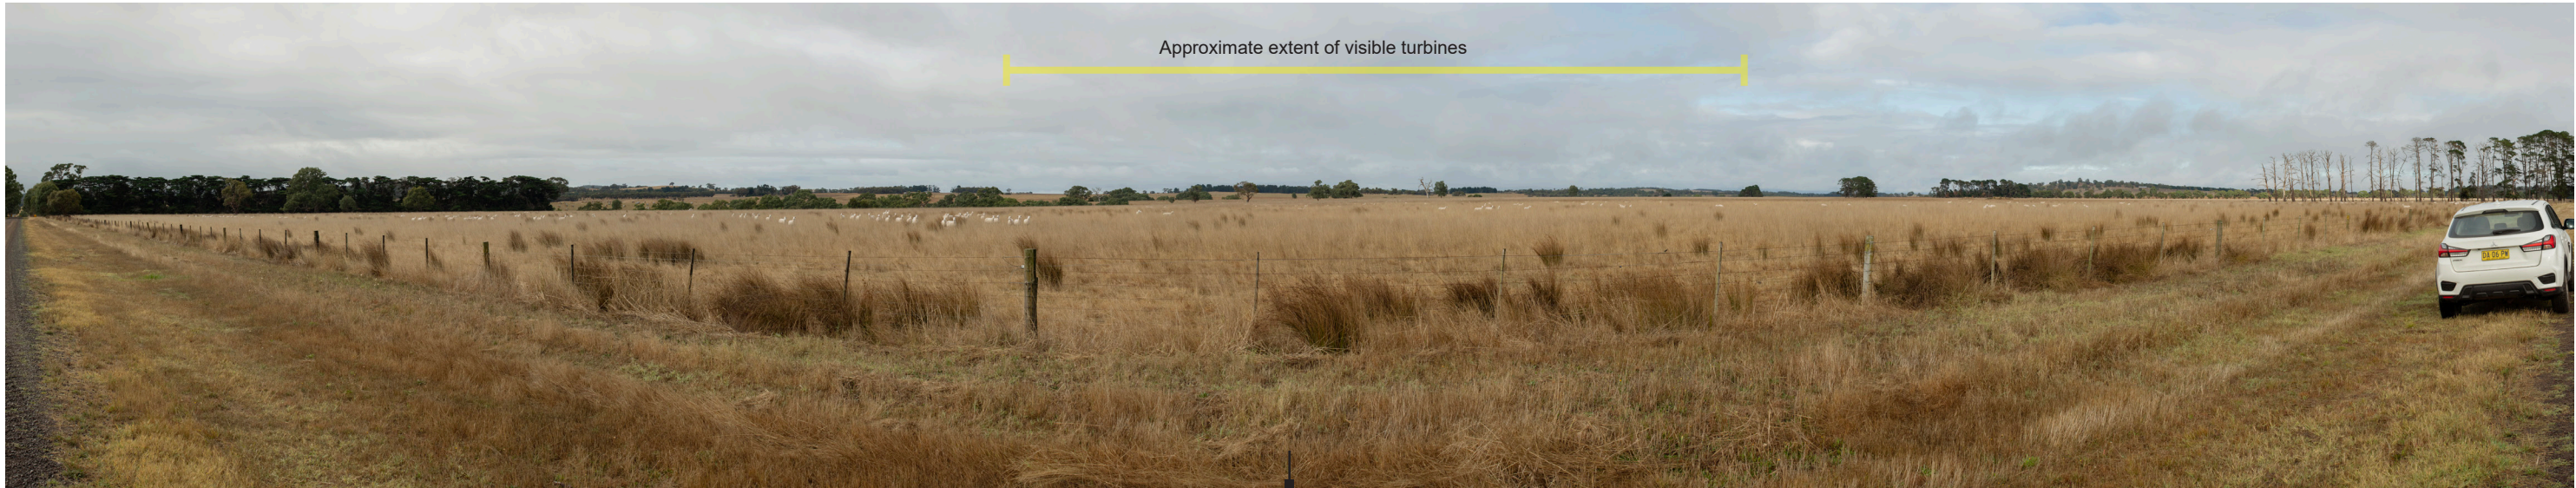
An assessment based on topography alone suggests that all turbines within 6 km are likely to be visible from Dwelling 4. The dwelling is located on flat terrain. Aerial imagery indicates that a row of dense roadside vegetation is present along Mount Emu Settlement Road, south of the dwelling. This vegetation is likely to screen the majority of the views towards the Project from the dwelling.

Dwelling 4 - Existing View  
View from Mount Emu Settlement Road - Darlington Road near Dwelling 4

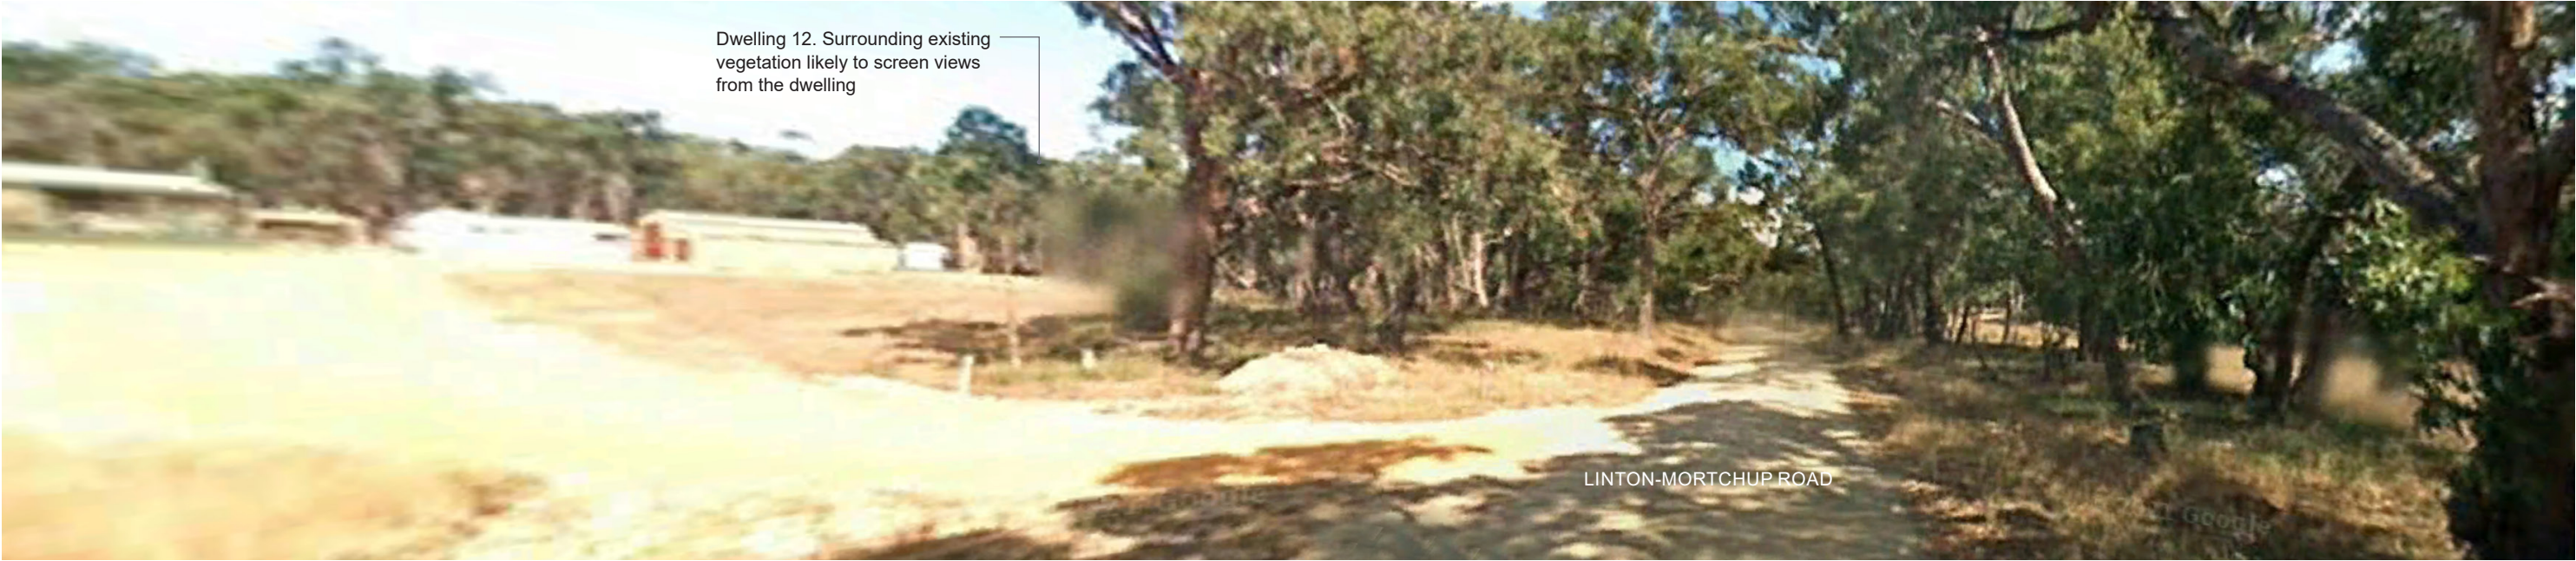
| Notes: |
|---|
| An assessment based on topography alone suggests that all turbines within 6 km are likely to be visible from Dwelling 12, however only the tip is visible, with majority of the turbine screened by undulating topography. The dwelling is located on undulating terrain, in an elevated position. Aerial and street view imagery indicate that it is situated within an area that is densely vegetated. The vegetation and undulating terrain will screen the Project from this dwelling. |

**Dwelling 12 - Existing View**  
View from Linton-Mortchup Road near mailbox of Dwelling 12 (Image Source: Google Street View 2008)

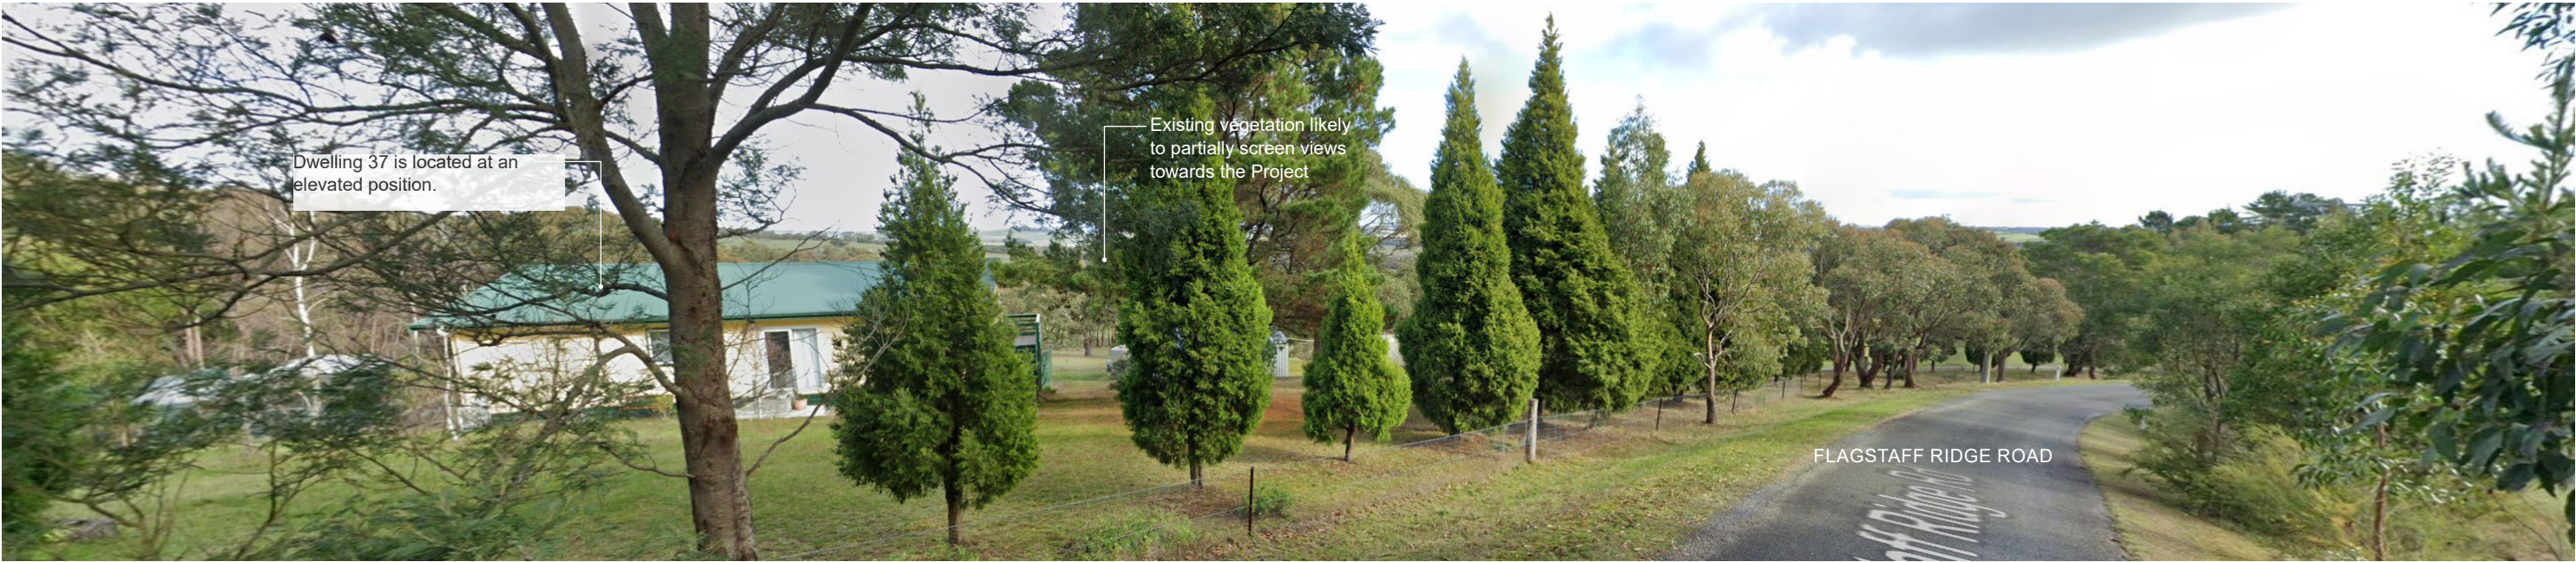
| Notes: | |
|---|--|
| An assessment based on topography alone suggests that all turbines within 6 km are likely to be visible from Dwelling 37. The dwelling is located on undulating terrain in an elevated position. Aerial imagery indicates existing windbreak planting on the southern and western sides of the residence and an existing farm building to the south west which will assist in fragmenting some views towards the Project. However due to the elevated position of the dwelling, and the direction of the Project, it is likely that the Project will be clearly visible and potentially dominant from this dwelling. | |

Dwelling 37 - Existing View  
View from Flagstaff Ridge Road near mailbox of Dwelling 37 (Image Source: Google Street View 2024)

| Notes: | |
|---|--|
| Additional screening in the immediate foreground could assist in reducing the visual impacts from the Project. Consultation with the landowner will be required to recommend screen planting. | |

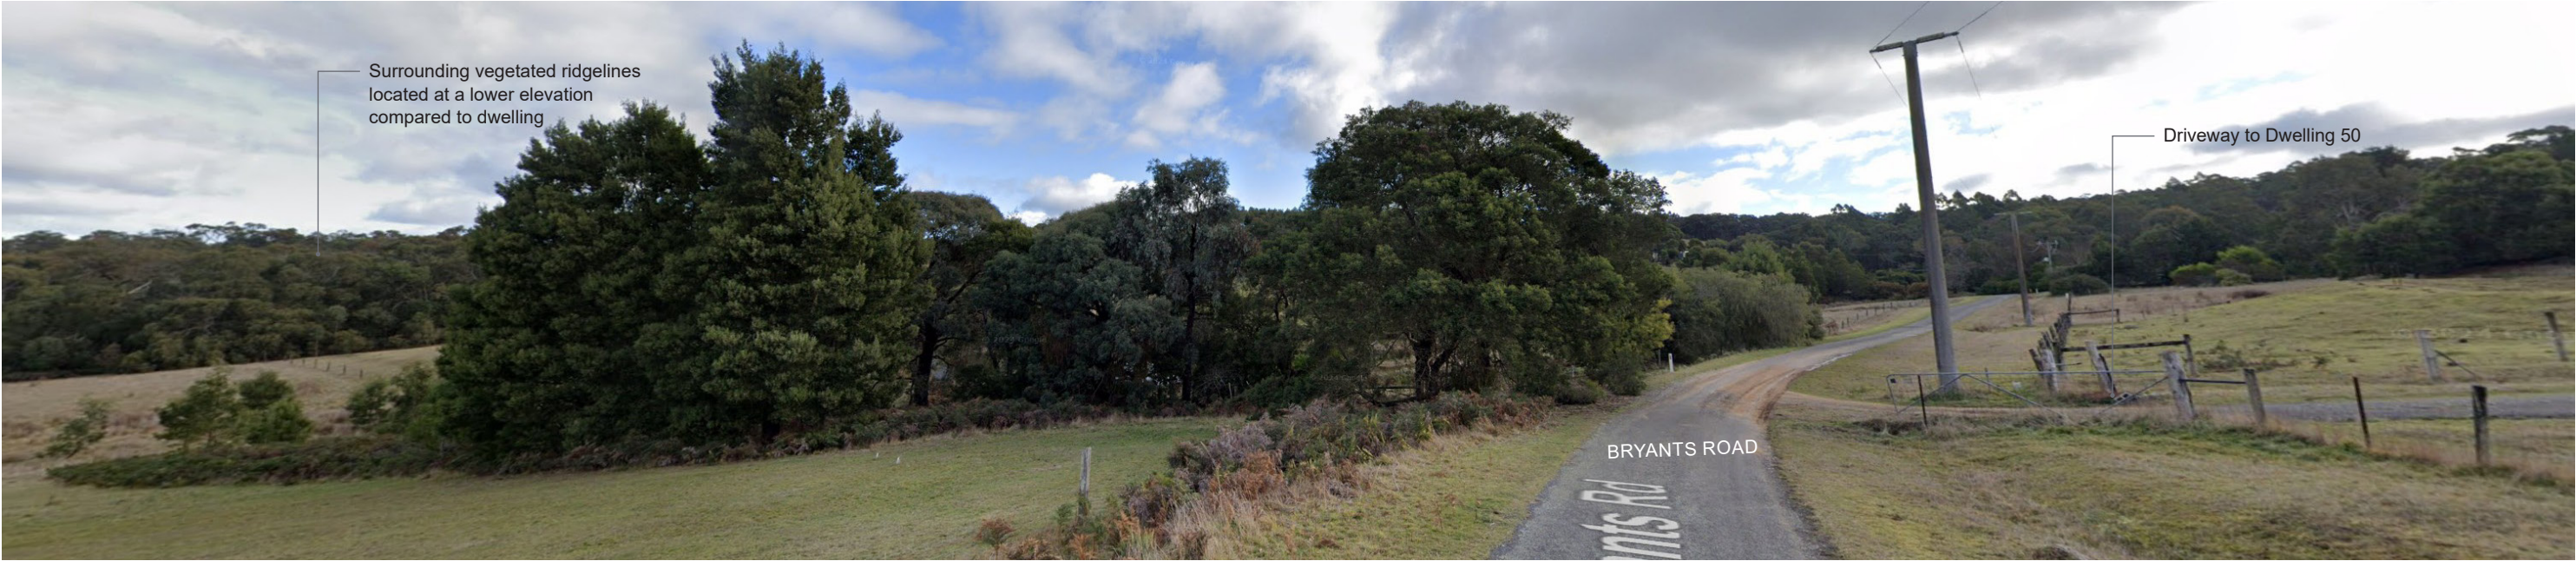
| Notes: | |
|---|---|
| An assessment based on topography alone suggests that majority of the Project is screened by intervening topography. Some turbines could be visible above the ridge line, however it is likely they will be screened by vegetation present along the ridge line. | Note: Labelled WTGs are located within 6 km of this nominated non-associated dwelling. WTGs that are not labelled are located beyond this distance. |

Dwelling 50 - Existing View  
View from Bryants Road near mailbox of Dwelling 50 (Image Source: Google Street View 2024)

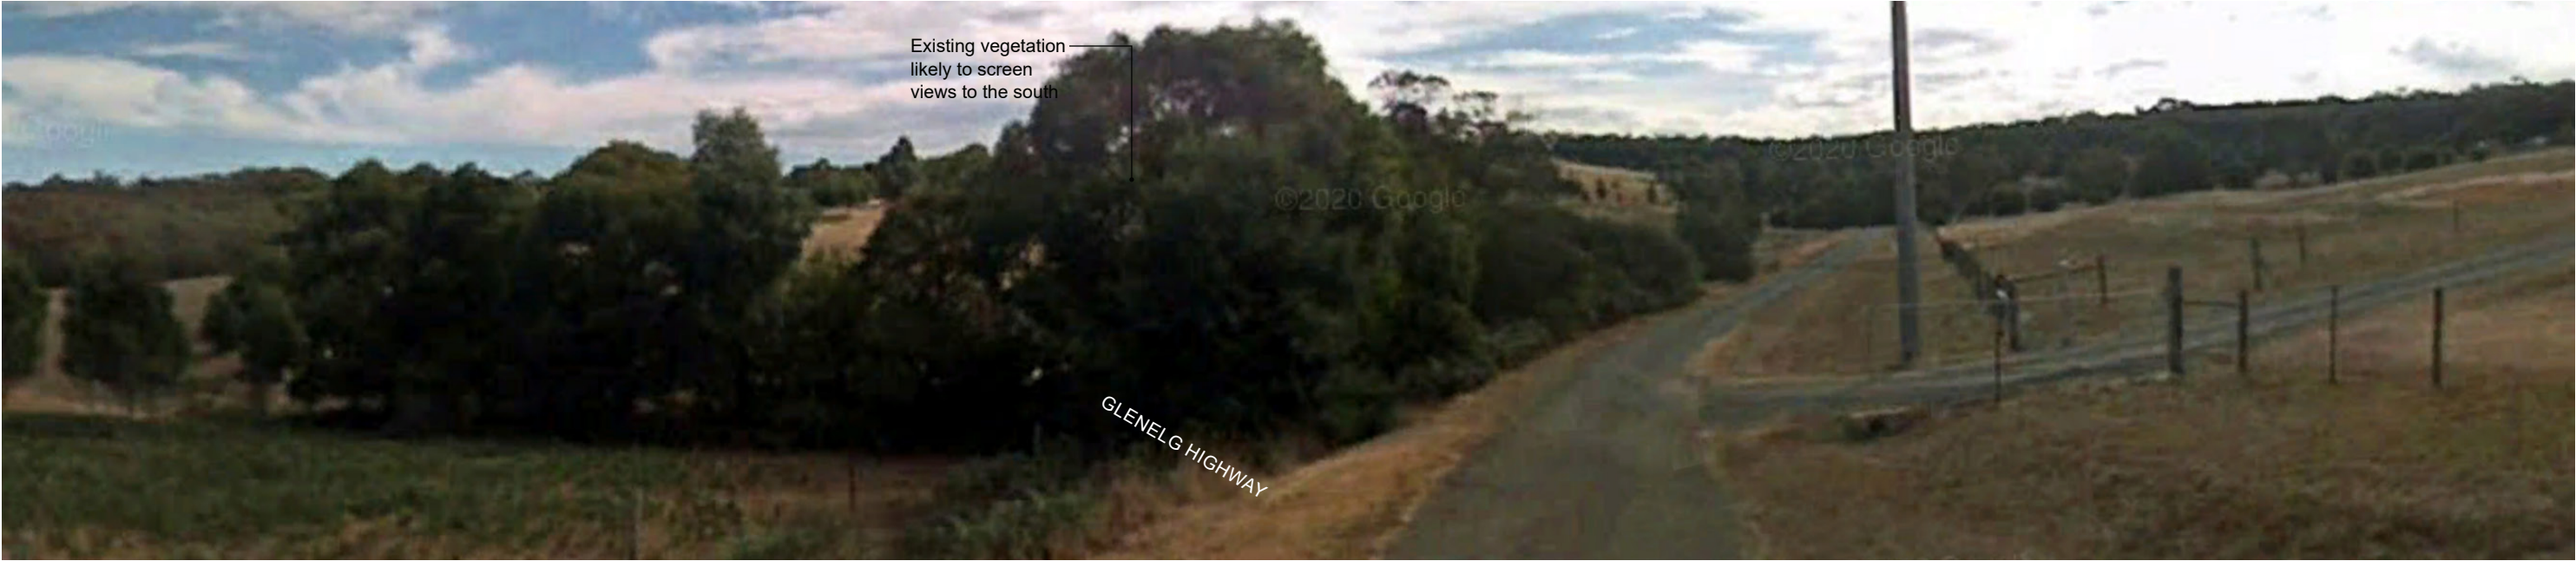
| Notes: |
|---|
| An assessment based on topography alone suggests that all of the turbines within 6 km are visible from this dwelling. Aerial imagery indicates there is little vegetation present in the immediate curtilage of the dwelling, however dense planting is present along the southern boundary of the property between the dwelling and the Project. Due to the elevated position of the dwelling, the tips of some turbines may be visible above the tree line. It is also possible that the existing Stockyard Wind Farm is partially visible from this dwelling. |

Dwelling 60 - Existing View  
View from Glenelg Highway near mailbox of Dwelling 60 (Image Source: Google Street View 2010)

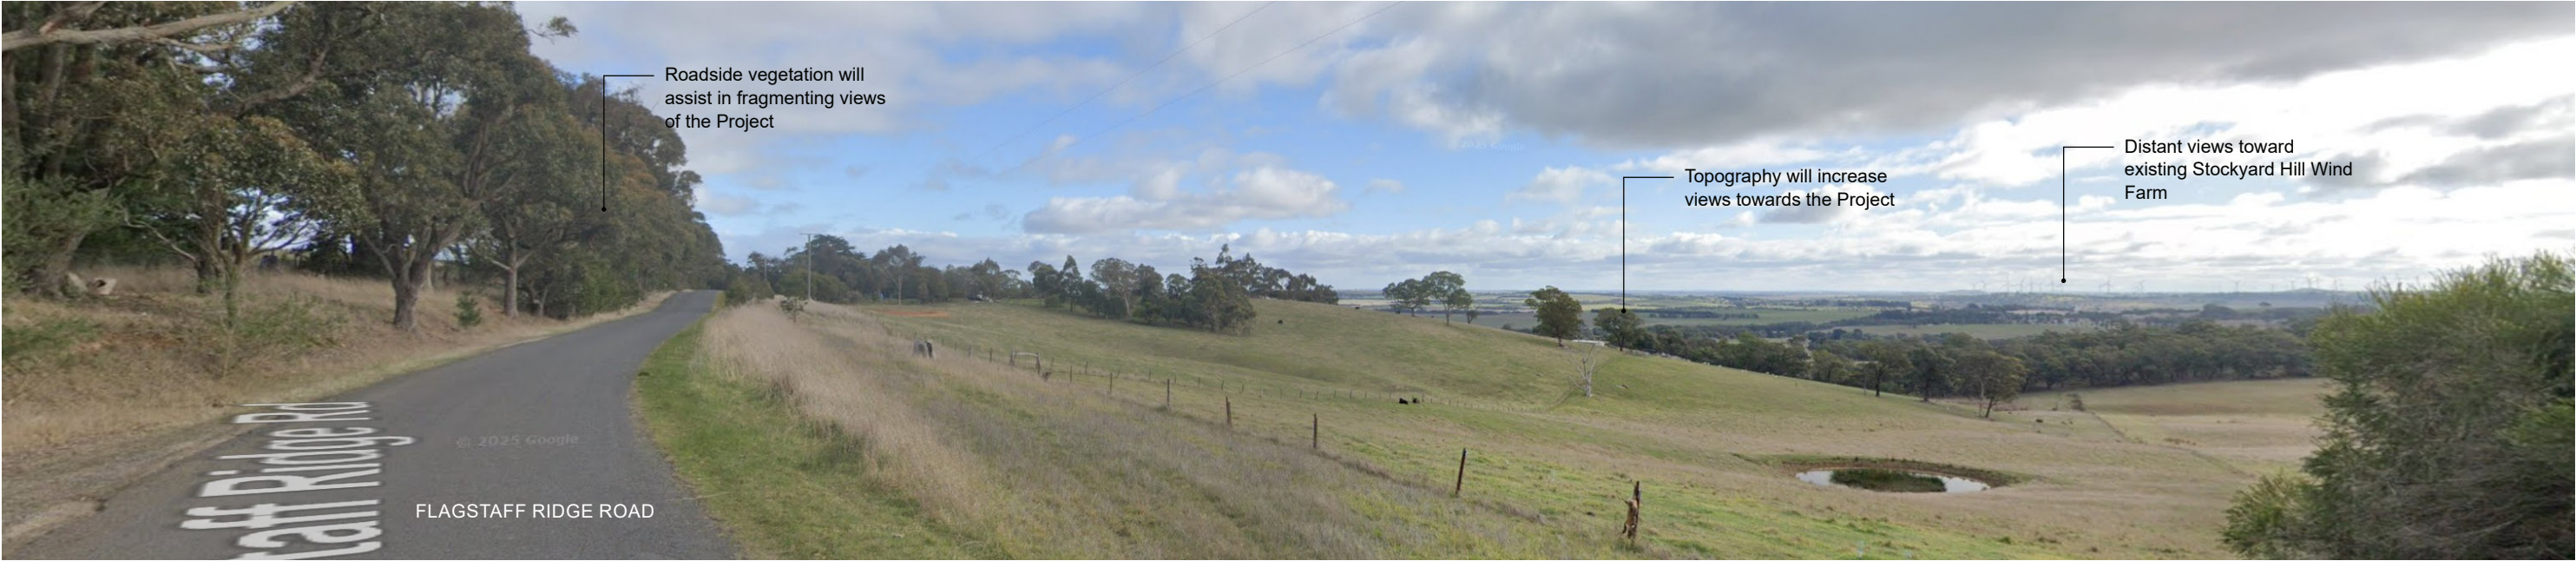
**Dwelling 62 - Existing View**  
View from Flagstaff Ridge Road near mailbox of Dwelling 62

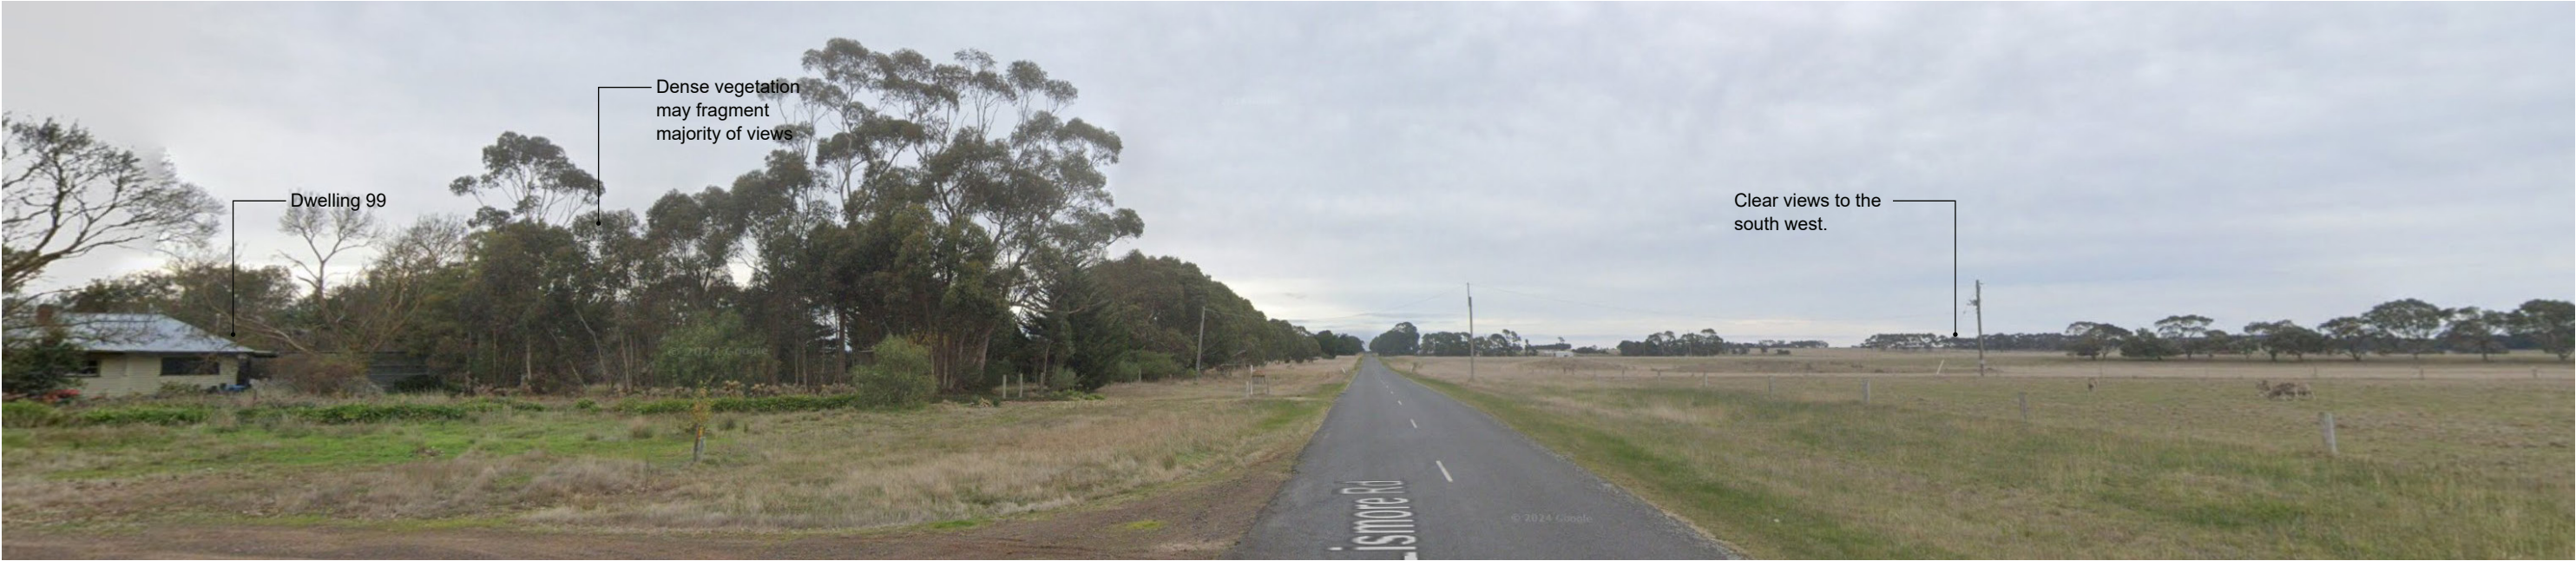
| Notes: | |
|---|---|
| An assessment based on topography alone suggests that all of the turbines within 6 km are visible from this dwelling. Aerial imagery indicates there is dense vegetation surrounding the immediate curtilage of the dwelling which will assist in screening the majority of the Project. However, gaps in the vegetation to the northwest will allow for views to approximately 8 turbines, some in close proximity to the dwelling. | Note: Labelled WTGs are located within 6 km of this nominated non-associated dwelling. WTGs that are not labelled are located beyond this distance. |

Dwelling 99 - Existing View  
View from Pittong-Lismore Road near mailbox of Dwelling 99 (Image Source: Google Street View 2024)

| Notes: | |
|---|---|
| Additional screening in the immediate foreground could assist in reducing the visual impacts from the Project. There is opportunity for screen planting on the western side of Pittong-Lismore Road within the Site Boundary. If further planting is required on the eastern side, there is also opportunity for screen planting within the Site Boundary to the east of the dwelling. | |

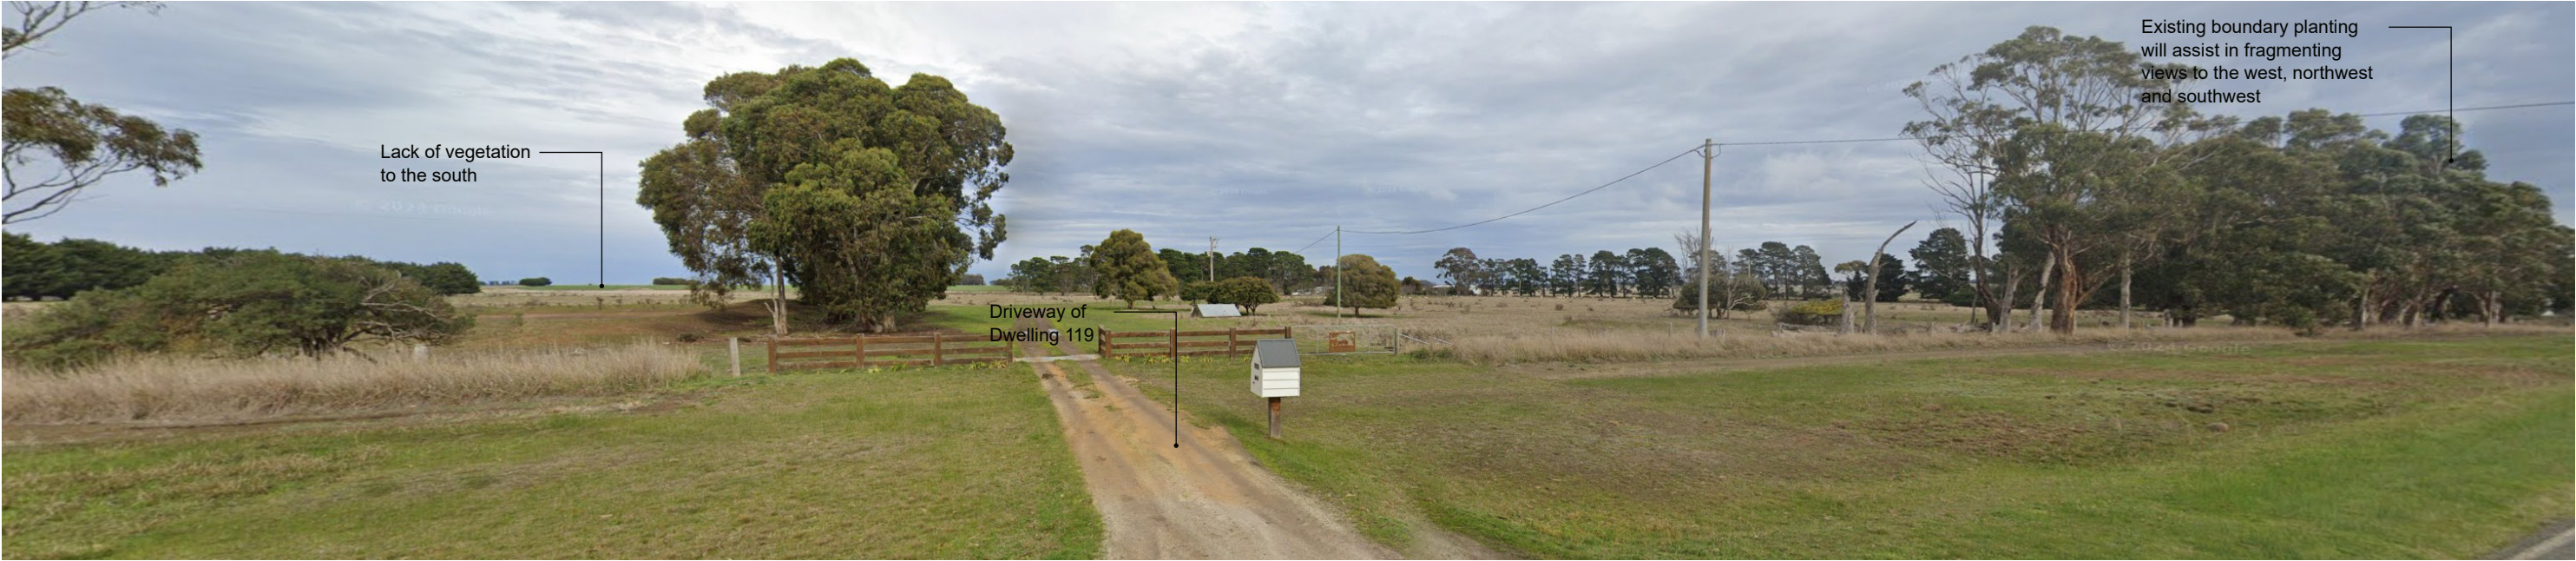
**Dwelling 60 - Existing View**  
View from Rokewood-Skipton Road near mailbox of Dwelling 119 (Image Source: Google Street View 2024)

| Notes: |
|---|
| Additional screening in the immediate foreground could assist in reducing the visual impacts from the Project. Consultation with the landowner will be required to recommend screen planting. |

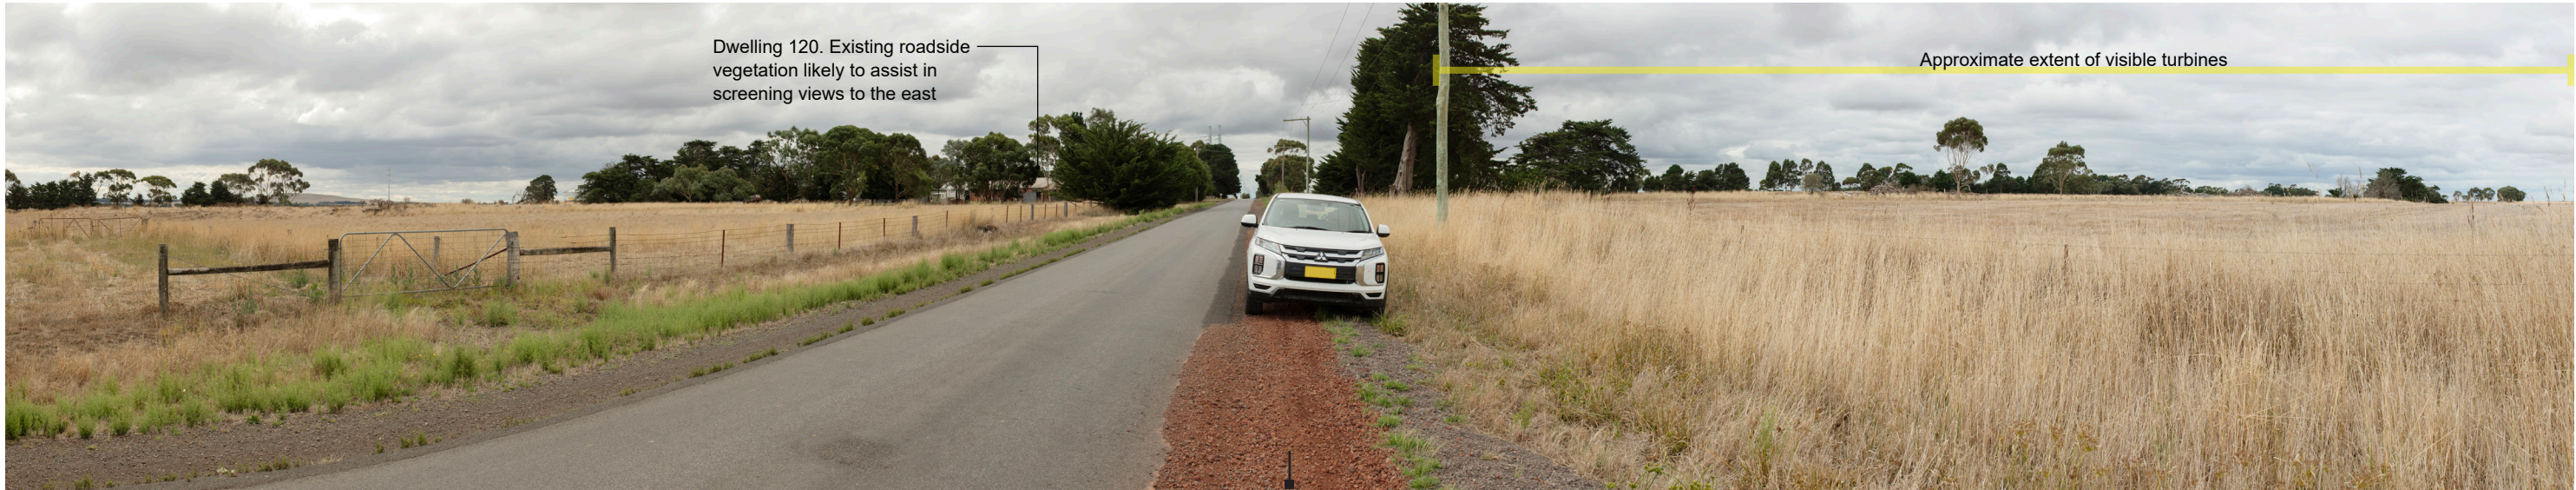
An assessment based on topography alone suggests that all of the turbines within 6 km are visible from this dwelling. Aerial imagery indicates that the residence is orientated northeast and is surrounded by dense windbreak vegetation. This vegetation will help in fragmenting some views north and south toward the Project. It is noted that a break in this existing vegetation is located along the eastern boundary. A combination of distance to the Project and the lack of vegetation to the east is likely to result in visibility towards turbines to the east of this location. The closest turbines to the south, particularly T46, T47 and T48, may be visible above the tree line due to the close proximity to the dwelling.

Dwelling 120 - Existing View  
View from Mount Bute Road near Dwelling 120

Additional screening along Mount Bute Road to the east, within the Site Boundary, could assist in reducing the visual impacts from the Project.

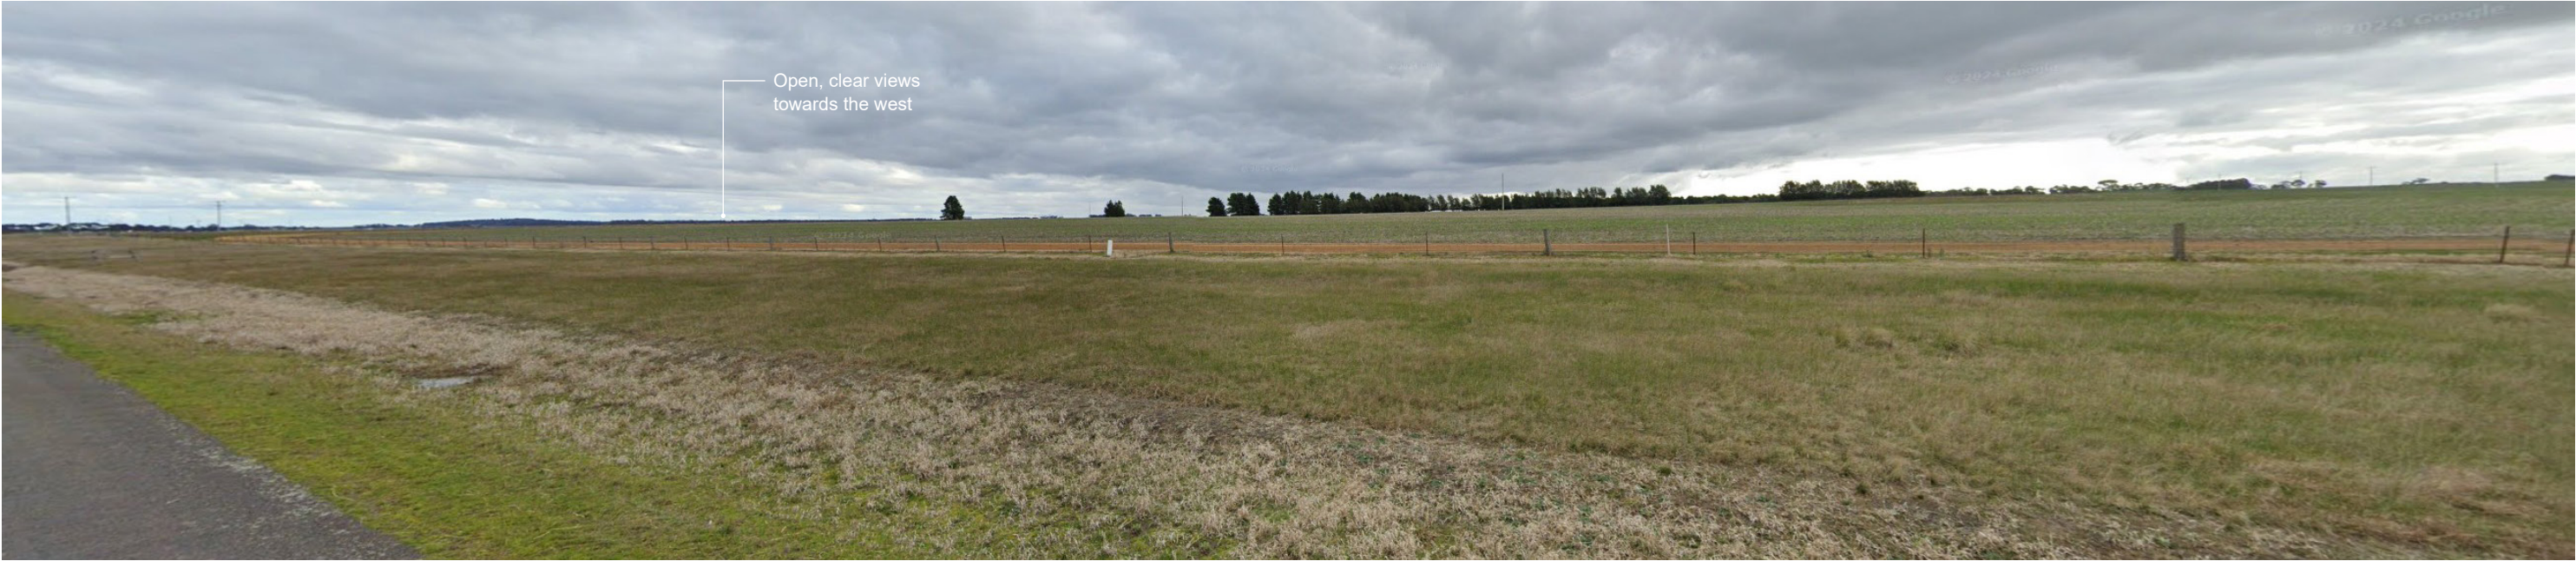
| Notes: |
|---|
| An assessment based on topography alone suggests that all of the turbines within 6 km are visible from this dwelling. Aerial imagery indicates that there is boundary vegetation to the dwelling's west. However, it is noted that the vegetation opens up directly to the west, allowing for views out from the dwelling in this direction. The existing vegetation is likely to fragment views towards the closest turbines (within 6 km) from this location. Fragmented views are likely through the breaks in vegetation but due to the distance from the dwelling, the Project is unlikely to form a dominant element in the view. |

Dwelling 134 - Existing View  
View from Linton-Naringhil Road near mailbox of Dwelling 134 (Image Source: Google Street View 2024)

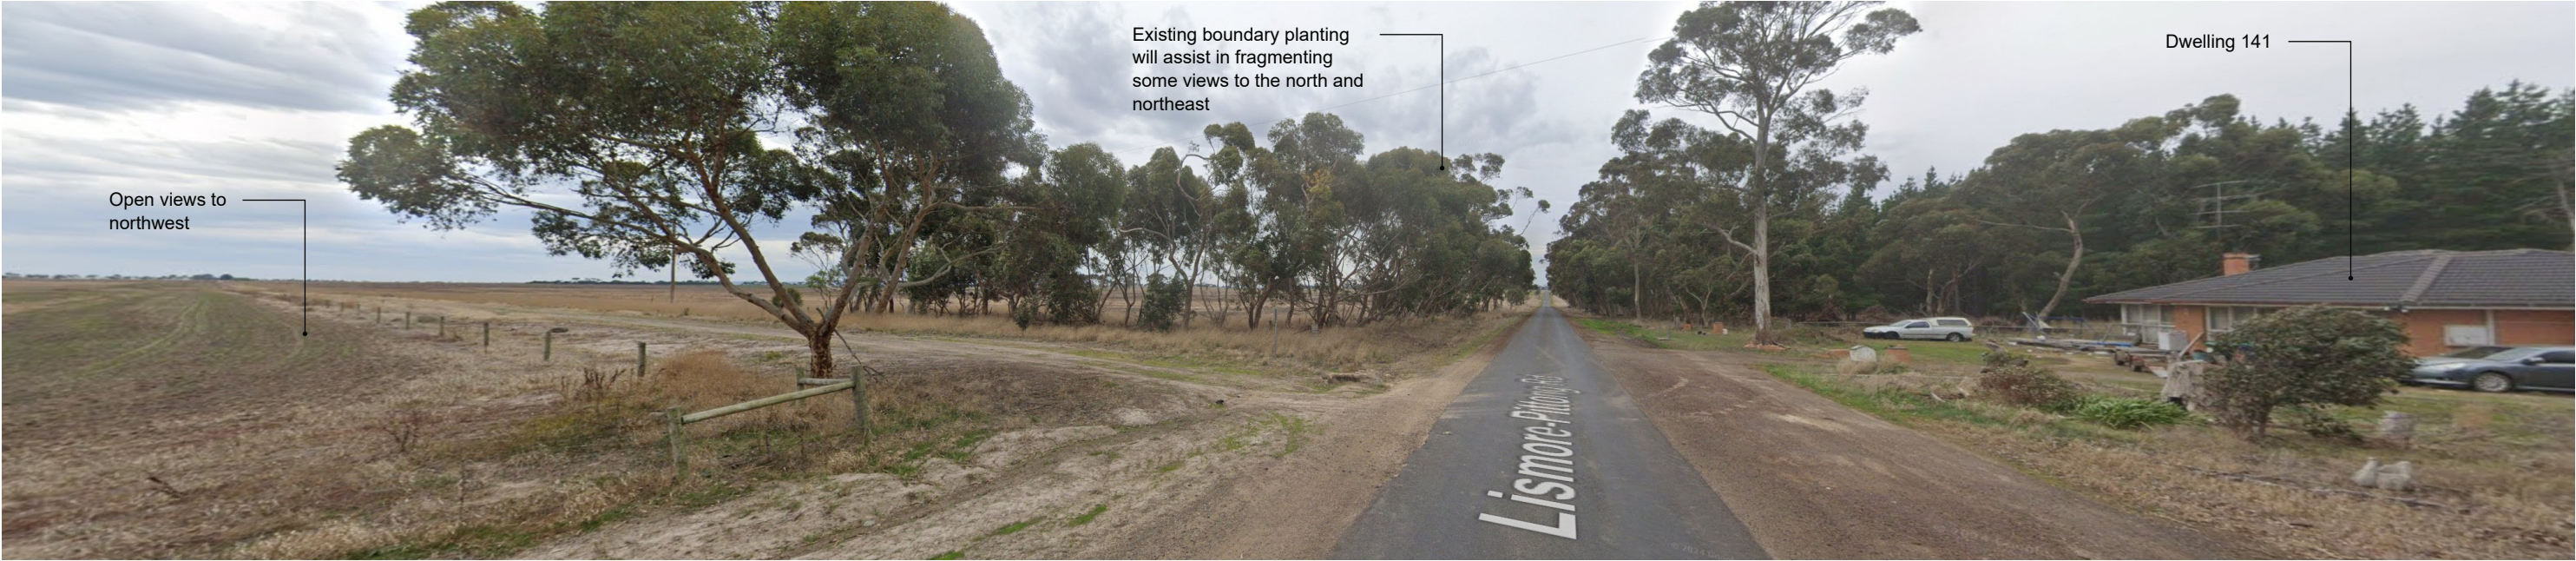
Dwelling 141 - Existing View  
View from Lismore-Pittong Road near mailbox of Dwelling 141 (Image Source: Google Street View 2024)

| Notes: |
|---|
| If deemed necessary, additional screening can be provided in the immediate foreground of this dwelling on the northwestern side, or along Lismore-Pittong Road. |

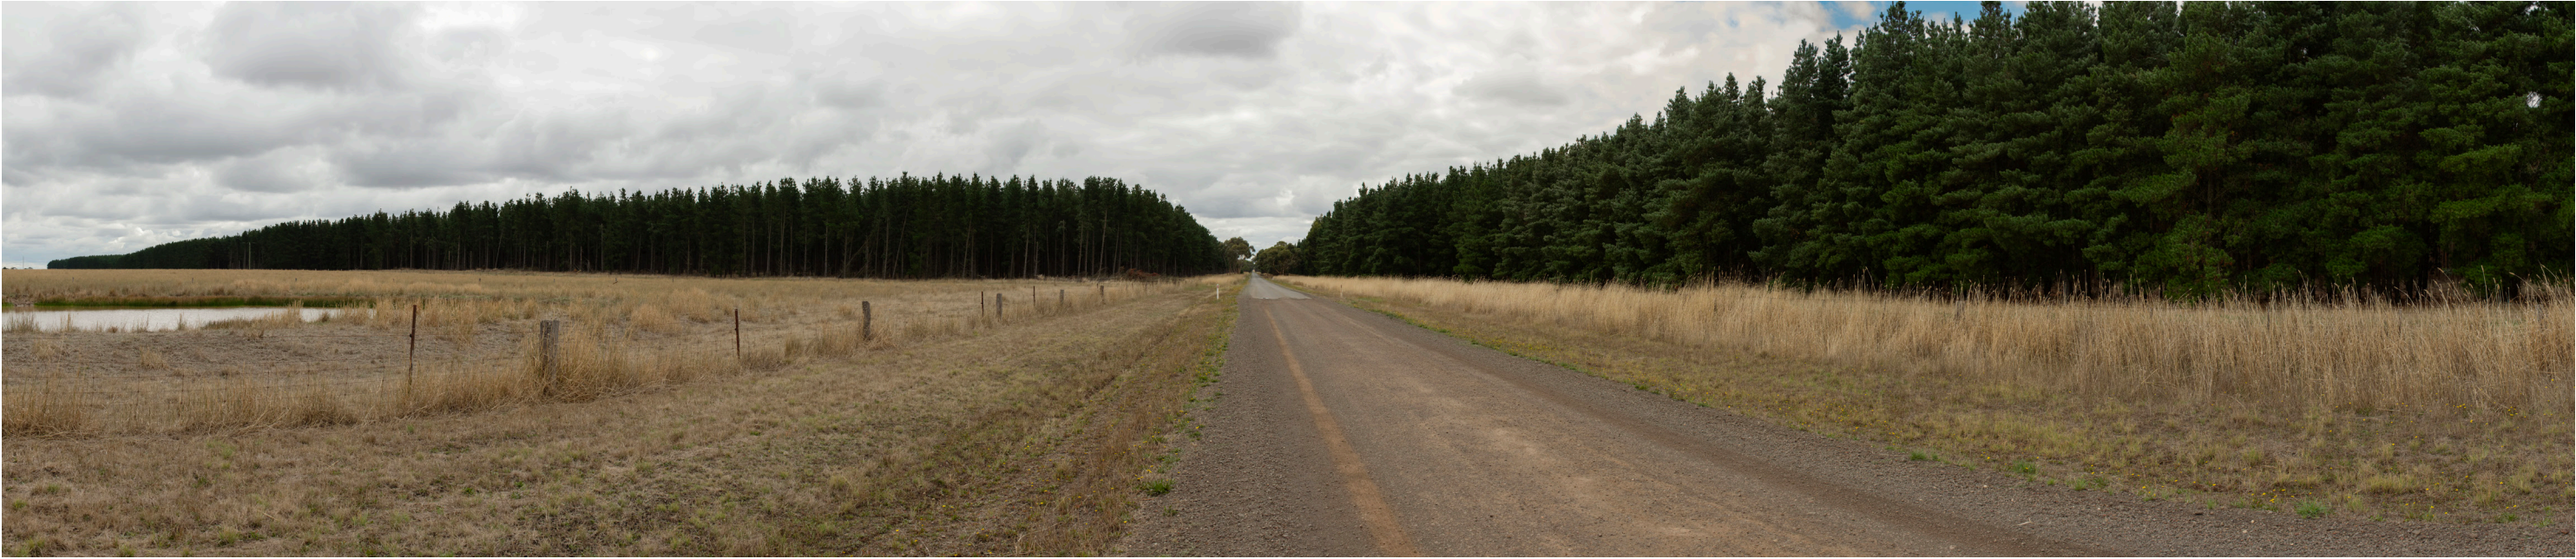
NOTE: Street view imagery was not available near this dwelling. The photograph below is used to represent the view toward the pine forest to the north and northeast that will assist in fragmenting views to the Project.

**Dwelling 141 - Nearby View of Pine Forest**  
View from Lismore-Pittong Road near intersection with McIntyres Road

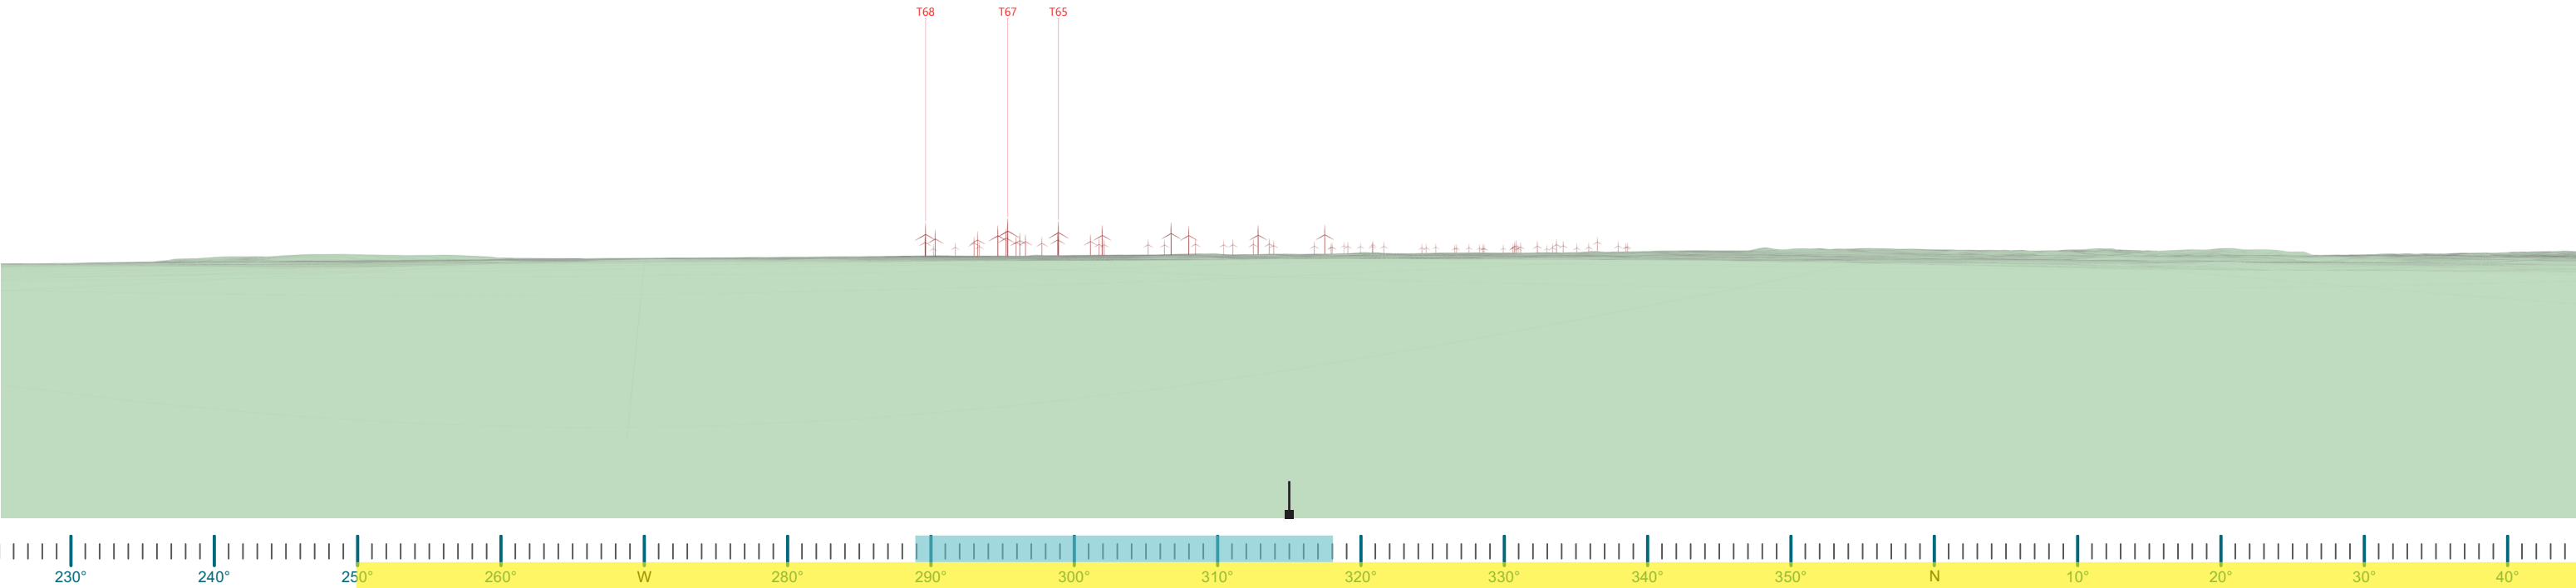
Dwelling 149 - Wireframe View  
View from Dwelling 149 based on topography alone
