Hydrologic report for proposed
Corop solar farm

19 August 2019

Technical report for Leeson Group

Hydrologic report for proposed Corop solar farm

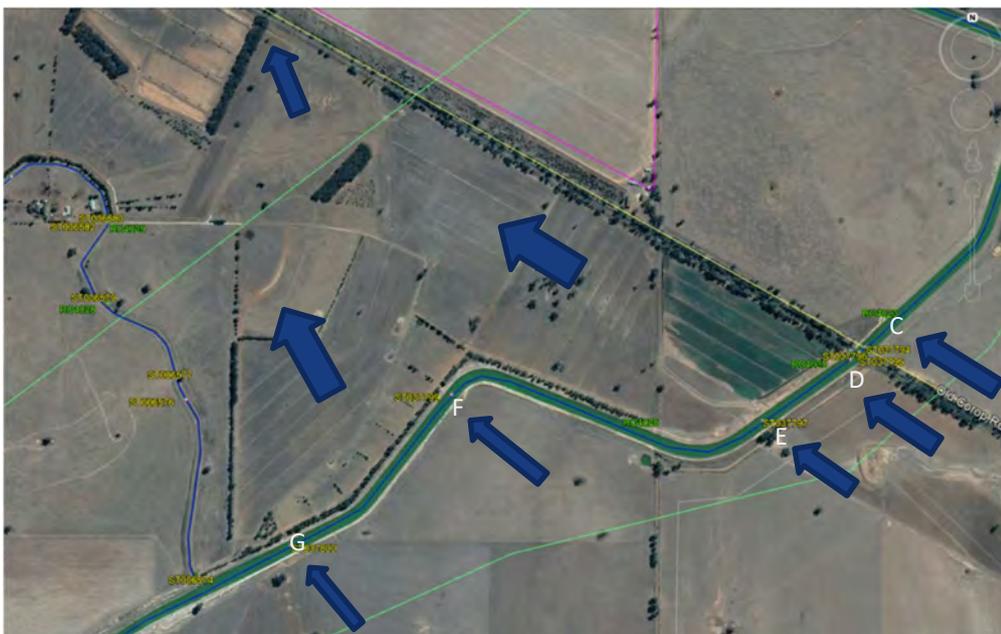
Figure 5: Current overland flow into/from water control structures

Note: Sites C, D and E are located along the main flow path adjacent to Old Corop Road (see Figure 5).

The primary rainfall runoff path towards the site is along the southern side of Old Corop Road. North of the Waranga Western Channel the runoff is confined to the property between Corop Road and the GMW No 11 channel (Figure 5). Water then spills into the property of interest at the floodway opposite a recycle dam on located on the southern side of Old Corop Road (Figure 6 for photos of water entry points). This location is nominally the origin of the Woolwash depression. This general water flow arrangement is confirmed through the planning overlays which show an LSIO overlay along the Old Corop road extending into the property.

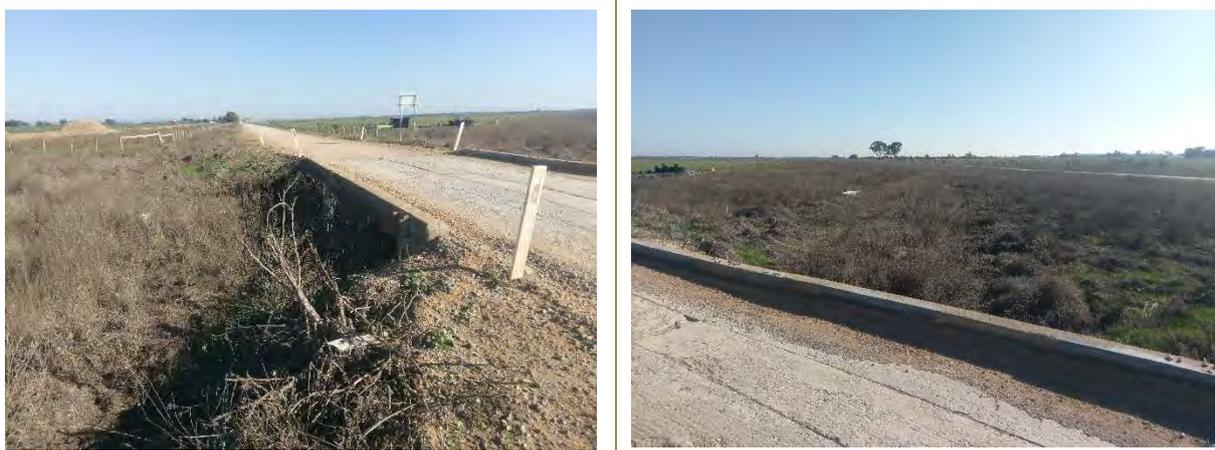
Figure 10: Downstream flood infrastructure [box culvert (left) and downstream of culvert looking north west (right)]

Analysis of natural surface levels along the Carag Road (and along the Woolwash depression) show that there is little to no relief once water passes downstream of Bedwell Road. Downstream of the northern property boundary there is a double box culvert under Carag Road and a defined, albeit shallow and flat, floodway (Figure 10). Other sub-catchments also discharge water to the area upstream of the Carag Road culvert. The size of this culvert indicates that substantial water movement occurs along Carag Road.

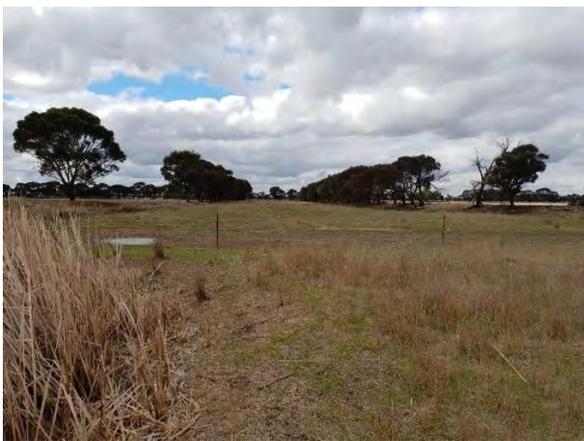
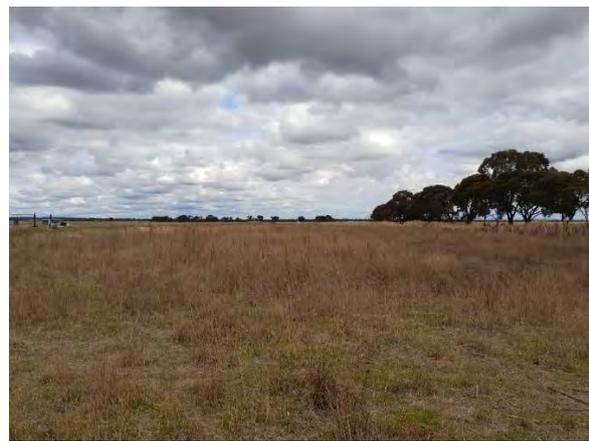
Figure 11: Woolwash depression photos

Eastern arm Woolwash depression – looking north Bedwell Road

Western arm Woolwash depression – looking south towards Bedwell Road

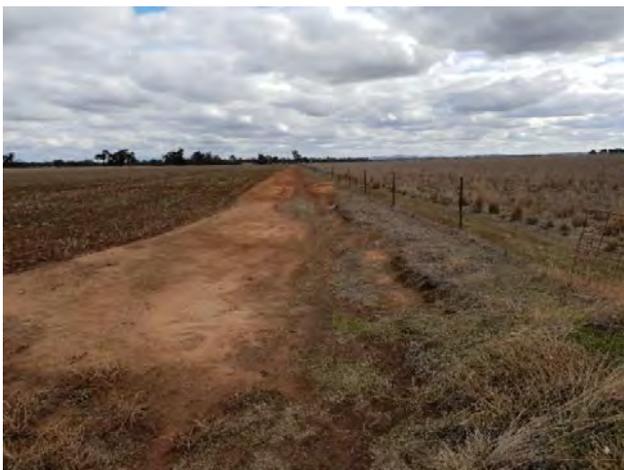
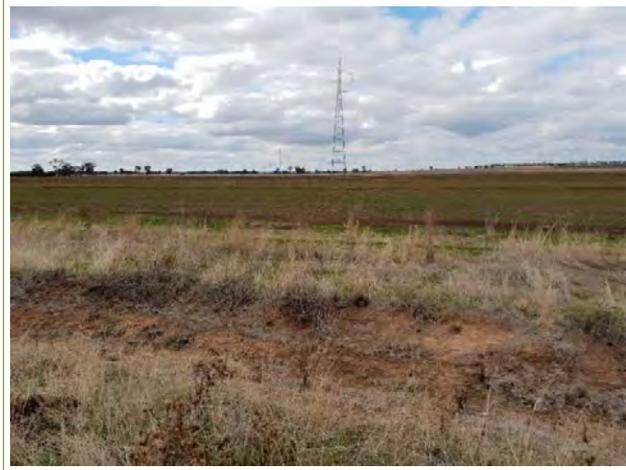
Figure 17: Examples of the form of existing drainage lines on property

Internal drainage commencement– eastern boundary – southern block

Internal drainage mid -section, southern block – note scouring

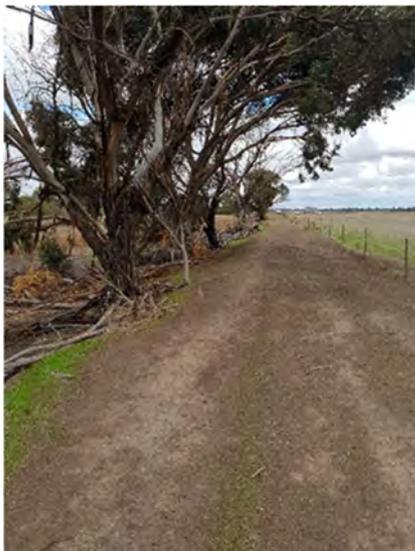
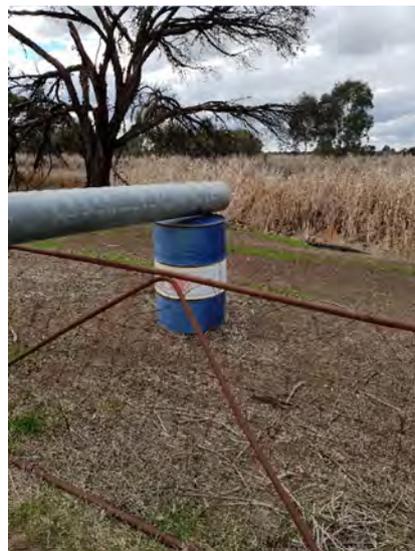
Figure 20: Engineering works at Bedwell Road

Eastern embankment and access track mid-section of northern block (looking north, depression on left, farm layout on right)

Discharge point into Woolwash depression eastern boundary

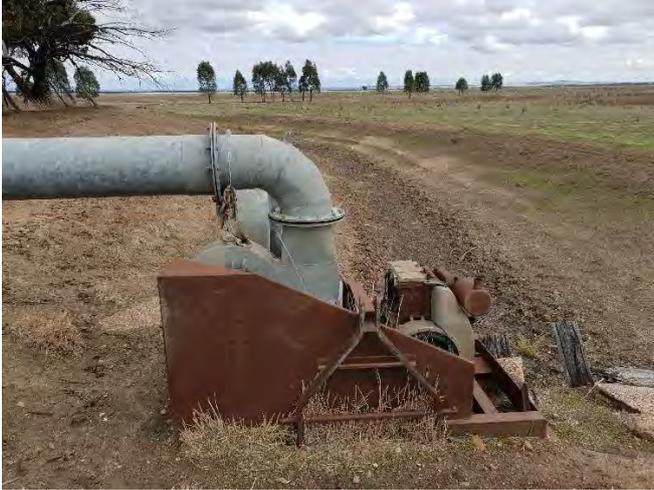
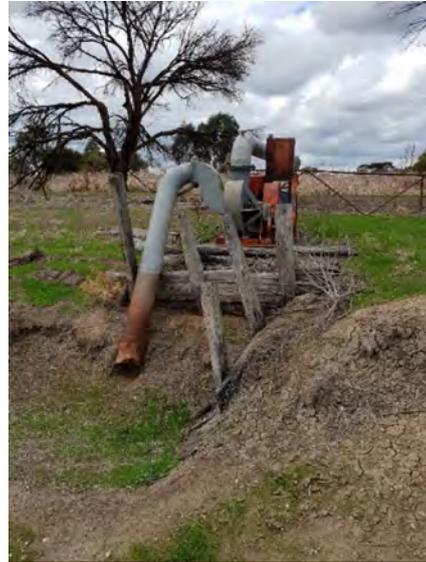
Figure 21: Discharge point to Woolwash depression

Internal drainage leading to pump on Western arm of depression

Discharge point into Woolwash depression eastern arm (located on western boundary)

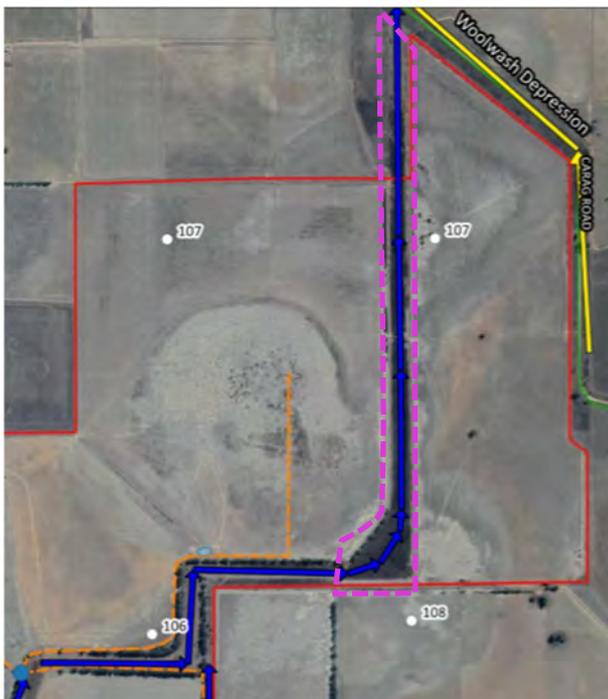
- 60109 – Part of the Woolwash depression immediately upstream of Carag Road (pink dashed outline)

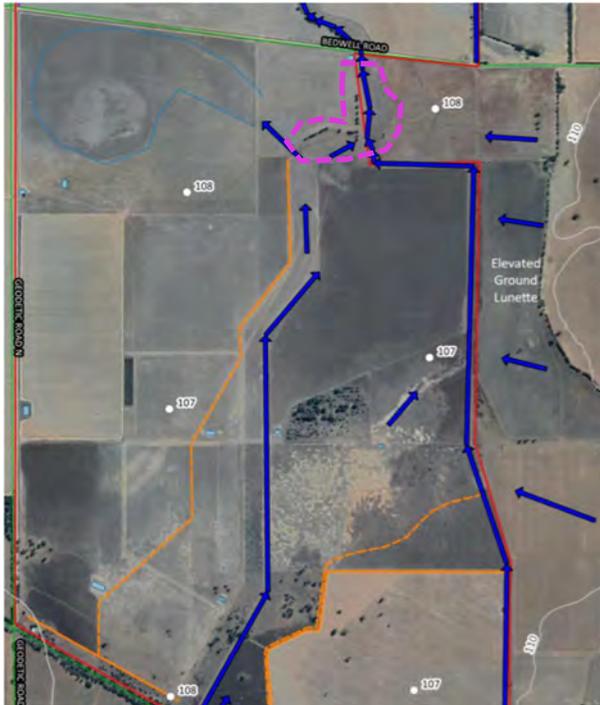
- 60108 – Located immediately upstream of Bedwell road on the drainage depression (pink dashed outline)

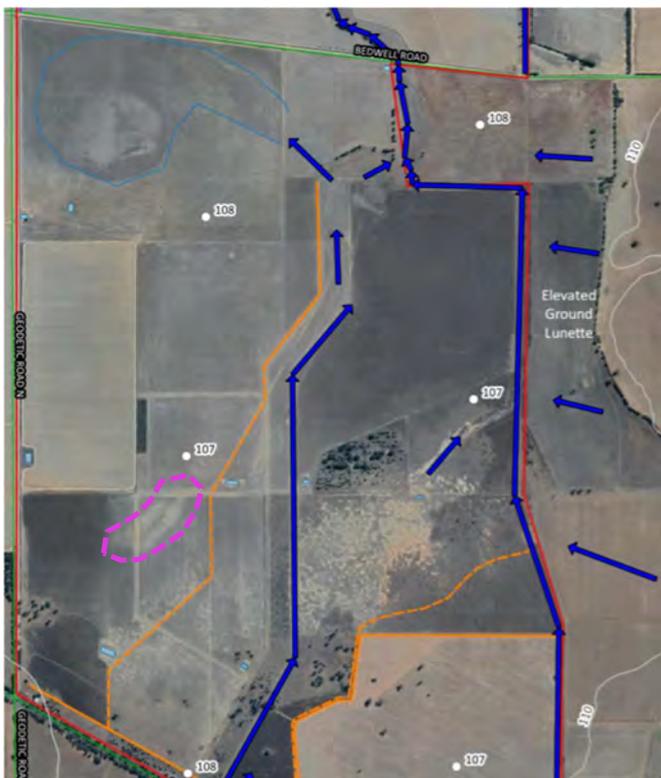
- 60106 – Located on southern property west of the central depression (pink dashed outline)
