Arboricultural Assessment for:  
**Kardinia International College,  
Junior School Development**

29 -31 Kardinea Drive,  
Bell Post Hill, 3215

**Tree Health, Condition, Retention,  
Protection of retained trees using AS4970 – 2009  
Calculations during Development**

**INCLUDES TREE IMPACT ASSESSMENT AND TREE  
MANAGEMENT PLAN FOR THE SITE**

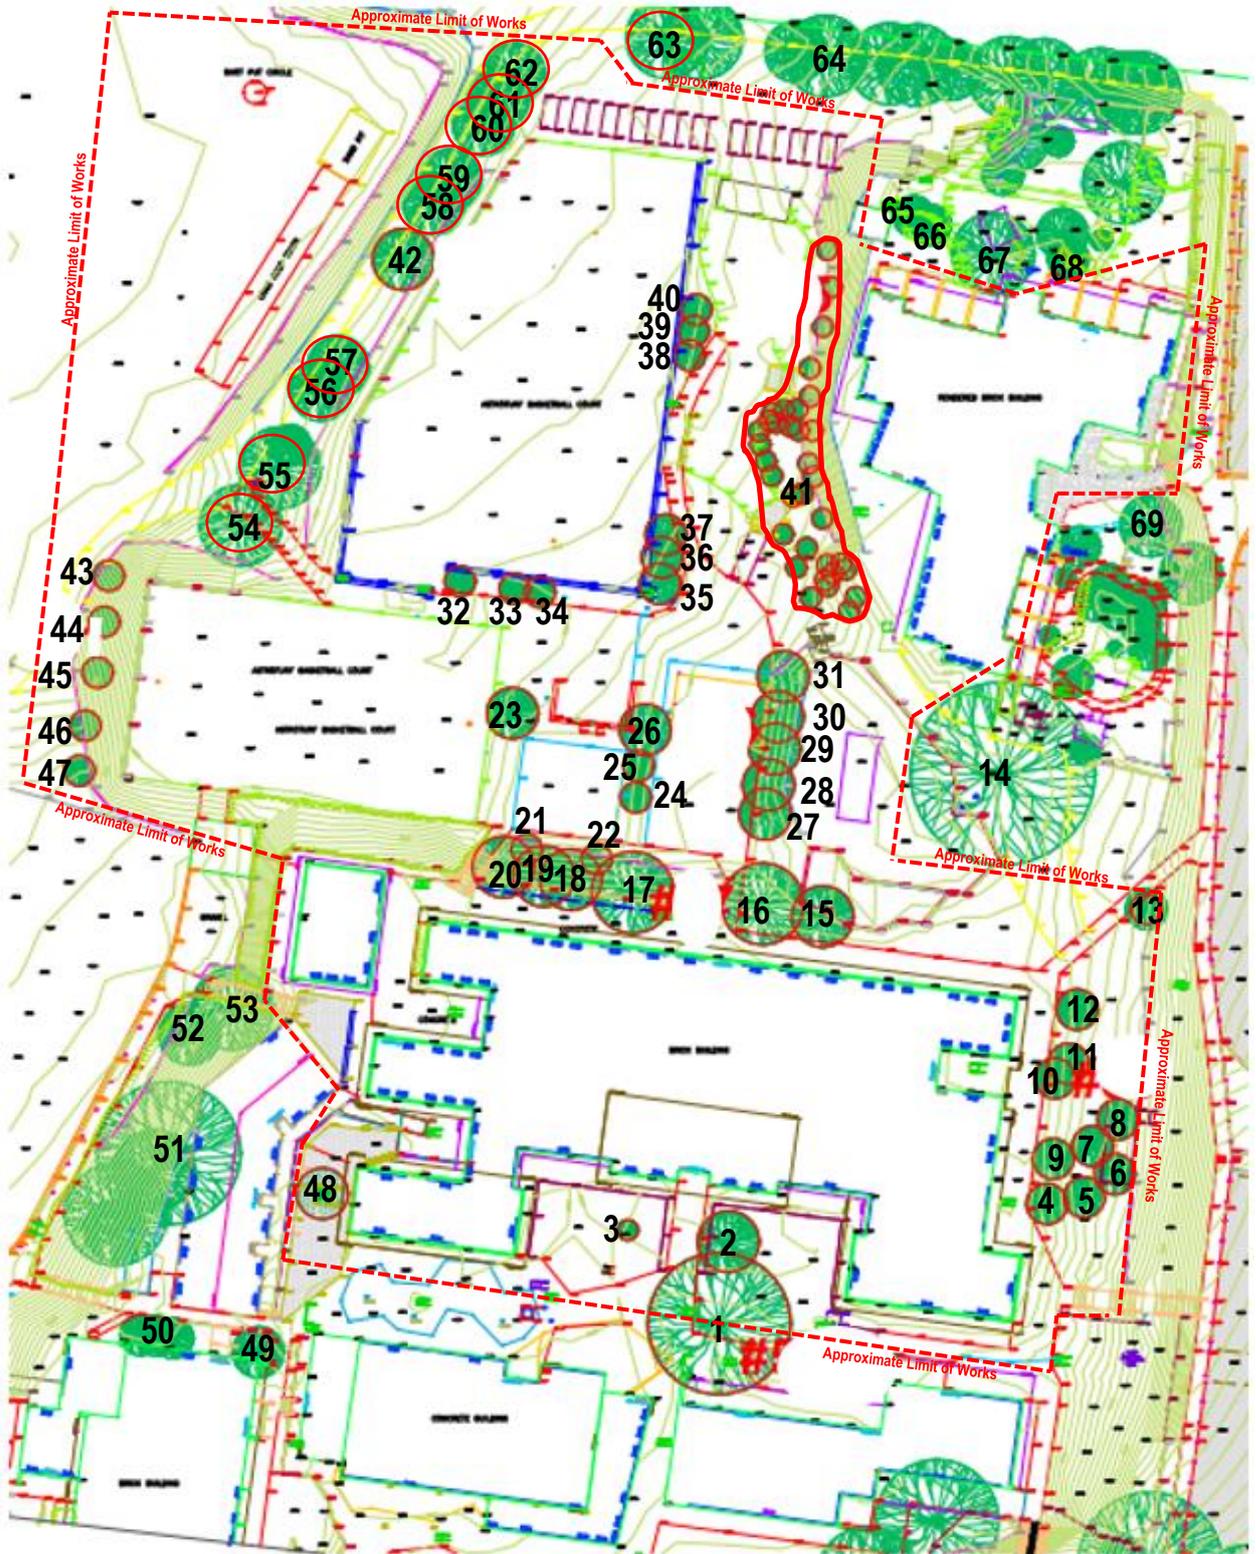
Trees for removal impacted by development (Red)

Trees impacted by development are to be removed from site.

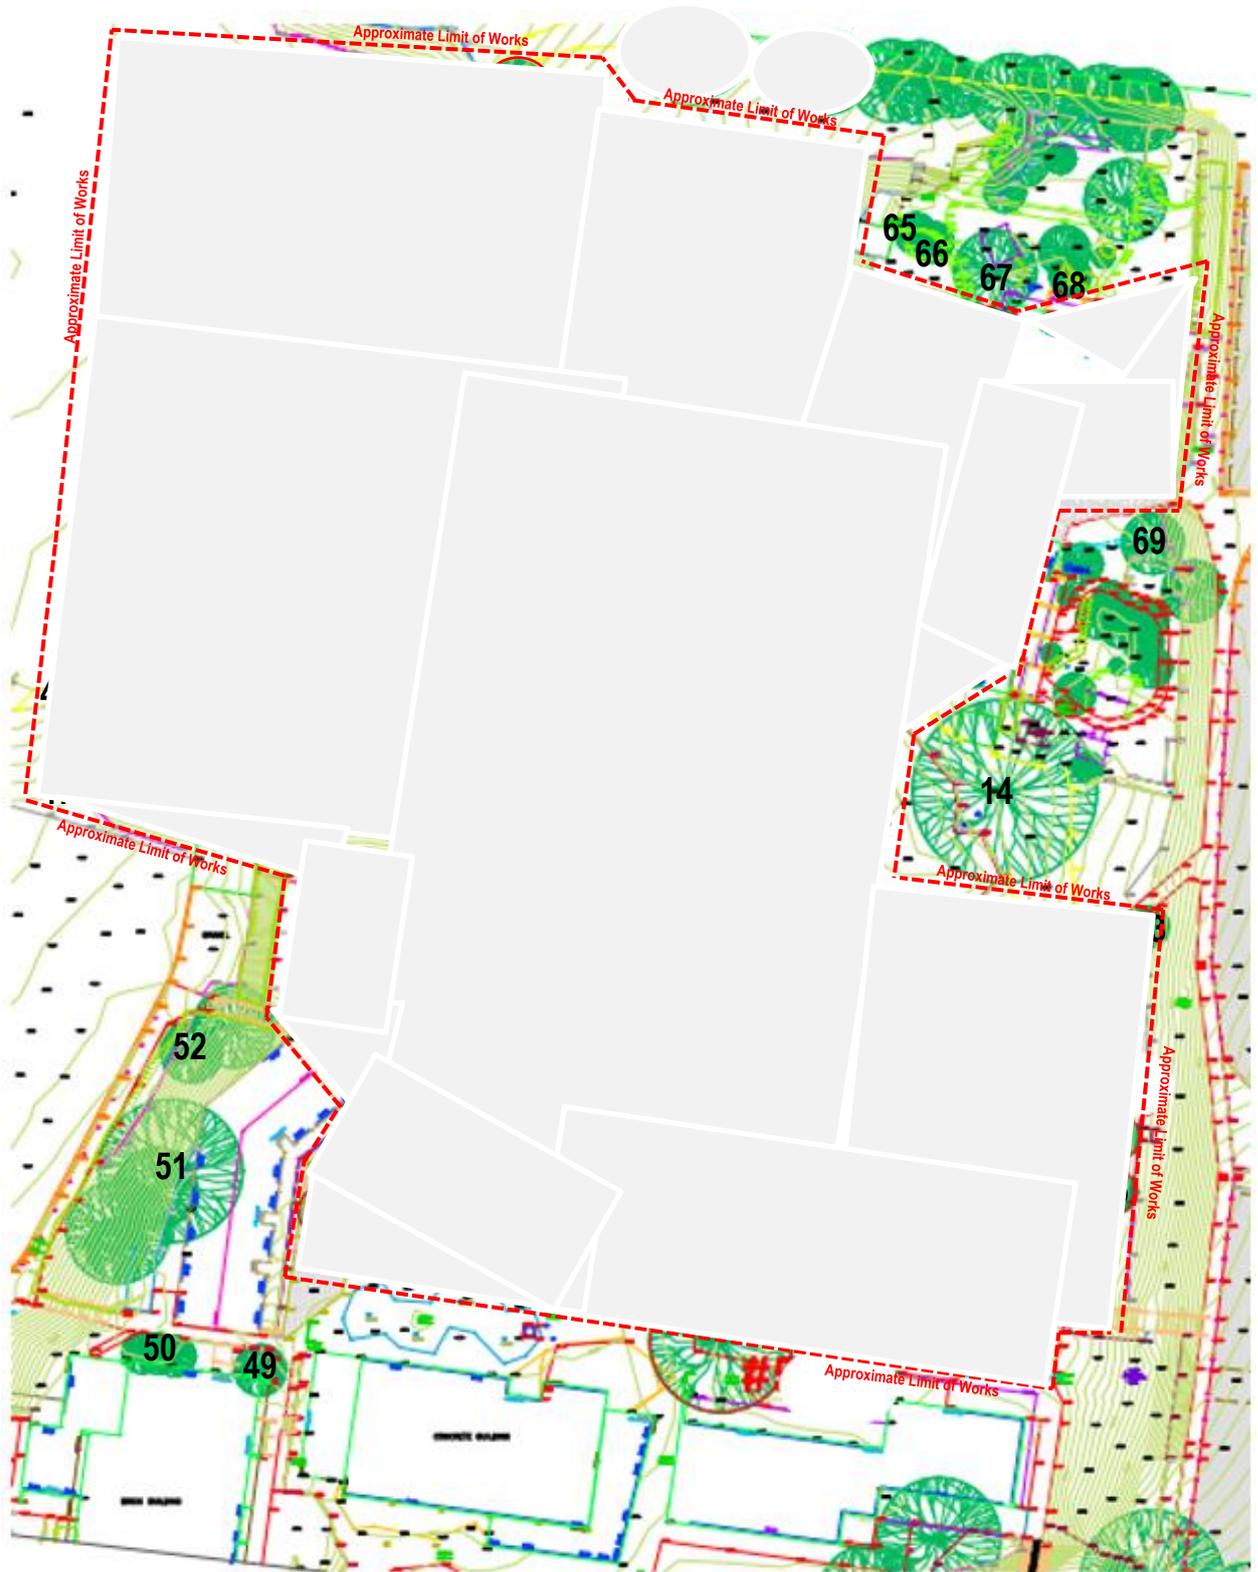
Trees, 14, 49, 50, 51, 52, 65, 66, 67, 68 and 69

All retained trees with the exception of tree 14, fall outside the scope of works. The calculated tree protection zones presented in table 1 present these trees as not impacted by development. These trees will be protected from site works by the erected boundary fence of the work site.

With the exception of tree 14, all trees retained on site surrounding the development site will protected without impact.

In order to double as a tree protection fence, the fence which delineates works from the school grounds surrounding the development site should be of a rigid construction and maintained in place for the entire development of the project.

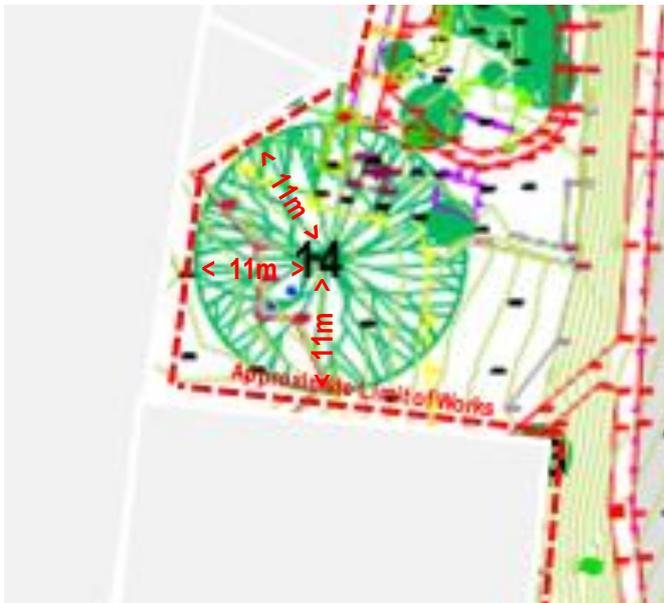
### 6.0 Tree protection measures - Managing tree 14 in development.

AS4970-2009 Protection of trees on development sites allows a 10% impact to the root structure of a tree before impact becomes major in nature. Works propose encroachment in final landscape into the TPZ of this tree to a greater distance than 10% of TPZ. Tree protection fencing as such is to be established at a distance of 11m from the trees trunk, for the main project works, and works outside the protection fence must be undertaken in the presence of the site arborist.

1. Site arborist is to be on site for works undertaken inside the tree protection fence of tree 14. (within 11m of the trees trunk).
2. Hand excavation only within the tree protection zone of tree 14, to be undertaken at all times.

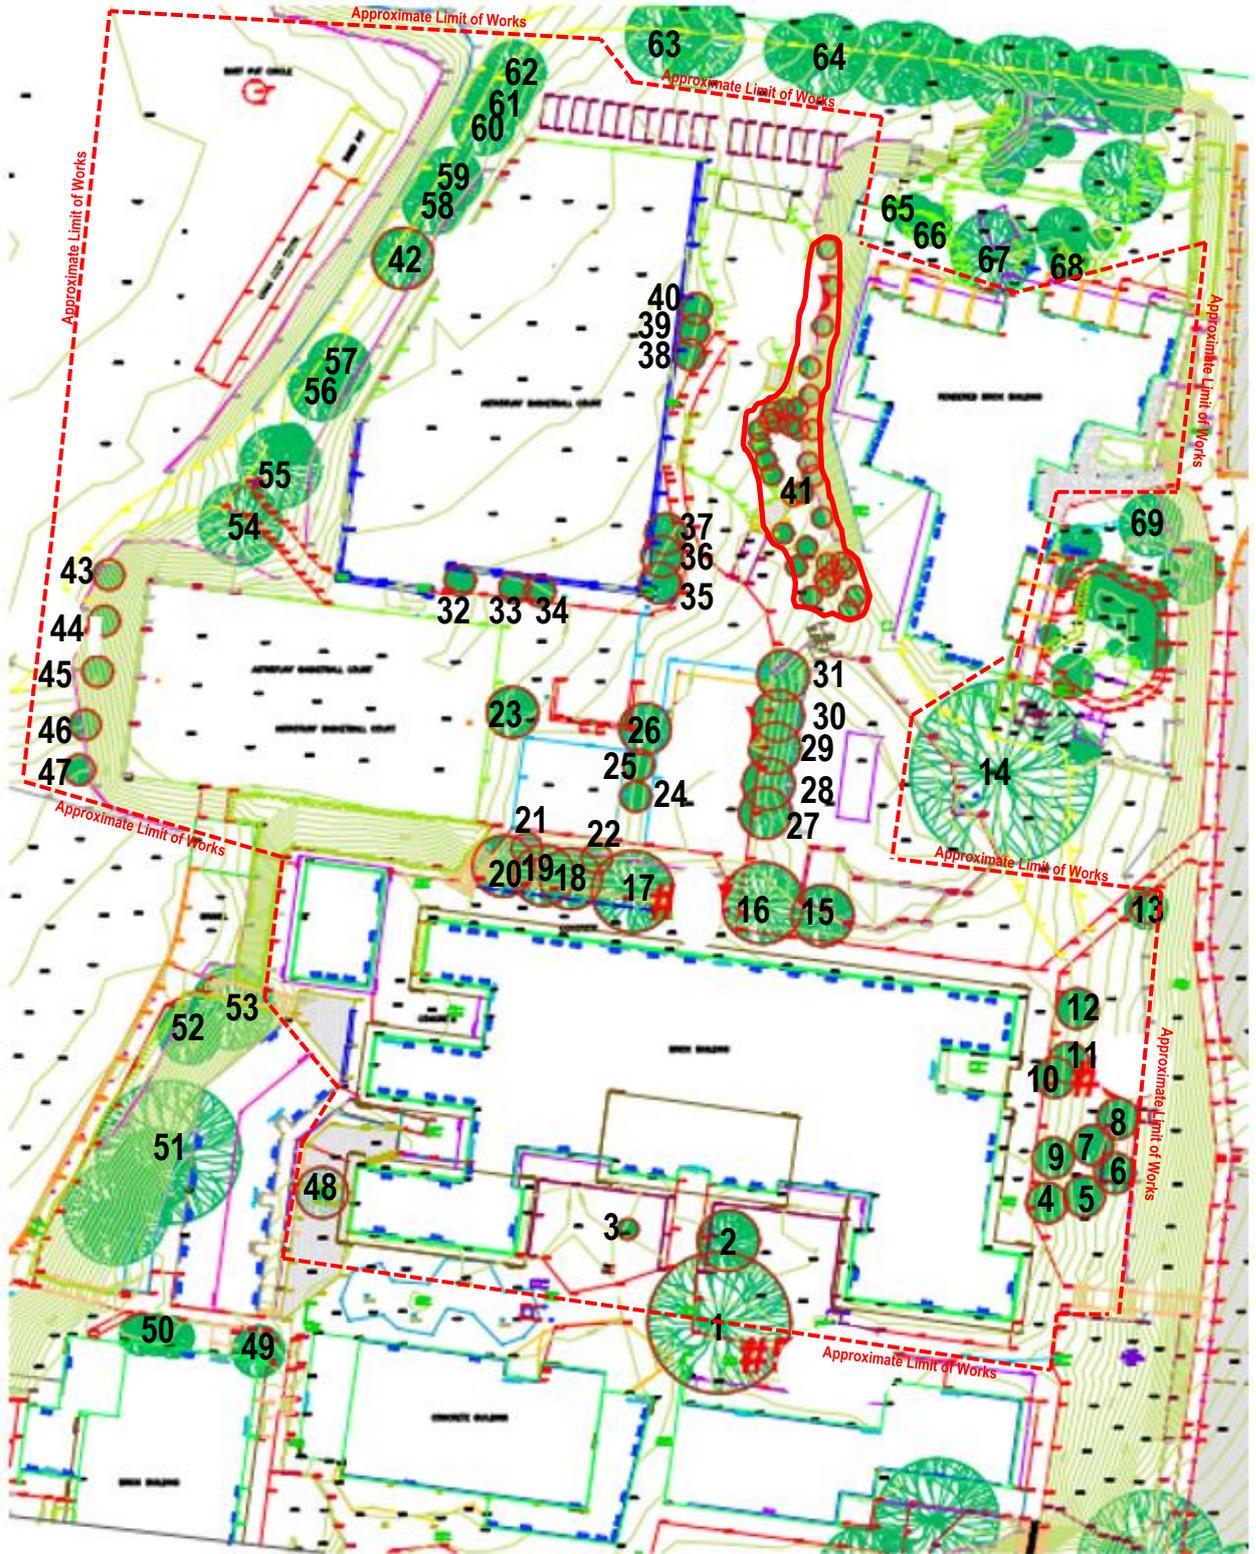
### 20.1 Location of trees on the site

The tree numbers in the table reference the site map for tree location and

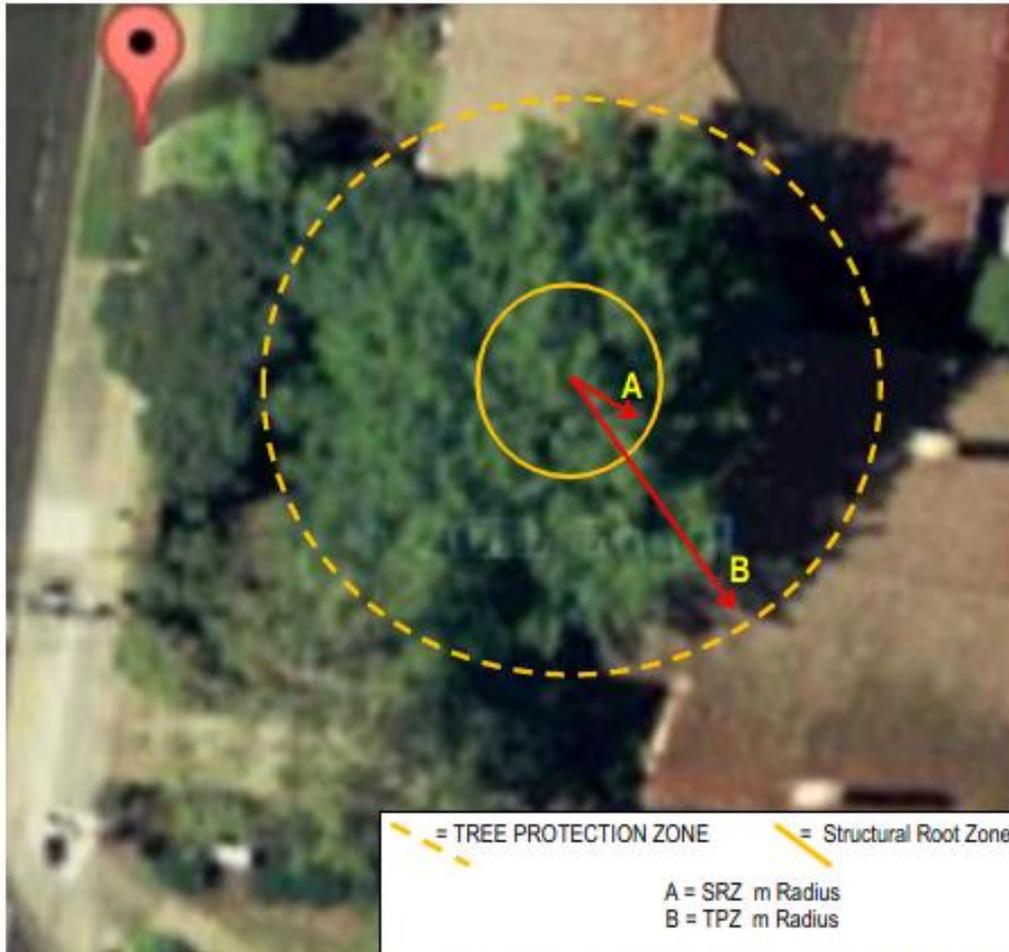
## 20.5 Applying the Tree Protection Zone (TPZ)

The diagram below indicates how the dimensions of the Structural Root Zone and the Tree Protection Zone are applied.

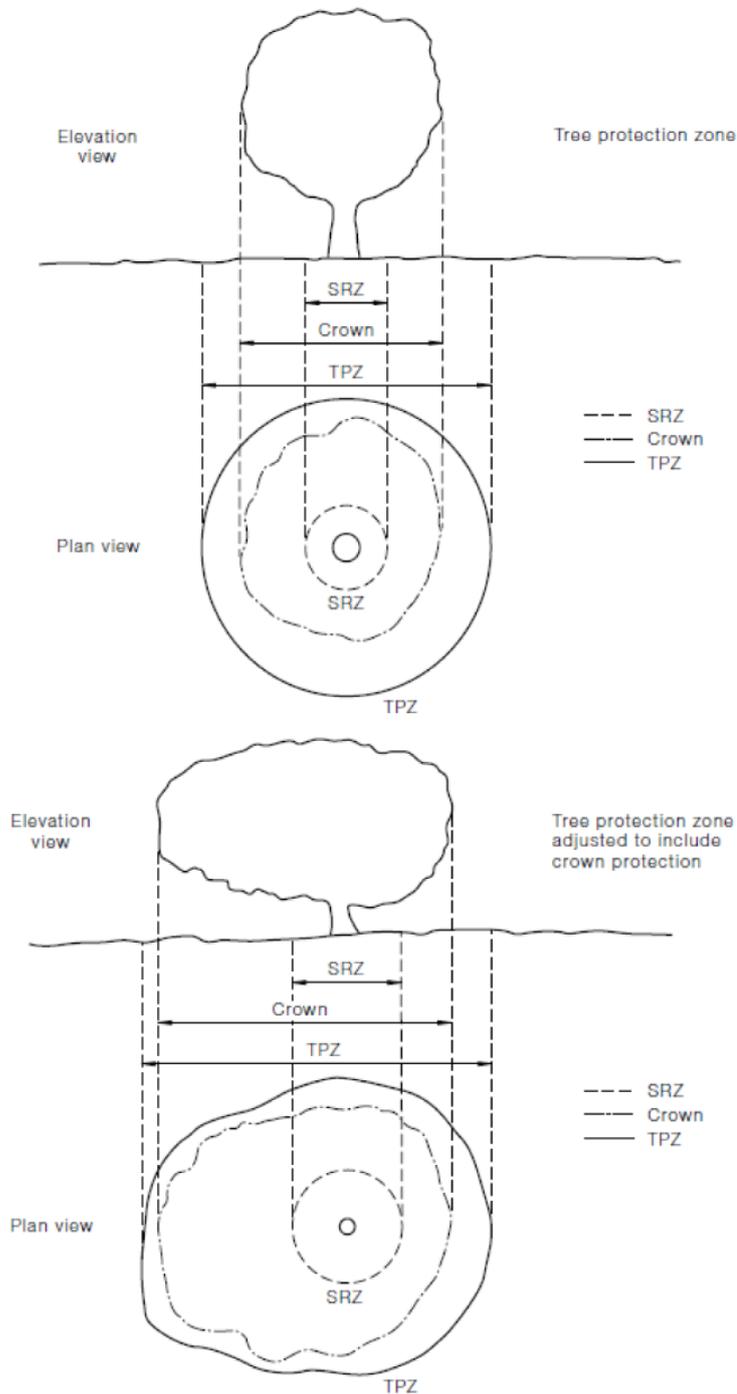
FIGURE 2 INDICATIVE TREE PROTECTION ZONE

NOTE: Refer to Clause 3.2 for calculation of TPZ.

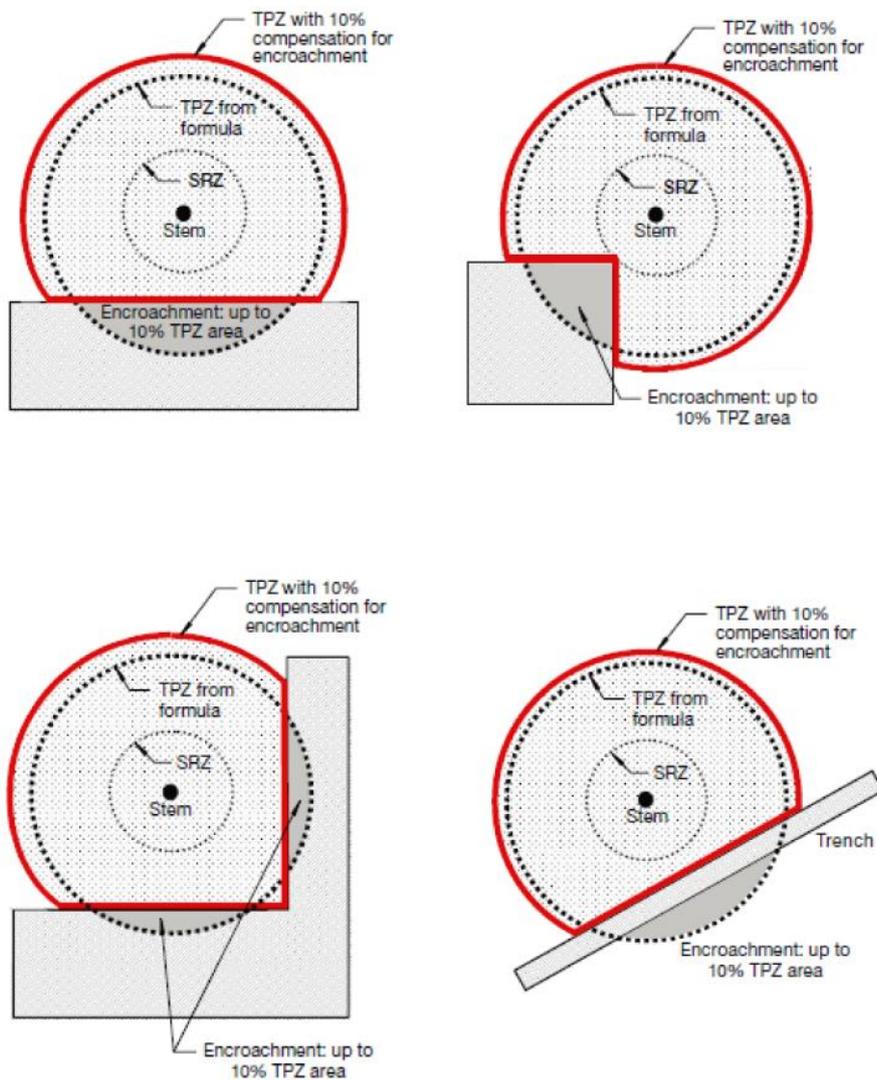
FIGURE D1 EXAMPLES OF MINOR ENCROACHMENT INTO TPZ

Encroachment into the tree protection zone (TPZ) is sometimes unavoidable. Figure D1 provides examples of TPZ encroachment by area, to assist in reducing the impact of such incursions.

NOTE: Less than 10% TPZ area and outside SRZ. Any loss of TPZ compensated for elsewhere.

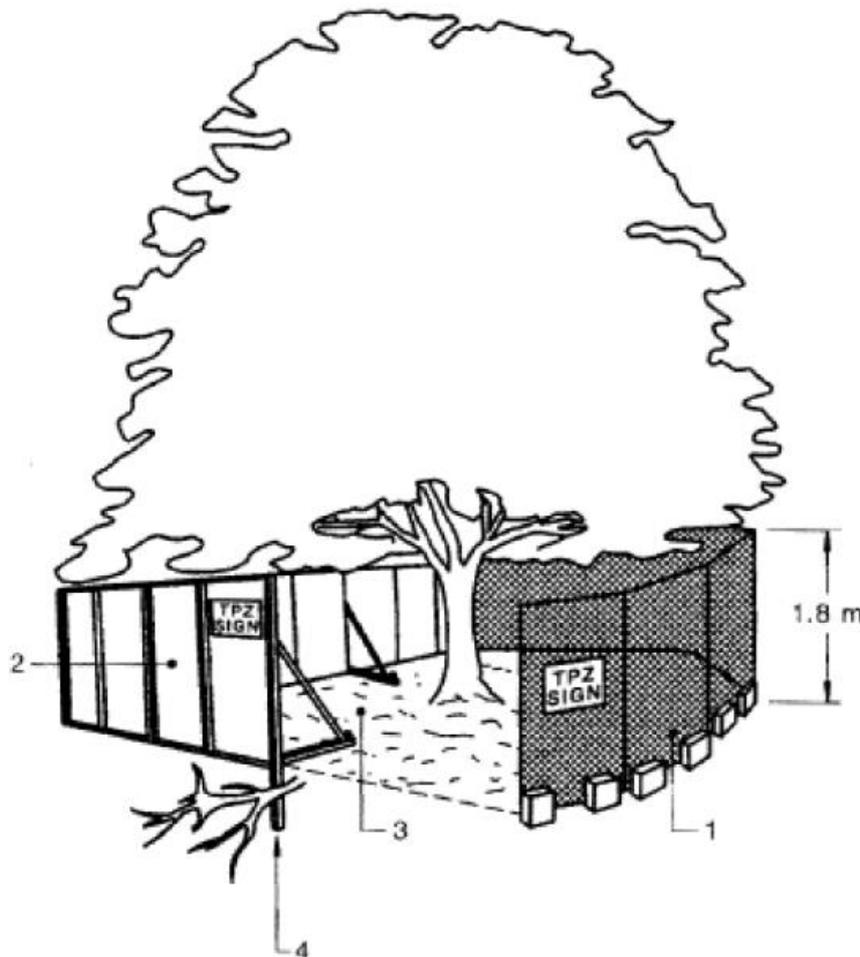
Signs identifying the TPZ should be placed around the edge of the TPZ and be visible from within the development site (refer Figure 3). The lettering on the sign should comply with AS 1319. Appendix C provides an example of a suitable TPZ sign.

- 1 Chain wire mesh panels with shade cloth (if required) attached, held in place with concrete feet.
- 2 Alternative plywood or wooden paling fence panels. This fencing material also prevents building materials or soil entering the TPZ.
- 3 Mulch installation across surface of TPZ (at the discretion of the project arborist). No excavation, construction activity, grade changes, surface treatment or storage of materials of any kind is permitted within the TPZ.
- 4 Bracing is permissible within the TPZ. Installation of supports should avoid damaging roots.

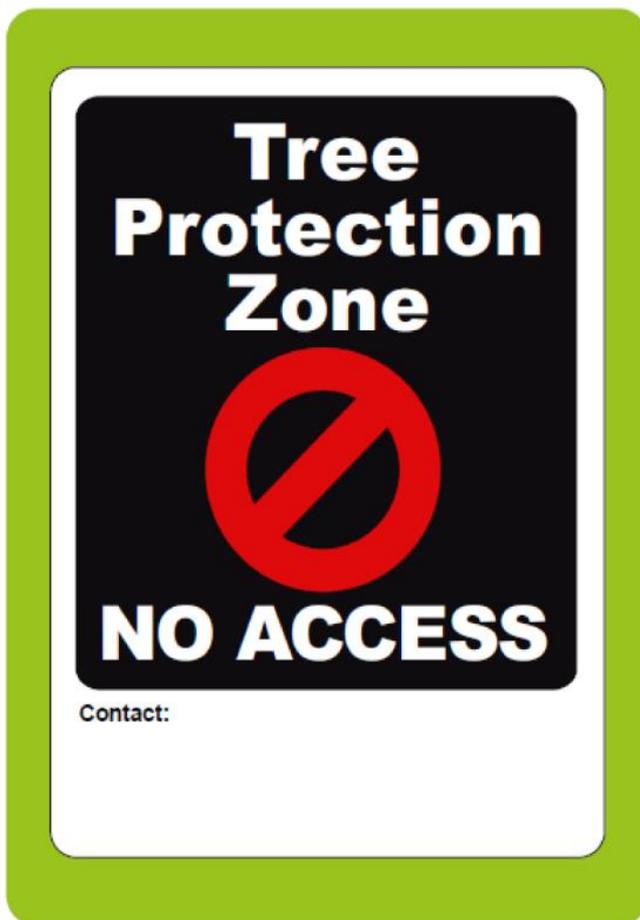
FIGURE C1 TREE PROTECTION ZONE SIGN

A TPZ sign provides clear and readily accessible information to indicate that a TPZ has been established. Figure C1 provides an example of a suitable sign.
