**REPORT****Mt Buller Summit Trail**  
*Geotechnical Assessment and Investigation***ADVERTISED  
PLAN**

**Mt Buller Mt Stirling Resort Management**10 Summit Road  
Mt Buller VIC 3723

21493847-001-R-Rev0

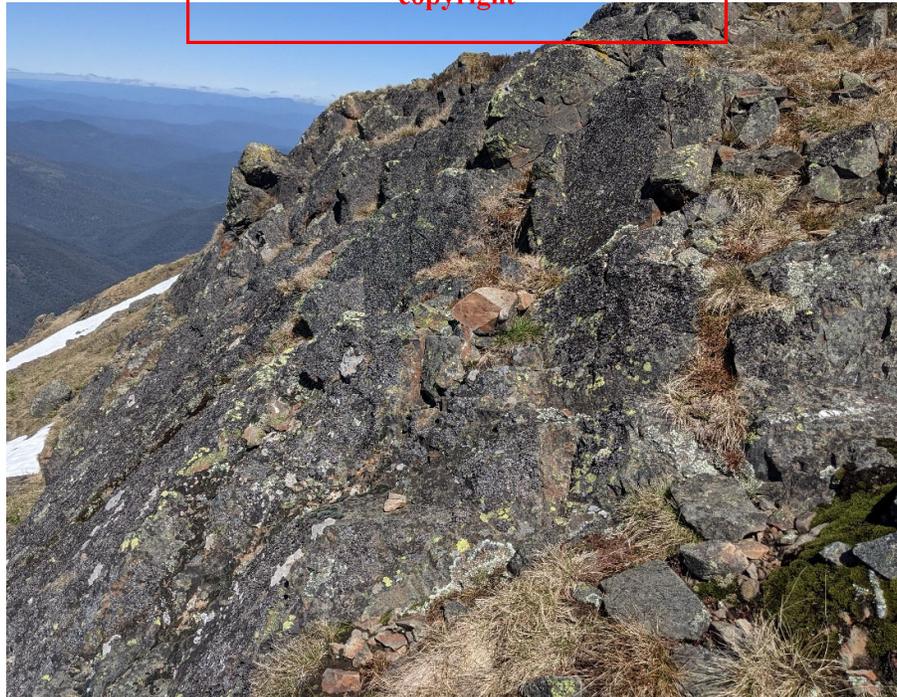
Figure 6: Outcrop above proposed trail with numerous loose blocks

There are numerous outcrops in this area which generally block the numerous loose cobbles and boulders were identified on the outcrops and across the vegetated slopes. These blocks are in the order of 0.1 m to 0.5 m diameter and mostly angular or tabular in shape. Figure 6 shows one section of outcrop with numerous loose blocks.

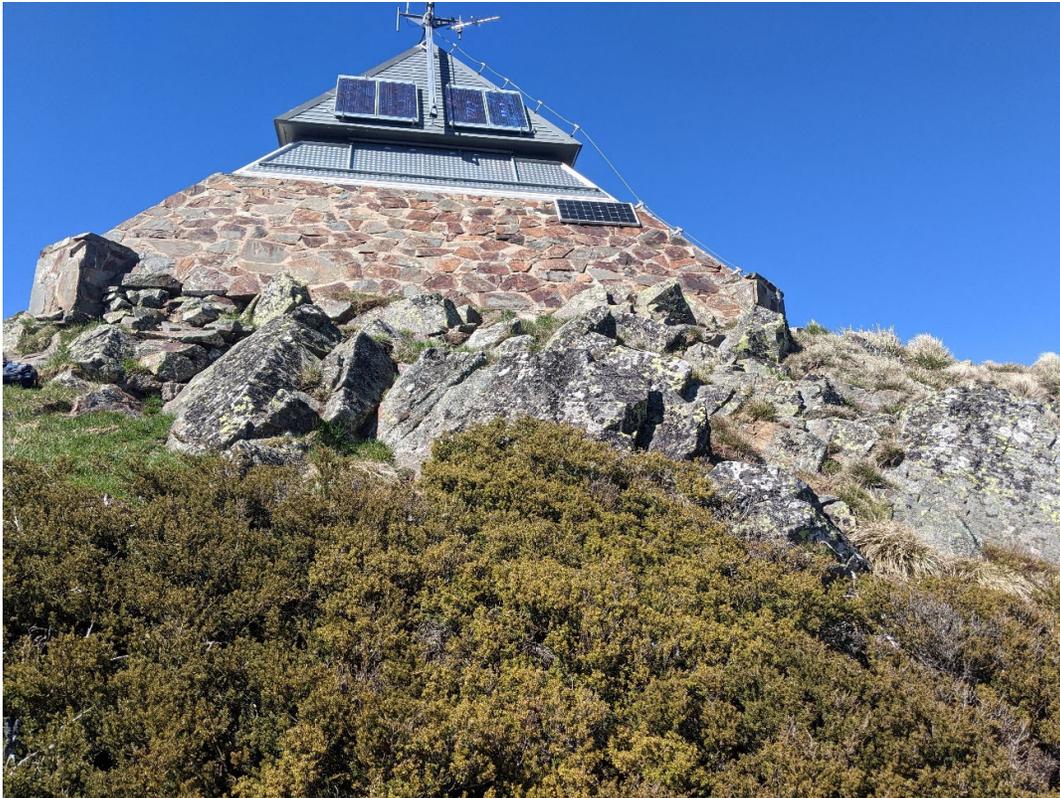
Figure 7: Rock outcrop on the north side of Mount Buller summit

The proposed viewing platform at the summit is to be a lookout deck protruding out over the north side of the summit with foundations anchored back into the rock below. This area is shown in Figure 7.

There are two major joint sets in this outcrop. The orientation of the large flat face of the tabular blocks varies between  $50^{\circ}/065^{\circ}$  (dip/dip direction) at the east to  $50^{\circ}/020^{\circ}$  at the west. The shorter side is defined by a joint set at  $50^{\circ}/310^{\circ}$ . The thickness of the tabular blocks varies between about 0.5 m and 0.8 m. Larger blocks at the east end are up to 2 m long, however, the block size tends to be smaller at the west end, mostly less than 1 m on the large face of the tabular blocks. The majority of the outcrop appears to comprise in-situ rock.

It is understood that the concept design for the Summit viewing platform involves shallow footings anchored to the underlying rock. If footings are supported on high strength rock, we recommend an allowable bearing pressure of 1000 kPa. The rock on which the footing is to be supported must be in-situ rock and free of loose material and debris. A suitably qualified geotechnical practitioner should inspect the footing locations prior to construction of the footing to ensure they are to be supported on in-situ rock free of loose debris.

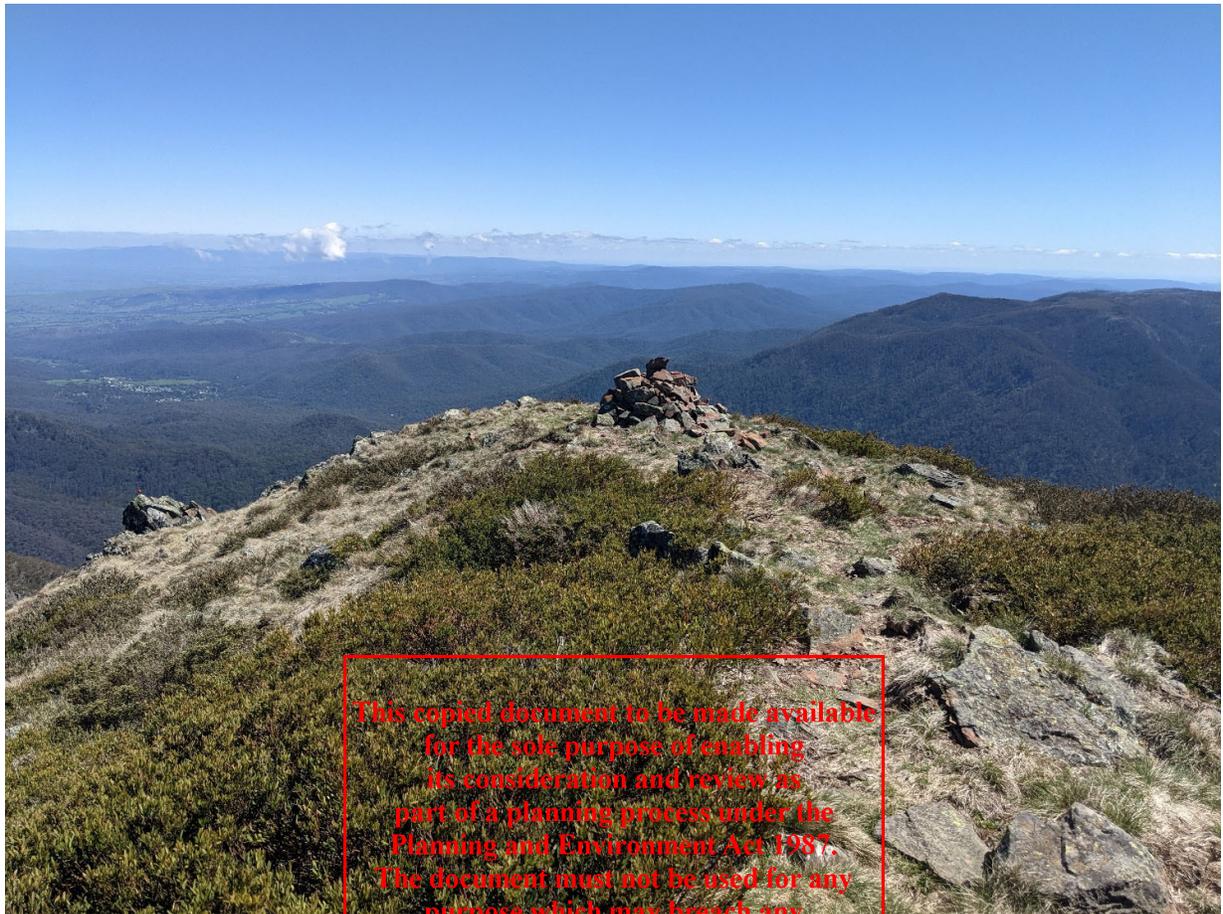
Figure 9: Proposed McLaughlin's Shoulder viewing platform location

The rock exposed at the proposed location of the McLaughlin’s Shoulder viewing platform consists of tabular blocks with large face dimensions of generally 0.5 m to 1.0 m and thicknesses of 0.3 m to 0.6 m. There is a greater proportion of small loose blocks on the surface as well as more thin soil and vegetation at this location. Although the vegetation obscures much of the rock on the top of the ridge here, sections of in-situ outcrop were observed and the founding conditions for design purposes are considered to be generally the same at this location as at the Summit. Figure 9 shows a view of the proposed McLaughlin’s Shoulder viewing platform area.
