Summit & McLaughlin's Shoulder Walk, Mt Buller Cultural Heritage Management Plan 18340

Sponsor: Mt Buller Mt Stirling Resort Management

9 January 2023

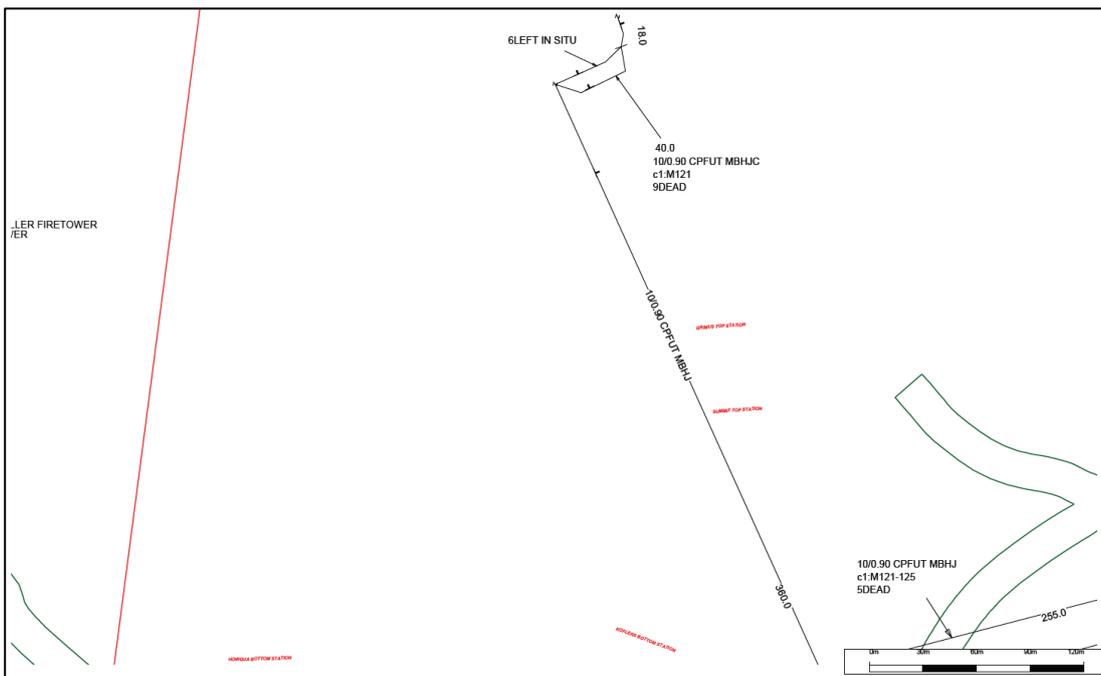
Figure 12 Detail from cable plan supplied by Telstra in DBYD search

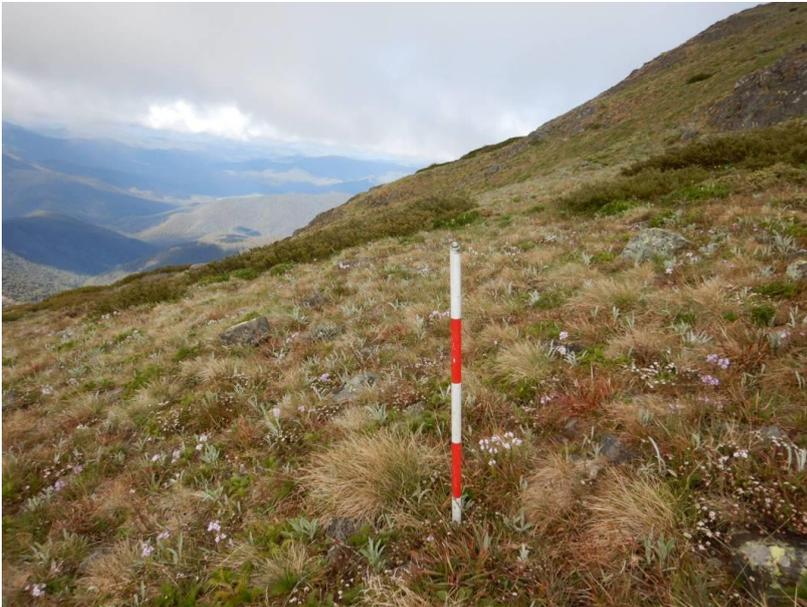
Photograph 1 Typical landforms within SU1 (facing west) (Z. Carter 7/12/21)

present within SU1 including ski infrastructure and the presence of man holes for subsurface utilities. The ground surface visibility across SU1 was 0-5%, with grass and moss covering the majority of the survey unit. Whilst three areas which demonstrated potential were identified on flat open spaces on the mountain face, no suitable soil deposition with the potential to contain subsurface Aboriginal archaeological deposits was observed. This is likely due to natural periods of high snowfall and subsequent snowmelt periods displacing any remnant soils downslope from the Activity Area. As a result, there is negligible archaeological potential present within SU1.

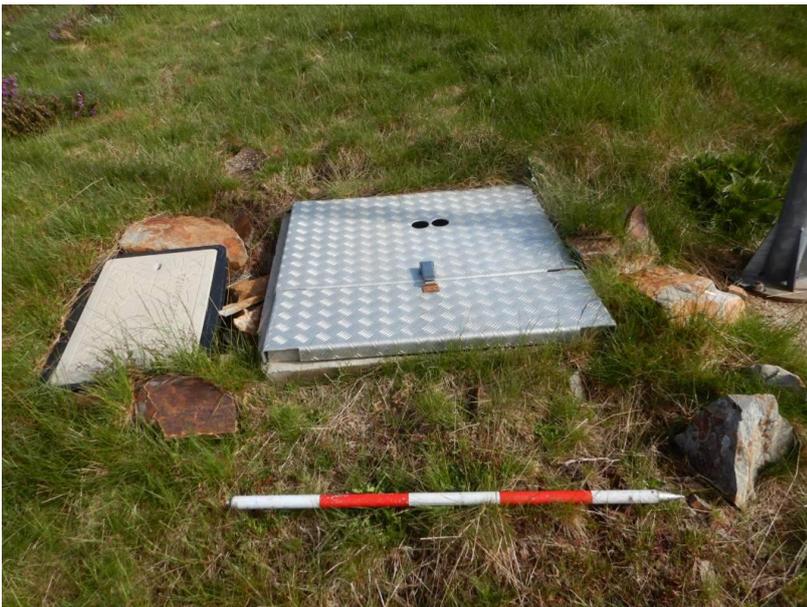
Photograph 2 Example of ground disturbance within SU1 (Z. Carter 7/12/21)

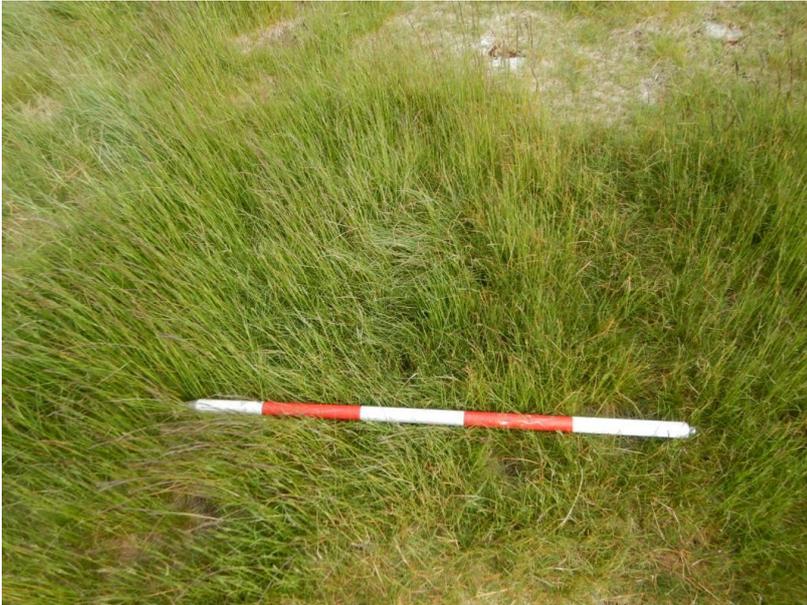
Photograph 3 Typical ground surface visibility within SU1 (Z. Carter 7/12/21)

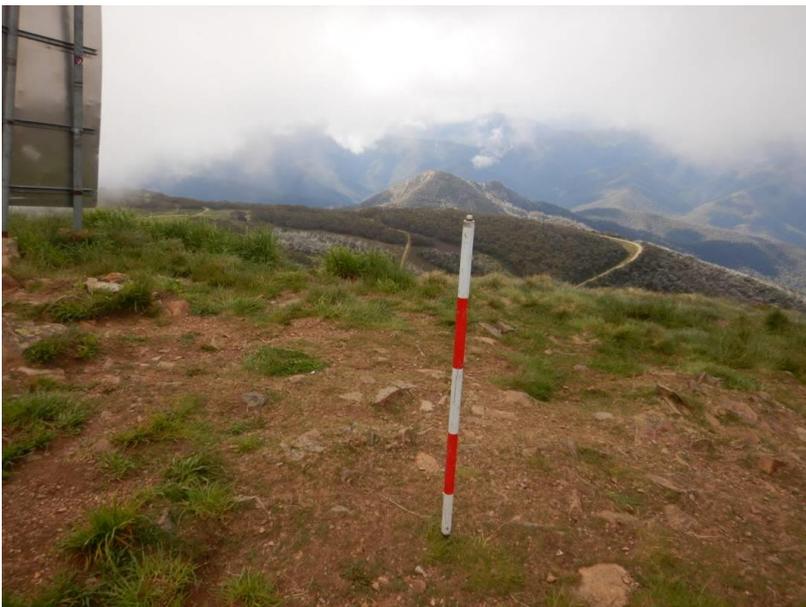
Photograph 4 Typical landforms within SU2 (facing east) (Z. Carter 7/12/21)

Survey Unit 2 (SU2) is situated on a ridge and summit of a mountain. The survey unit covers a section of the Activity Area where there is a pre-existing trail which extends towards the fire tower. Sections of carved stone steps are present along the trail, with a high proportion of exposed rocky outcrops across the survey unit. The survey unit is steady with sharp inclines. The soil type was a dry silt with a high proportion of degrading rock, with predominate vegetation comprised of short, dense grasses. The previous and current land use include ski slopes and informal walking trails. Disturbances were present within SU2 include the pre-existing trail, carved stone steps, historic marker and fire tower. The ground surface visibility across SU2 was 0-5%, with grass and moss covering the majority of the survey unit. Due to the level of disturbance observed and the lack of suitable landforms for soil retention, in association with natural periods of high snowfall and subsequent snowmelt periods displacing any remnant soils downslope. As a result, there is negligible archaeological potential present within SU2.

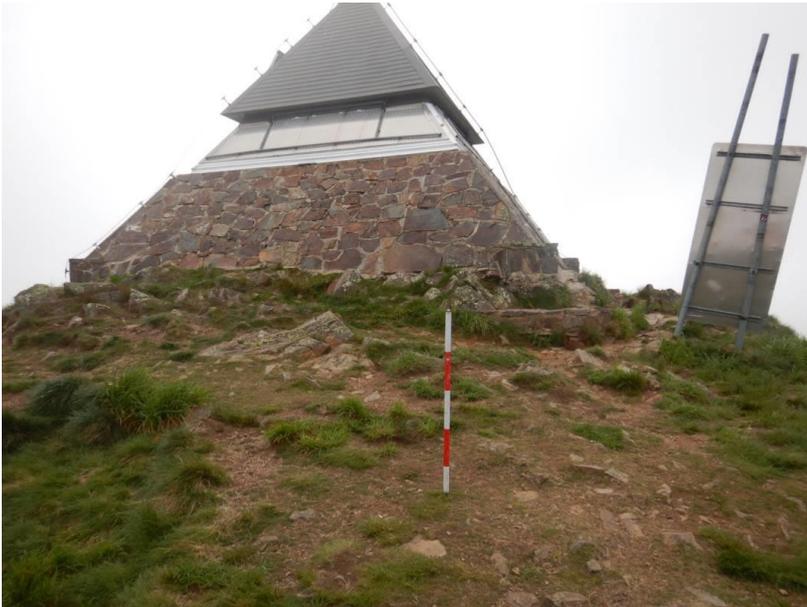
Photograph 5 Example of ground disturbance within SU2 (Z. Carter 7/12/21)

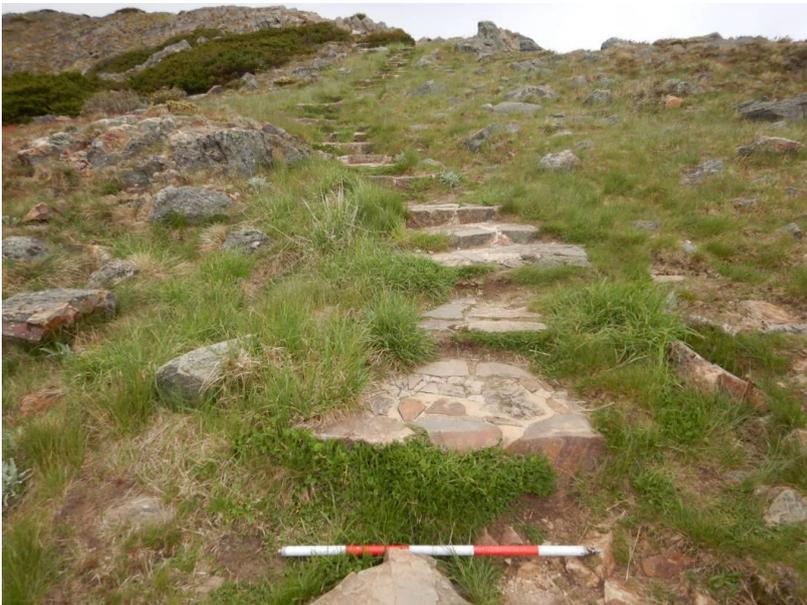
Photograph 6 Typical ground surface visibility and disturbance within SU2 (Z. Carter 7/12/21)

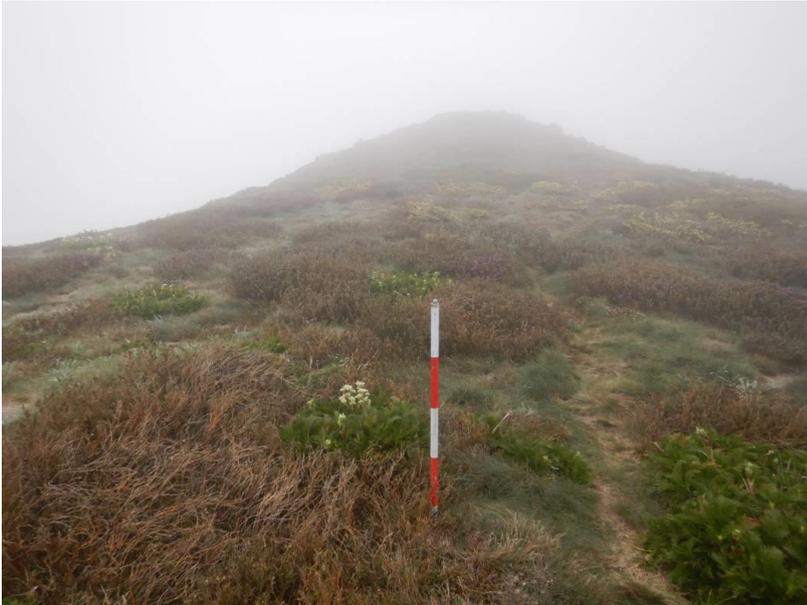
Photograph 7 Typical landforms within Survey Unit 3 (facing east) (Z. Carter 7/12/21)

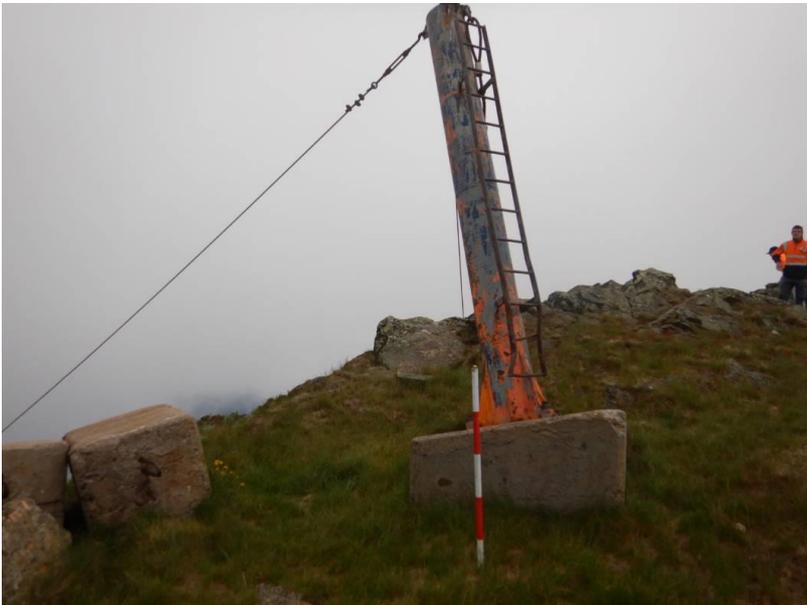
Photograph 8 Example of ground disturbance within SU3 (Z. Carter 7/12/21)

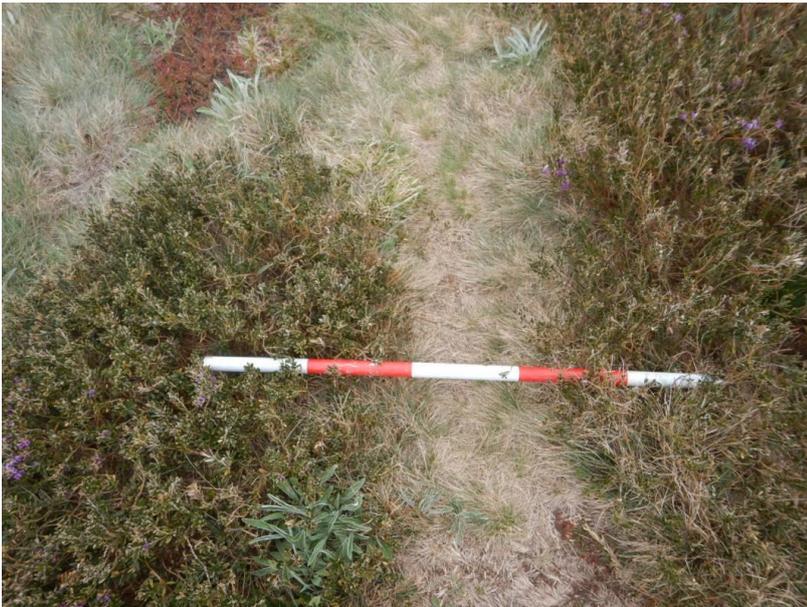
Photograph 9 Typical ground surface visibility within SU3 (Z. Carter 7/12/21)
