AEA Ref: EA1304\_C01a

### Auditor Advice Letter

#### Compliance with Audit Recommendations – Phase 1 of the Development 44 – 76 Simcock Avenue, Spotswood, Victoria

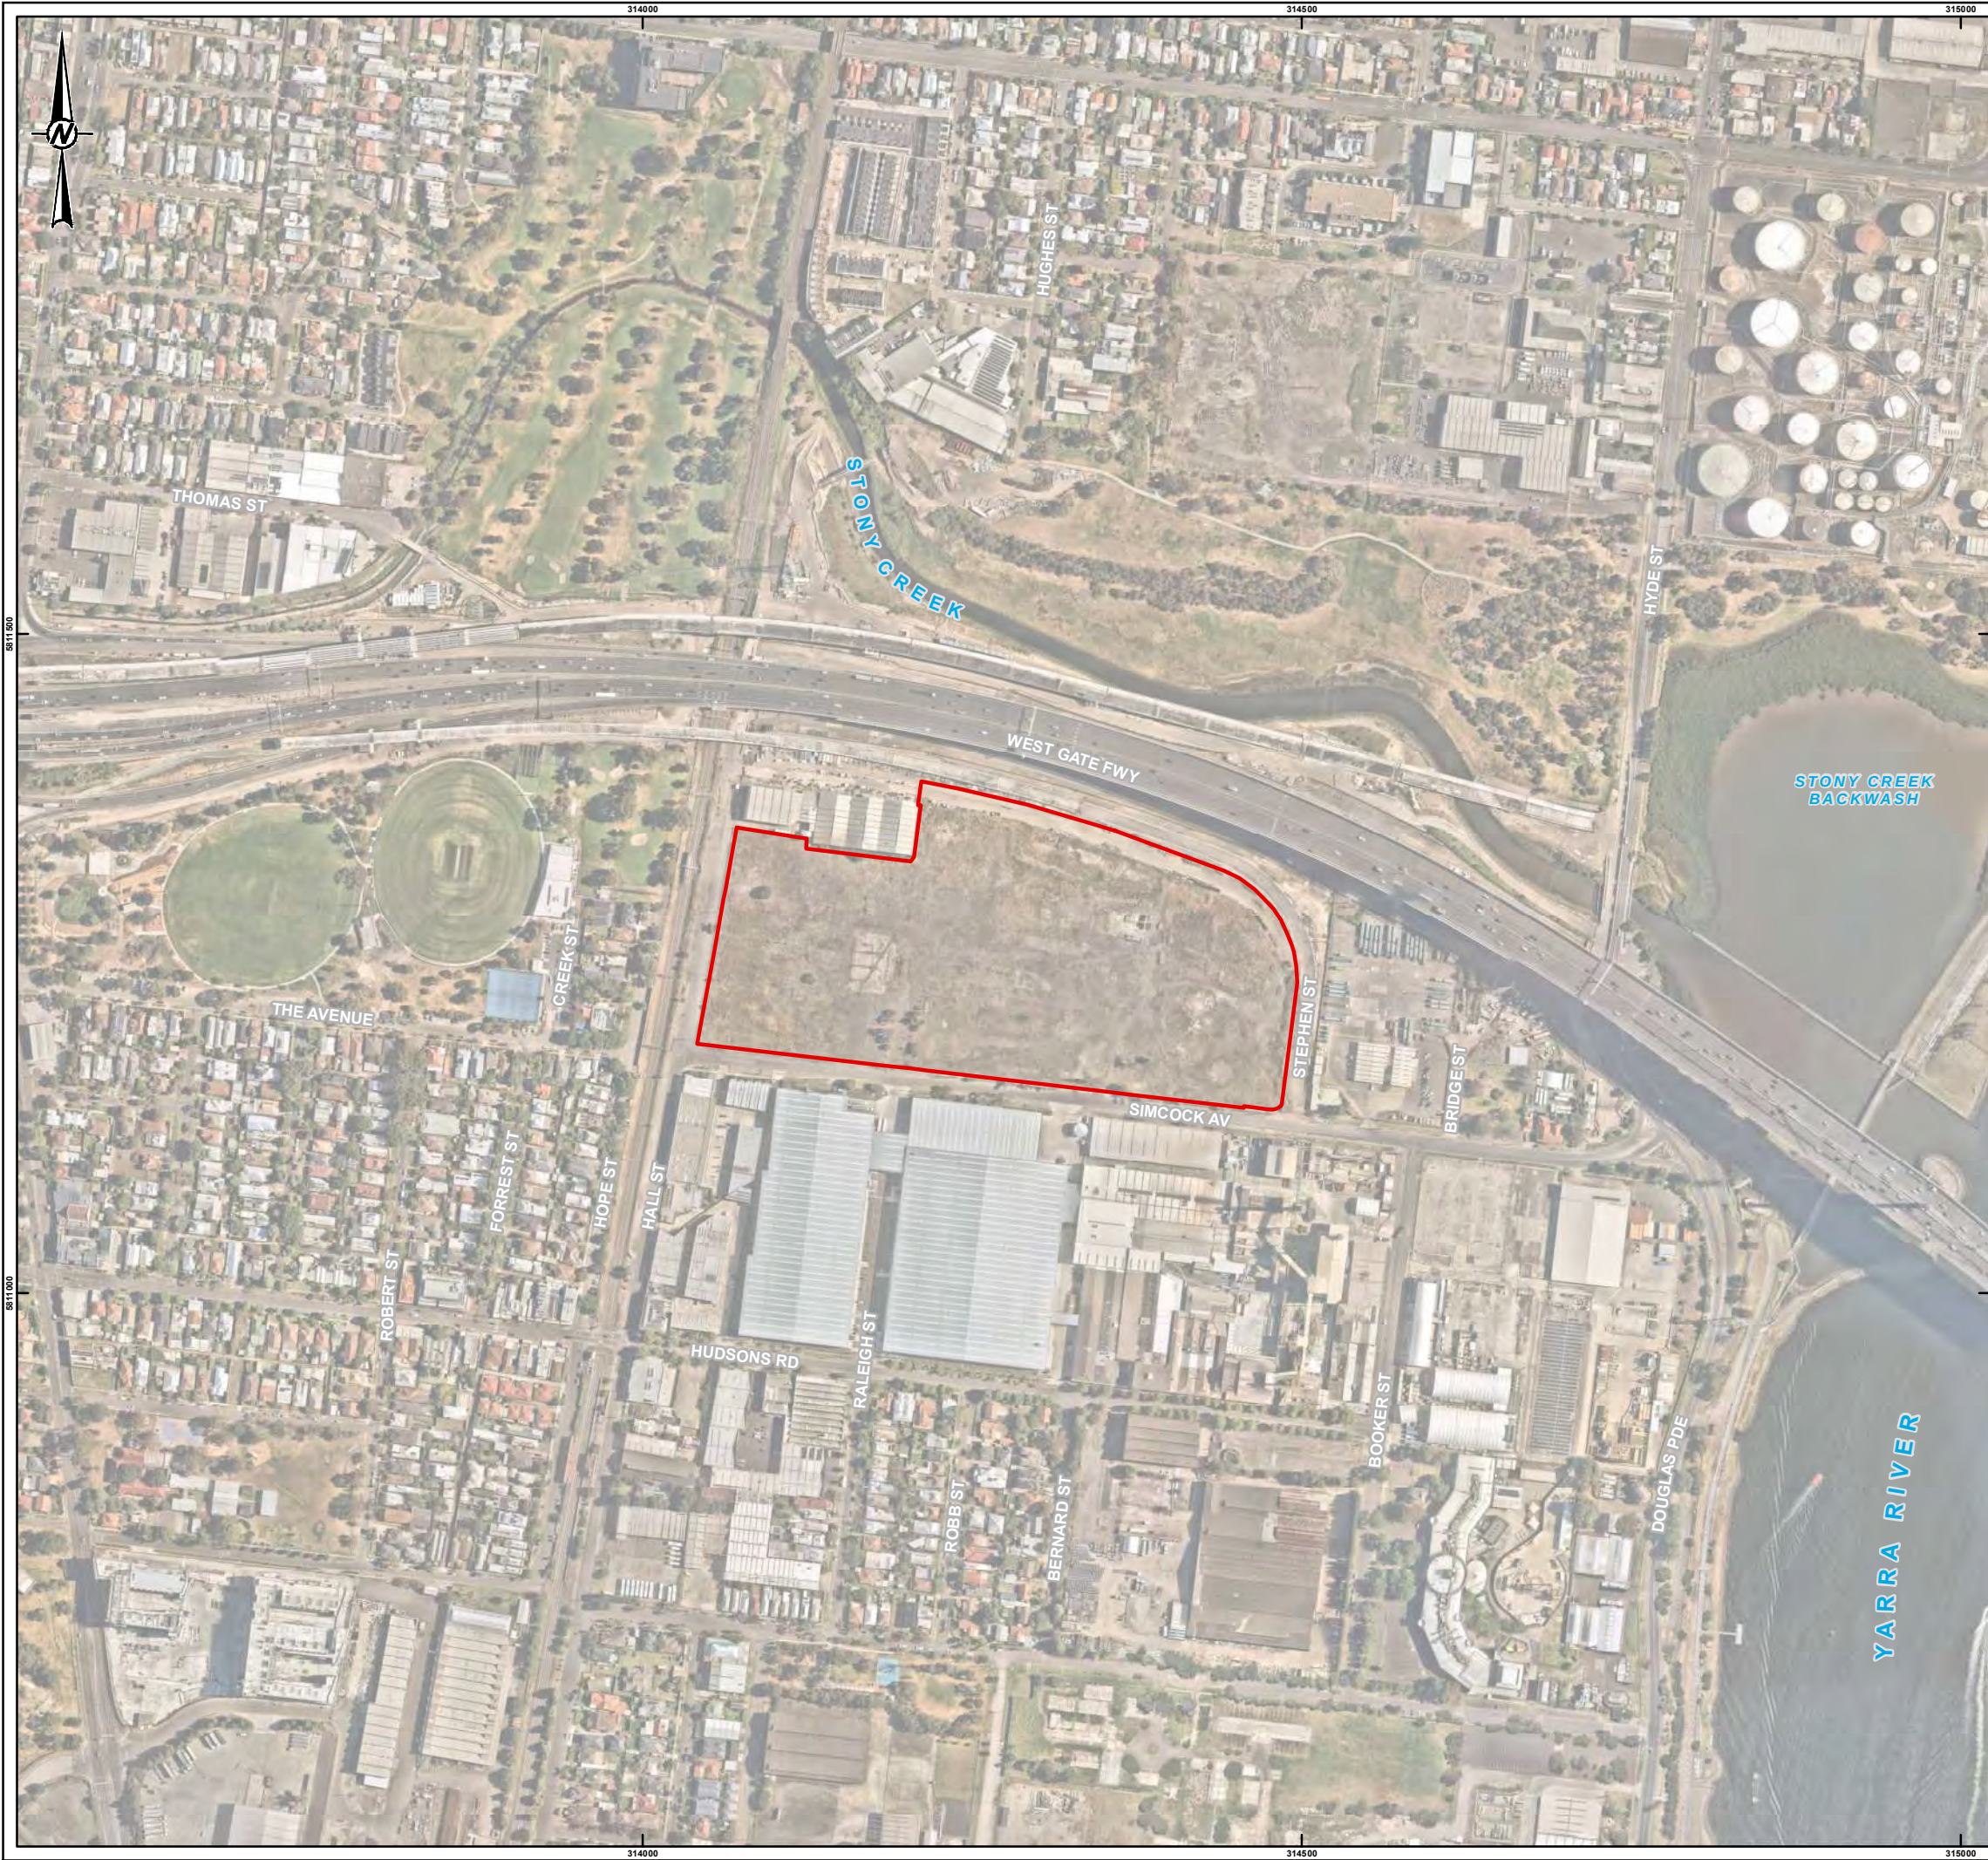
PROJECT NO. 1418584 CONTROL 538-R REV. 0 FIGURE 4

Elevated concentrations of dissolved phase organic compounds (MAHs, TRH and PAHs) were detected in groundwater monitoring wells in 2020 to 2022 (refer to Figure 4 in Appendix A – organic impacts denoted by blue halos) primarily offsite to the south and east of the site.

Refer to Figure 4 in Appendix A for the site derived PFAS distribution in 2020/2022 (denoted by green halos).

Elevated concentrations of metals, including arsenic, copper, manganese and nickel were detected in groundwater monitoring wells in 2020 to 2022 generally along the northern boundary of the site and to the north of the site as a result of the presence of a backfilled quarry. Elevated concentrations of metals were detected in offsite wells along the length of the northern boundary in wells UB15, Q06, Q07, P06, UB04, B01R, F15, E15, F09, Q08, B03 and B19 (refer to Figure 4 in Appendix A – metal impacts denoted by yellow halos).

Based on the above distribution of COIs, an area across which the extraction of groundwater for uses such as stock watering, irrigation, industrial and commercial and recreation (i.e. filling swimming pools) should be restricted, referred to as an area of restricted groundwater use herein, was defined as part of the Environmental Audit and is presented in Figure 4 (Appendix A).

Due to the presence of the COIs (LNAPL, TRH, MAHs, PAHs, PFAS and metals), groundwater within the boundaries of the area of restricted groundwater use (Figure 4) is not to be extracted and used for any purpose.

At the time of completion of the Environmental Audit in April 2023, those parties within the area of restricted groundwater use (Figure 4) had been notified. A copy of the communications issued to the offsite stakeholders is provided in Appendix B.

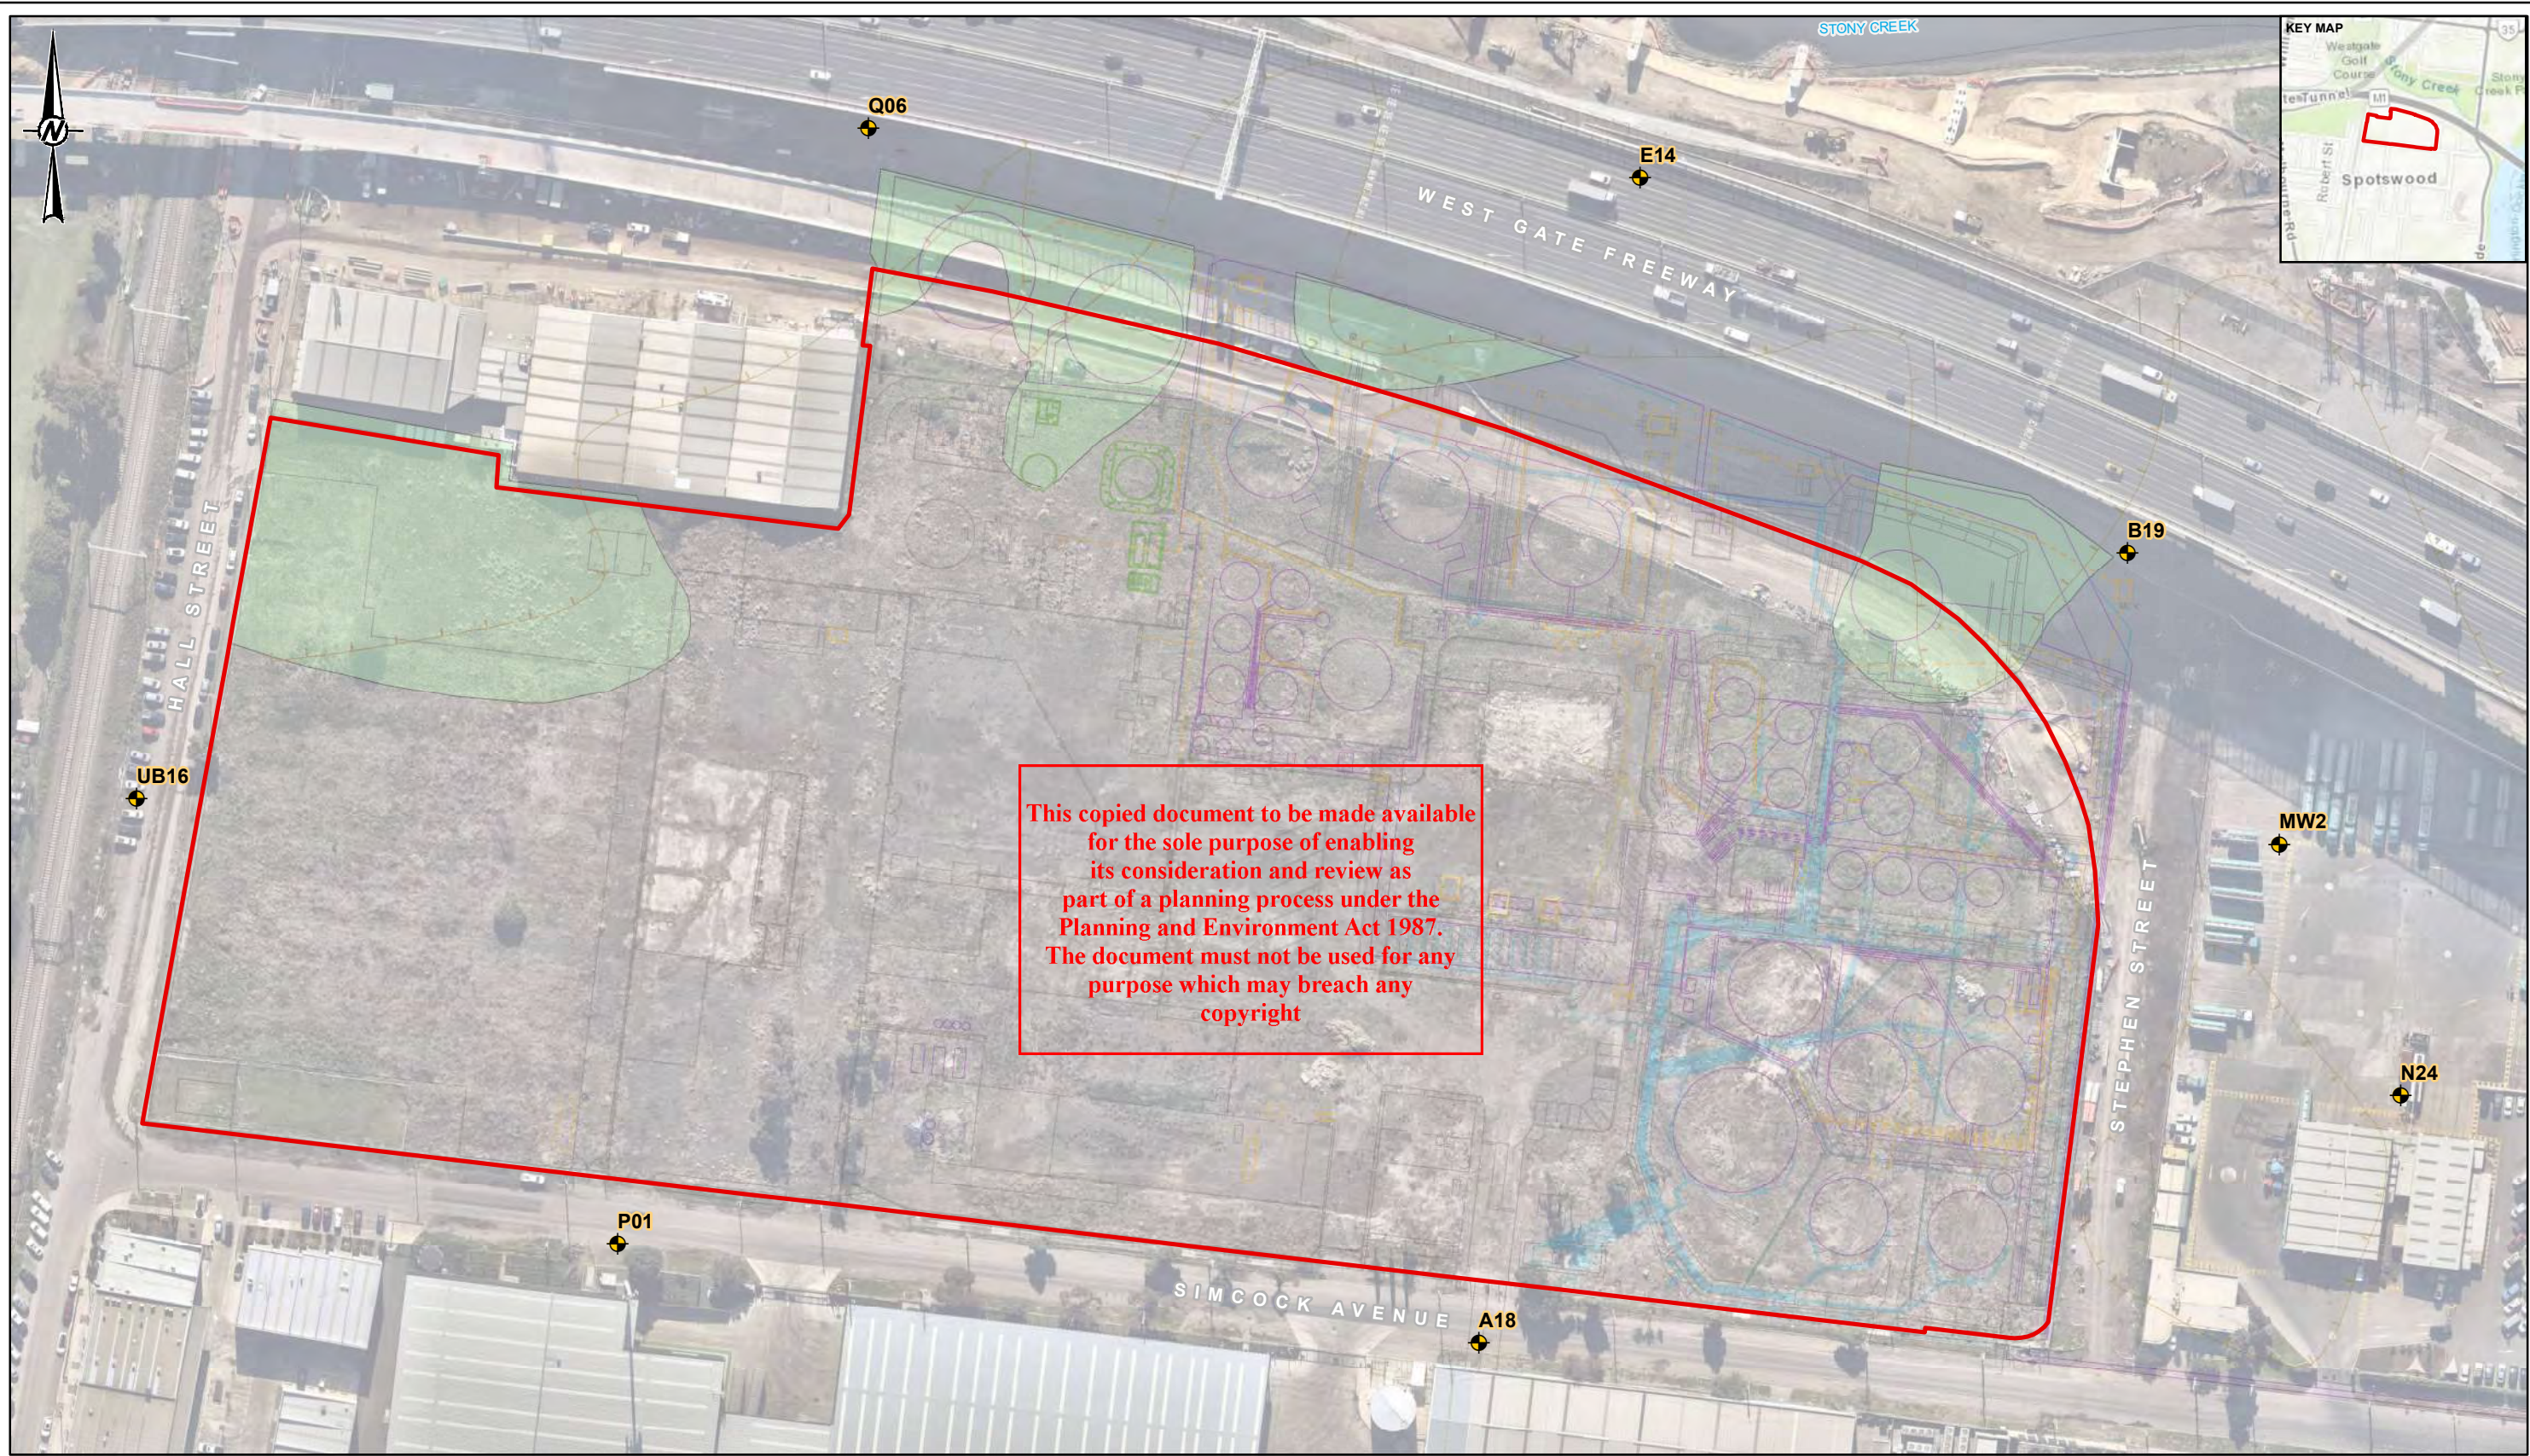
Well for Dissolved Phase Monitoring

A one-off monitoring event one year after the Environmental Audit to reconfirm that dissolved phase PFAS and benzene concentrations in groundwater are stable was a recommendation of the Environmental Audit. The wells that should be sampled are summarised below and presented in Figure 6.

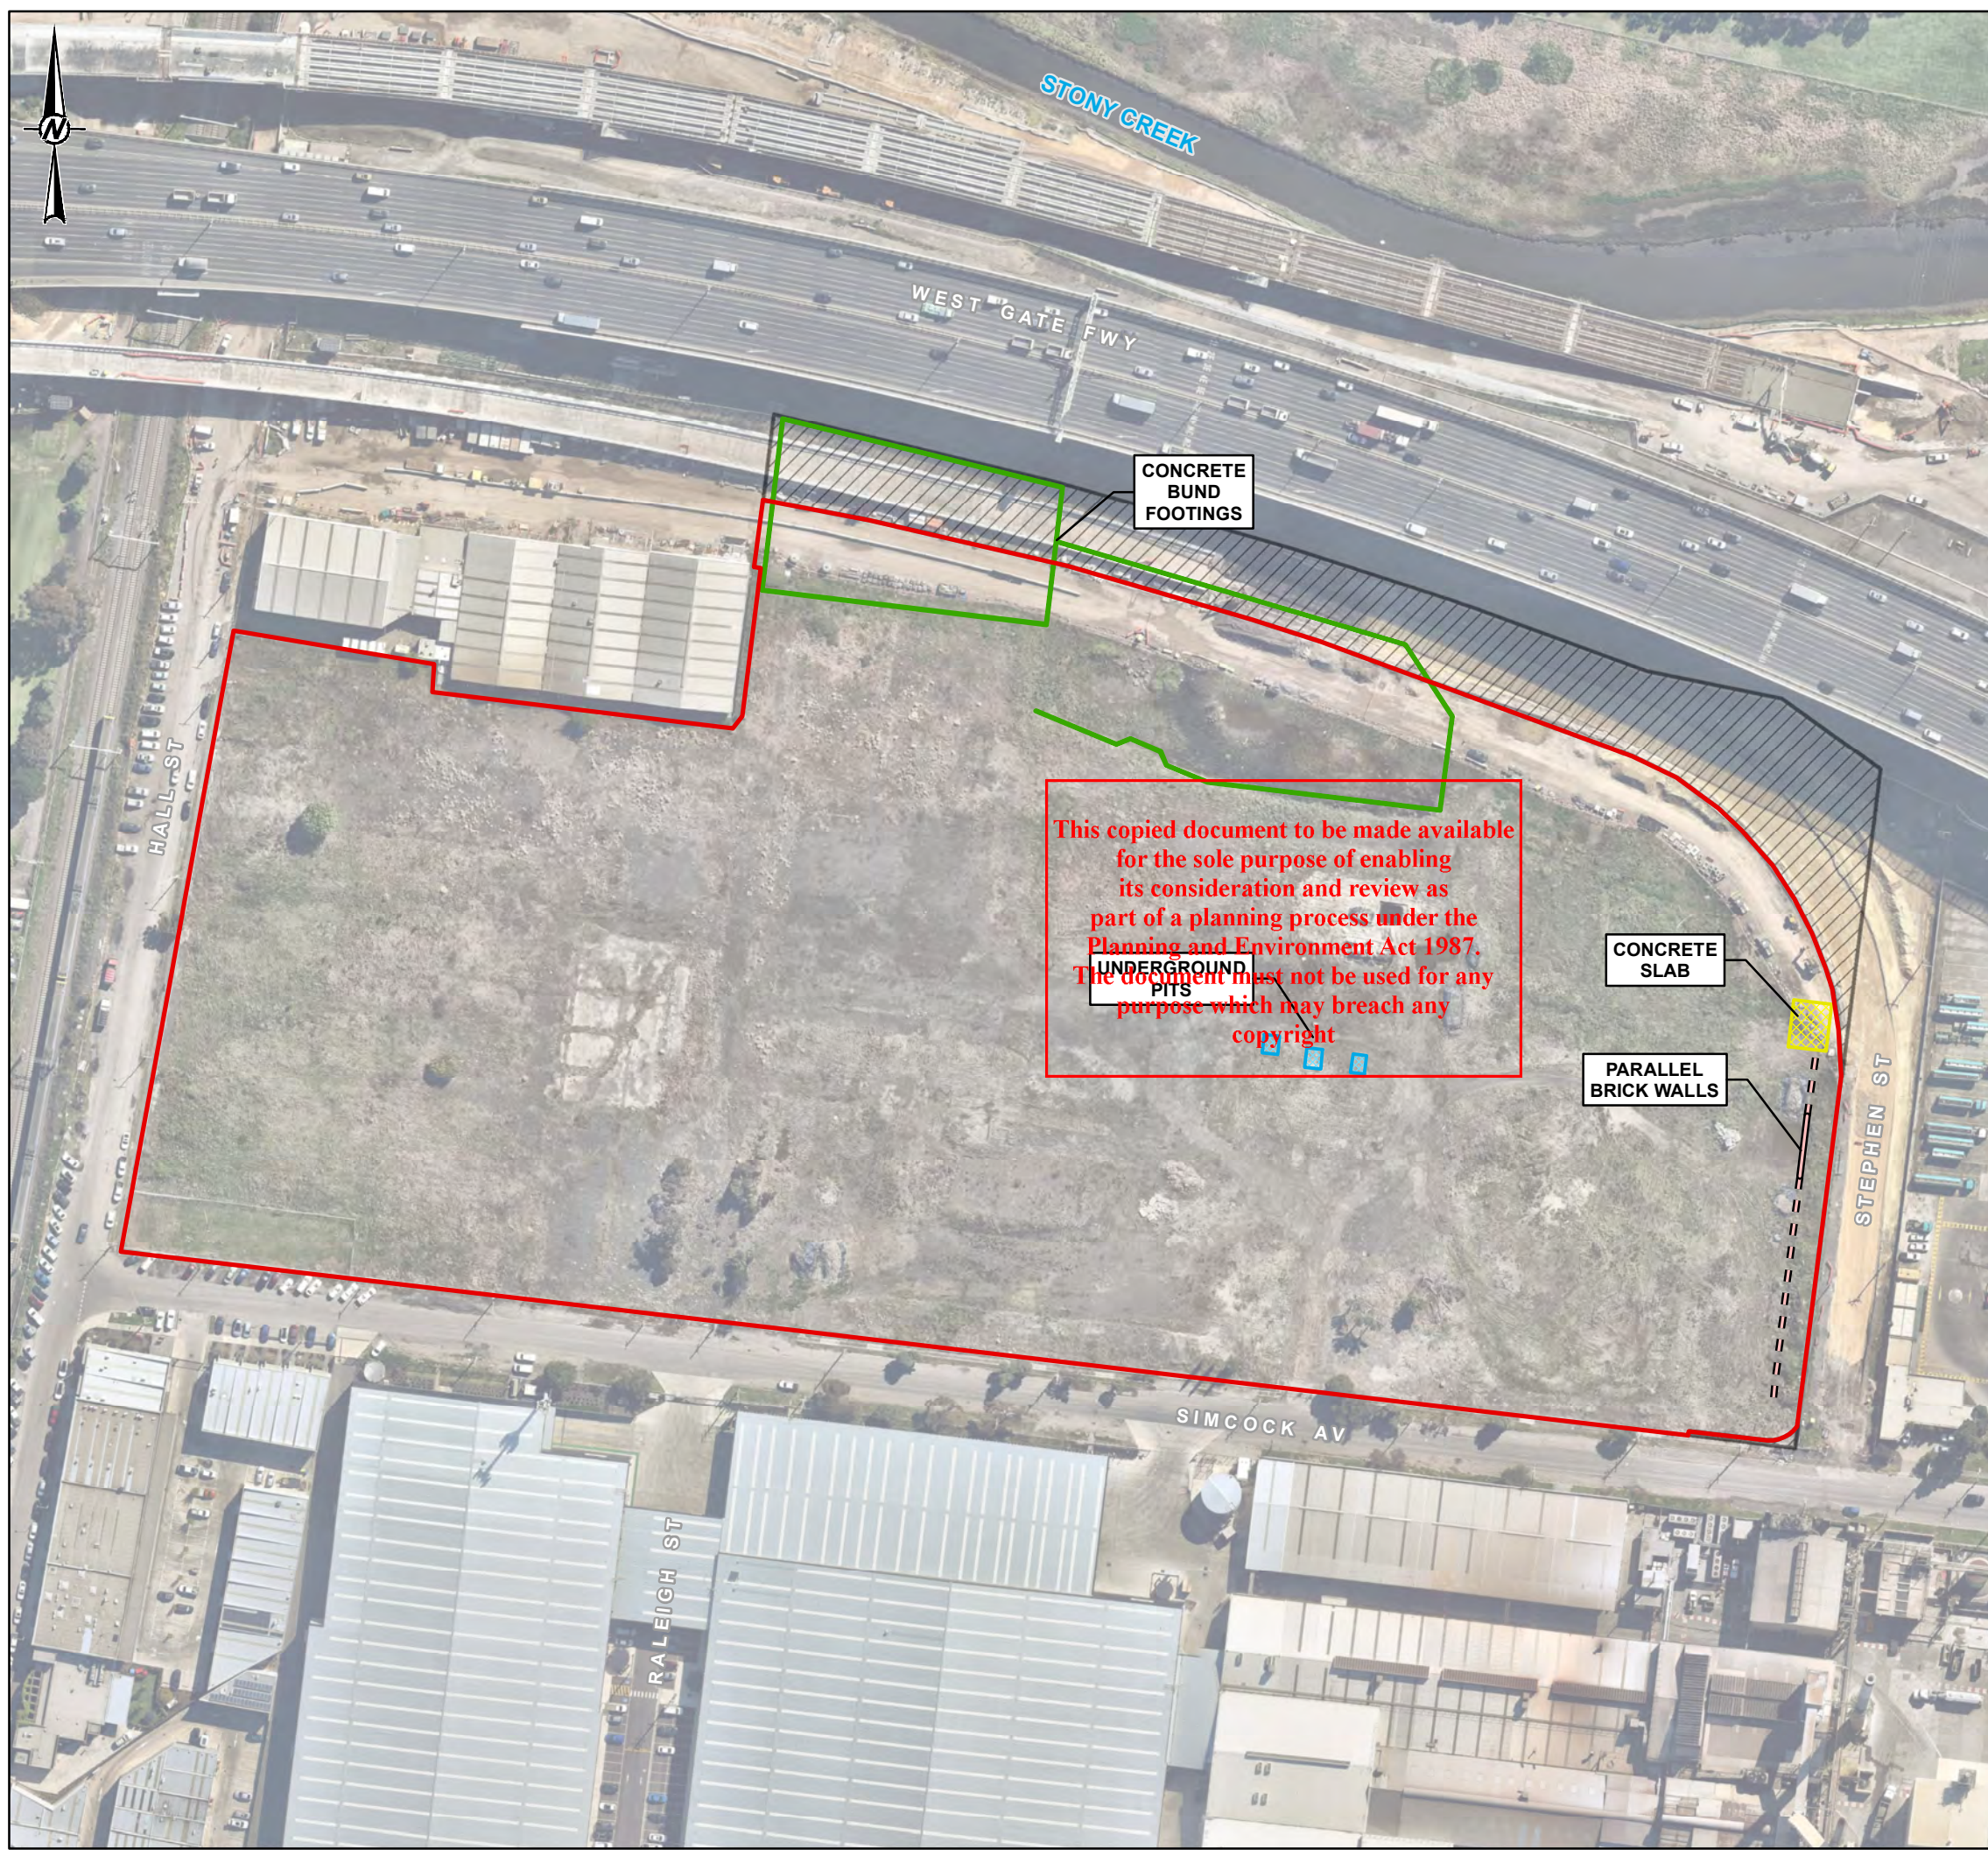
PROJECT NO. 1418584 CONTROL 405-R REV. 0 FIGURE 4

- LEGEND**
- Site Boundary
  - Land Acquired for Road Construction
  - Deep Concrete Footing
  - Underground Pit
  - Concrete Slab
  - Brick Walls Delineated
  - Brick Walls Inferred

Known above ground and below ground infrastructure relating to the site's operation as a petroleum storage facility has been removed with the exception of the following as shown on Figure 4:
