ARBORICULTURAL REPORT – ADDENDUM

ST PAUL'S ANGLICAN GRAMMAR SCHOOL SITE – 540 MCGLONE RD, LONGWARRY NTH

Previous Report: Drouin Tree Services – Arboricultural Report, *Ref No. 20051, 08/04/2020*

Date of Revision: 22/11/2023

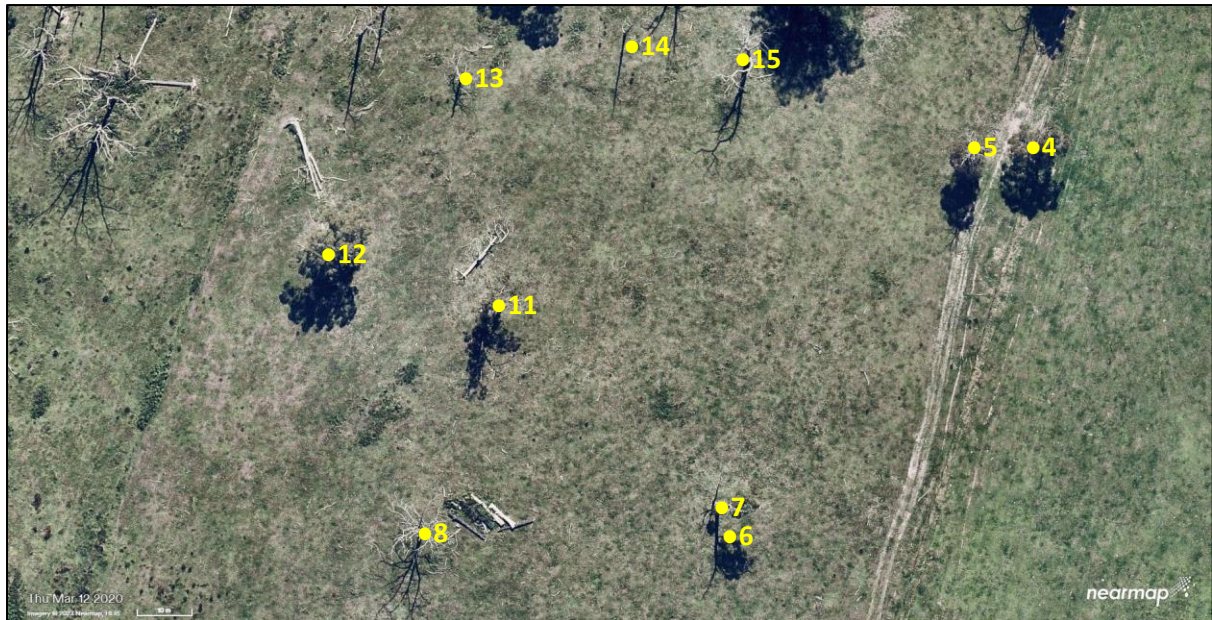
Figure 2. Aerial image 12/03/2020 (Nearmap) – Note the multiple dead/fallen trees at the time of the initial assessment

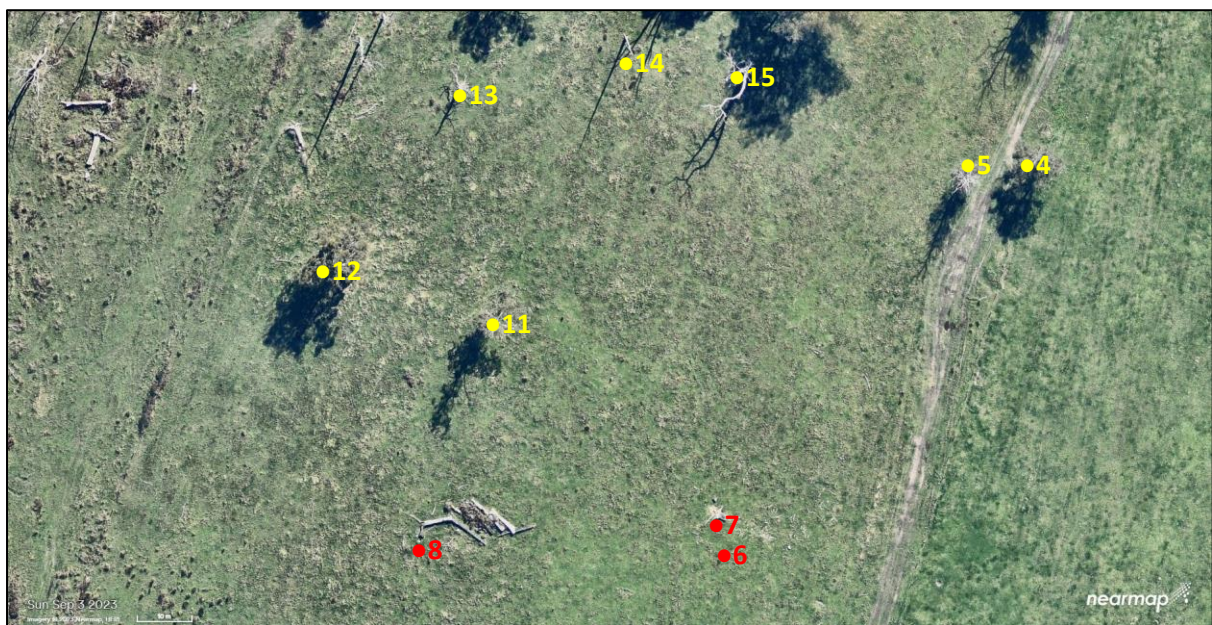
During the 3 years since the initial tree assessment significant changes have occurred within the tree population, most notably the loss of trees 6, 7 & 8 (see figures 2 & 3). These 3 trees are likely to have succumb to naturally occurring environmental forces. The condition of many of the trees within the site were recorded as poor during the 2020 assessment and further tree decline, death and failure is expected to be a common occurrence within the site over the coming years (see figures 4 – 7). The risk presented by falling trees and branches will need to be assessed regularly (at intervals no greater than 12 months) as the site is developed and targets occupy the fall zone of the trees more frequently.

Figure 3. Aerial image 3/09/2023 (Nearmap) Trees 7 – 9 have fallen since the initial assessment

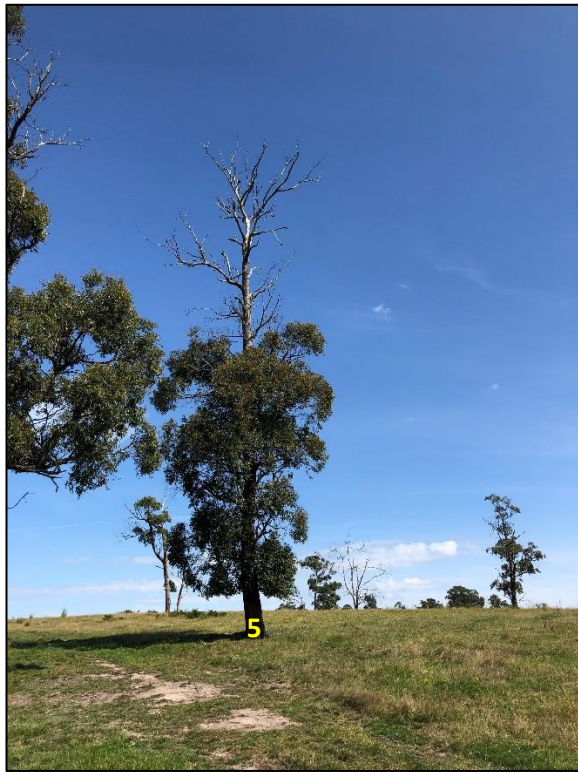
Figure 4. Tree 5 – March 2020

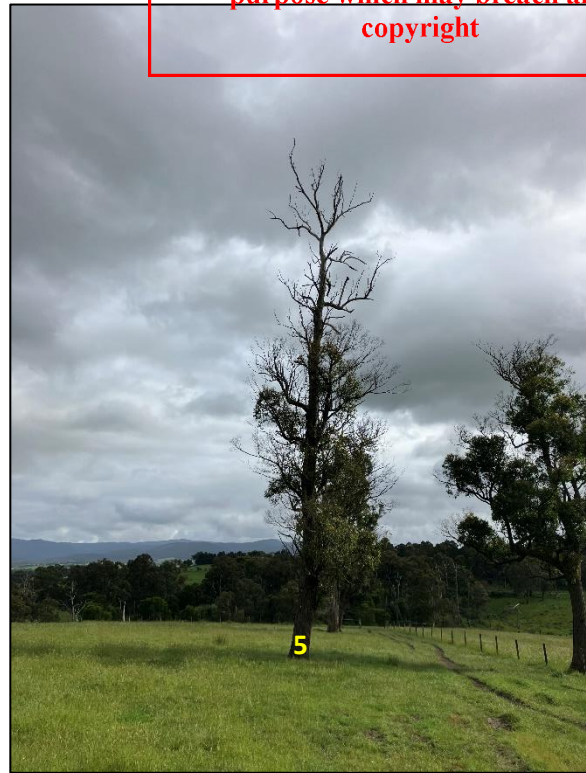
Figure 5. Tree 5 – November 2023, displaying further dieback of mid & lower canopy

5	<i>Eucalyptus globoidea</i>	White Stringybark	Indigenous	Senescent	63	24x8	Poor	Poor	0-5	Ecological	Poor	Yes	Retain/Protect	High	Mulch & plant understory plants within fall zone***	Prune all deadwood >50mm dia.	7.56	2.90	
6	Tree has failed																		
7	Tree has failed																		
8	Tree has failed																		
9	<i>Eucalyptus globoidea</i>	White Stringybark	Indigenous	Mature	88	17x9	Fair	Fair-Poor	5-10	Ecological	Poor	Yes	Retain/Protect	High	Mulch & plant understory plants within fall zone***	Prune all deadwood >50mm dia.	10.56	3.28	
10	<i>Eucalyptus sp.</i>	Dead Eucalypt	Indigenous	Dead	50	10x4	Dead	Dead	0	Low	Poor	Yes	Retain/Protect	High	Mulch & plant understory plants within fall zone***	Habitat prune	6.00	2.67	
11	<i>Eucalyptus obliqua</i>	Messmate	Indigenous	Mature	74	20x9	Fair	Fair-Poor	5-10	Ecological	Poor	Yes	Retain/Protect	High	Mulch & plant understory plants within fall zone***	Prune all deadwood >50mm dia.	8.88	3.08

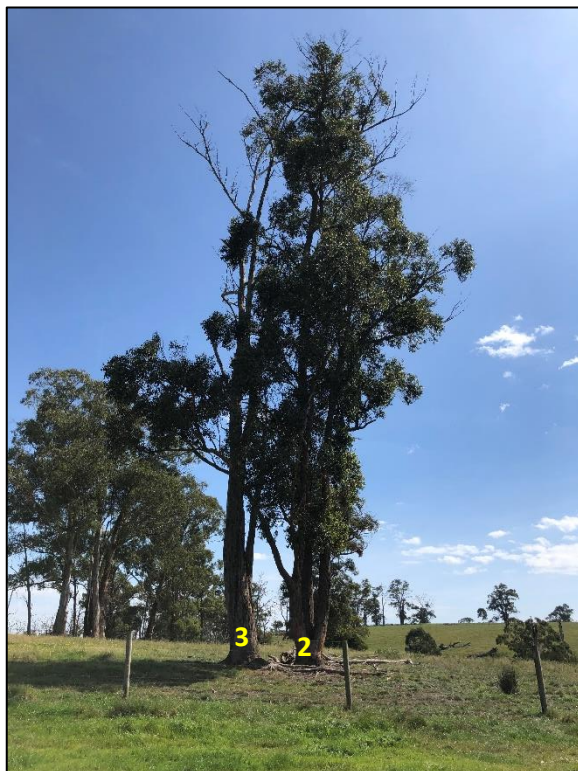
Figure 6. Trees 2 & 3 – March 2020

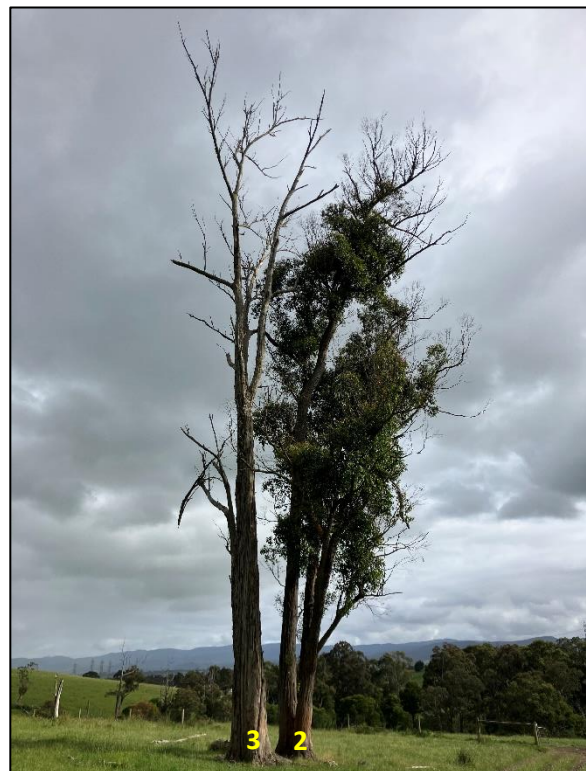
Figure 7. Trees 2 & 3 – November 2023

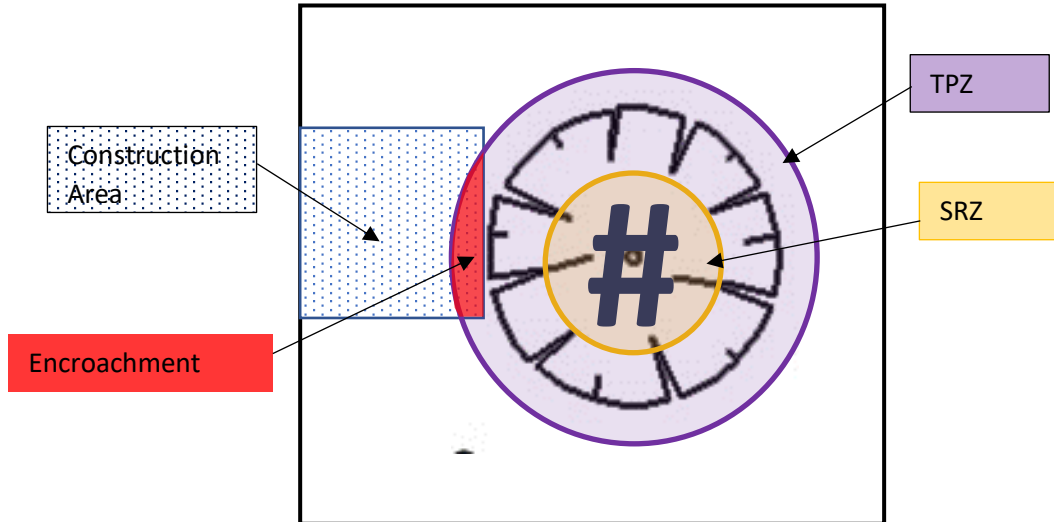
An encroachment of the TPZ is where the calculated TPZ is modified to allow permitted construction activities to occur. If the area proposed to be encroached is less than 10% of the total TPZ area, and is outside of the SRZ, it is considered a minor encroachment. A minor encroachment of the TPZ is generally acceptable, however individual tree requirements and site conditions will need to be considered to determine the overall impact on the tree.

Figure A.2. Minor encroachment (<10% of TPZ area with no encroachment of the SRZ)

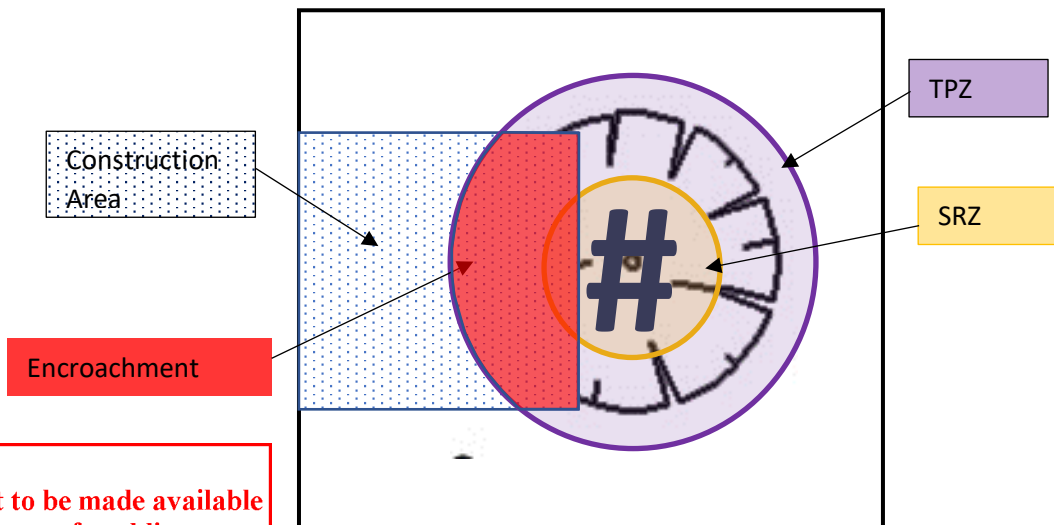
When a proposed encroachment is greater than 10% of the TPZ or inside the SRZ, it is considered a major encroachment. When a major encroachment is proposed the consulting arborist must determine if the tree/s will remain viable. Considerations including; species, soil characteristics, age & vitality of the tree along with construction methods, will help determine if a tree/s will be tolerant.

Figure A.3. Major encroachment (>10% of TPZ area with encroachment of the SRZ)

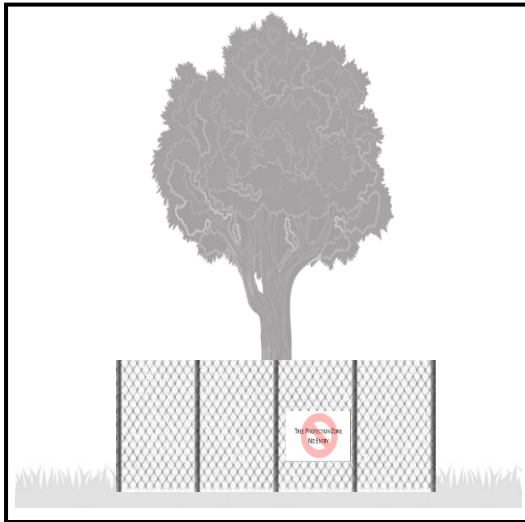
Figure 5.5. Standard TPZ Sign

Ideally the tree protection fencing shall be a minimum of 1.5 meters high above ground level and be constructed of prefabricated wire mesh (or similar). However, in some situations less substantial fencing in the form of high visibility flagging, attached to timber/steel pickets, at height of 1.2m may be considered adequate, see figures A.5 & A.6. All TPZ areas need to be clearly identified by suitable signs. Signs should be attached to the TPZ fencing at intervals no less than 5m apart.

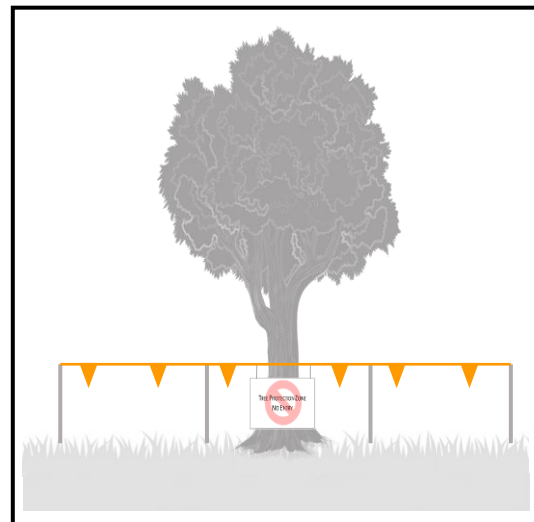
Figure 5.6 Tree Protection Zone
