Hanson Construction Materials

Yannathan Quarry Extension

Surface Water Management Plan

V1259_002-REP-001-6

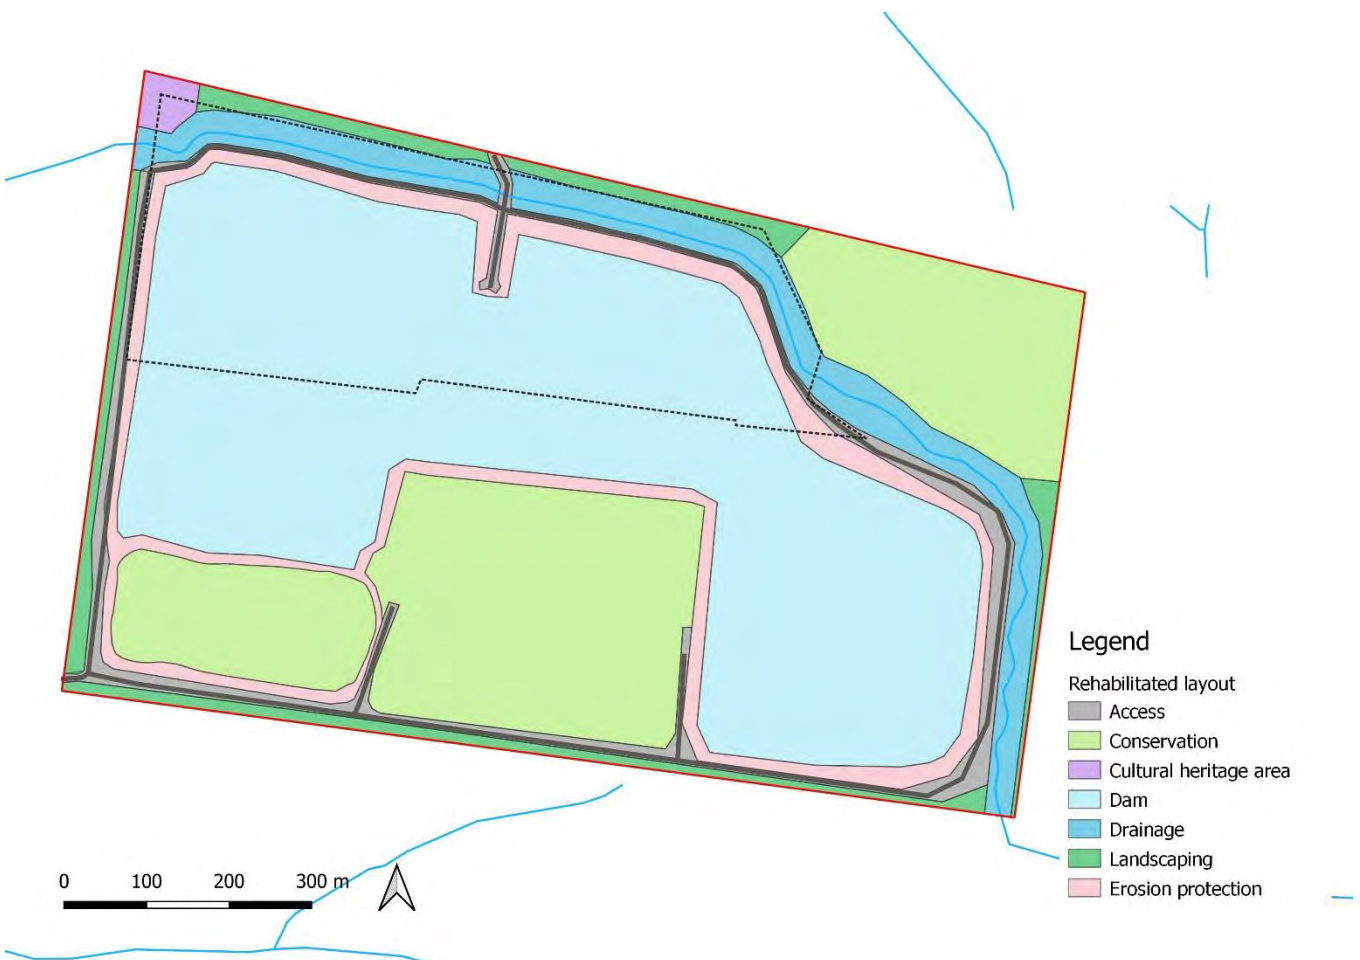
Figure 1-2: Proposed rehabilitation plan (concept design for context)

At each stage of the works the quarrying pits will be protected from flooding in up to a 1% AEP event to prevent water from flowing into any of the pits.

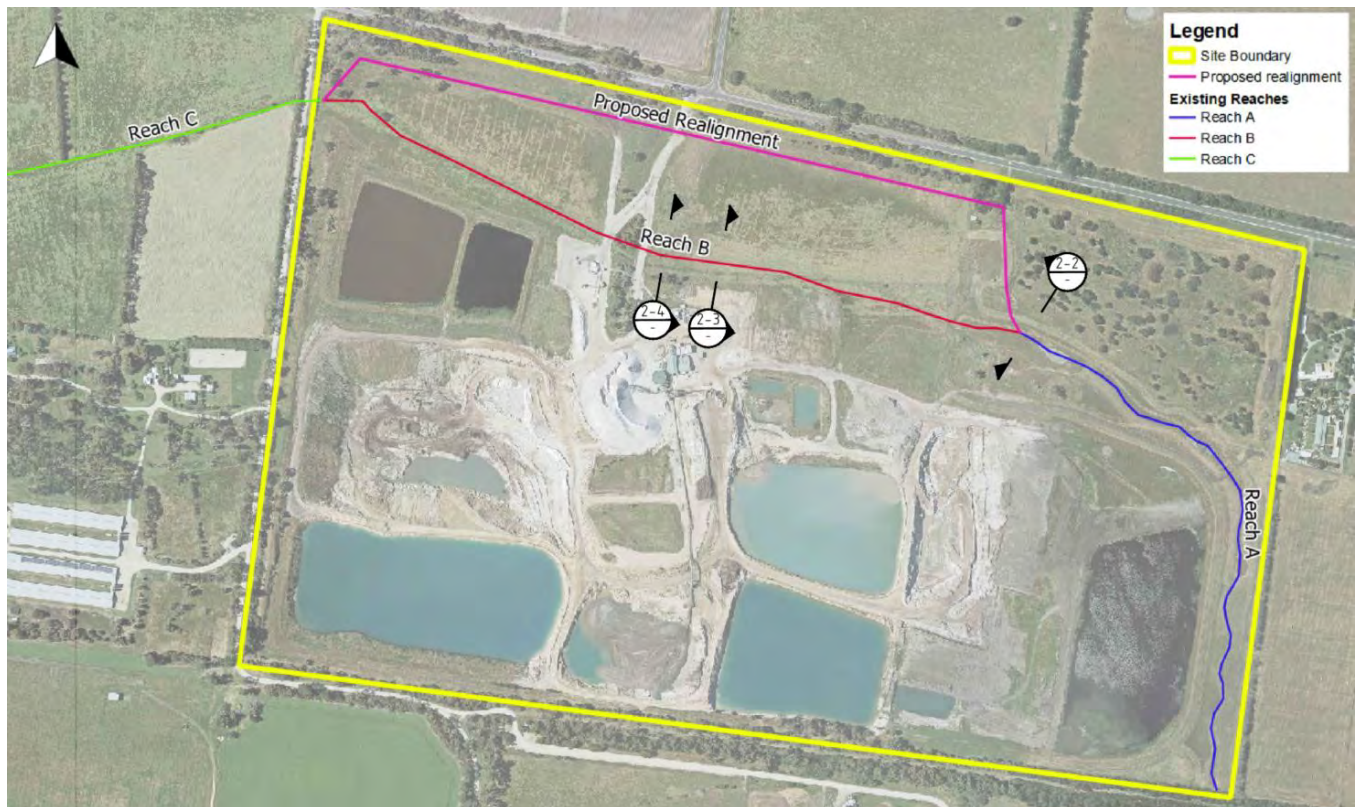
Figure 2-1: Site Waterway Reaches

The inspection involved undertaking measurements of the existing culverts and to obtain information regarding the conditions of the current. In addition, an understanding of the design constraints and requirements of the proposed diversion channel were developed.

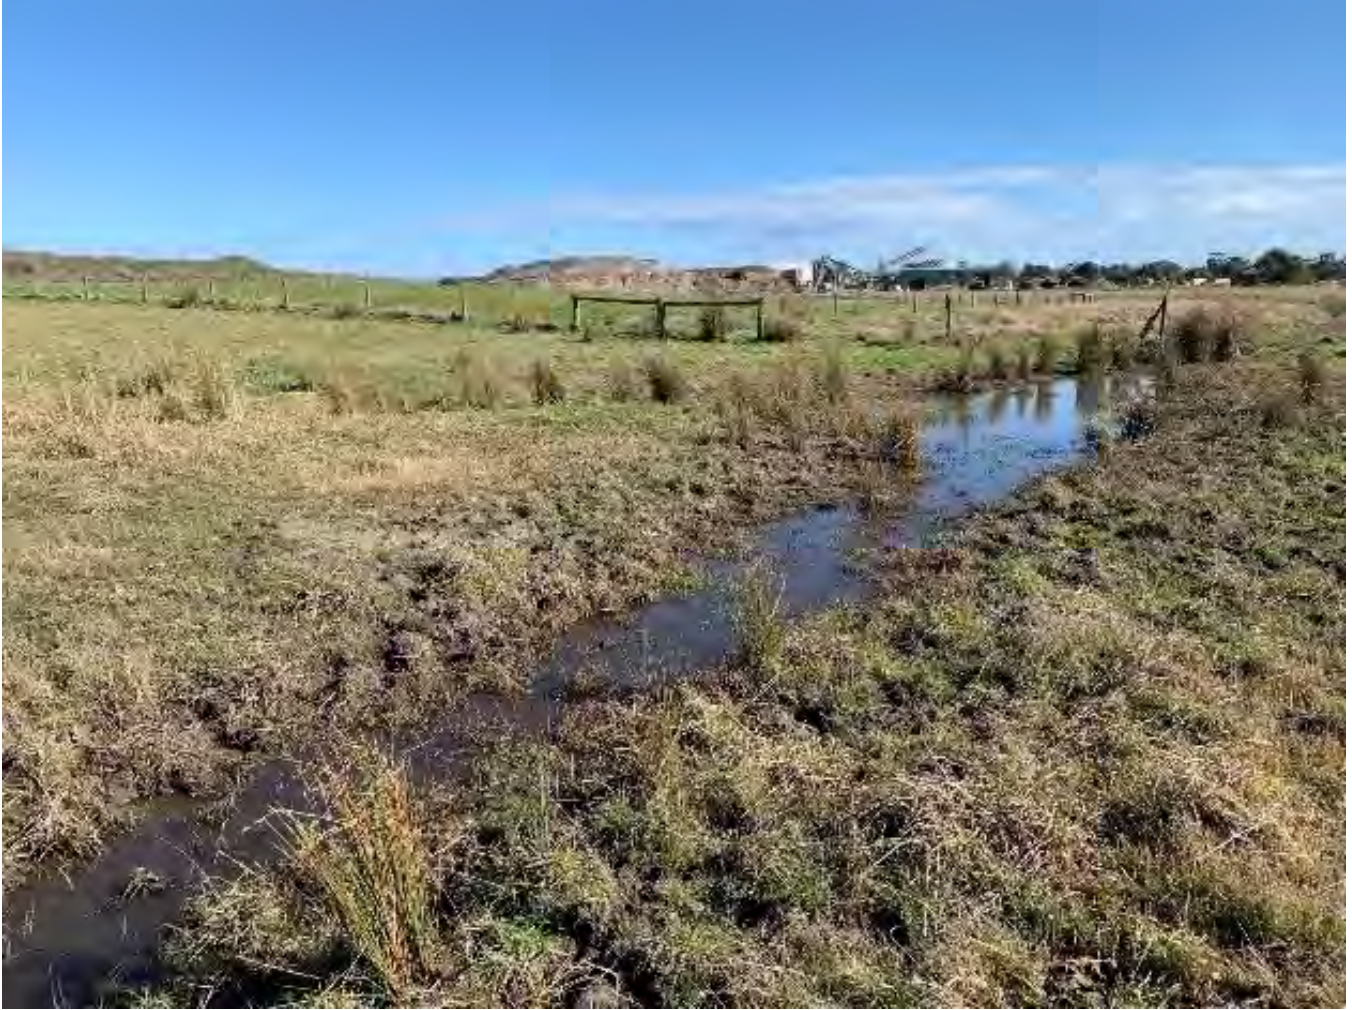
Figure 2-2: Constructed low flow channel (Reach A)

Reach A represents a previously re-aligned constructed waterway from the east of the quarry site flowing in the north-west direction towards Reach B. The waterway has low vegetation with some pasture grasses within some sections as shown in Figure 2-2. The surrounding broad floodplain consists mostly of a low-lying groundcover of pasture.

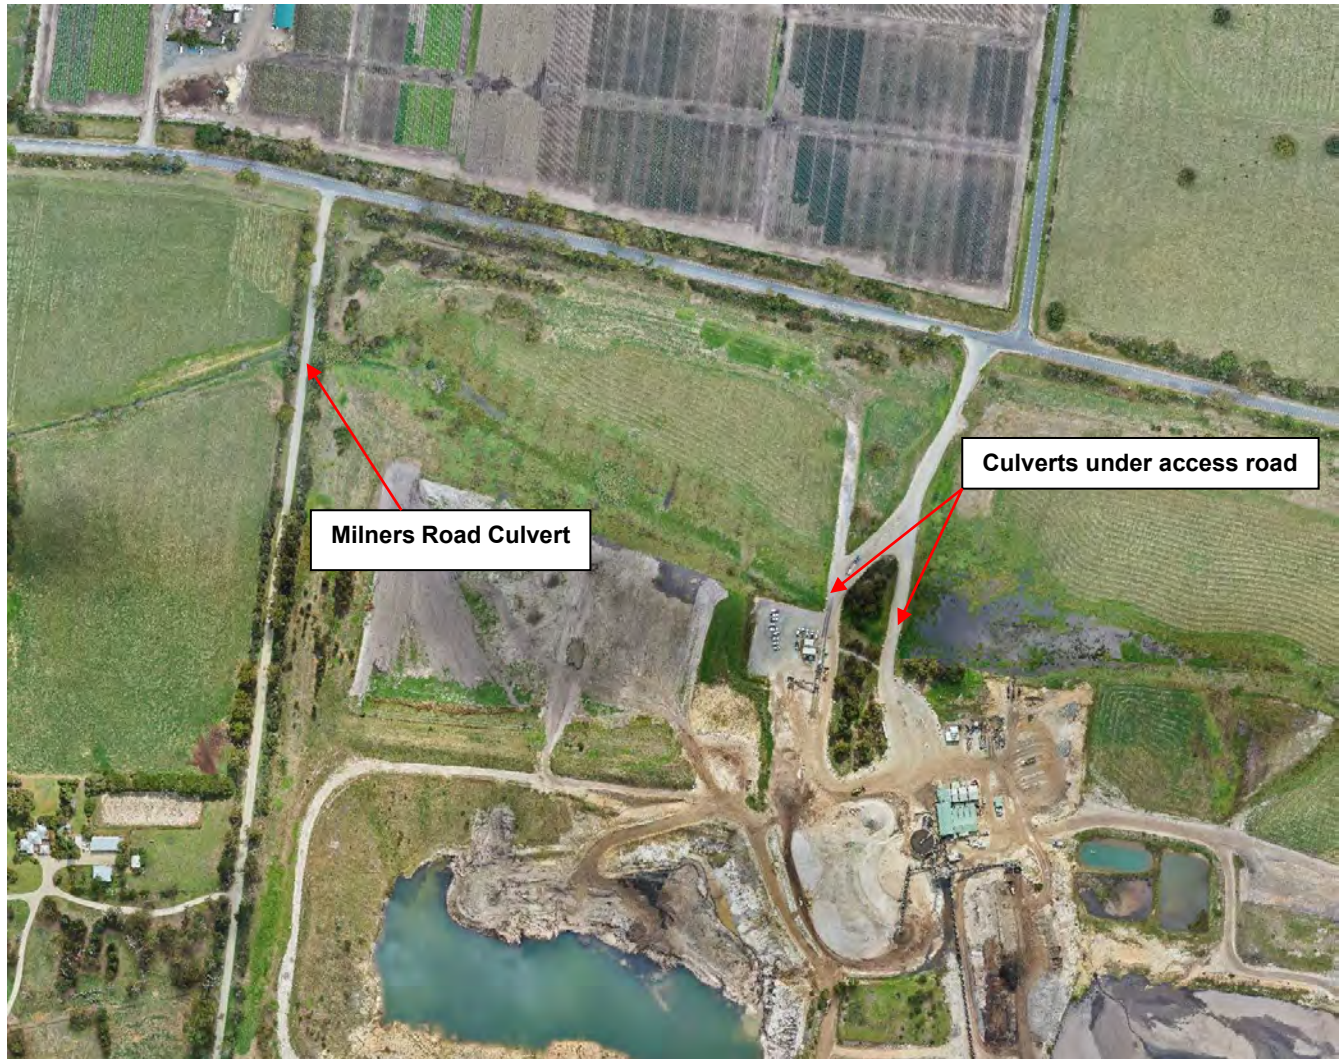
Figure 2-5: Existing Culvert Crossing Locations

Refer to Figure 2-5 for existing culvert crossing locations.

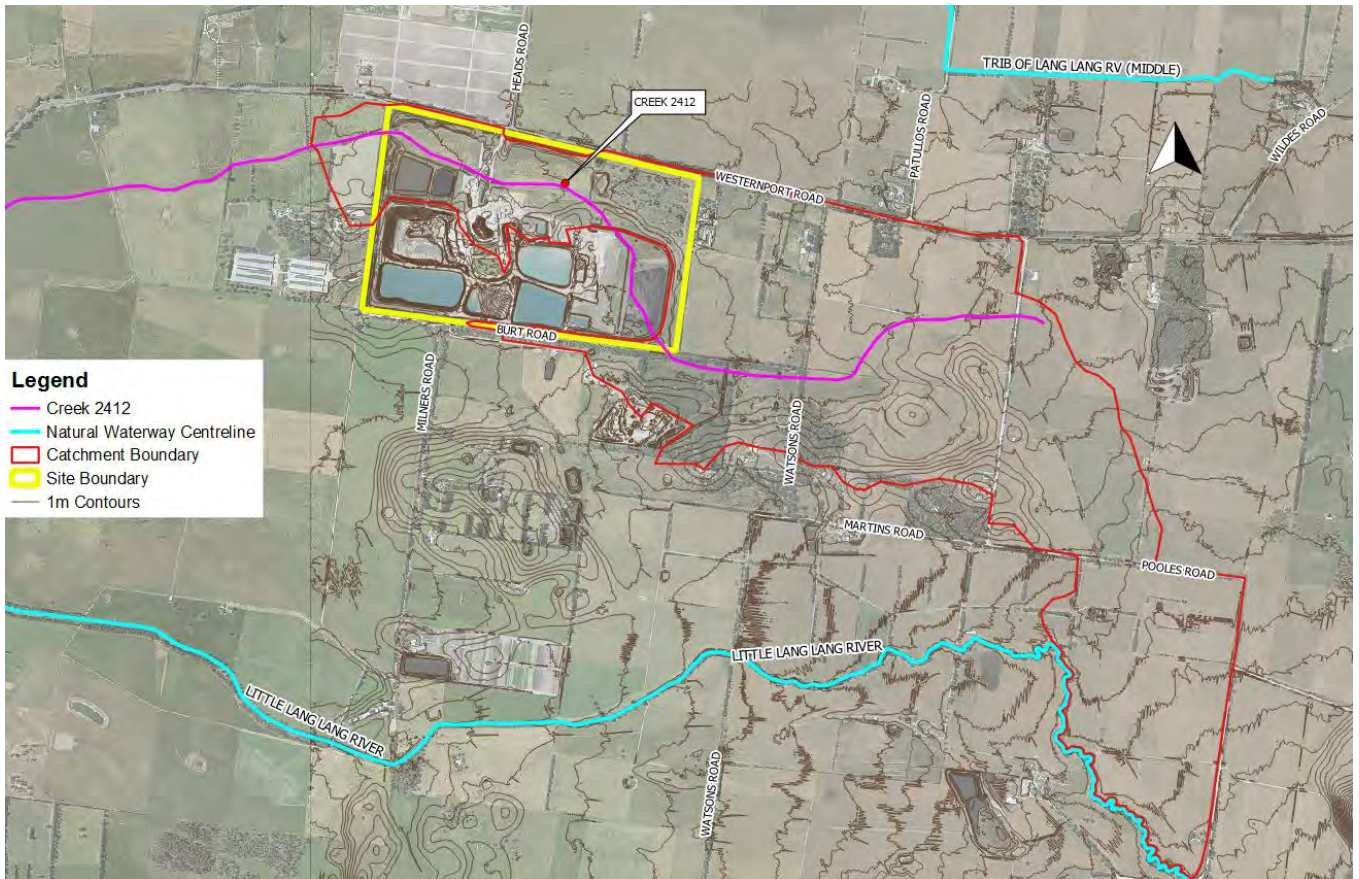
Figure 4-1: Local catchment contributing flows to the study area (delineated by Engeny)

As part of the hydrological model development, a catchment delineation has been undertaken for the site to determine the expected catchment area that would contribute flows to the site. Engeny has determined an upstream catchment area of approximately 2.7 km² would contribute flows to the site. Refer to Figure 4-1 for catchment area.

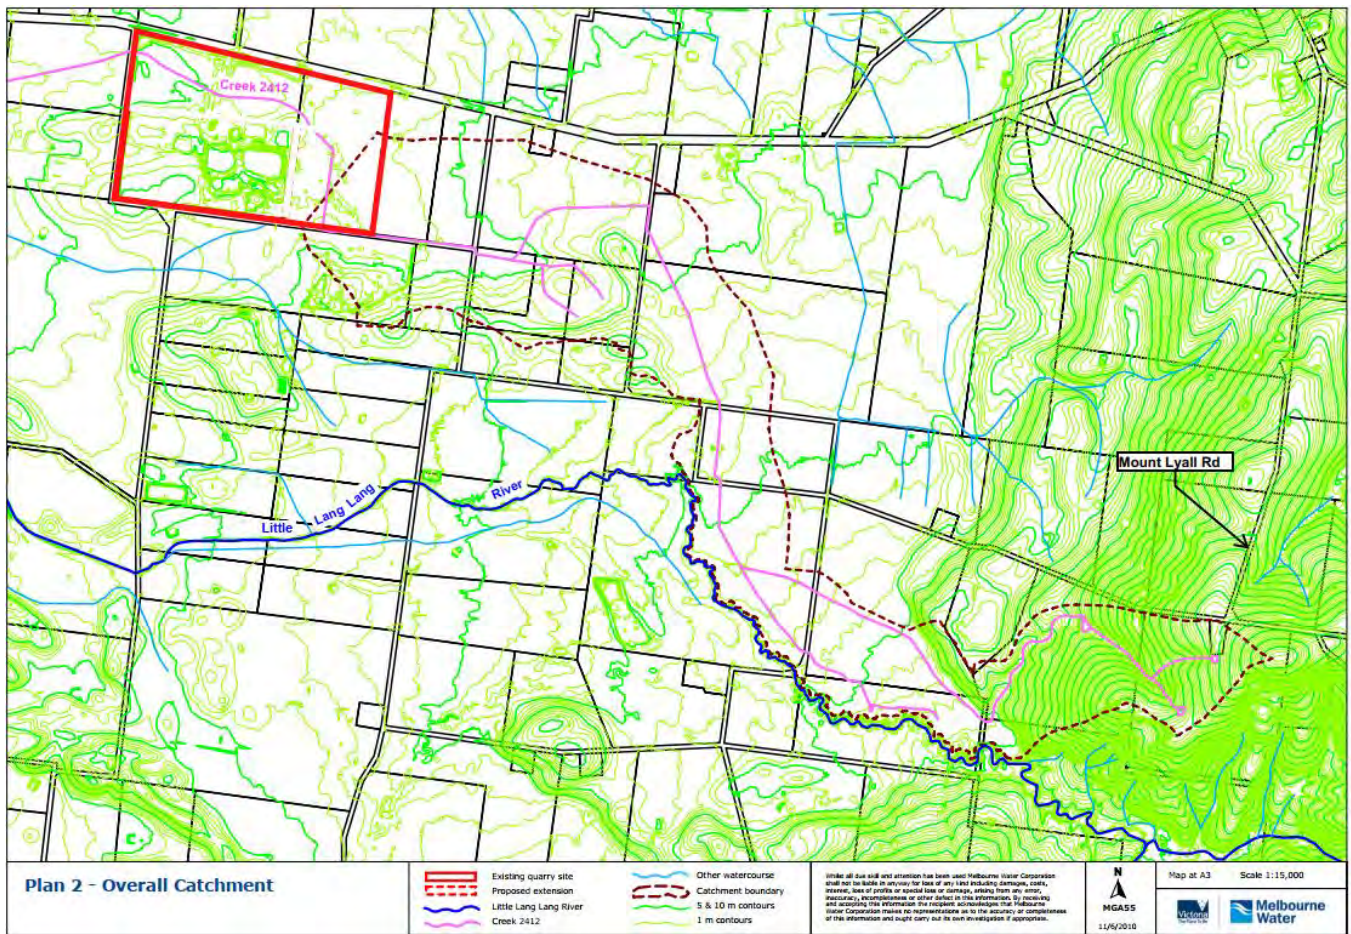
Figure 4-2: Larger catchment contributing flows to the study area from Little Lang Lang River (identified by Melbourne Water)

Figure 4-2 has been provided by Melbourne Water which shows the Little Lang Lang River, Creek 2412 and other watercourses (natural waterways that are above Melbourne Water's limit).

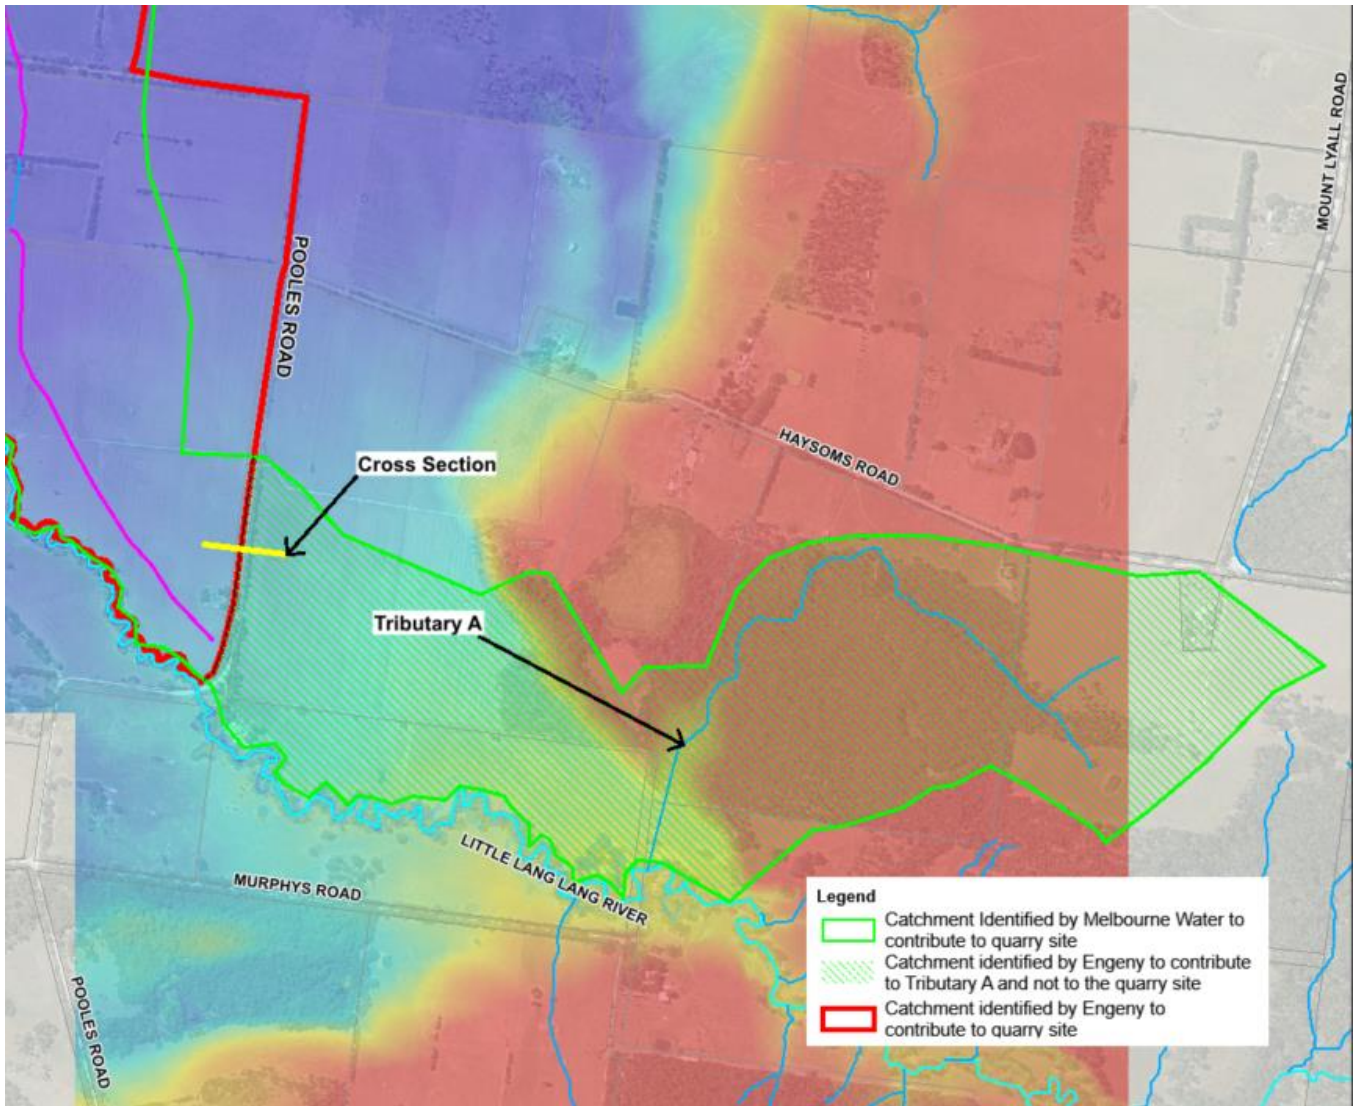
Figure 4-3: Digital Terrain Model east of Pooles Road

As shown in Figure 4-3, Tributary A (nominally labelled for this study as a tributary of the Little Lang Lang River) flows into Little Lang Lang River and therefore was not considered to contribute to the local catchment flows of the site. Furthermore, analysis of the Pooles Road surface levels indicates embankments on the eastern side of Pooles Road, as shown on Figure 4-4. Therefore, flows flowing from the east towards Pooles Road are expected to be diverted along the eastern embankment and flow towards Haysoms Road without contributing to flows at the quarry site.

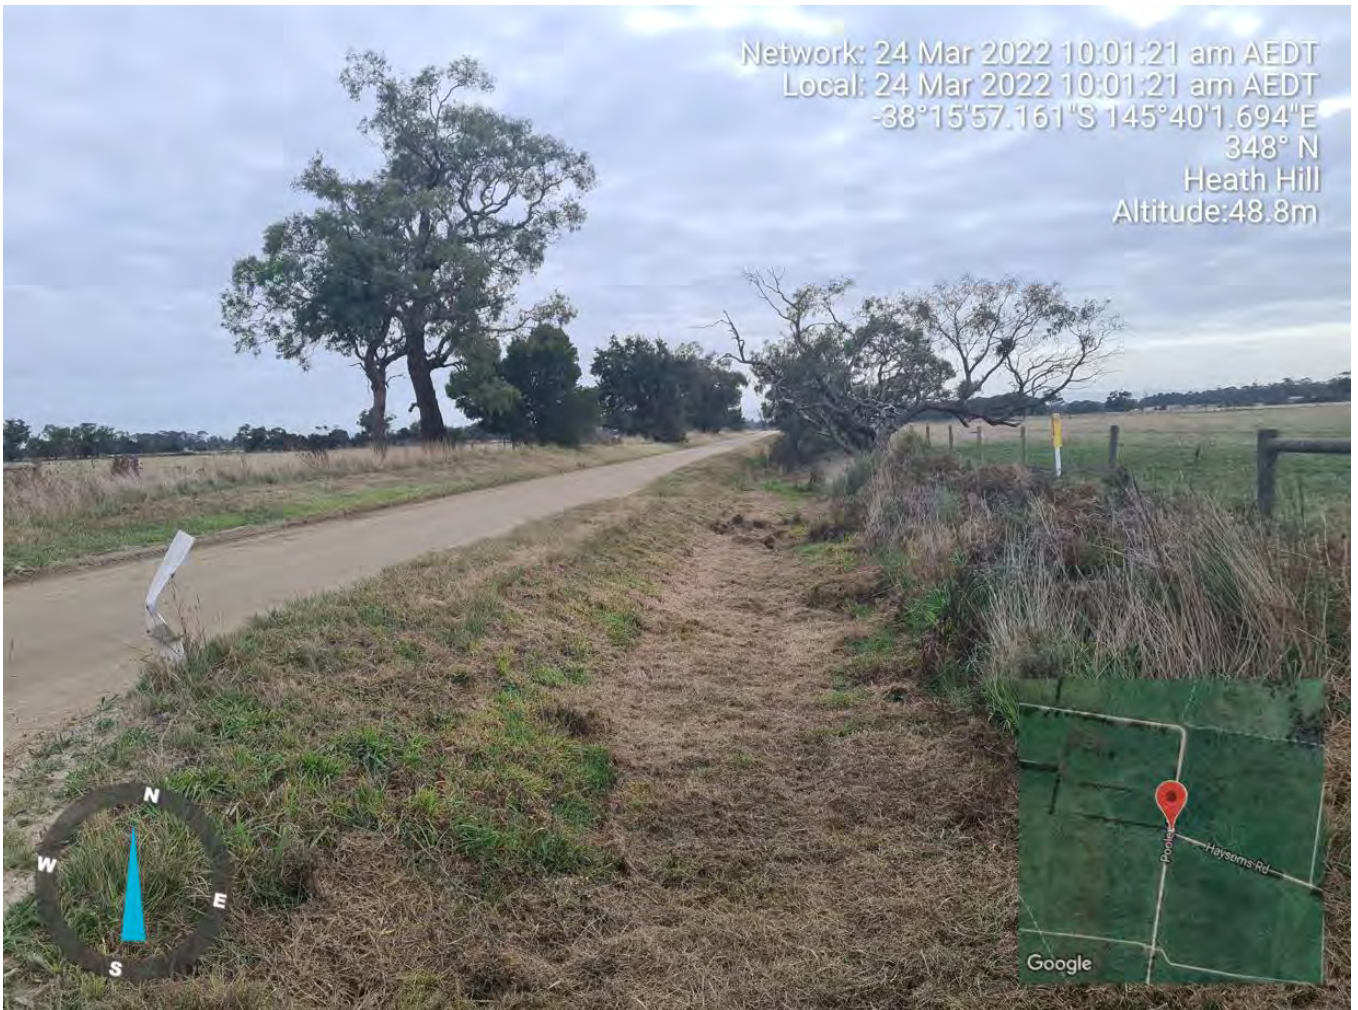
Figure 4-5: Channel along Pooles Road

A site investigation was undertaken by Engeny on 24 March 2022 to validate whether surface water upstream of Pooles Road, to the east, would be directed towards the quarry site or diverted north along Pooles Road. The findings of the site investigation confirmed embankments on both the eastern and western side of Pooles Road, for the entire length of the road that direct flows towards a channel on the east side of Pooles Road at the intersection of Pooles Road and Haysoms Road as shown in Figure 4-5.

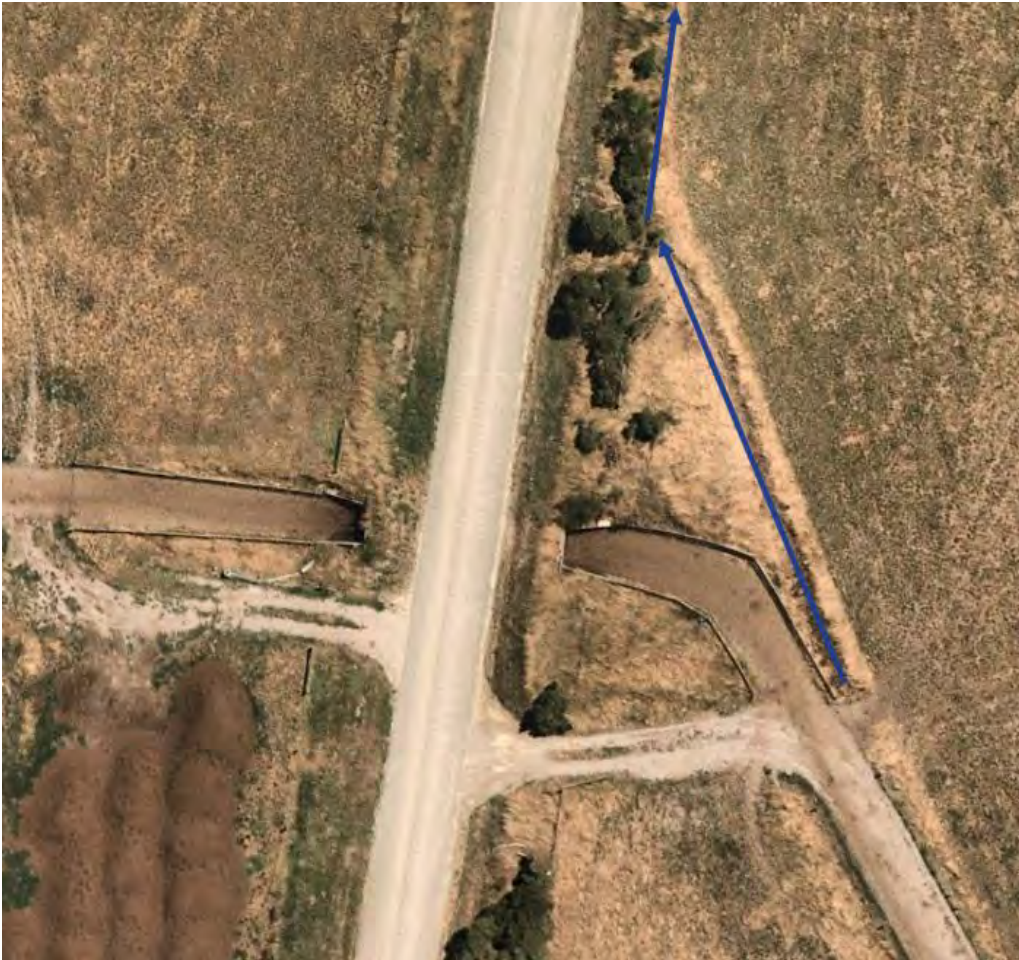
Figure 4-7: Cattle Crossing

A cattle crossing was found that crosses Pooles Road, south of Haysoms Road, however a diversion channel was observed at the upstream end of the crossing, that directs flow along the western embankment and towards Haysoms Road. Refer to for diversion channel location.

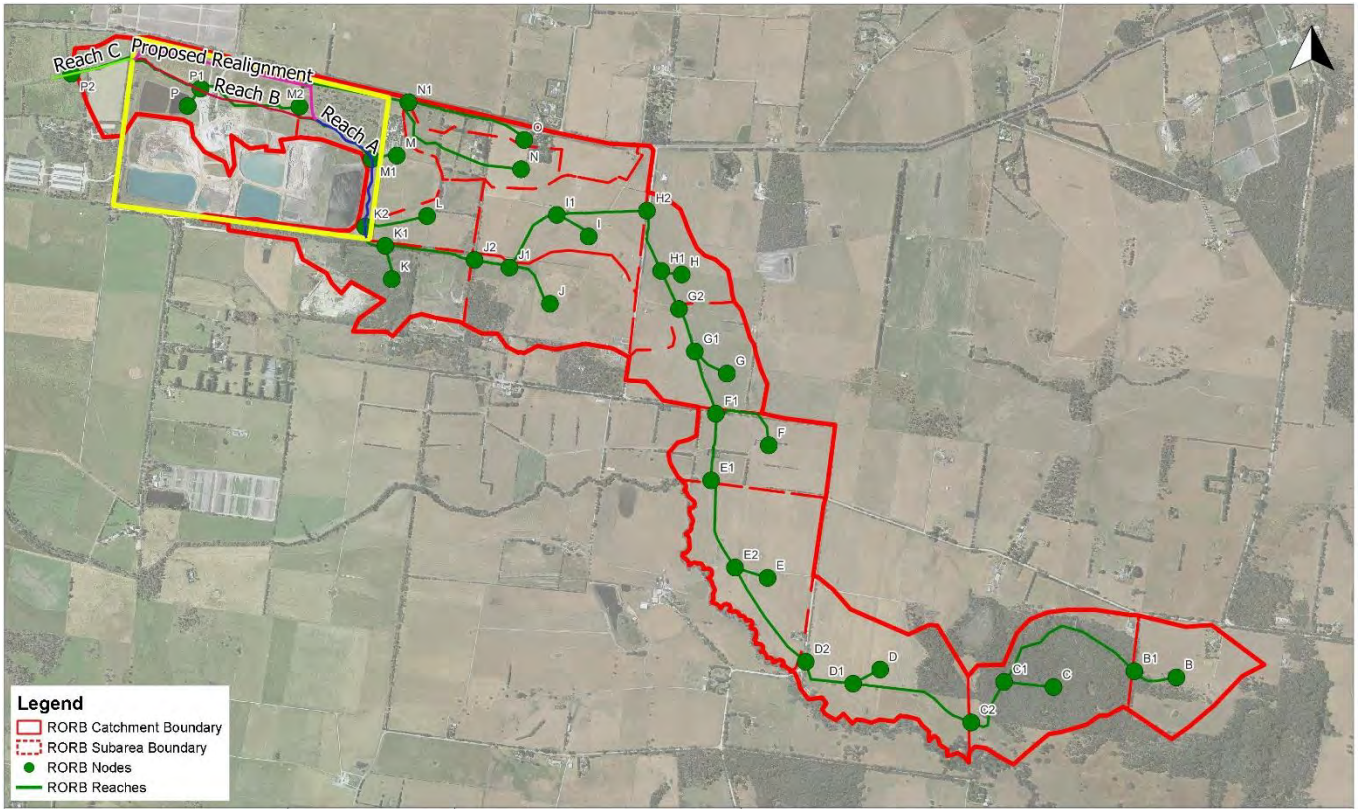
Figure 4-8: Adopted Yannathan RORB model layout

Figure 4-8 shows the adopted RORB model catchment layout including the additional catchment area to the east of Pooles Road.

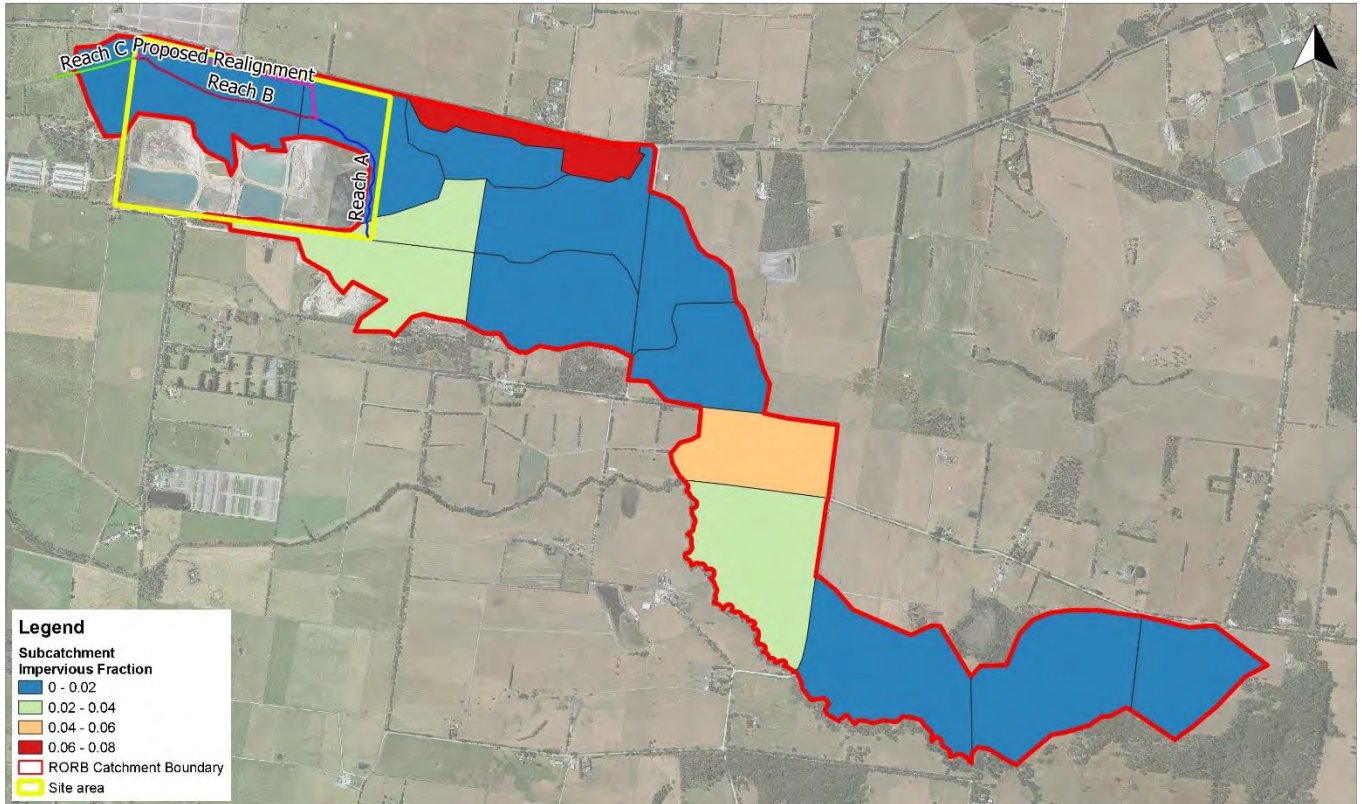
Figure 4-9: Yannathan RORB Fraction Impervious

The impervious fraction (FI) values were assigned at a parcel scale based on the recommended values for different planning zones and allotment size (Melbourne Water MUSIC Guidelines, 2018 and Melbourne Water Technical Specifications, September 2019). A visual assessment of these initial values was undertaken, and values were adjusted to better reflect the extent of current development and land use (defined by Modella 2018 DELWP aerial dataset) across the study area. Figure 4-9 displays the fraction impervious adopted across the study area.

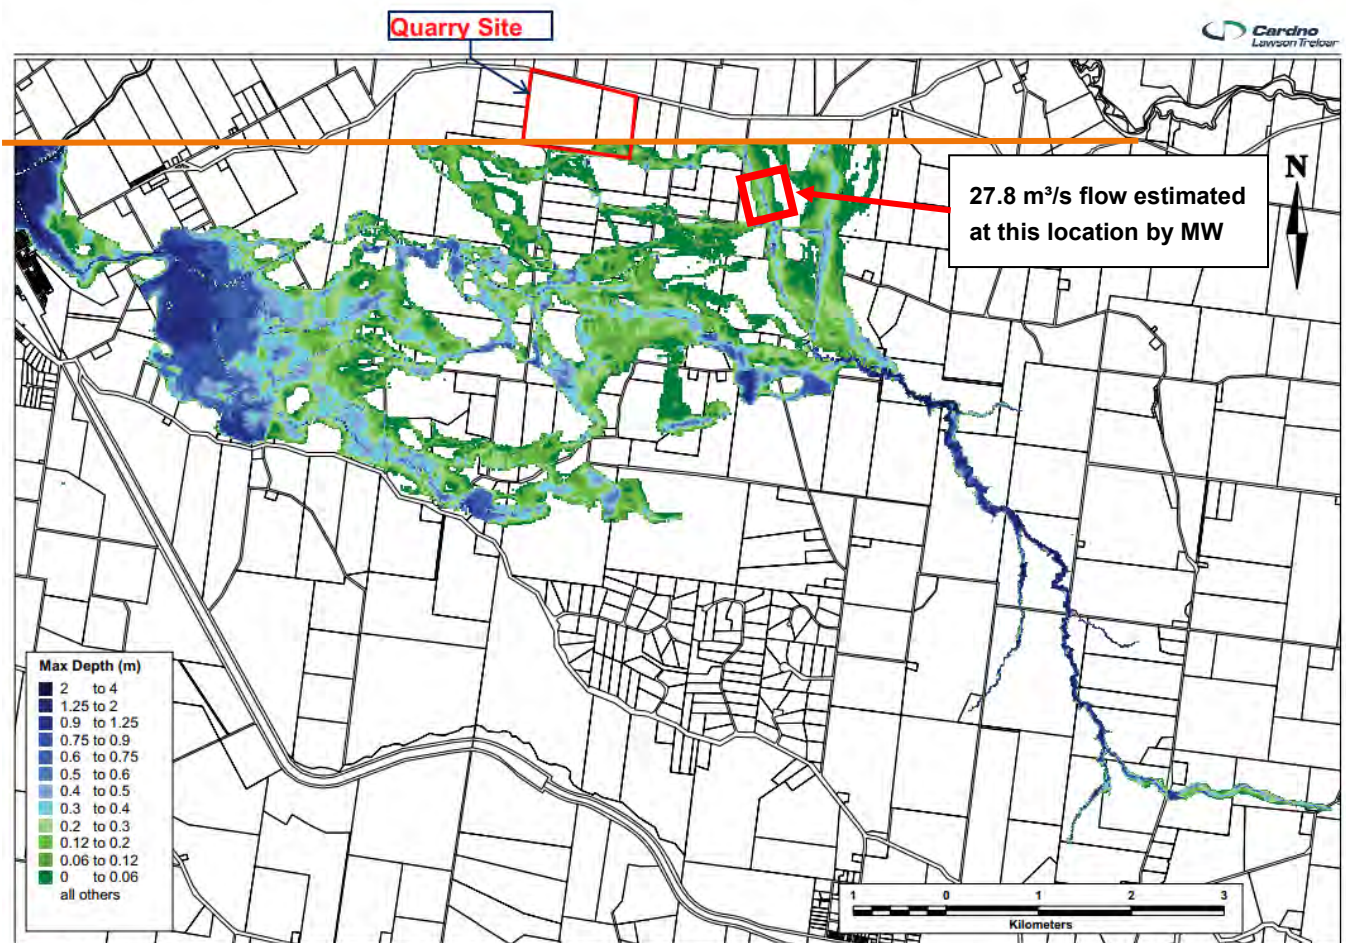
Figure 5 - Maximum flood depth for the 100-year ARI for the Little Lang Lang catchment

As per Melbourne Water correspondence and the ATC Williams report, a flow of 27.8 m³/s has been adopted in the HECRAS modelling. Figure 4-10 shows the flood modelling results provided by Melbourne Water for the 1 % AEP event.

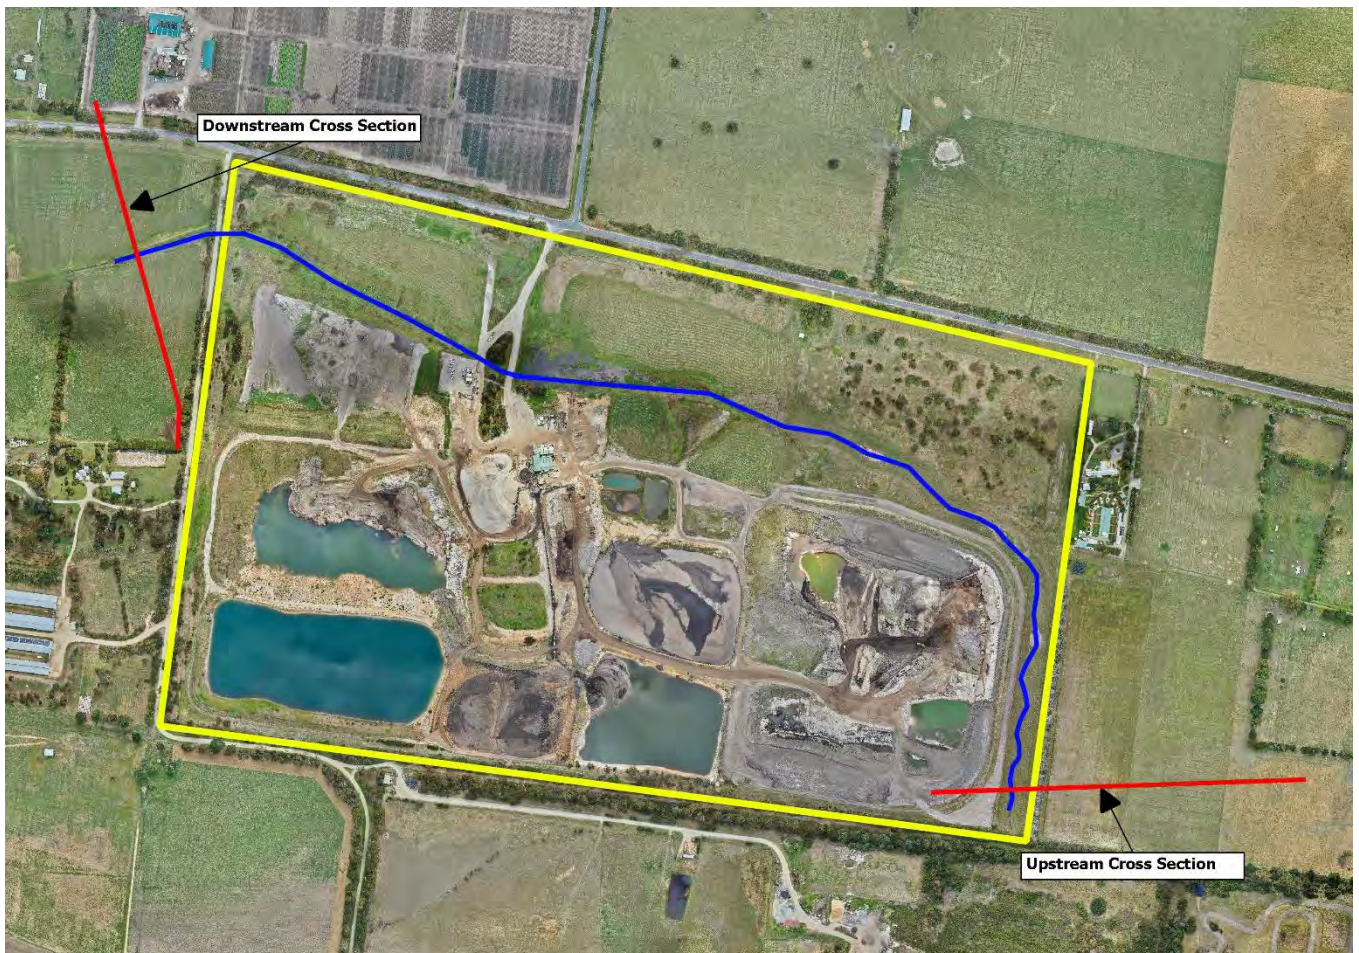
Figure 5-1: HECRAS Model Extents

The HECRAS model extents are from the south-east boundary of the quarry site at the upstream end to approximately 150 metres west of Milners road at the downstream end, past the north-west boundary of the quarry site (Figure 5-1). A summary of the parameters used for the existing conditions and design conditions modelling is shown on Table 5-1.

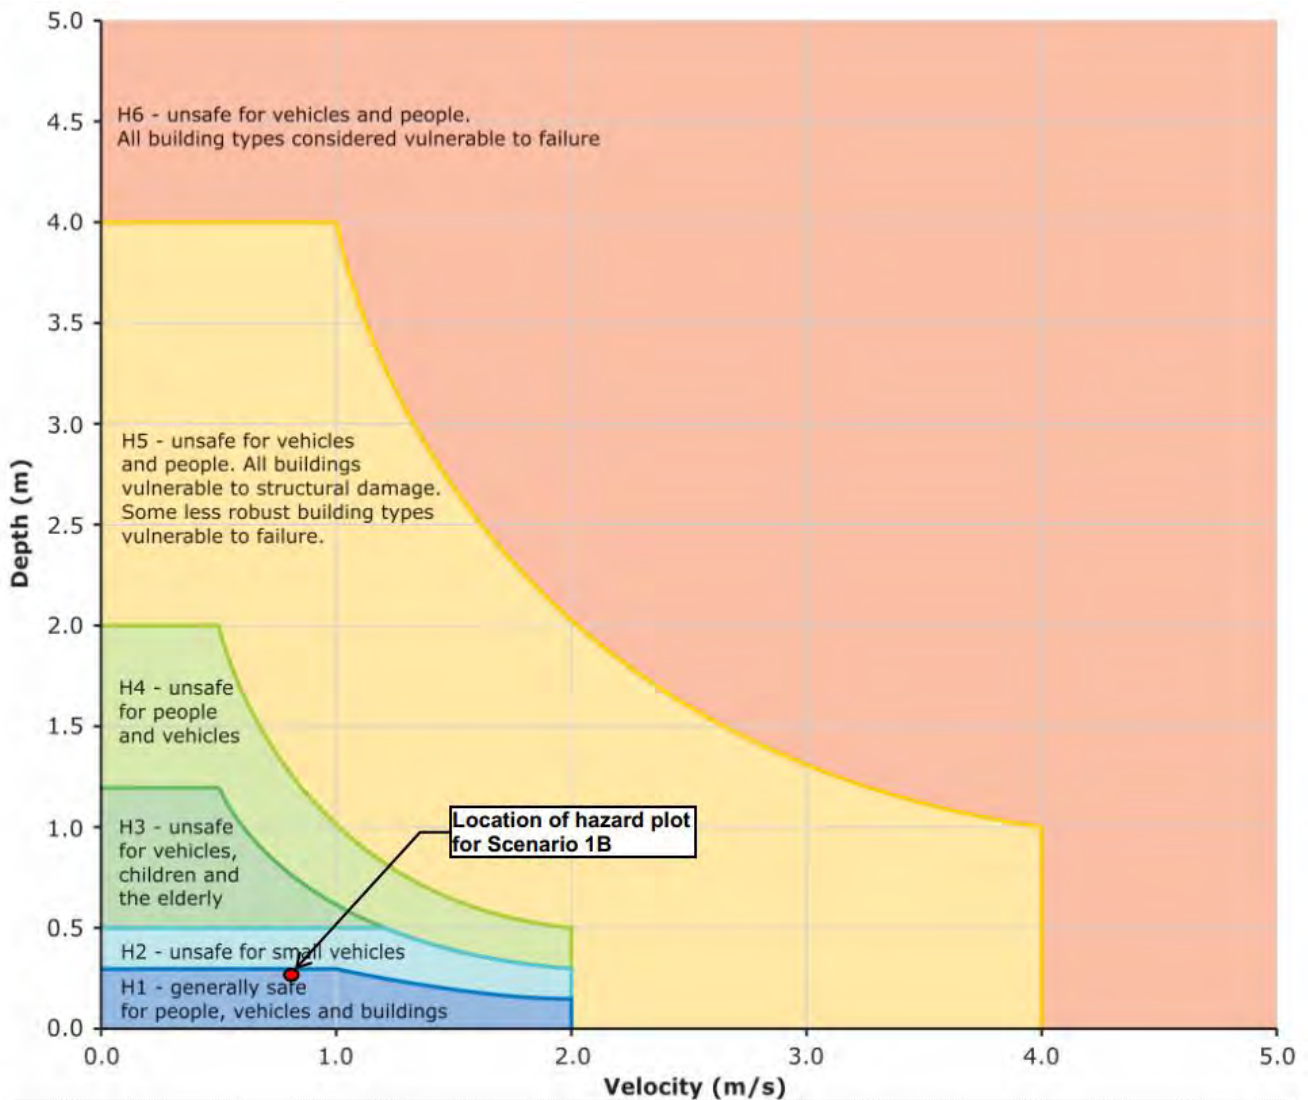
Figure 5-2: Flood Hazard Curve

The proposed five (5) 600 mm (wide) by 450 mm (high) box culverts on the quarry site, underneath the existing access road exhibits an overtopping depth of 0.30 metres in scenario 1B. Based on the ARR 2019 guidelines for flood hazard assessment, as shown in Figure 5-2, a hazard rating of H1 is generally safe for people, vehicles and buildings. For scenario 1B, the overtopping velocity multiplied by the overtopping depth ($V \times D$) is $0.25 \text{ m}^2/\text{s}$. This is within the H1 category and therefore meets Melbourne Water’s Floodway Safety Criteria requirements.

In Scenario 2, existing conditions, based on the capacity of the culverts under the access road and the existing waterway capacity, the expected depth and velocity of overtopping are 0.88 m and 0.19 m/s respectively resulting in a hazard rating of H3 which is classified as unsafe for people and vehicles.

Under Scenario 2 design conditions, there is a more significant overtopping of the access road into the site compared to scenario 1. The expected depth and velocity of the overtopping are **0.65 m** and **1.28 m/s**, where the overtopping velocity multiplied by the overtopping depth ($V \times D$) is $0.83 \text{ m}^2/\text{s}$. This corresponds to a hazard category of H4. This exceeds Melbourne Water’s recommended safety criteria for overtopping. The value quoted for the peak hazard rating is at the peak of the flood event, so there would be a significant portion of the flood event where the access path would still meet Melbourne Water’s safety criteria. There is also an alternative access route out of the site to the south onto Burt Road which could be used in the event of an emergency to evacuate the site. Safety considerations should also be made during the detailed design of the culvert crossing to

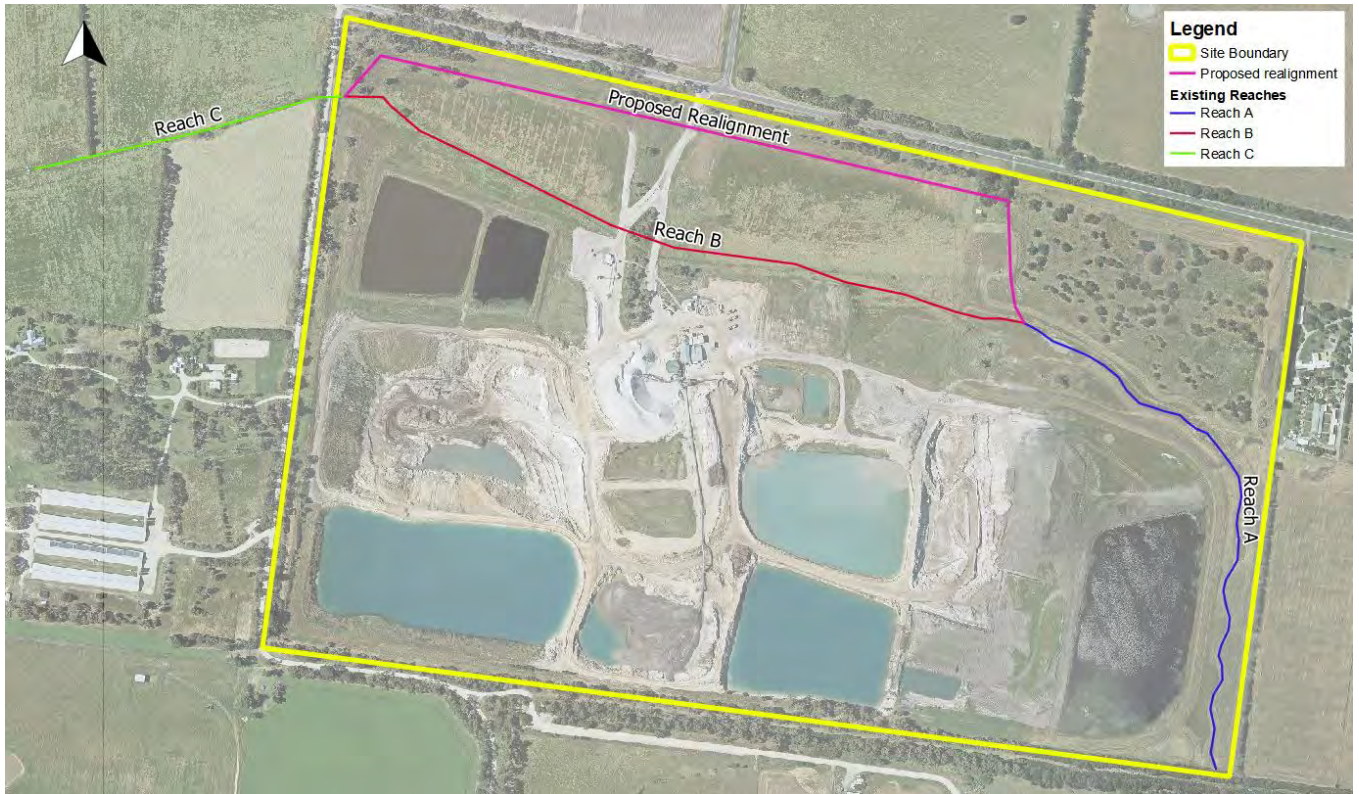
Figure 7-1: Site Waterway Reaches

In 2021 Engeny undertook a geomorphic assessment of the current and proposed waterway through the quarry site. A full copy of the report is contained within Appendix C. Figure 7-1 shows the waterway locations and the reach (segments) breakdowns which was used in the assessment.

Reach	Condition	Justification
Reach A	Moderate	Reach has some bank instability, and limited habitat diversity. some lateral connectivity value. Reach form partly impacted by land use activities.
Reach B	Poor	Reach form impacted by land use activities, little to no geomorphic characteristics, limited instream habitat value, no erosion, limited riparian vegetation, some lateral connectivity value, dense homogenous vegetation, no marked erosion noted
Reach C	Poor	Little to no geomorphic characteristics, limited instream habitat value, no erosion.

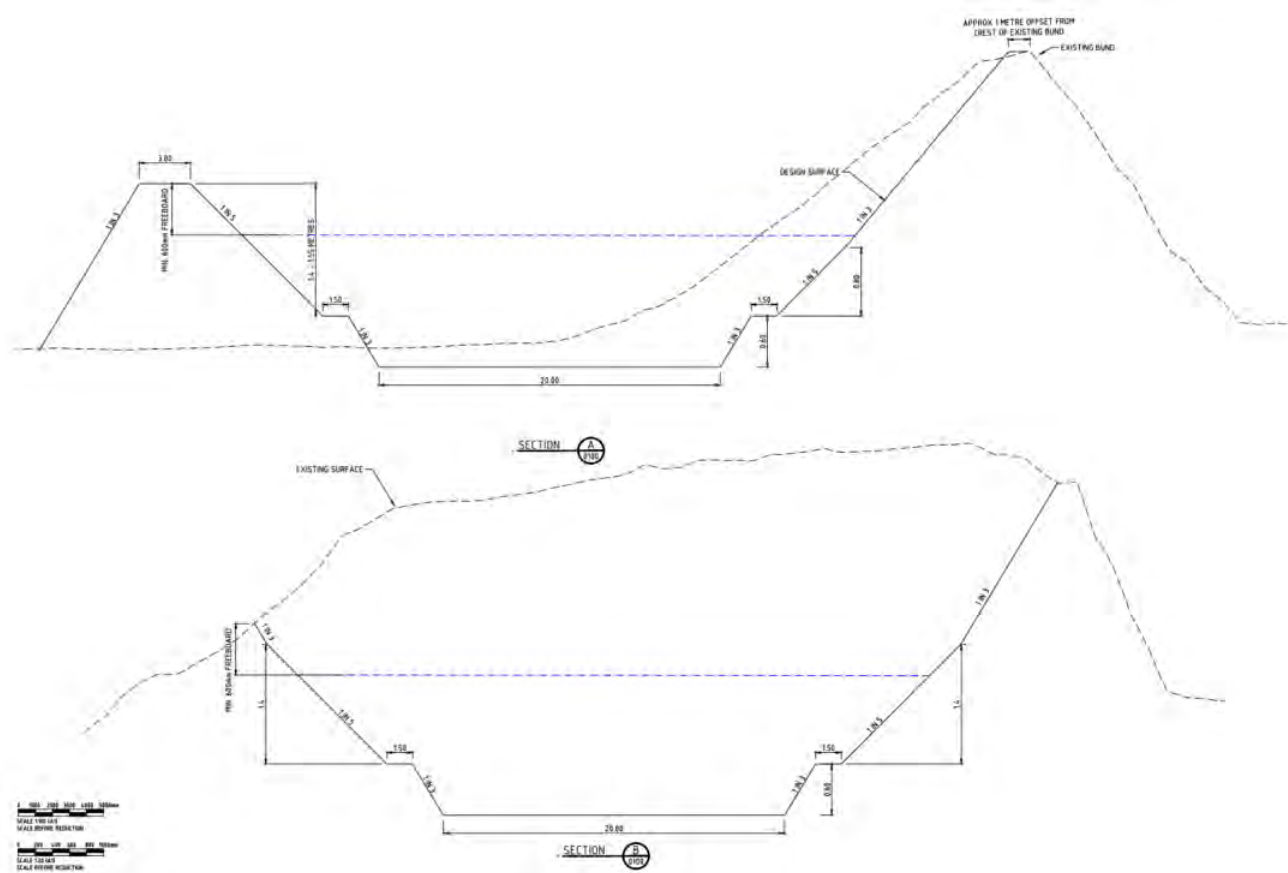
Figure 4.2: Re-aligned Channel – Typical Cross Section

A typical cross section profile has been provided in Figure 4.2 which shows that the channel is in cut and utilises the existing visual screening bund (northern bund) and proposes a new bund to the south of the realigned channel to contain the 1 % AEP peak flow.
