Appendix G: Existing Conditions HEC-RAS Longitudinal Section and Cross Sections

Appendix H: Design Conditions HEC-RAS Longitudinal Section and Cross Sections

Hanson Construction Materials is preparing a Work Plan Variation to expand their quarrying operations towards the northern boundary of their sand quarry located at 870-910 Westernport Road in Yannathan (Figure 1-1). There is an existing drainage channel (identified by Melbourne Water as Creek 2412) within the location of the proposed expansion, as shown in blue in Figure 1-1. The expansion will require the realignment of the existing channel towards the northern boundary of the site as shown indicatively by the red line in Figure 1-1.

Concept Design of Proposed Channel

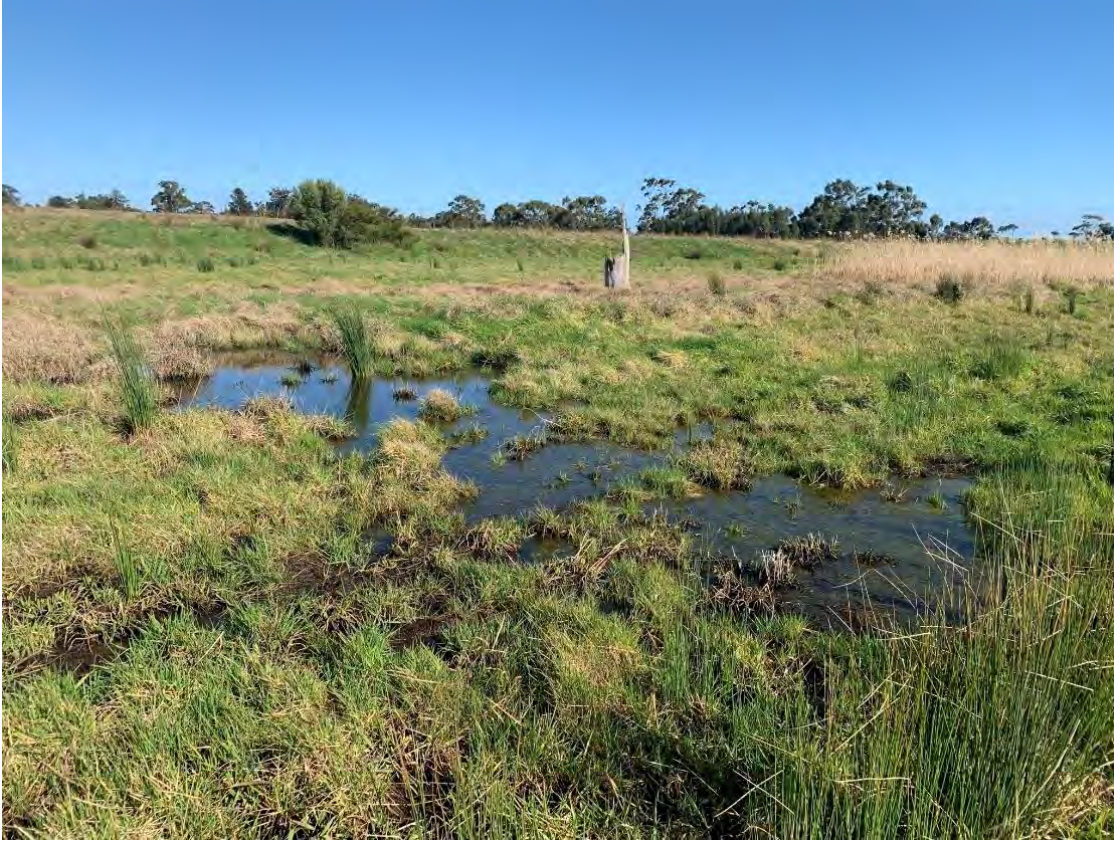
Figure 2-3: Channel at Reach B flows on broad floodplain

The in-channel vegetation is thick, spreading across the channel at various sections (Figure 2-3). Some ponding was observed along this reach of the waterway (Figure 2-4). Isolated areas of localised ponding likely formed after a storm event were observed along the length of the reach east of the access road leading to the upstream end of Reach B.

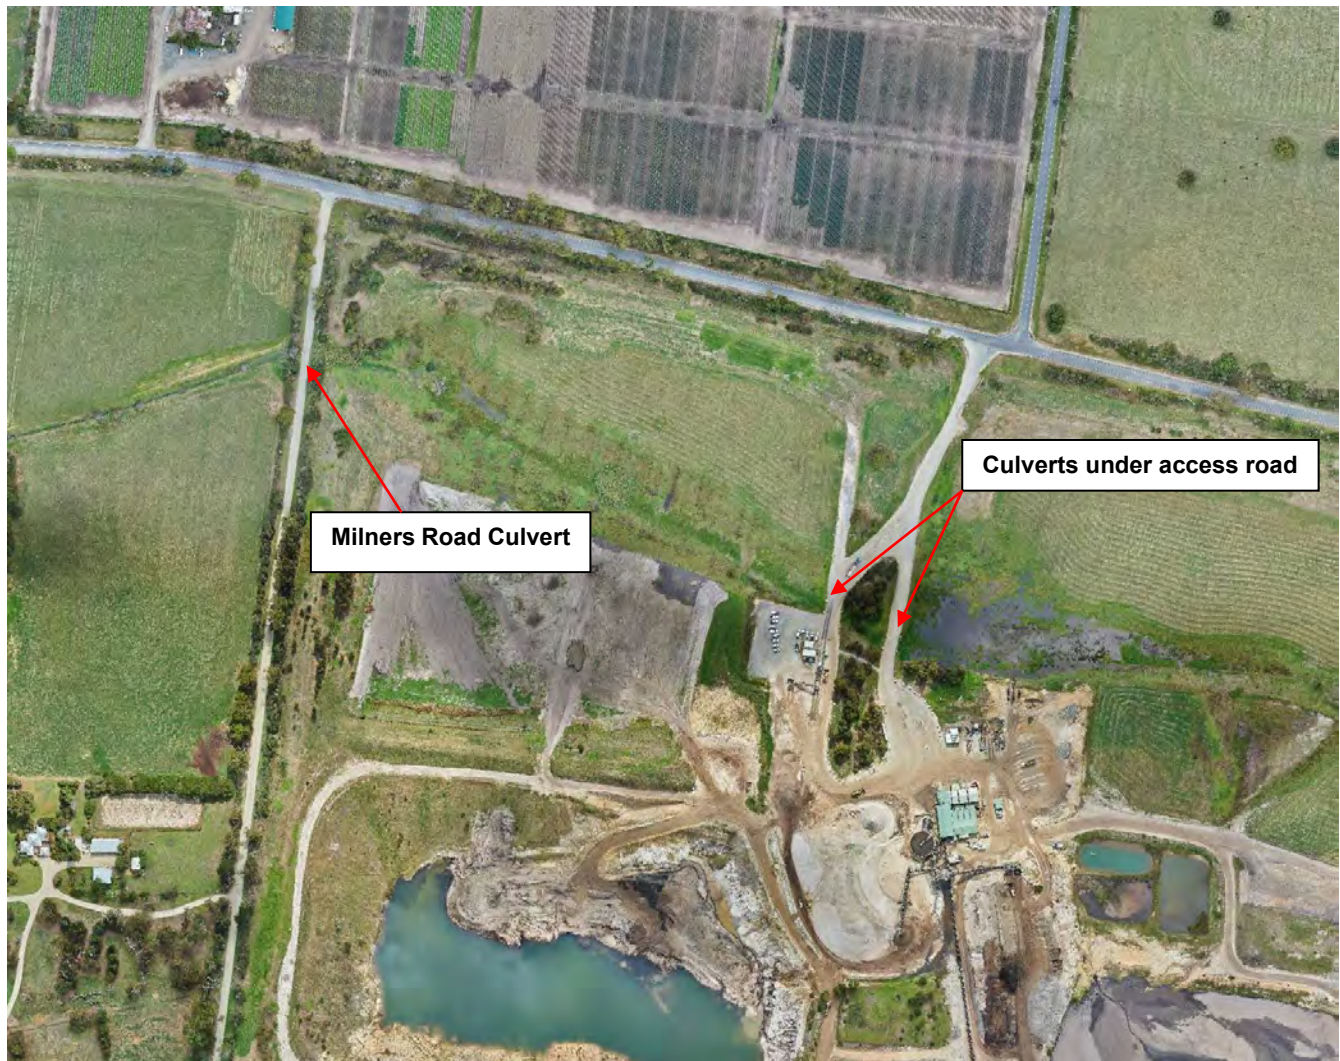
Figure 2-5: Existing Culvert Crossing Locations

Additionally, Hanson have confirmed that the box culvert at Milners Road has dimensions of 1200 mm wide and 500 mm high. This culvert has also been included in the hydraulic model.

Refer to Figure 2-5 for existing culvert crossing locations.

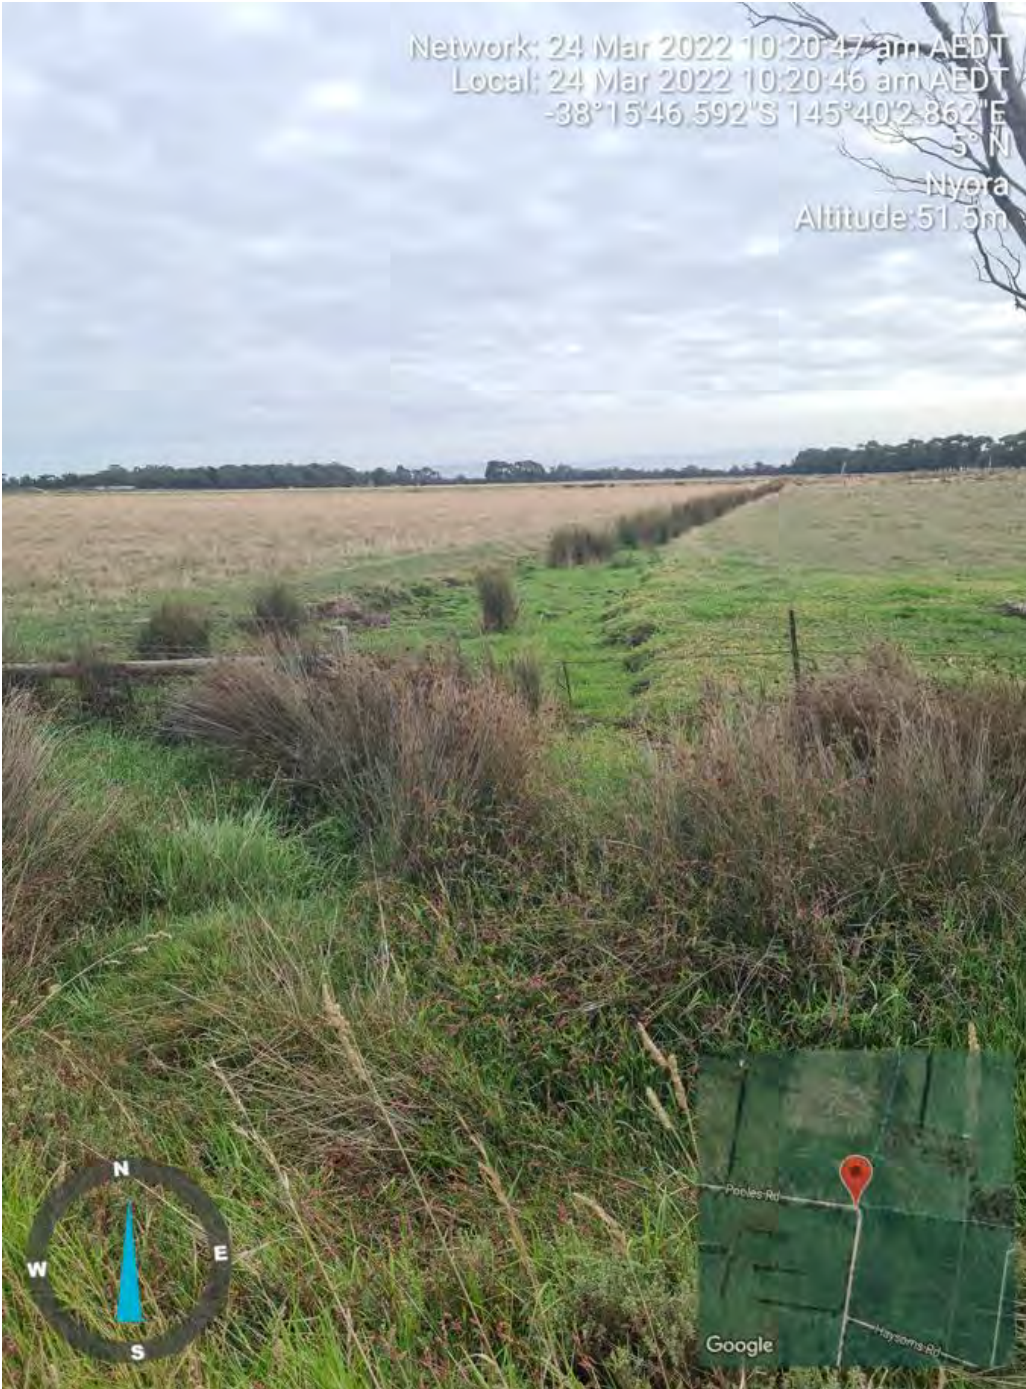
Figure 4-6: Channel towards Westernport Road

This channel runs north, along the eastern side of Pooles Road and directs flow north, towards Westernport Road as shown in Figure 4-6.

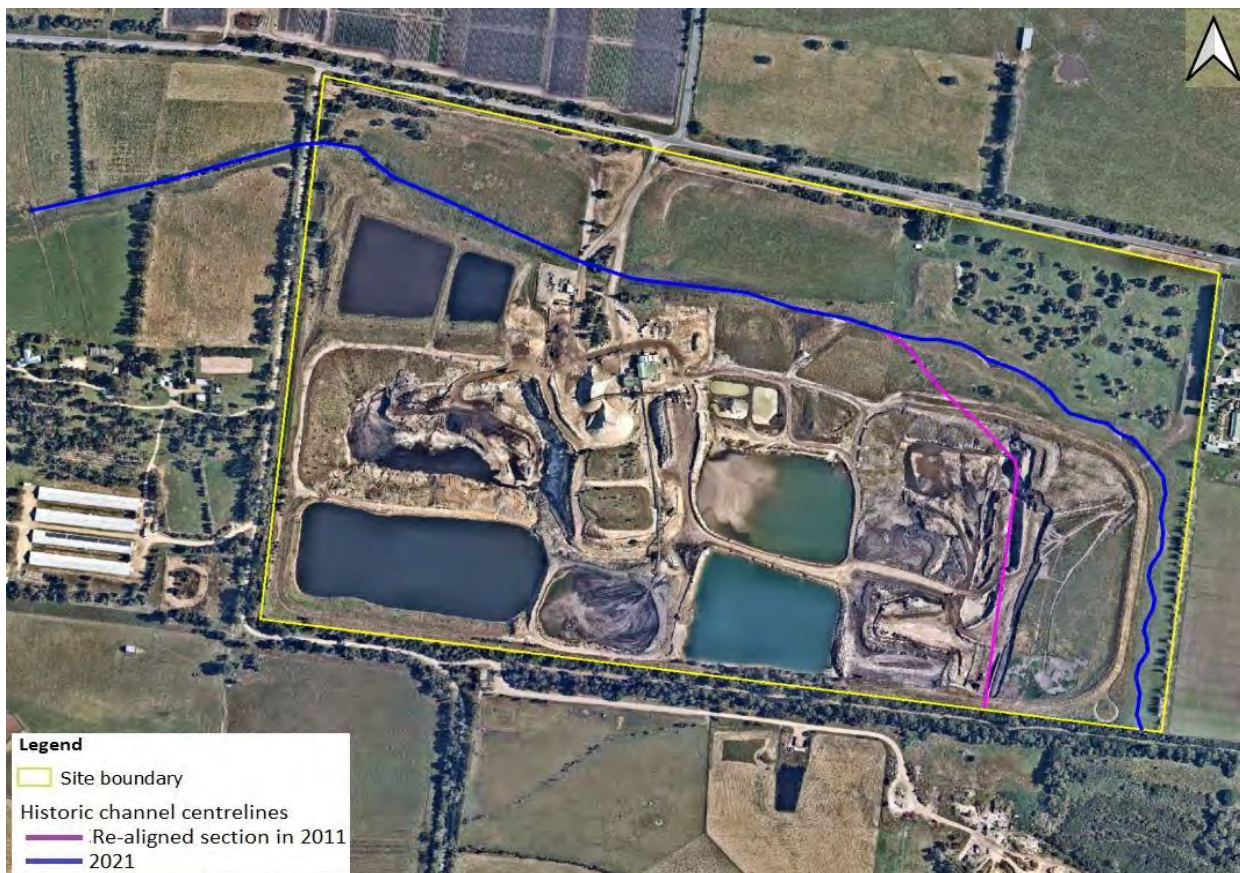
Figure 2.1: Site overview

The drainage channel traverses the site from the eastern boundary towards the northern edge of the existing quarry operations and exits at the western boundary. The upstream section of the waterway has been previously re-aligned in 2011 as shown in Figure 2.1 to allow for quarry works expansion towards the eastern boundary at that point in time.

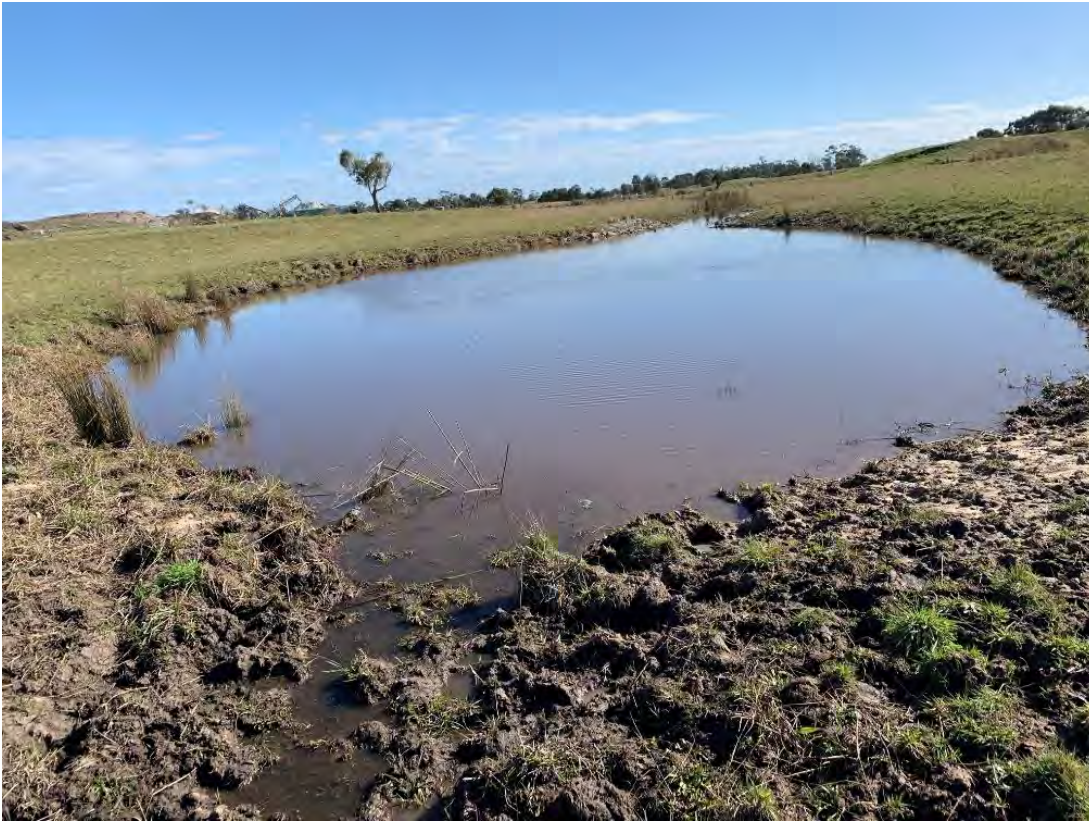
Figure 3.4: Typical chain of ponds at Reach A showing signs of bank instability

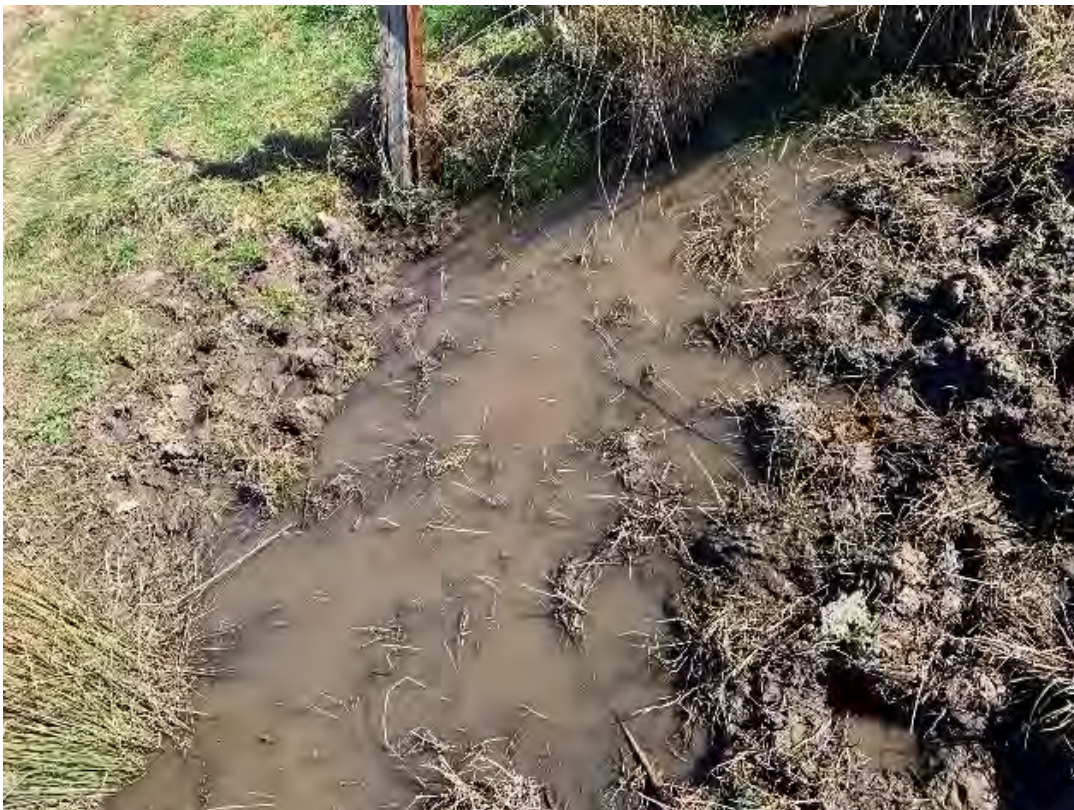
Figure 3.5: Localised areas of bank instability at Reach B

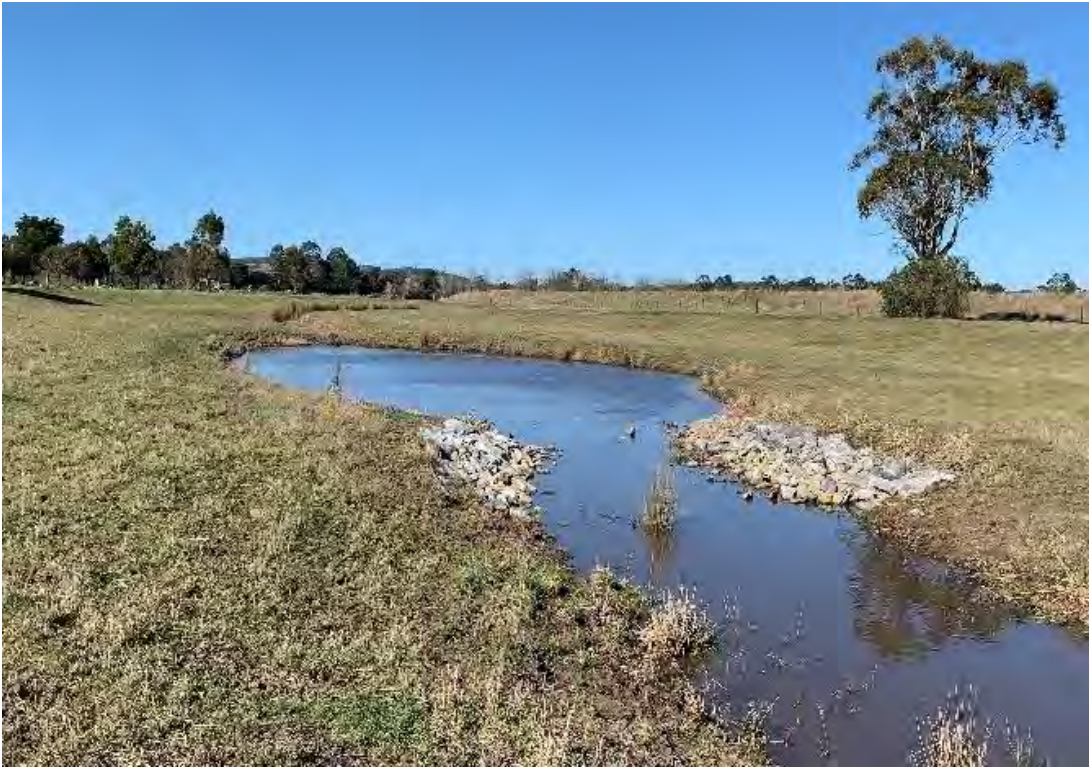
Figure 3.6: Pools sections at Reach A with rockwork

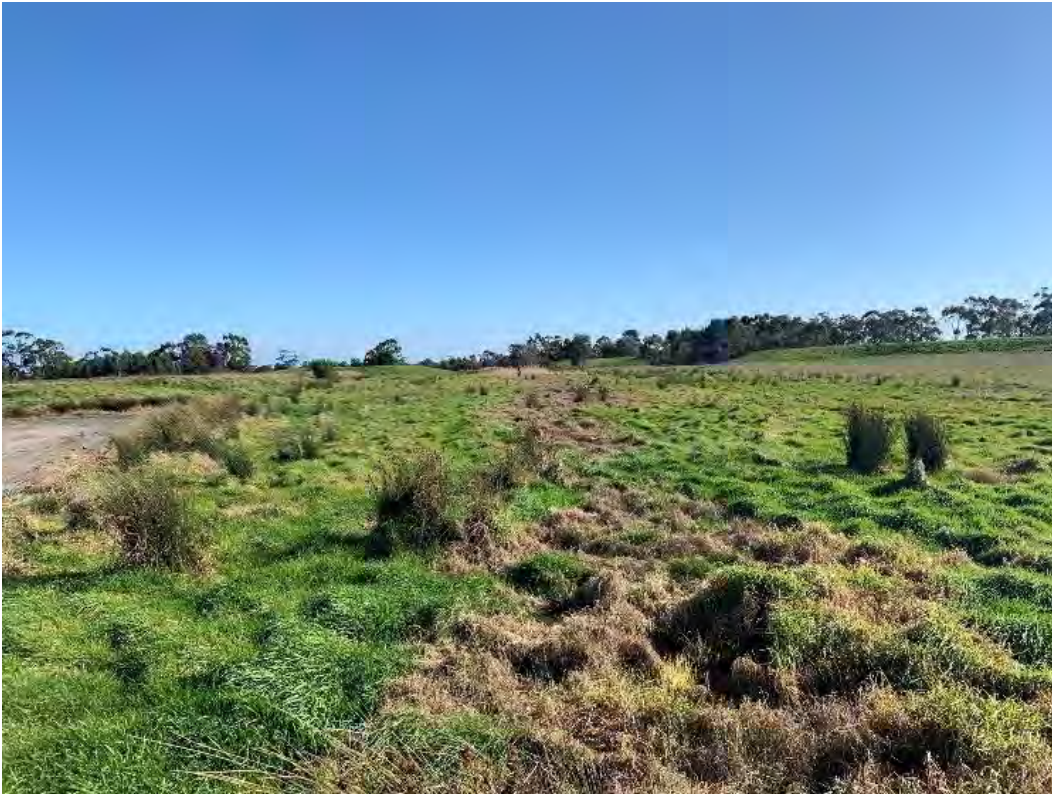
Figure 3.8: Reach B with no clearly defined channel

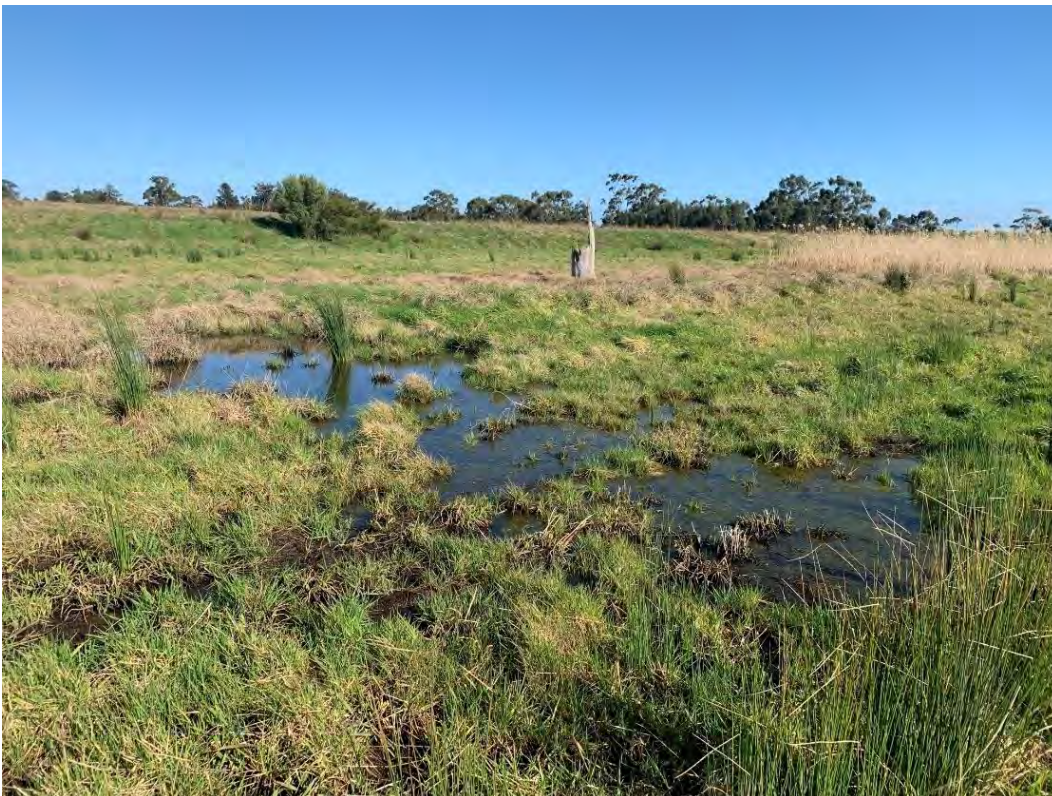
Figure 3.9: Channel at Reach B flows on broad floodplain (no defined channel)

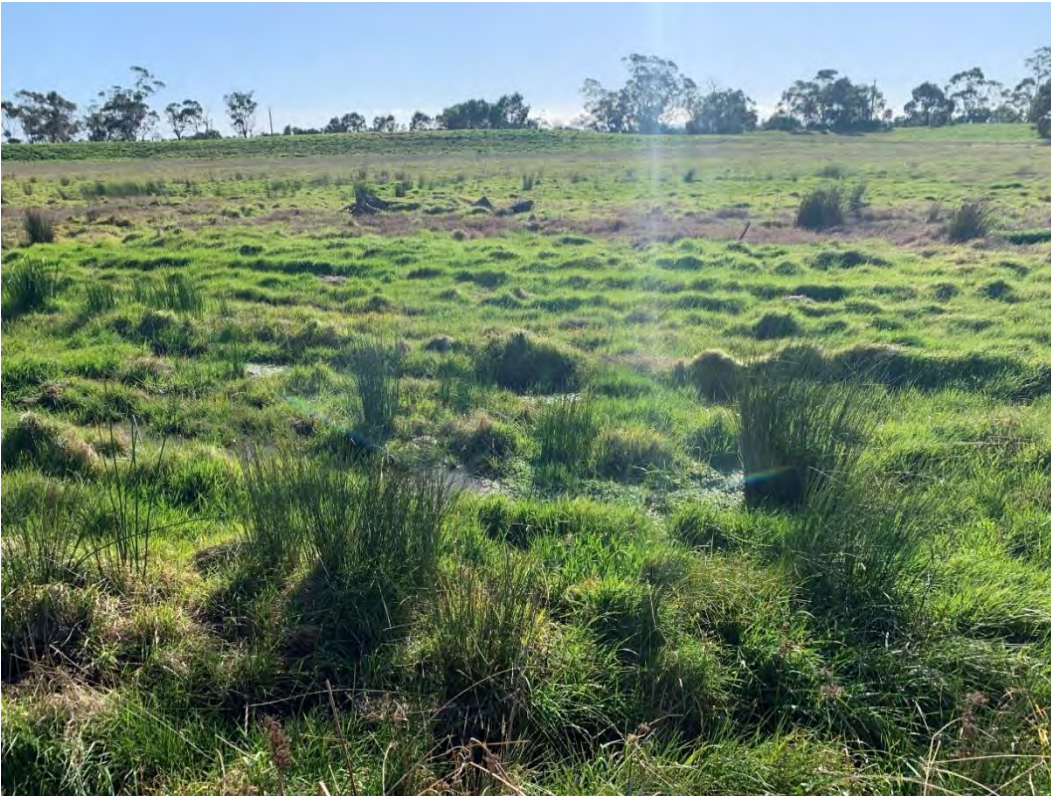
Figure 3.10: Channel at Reach B with excessive pasture grass growth filling the channel

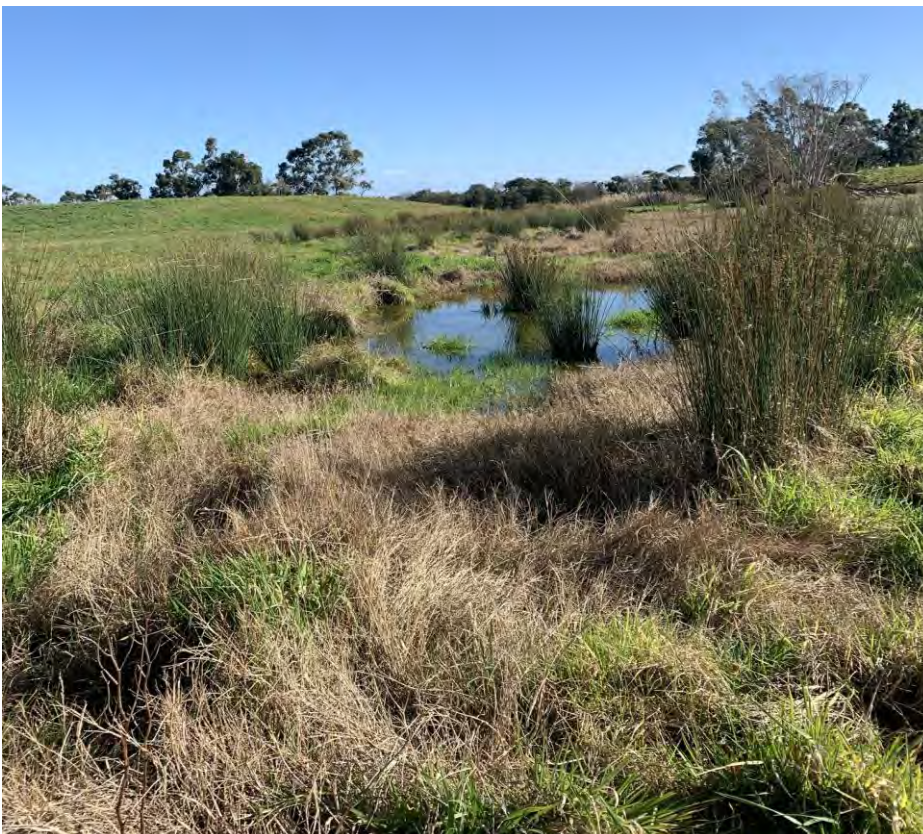
Figure 3.13: Areas of chain of ponds created in channel separated by dense vegetation (Reach B)

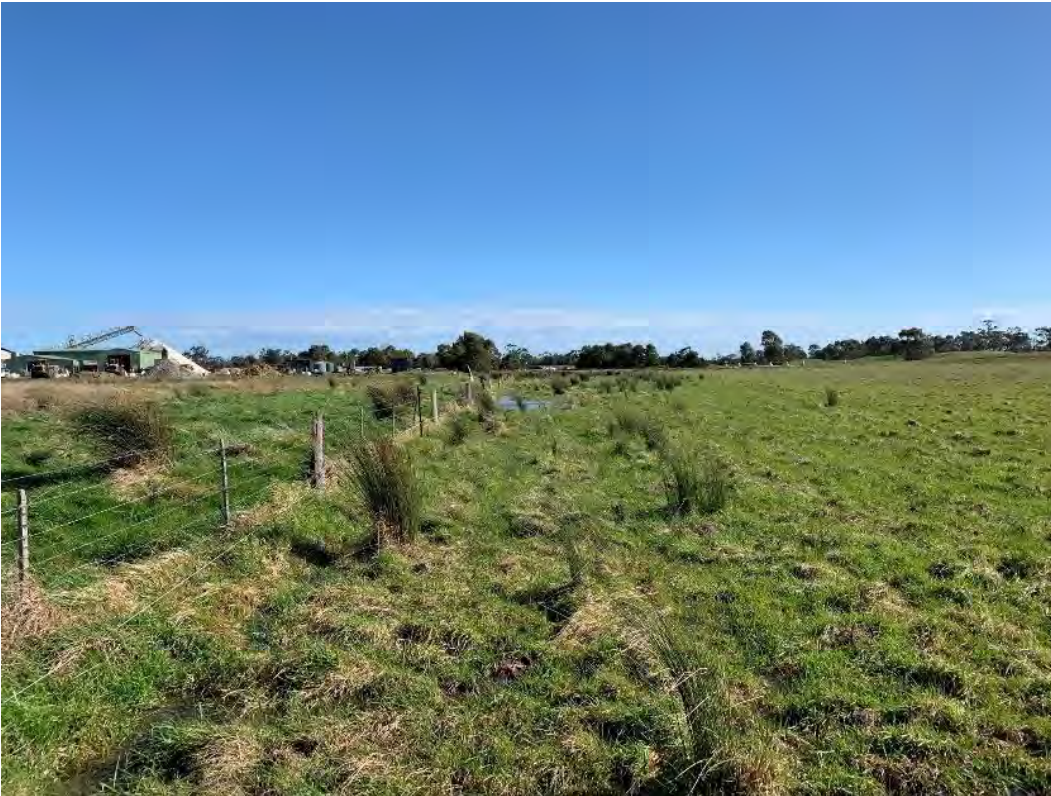
Figure 3.16: In-channel (highly dense) vegetation covers channel depth

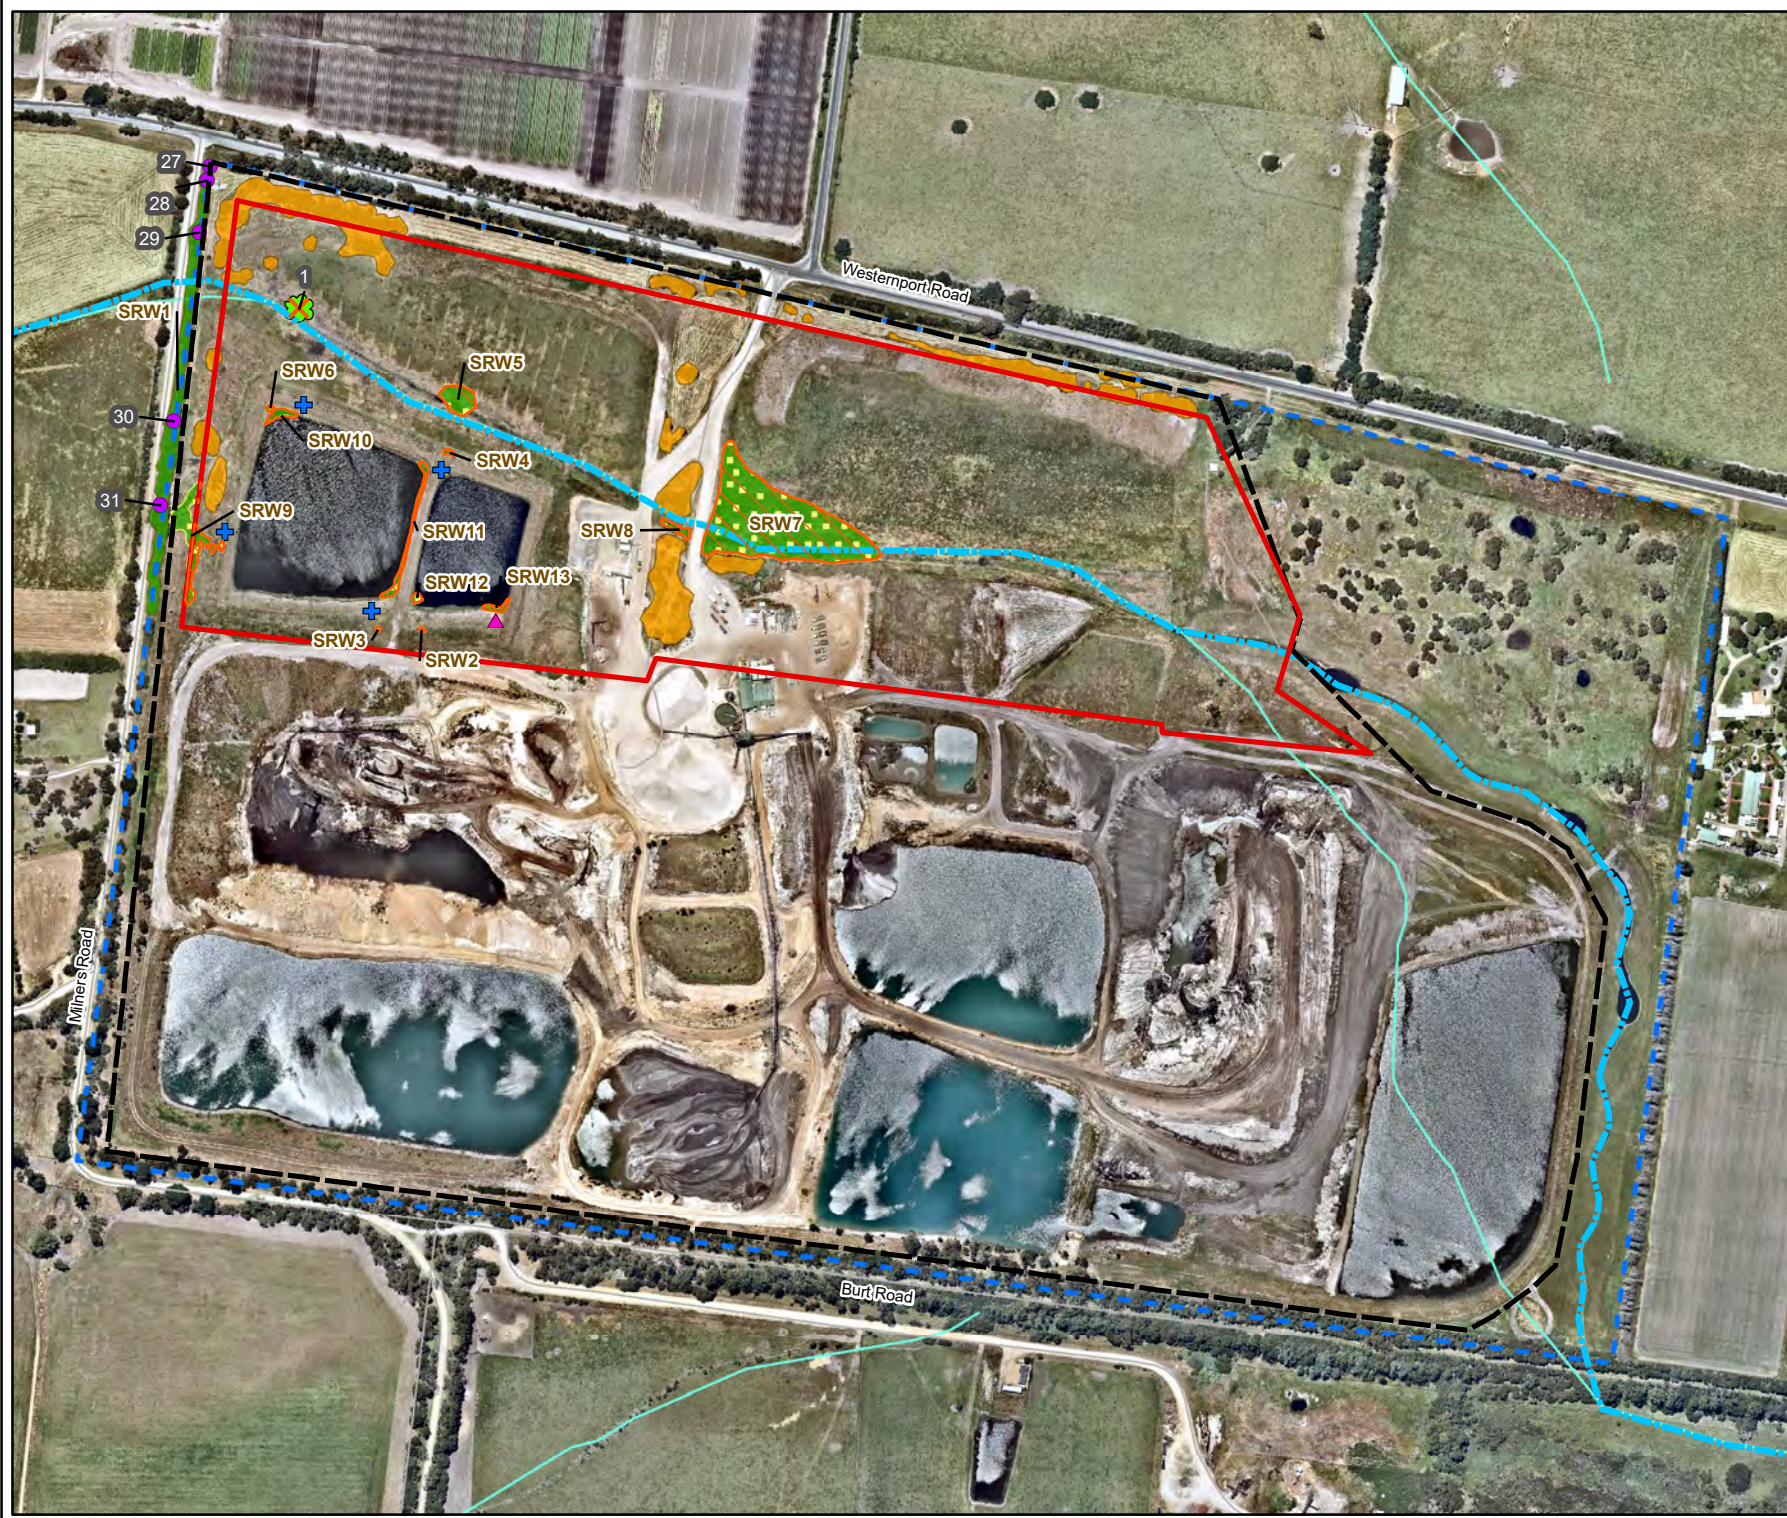
Figure 2
Ecological features
Biodiversity Assessment at Yannathan Quarry

Five Large Trees, comprising four Swamp Gums *Eucalyptus ovata* and one stag, were recorded in the Swampy Riparian Woodland patch located along the western boundary of the study area (Plate 5; Figure 2).

One scattered tree, a large Swamp Gum, was recorded within the study area (Plate 6; Figure 2).

Planted species occurred throughout the study area, with a selection of mixed native shrub species planted around the site office, containing Black Sheoak *Allocasuarina littoralis*, Prickly Tea-tree, Swamp Paperbark *Melaleuca ericifolia* and Blackwood. The location of planted vegetation is shown on Figure 2, which is mainly located on bund walls surrounding the outer edge of the western and northern side of the current study area (Plate 7).

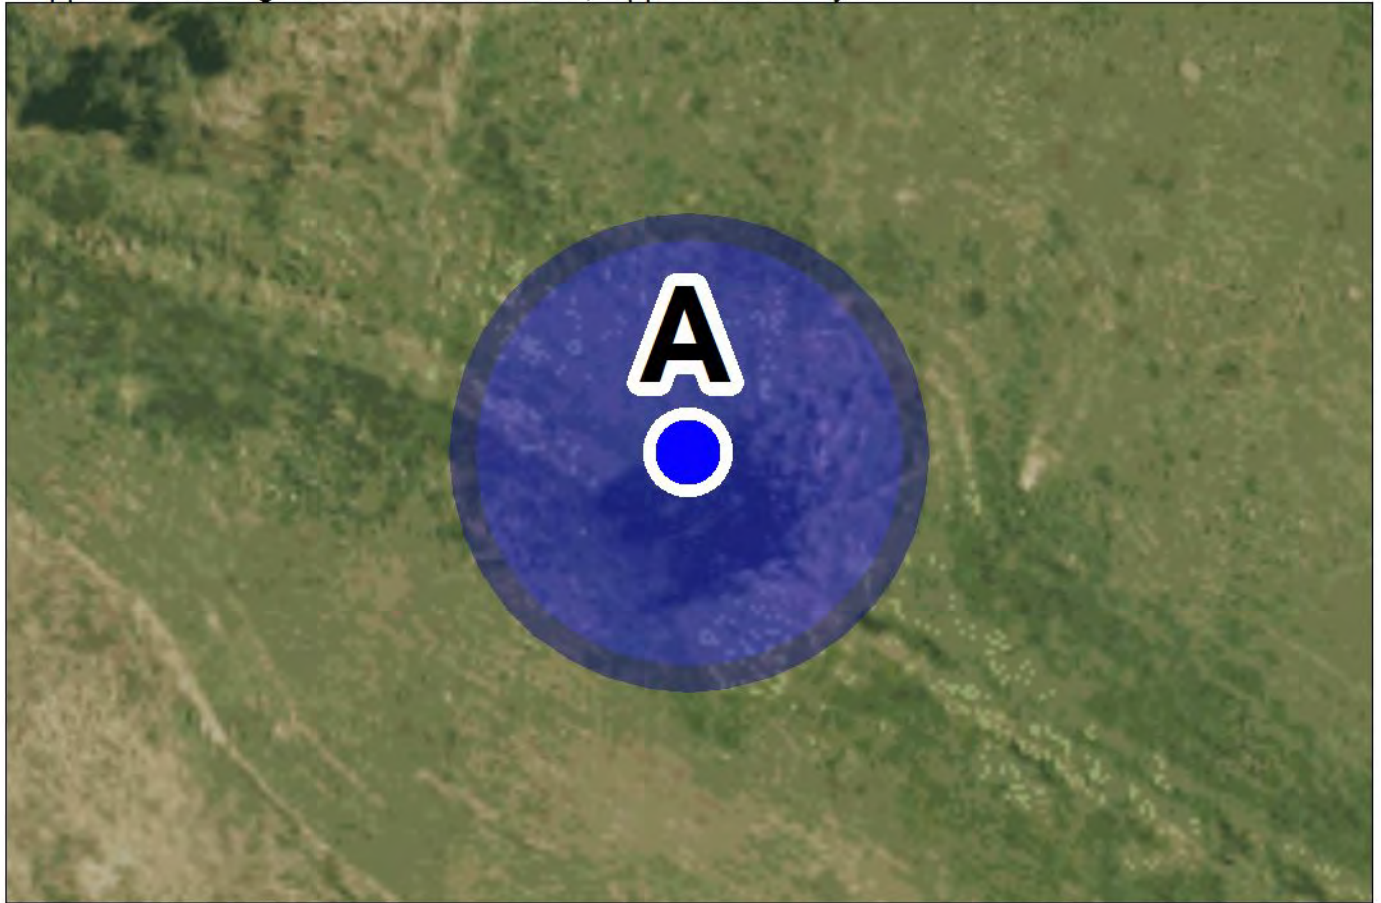
Figure 1 – Map of native vegetation to be removed, destroyed or lopped

Mapped native vegetation to be removed, lopped or destroyed

Additional information about trees to be removed, shown in Figure 1

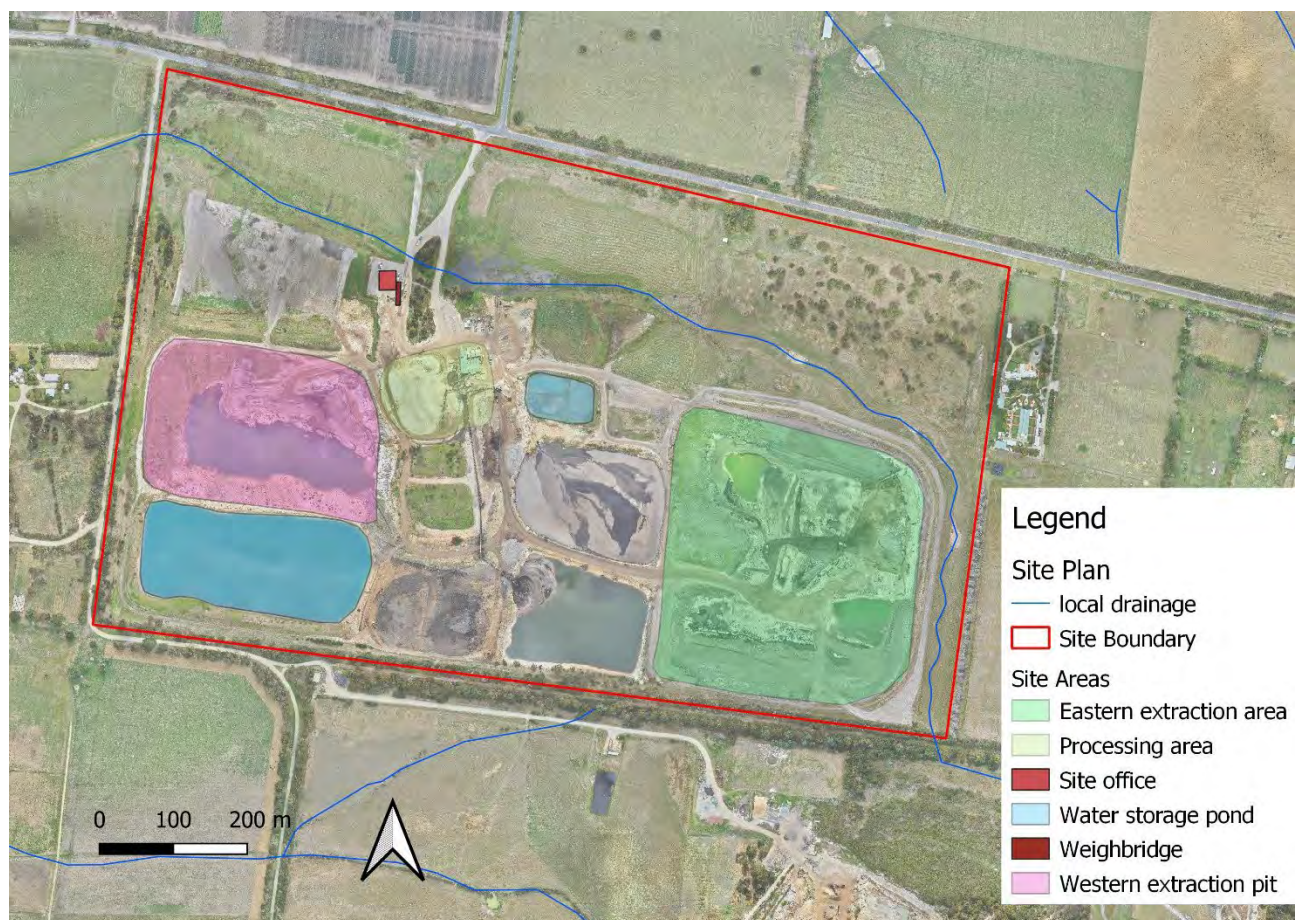
Figure 2-1 Site plan

The existing pits, shown in **Figure 2-1**, are operated using dry quarrying means, with the inflowing water draining to the base of the pit. Water is pumped from the base of the pit to onsite storages for use in sand processing or water storage.

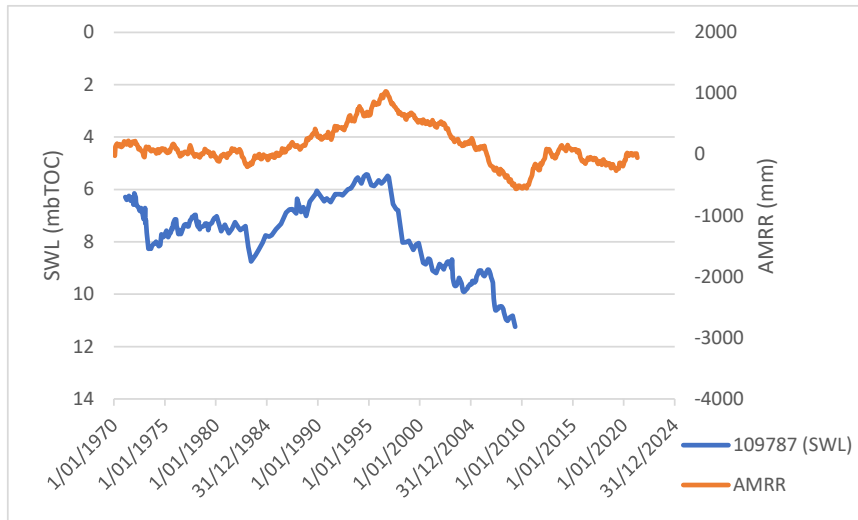
Figure 3-5 SWL Bore 109787 (mbTOC)

Bore 109787 has data from 1970-2009, to the end of the millennium drought. Standing water level at 109787 fluctuates between approximately 6.0 mbTOC and 10.0 mbTOC. Groundwater levels are relatively consistent indicating an absence of local extraction and broadly mirror the AMRR. In this area groundwater levels reflect climatic variability.

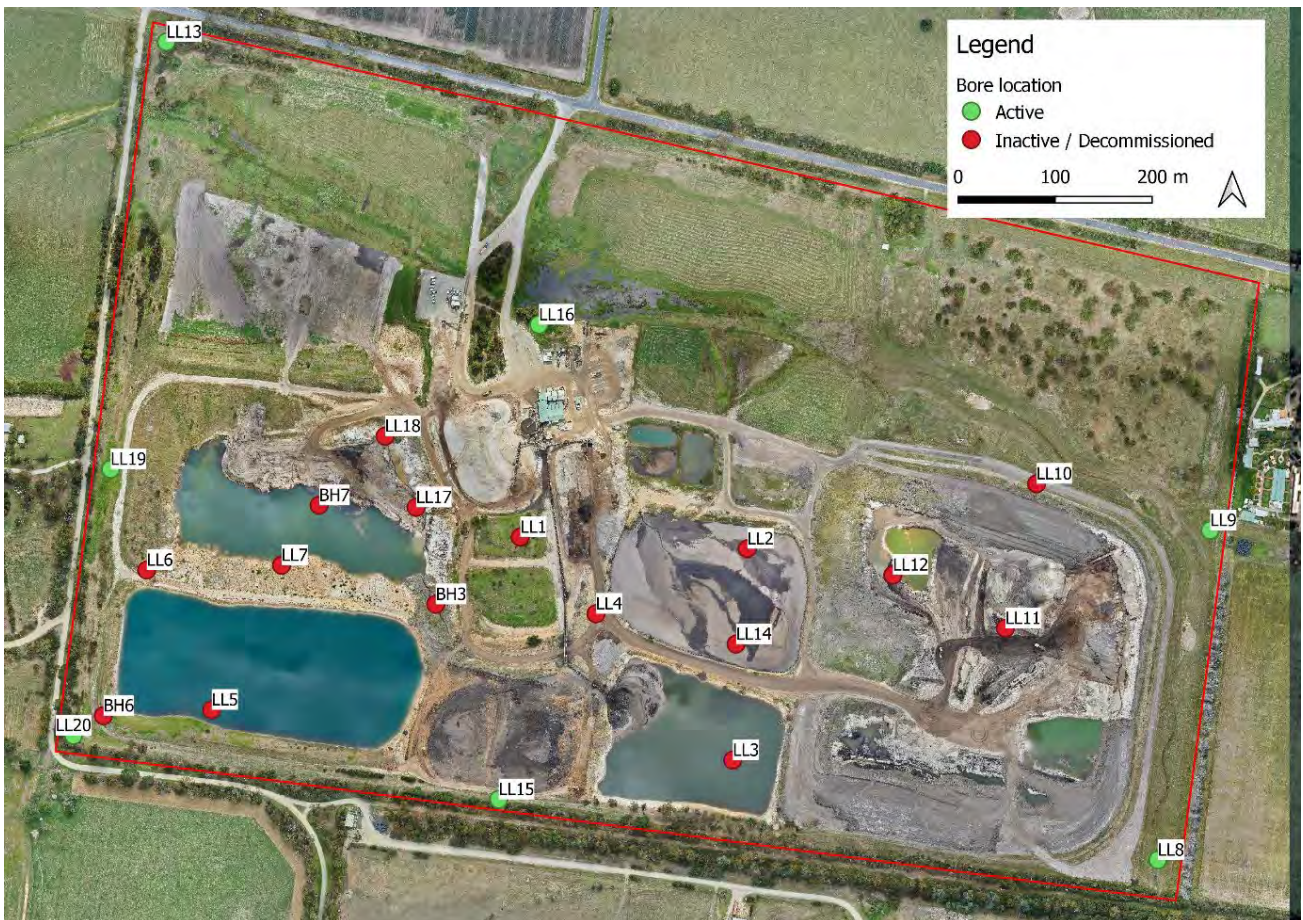
Figure 3-9 Site monitoring bores

The groundwater monitoring network is shown in **Figure 3-9**. The current monitoring network comprises of bores: LL8, LL9, LL13, LL15, LL16, LL19, and LL20. BH6 is still present but is now dry and considered inactive. Water levels have been measured at approximately monthly intervals and are shown in **Table 3-1** below. Bore logs, where available, are contained in **Appendix B**.

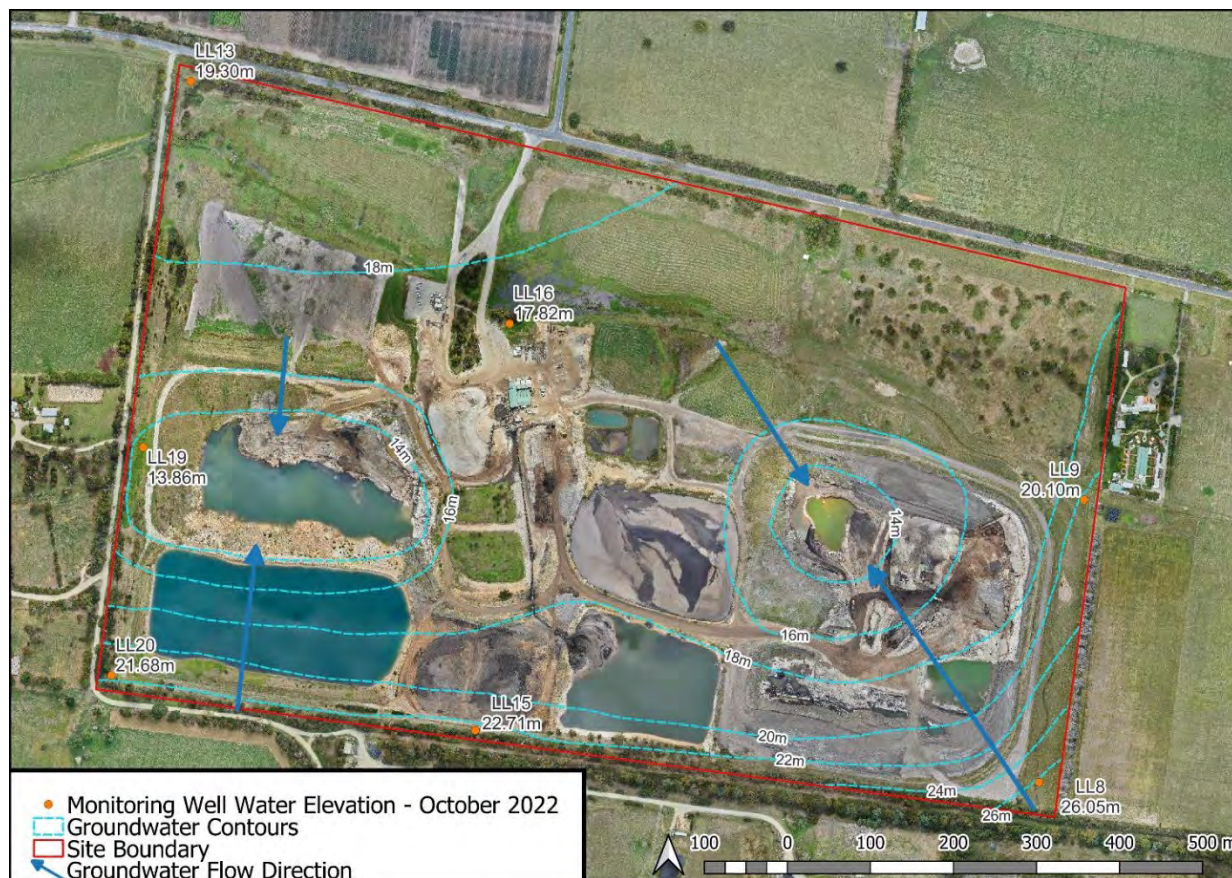
Figure 3-14 Groundwater flow Oct 2022

Groundwater flow is shown in Figure 3-14 below. The flow was interpreted from October 2022 water levels and is shown as approximately 26 mAHD in the south-eastern corner of the site and flows north-westerly. The two pits on the site are shown to be having a localised impact on groundwater flow.

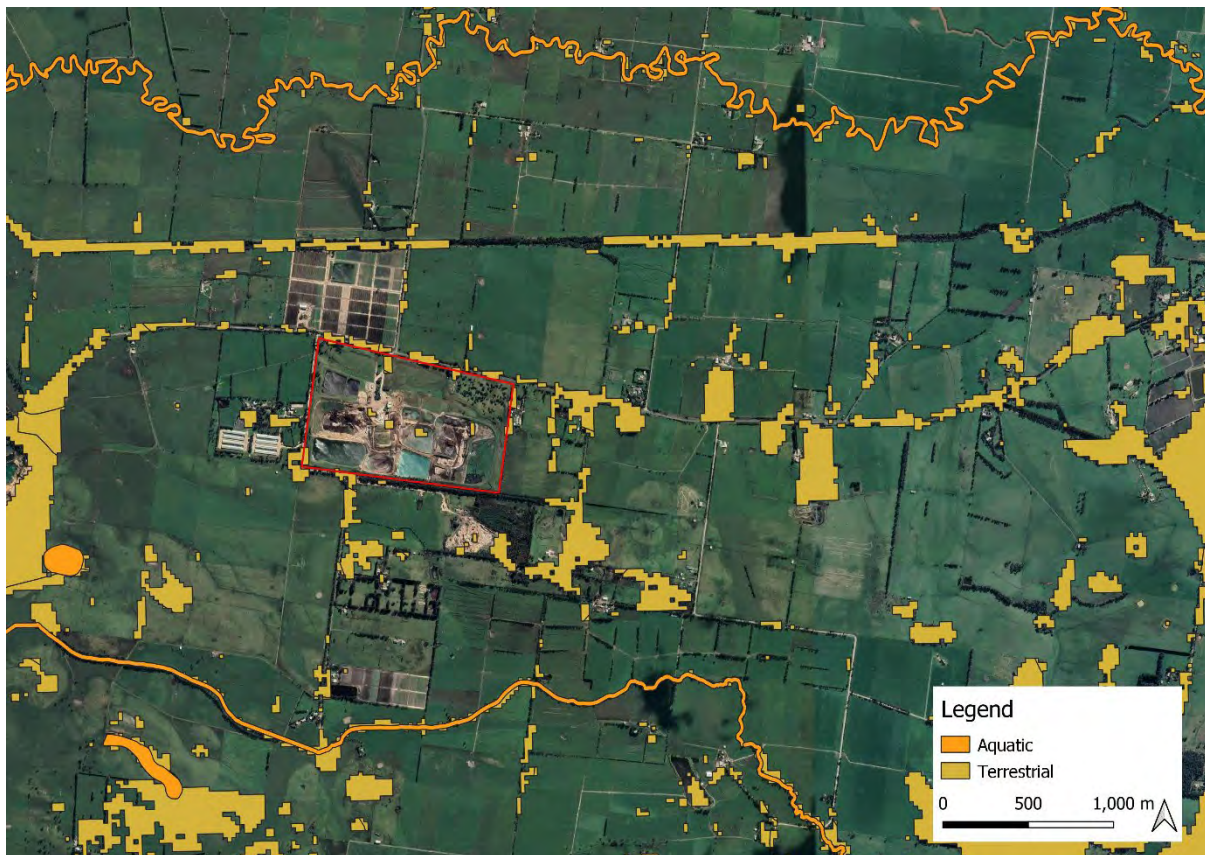
Figure 3-27 Groundwater dependent ecosystems

Groundwater dependant ecosystems in the vicinity of the site are shown in **Figure 3-27**. Vegetation surrounding the site is dependent on groundwater, as well as vegetation along the Lang Lang River to the north of the site.

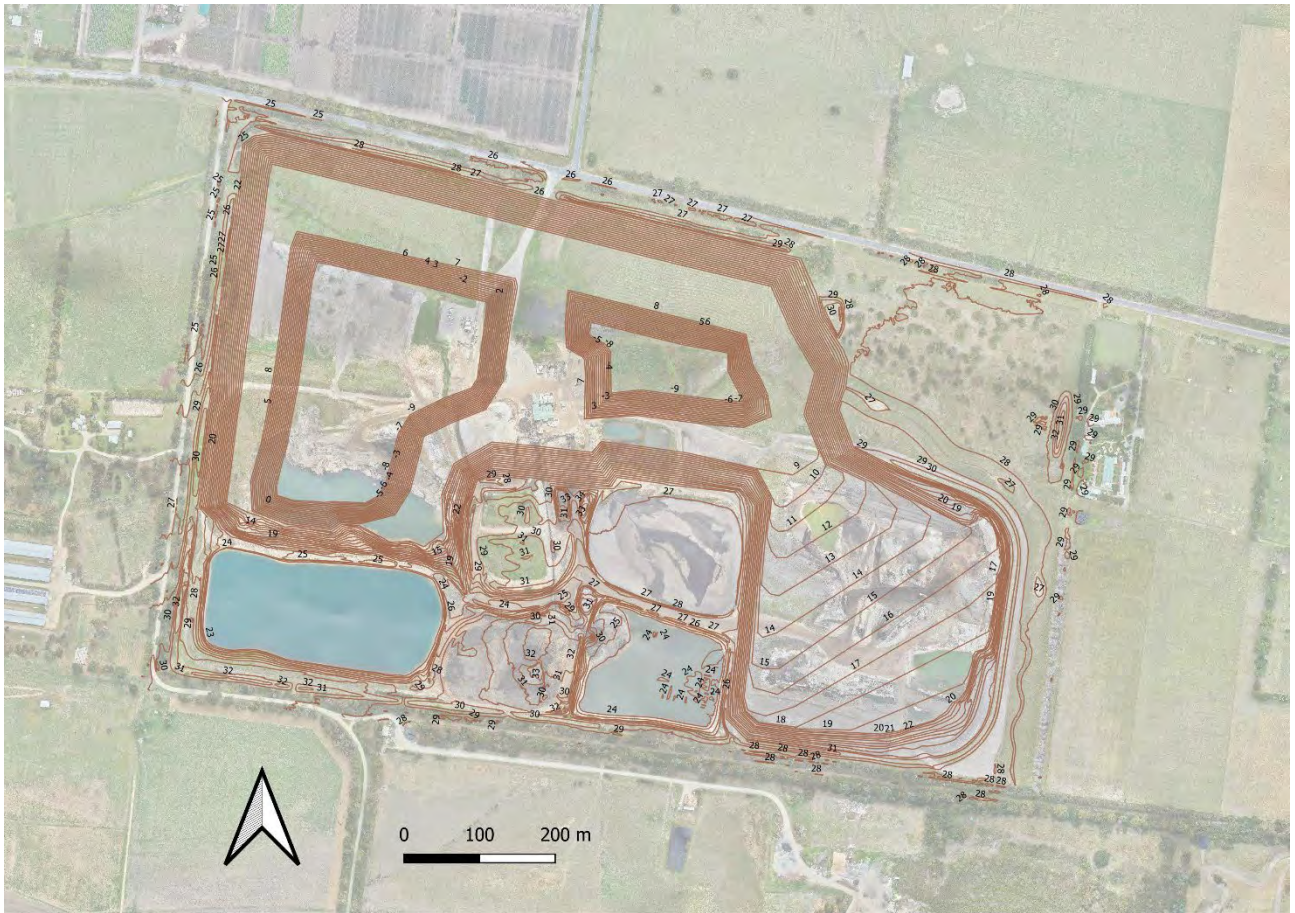
Figure A-8 Terminal Landform

The extent of excavation (terminal landform) and rehabilitation concepts are shown in **Figure A-8, A-9.**
