Appendix G: Existing Conditions HEC-RAS Longitudinal Section and Cross Sections

Appendix H: Design Conditions HEC-RAS Longitudinal Section and Cross Sections

Hanson Construction Materials is preparing a Work Plan Variation to expand their quarrying operations towards the northern boundary of their sand quarry located at 870-910 Westernport Road in Yannathan (Figure 1-1). There is an existing drainage channel (identified by Melbourne Water as Creek 2412) within the location of the proposed expansion, as shown in blue in Figure 1-1. The expansion will require the realignment of the existing channel towards the northern boundary of the site as shown indicatively by the red line in Figure 1-1.

Concept Design of Proposed Channel

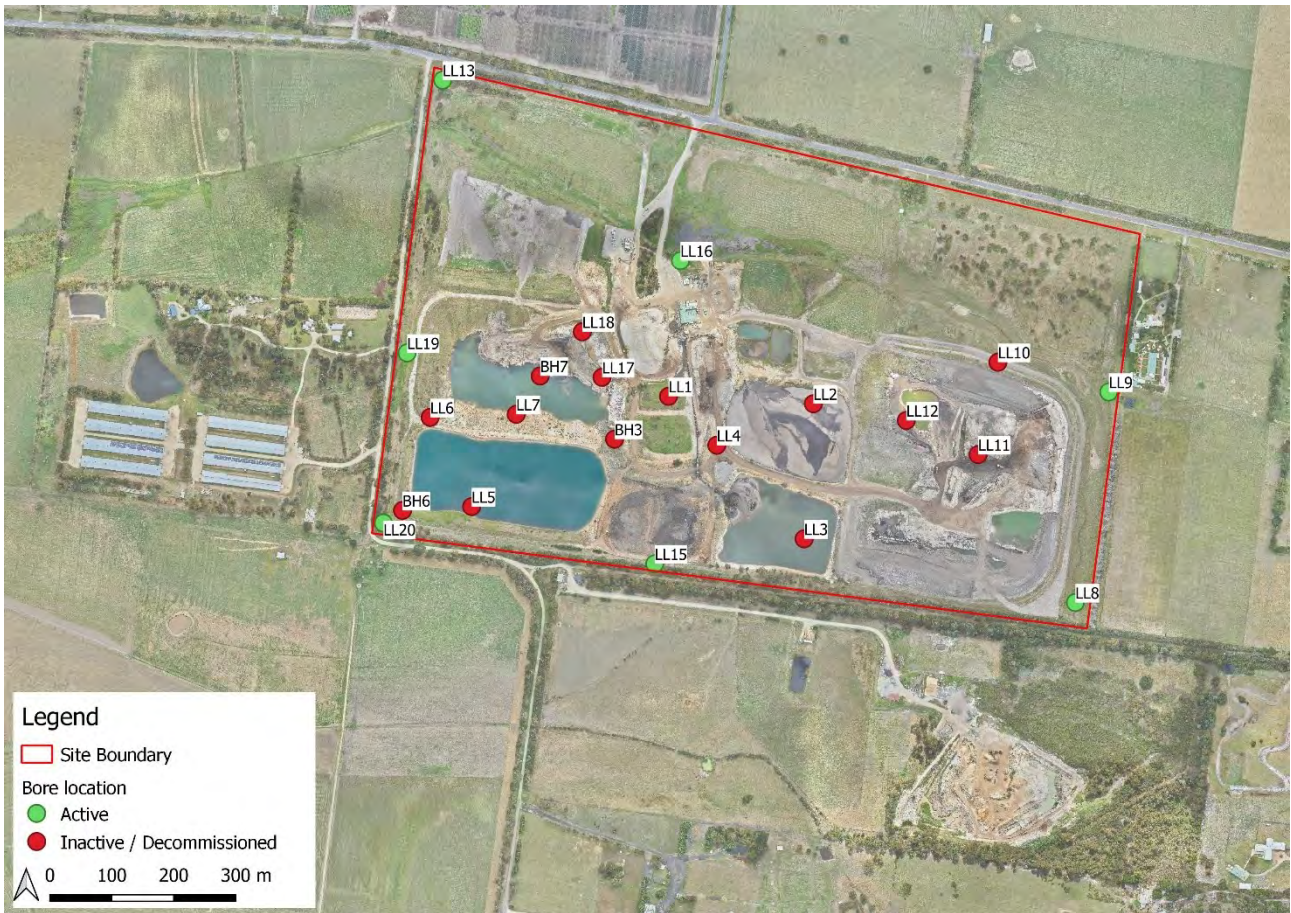
Figure 2-3 Groundwater monitoring network

Groundwater monitoring commenced with a network of eight monitoring bores. As operations have moved from pit to pit some bores have been decommissioned and other new bores have been added. The current monitoring network is shown in **Figure 2-3** below.

- Preparation of Safe Work Method Statement for field work.
- Prior to sampling, the depth to groundwater in each bore was gauged using a dip meter.
- Samples collected from monitoring bores LL8, LL9, LL13, LL15, LL16, LL19 and LL20 (**Figure 2-3**). The bores are located hydraulically upgradient, and hydraulically downgradient from the Hanson Construction Materials operations at Yannathan.

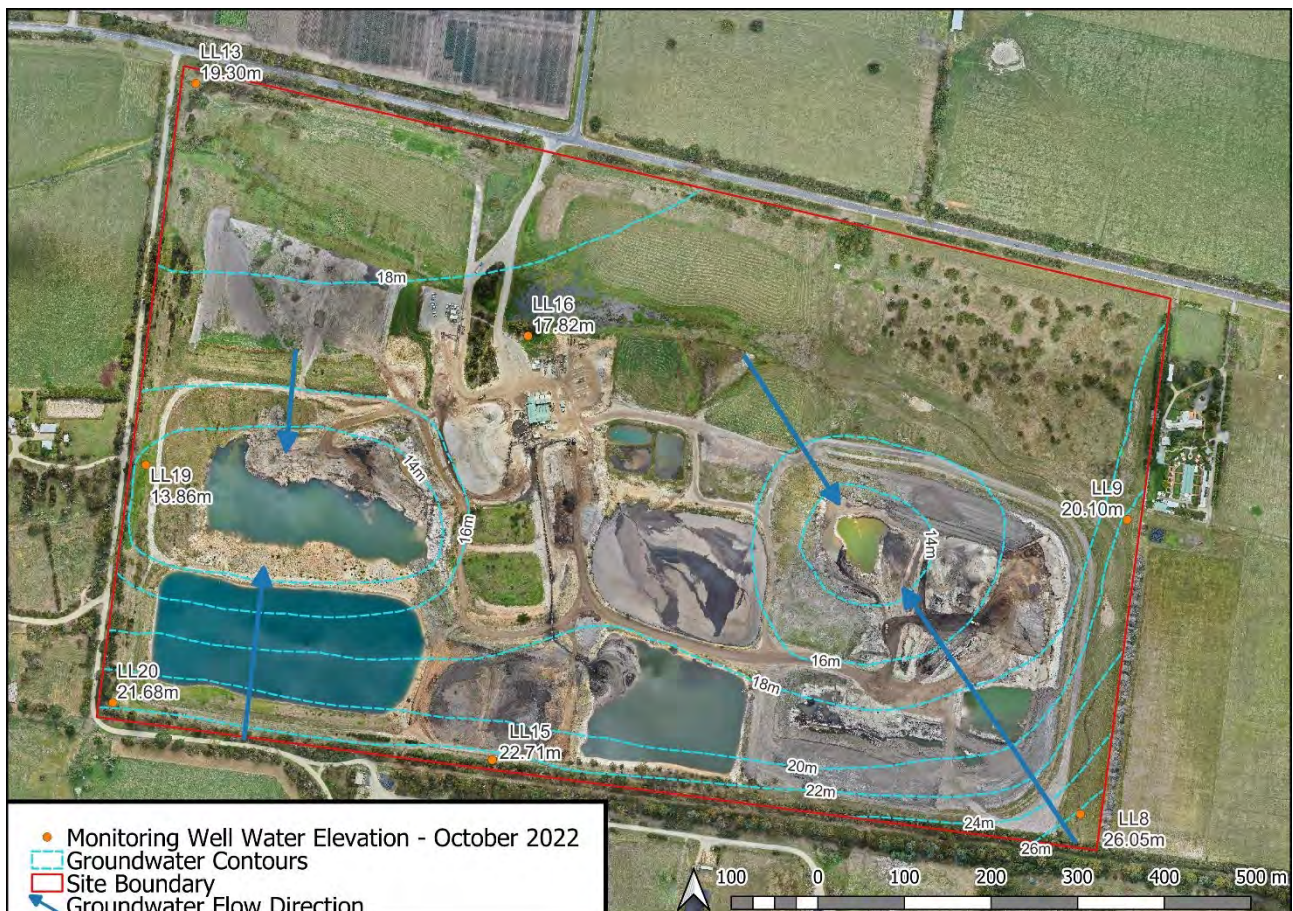
Figure 6-1 Groundwater Contours

Groundwater levels and interpreted contours are provided in **Figure 6-1**. Groundwater levels have increased in most wells since September 2020 (**Figure 2-4**) which is consistent with above average rainfall over the winter 2022 period. Overall groundwater flow directions are consistent with September 2020. Groundwater flow is generally from the south east to north west with localised depressions where extraction is occurring.

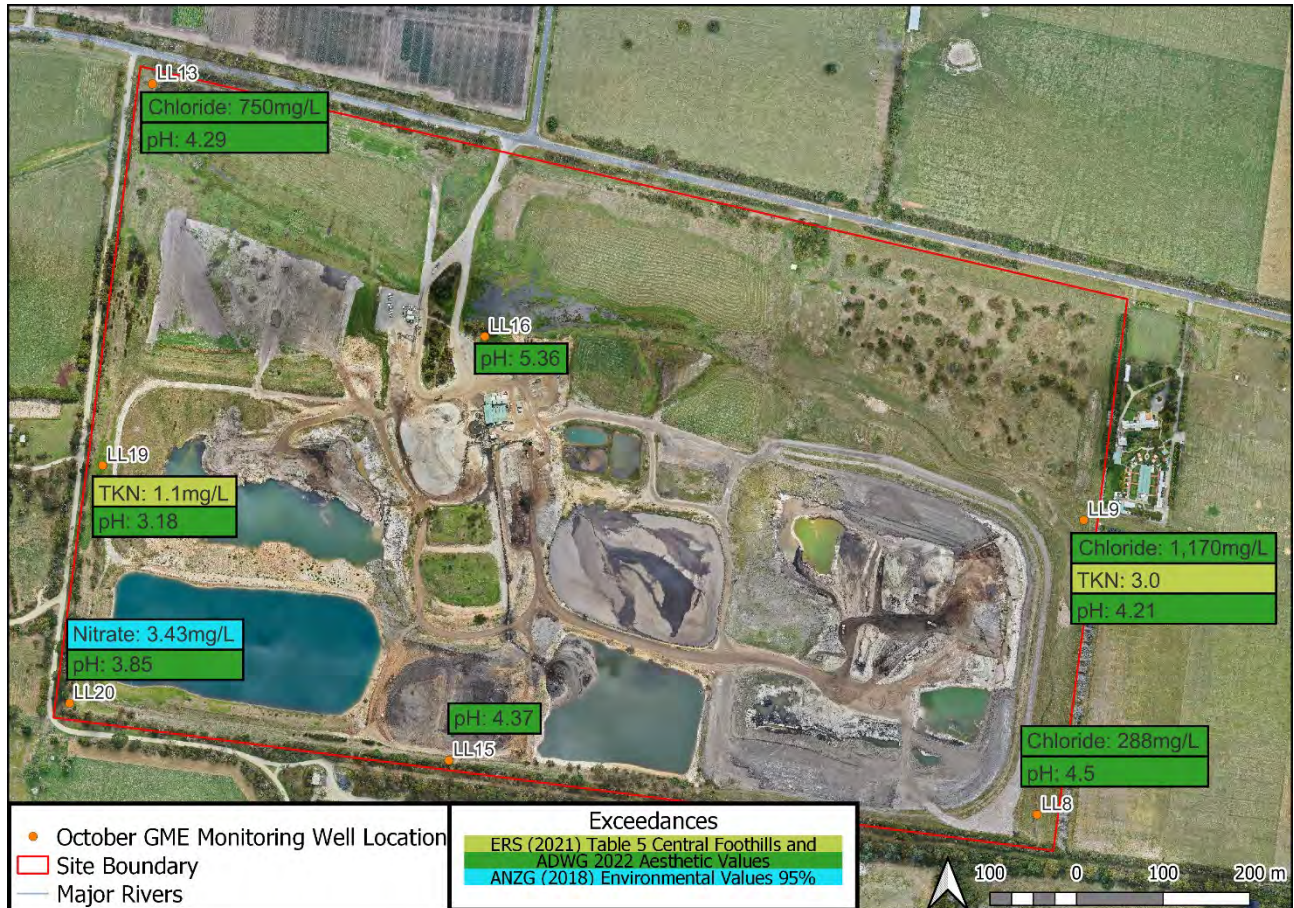
Figure 6-2 Groundwater Results Exceeding Assessment Criteria

Laboratory results and field pH readings are shown in **Appendix C** and results exceeding the adopted groundwater assessment criteria shown in **Figure 6-2**.

- No results exceeded assessment criteria in the cell receiving filter cake, with the exception of pH. The pH value of 6.28 was slightly below drinking water aesthetic criteria (6.5) and ERS criteria for the area (6.8).
