Company name:	Ricardo Energy Environment & Planning PL
Contact name:	Sophie Smith
Project name:	YANNATHAN GME
Project ID:	30765.02
Turnaround time:	5 Day
Date/Time received	Oct 14, 2022 5:29 PM
Eurofins reference	931914

Proposed Expansion at Yannathan Quarry, Yannathan Cultural Heritage Management Plan

Map 3: Indicative Works Plan

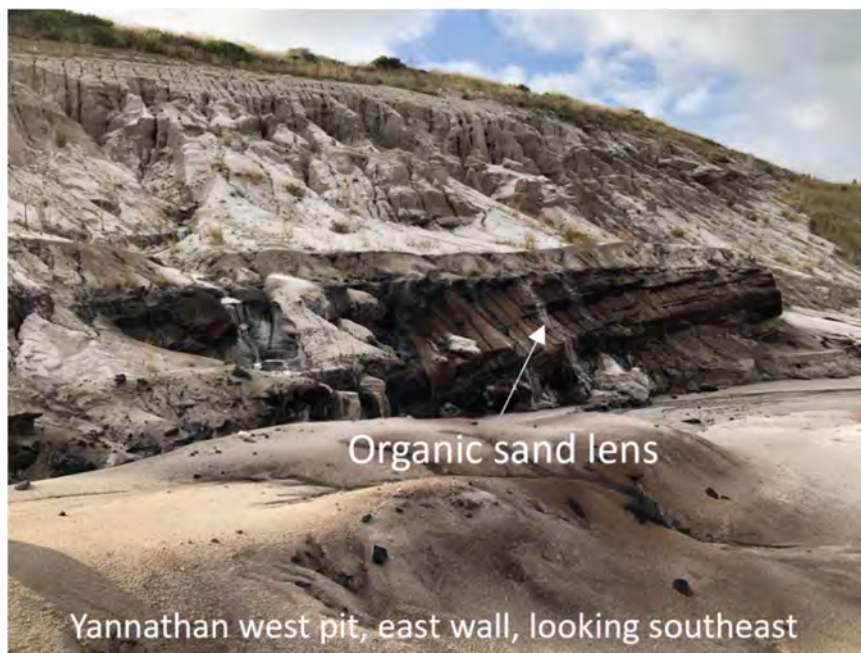
Figure 8: Organic sand exposure (approximately 2 m thickness visible) at Yannathan

Lignite/Coal was observed at the following depths in four boreholes in the southeast corner of the existing quarry area (Pioneer Concrete 1998). LL3 coal at 13m, LL4 coal at 15m, LL8 coal at 13.5m, LL14 coal at 11m (Annotated 'C' on Figure 6). The black/dark sands in the expansion area are inferred to be non-lignite bearing and to be similar to those observed in the west pit (Figure 8).

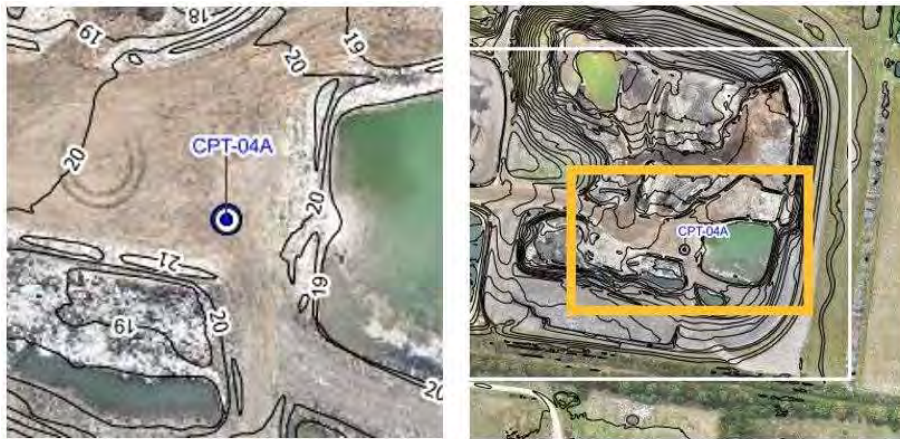
Figure 13: CPTu locations - eastern area haul road

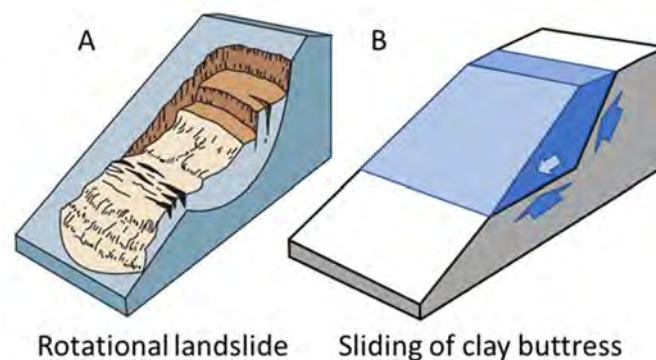
Figure 17: A) Illustration of the rotational landslide failure mechanism, AGS 2007C Practice Note Guidelines of Landslide Risk Assessment. B) Illustration of potential sliding of clay buttress under the influence of water pressure

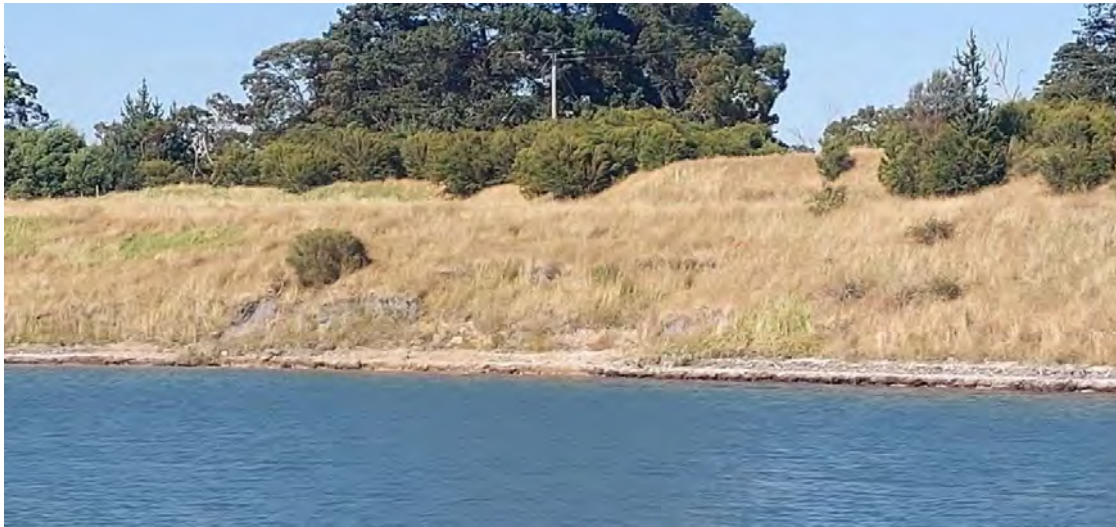
Figure 20: Grass cover on batters of the west pit (facing southwest 11 January 2023)

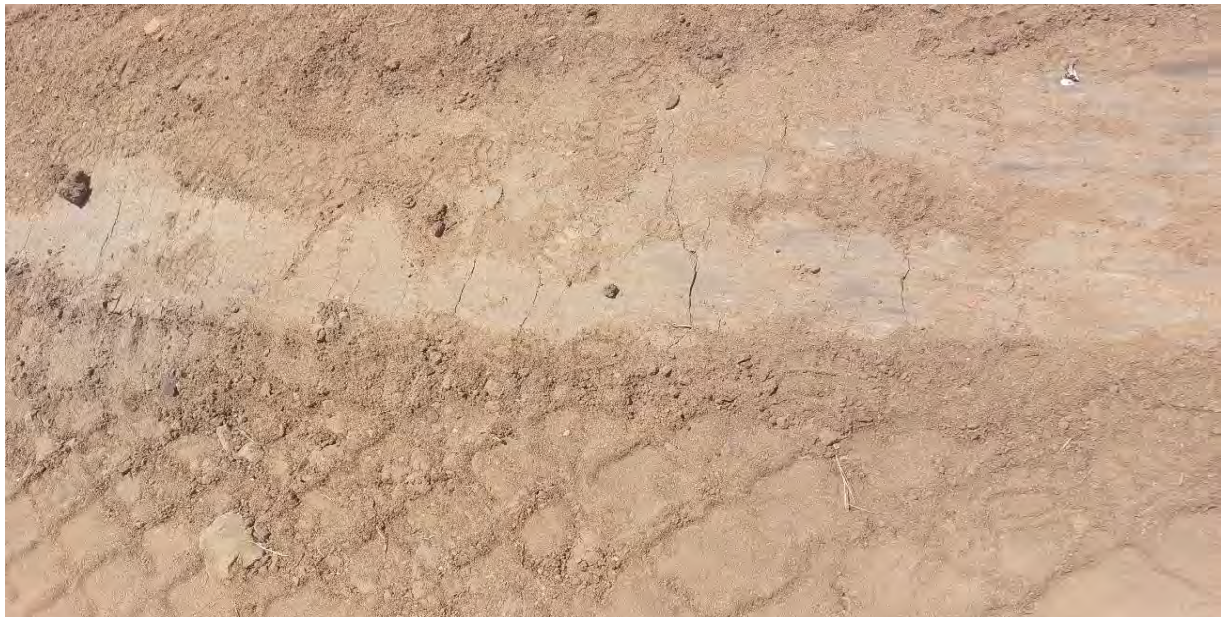
CPT-03A - SURFACE CRACKING - 12/01/2023
