Agricultural Assessment

Proposed Solar Farm - Naring Hall Road - Numurkah

| Project Name: | Agricultural Assessment for Solar Farm |

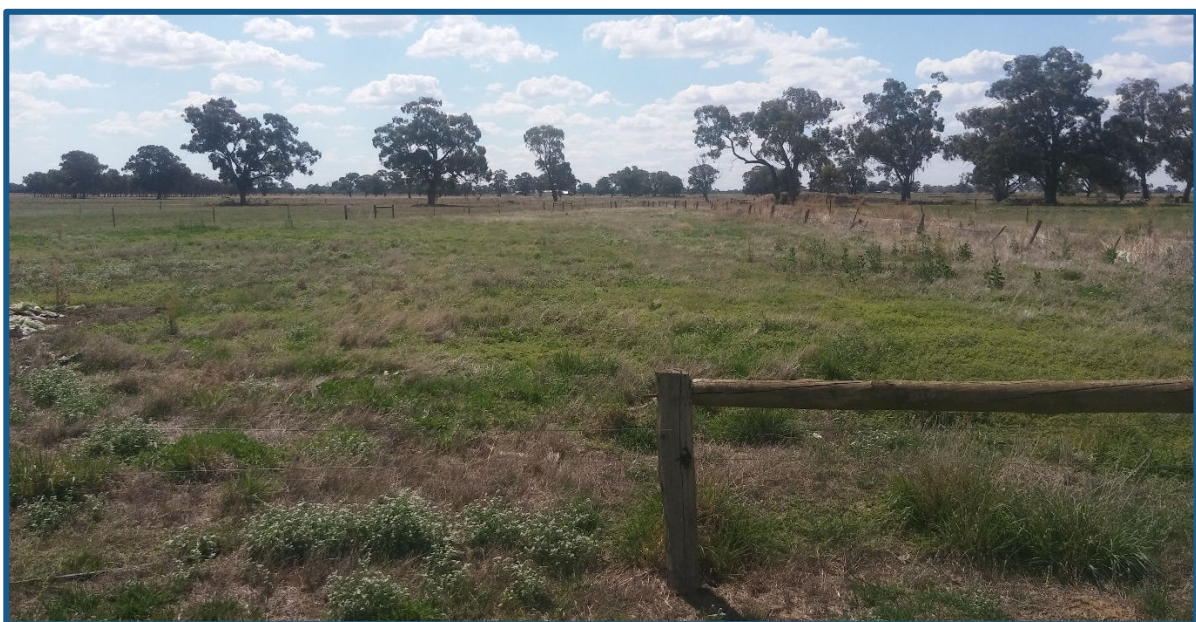
Image 1: The site consists predominantly of open agricultural grazing and cropping land.

Weeds – At the time of the site inspection, the majority of the site was covered with a range of weed species including Couch Grass, Heliotrope, Caltrop, Bathurst Bur, Barley Grass, Scotch Thistle, Clammy

Goose Foot, Hog Weed, Dock, Barnyard Grass, Marshmallow, Milk Thistle, Wild Oats, Cape Weed and Erodium (*Images 1 & 2*).

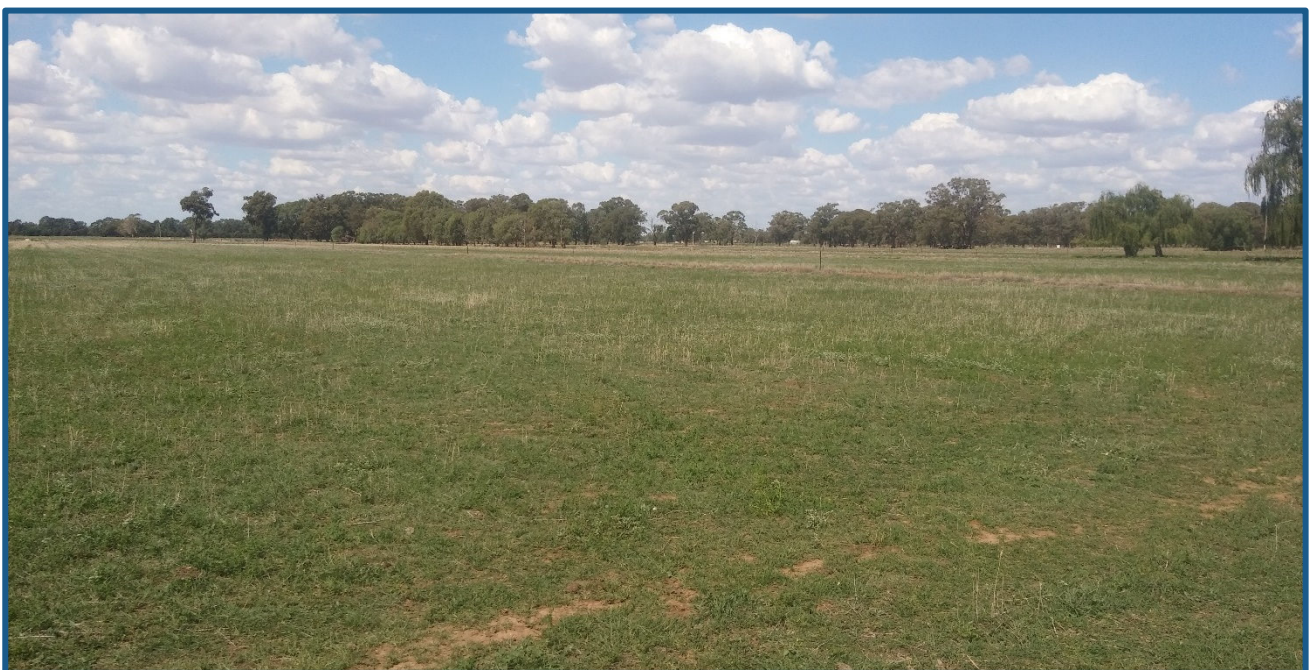
Image 2: At the time of the field inspection, the site consisted of remnants of a winter crop and weeds (March 2020).

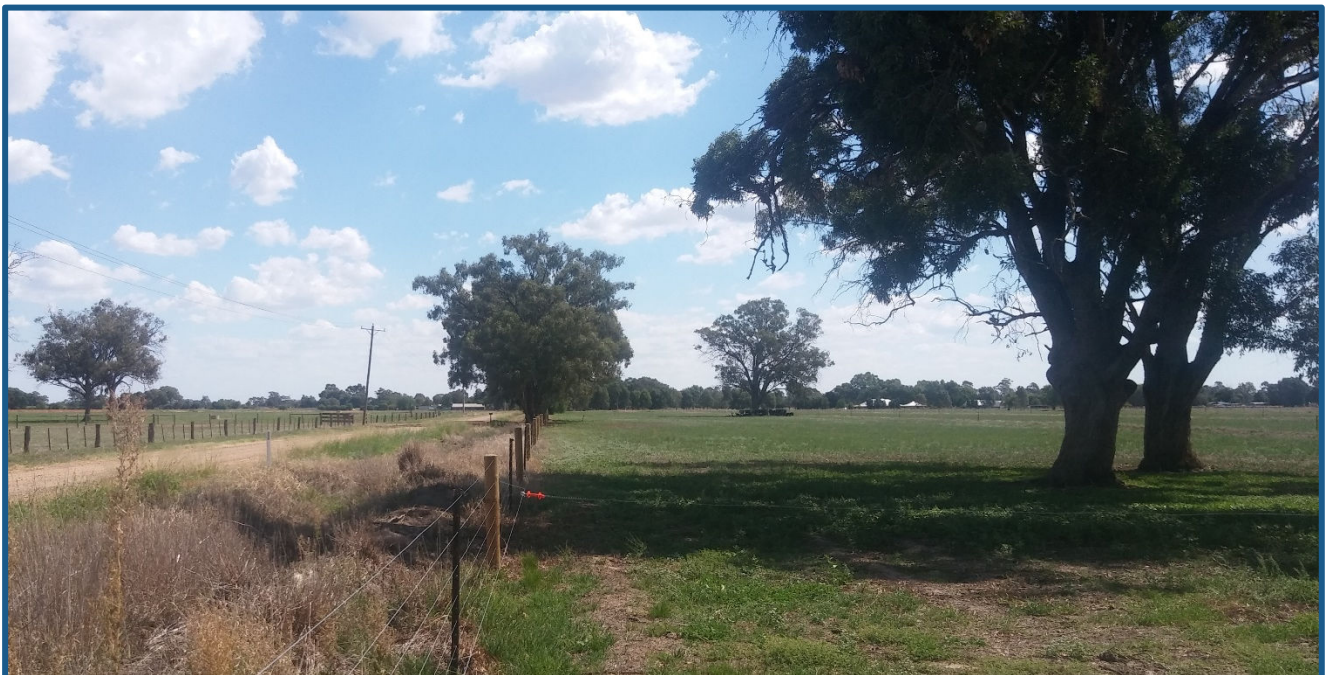
Image 3: Looking west from the southeast corner of the site with the gravel, all weather Naring Hall Road on the left, the southern boundary fence line and scattered remnant Grey Box (*Eucalyptus microcarpa*) trees.

Access – The site has adequate all weather access from the adjoining Naring Hall Road (*Image 3*).

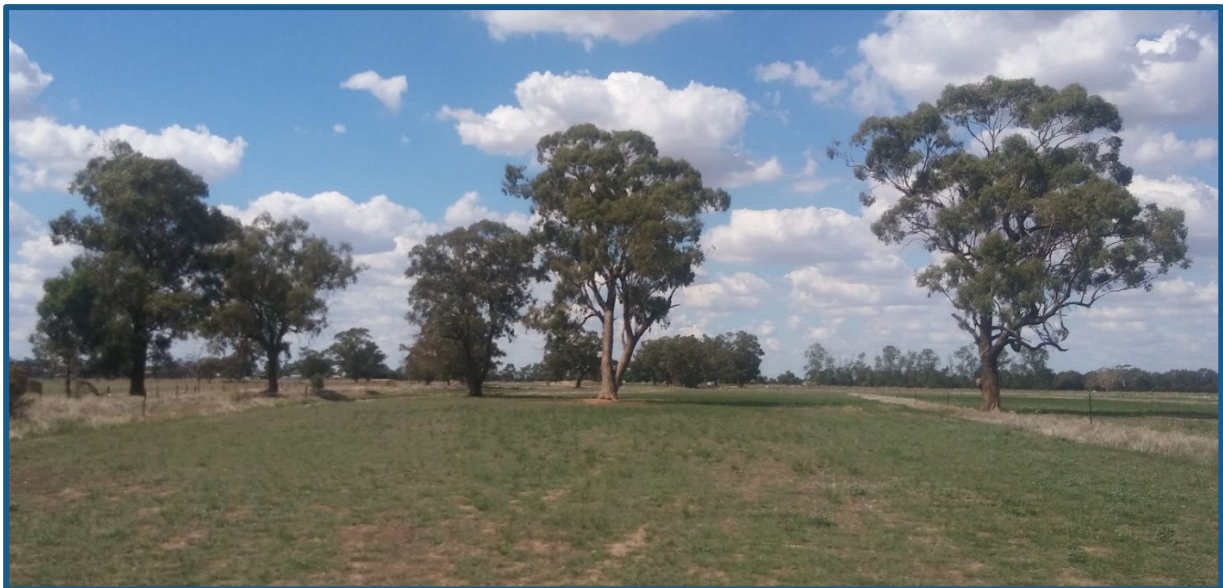
Image 4: Several scattered remnant Grey Box (*Eucalyptus microcarpa*) trees occur in the north of the site.

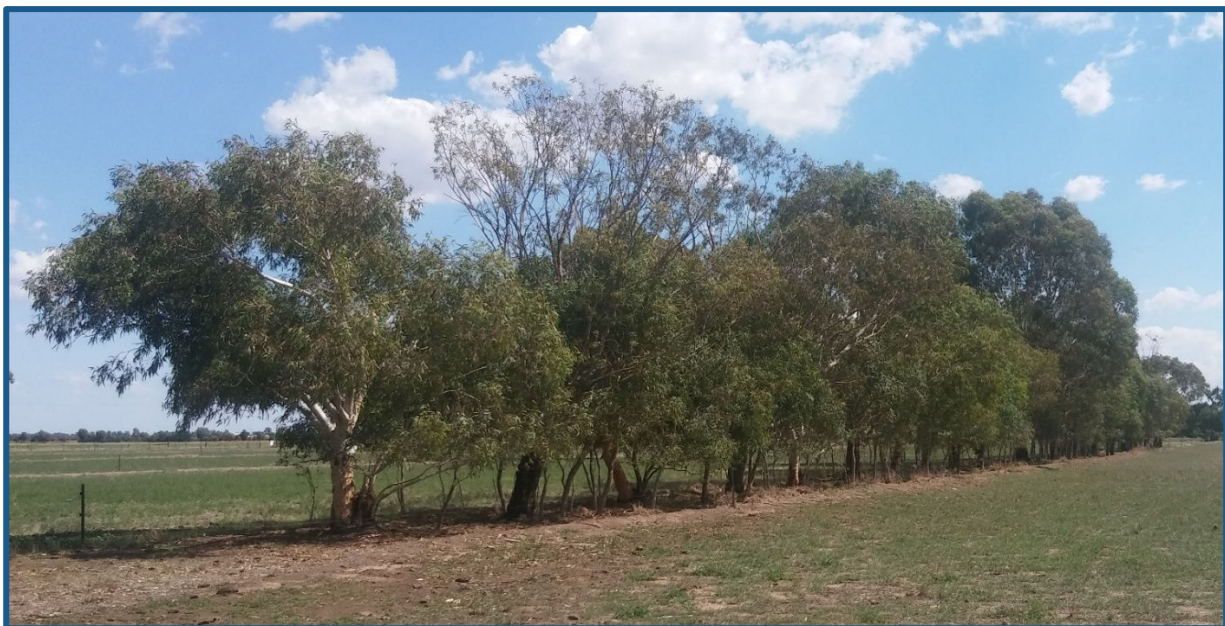
Image 5: An approximately 180 m long line of planted native trees along an irrigation check bank are located approximately 160 metres north of the southern boundary of the site.

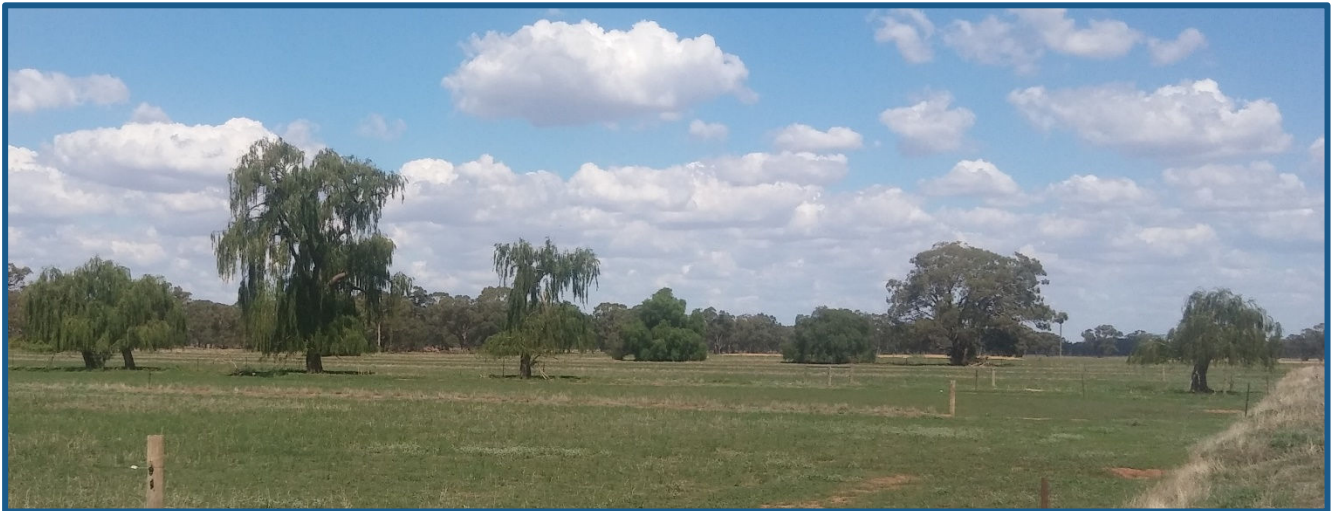
Image 6: Approximately 5 willow trees are located along an irrigation check bank in the west of the site.

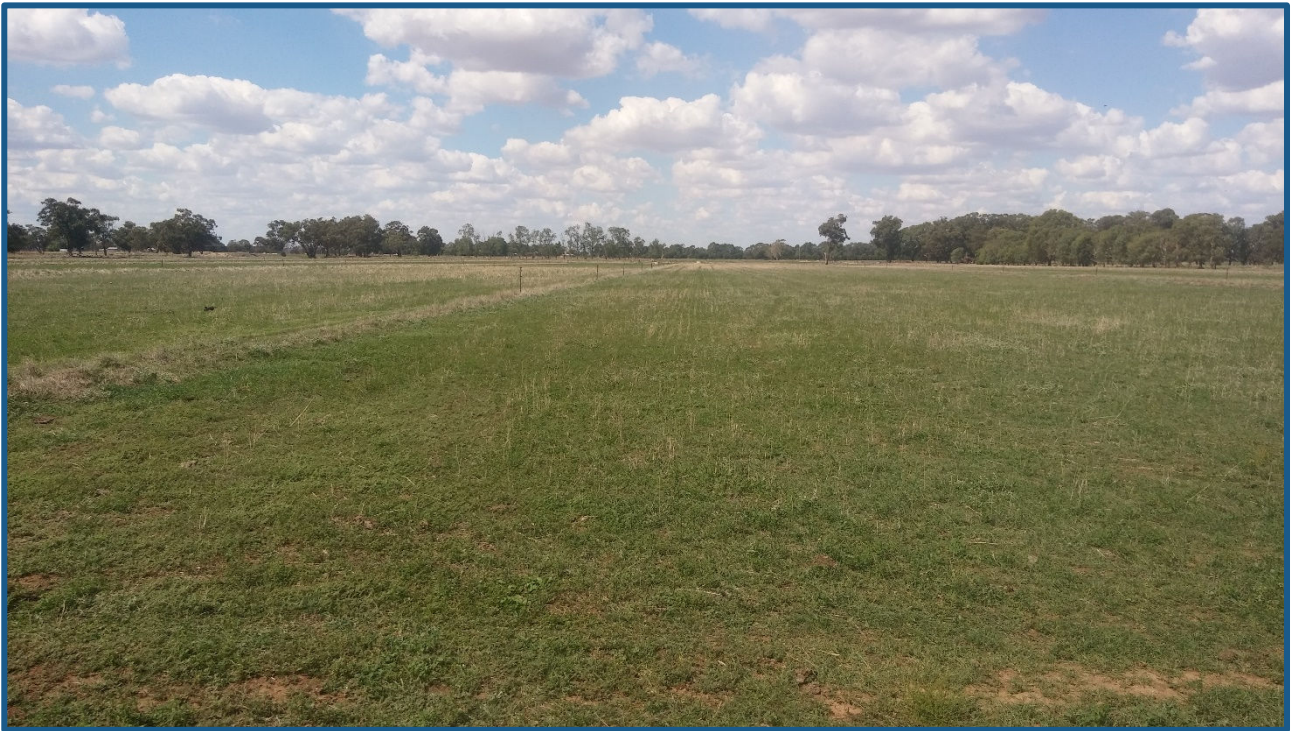
Image 7: *Approximately 55% of the site is suitable for a range of irrigated agriculture and is typical of average, mediocre, agricultural land throughout the GMID.*

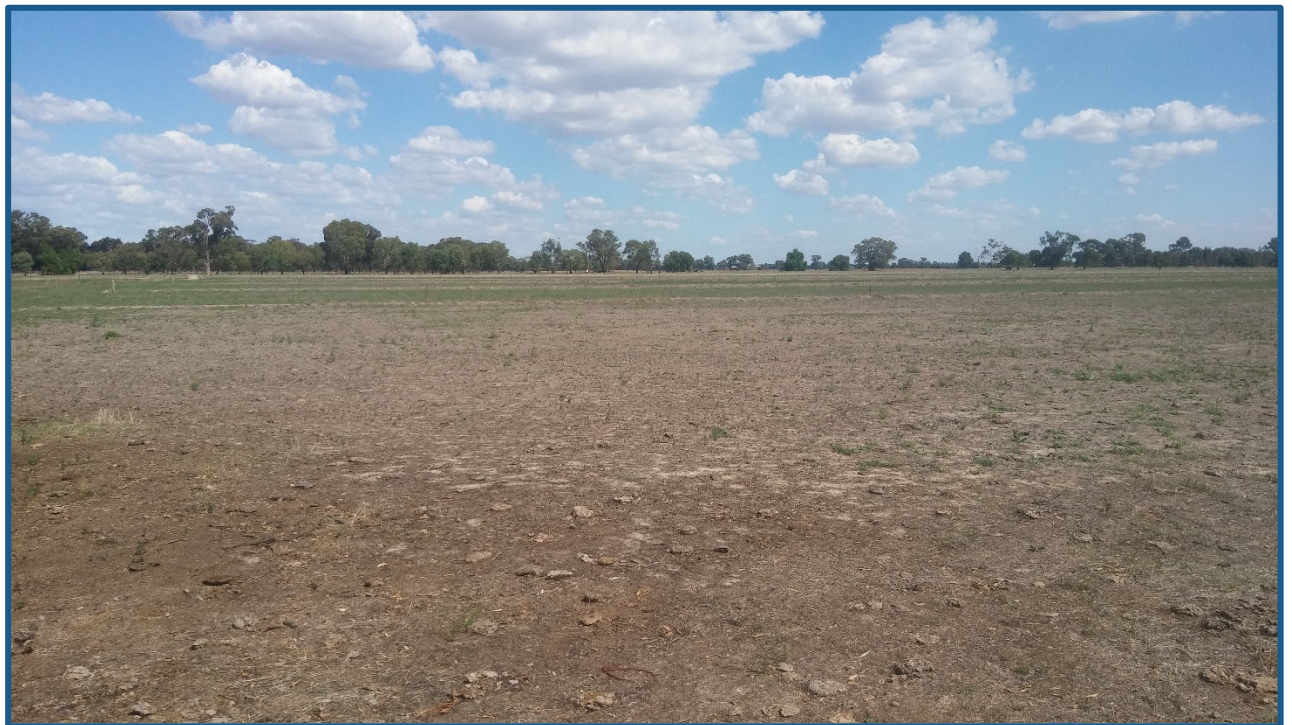
Image 8: *Approximately 45% of the site consists of heavy textured, poorly drained soils subject to flooding and sodicity which are unsuitable for commercial irrigated agriculture and are only suited to low intensity dryland grazing and/or opportunistic cropping.*

From an agricultural utility perspective, the site has the advantages of predominantly cleared land with adequate topography, surface drainage and access, a proportion of suitable soils, no adverse impacts from salinity or shallow groundwater, and no evidence of vermin (*Image 7*). The agricultural utility of the site is reduced due to the significant proportion of heavy textured, poorly drained soils, a significant proportion of soils unsuitable for commercial irrigated agriculture, the propensity for flooding, a

propensity for sodicity, and significant weed infestations (*Image 8*). Based on experience, the site is typical of average, mediocre, agricultural land throughout the GMID.

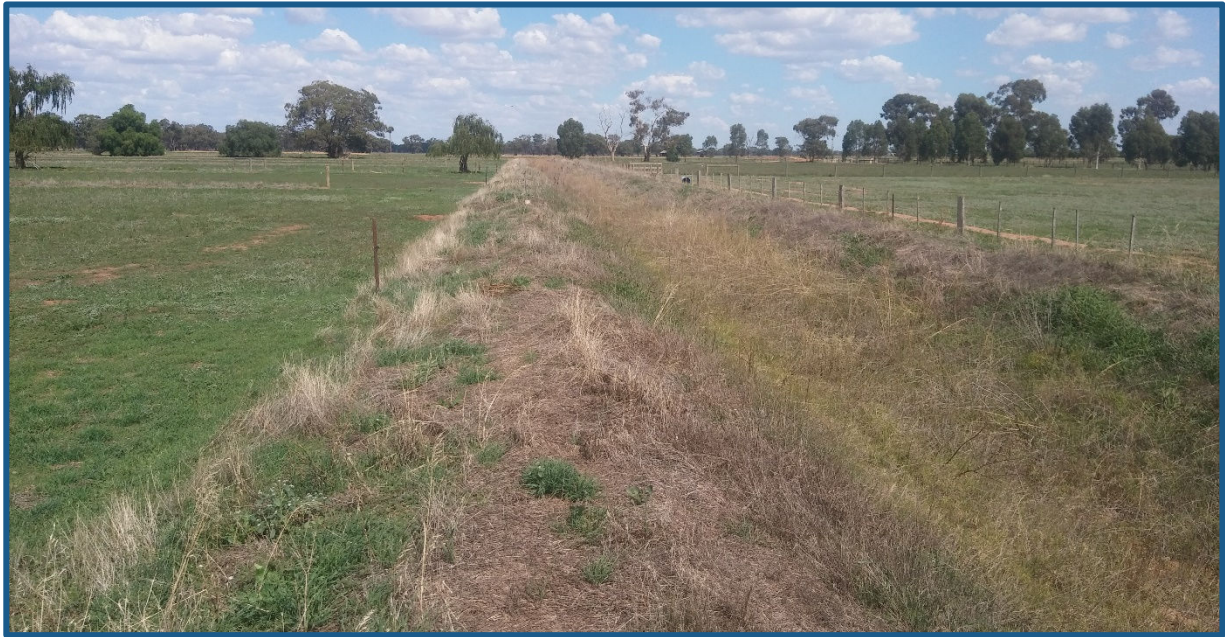
Image 9: The earthen farm irrigation water supply channel along the western boundary and north-western corner of the site will remain after development for the solar farm to convey water to Lot 1.

The gravity, border check (flood) irrigation system on the site currently consists of an earthen farm irrigation water supply channel along the western boundary and north-western corner of the site (*Image 9*), 11 fast flow 'Padman' irrigation bay outlets (*Image 10*), an irrigation channel 'check' (*Image 11*), 11 laser-graded irrigation bays (*Image 7*), small earthen check banks (*Image 7*), and shallow, trafficable, earthen 'spoon' drains in the east of the site to collect and remove excess surface water (*Image 12*) (*Appendix C - Site Plan*).

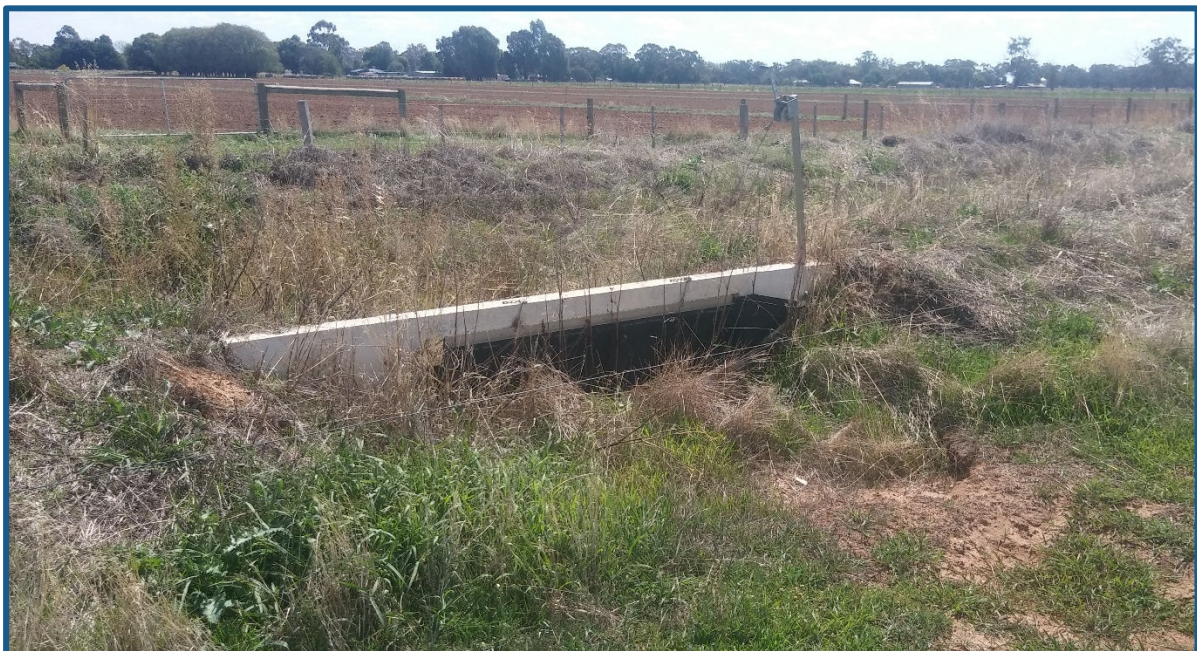
Image 10: One of the fast flow 'Padman' irrigation bay outlets which deliver irrigation water from the farm channel to the irrigation bays

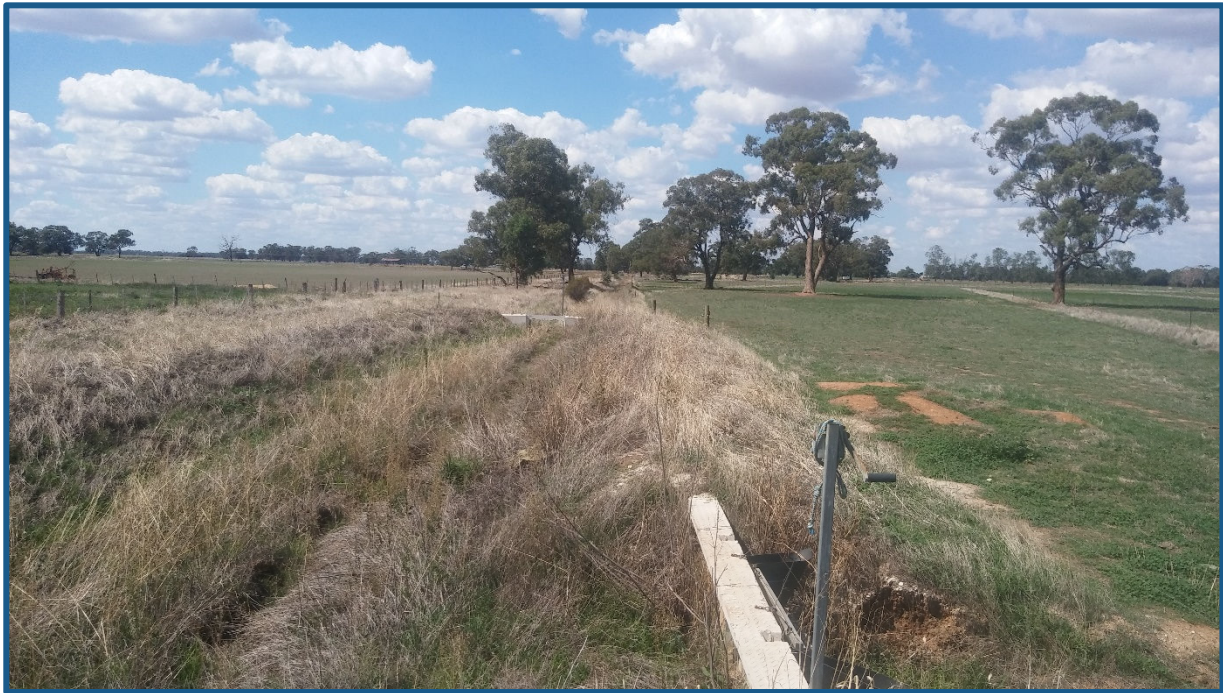
Image 11: The earthen farm irrigation water supply channel in the north-western corner of the site looking east along the northern boundary of the site with an irrigation bay outlet in the foreground, an irrigation channel 'check' at the end of the farm channel and scattered remnant trees in the north of the site in the background.

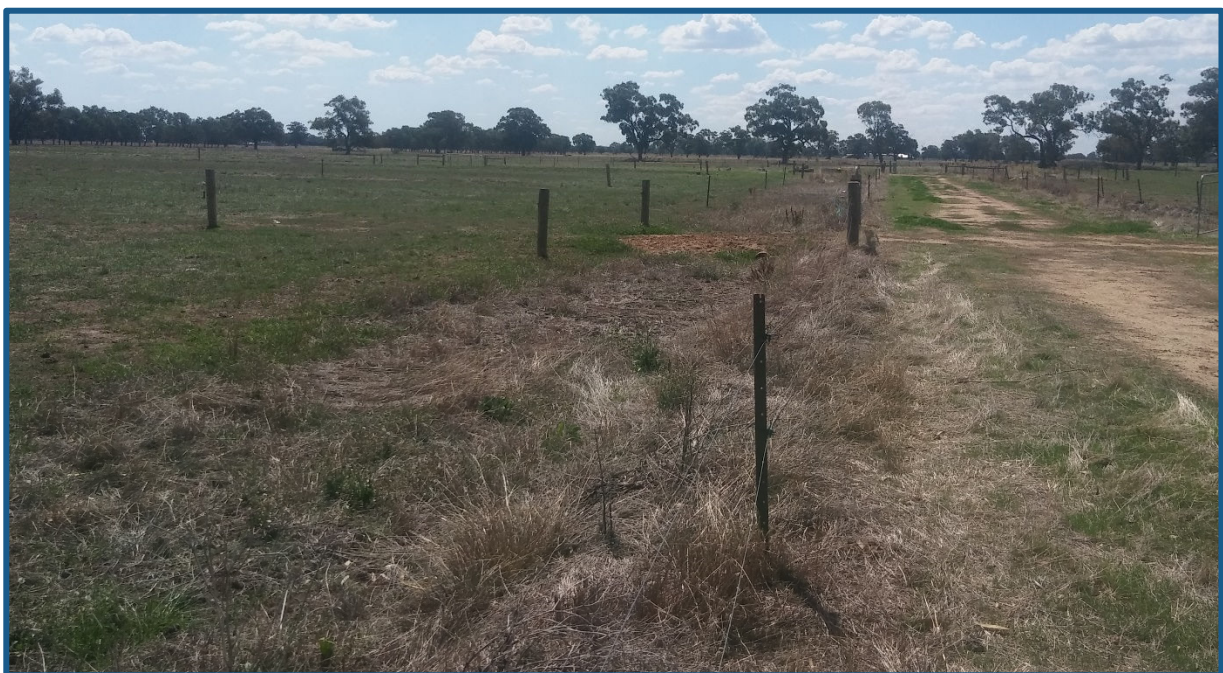
Image 12: At the east (lower) end of the irrigation bays is a shallow, trafficable, earthen 'spoon' drain which collects and removes excess surface water.

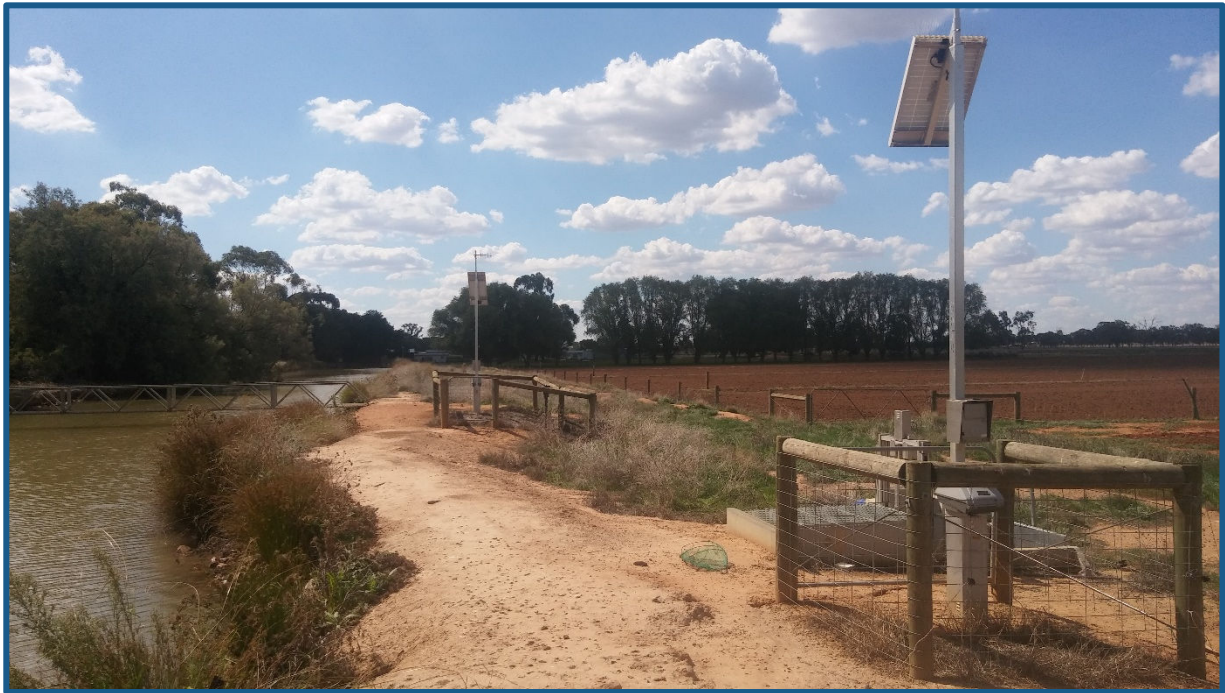
Image 13: Lot 1 is currently serviced by metered outlet MV6071 which is located adjacent to the 6/6 GMW irrigation channel approximately 500 metres west of the site.

Lot 1 is currently serviced by metered outlet MV6071 which is located adjacent to the 6/6 GMW irrigation channel (*Image 13*). Irrigation water from this metered outlet is initially conveyed through a private irrigation water supply pipeline (500m long; 500 mm diameter) located on a water supply easement on the property to the west of the site. This pipeline discharges into a farm irrigation water channel located on a water access easement on the site and parallel to the western boundary of the site (*Image 14*). This water access easement is the one referred to earlier which was created by the Landholder in 2020. This water access easement encompasses a farm irrigation water channel which conveys irrigation water from the pipeline discharge point, north along the western boundary of the site, east along the northern boundary of the site (south of the existing drainage easement referred to earlier in the report) (*Appendix D - Title Plan*) and which then facilitates discharge of the water from the northeast corner of the site and into the sump located in the adjoining Lot 1 (which is located east of the site) (*Image 15*). The delivery of irrigation water through metered outlet MV6071 is now dedicated to Lot 1, along with the delivery share described by GMW; '*There is delivery share of 1.690 ml/day and a Water-use Licence of 329.2 ml for service ID: 8004914 relating to lots 1 & 2 on PS613623U.*'

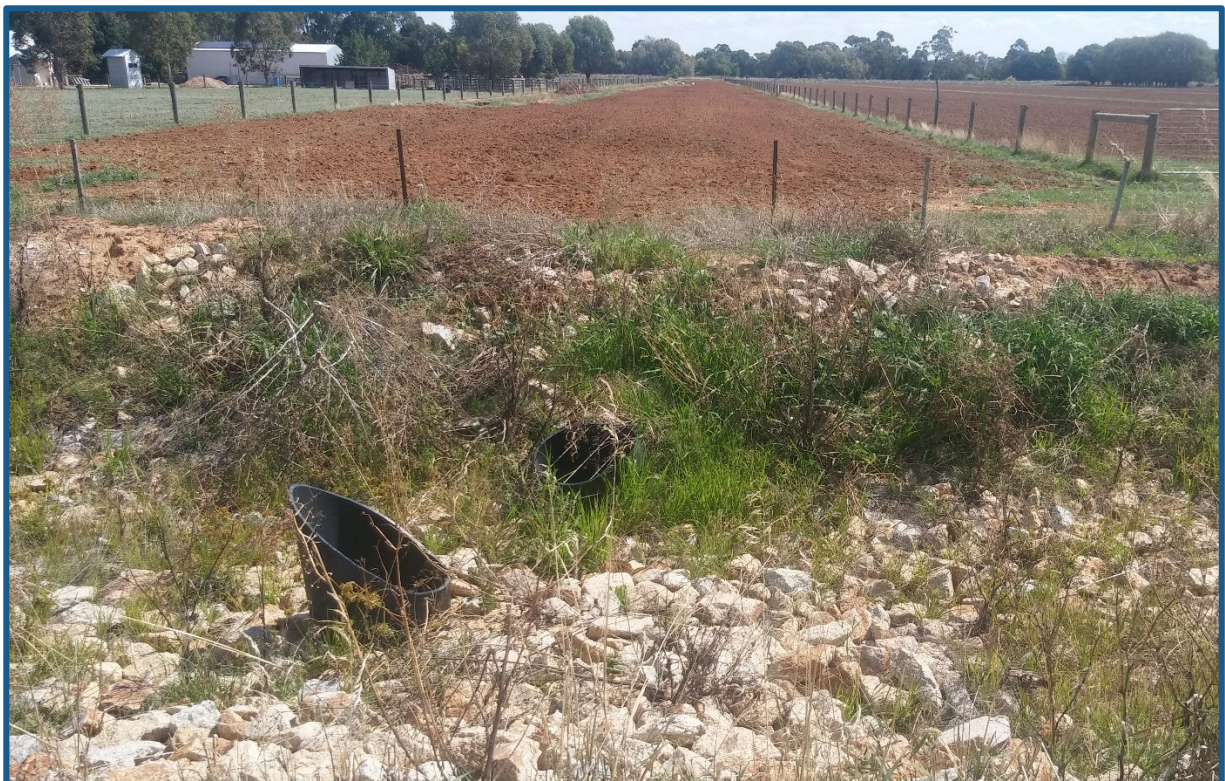
Image 14: Irrigation water is conveyed through a private irrigation water supply pipeline (500m long; 500 mm diameter) from the 6/6 Channel which discharges into a farm irrigation water channel located on a water access easement in the west of the site.

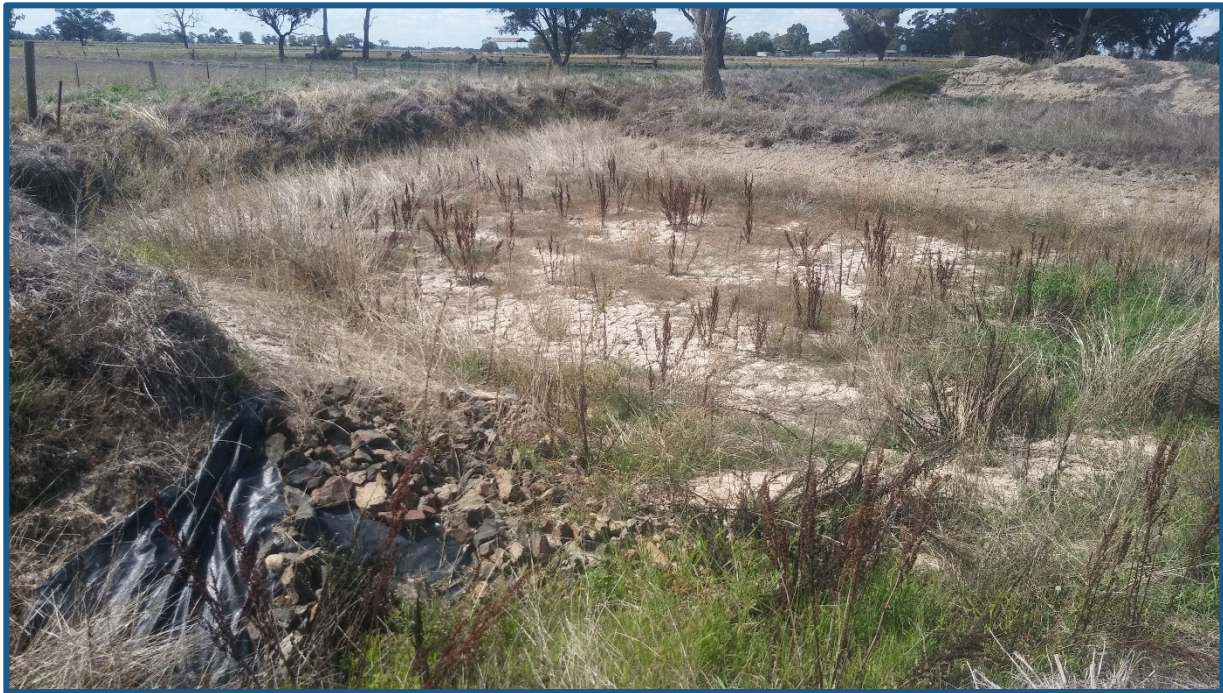
Image 15: Irrigation water is conveyed in an earthen farm channel and an earthen farm drain located in a water access easement along the northern boundary of the site, and is then discharged from the northeast corner of the site into a sump located in the adjoining Lot 1.

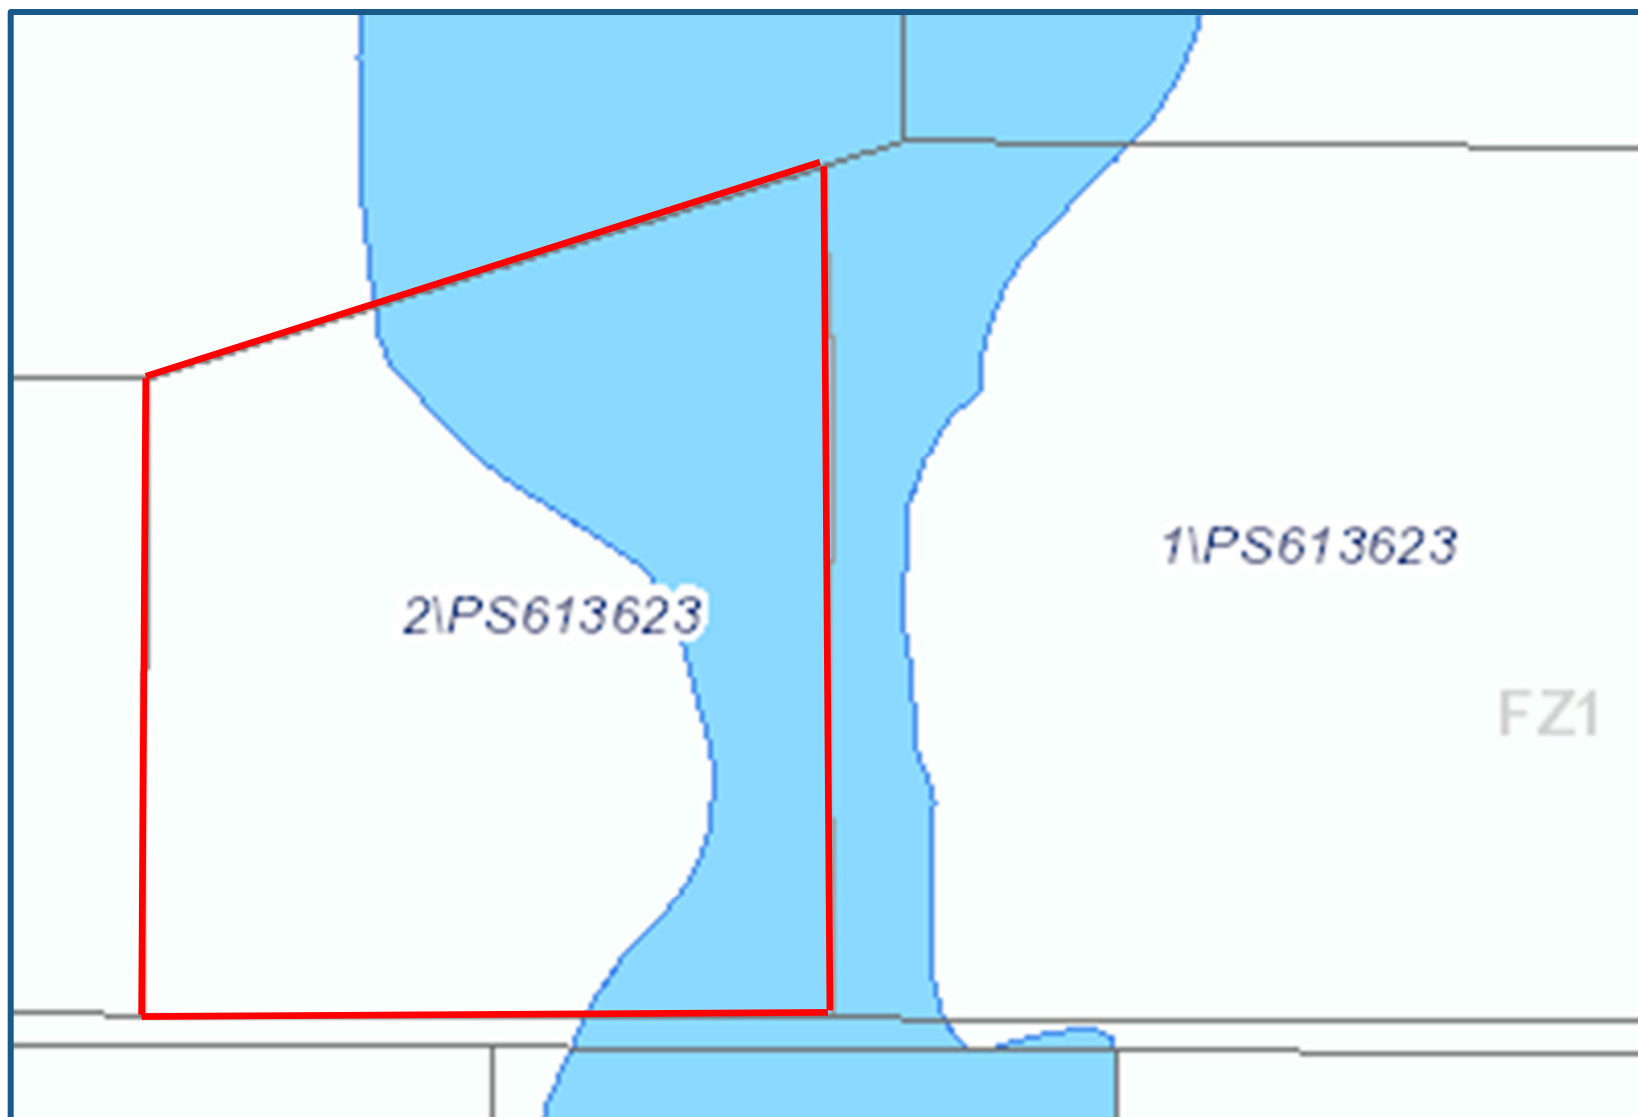
7.8 Appendix H - Flooding Plan

Flooding – Approximately 40% of the site is covered by the Flood Overlay as detailed on the Flooding Plan in the appendices (*Appendix H - Flooding Plan*). This area of the site is subject to flooding in wet climatic periods when excess surface water builds up in the aforementioned community surface drain and backs up across the site.
