Preliminary Geotechnical Assessment

Lot. 2029, No 34A, Great Alpine Road,
Hotham Heights, VIC, 3741

210126-PRJ1010393-GEO-REP-01

4/09/2023

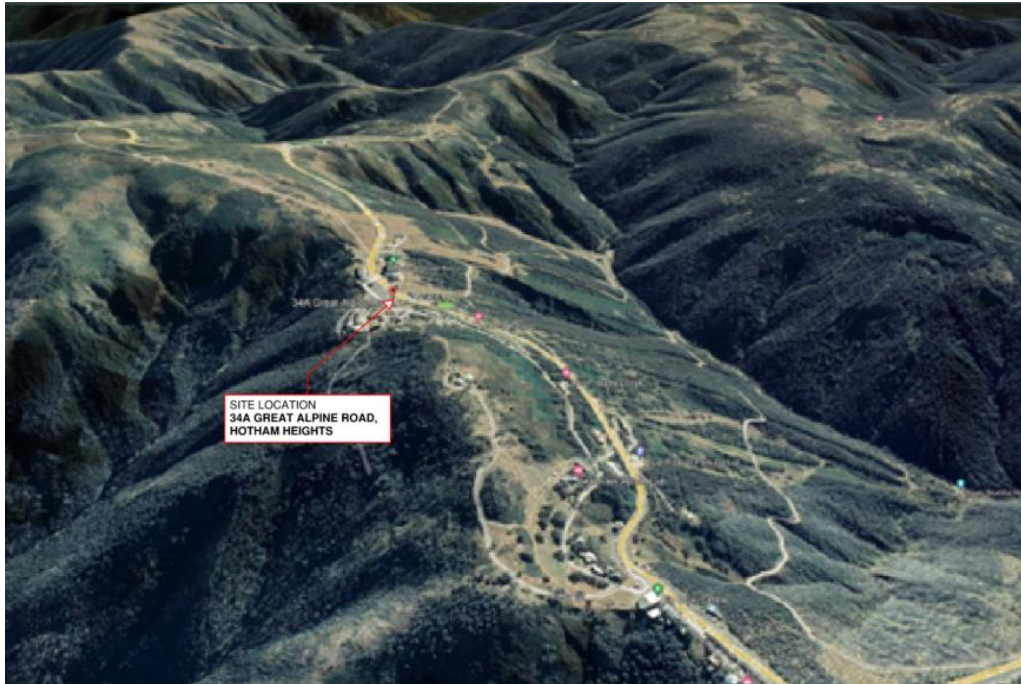
Figure 1. Site Locality (Source: Google Earth) Image Dated 31/07/2023

The site is located within the existing Hotham Village at the peak of Mount Higginbotham. The crest of Mount Higginbotham is approximately 60 m higher than the site, located approximately 400 m to the south. The topography slopes steeply to the east towards the current ski-slope trails, and west towards the Alpine National Park.

The site is situated southwest of Great Alpine Road, with main access to the site is from Higgi Drive. The site is occupied by an existing telecommunications facility. Structures at the site are noted as steel sheet clad single storey storage structures founded on concrete slabs. It appears that previous excavations at the site, assumed to facilitate original access and construction, has created gentle slopes and minor retaining walls across the site.

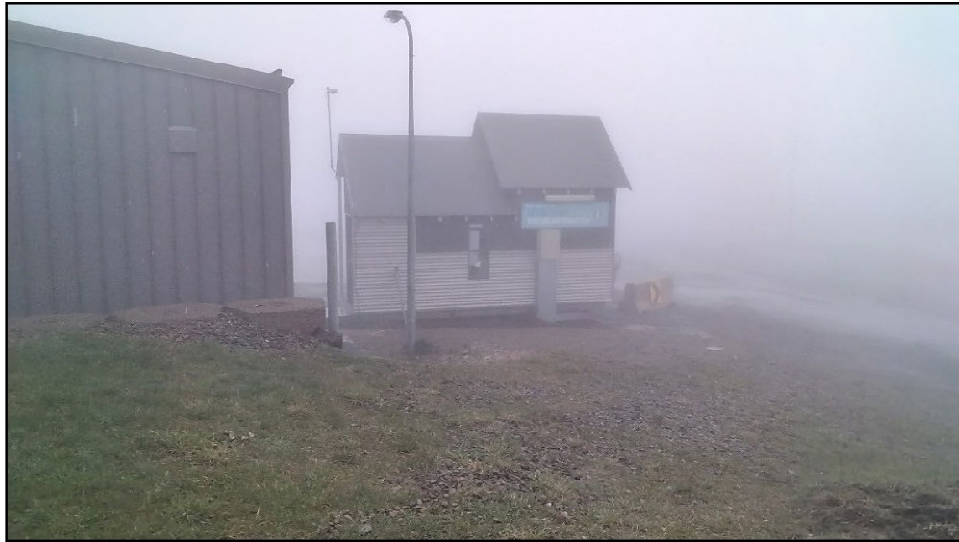
Figure 1: Site photograph showing the existing surface conditions

The ground surface over the site is gently inclined with the fall down to the north. The ground cover comprises of natural grasses. A photograph of the proposed ingal pole site taken during the site investigation is presented in **Figure 1**.

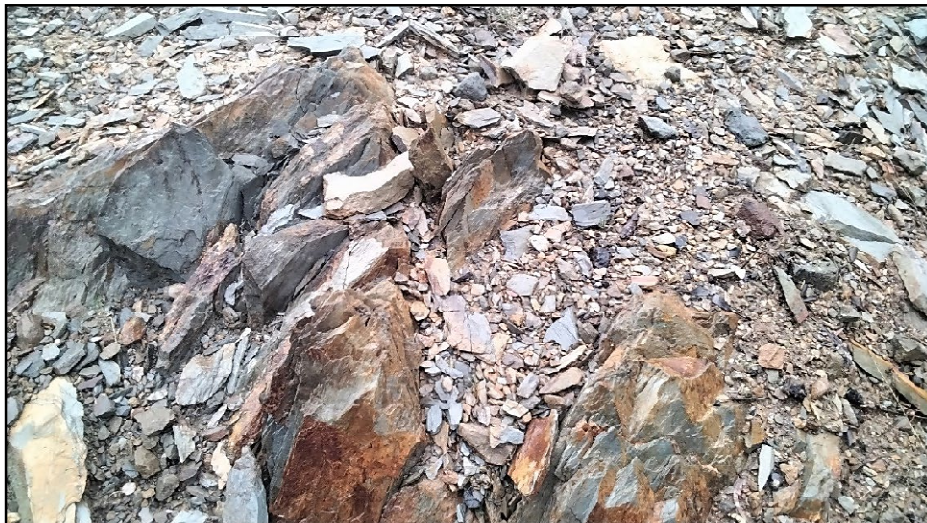
Figure 2: Exposed weathered ROCK noted within the vicinity of the proposed tower site

The boreholes revealed that the natural soil profile consisted of silty CLAY overlying gravelly SAND, grading into weathered ROCK. It is assumed, based on the local geology, that auger refusal was on weathered ROCK of medium to high strength. A photograph of the exposed weathered ROCK within the vicinity of the proposed ingal pole site is provided in **Figure 2**.
