**D M LAWRENCE** EST. 1997  
SOIL TESTING PTY LTD

## **GEOTECHNICAL ASSESSMENT AND LANDSLIDE RISK ASSESSMENT REPORT**

**SITE: CABIN B7, PARCEL B WHITEHORSE VILLAGE ROAD, MOUNT BULLER.**

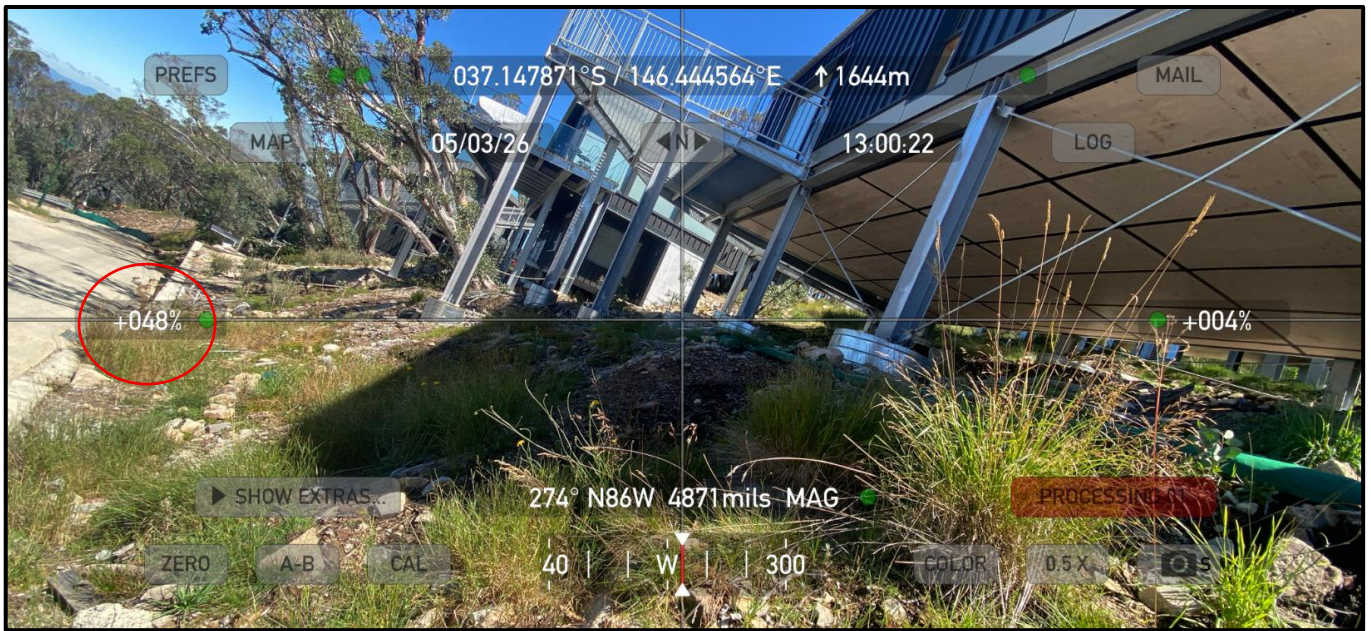
There is a site cut across the front (low side) of the subject property. This cut embankment appears to be associated with the construction of Whitehorse Village Road. As can be seen from the photographs below, this cut embankment is in the order of 1.0 to 1.5 m high and is currently resting at an angle of less than one vertical to two horizontal (1V : 2H). Apart from some loose surface rocks and floaters this road embankment appears to be largely stable at present.

Photo 1 view of typical degree of slope on road CUT embankment (taken on angle to match the slope).

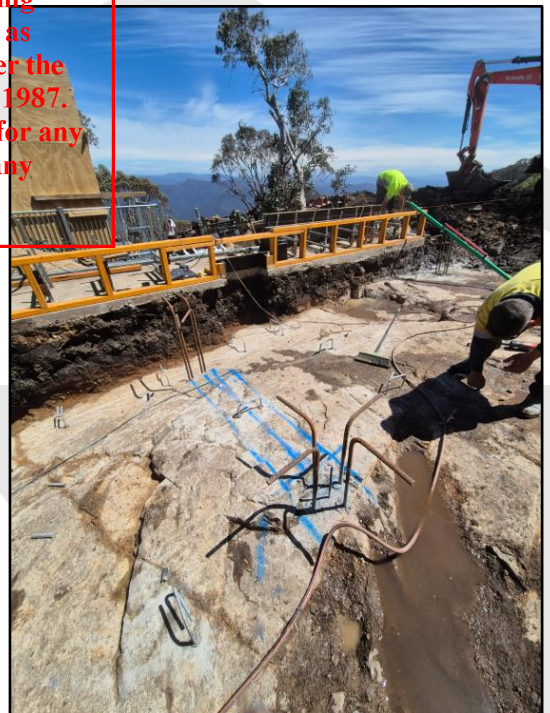
Photo 3 (previously taken by contractor) of insitu, slightly weathered granodiorite bedrock exposed in the footing excavations for a nearby building.

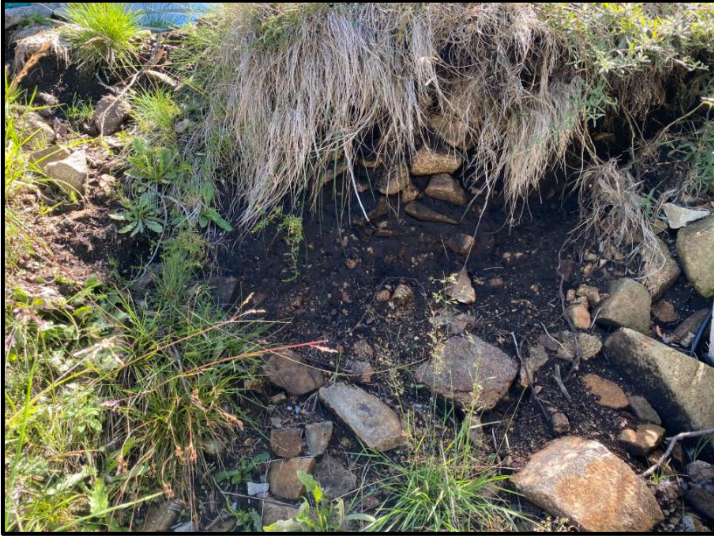
Photo 4 view of typical insitu soil/rock profile exposed in a site cut at the south-eastern corner of the subject site.

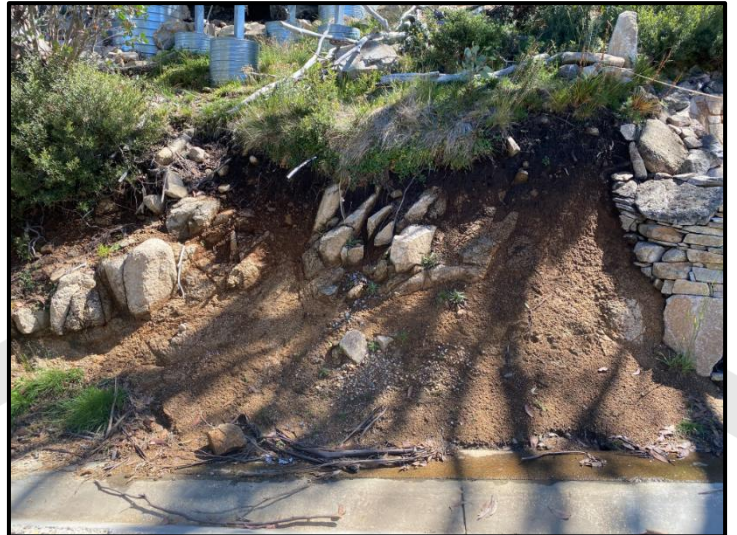
Photo 5 view of typical insitu soil/rock profile exposed in a site cut above Whitehorse Village Road near the south-western corner of the subject site.

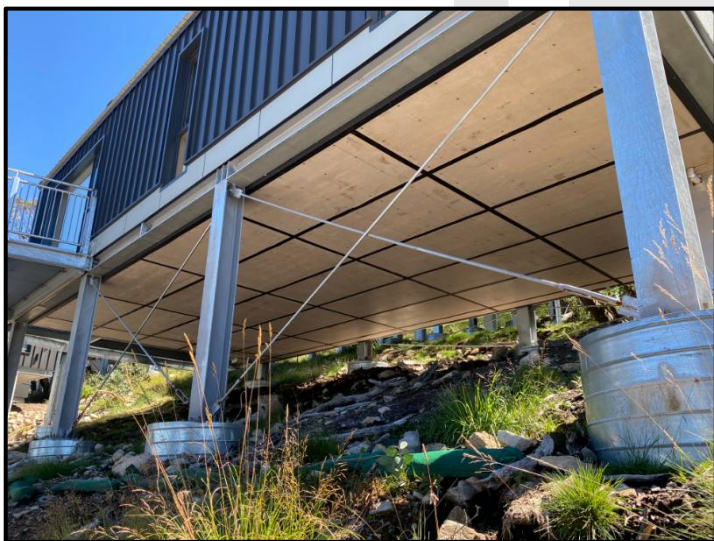
Photo 6 View of sub-floor area beneath the subject building.

Given that the excavations will be undertaken beneath the existing building, extreme care must be taken to ensure the proposed building works at this site do not cause any instability to any remaining footing systems or structures. Short and long-term protection works required by the design must be adopted and maintained as necessary over the design life of the building. It is critical that appropriate drainage is installed and maintained behind the retaining wall at all times.
