# Warwick's Block Cage Free Layer Farm | Torrumbarry

Egg Industry Design Philosophy

Project Number 25E-0010

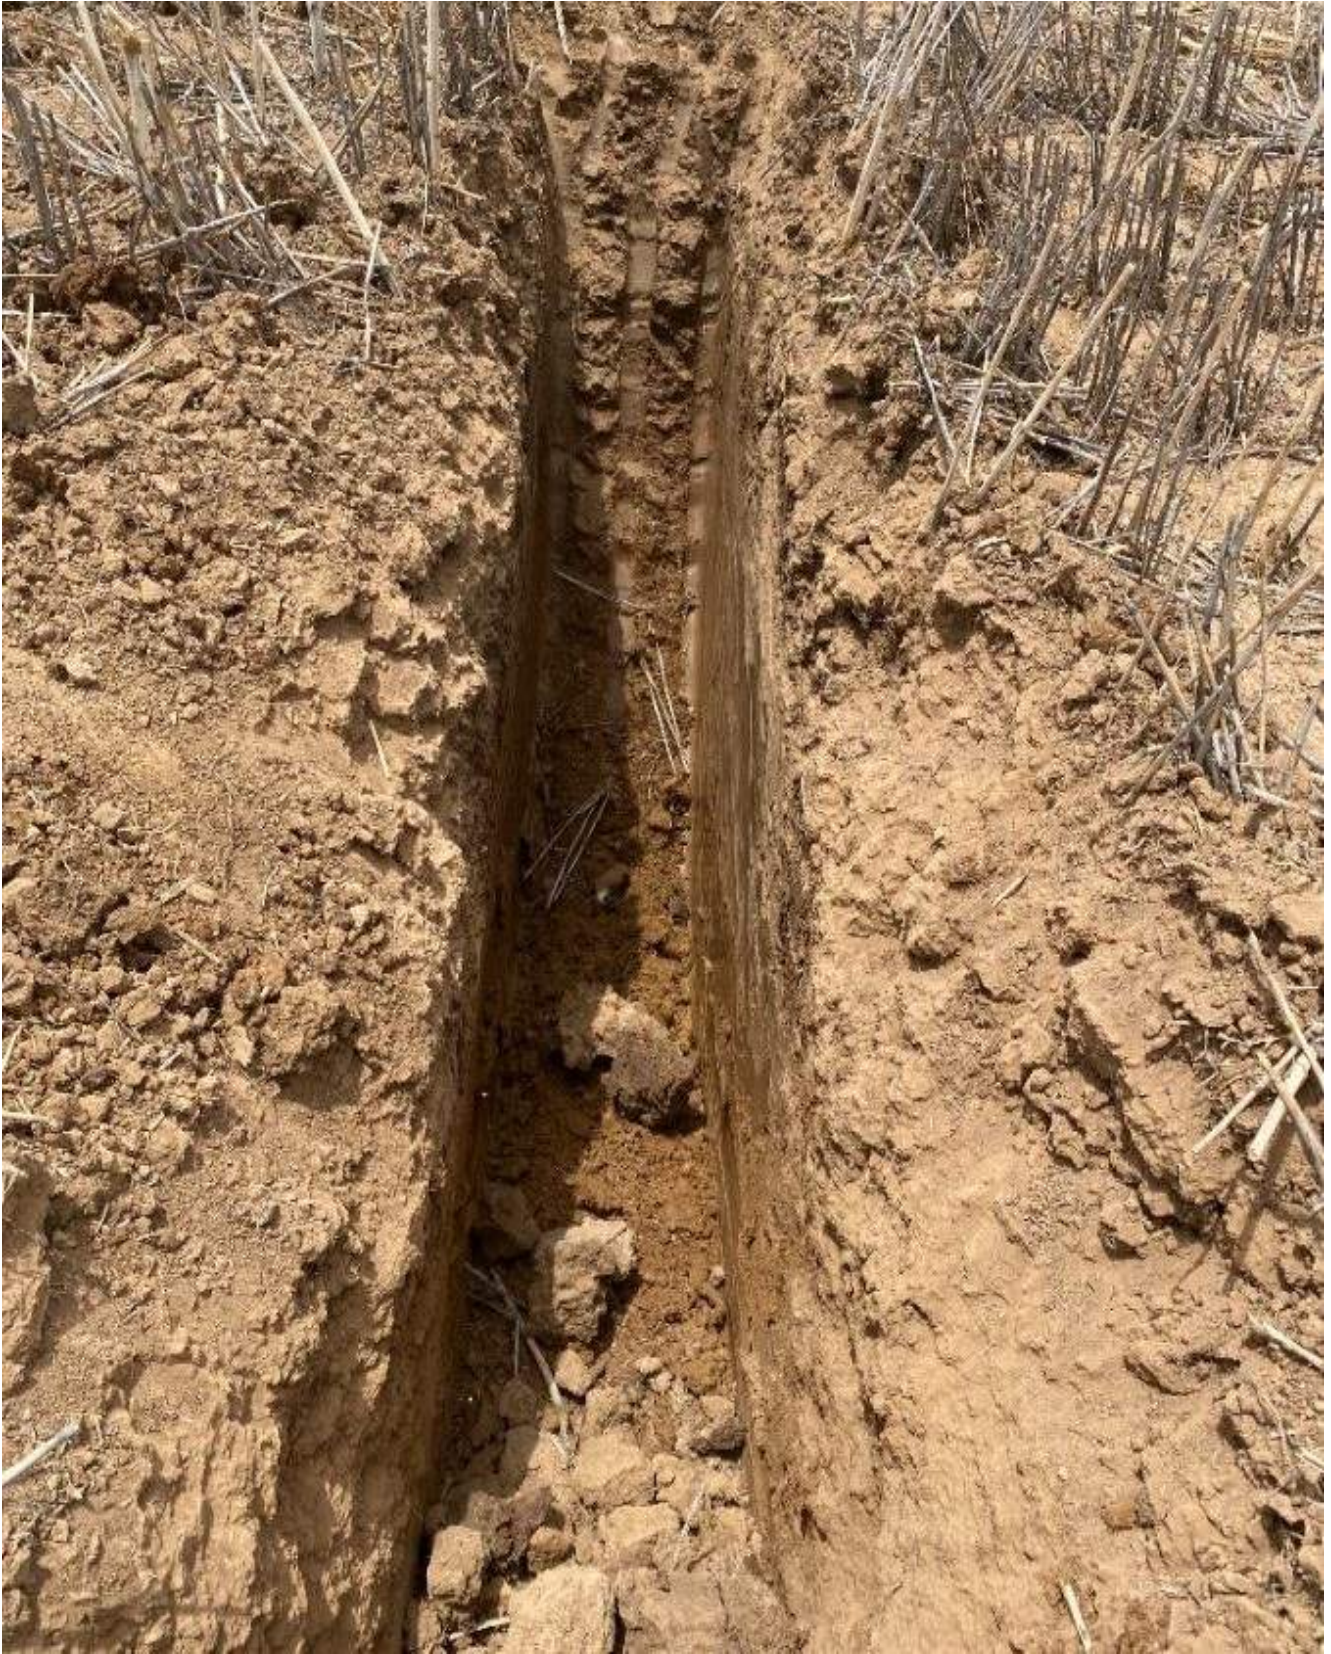
TP01

0.9	Natural		CH	Natural Sandy CLAY CH: stiff, high plasticity, light brown and yellow mottled white, fine grained sand, inorganic, moist to dry.				Atterberg Limits / Emerson Class: LL - 54% LS - 15.5% Iss - 3.3 EC - 4
<b>TP01 Terminated at 1m</b>

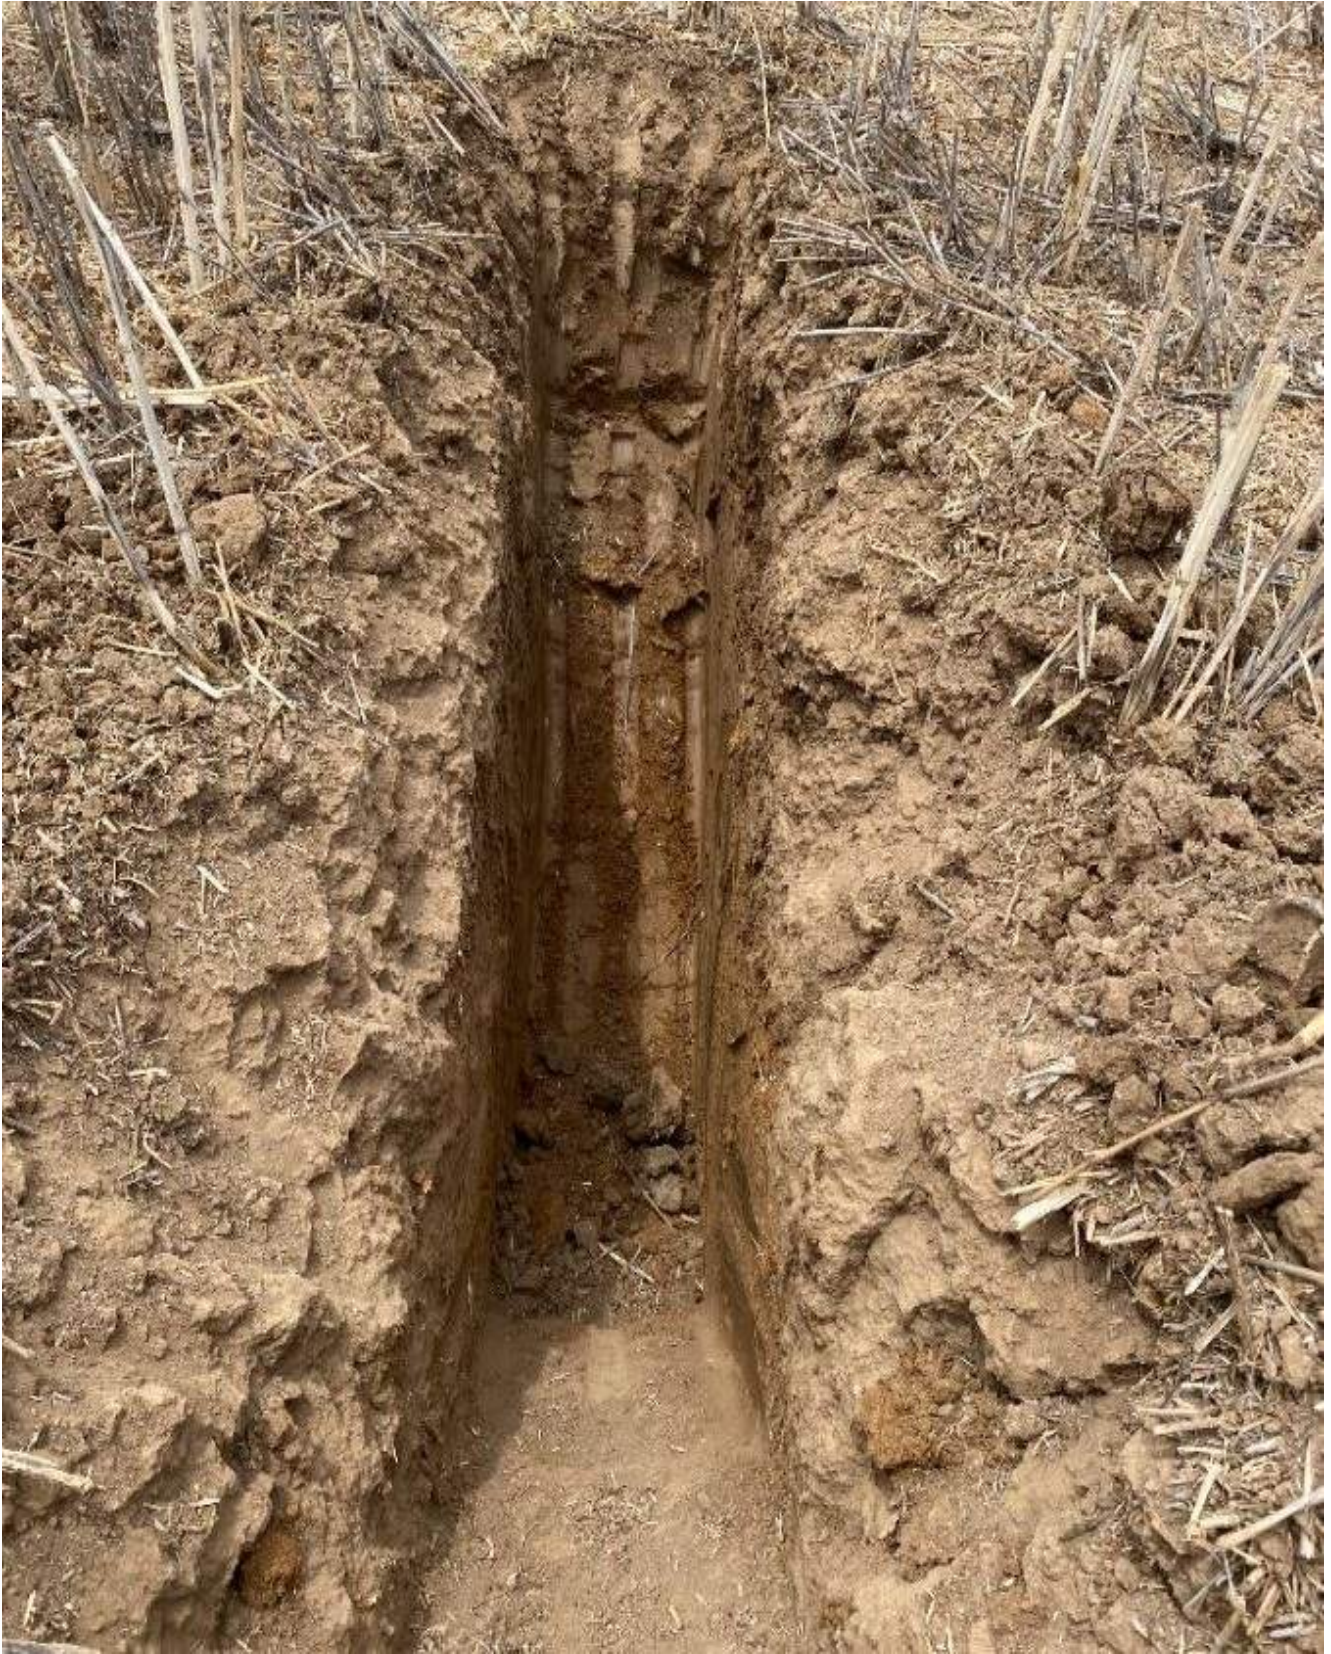
TP02

Excavator Attachment	Depth (m)	Soil Origin	Graphic Log	Classification Code	Material Description	Weathering	Moisture	Consistency/Density	Samples
		Natural		CH	Natural Sandy to silty CLAY CH: stiff, high plasticity, light grey brown, fine grained sand, inorganic, dry.		D	St	
	0.2	Natural		CH	Natural Sandy to silty CLAY CH: stiff, high plasticity, brown, fine grained sand, inorganic, moist.		M		
	0.8	Natural		CH	Natural Sandy CLAY CH: stiff, high plasticity, light brown yellow mottled white, fine grained sand, inorganic, moist to dry.		M-D		
<b>TP02 Terminated at 1m</b>

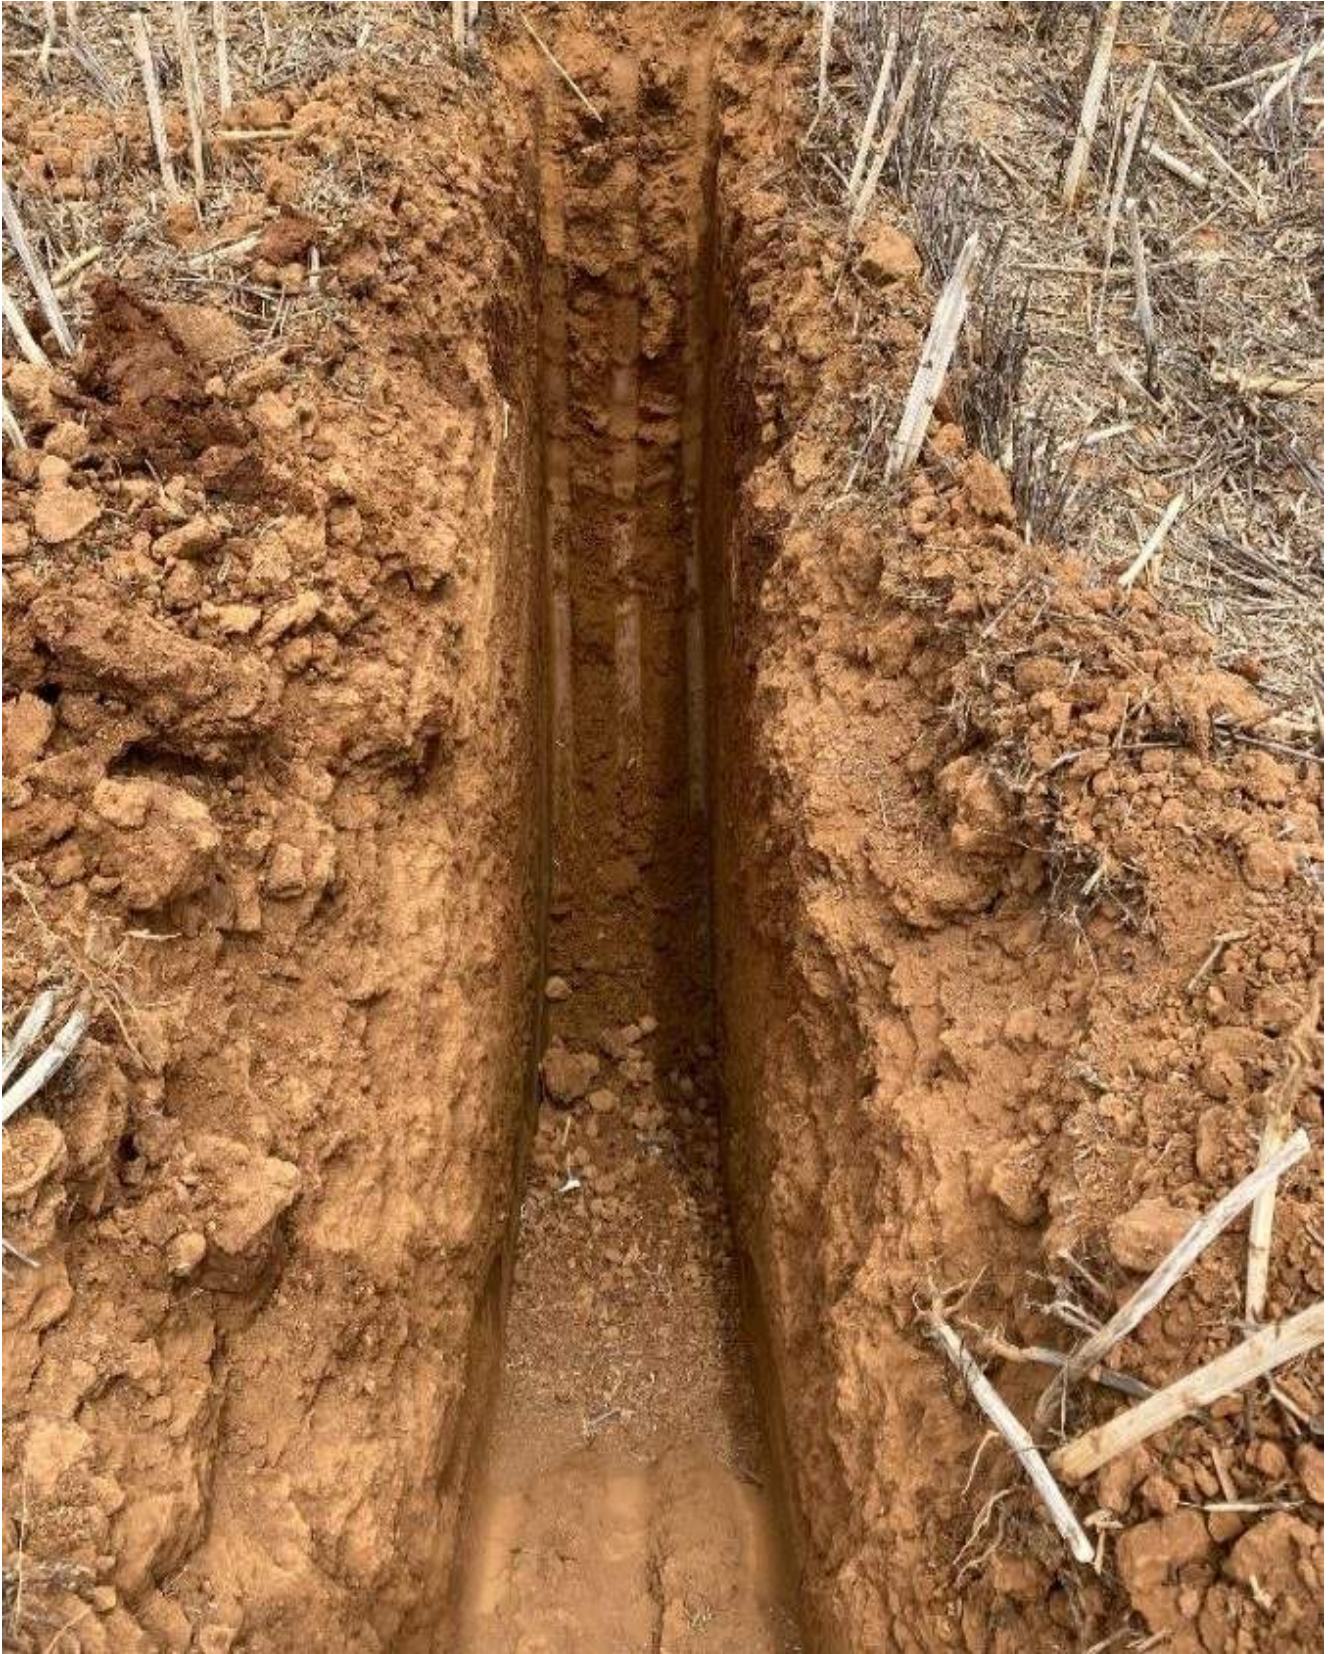
TP03

Excavator Attachment	Depth (m)	Soil Origin	Graphic Log	Classification Code	Material Description	Weathering	Moisture	Consistency/Density	Samples
		Natural		CH	Natural Sandy to silty CLAY CH: stiff, high plasticity, light grey brown, fine grained sand, inorganic, dry.		D	St	
	0.2	Natural		CH	Natural Sandy to silty CLAY CH: stiff, high plasticity, brown, fine grained sand, inorganic, moist.		M		
	0.5	Natural		CH	Natural Sandy to silty CLAY CH: soft, high plasticity, light orange brown, fine grained sand, inorganic, moist to dry.		M-D	S	
	0.7	Natural		CI-CH	Natural Sandy CLAY CI-CH: stiff, medium to high plasticity, orange brown mottled white, fine grained sand, inorganic, moist to dry. fine to coarse sand size crystals were observed..			St	Atterberg Limits / Emerson Class: LL - 51% LS - 16.5% I <sub>ss</sub> - 3.7 EC - 4
<b>TP03 Terminated at 1m</b>

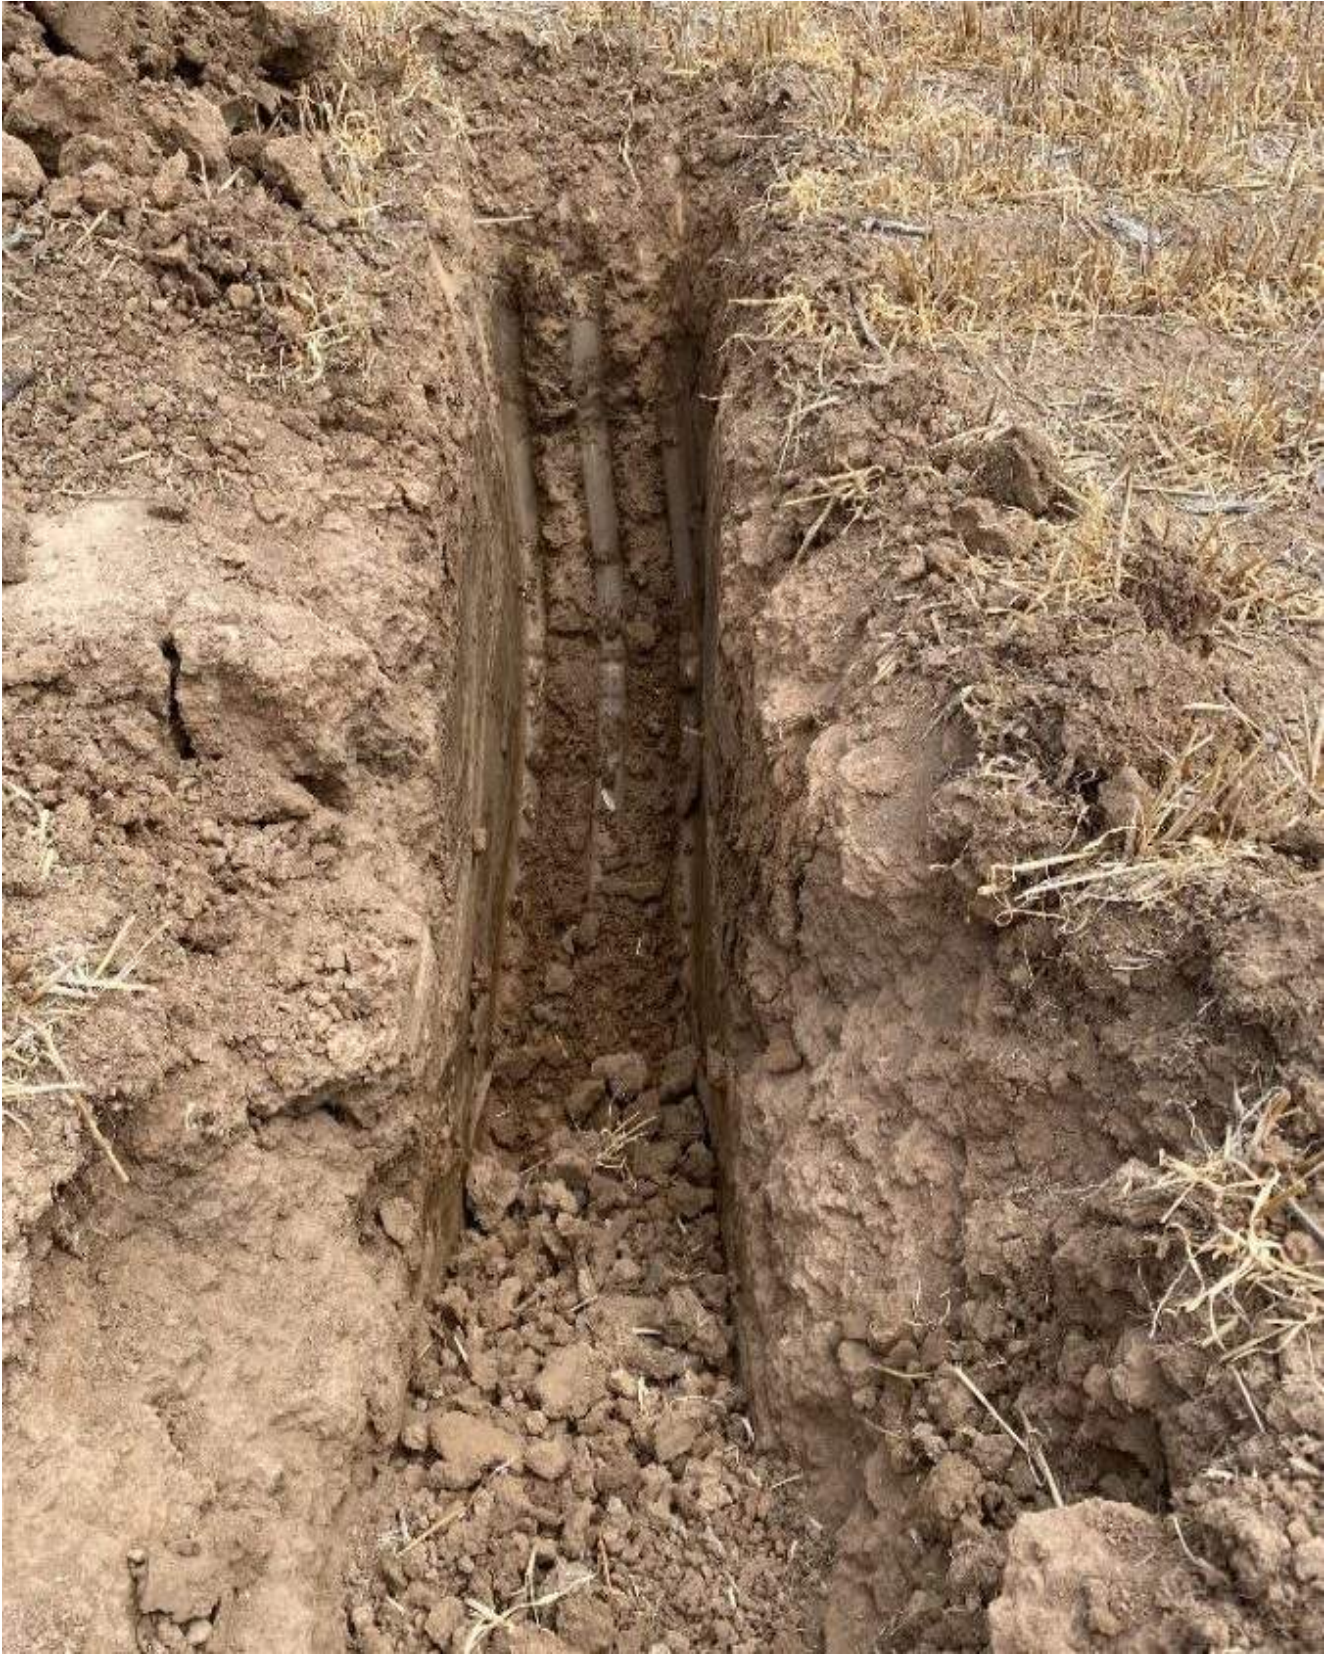
TP05

Excavator Attachment	Depth (m)	Soil Origin	Graphic Log	Classification Code	Material Description	Weathering	Moisture	Consistency/Density	Samples
	0.1	Natural		CH	Natural Sandy to silty CLAY CH: stiff, high plasticity, light grey brown, fine grained sand, inorganic, dry.		D	St	
	0.6	Natural		CH	Natural Sandy to silty CLAY CH: high plasticity, dark brown, fine grained sand, inorganic, moist to dry.		M-D		Atterberg Limits / Emerson Class: LL - 63% LS - 17.5% Iss - 3.1 EC - 6
		Natural		CI-CH	Natural Sandy CLAY CI-CH: stiff, medium to high plasticity, orange brown mottled white, fine grained sand, inorganic, moist to dry. fine to coarse sand crystals were observed.			St	
<b>TP05 Terminated at 1m</b>
