### APPENDIX D – ARBORIST REPORT

# Tree Assessment Report

## Esso

# Long Island Facility, Hastings

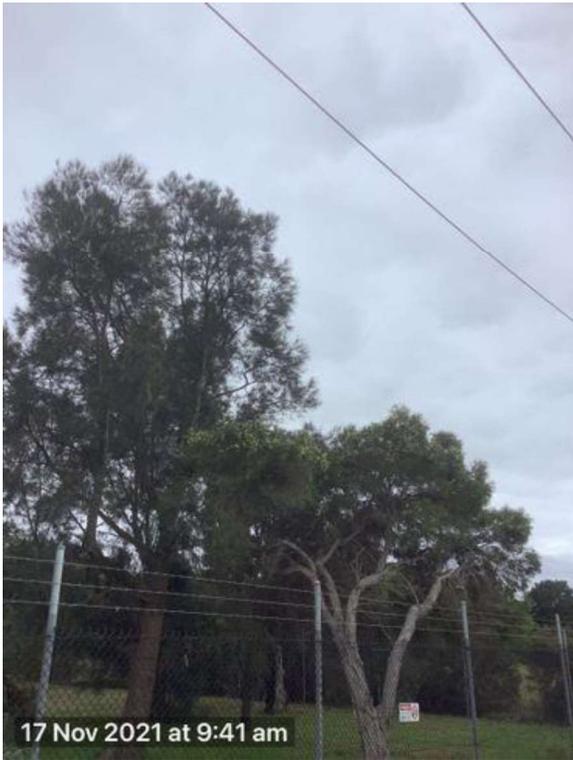
JOB 1	
Street	Barkley cres
House Number	
Pole Number	
LIS #	
Voltage	66kV
Land Owner

Photo 1	
Trims	2
Removals	
Species	Mel
Equipment Required	EWP
Comments	Melaleuca and 2 trims in substation HGS

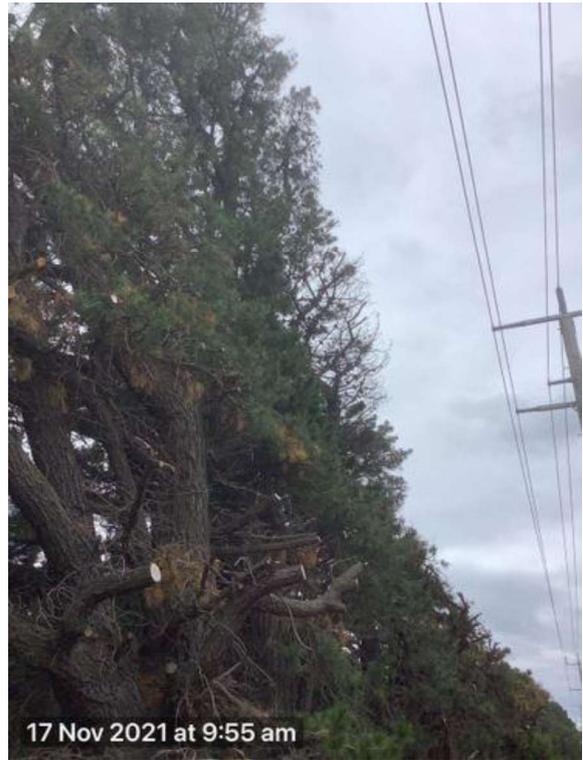
Photo 2

<b>JOB 2</b>	
Street	Barkley cres
House Number	
Pole Number	
LIS #	
Voltage	66kV
Land Owner	Vic Roads

<p>Photo 2</p>	
Trims	3
Removals	
Species	Pine
Equipment Required	EWP
Comments

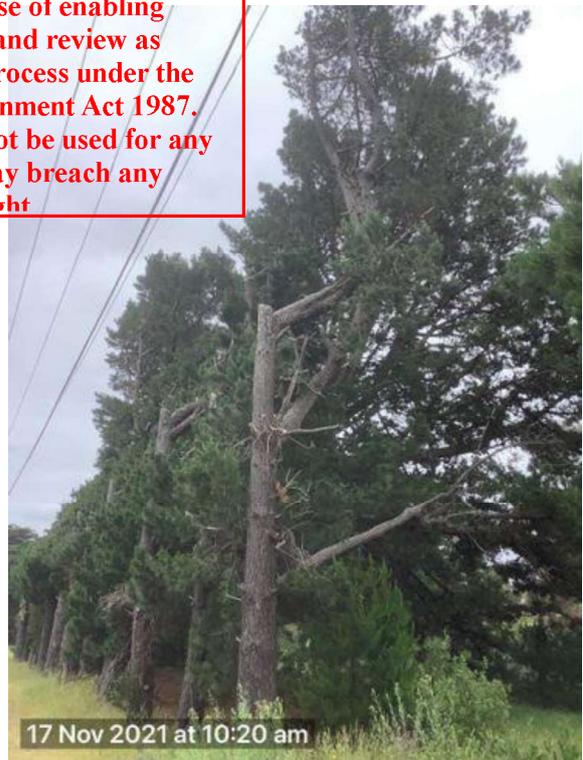
JOB 4	
Street	Barkley st
House Number	
Pole Number	
LIS #	
Voltage	66kV
Land Owner	Vline

Photo 4	
Trims	10
Removals	
Species	Pine
Equipment Required	EWP
Comments

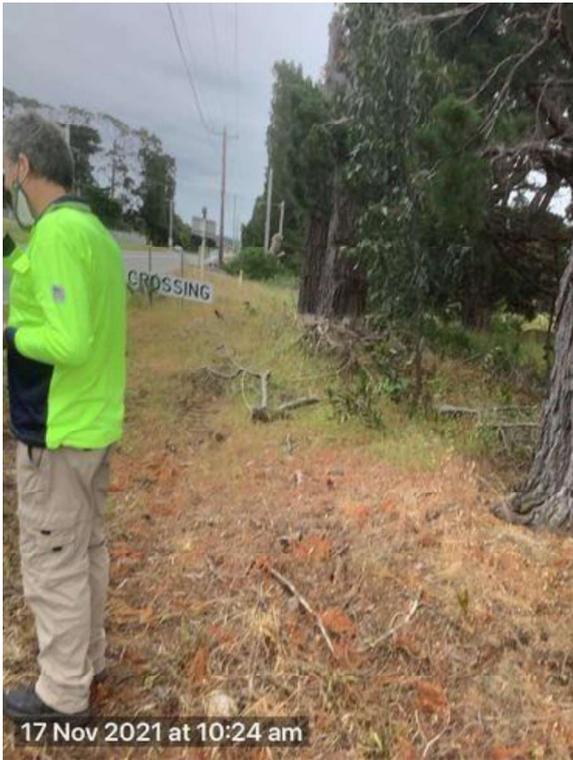
Photo 5

JOB 5	
Street	
House Number	
Pole Number	
LIS #	
Voltage	66kV
Land Owner	Vline

<p>Photo 5</p>	
Trims	3
Removals	
Species	Pine
Equipment Required	EWP
Comments

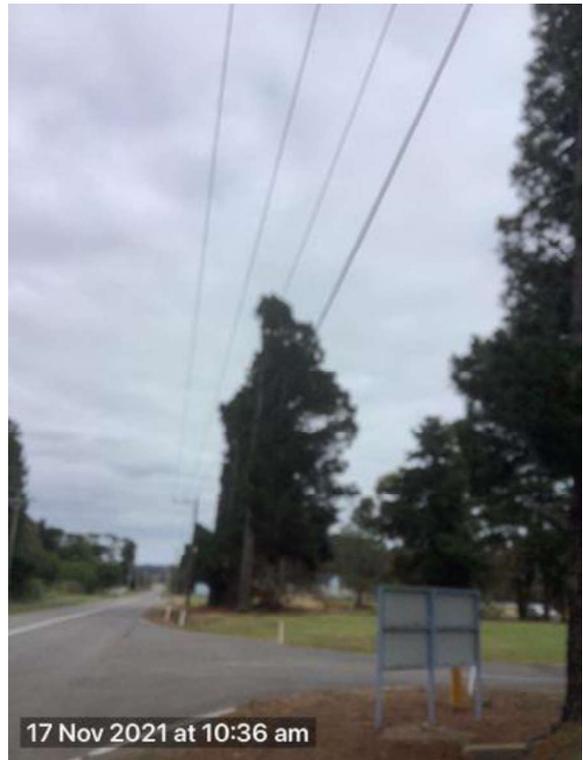
Photo 6

JOB 6	
Street	Barkley st
House Number	
Pole Number	18
LIS #	11=06886
Voltage	66kV
Land Owner	Vic Roads

<p>Photo 6</p>	
Trims	8
Removals	
Species	Pine
Equipment Required	EWP
Comments	23 metre

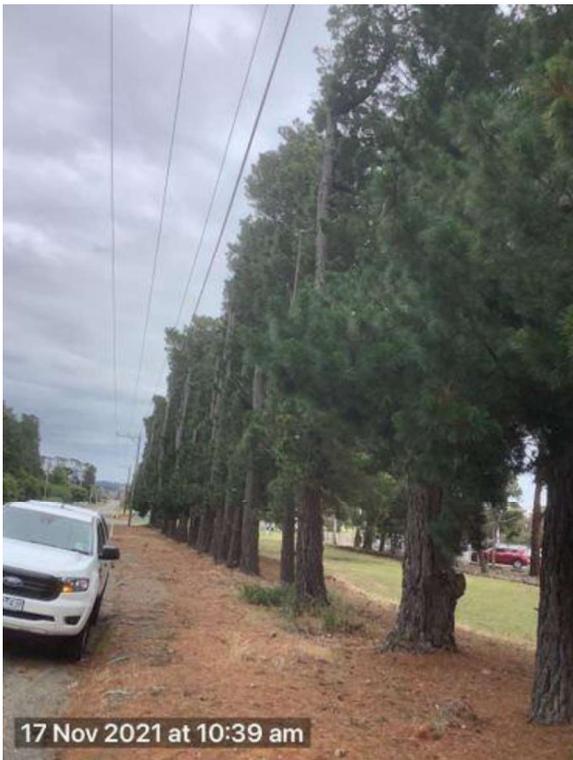
Photo 7

JOB 7	
Street	Barkley st
House Number	
Pole Number	19
LIS #	11-06887
Voltage	66kV
Land Owner	Vic Roads

<p>Photo 7</p>	
Trims	26
Removals	
Species	Pine
Equipment Required	EWP
Comments	23 metre

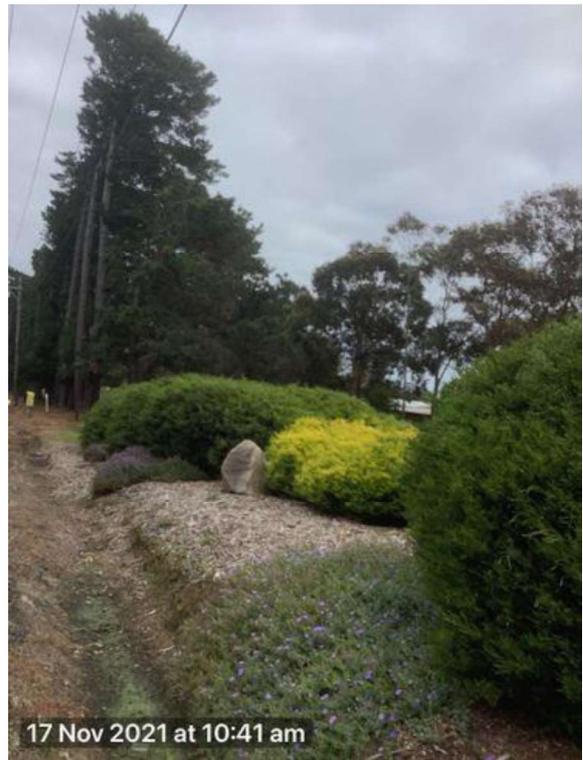
JOB 8	
Street	Barkley st
House Number	
Pole Number	
LIS #	
Voltage	66kV
Land Owner	Vic Roads

Photo 8	
Trims	8
Removals	
Species	Pine
Equipment Required	EWP
Comments	Trim top out of 6 pines 23 metre EWP

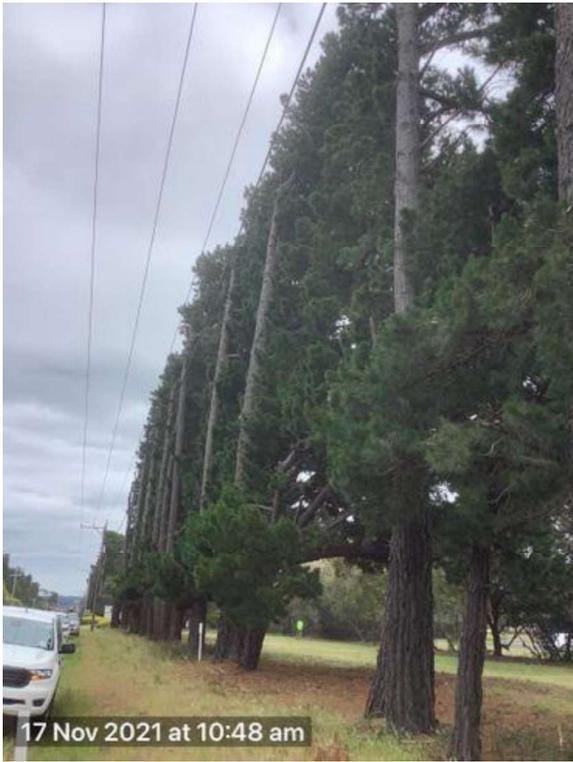
Photo 9

JOB 9	
Street	Barkley st
House Number	
Pole Number	22
LIS #	11=06890
Voltage	66kV
Land Owner	Vic Roads

<p>Photo 9</p>	
Trims	20+
Removals	
Species	Pine
Equipment Required	EWP
Comments	Check clearances after conductors strung & sagged

1. Recommend a follow up Inspection after the Conductors have been Strung & Sagged and prior to the Overhead Powerline being energized to precisely measure the distance between the Trees and Conductors
2. Some Major Pruning and Removals of the Mature Pine Trees from Pole 2 to Pole 11 as currently the Trees are trimmed back to the Main Stem and with the Larger Conductor and increased Voltage of 66KV extra Clearances will be required.
3. As less than 33% of the canopy of the Eucalypts & Melaleuca's will be removed to allow for the required clearances it is envisaged that Planning Permits will not be required to undertake these works

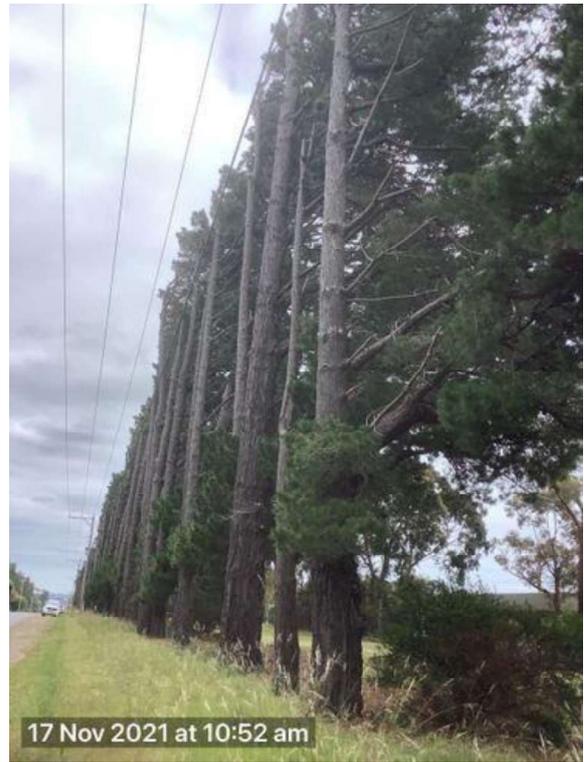
Photo 10

JOB 10	
Street	Barkley st
House Number	
Pole Number	23
LIS #	11-06891
Voltage	66kV
Land Owner	Vic Roads

<p>Photo 10</p>	
Trims	20+
Removals	
Species	Pine
Equipment Required	
Comments	Check clearance after condors strung & sagged, some trees will require heads taken out

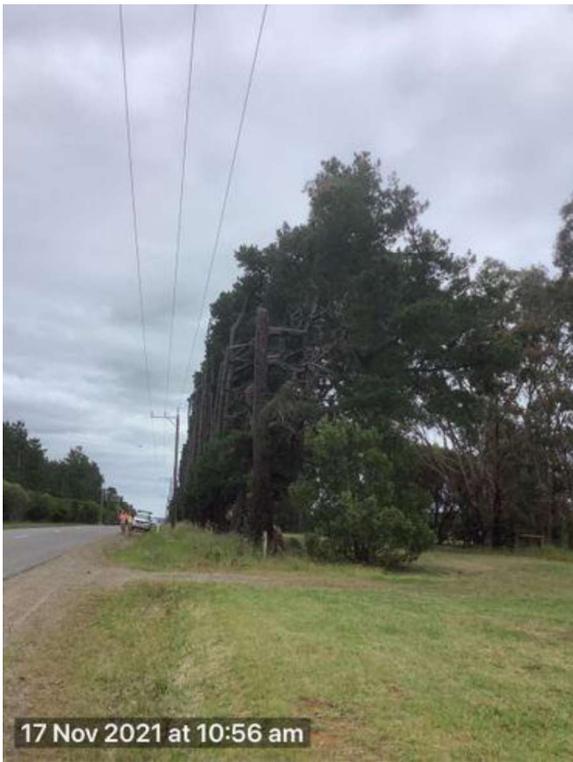
Photo 11

JOB 11	
Street	Barkley st
House Number	
Pole Number	24
LIS #	11-06892
Voltage	66kV
Land Owner	Vic Roads

<p>Photo 11</p>	
Trims	4
Removals	
Species	Pine
Equipment Required	
Comments	23 metre EWP

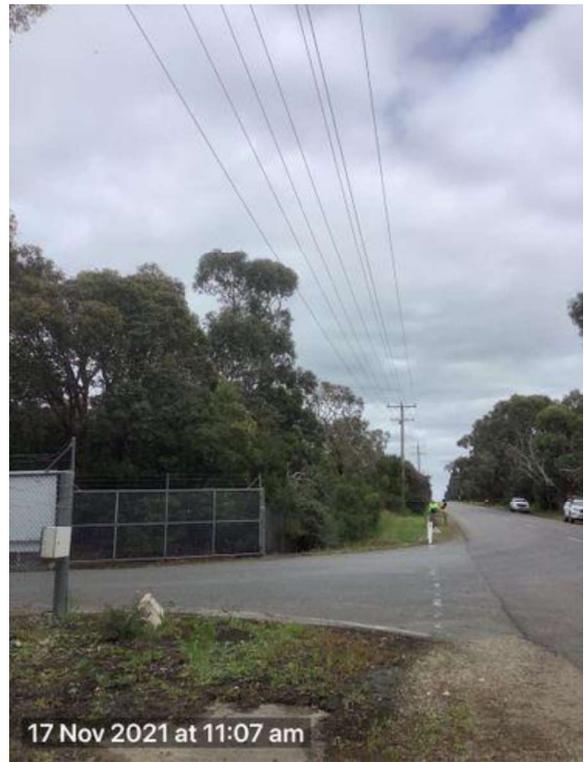
Photo 12

JOB 12	
Street	
House Number	
Pole Number	32
LIS #	11-06901
Voltage	66kV
Land Owner	Evergreen garden care

<p>Photo 12</p>	
Trims	
Removals	
Species	Rough hardest mana gum
Equipment Required	EWP
Comments	Minor trim

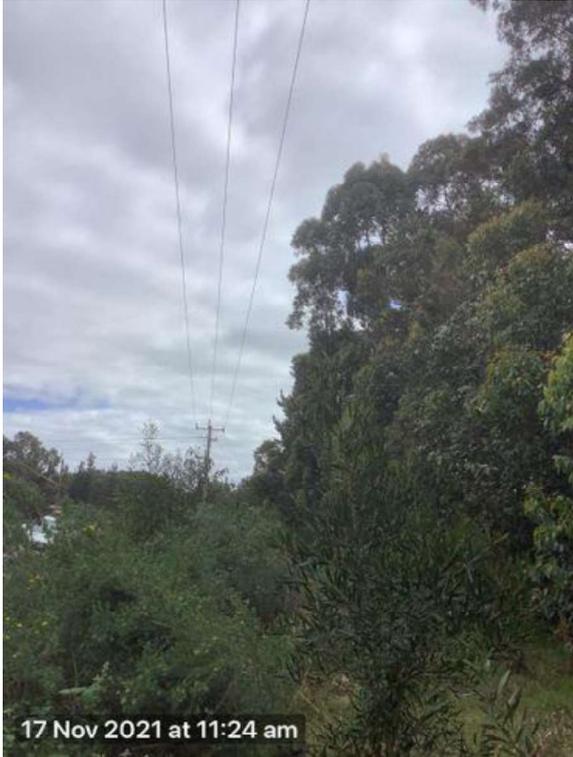
Photo 13

JOB 13	
Street	Barkley st
House Number	
Pole Number	36
LIS #	11-06906
Voltage	66kV
Land Owner	Vic Roads

<p>Photo 13</p>	
Trims	4
Removals	
Species	Euc
Equipment Required	Ground Crew
Comments	Trim 4 x spotted gums

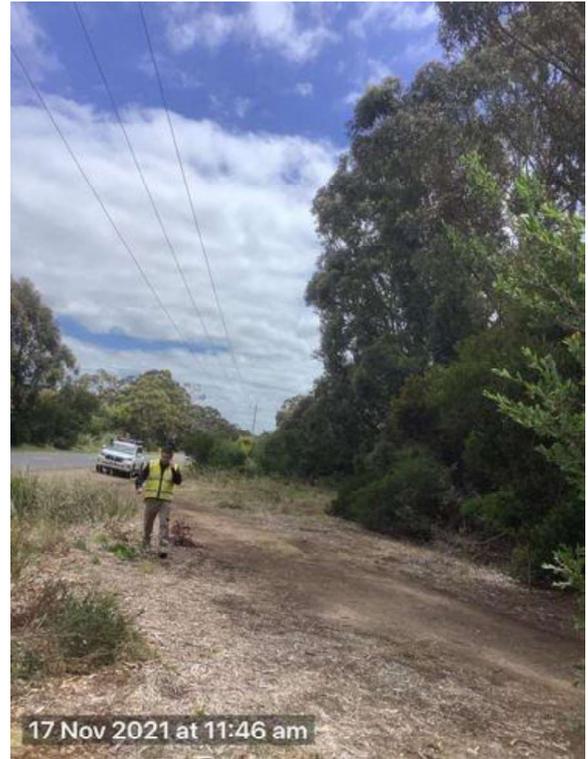
Photo 14

JOB 14	
Street	Long Island drive
House Number	
Pole Number	38
LIS #	06908
Voltage	66kV
Land Owner	Vic Roads

<p>Photo 14</p>	
Trims	3
Removals	
Species	Euc
Equipment Required	EWP
