**APPENDIX 11 EGG INDUSTRY DESIGN PHILOSOPHY**

# T-Block Free Range Layer Farm | Torrumbarry

Egg Industry Design Philosophy

**Project Number** 25E-0010

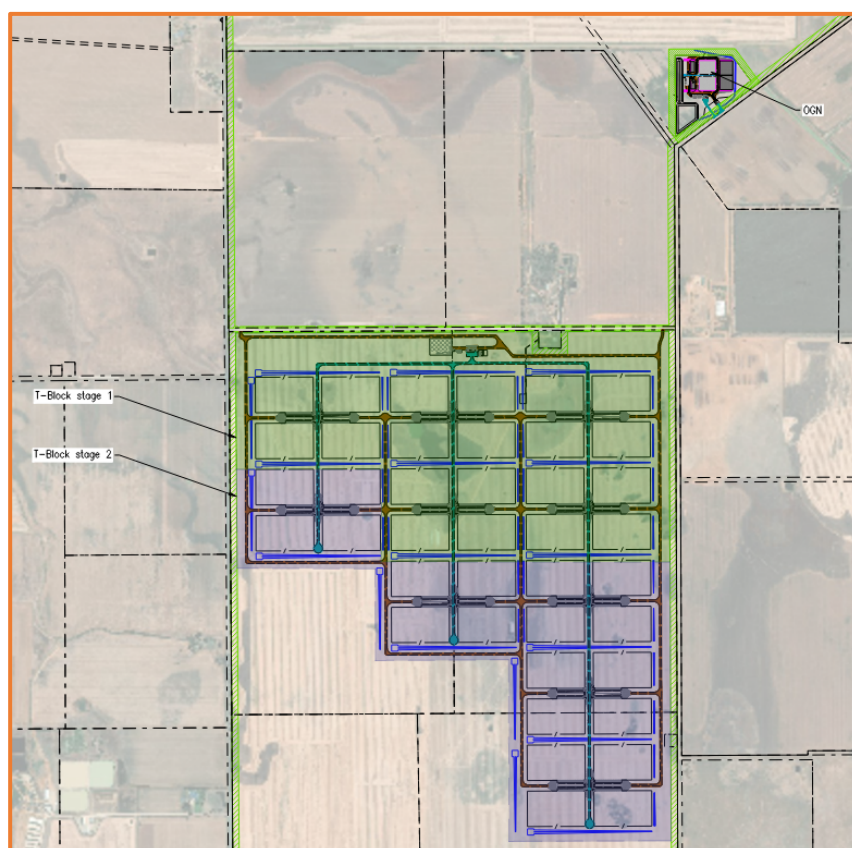
**Figure 1-2: Proposed Development Site Layout Plan**

Refer to **Figure 1-2** below for the individual proposed development site layout plan that will be assessed in this report.

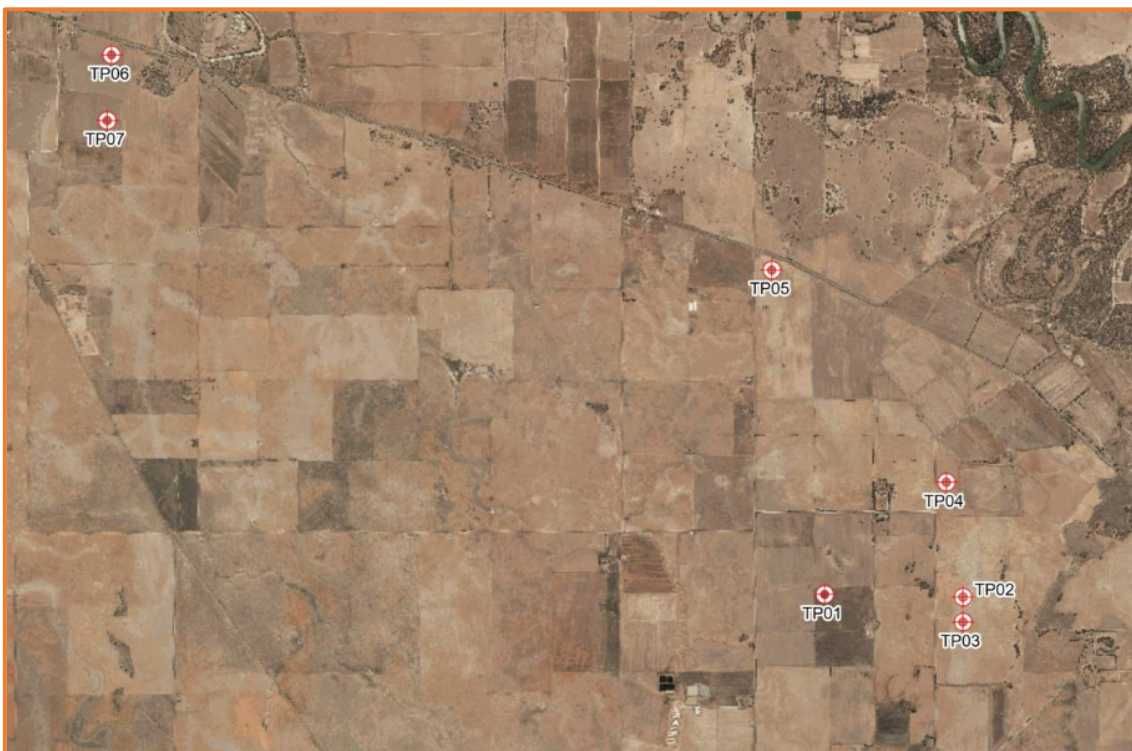
**Figure 3-2: Test Pit Location Plan**

The borehole test pit locations can be seen in **Figure 3-2** below.

Within the Geotechnical Report (**Appendix B**), the following Test Pit locations are relevant to the T-Block Free Range Laying Farm development:

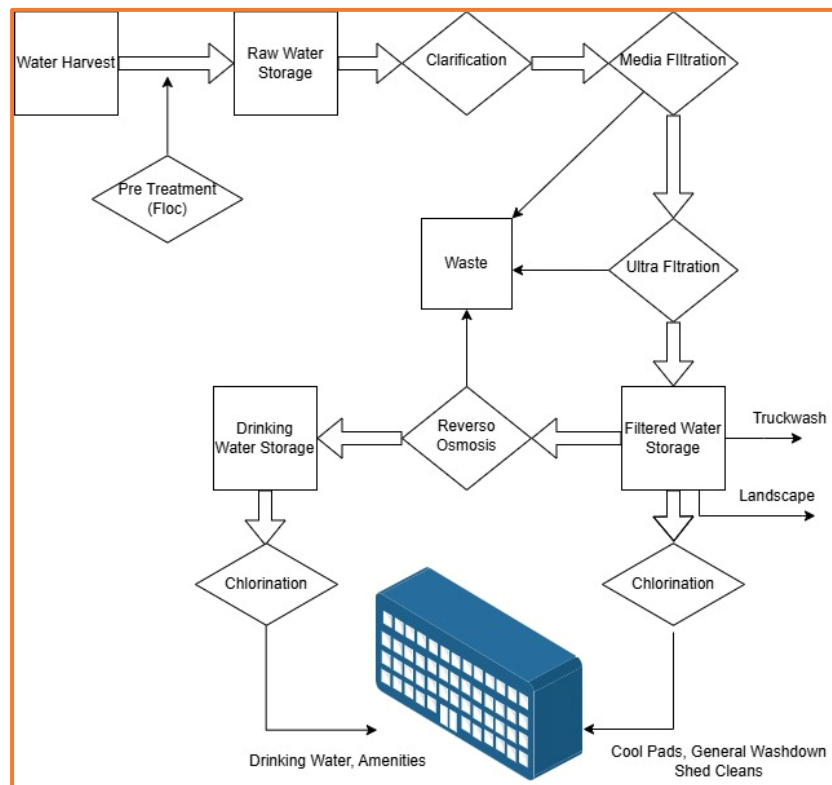
**Figure 4-1: Water Treatment Process.**

Refer to **Figure 4-1** below for the water treatment process to be utilised for treatment of extracted water from bodies of water.

The water treatment process will result in various by-products in the form of waste. These by-products are intended to be disposed of in suitable ways by a licensed contractor or taken to the proposed composting site.

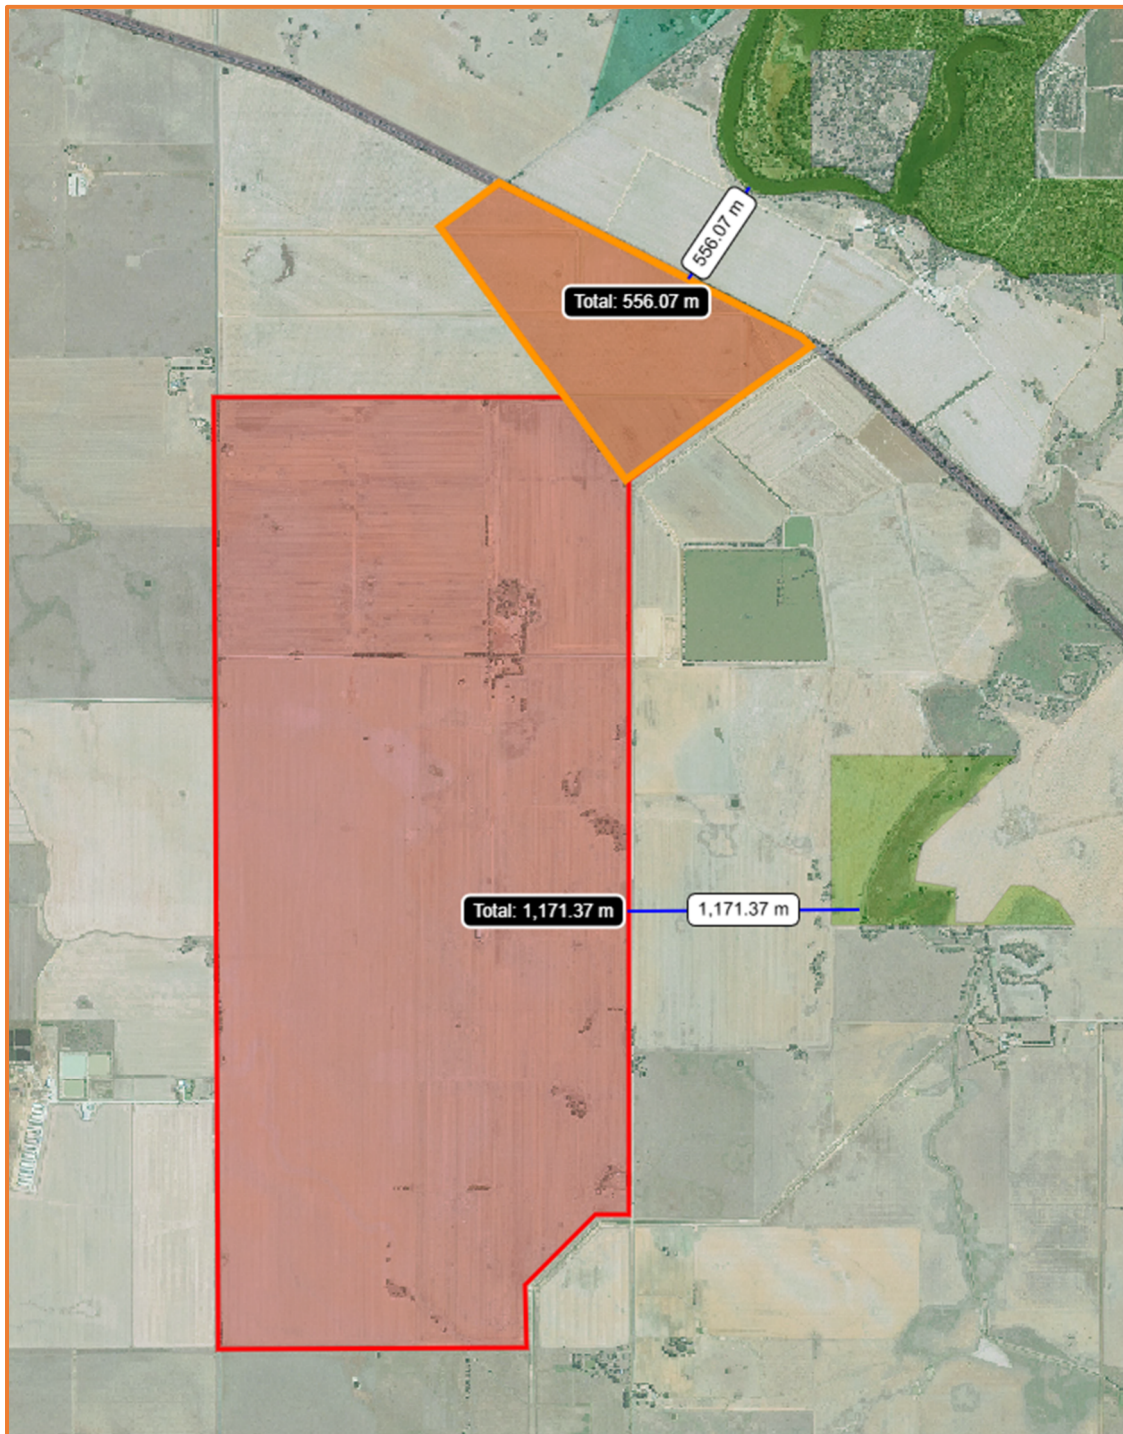
**Figure 5-5: Distance to nearest mapped waterways from site boundary.**

- Rainfall Factor: < 5,000 (refer to **Figure 5-4** above).
- Distance to Waterways: >200m (refer to **Figure 5-5** below).
- Farm Size: 20 Sheds at 40,000 birds, total of 800,000 birds per farm.
- Soil Profile: Well-structured/draining soils – sandy clay soils (refer to **Appendix B** for results).
- Land Shape: Uniform flat or sloping flat.
- Groundcover: 80-100%.
- Stocking Rate: >5000 birds/ha.
- Slope: <1.
- Soil Phosphorus: 8-12 (assumption).
- Topsoil PBI: >280 (clay).

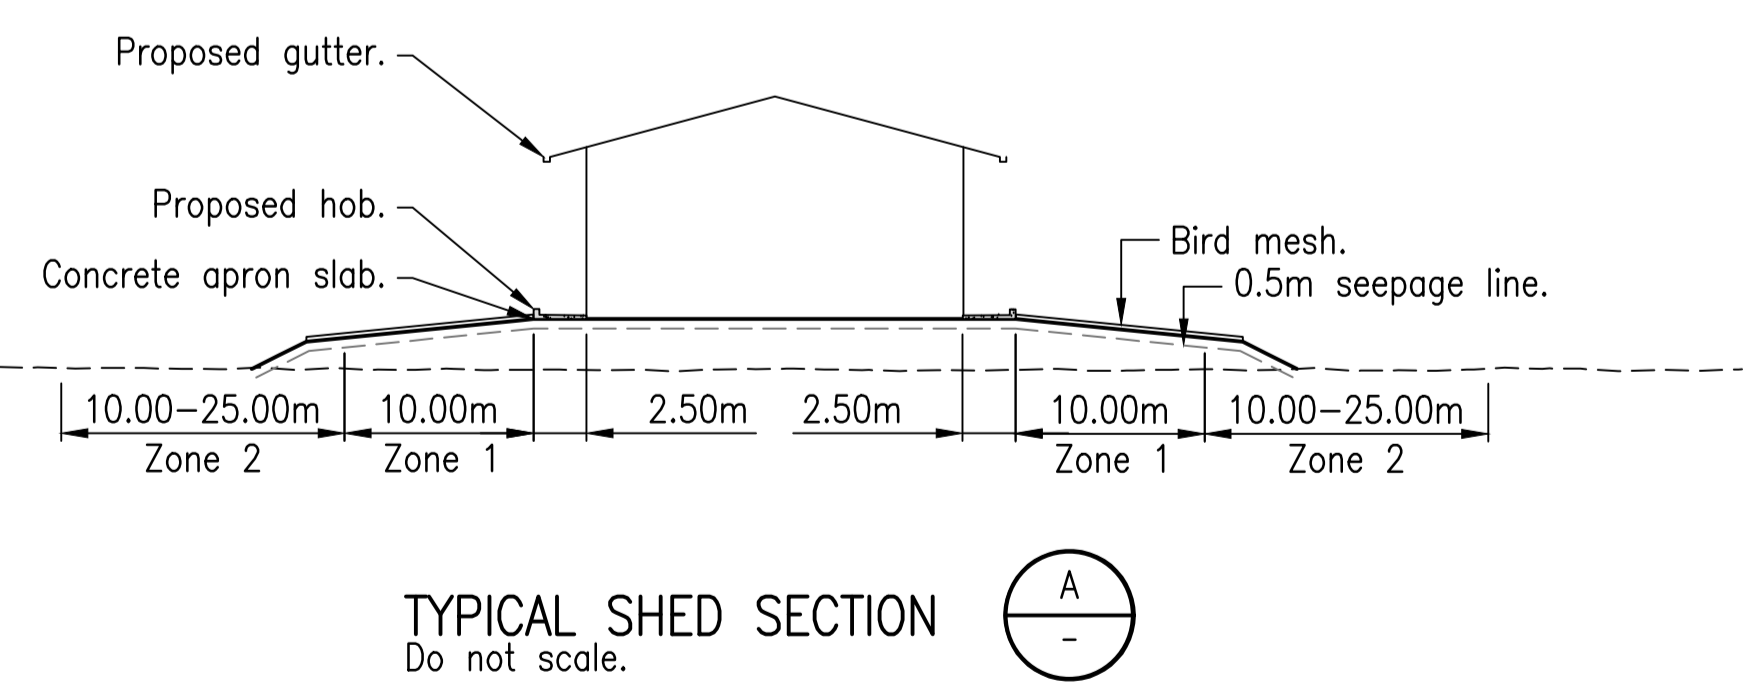
# EGG INDUSTRY GUIDELINES DESIGN SITE LAYOUT PLAN

E.1. Zone 1: 0-10m  
E.2. Zone 2: 10-25m  
E.3. Zone 3: >25m

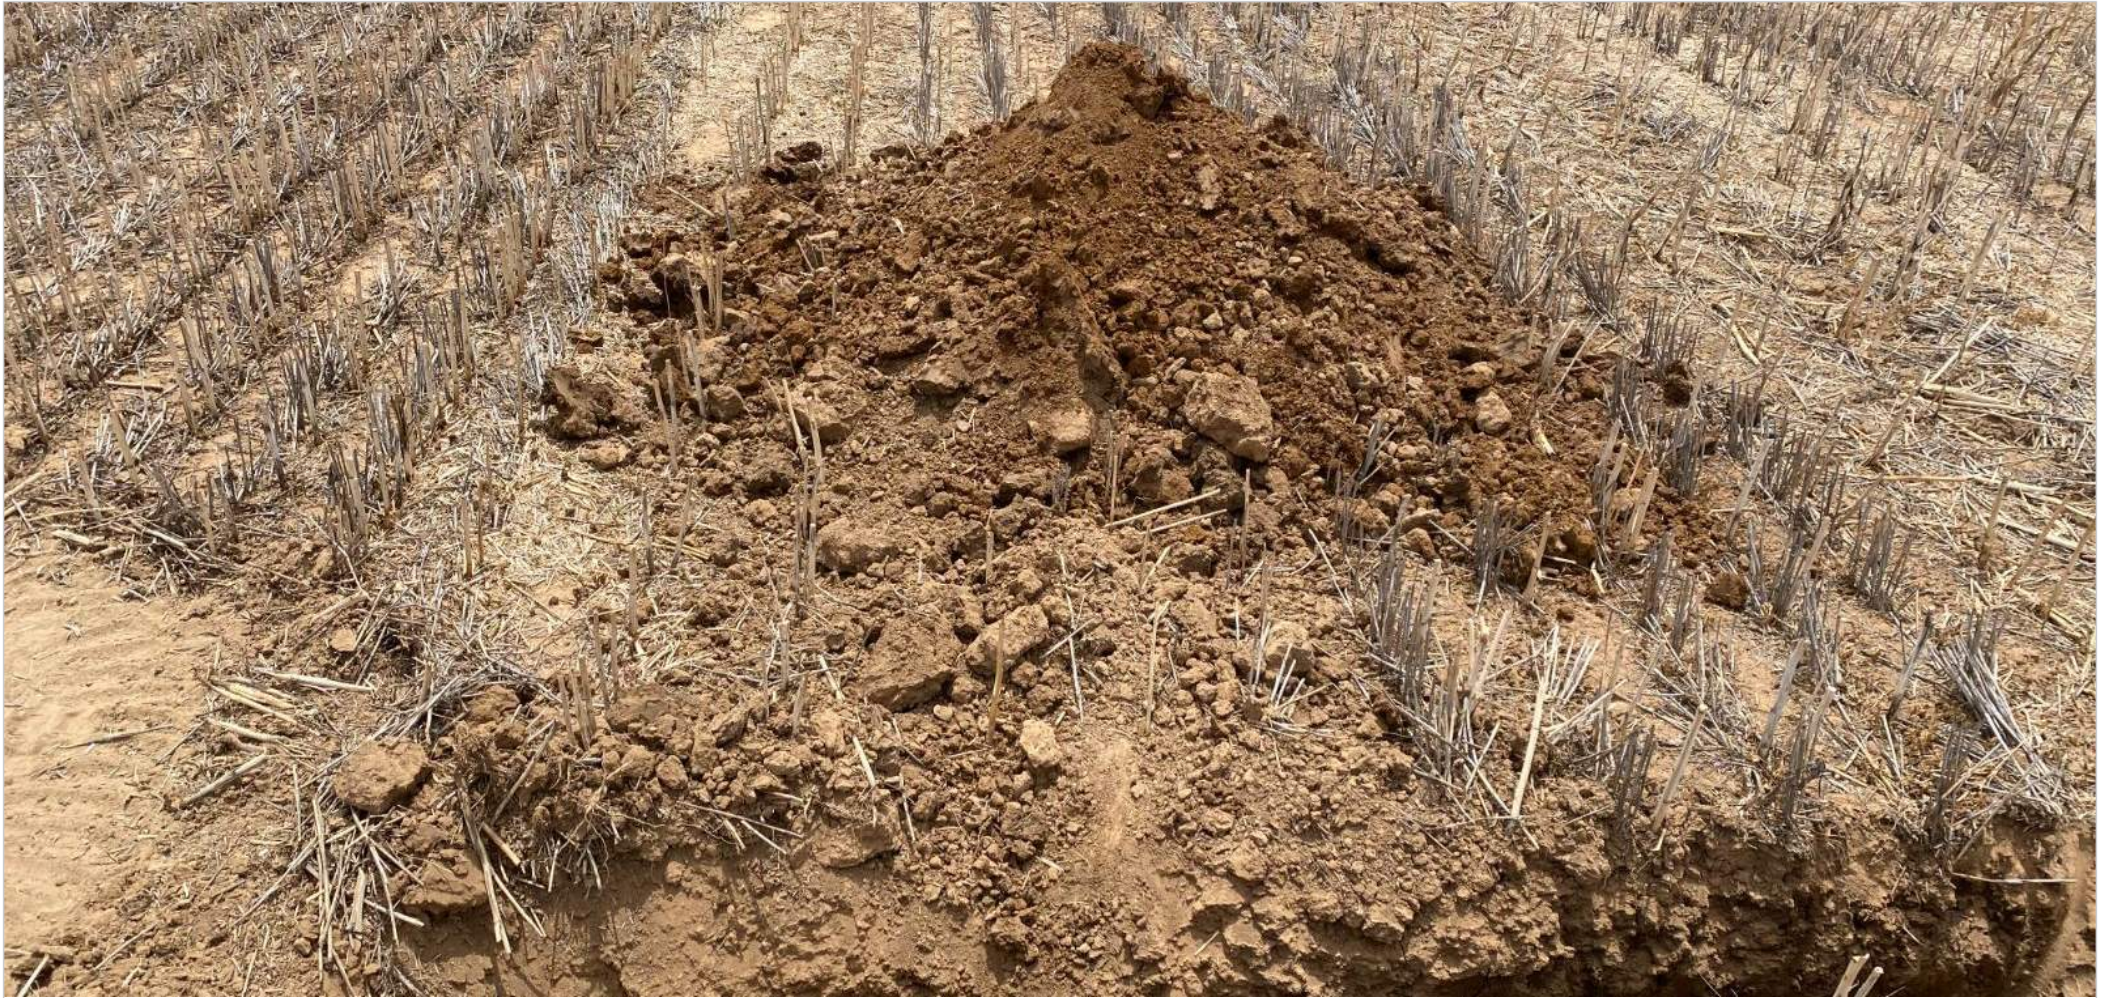
(07) 4639 4100	<b>Photo description</b>	TP01 Spoil		
	  5 Bowen Street. Toowoomba Qld 4350	<b>Client</b>	Maclean Farms		
	  enquiries@rmasoils.com.au	<b>Location</b>	Echuca VIC, Australia		
		<b>Project name</b>	GA - Torrumbarry Property Victoria		
		<b>Project No</b>	25-S-0016	<b>Scale</b>	Not to Scale
		<b>BH No</b>	TP01	<b>BH Depth</b>	CorePhoto

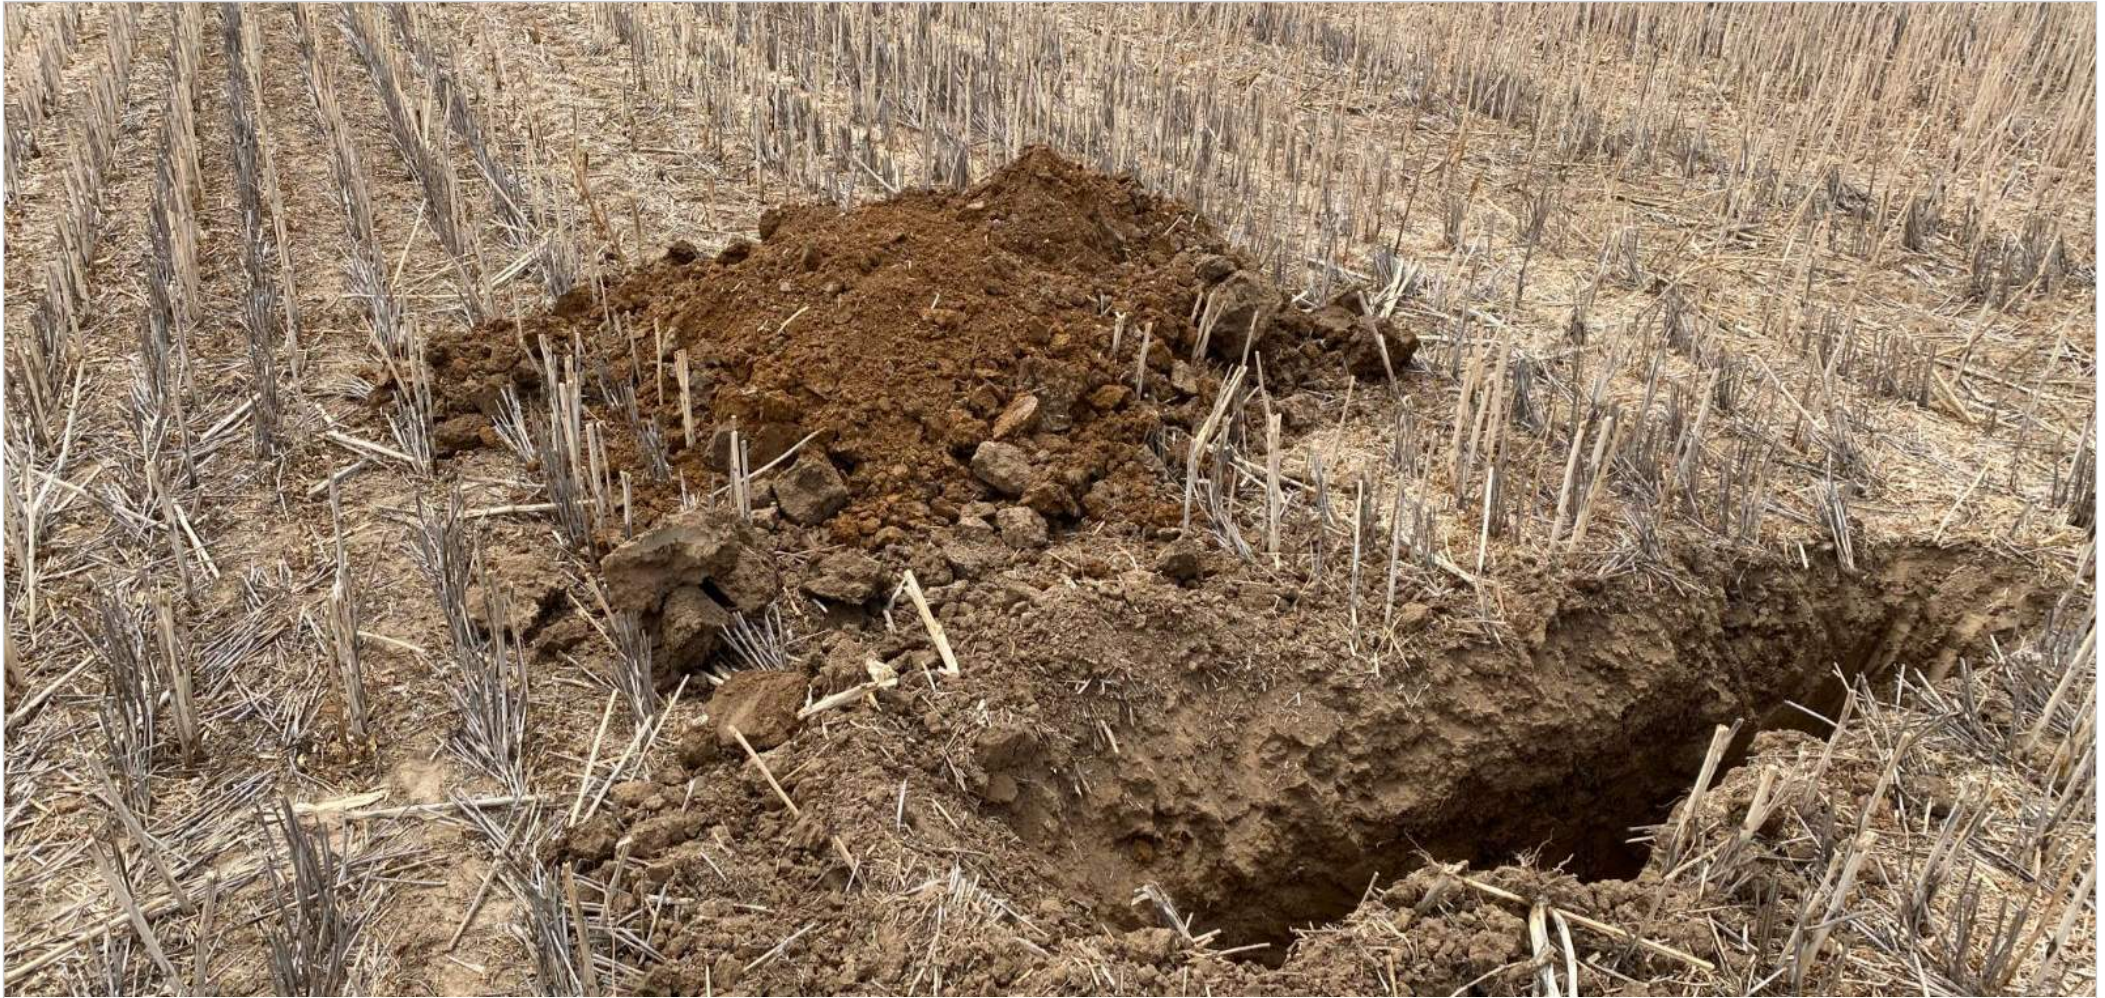
(07) 4639 4100	<b>Photo description</b>		TP02 Spoil	
	  5 Bowen Street. Toowoomba Qld 4350	<b>Client</b>		Maclean Farms	
	  enquiries@rmasoils.com.au	<b>Location</b>		Echuca VIC, Australia	
		<b>Project name</b>		GA - Torrumbarry Property Victoria	
	<b>Project No</b>	25-S-0016	<b>Scale</b>	Not to Scale	
	<b>BH No</b>	TP02	<b>BH Depth</b>	CorePhoto

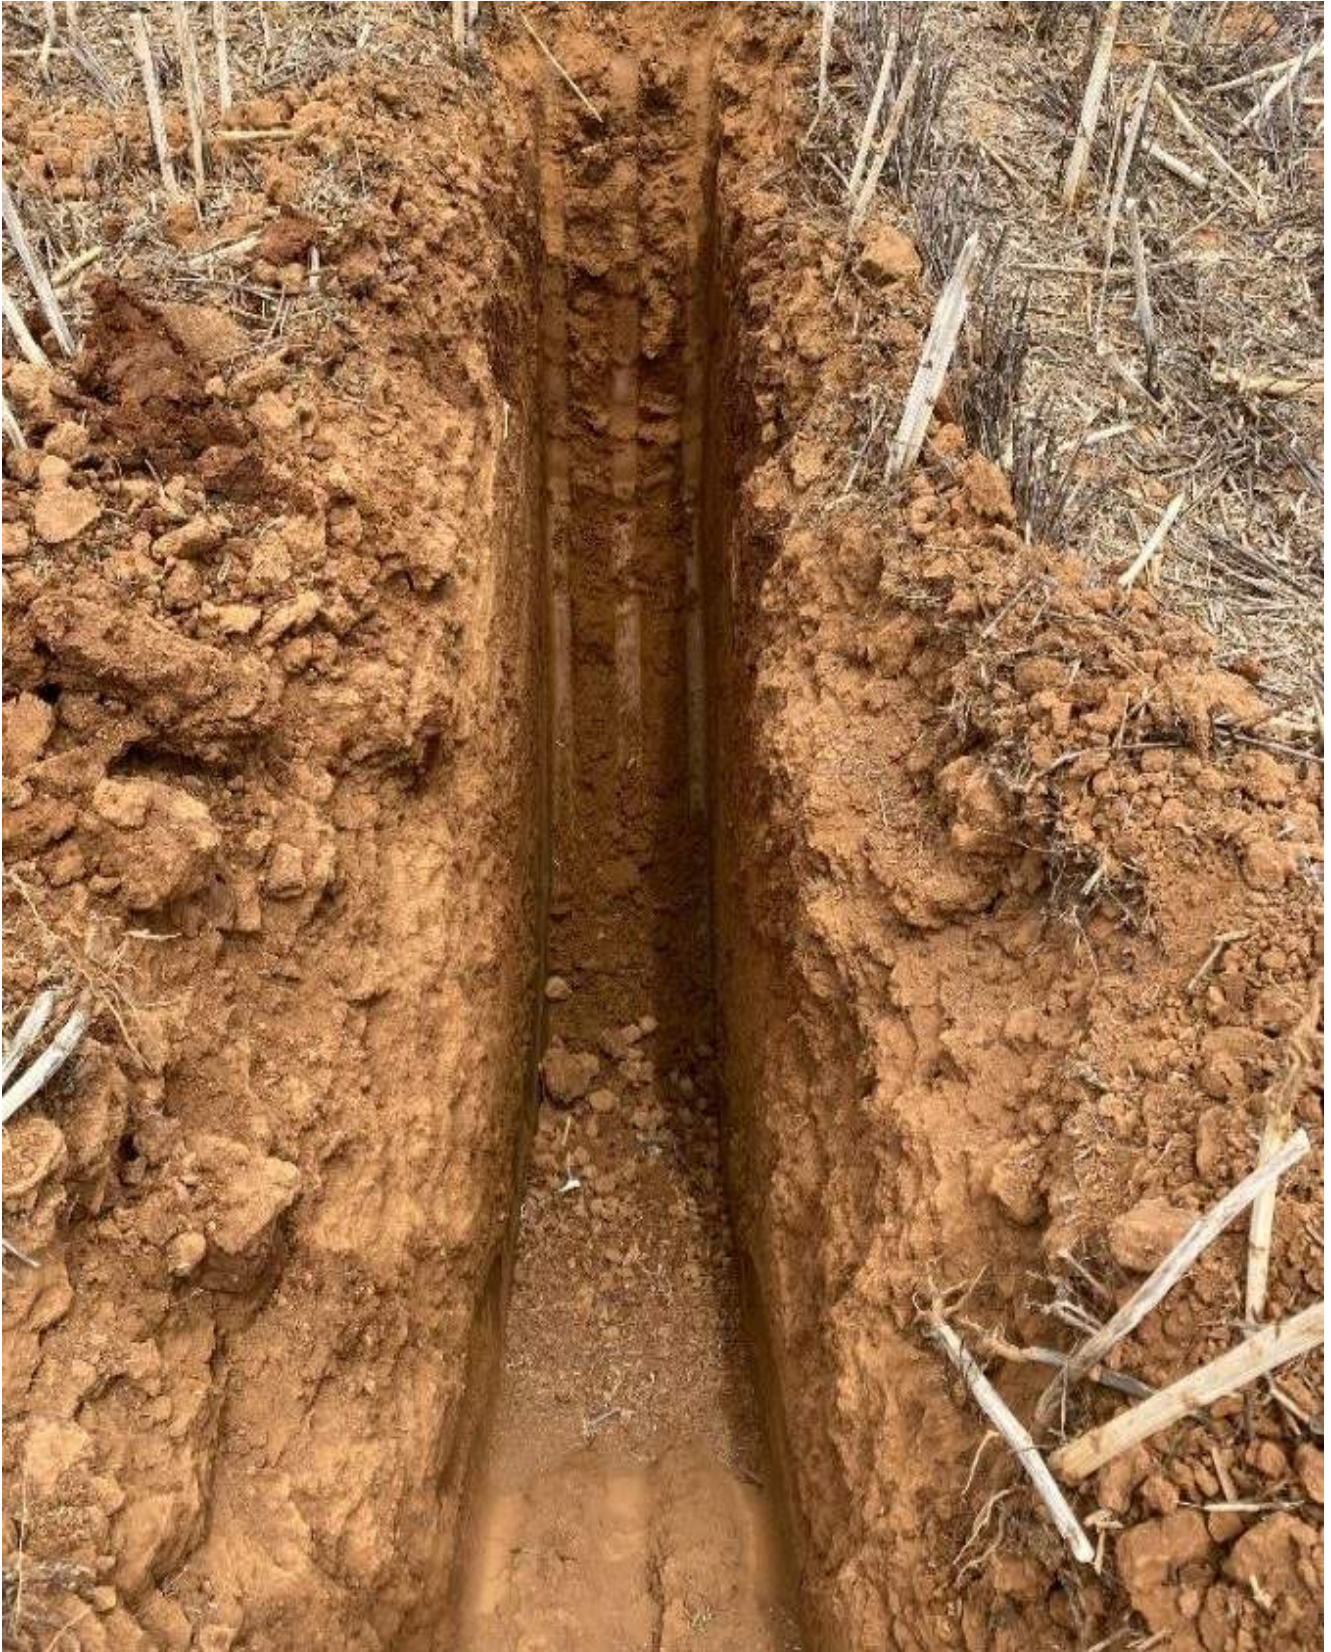
TP03

Excavator Attachment	Depth (m)	Soil Origin	Graphic Log	Classification Code	Material Description	Weathering	Moisture	Consistency/Density	Samples
		Natural		CH	Natural Sandy to silty CLAY CH: stiff, high plasticity, light grey brown, fine grained sand, inorganic, dry.		D	St	
	0.2	Natural		CH	Natural Sandy to silty CLAY CH: stiff, high plasticity, brown, fine grained sand, inorganic, moist.		M		
	0.5	Natural		CH	Natural Sandy to silty CLAY CH: soft, high plasticity, light orange brown, fine grained sand, inorganic, moist to dry.		M-D	S	
	0.7	Natural		CI-CH	Natural Sandy CLAY CI-CH: stiff, medium to high plasticity, orange brown mottled white, fine grained sand, inorganic, moist to dry. fine to coarse sand size crystals were observed..			St	Atterberg Limits / Emerson Class: LL - 51% LS - 16.5% Iss - 3.7 EC - 4
<b>TP03 Terminated at 1m</b>

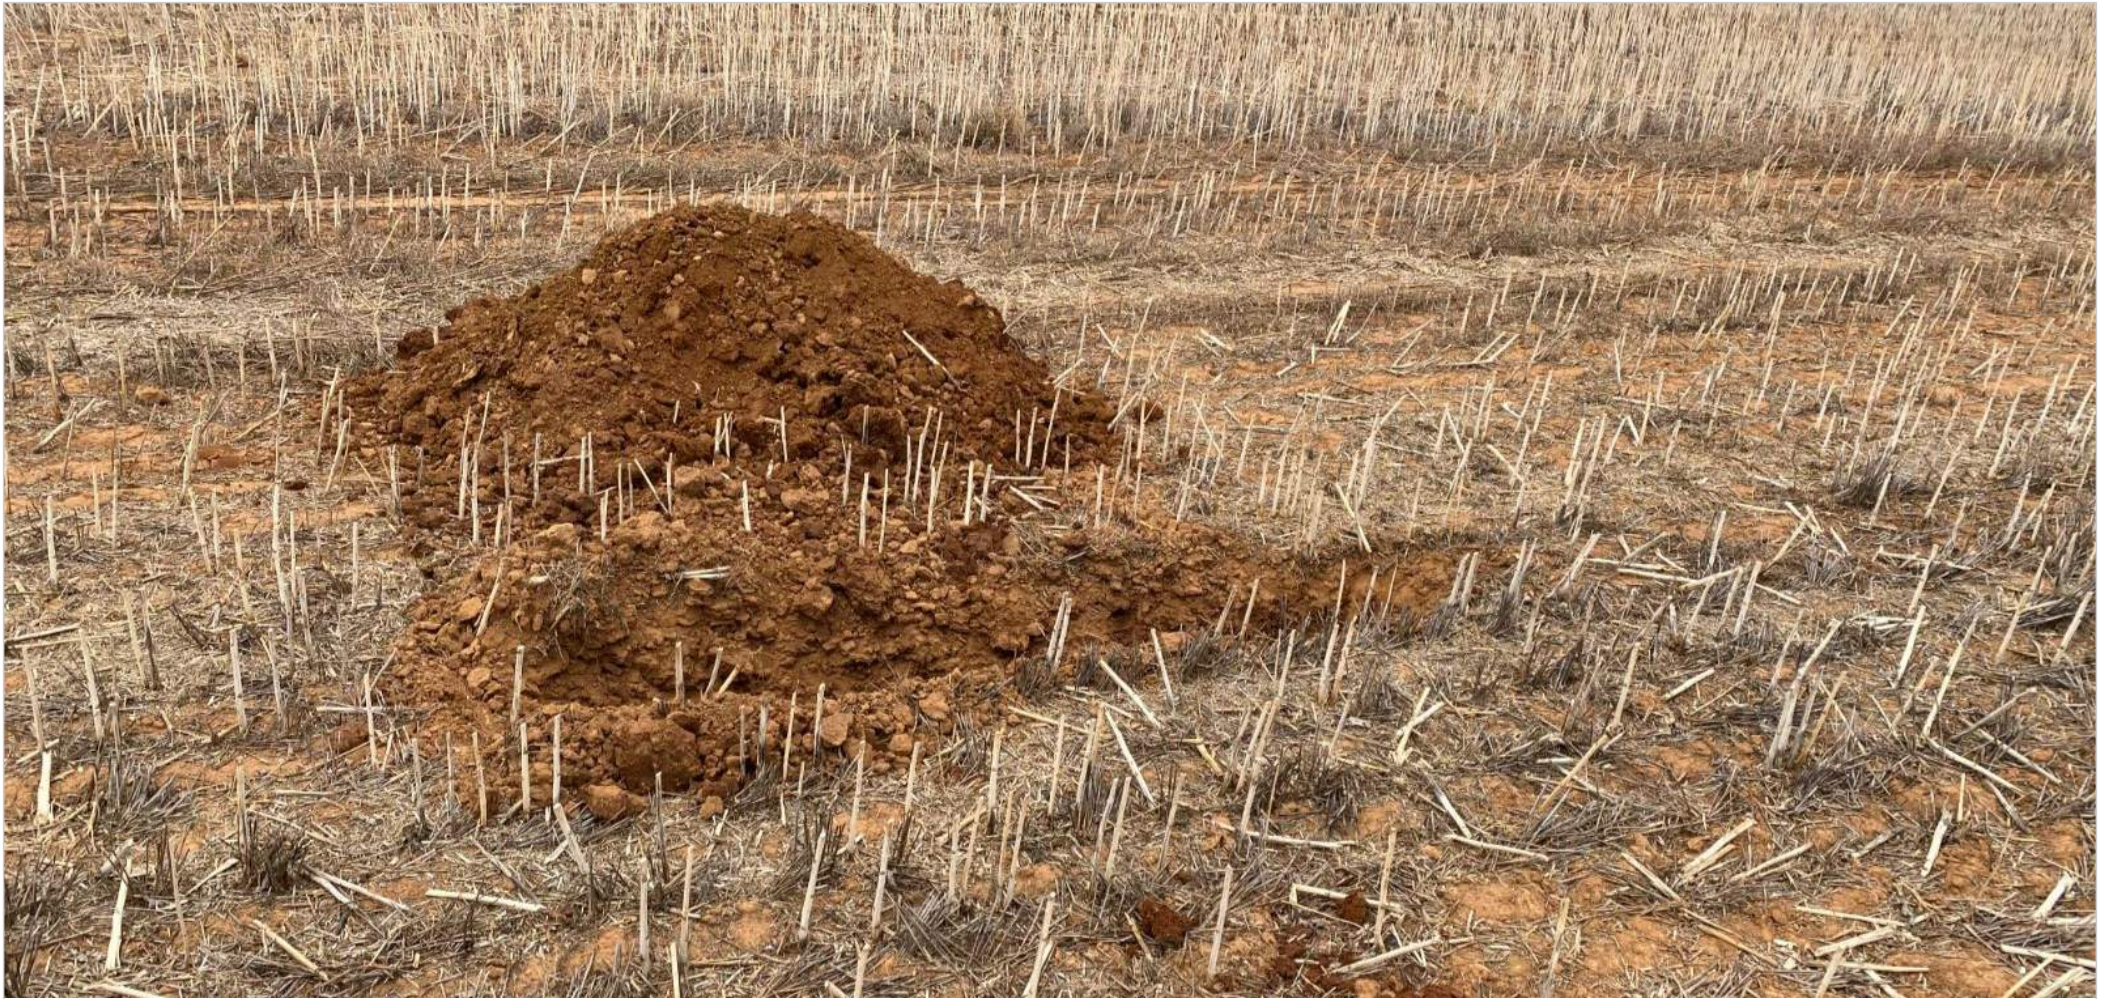
(07) 4639 4100	<b>Photo description</b>		TP03 Spoil	
	  5 Bowen Street. Toowoomba Qld 4350	<b>Client</b>		Maclean Farms	
	  enquiries@rmasoils.com.au	<b>Location</b>		Echuca VIC, Australia	
		<b>Project name</b>		GA - Torrumbarry Property Victoria	
		<b>Project No</b>	25-S-0016	<b>Scale</b>	Not to Scale
		<b>BH No</b>	TP03	<b>BH Depth</b>	CorePhoto

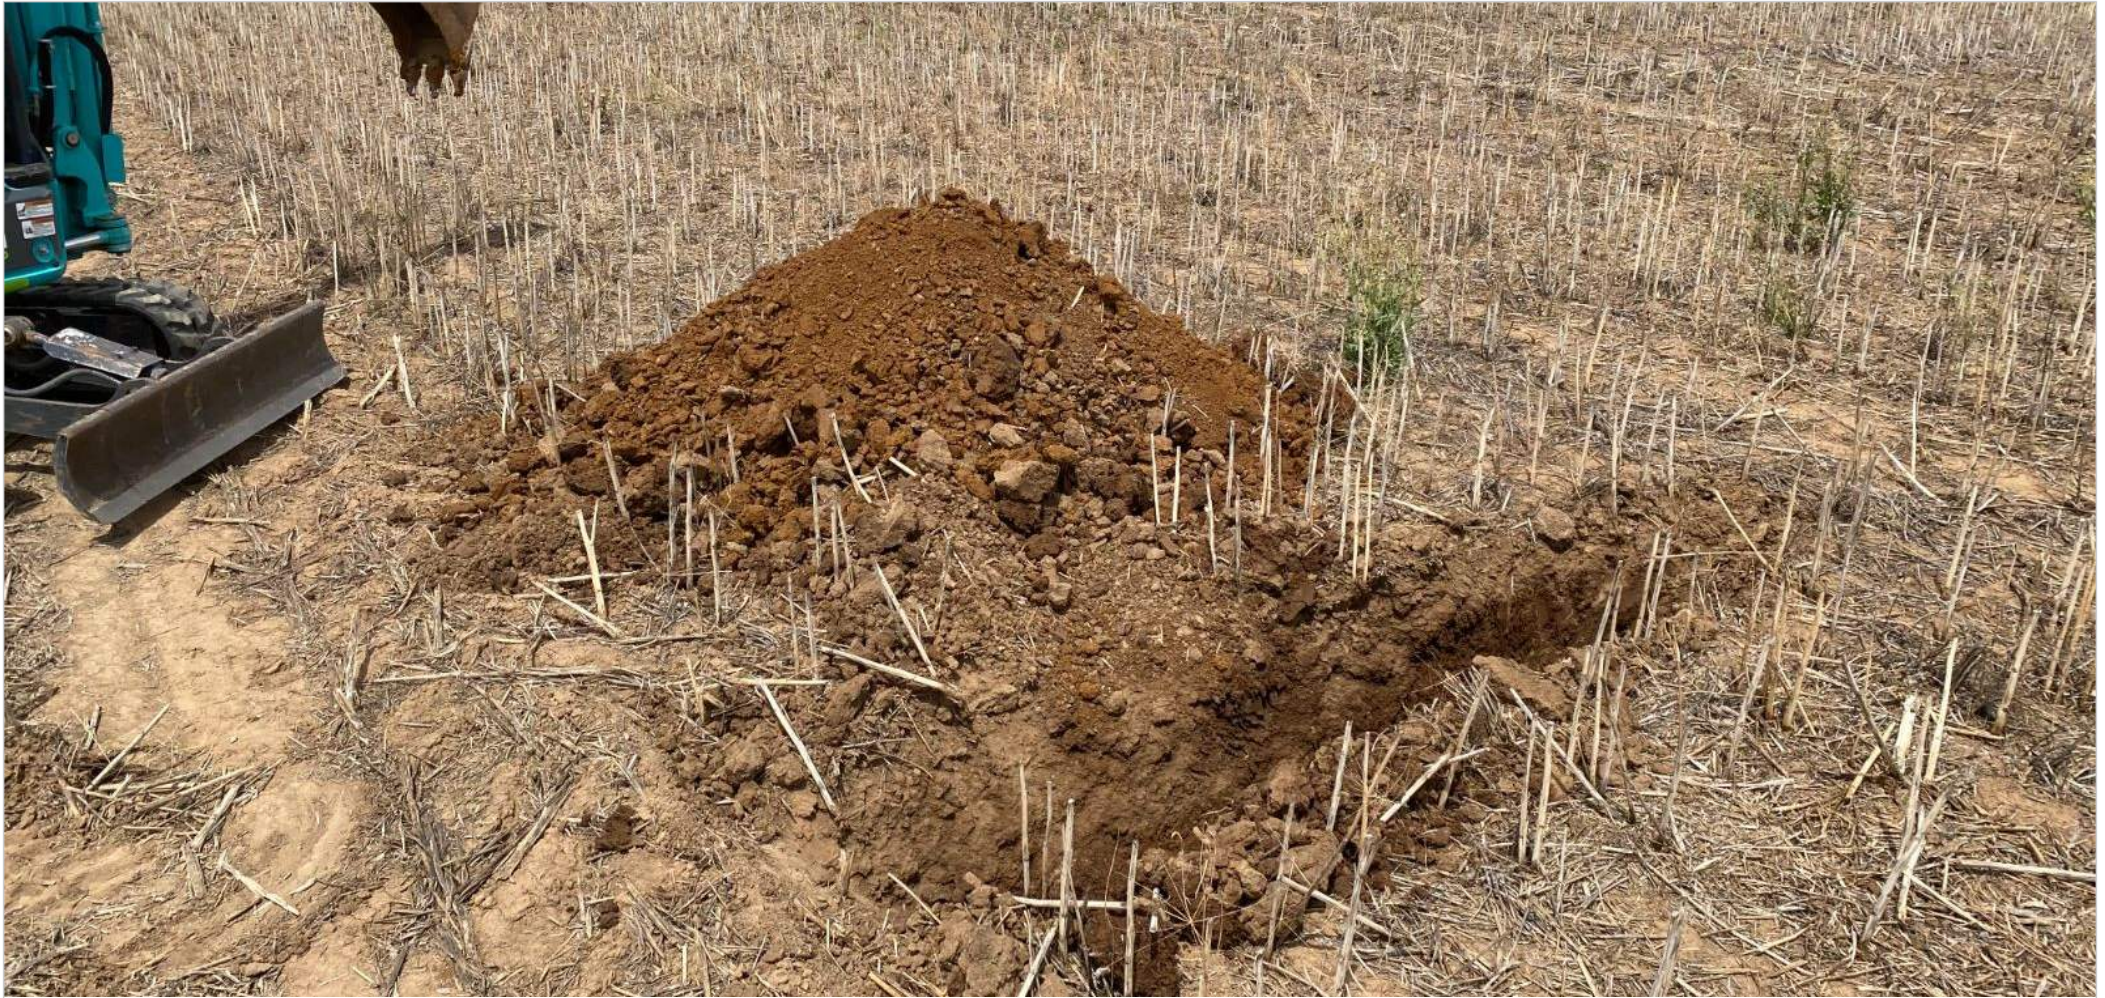
(07) 4639 4100	<b>Photo description</b> TP04 Spoil
	  5 Bowen Street. Toowoomba Qld 4350	<b>Client</b> Maclean Farms
	  enquiries@rmasoils.com.au	<b>Location</b> Echuca VIC, Australia
		<b>Project name</b> GA - Torrumbarry Property Victoria
	<b>Project No</b> 25-S-0016	<b>Scale</b> Not to Scale
	<b>BH No</b> TP04	<b>BH Depth</b> CorePhoto

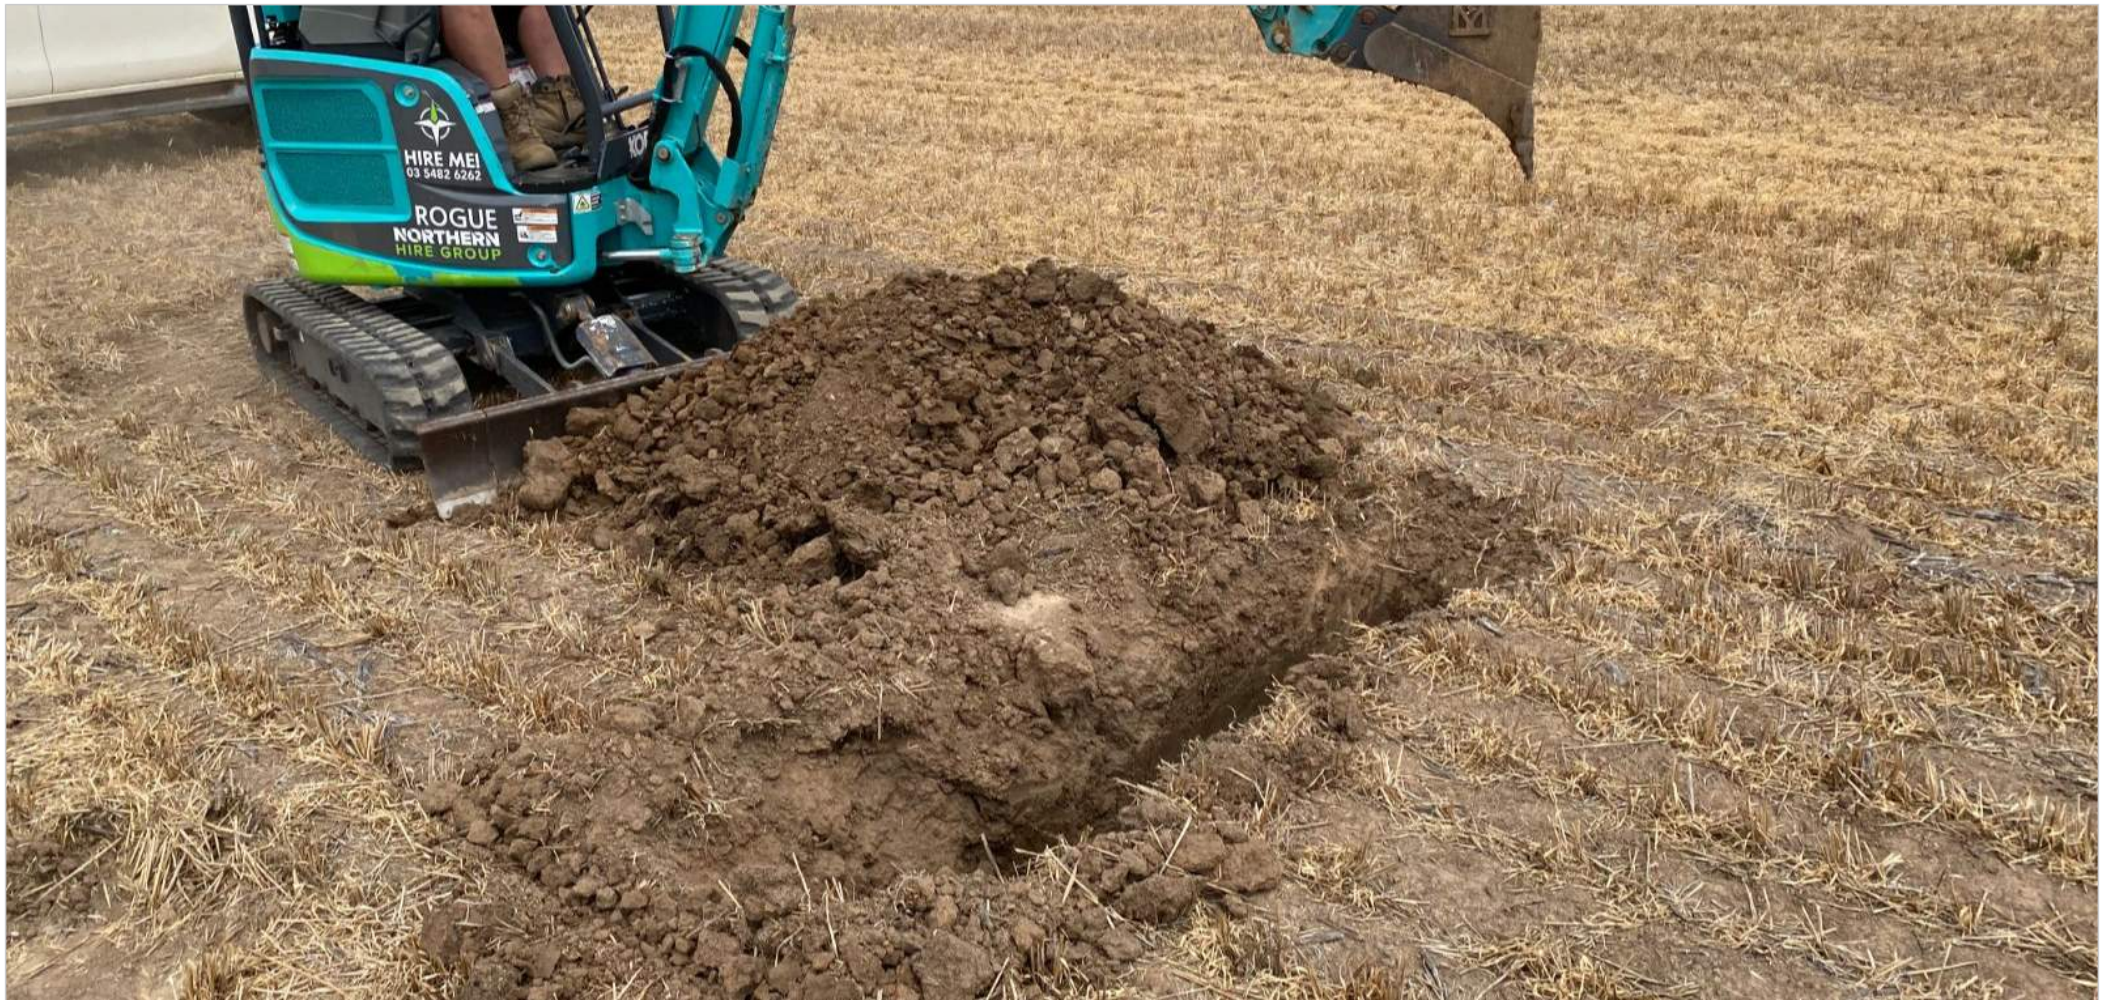
(07) 4639 4100	<b>Photo description</b>	TP05 Spoil		
	  5 Bowen Street. Toowoomba Qld 4350	<b>Client</b>	Maclean Farms		
	  enquiries@rmasoils.com.au	<b>Location</b>	Echuca VIC, Australia		
		<b>Project name</b>	GA - Torrumbarry Property Victoria		
		<b>Project No</b>	25-S-0016	<b>Scale</b>	Not to Scale
		<b>BH No</b>	TP05	<b>BH Depth</b>	CorePhoto

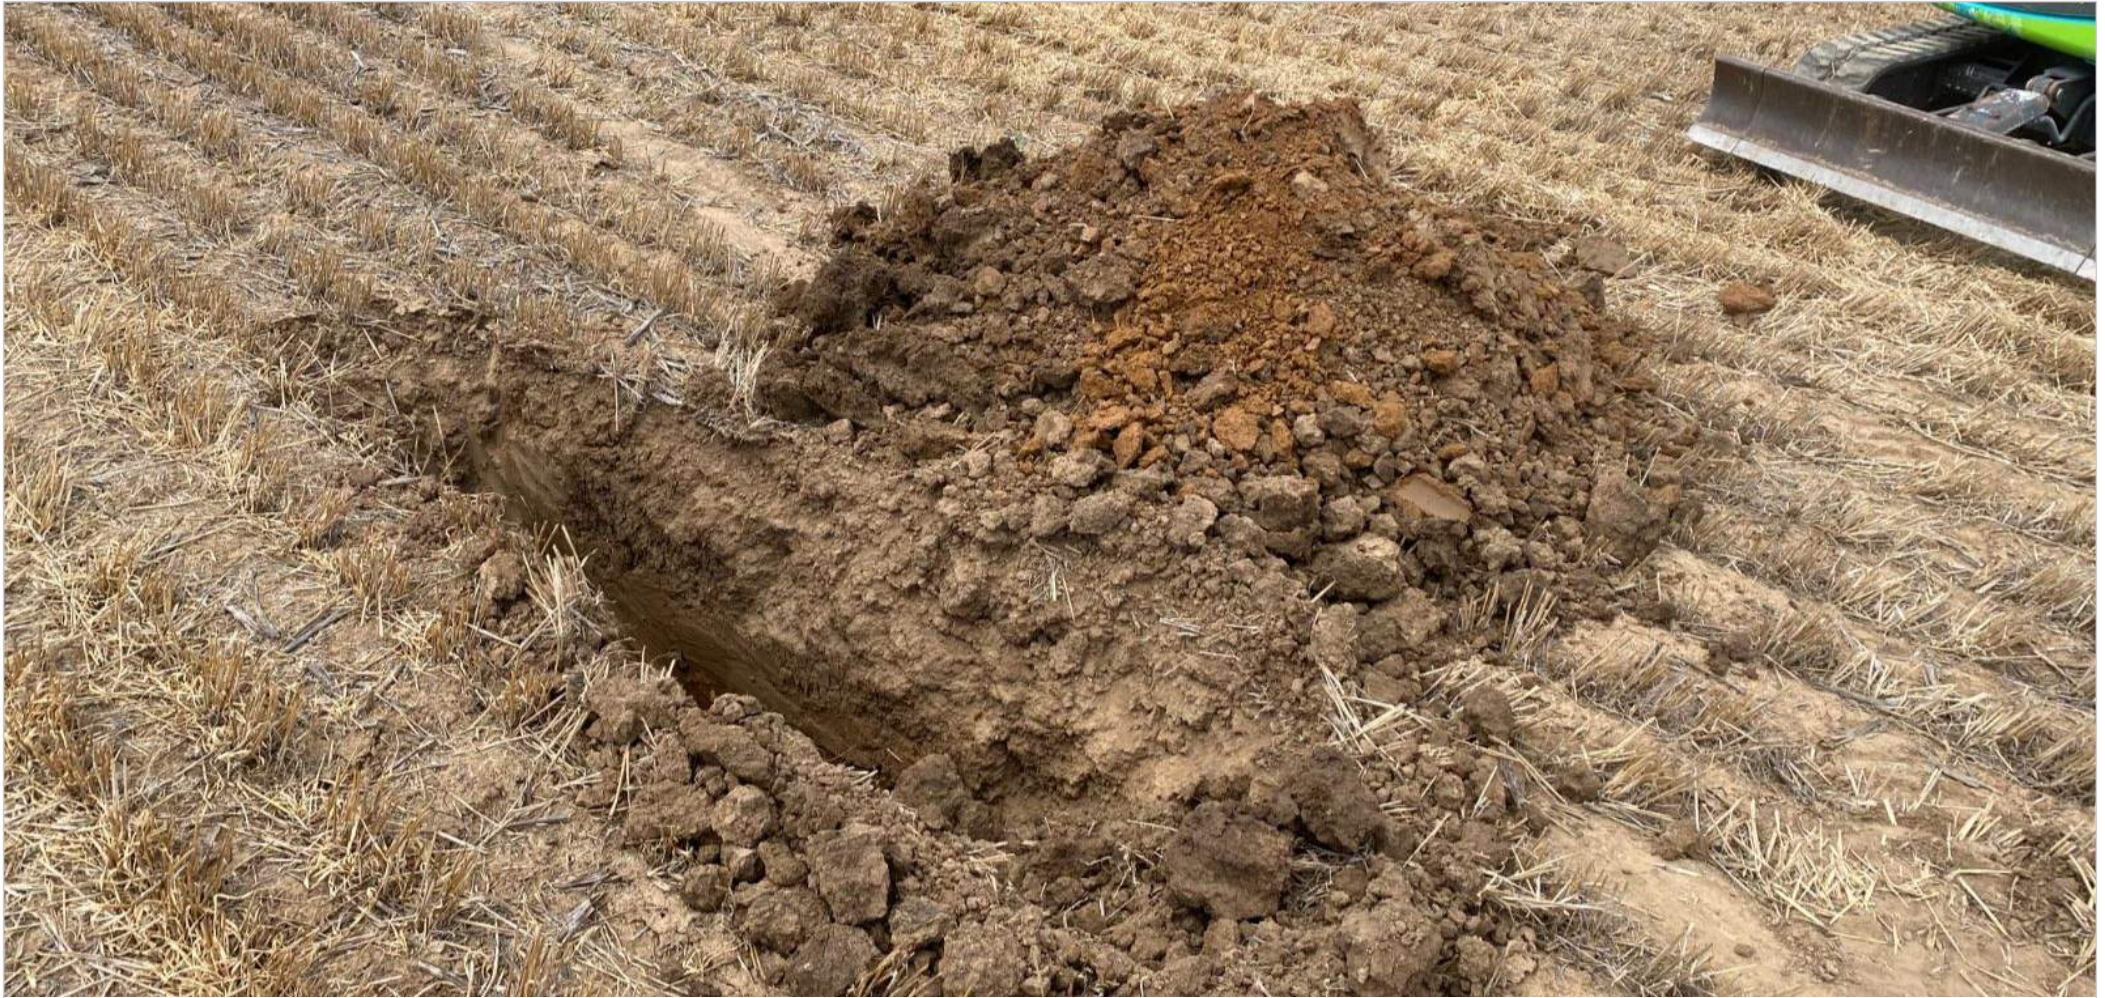
(07) 4639 4100	<b>Photo description</b>		TP06 Spoil	
	  5 Bowen Street. Toowoomba Qld 4350	<b>Client</b>		Maclean Farms	
	  enquiries@rmasoils.com.au	<b>Location</b>		Echuca VIC, Australia	
		<b>Project name</b>		GA - Torrumbarry Property Victoria	
	<b>Project No</b>	25-S-0016	<b>Scale</b>	Not to Scale	
	<b>BH No</b>	TP06	<b>BH Depth</b>	CorePhoto

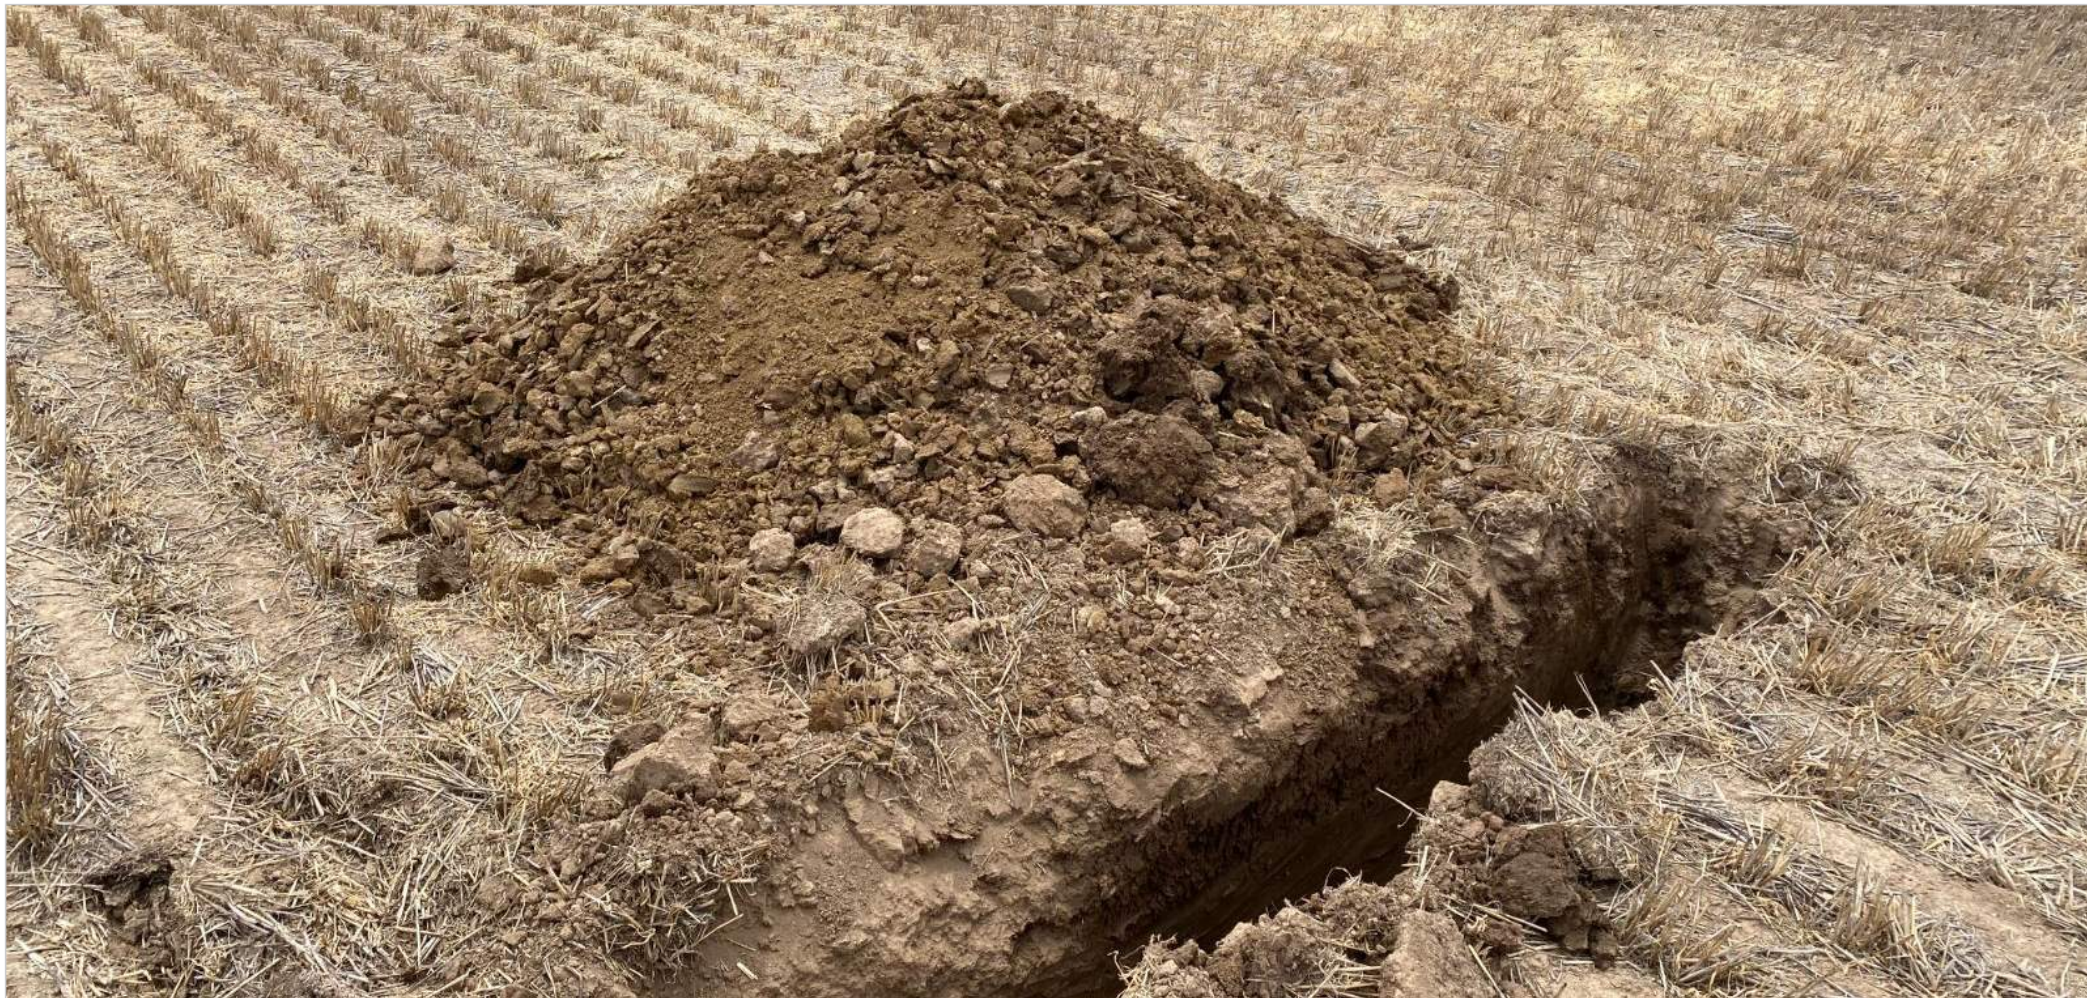
(07) 4639 4100	<b>Photo description</b>		TP07 Spoil	
	  5 Bowen Street. Toowoomba Qld 4350	<b>Client</b>		Maclean Farms	
	  enquiries@rmasoils.com.au	<b>Location</b>		Echuca VIC, Australia	
		<b>Project name</b>		GA - Torrumbarry Property Victoria	
	<b>Project No</b>	25-S-0016	<b>Scale</b>	Not to Scale	
	<b>BH No</b>	TP07	<b>BH Depth</b>	CorePhoto
