# APPENDIX E

## HISTORIC HERITAGE DUE DILIGENCE REPORT

## EXECUTIVE SUMMARY

This report outlines the results of a historical (non-Aboriginal) heritage due diligence assessment prepared for the Victorian component of EnergyConnect (the proposal) which would occur on a section of land approximately 8.44 ha in size, located at Woomera Avenue, Red Cliffs (the study area – Figure 2). The proposal comprises the upgrade of an existing TransGrid 220 kilovolt (kV) single circuit transmission line between the NSW/Victorian border and the Red Cliffs substation in Victoria to a 220kV double circuit transmission line.

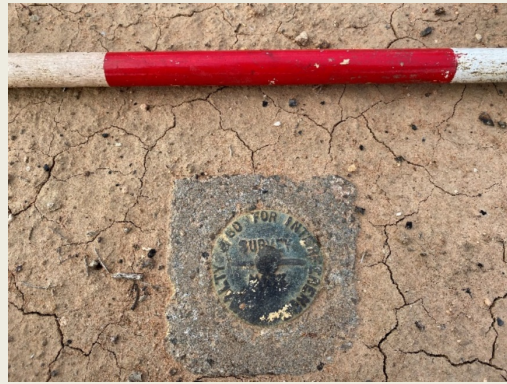
**Plate 8:** Surveyors Mark along southern boundary of Terminal Station (Krista Whitewood; 6 August 2020; Facing north)

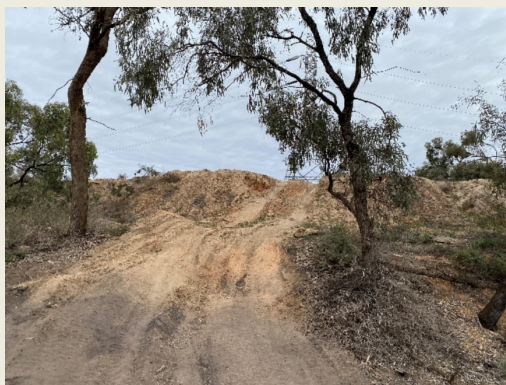
**Plate 9:** Levees north of Red Cliffs Terminal Station (Krista Whitewood; 6 August 2020; Facing south)

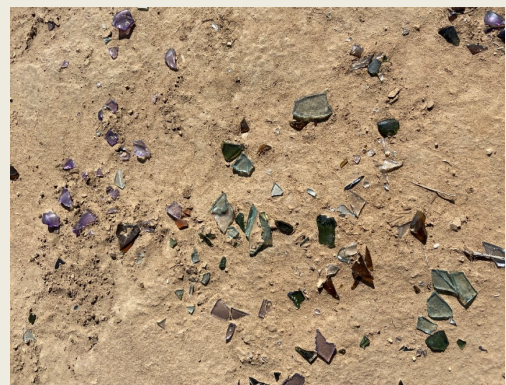
A field inspection undertaken as part of this assessment identified a historical glass scatter conservatively dated to the 1920s in the southern part of the study area. This scatter does not on its own constitute an archaeological site/s eligible for entry on the Heritage Inventory in its own right. Other archaeological features in the form of a metal artefact and the remains of a timber and centrifugal pump structural were identified outside of the study area.

**Plate 11:** Historical glass scatter along the central portion of the floodplain (Karen Kapteinis; 5 August 2020; Facing east)

A historical glass scatter identified in the study area sits outside of the development footprint. This scatter is not eligible for listing on the Heritage Inventory on its own merit, however if it was associated with the Red Cliffs Main Pumping Station, then it may fulfill the criteria for a Heritage Inventory listing and attract protection under the Victorian *Heritage Act 2017* (see Appendix 1). Further research is required to establish whether there is a link with any prior structures of the Red Cliffs Main Pumping Station that have not been identified in this due diligence report. This research should be undertaken at PROV.

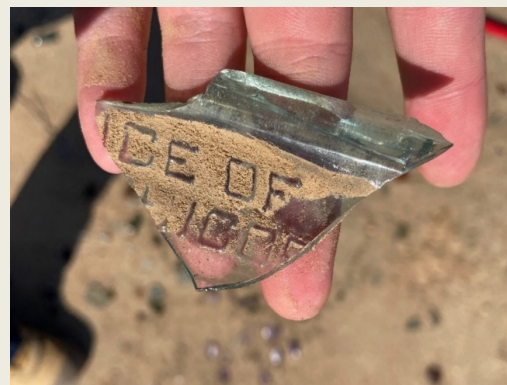
**Plate 12:** Historical glass scatter: bottle label (Karen Kapteinis; 5 August 2020; Facing east)

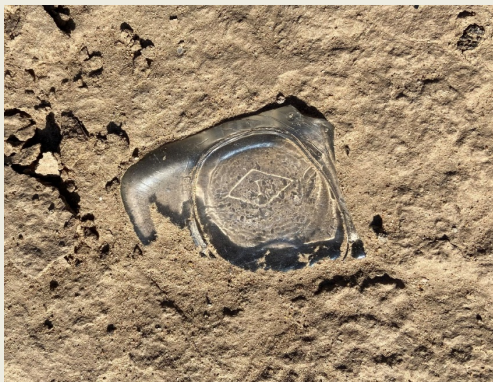
**Plate 13:** Historical glass scatter: Makers mark (Karen Kapteinis; 5 August 2020; Facing north)

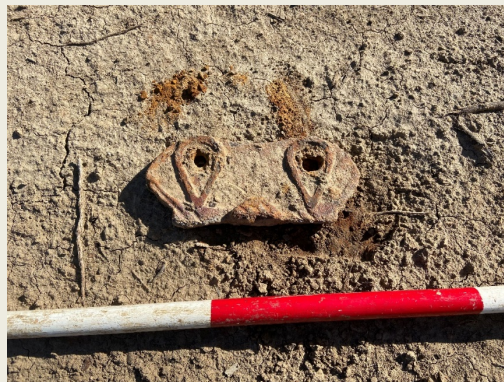
- A metal surveyors mark was identified adjacent the western boundary of the terminal station, and is likely associated with the c. 1922 Red Cliffs Main Pumping Station (Figure 4; Plate 14);
- Structural timber remains and a part of a centrifugal pump were located south west of the study area (Plates 15-18, see also Figure 4). A pipe associated with these features is shown buried near the southern boundary of the Terminal Station (Plates 17 & 18), and potentially extends underneath it.

**Plate 14:** Metal Object potentially associated with the Red Cliffs Pumping Station (Karen Kapteinis; 5 August 2020; Facing east)

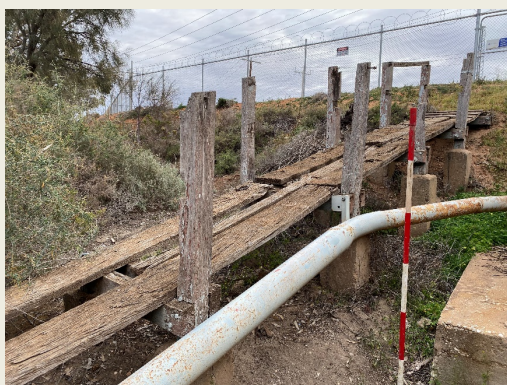
**Plate 15:** Historical timber structure and pipe extending south from Terminal Station (Karen Kapteinis; 5 August 2020; Facing north)

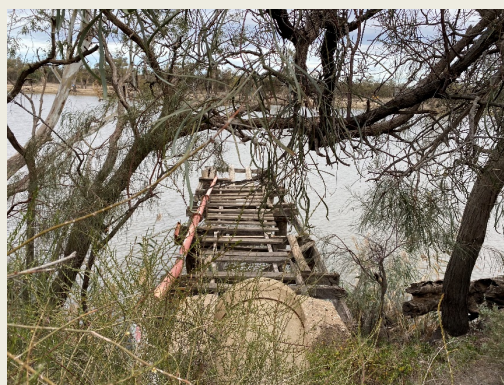
**Plate 16:** Historical pumping station infrastructure located south of the Terminal Station (Karen Kapteinis; 5 August 2020; Facing south)

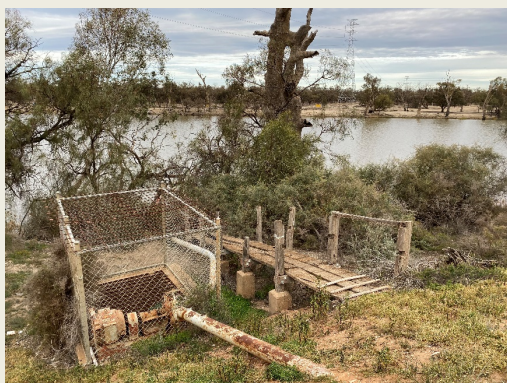
**Plate 17:** Showing pump and timber infrastructure, with pipe partially buried in the direction of the Terminal Station (Karen Kapteinis; 5 August 2020; Facing south west)

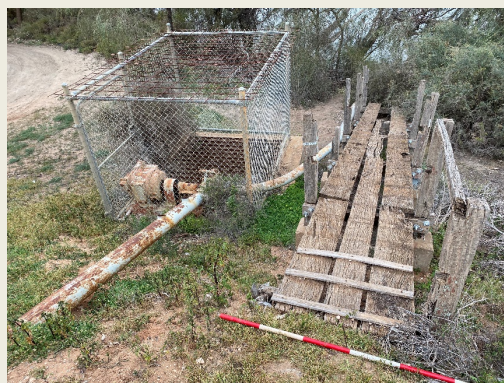
**Plate 18:** Pump and timber infrastructure, view south (Karen Kapteinis; 5 August 2020)

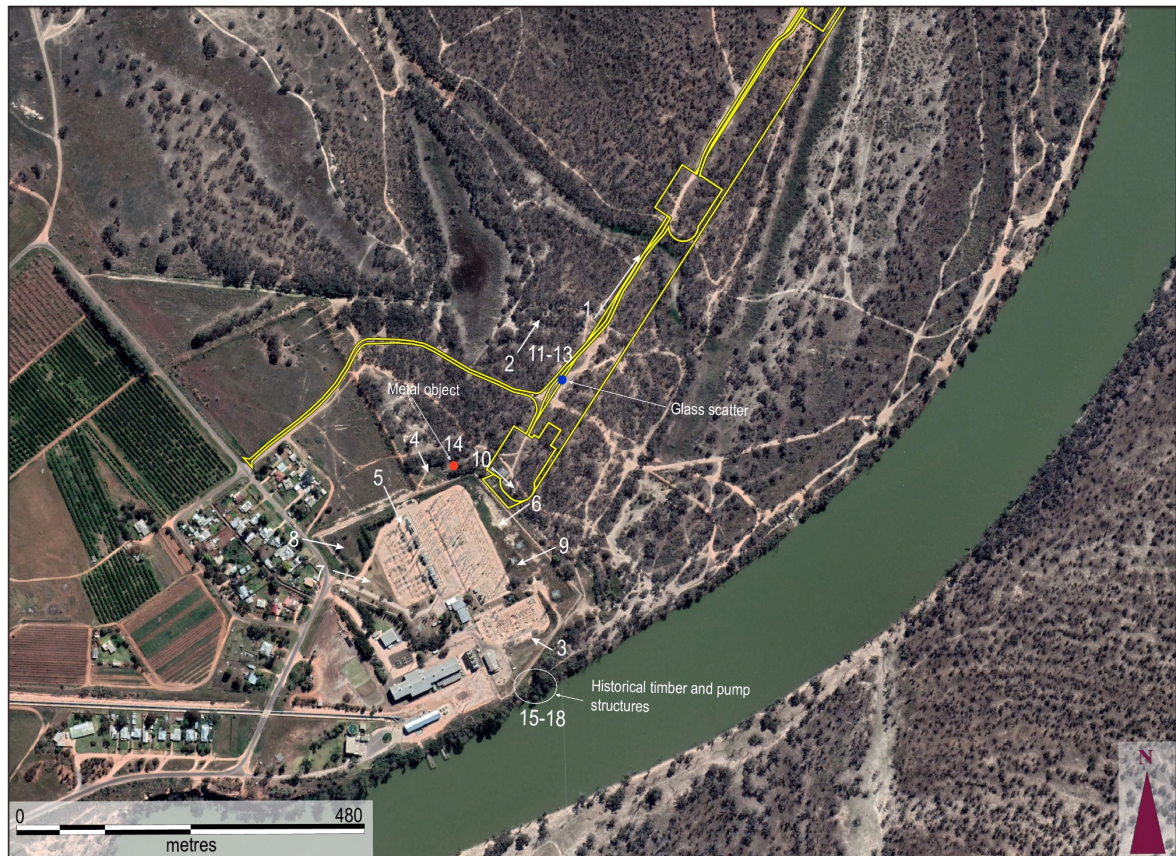
Figure 4: Contemporary aerial of the study area showing locations of photographs taken during the field inspection (numbers reference plate numbers). Base map source: Google Earth.

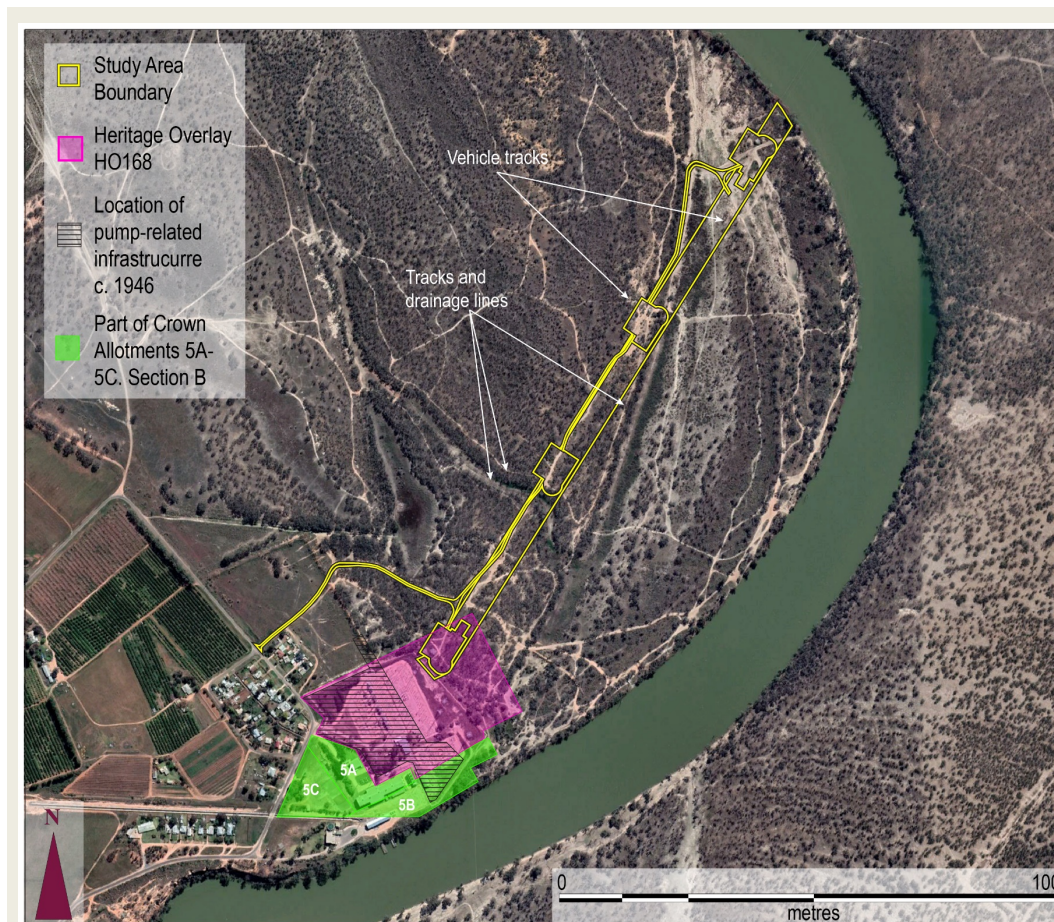
The location of the area covered by HO168 (as mapped on VicPlan) is presented in Figure 5 of this report. The bulk of the physical infrastructure associated with the historical Red Cliffs Main Pumping Station, however, appears to have been located to the south and south west of the study area (see Figure 4) as discussed in Section 3.2 of this report. Very little information is available about this Heritage Overlay listing, and how its location and extent came to be mapped on VicPlan. It is noted that the schedule to the overlay lists its address as within section B of an unspecified Crown Reserve, whereas the mapped extent of the overlay covers the property known as SPI 1\TP12019.

Figure 5: Contemporary aerial of the study area showing locations HO168 as mapped on VicPlan, as well as locations of crown allotments and pumping plant infrastructure in the study area c. 1946. Base map source: VicPlan.

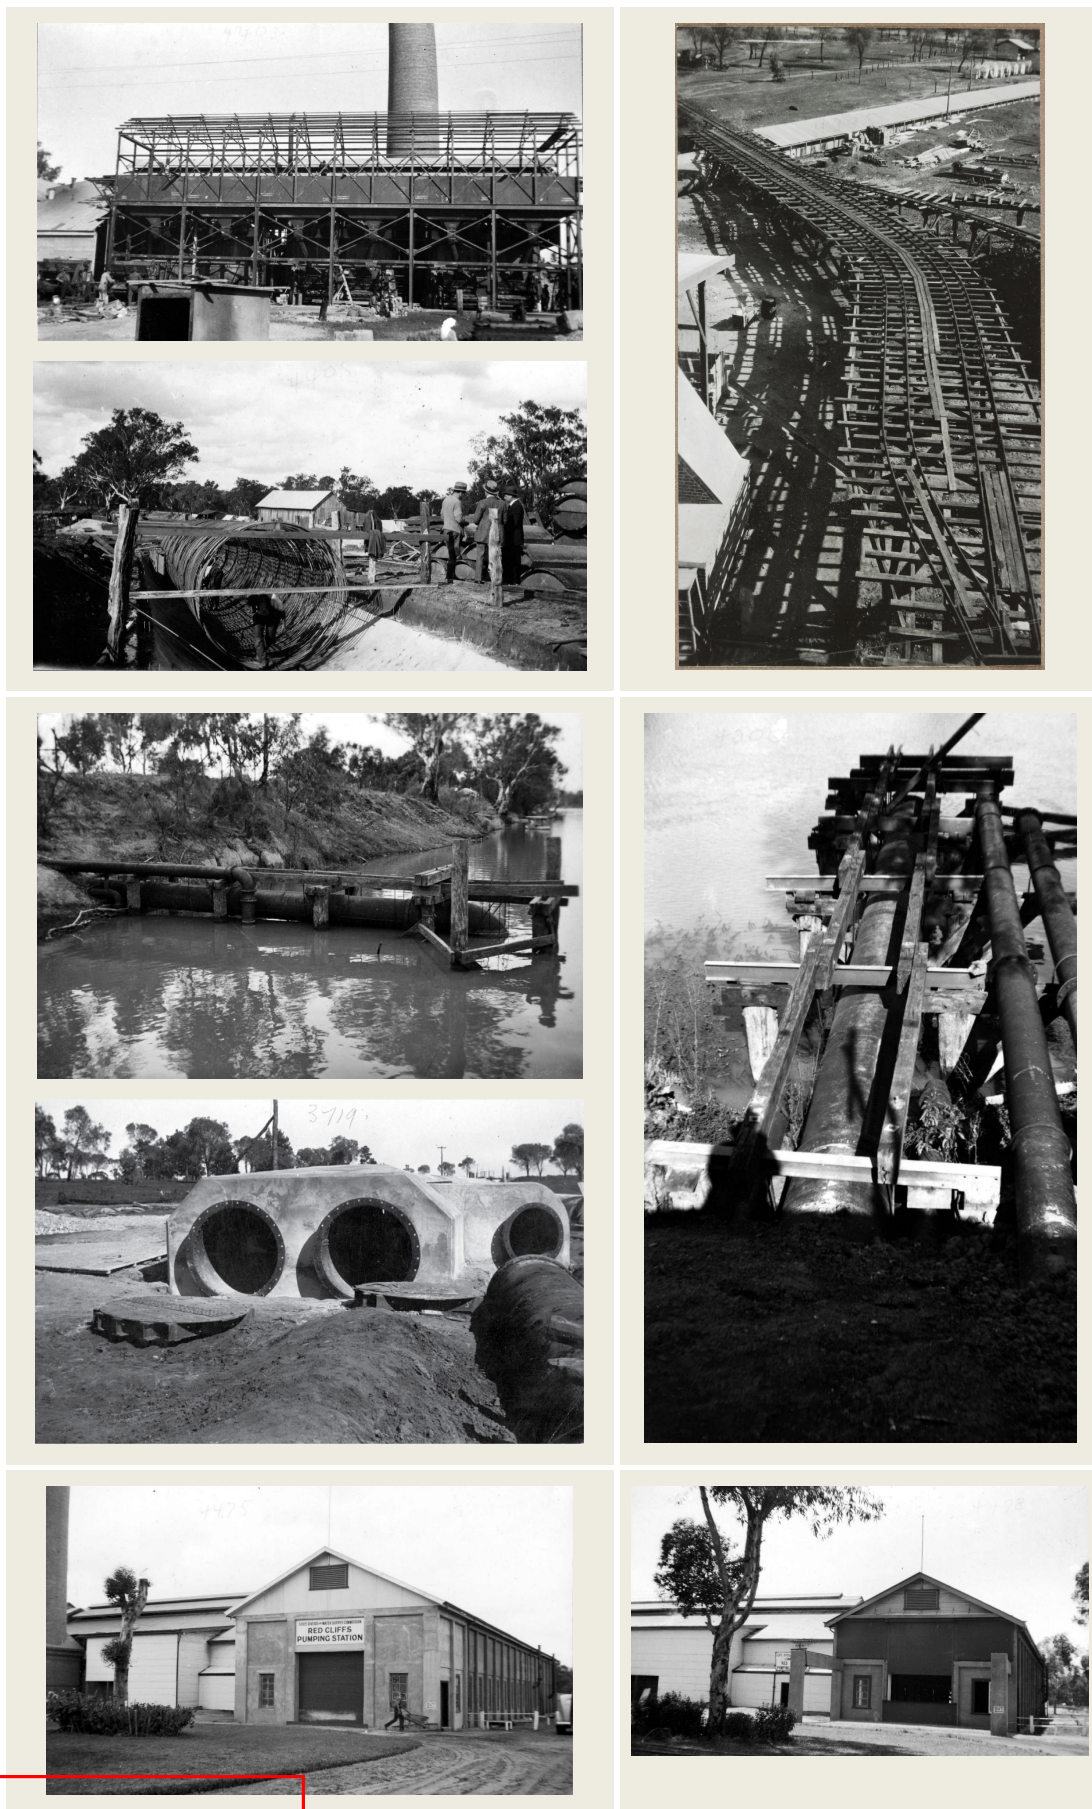
Figure 9: A series of photographs taken in the first half of the twentieth century, showing construction and infrastructure associated with the Red Cliffs Main Pumping Station. Images Source: State Library of Victoria.

Initially powered by coal brought in via tram tracks, the Red Cliffs Main Pumping Station was ultimately converted to an electrically powered station, with a large generator constructed on site, adjacent the pumping house. Flooding of the Murray in 1956 put this infrastructure at risk, and 'the Army, along with the SRWAC, SEC, and Commonwealth Government prioritized the highly productive irrigation area, diverting equipment from other places to help protect the Red Cliffs pump and generator (O'Gorman 2012: 151). Levees were raised and reinforced in the vicinity of the pumping station at this time, when 'some shire employees worked on the levee banks 24 hours a day' (O'Gorman 2012: 151).

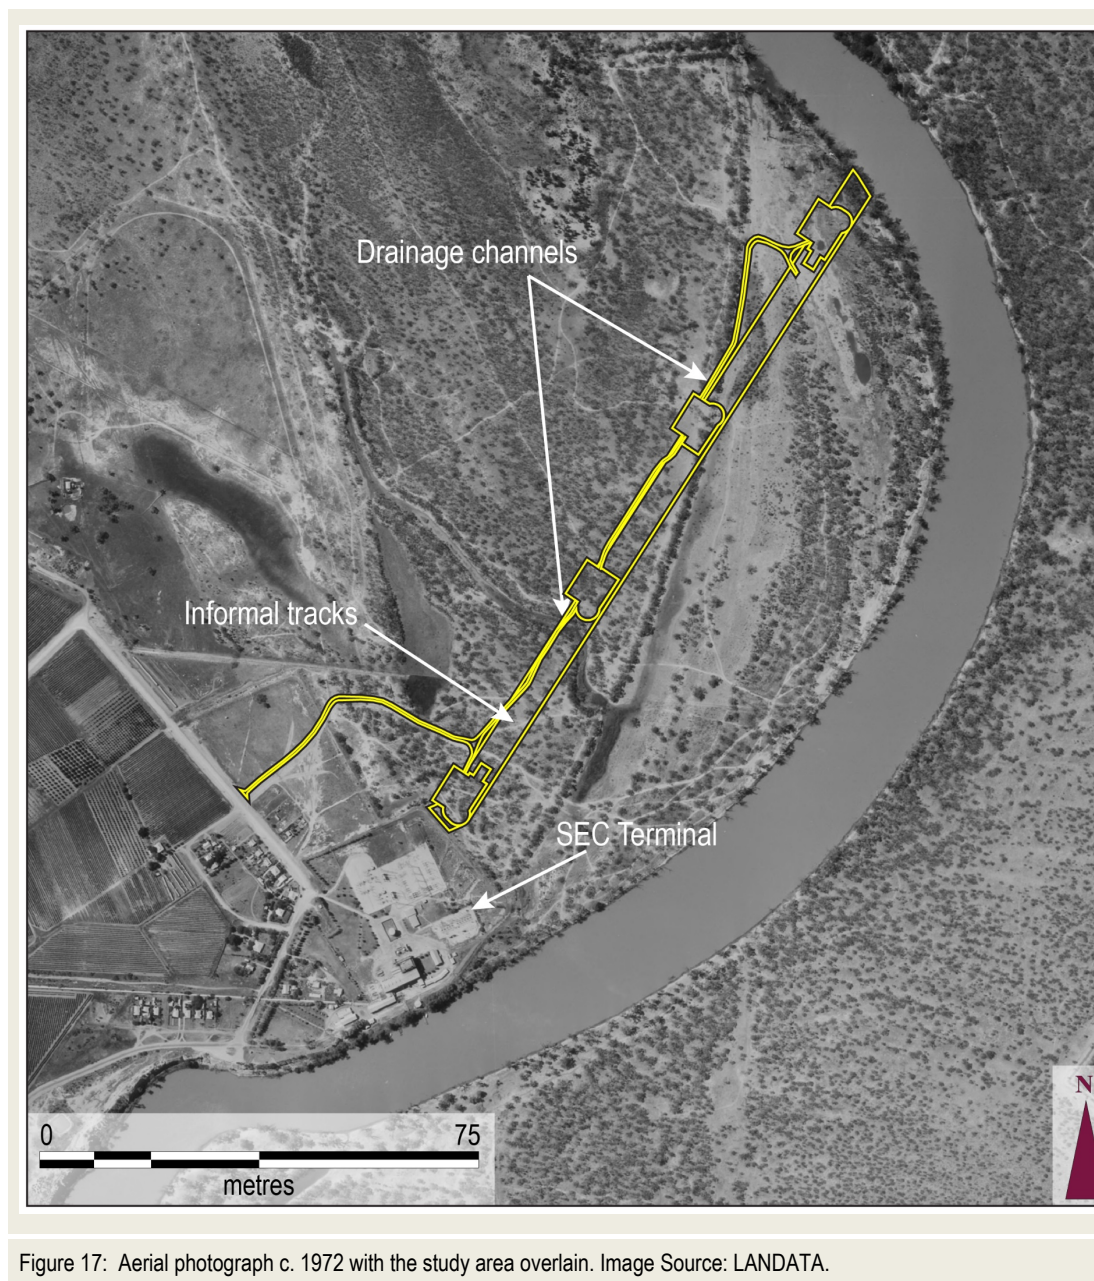
Figure 17: Aerial photograph c. 1972 with the study area overlain. Image Source: LANDATA.

A c. 1972 aerial photograph (Figure 17) shows the bulk of the study area largely unchanged, while the area south of the study area by this stage contains an established electricity terminal. Infrastructure in this area includes a number of buildings, car parking areas and paved driveways/roadways, two separate terminal grid areas as well as fencing and landscaping. Recent aerial photography showing existing conditions in the study area (Figure 3) shows the study area as largely unchanged with the exception of the installation of an overhead electrical corridor running through the centre of the study area, from the terminal in the south and crossing the Murray River in the north.

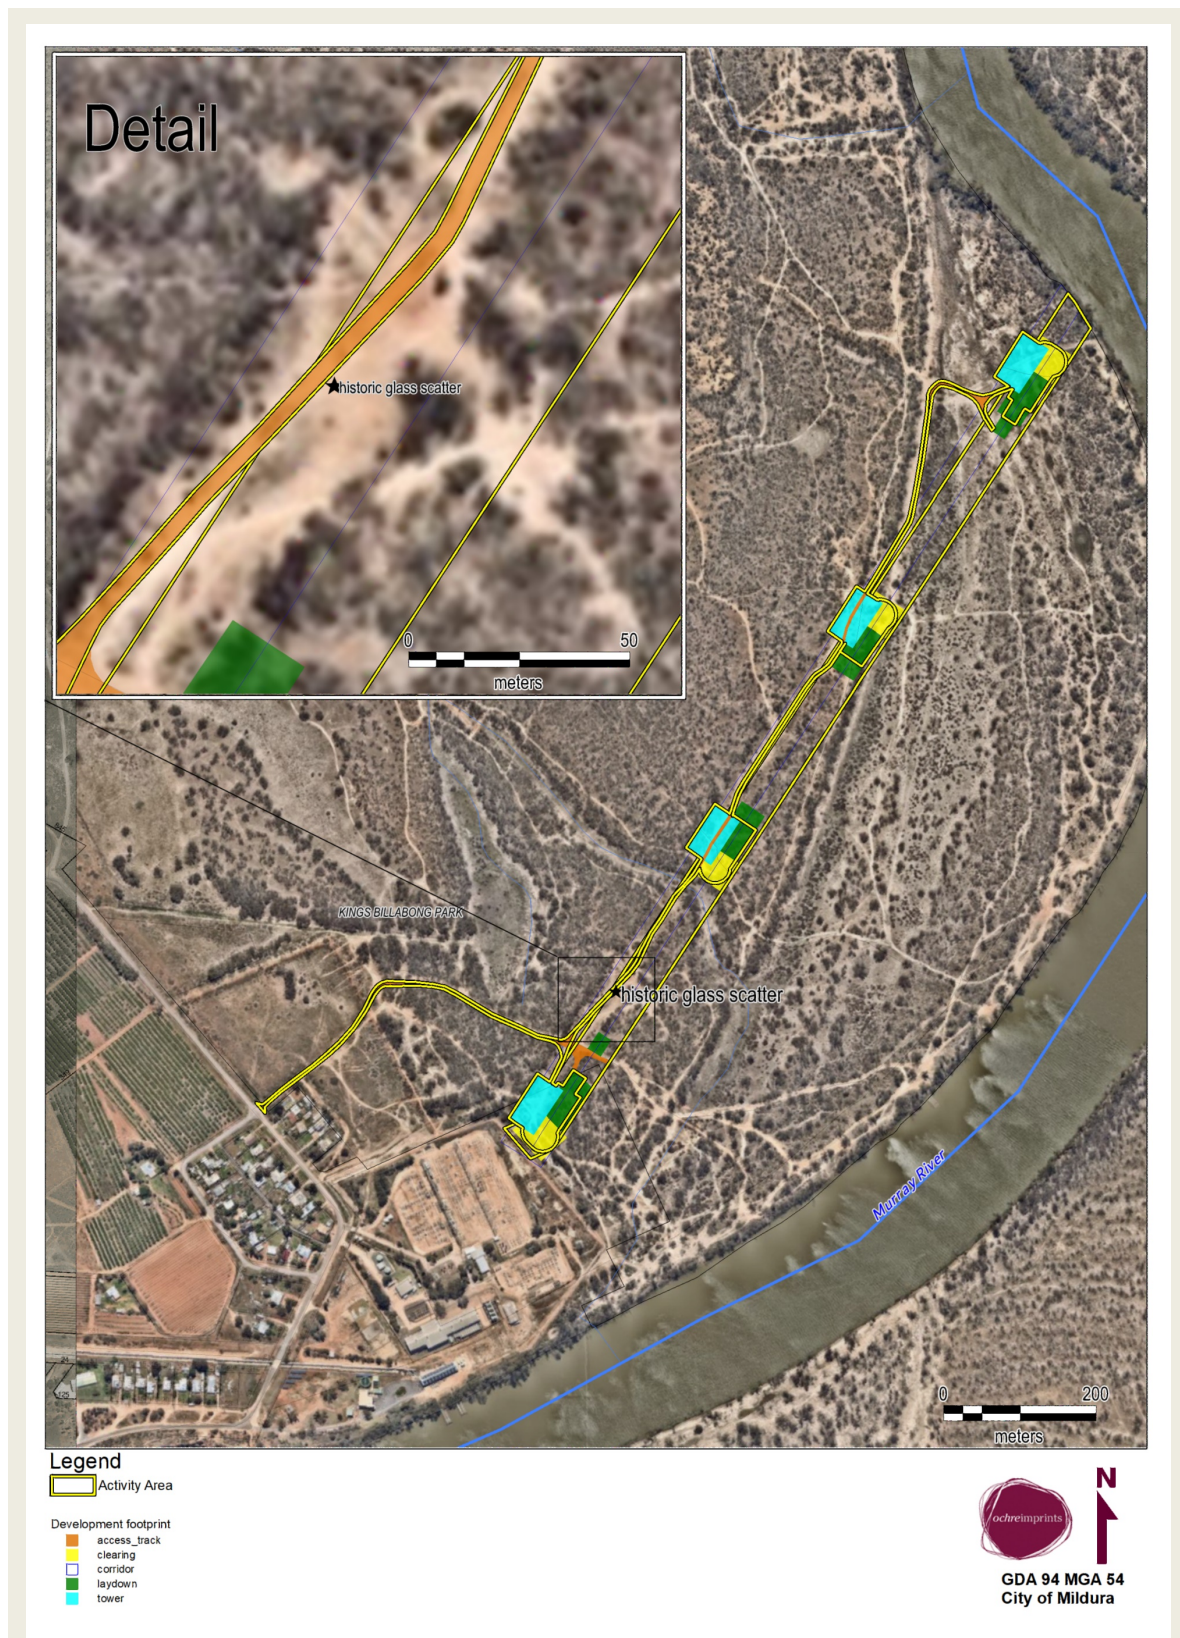
Figure 18: Historical features in relation to the proposed development footprint

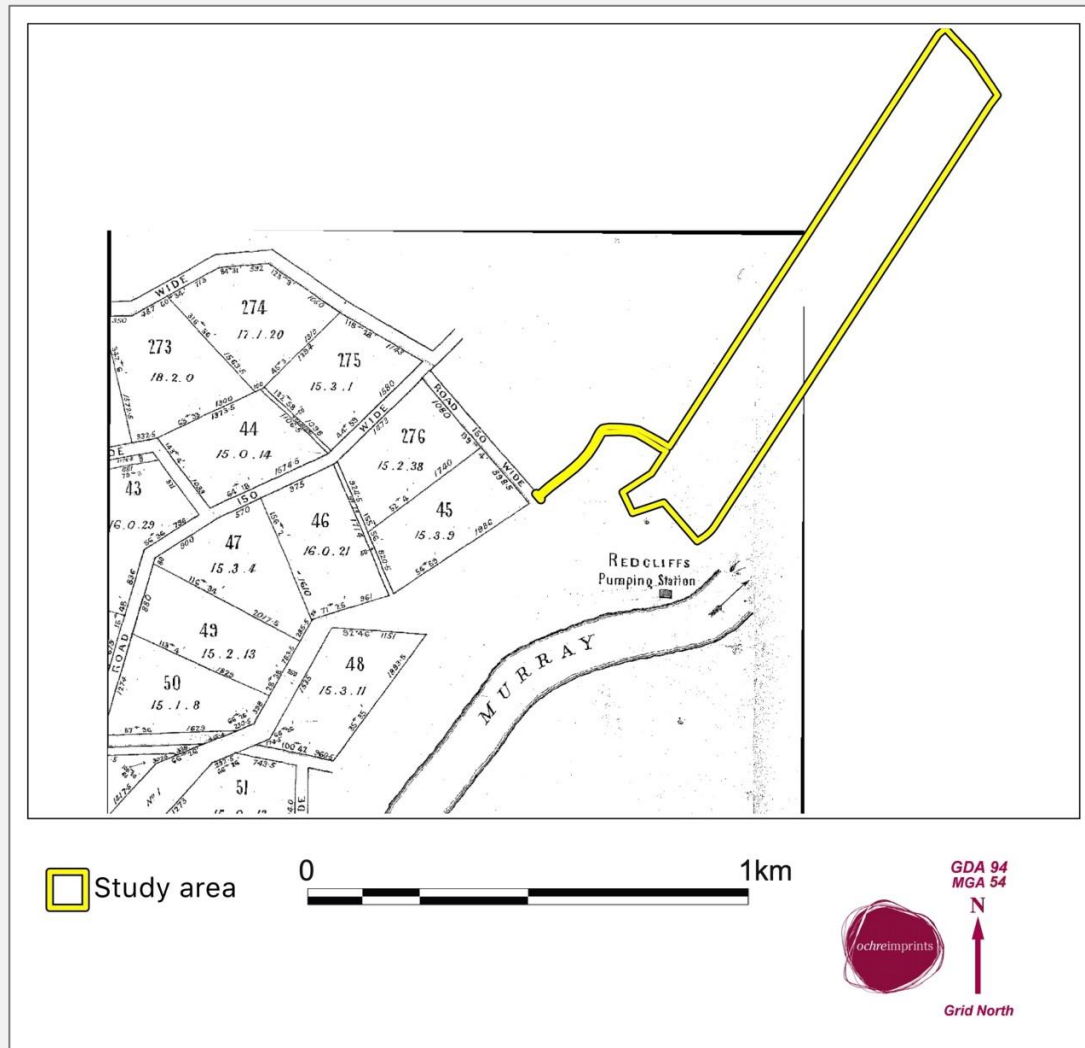
The Mildura Put Away plans (series Mildura M556) show both the earliest pumping station footprint in the 1920s (Figure 4) and a later, expanded footprint (Figure 5). The larger footprint

Figure 4 – c.1922-1925 showing the footprint of the earliest pumping station building (built about 1921, opened 1922) (M556-U-5).

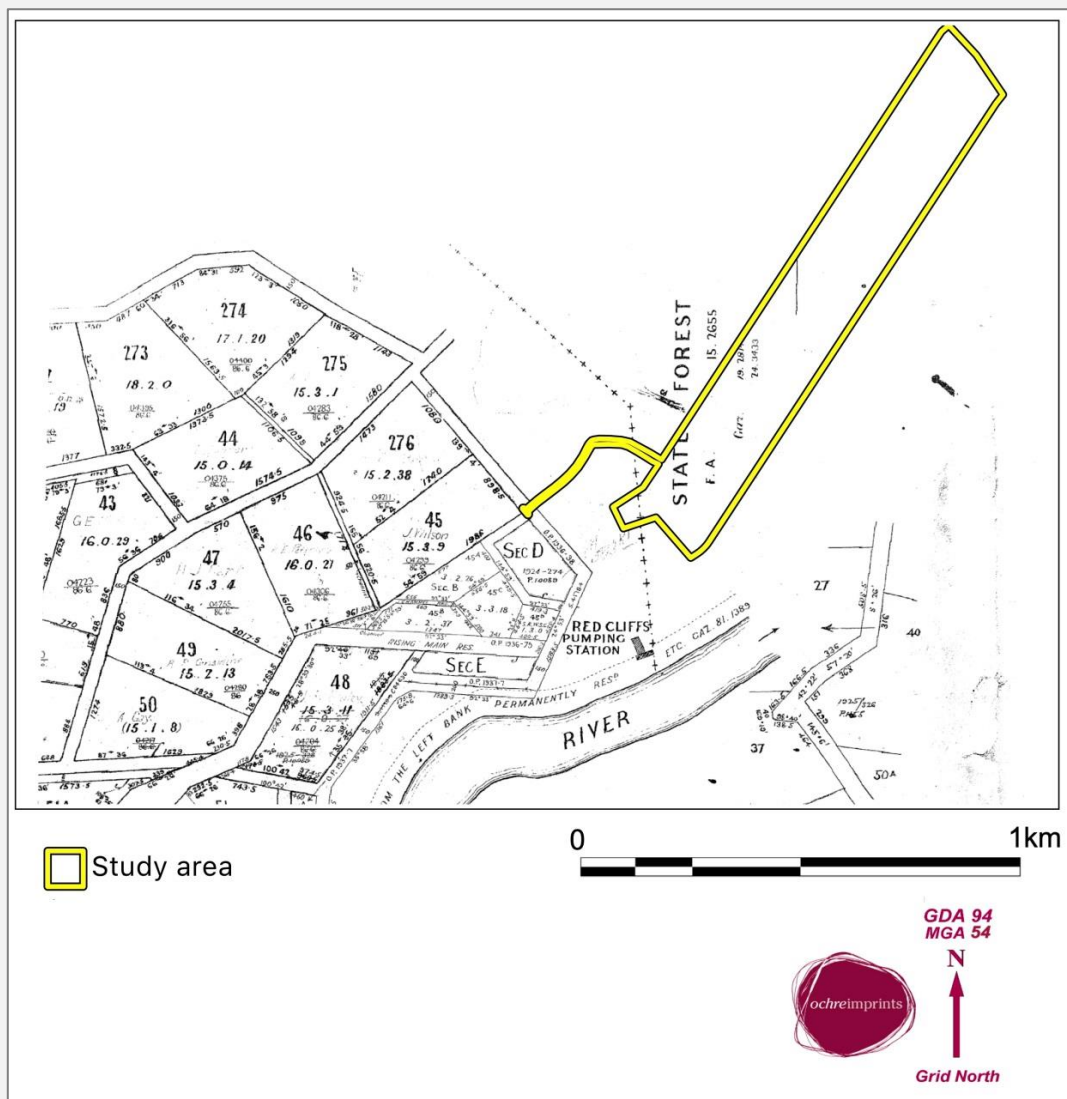
The Figure 5 plan also shows the easement or reserve set aside for the route of the rising main travelling in an east-west direction to the west of the pumping station towards Channel No. 1 which, in turn, took a somewhat circuitous route toward Mildura to the northwest.

Figure 5 – Dated to after 1935 showing the updated pumping station building outline (possibly undertaken in 1924) (M556-W-1).

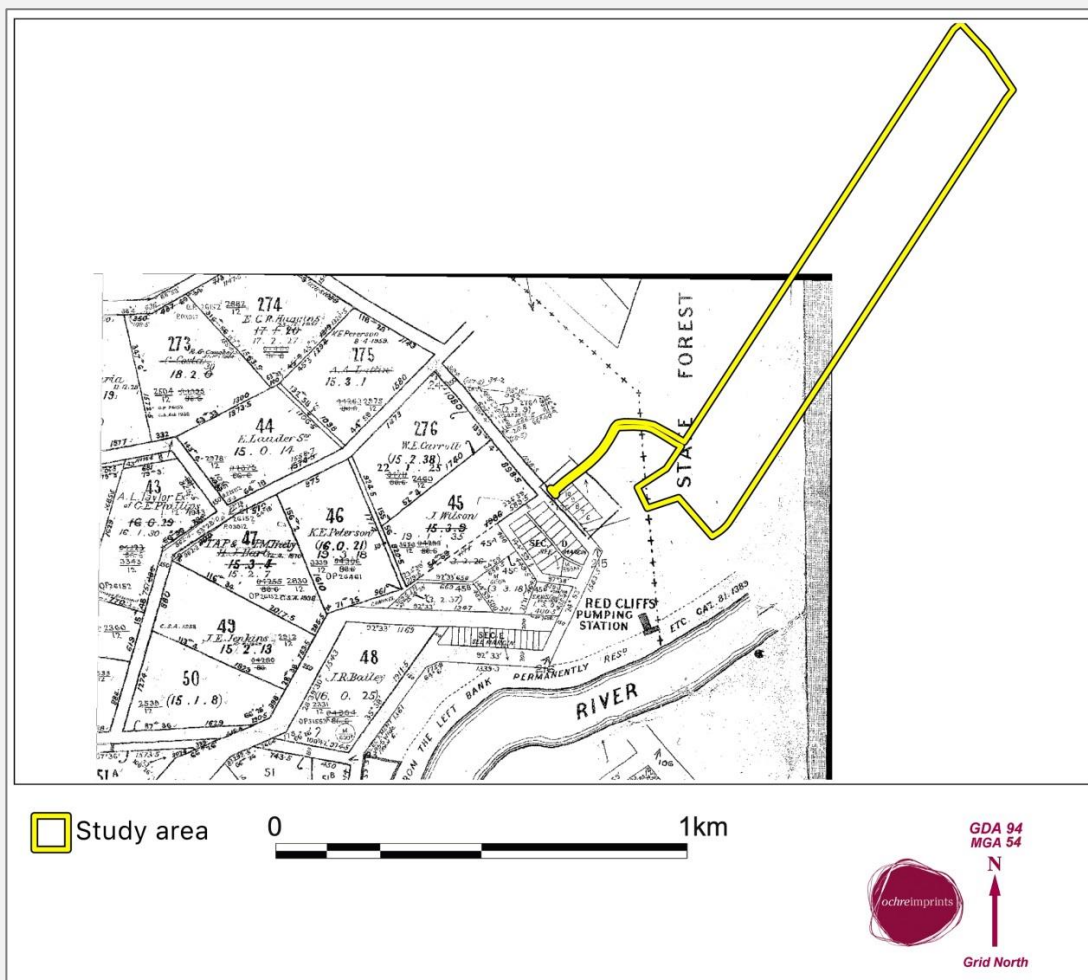
Figure 6 – c. 1970 Put-away plan showing the pumping station in much the same configuration (M566 – W3).
