Preliminary Geotechnical Desktop Assessment

22-Feb-2023
Kennedys Creek Solar Farm

433 Link Development Pty Ltd
09-Sep-2019
Doc No. 60597829-RPTGT-0001

Geotechnical Desktop Assessment

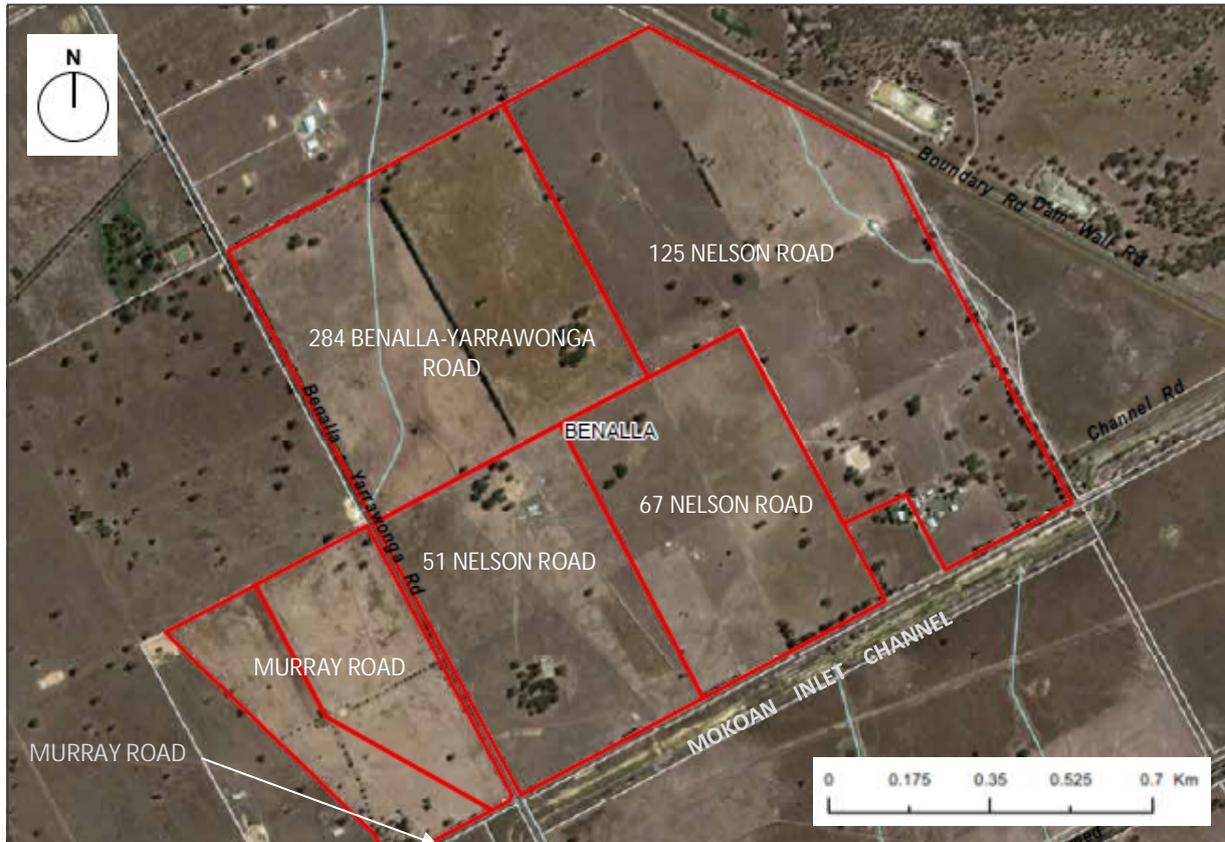
Figure 2: Individual properties of Kennedy's Creek Solar Farm

At the time of the report, the site is made up of five properties identified in Figure 2 overleaf and listed below:

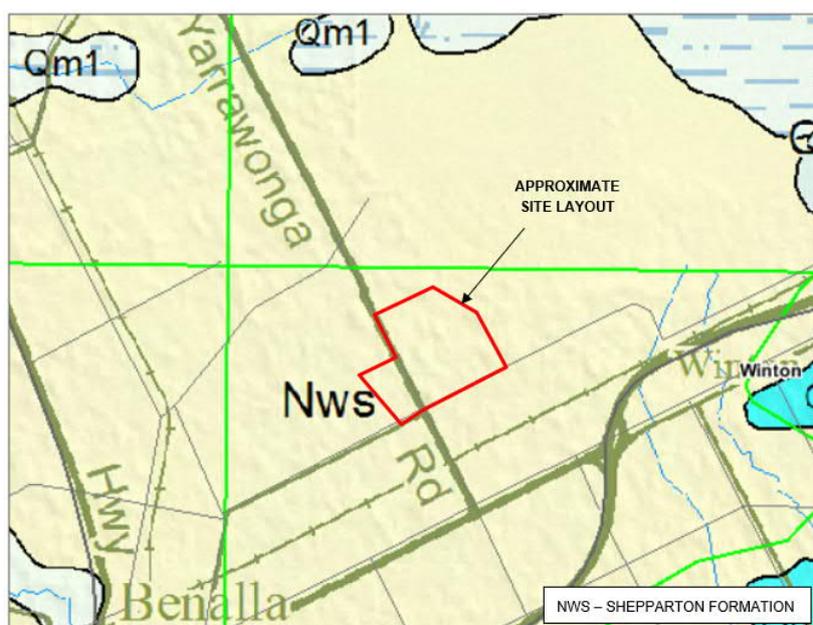
Figure 3: Geological extract from DPI website (NTS)

The heterogeneous sedimentary unit typically comprises flood plain clays, silts, channel sands and minor gravel. The deposits are also known to contain quartz, mica, feldspar and ironstone and cemented sands.

The Geological Survey of Victoria's 1:250,000 series 'Wangaratta' map sheet indicates the site is located in an area comprising Quaternary age fluvial and lacustrine sediments of the Shepparton Formation, generally associated with extensive prior stream networks, floodplains and colluvium.

The geological map sheets do not indicate any faulting, geological structures or mining activities on, or in close proximity to the site.

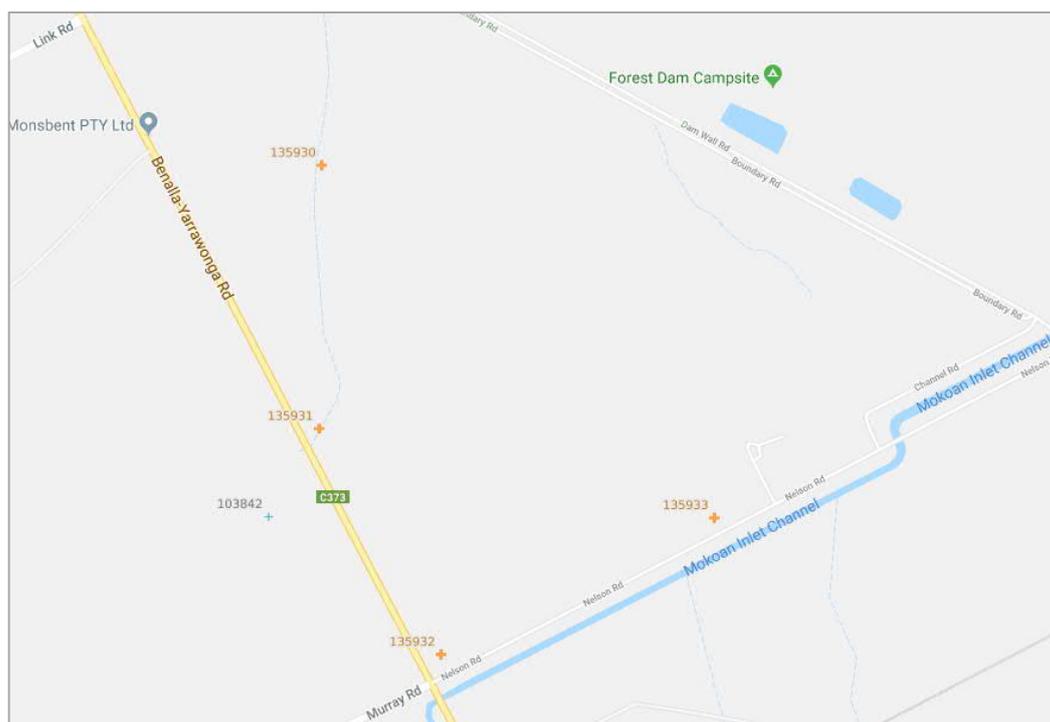
Figure 4: Groundwater bores on site Source: Visualising Victoria's Groundwater (www.vvg.org.au)

The Department of Environment, Land, Water and Planning web-based groundwater reporting tool 'Visualising Victoria's Groundwater' (www.vvg.org.au) indicates there are a number of groundwater bores within or close to the site boundary (see Table 1 and Figure 4).

Lithology logs for the bores 135930, 135931, 135932 and 135933 are summarised in Table 2 to Table 5. The material described on the logs is (based on AECOM's experience) considered consistent with the Shepparton Formation deposits. It is noted that the logs are not in accordance with AS1726 Geotechnical Site Investigations, but provide an indication of the type of materials that could be encountered in this area.

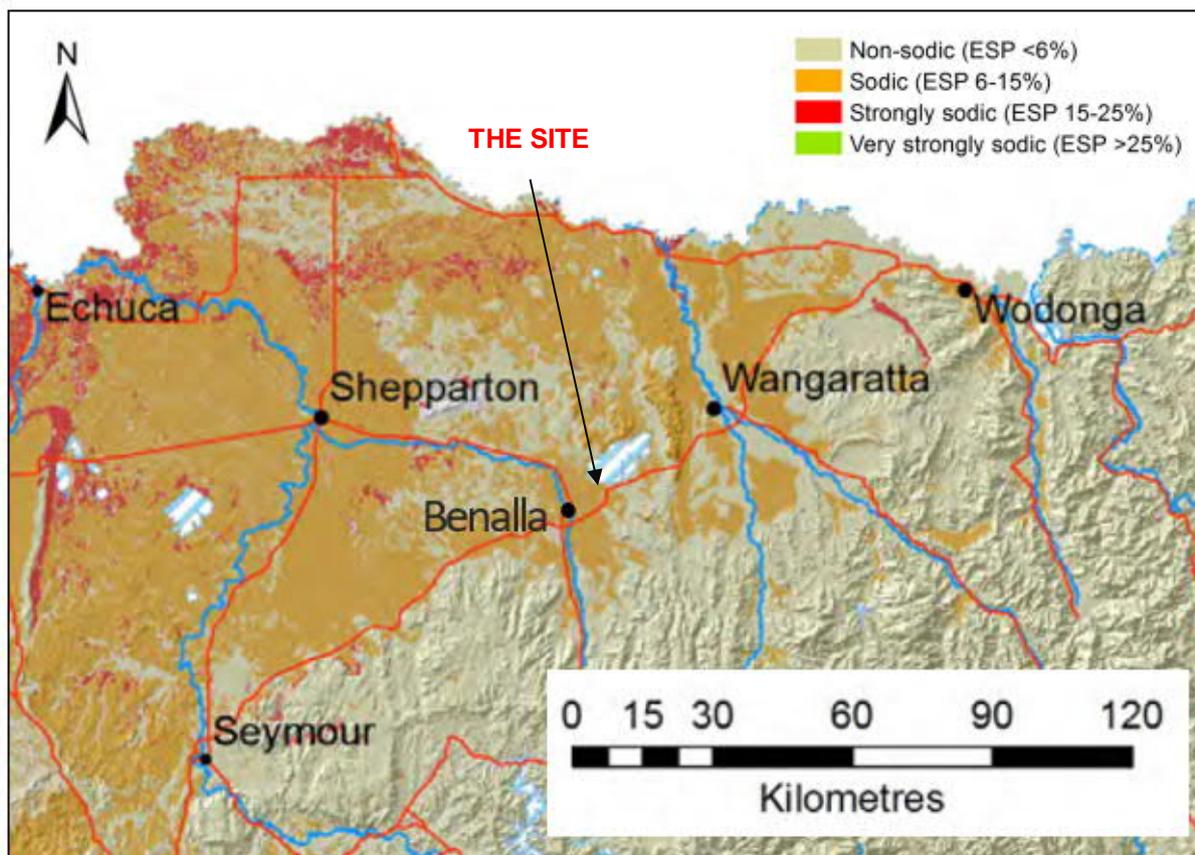
Figure 5: Generalised regional map of Victorian sodic soil distribution

The maps indicate that sodic soils (a soil with exchangeable sodium greater than 6%) could be present onsite (Figure 5). Sodic soils typically occur on broad, flat landscapes with poor drainage, particularly in arid environments. The Bureau of Meteorology (BOM) indicates Benalla has a mean annual rainfall of approximately 670 mm. Sodic soils are susceptible to dispersion and waterlogging, and earthworks which contain dispersive soils are generally more erodible.

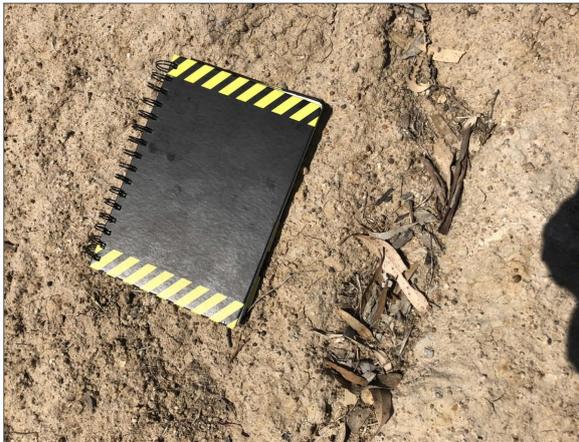
Figure 6: Gravel exposed on farm dam embankment

The materials exposed along the farm dam embankments were observed to be a dry silty/sandy clay. In some sections of the dam embankments, a thin covering of fine to medium grained, red-brown ferruginous gravel was observed (Figure 6). The sediments in the base of the empty farm dams showed evidence of desiccation cracks, due to the prolonged dry spell (Figure 7).

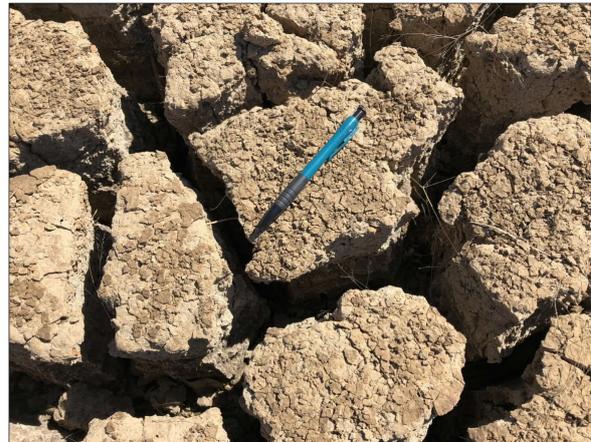
Figure 7: Surface desiccation feature

The clays are likely to be reactive and hence prone to shrink and swell movements upon wetting and drying. Cracking of the exposed ground surfaces was observed, indicating the potential for shrink-swell activity due to seasonal moisture variations.

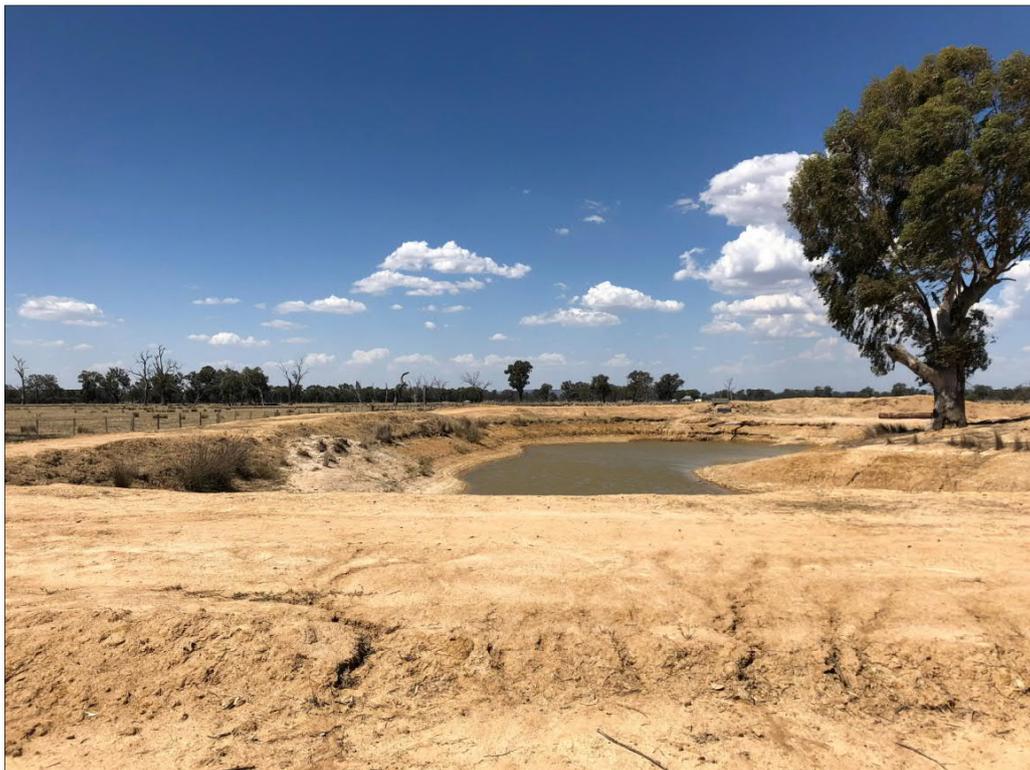
Photograph KC 26

At the northern end of the wedge-shaped property adjoining the Murray Road property, there is a large farm dam which abuts the northern end of the site (Ref: KC26).
