ADDENDUM TO PRELIMINARY GEOTECHNICAL RISK AND FOUNDATION ASSESSMENT

NORTHSIDE SNOW FACTORY, MT BULLER, VIC 3723

**PRELIMINARY GEOTECHNICAL AND FOUNDATION ASSESSMENT
ADDENDUM NO. 1**

**CONSTRUCTION OF FOUNDATION AND INSTALLATION OF SNOW FACTORY AT
NORTHSIDE SPURS**

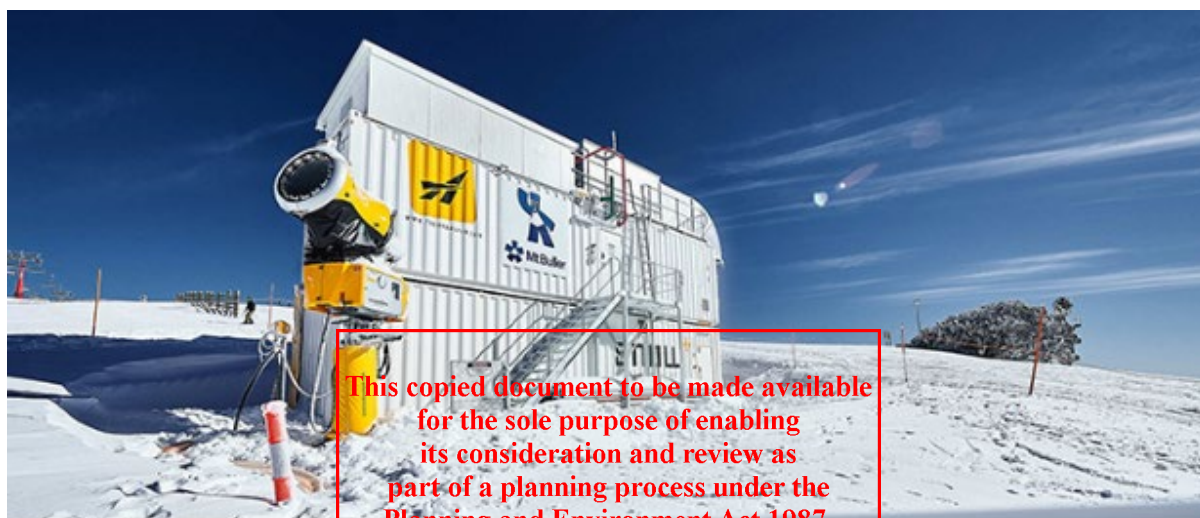
Figure 1: Snow factory, typical installation using 40' modified containers.

Information provided shows the proposed machinery housing structure to be a modular containerised building which is transportable, being placed on a concrete slab foundation. A typical layout was provided in an email from Timothy Meier dated 17/11/2023. Refer Figure 1 below.

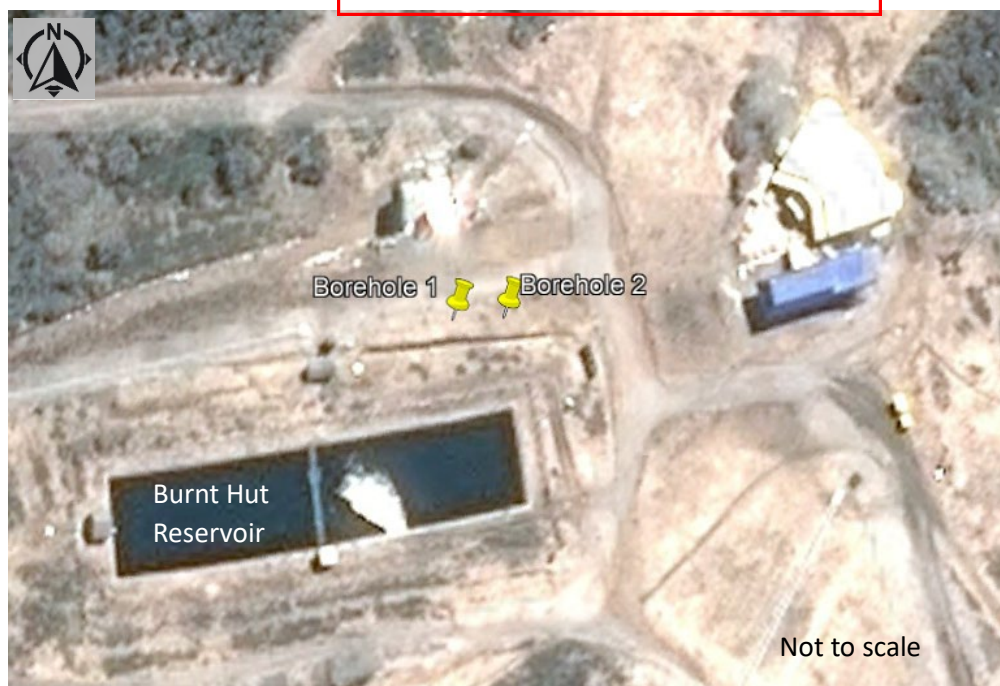
Test site location plan.

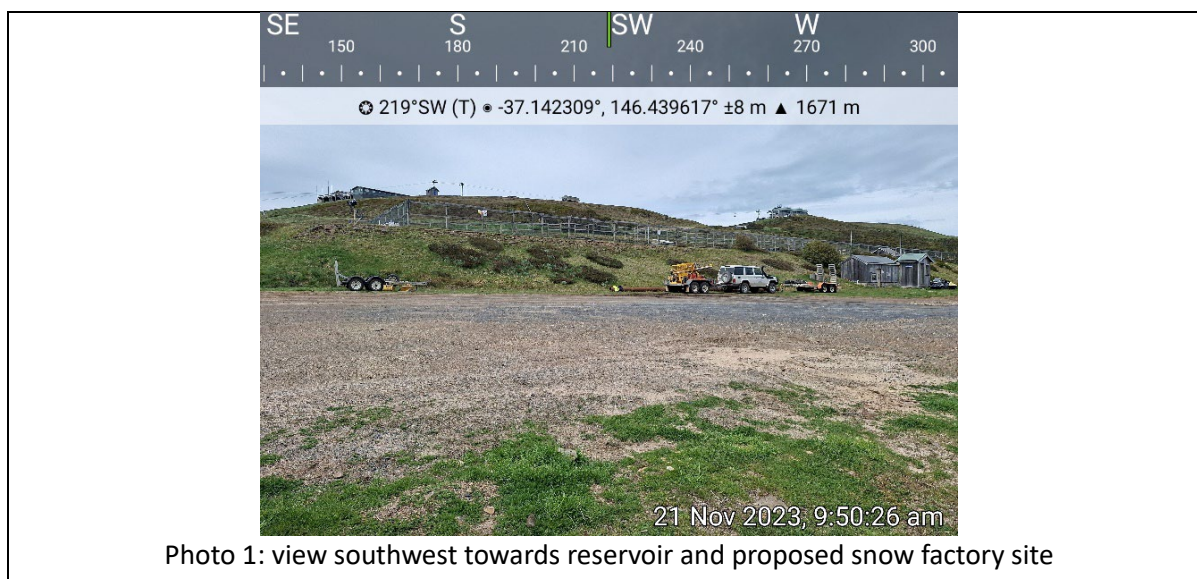
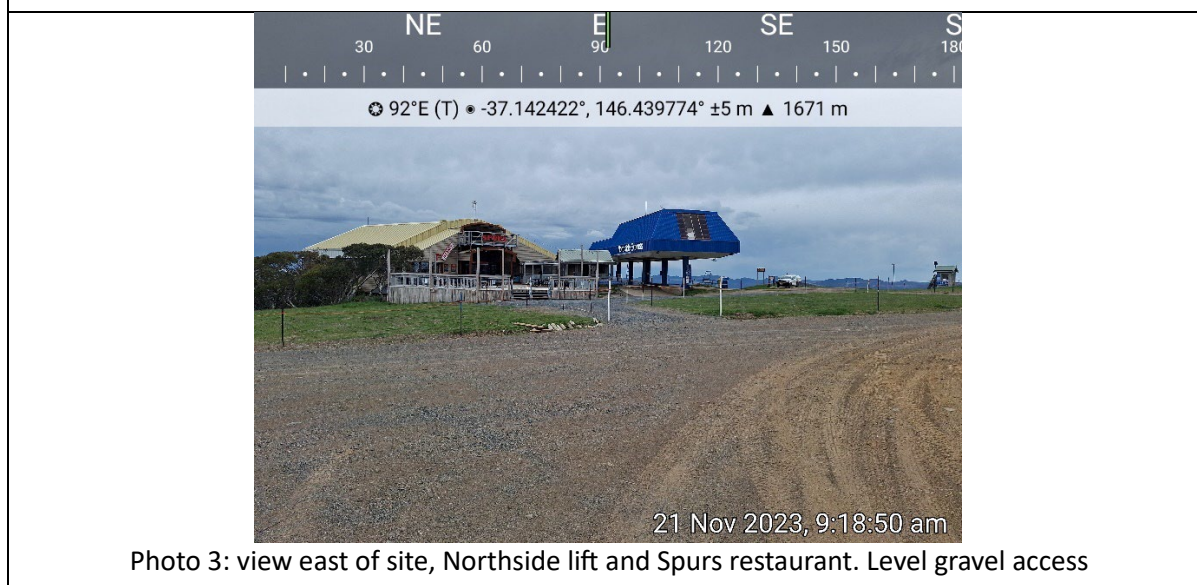
- The site has been levelled. Imported gravel hardstand has been placed to form a trafficable surface. Refer photos 1-3, 9-10.
- The snow factory site is located directly adjacent the concrete lined Burnt Hut Reservoir.
- Free water was observed on the northern batter slope of the reservoir, which anecdotally has an ongoing history of minor leakage. Refer photo 5.
- There is an open, unlined drain at the toe of the northern batter. It is our understanding that this drain has been constructed to collect the seepage from the embankment face and channel it away from the road. The drain contained water at the time of the inspection. Refer photos 2, 4, 8-10.

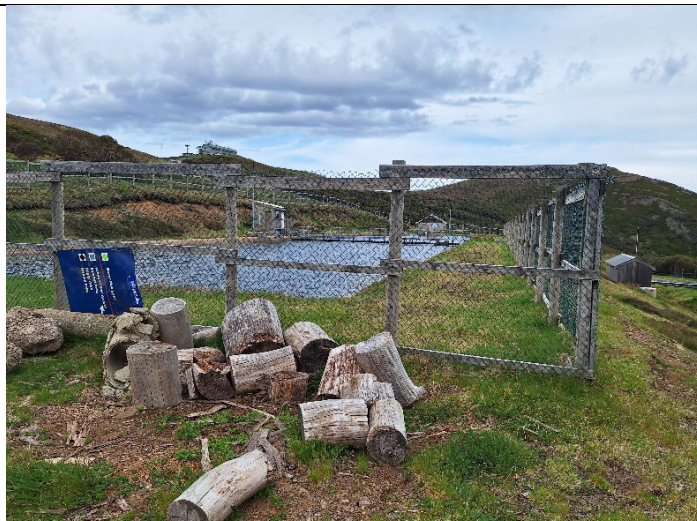
Photo 4: view west across reservoir. Site downslope to the right

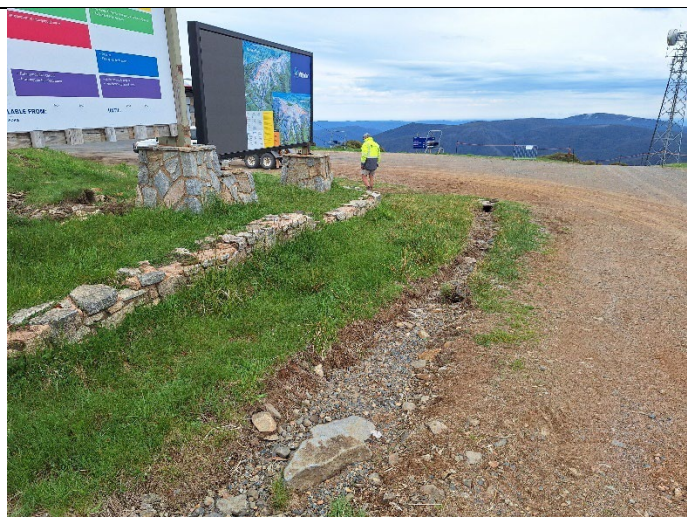
Photo 6: view north noting downslope drainage. Site to the left

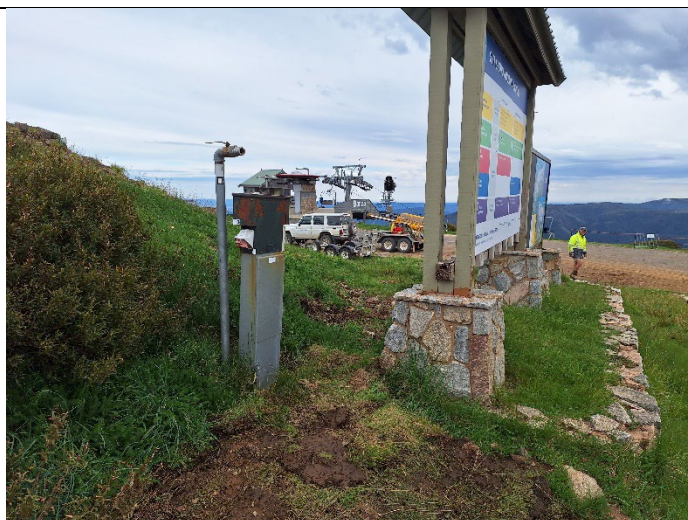
Photo 7: existing standpipe water supply by information boards

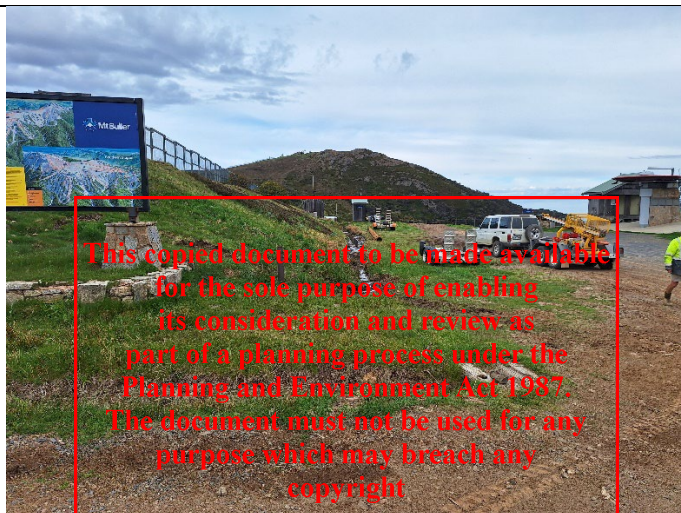
Photo 8: view west along reservoir batter. Note drain along toe

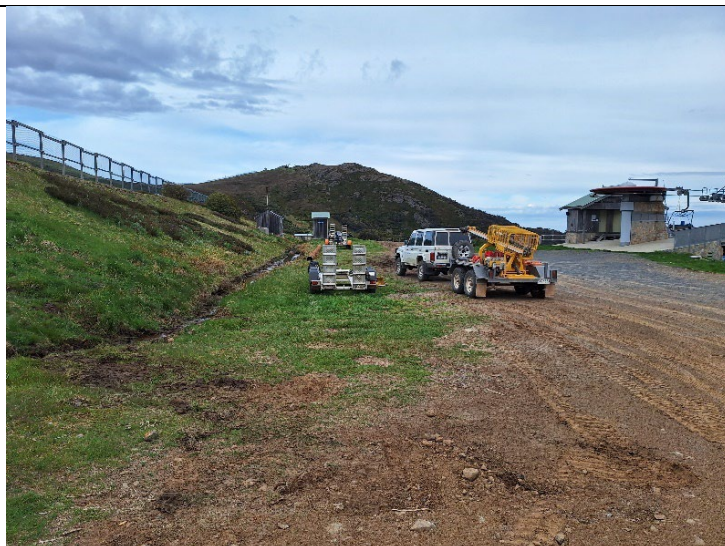
Photo 9: view west along reservoir batter. Noting reservoir, levelled site and drain along toe

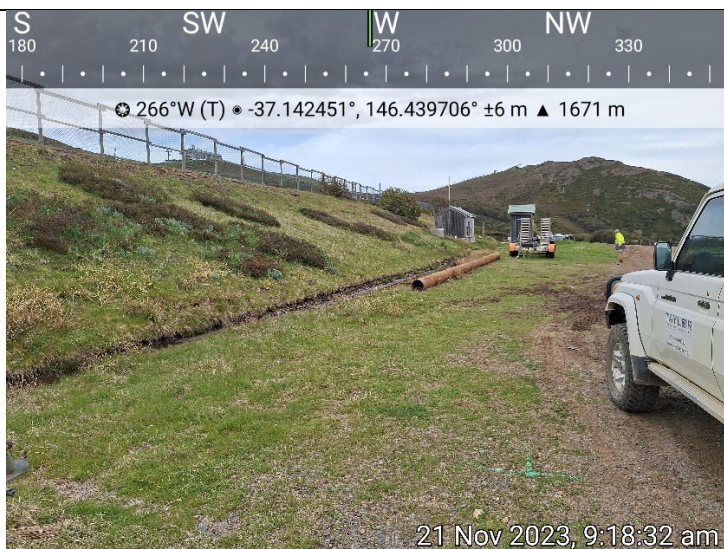
Photo 10: proposed site location

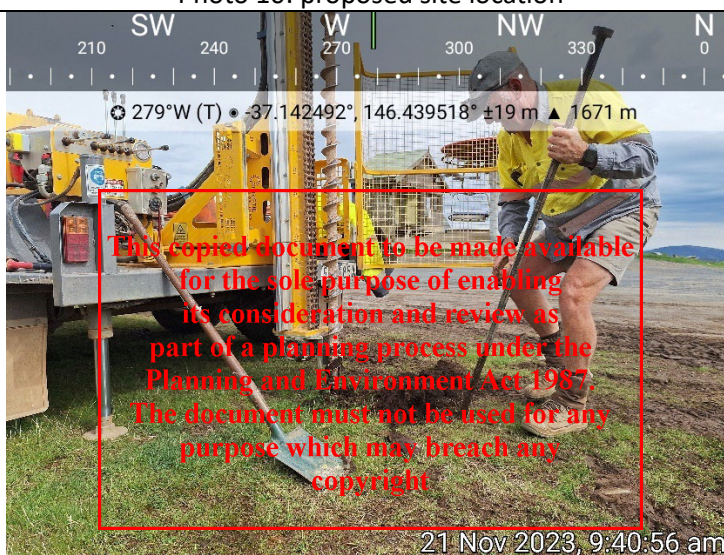
Photo 11: refusal of auger at 0.2 m and fencing bar at 0.3 m

The walkover and borehole investigation (refer photos 11 & 12) noted the presence of around 200 mm of rock fill and black 'topsoil' consisting of basalt gravel, cobbles and boulders. This was consistent with the exposed batter material in the embankments of the adjacent reservoir.

The two boreholes were drilled using auger bits and failed to penetrate any deeper than 0.2 m as the augers met drilling refusal on cobbles and boulders. Further attempts to investigate deeper using a fencing bar achieved a total depth of 0.3 m before experiencing refusal on cobbles.

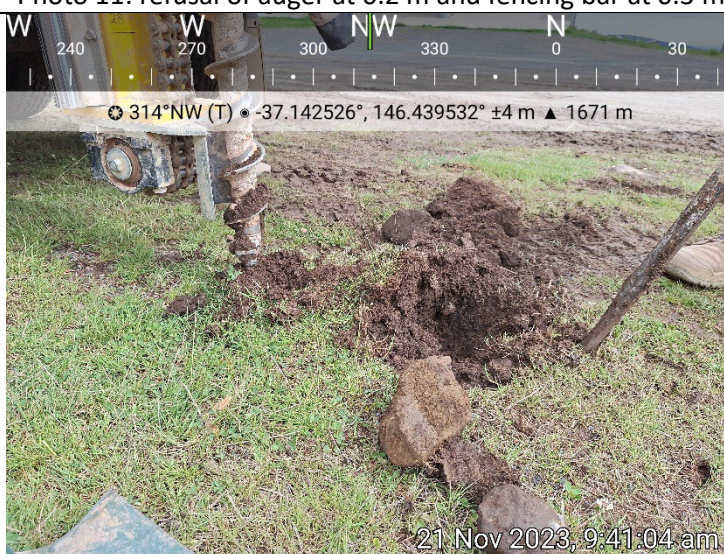
Photo 12: 'topsoil', clay, sand, gravel, & basalt cobbles
