**ARBORICULTURAL IMPACT ASSESSMENT  
REPORT- AMMENDMENT 2**

**Penola Catholic College**

445-465 Camp Road Broadmeadows VIC  
(Accessed at 29A Gibson Street)

25<sup>th</sup> June 2021

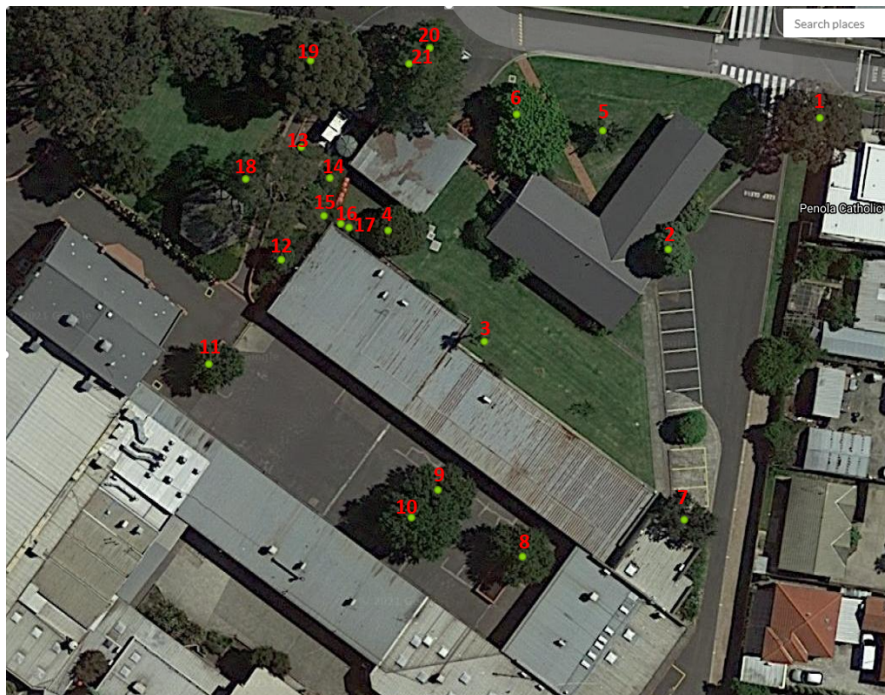
Figure 1. Overhead Site Image existing buildings.

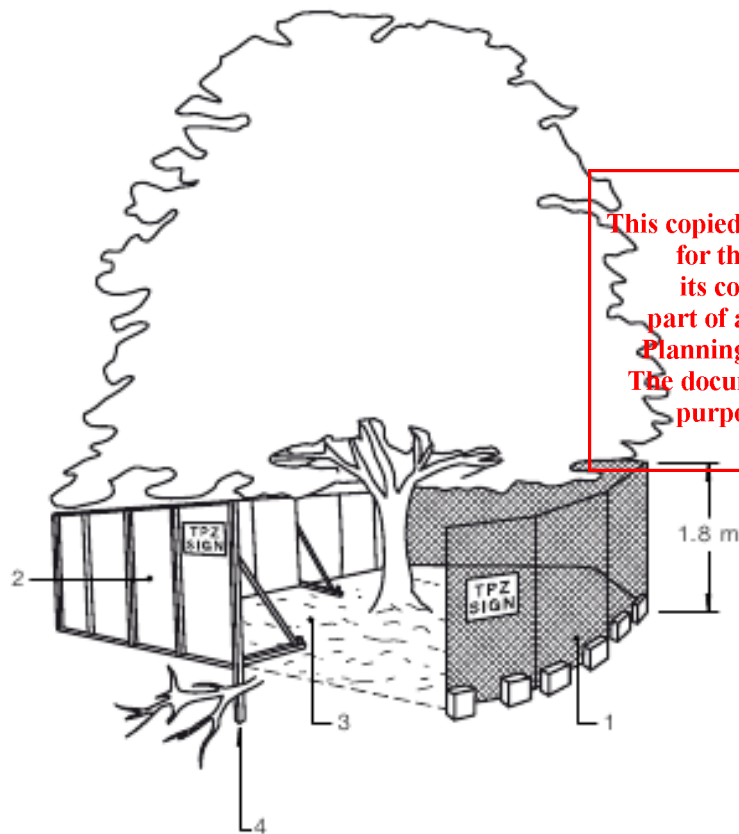
**16.5 Indicative Tree Protection Fencing**

- 1 Chain wire mesh panels with shade cloth (if required) attached, held in place with concrete feet.
- 2 Alternative plywood or wooden paling fence panels. This fencing material also prevents building materials or soil entering the TPZ.
- 3 Mulch installation across surface of TPZ (at the discretion of the project arborist). No excavation, construction activity, grade changes, surface treatment or storage of materials of any kind is permitted within the TPZ.
- 4 Bracing is permissible within the TPZ. Installation of supports should avoid damaging roots.

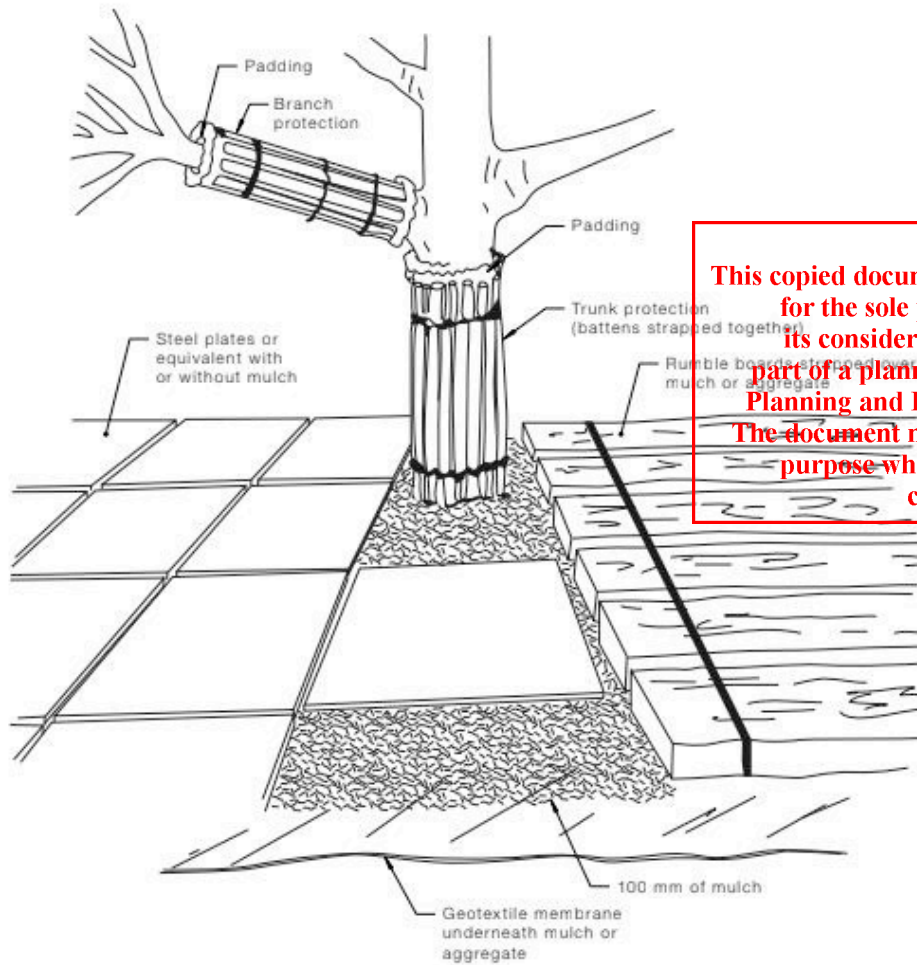
- 1 For trunk and branch protection use boards and padding that will prevent damage to bark. Boards are to be strapped to trees, not nailed or screwed.
- 2 Rumble boards should be of a suitable thickness to prevent soil compaction and root damage.
