Arbor Survey

**CONSTRUCTION IMPACT ASSESSMENT**

**Site Address:**  
7 Princes Highway  
**DANDENONG SOUTH**

**Document Ref:**  
R6702 7 Princes Highway DANDENONG SOUTH

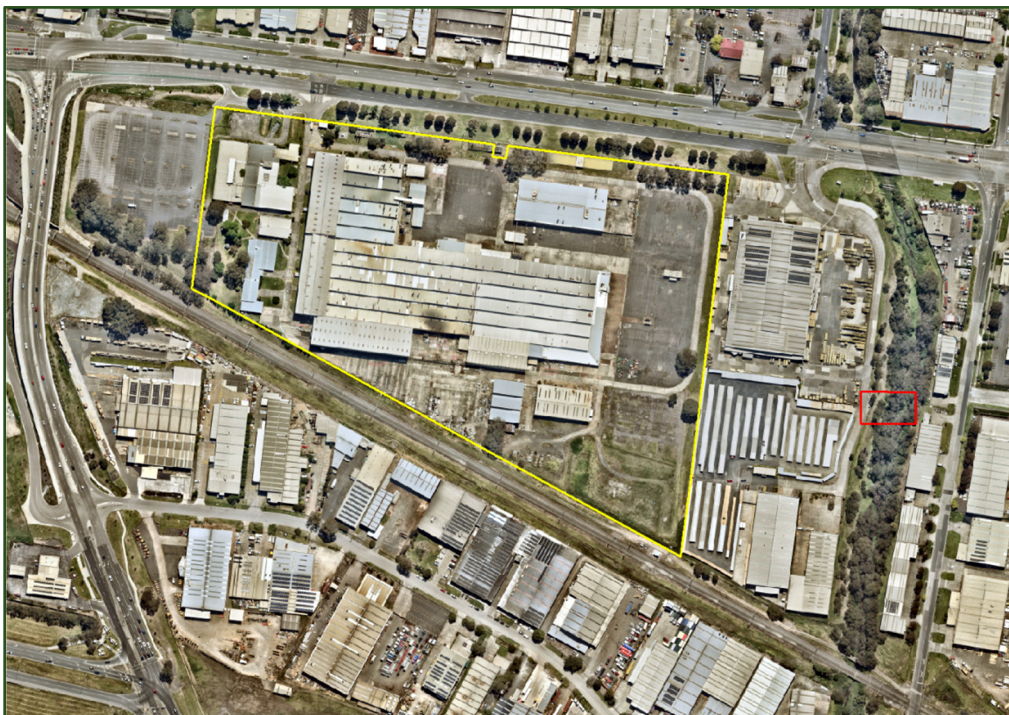
**Figure 1:** Aerial photograph and property outline (Nearmap™, Dated: 29/10/2023)

The tree assessment area is located to the east of the project site, 7 Princes Highway, Dandenong South along the existing drainage pipes within the Eumemmerring Creek reserve. The aerial photograph in Figure 1 shows the project site boundary (yellow polygon) and the assessment area (red polygon). The 4 *Eucalyptus camaldulensis* (River Red Gum) trees assessed are located on the western bank of Eumemmerring Creek within the vicinity of the existing drainage pipes. There is a change in grade of approximately 4.5 metres from the access road to creek level.

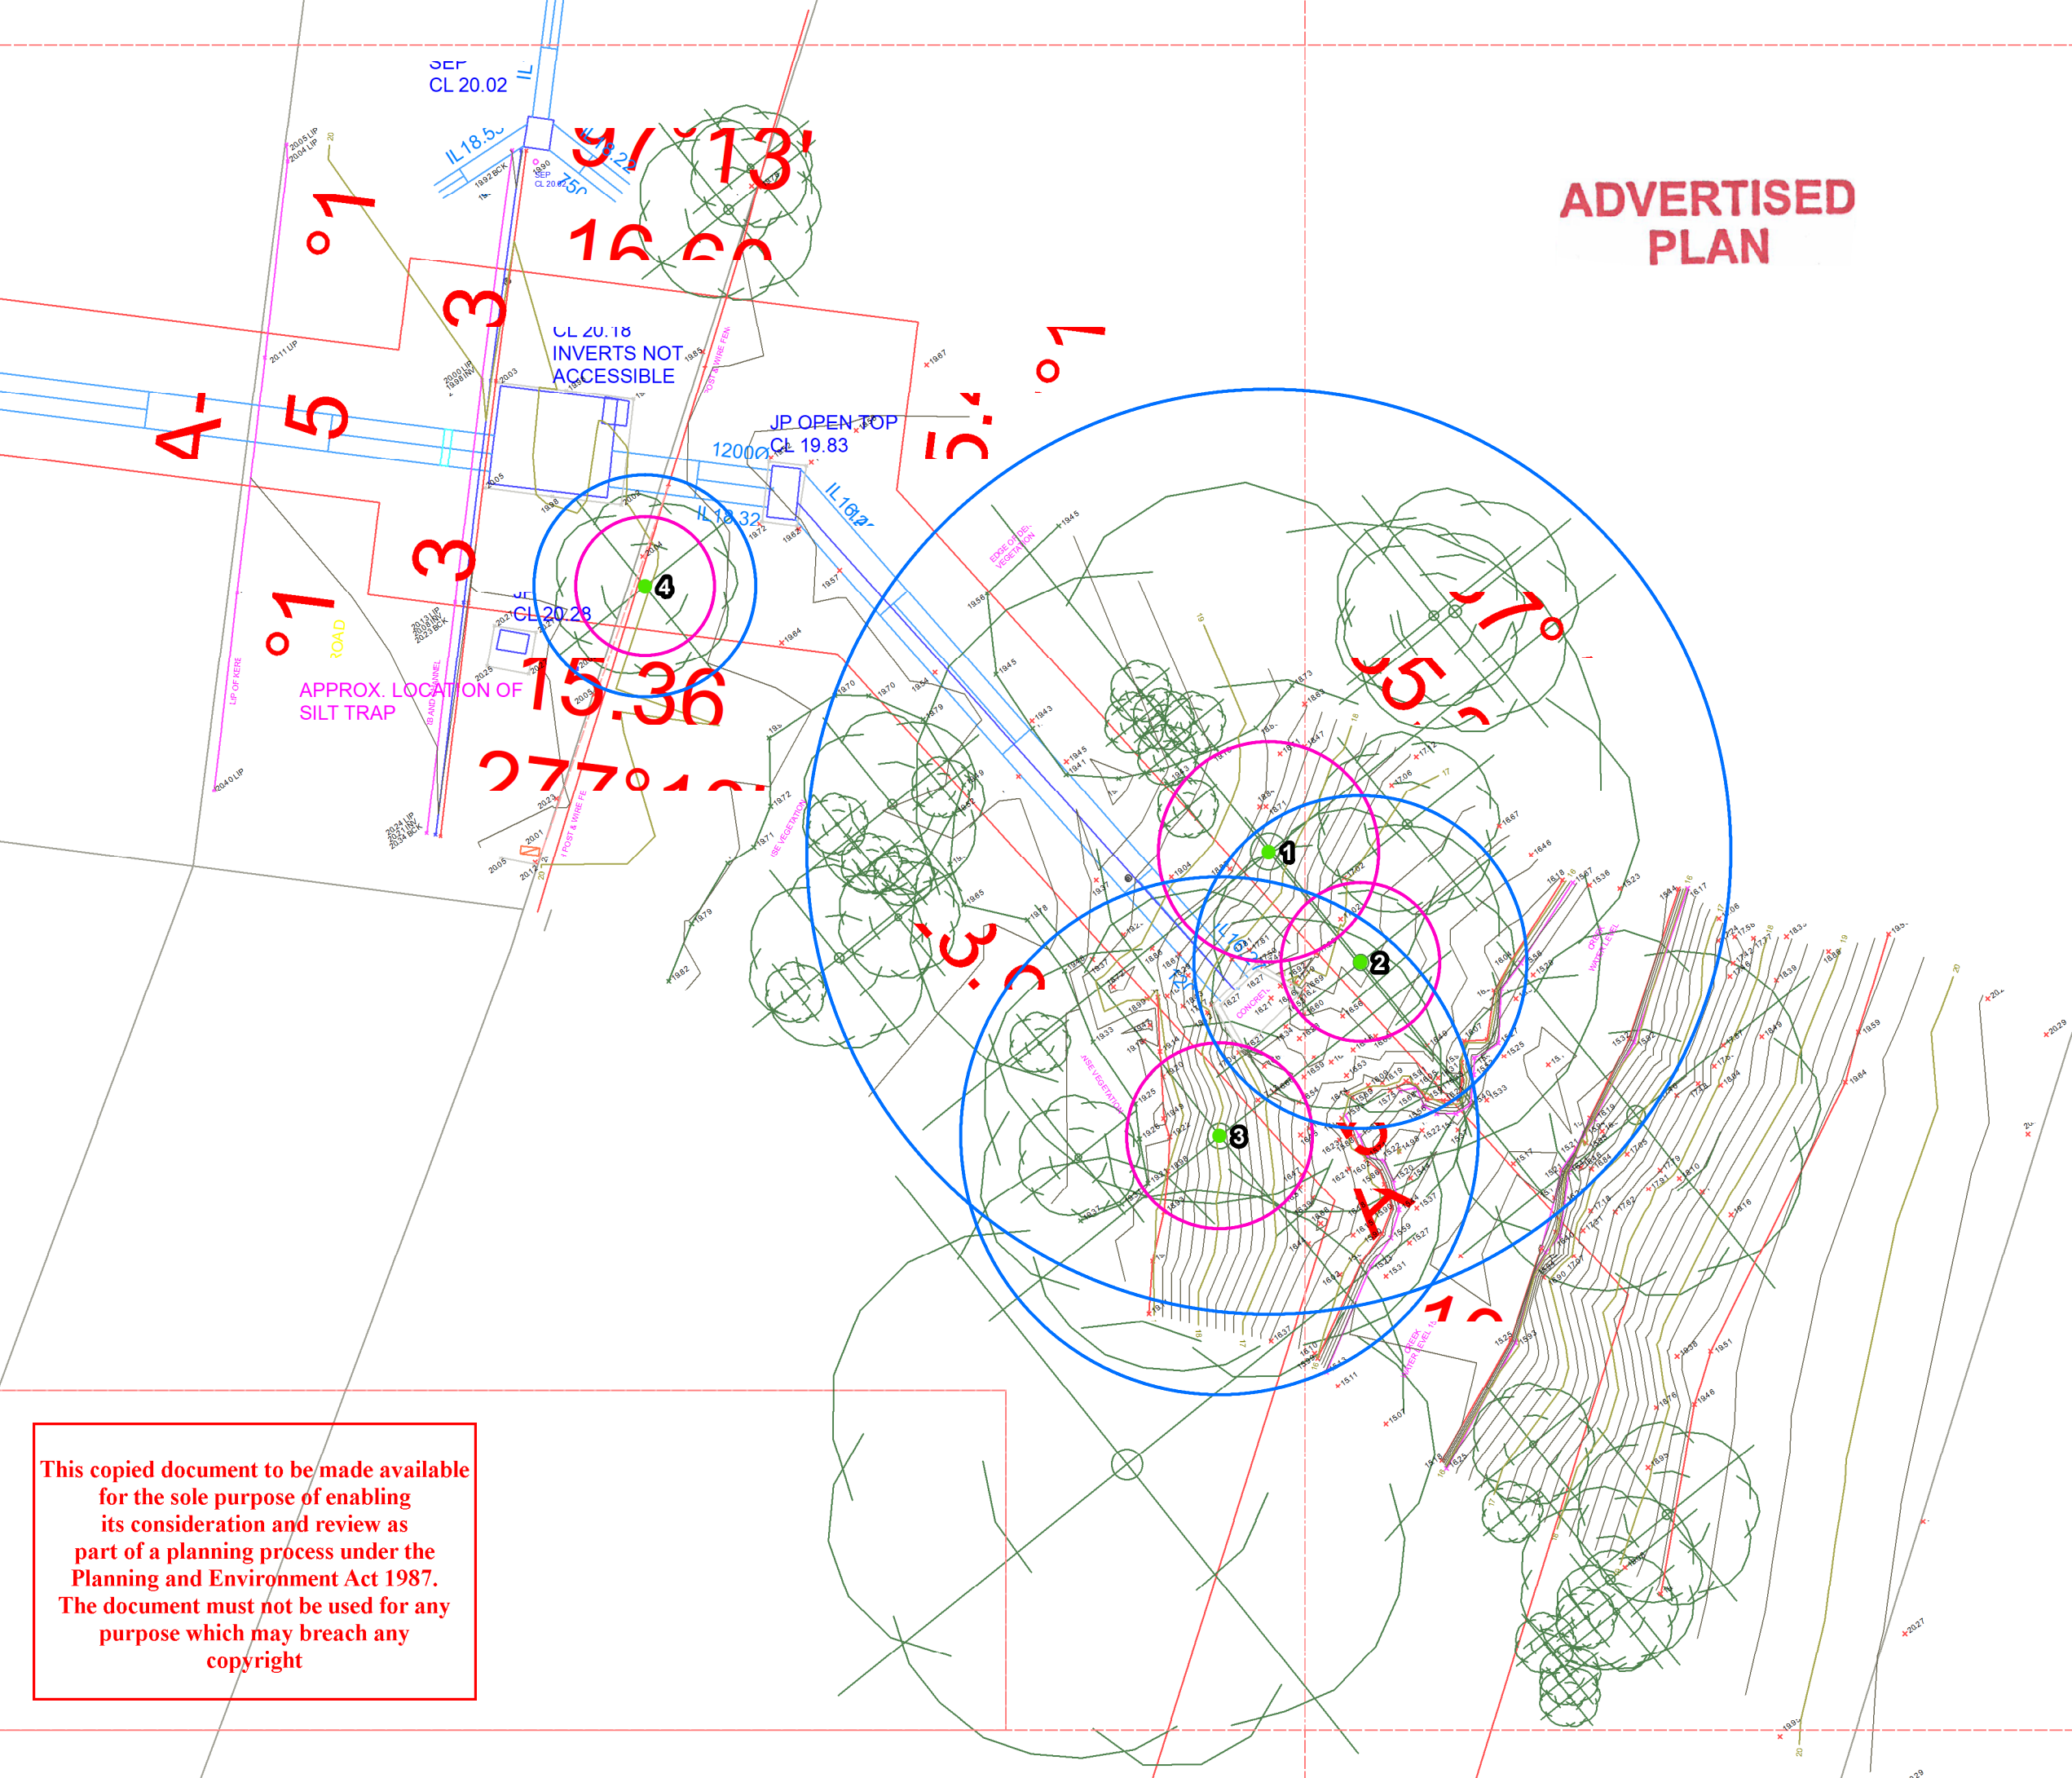
The Tree Location Plan (Existing Conditions) and Construction Impact Plan in Section 7.2 provide a visual representation of the protection values of the trees and indicates the Tree Protection Zone (TPZ), Structural Root Zone (SRZ) and encroachment from proposed works for trees that are considered to be of high protection value.

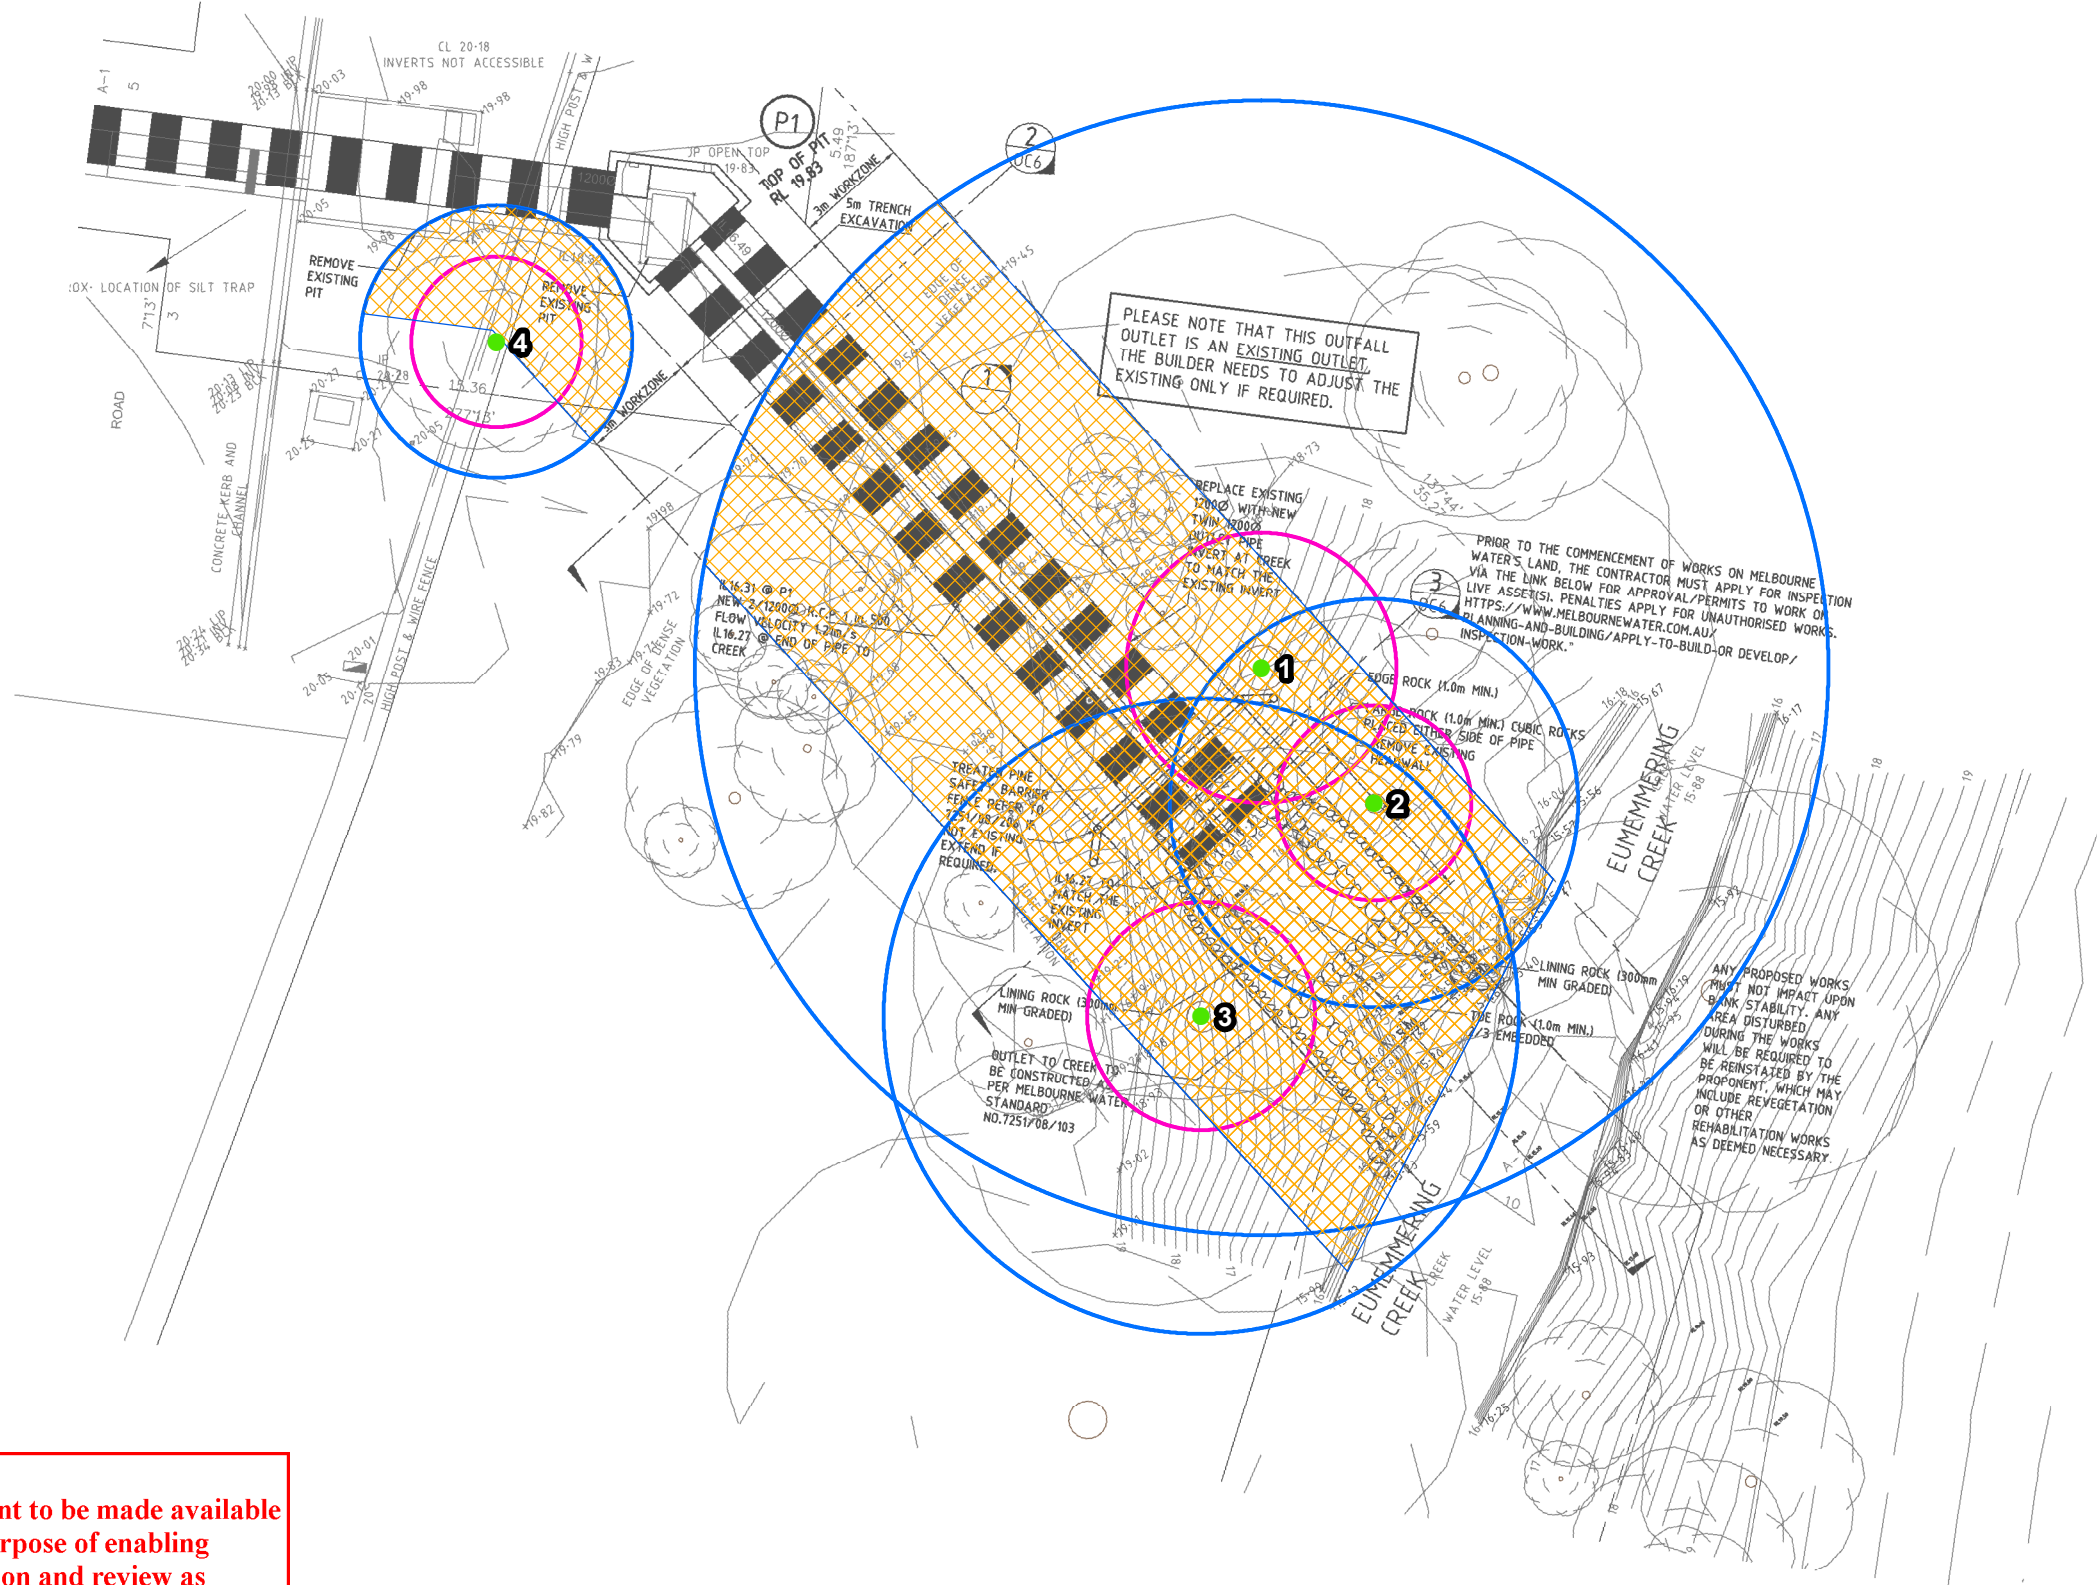
- Tree Protection Zone (TPZ)
- Structural Root Zone (SRZ)
- Encroachment

- None required other than a work zone fence which could be noted as a condition of permit
