JEM ARCHAEOLOGY

16 August 2023

**RE: Proposed Warehouse Development, 7 Princes Highway, Dandenong South VIC 3175
- Matters relating to the *Aboriginal Heritage Act 2006***

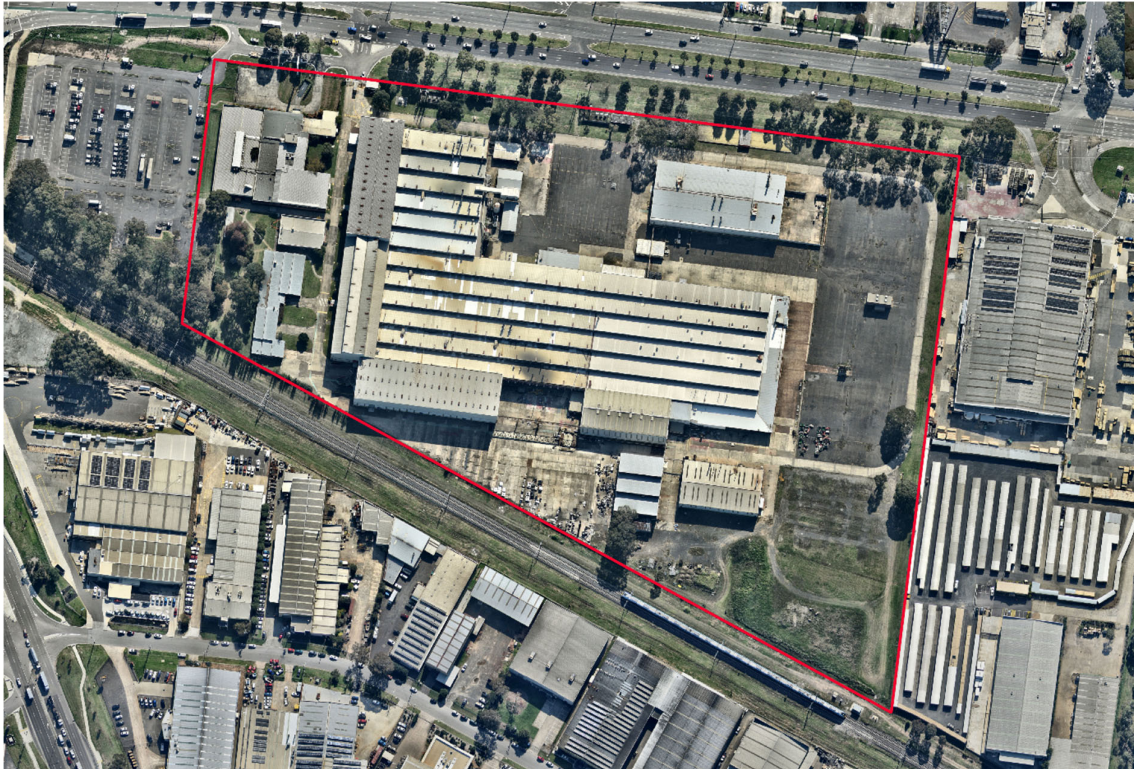
Figure 1: Satellite image dated to 26 April 2023 showing the current state of the activity area (Nearmap 2023).

Based on the most recent satellite imagery of the activity area (Figure 1), it is considered possible that the activity area may have experienced significant ground disturbance. Therefore, an examination of its land use history has been undertaken.

Conditions within the activity area have remained generally consistent since this time and are comparable with those depicted in Figure 1.

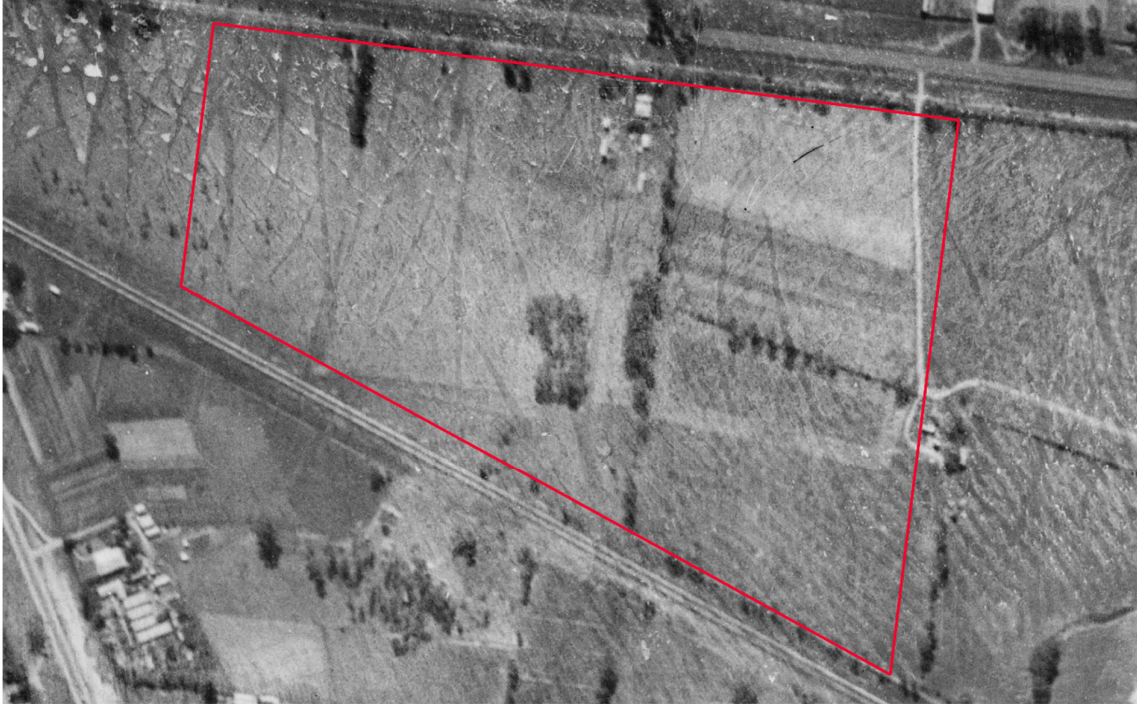
Historical aerial imagery indicates that the activity area has been subject to modification as early as 1939 (Figure 3). By this time, the activity area had been cleared of most remnant vegetation and comprised of pastoral land. A fence line bisected the activity area approximately to its centre, with small structures present to the centre of the northern boundary. A track running south from the road currently known as Princes Highway was present in the northeast corner of the activity area. By 1951, the Dandenong International Harvester Factory had been constructed within the activity area (Figure 4). The primary structure was present towards the centre of the activity area and surrounded by ancillary structures. Unsealed internal roads were present in the western, eastern and central portions of the activity area. The balance of the activity area was cleared, undeveloped land. By 1968, further development had occurred within the activity area (Figure 5). Extensions to the factory were built to the northeast and east, with formal car parking and/or vehicle storage now present to the north and south. Most internal roads appear to have been sealed. Additional smaller structures had also been constructed to the far west and south of the activity area. Some cleared land remained to the east. Aerial photography dated to 1984 (Figure 6) shows further development within the activity area, particularly in the eastern portion where an additional structure and sealed asphalt car park were now present. Possible ground disturbance can be seen along the activity area’s eastern boundary. An additional car park was also present in the southeast corner of the activity area, and various utilities were present along its northern boundary with Princes Highway.

Figure 3: Aerial image dated to December 1939 showing the activity area in red, and earliest evidence of ground disturbance within the activity area (Geoscience Australia 2023).

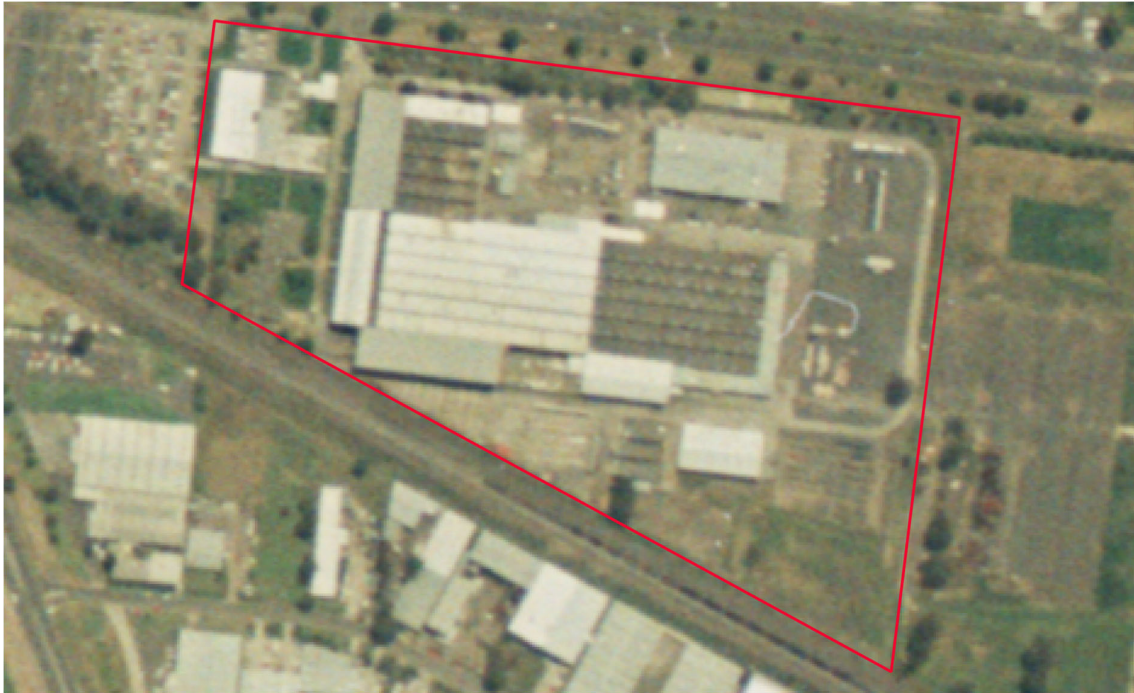
By 1992, further structures were present in the far eastern corner and southeastern portion of the activity area (Figure 7).

Figure 7: Aerial image dated to 29 October 1992 showing the activity area in red (Geoscience Australia 2023).

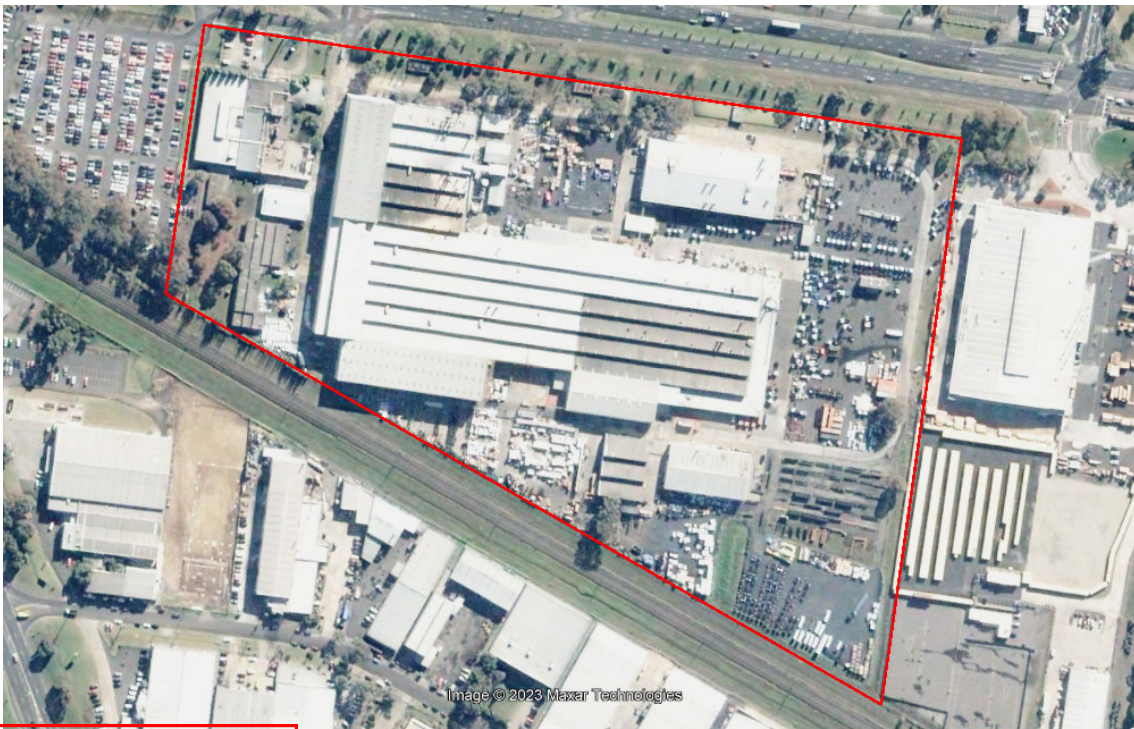
Satellite imagery dated to April 2005 demonstrates that land in the southeastern corner of the activity area was developed into a sealed asphalt car park and storage area (Figure 8).

Figure 8: Satellite image dated to 29 April 2005 showing the activity area in red (Google and Maxar Technologies 2023).

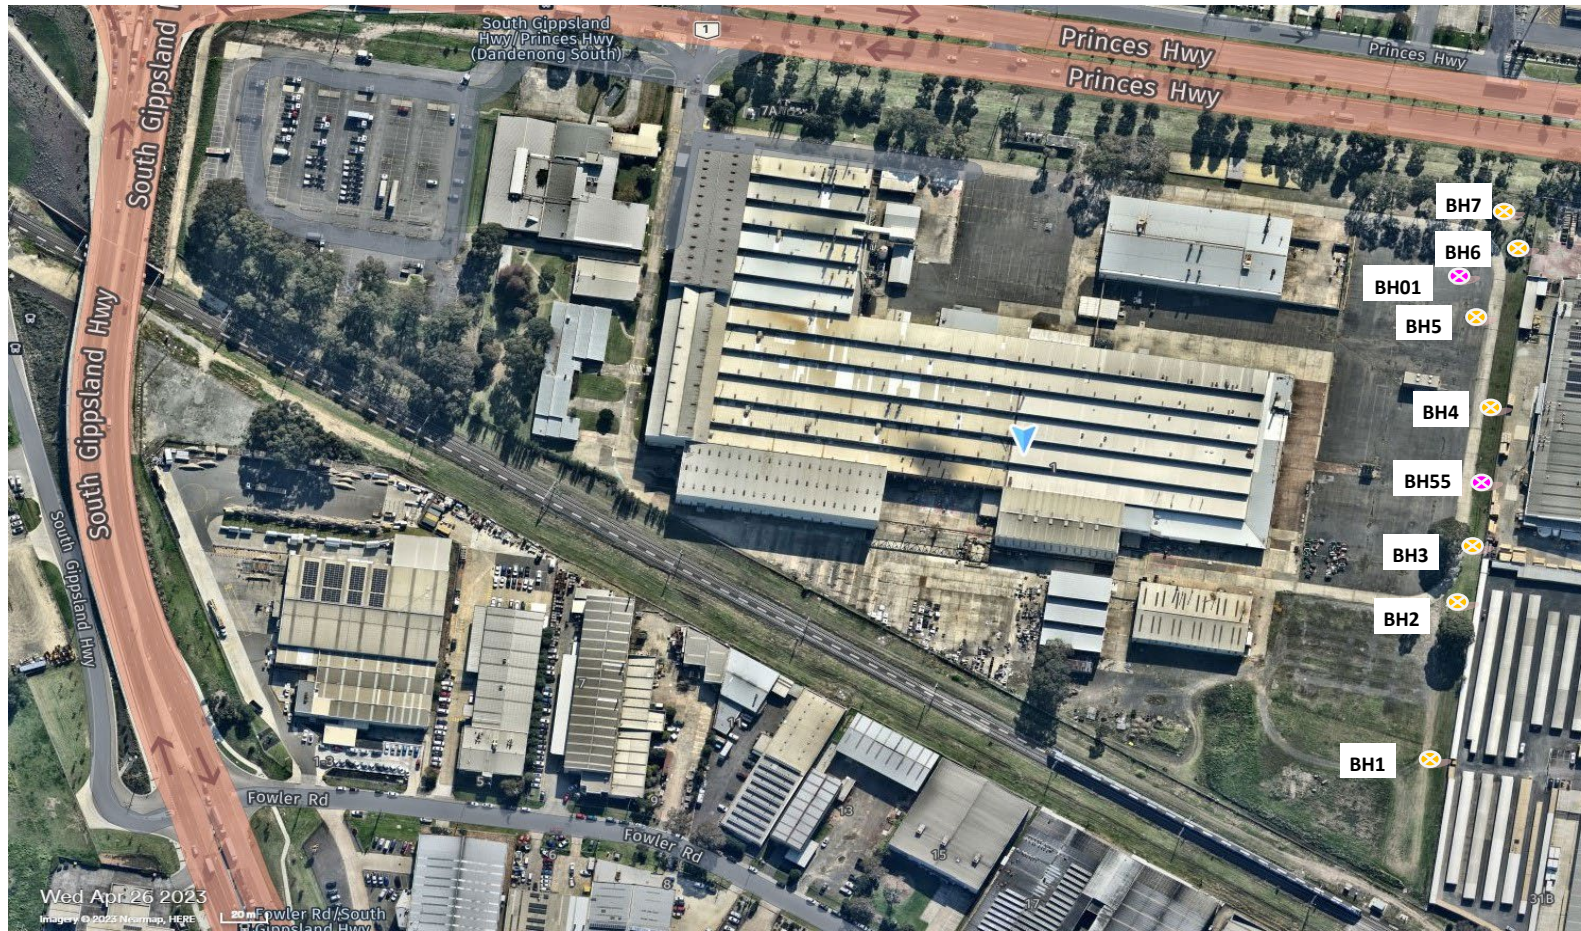
</div>
<p>JOB: Iveco Site 1-27 Princes Highway DANDENONG SOUTH</p>		<p style="text-align: right;">Figure 1</p>
<p>Job No: 122382 A Rev1 Date: July `23</p>

Denotes approximate borehole location - AS James

Denotes approximate borehole location - Greencaps 	<p>BOREPLAN</p> <div style="text-align: right;">
