Byron Reef Mines

Report on the Byron Reef Mines

Site Inspection

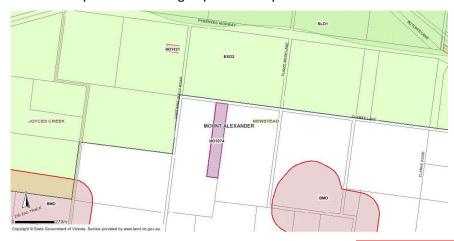
The Planning Scheme mapping marks an area of land running south from Clarke Lane and along the east side of a paddock fronting Captain's Gully Road.

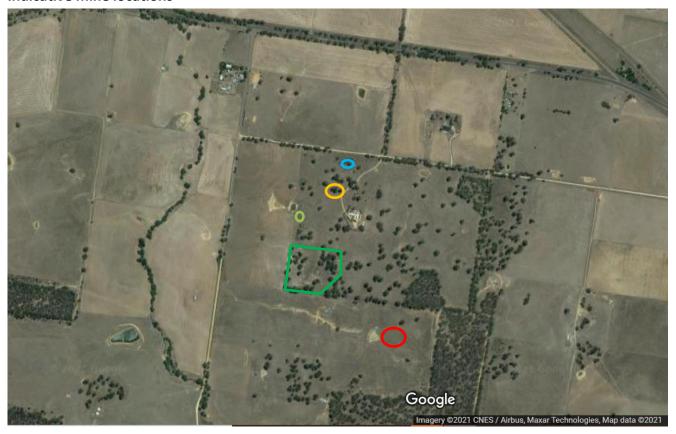
Indicative mine locations

South Byron Mine

Byron Reef Mine

North Bryon Mine

Cottage: chimney and peppercorn grove

Probably cottage remnant and single peppercorn tree

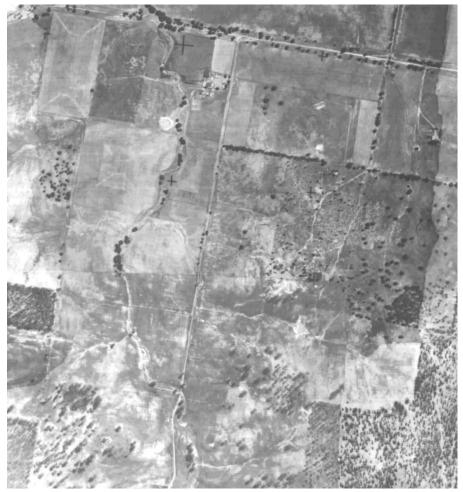
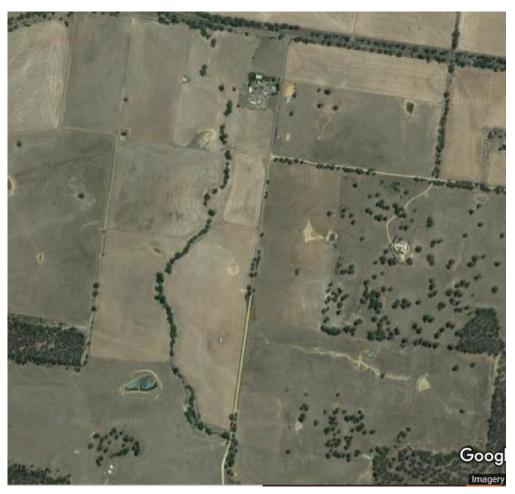
Comparison of the 1946 and current aerial imagery

1946 Aerial

Google maps: c2021
