Report

Viewbank Solar Farm Surface Water Assessment

ERM

15 June 2020

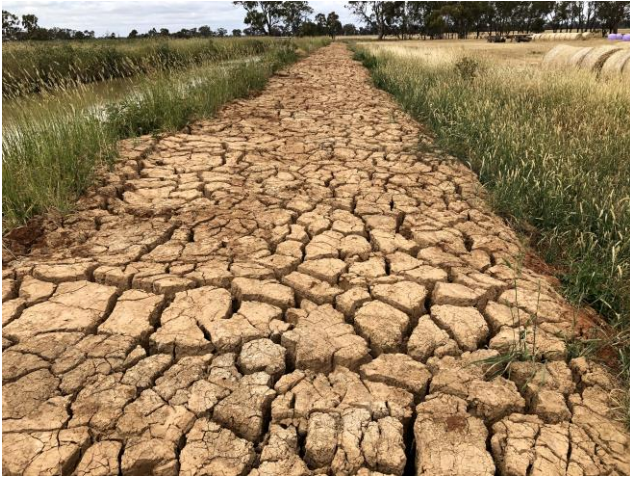
The study site is shown in Figure 3-2, showing the current LSIO and FO and several photo points. Through the site inspection, the irrigation channel at the east of Poole Road was confirmed to exist (Figure 3-3 to Figure 3-5). It was also confirmed that the overland flows from the eastern side of this channel cannot cross the channel and flow west due to the high channel banks that acts as levees to the overland flow. This suggests that the LSIO and FO extents in this area should be significantly reduced as the external catchment to the east will not contribute flows across this land. The low depression which grades east to west will fill with local surface water drainage runoff.

Figure 3-3 Photo 1, on top of the irrigation channel bank facing south

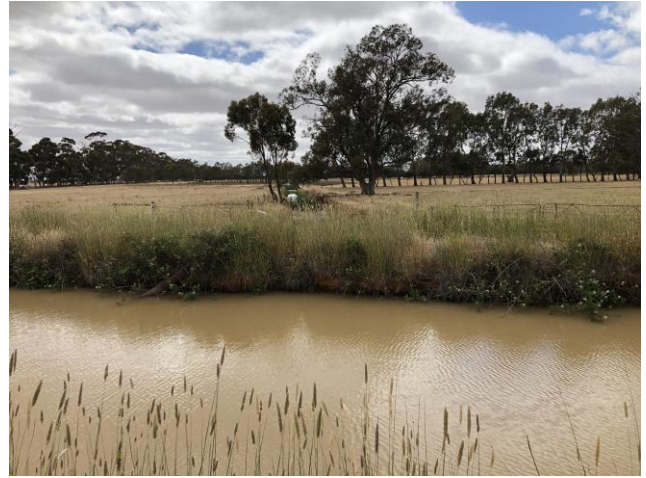
Figure 3-4 Photo 2, on top of the irrigation channel bank facing east

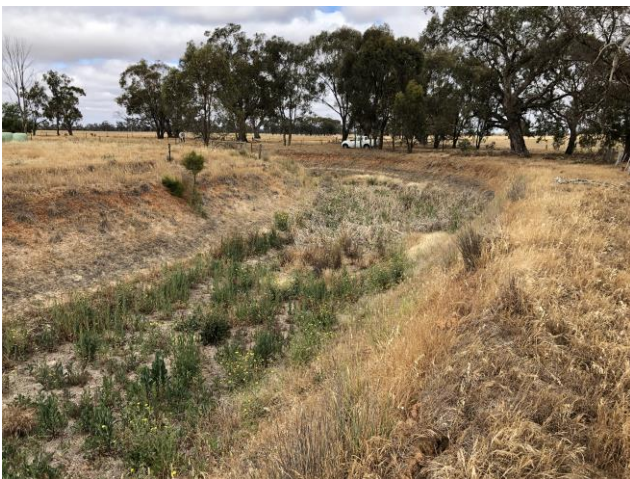
Figure 3-5 Photo 3, irrigation dam, facing west

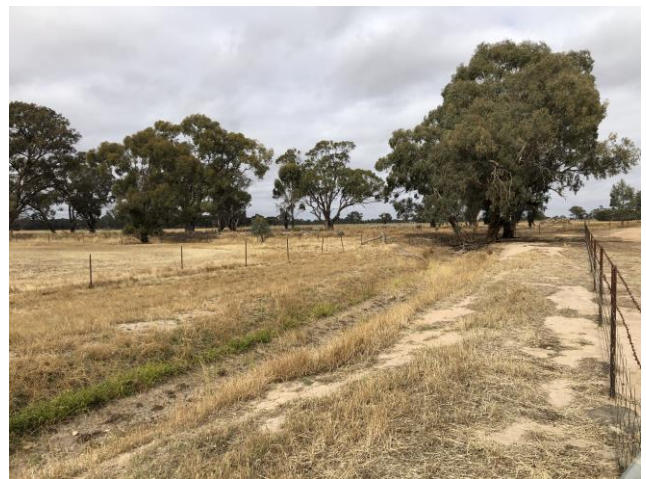
Within the site, the existing dwelling is located at the contour level of 120 m AHD at the top of the hill as shown in Figure 3-2. Drainage and irrigation channels exist across the southern side of the hill slope (shown in Figure 3-6 and Figure 3-7. A natural wetland also exists in the south-west corner of the site (Figure 3-8).

Figure 3-6 Photo 4, drainage channel within the site

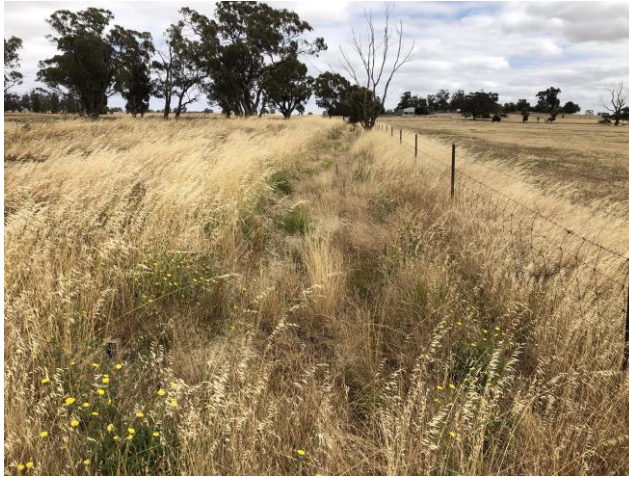
Figure 3-7 Photo 5, irrigation channel within the site

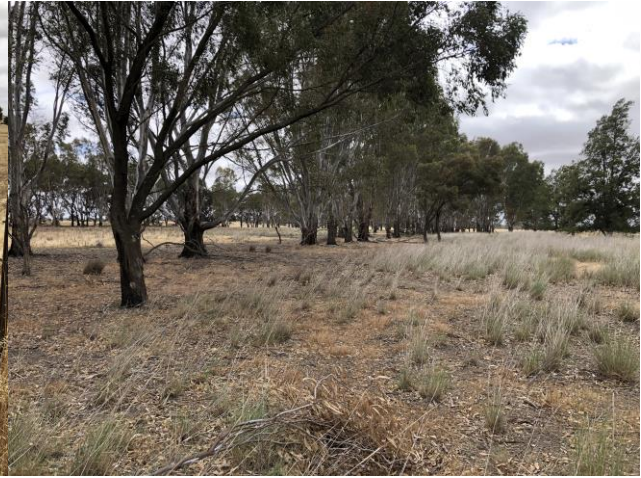
At the wetland, the water can discharge to the western neighbouring properties through a culvert crossing under McEwen Road. The extents of the LSIO and FO were estimated onsite to be limited to the extent of the wetland following contour level of 107.00 m AHD. This also extends south to Midland Hwy. The wetland is also likely to receive inflows from runoff to the south of Midland Hwy with the current LSIO/FO indicating that the highway may be overtopped. The area on the southern side is indeed low, and looks as though it would receive overland runoff, but there was no evidence suggesting if it would or would not overtop the highway.

Figure 3-8 Photo 6, natural wetland

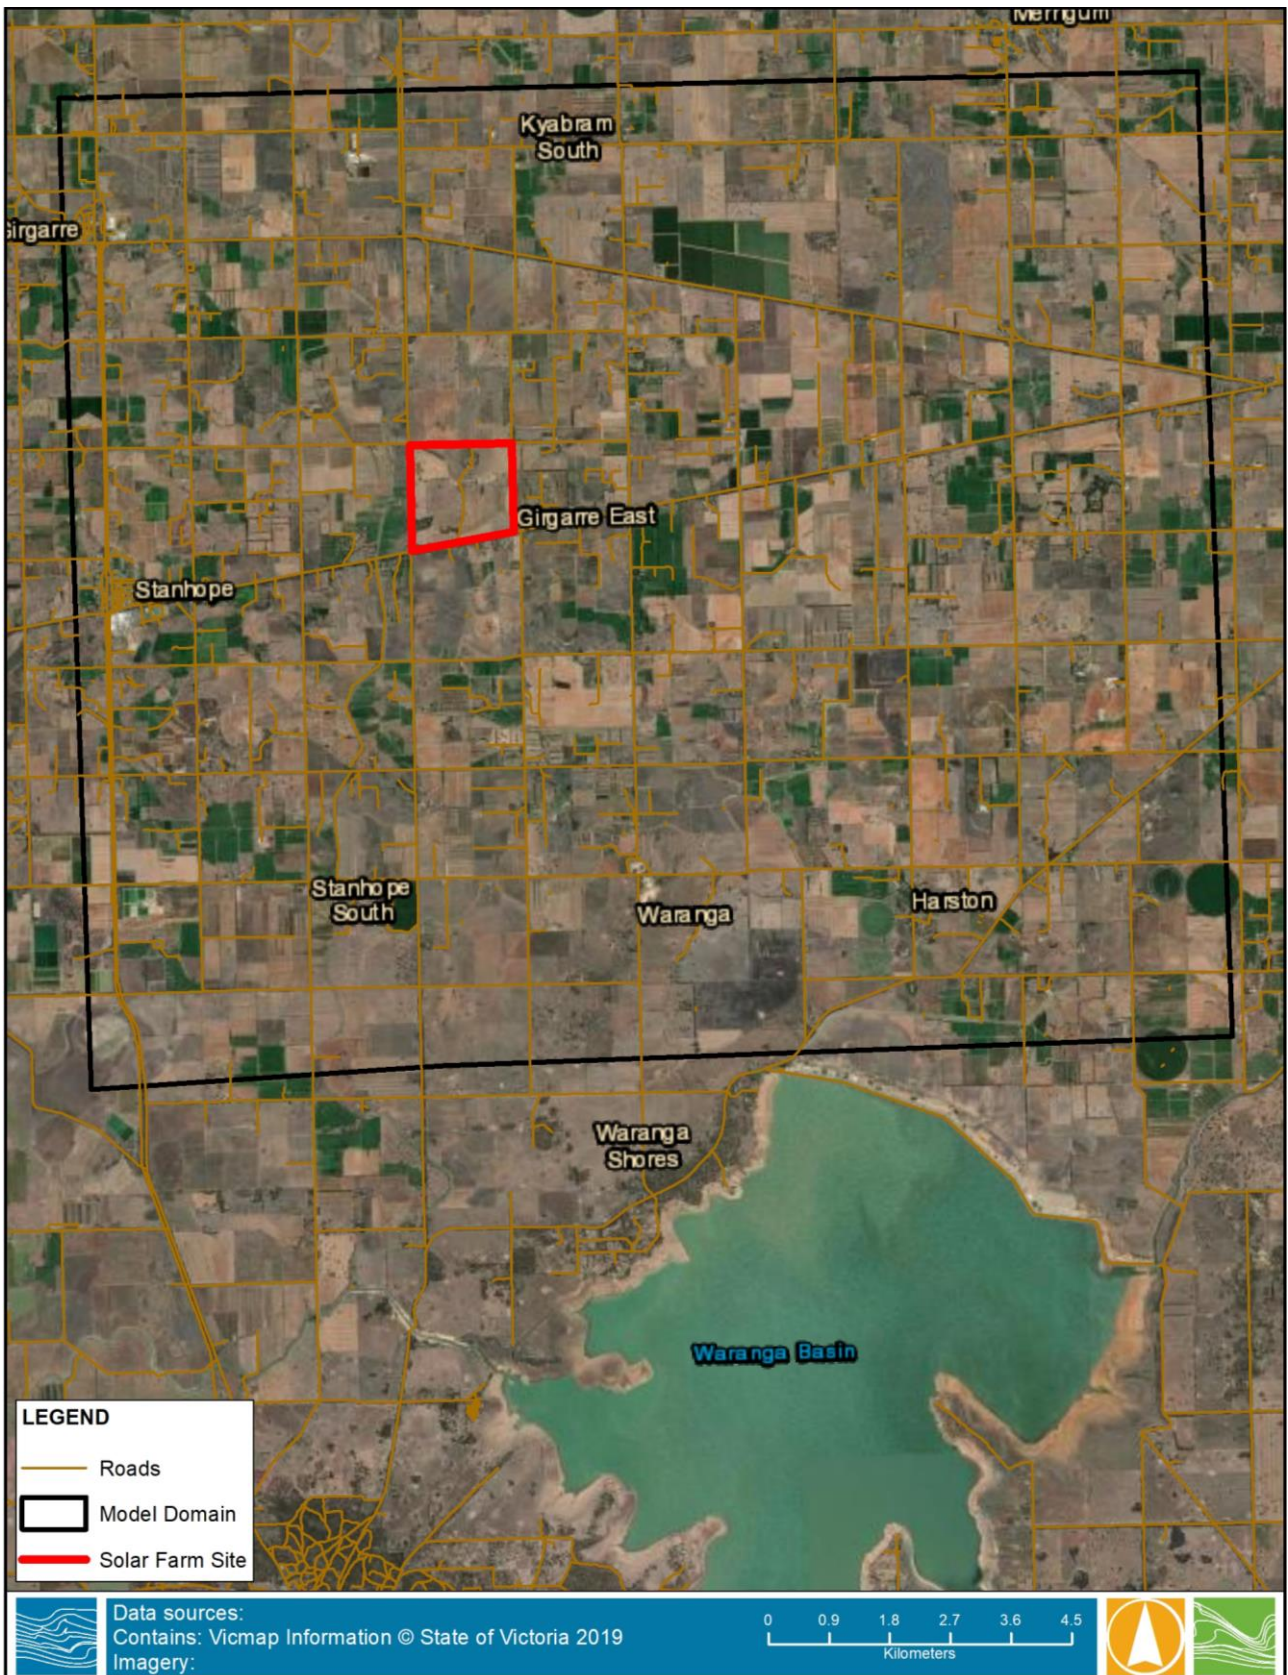
Figure 3-9 TUFLOW Model Domain

A course 2d TUFLOW model was developed to estimate the likely flood depths across the study area. The rain-on-grid approach was used to apply rainfall data across the full model area, representing a local storm falling on the site. The model area is shown in Figure 3-9. The model domain extends south down to the Waranga Basin, west of Stanhope, east near Byrneside and north to Kyabram South. The domain has not covered the entire contributing catchment that may contribute flows toward the site, but as discussed earlier the irrigation channel to the east of the site blocks the local overland runoff from continuing on to the site.

The 20 m Geoscience Australia satellite DEM was used along with the site survey to build the model topography. The 20 m DEM was modified to match the survey data in the area of overlap. No drainage structures were included such as pipes or culverts. The model was run for the 1% Annual Exceedance Probability (AEP), 72 hr storm event and Australian Rainfall and Runoff rainfall temporal pattern 2. This long duration storm event was adopted as the inundation extents are most likely impacted more by high volume, long duration storms.
