Memorandum

| TO: | KEVIN RAVEN, MYRTLEFORD SKI CLUB |
|---|---|
| SUBJECT: | SUMMARY OF FINDINGS FROM ENVIRONMENTAL ASSESSMENT FOR PROPOSED NEW WORKS, MYRTLEFORD SKI CLUB, FALLS CREEK ROAD, FALLS CREEK |

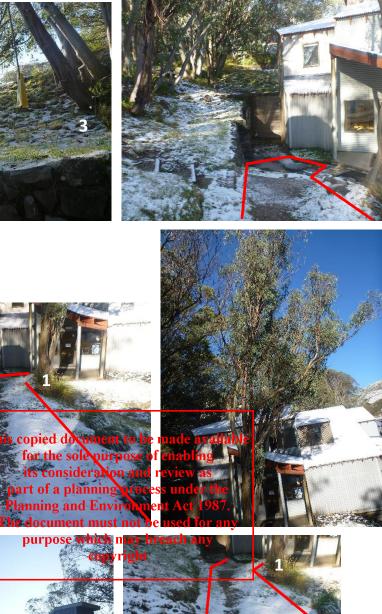
The proposed works area of approximately 35 m² (0.0035 ha) retains very little vegetation; the existing gravel path – over which the proposed ramp/stair is proposed for construction - is heavily compacted from use, and any ground layer vegetation on it is sparse (the ground surface is 90 % rock, gravel and bare earth), and any vegetation present is wholly introduced annual and perennial ground layer species, such as Winter-grass (*Poa annua*), Sheep Sorrel (*Acetosella vulgaris*), Creeping Fog (*Holcus mollis*), Kikuyu Grass (*Cenchrus clandestinum*) and White Clover (*Trifolium repens*)(10 % projective foliage cover). No indigenous ground layer vegetation was observed on this gravel path.

Views of the proposed works area: looking up the existing landscaped stairs to Falls Creek Road (top right), looking south along the existing gravel track as it approaches the Ski Lodge (top right), looking south along the existing gravel track (middle left), Tree 1 (middle right), looking north along the existing gravel track (bottom left), and looking south along the existing gravel track from the 8 Falls Creek Road car park (bottom right). Images taken by the author on 4th May 2023. Selection trees are numbered in white. Extent of the proposed development footprint is outlined with red lines.

Plate 1 shows views of the proposed development area.
