re: 23-47 Villiers St, North Melbourne

Introduction

TREE SURVEY

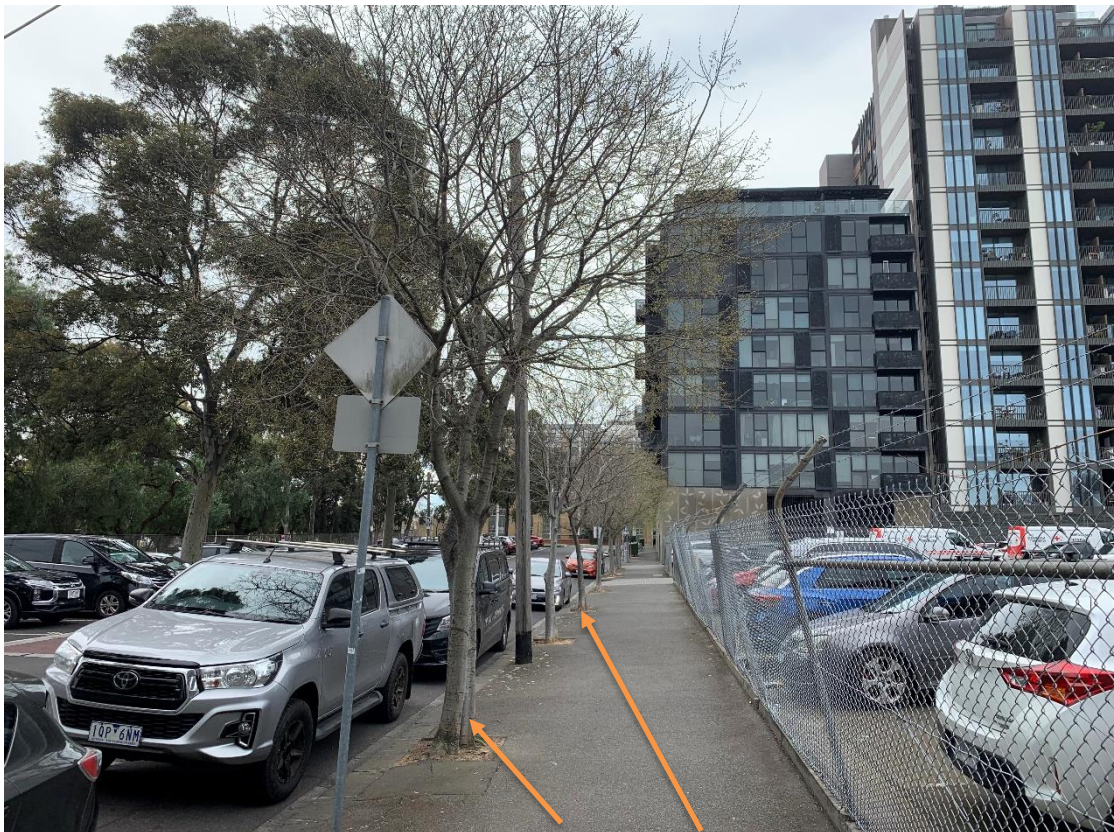
1289173 1289076

1064344	14	6x6	Small street tree in good condition. TPZ 2 SRZ 1.5
1016026	27	8x7	Good condition – lifting asphalt near the lamp post. TPZ 3.2 SRZ 2.1
1016027	28	6x7	Good condition. TPZ 3.4 SRZ 2.1
1016028	33	7x9	Good condition. TPZ 4 SRZ 2.3
1059147	18, 12	6x5	Fair-poor condition with dead lesions and sunscorch. TPZ 2.6 SRZ 1.8
1289026	30	8x8	Good condition but roots are lifting the blue stone kerb. TPZ 3.6 SRZ 2.2
1289124	29	7x8	Good condition but roots are causing minor lifting and cracking of the path. TPZ 3.5 SRZ 2.1
1289201	16	6x5	Good condition. TPZ 2 SRZ 1.5
1289076	16	6x5	Good condition. TPZ 2 SRZ 1.5
1289174	16	6x5	Good condition. TPZ 2 SRZ 1.5
1289173	29	8x8	Good condition TPZ 3.5 SRZ 2.1
