# Road Intersection Upgrade: Ballarto Road and Lyrebird Drive, Carrum Downs

## Aboriginal Cultural Heritage Management Plan

**CHMP No:** 18037

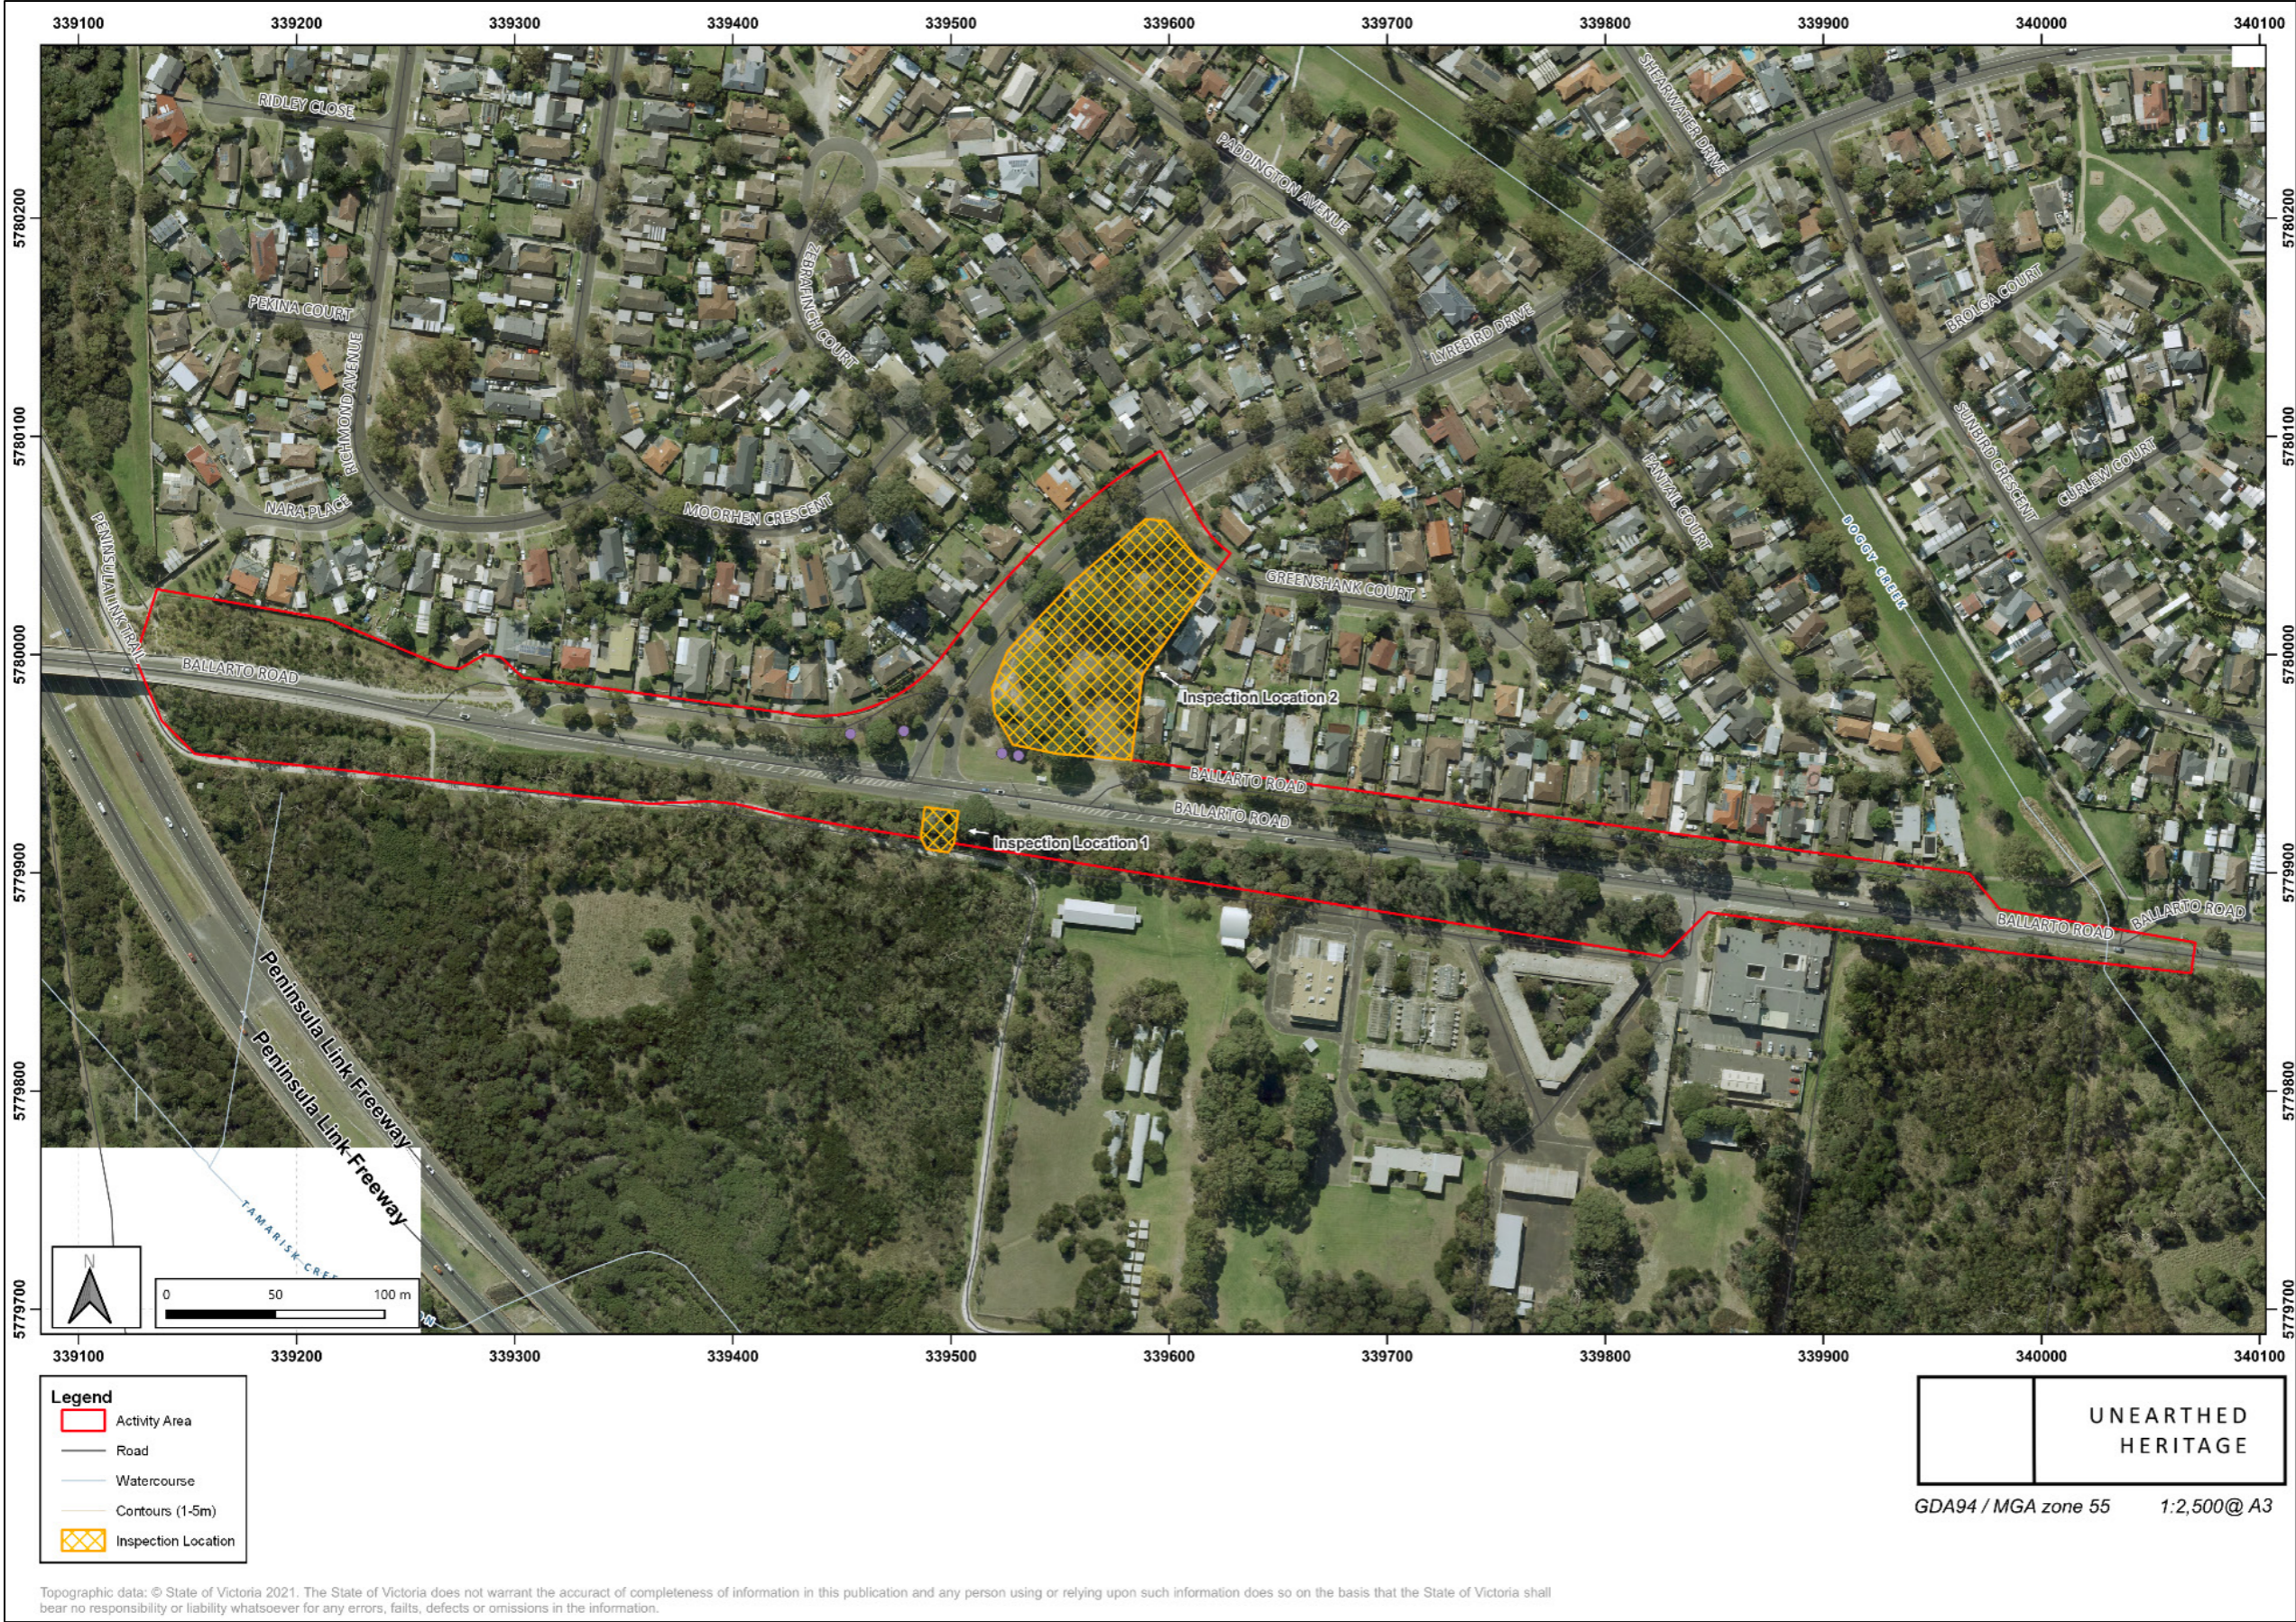
Figure 1-1 Locations of inspections that must be undertaken during the activity

A minimum of one BLCAC inspection must be undertaken during the activity. The purpose of the inspection is to examine excavated and exposed soils and to ensure the works are being undertaken in accordance with the conditions and contingencies of the approved CHMP.

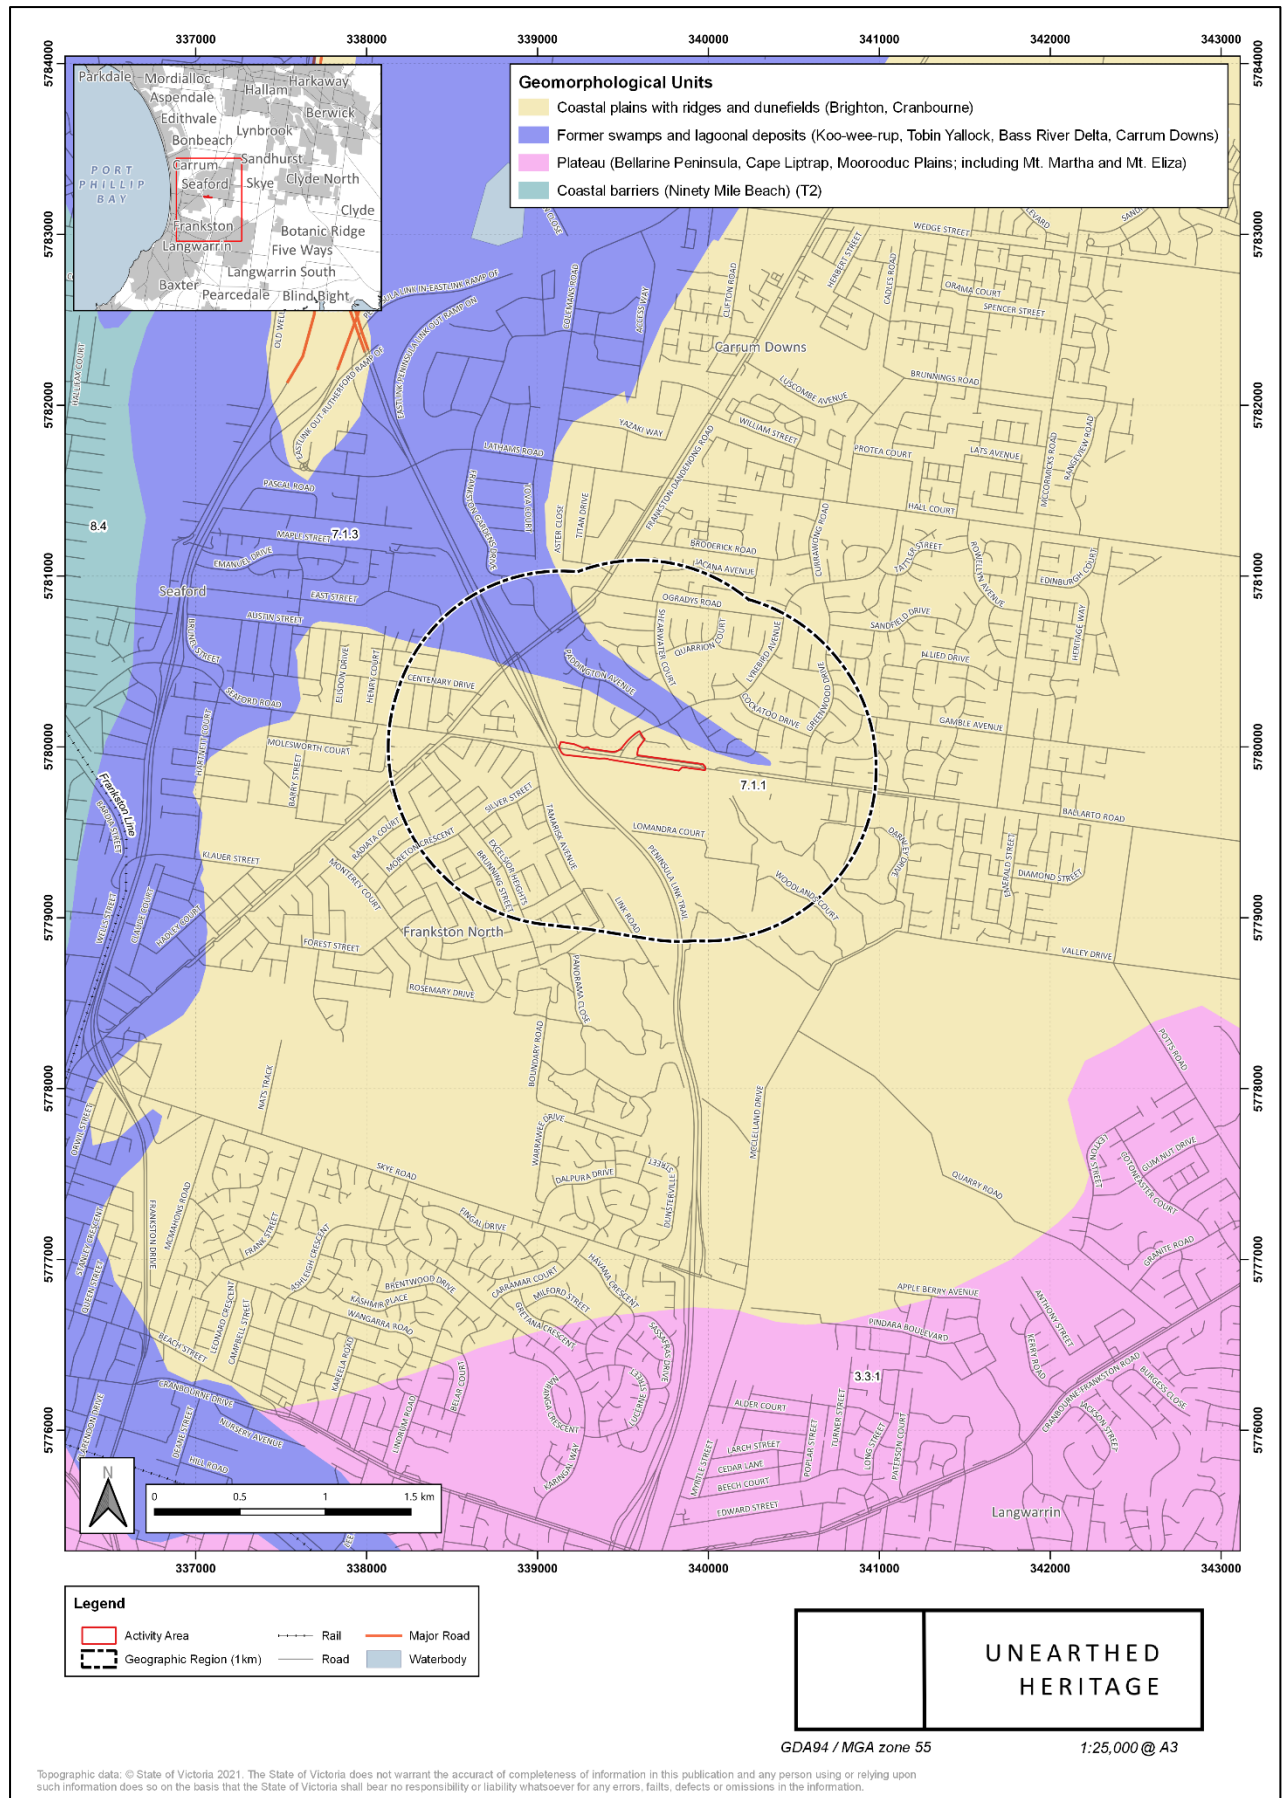
Figure 5-1 Geomorphology within the geographic region

The activity area comprises an undulating dunal landform which has been extensively modified by urban development. The heavily modified course of Boggy Creek lies to the immediate east of the activity area.

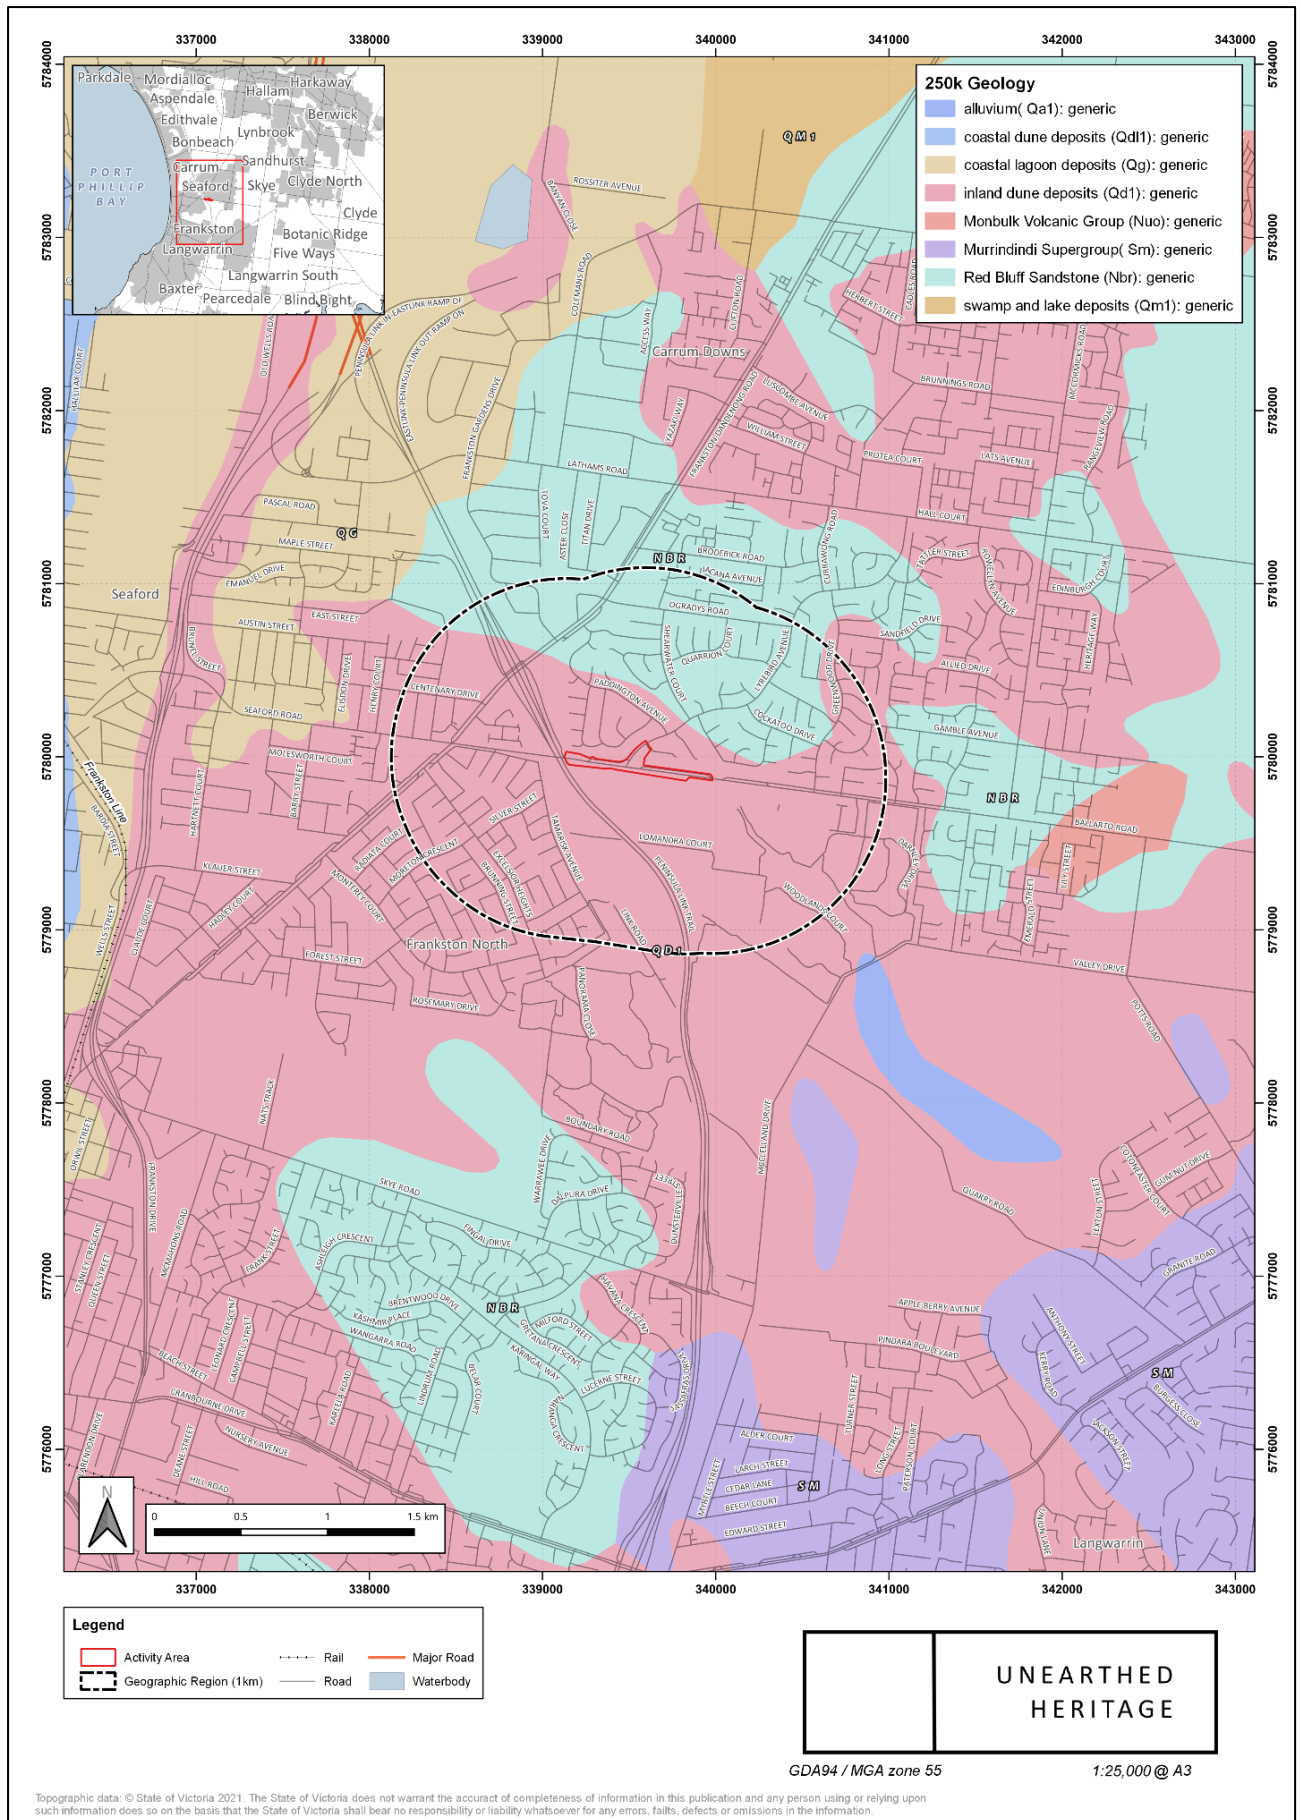
Figure 5-2 Geology within the geographic region

The surface geology across the geographic region consists primarily of inland dune deposits (Qd1) / Cranbourne Sands with an area of Miocene to Pliocene (23-5 million years ago) Red Bluff Sandstone (Nbr) (13.6%) – a fine to coarse grained massive to well bedded pale yellow and brown sandstone, conglomerate and ironstone channelled fluvial formation – occurring in the north, see Figure 5-2. The former swamp soils across the geographic region generally have a high clay content and crack when dry (Vertosols) (VRO 2021) (Figure 5-2).

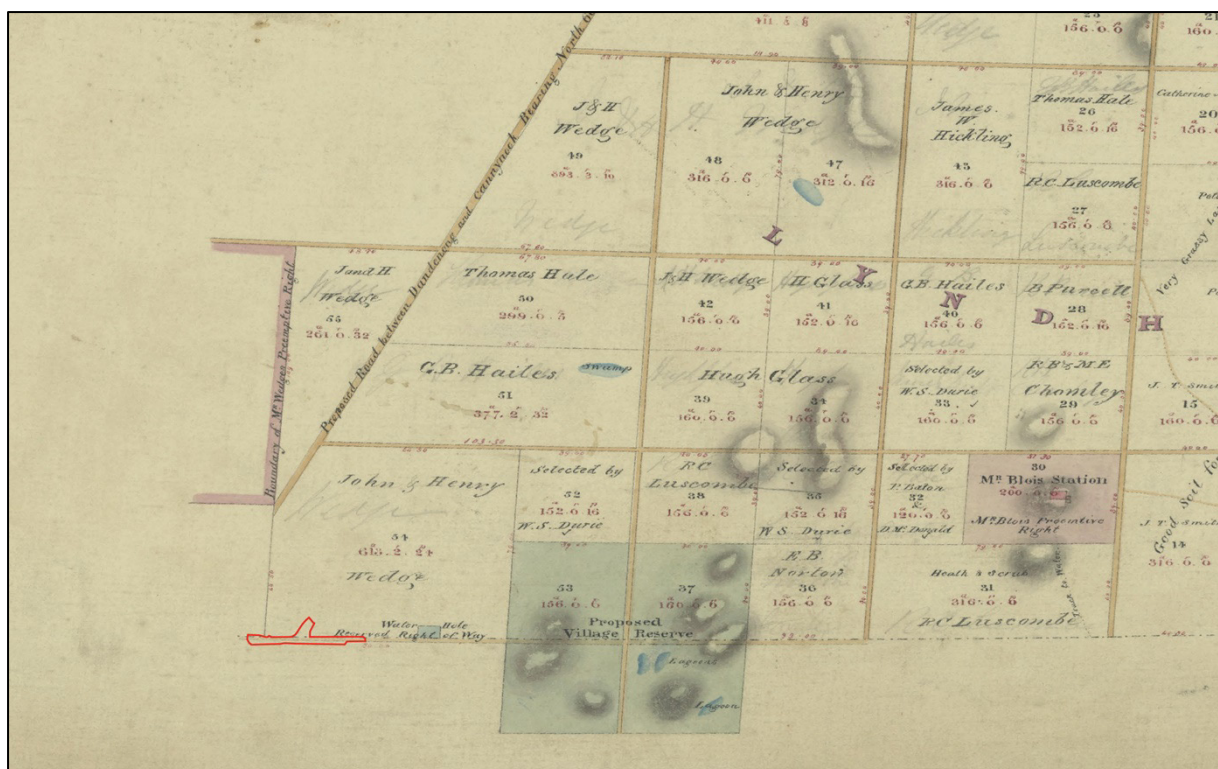
Figure 5-4 1856 plan of Lyndhurst parish (Windsor 1856), showing access track / later Ballarto Road; with the activity area marked in red.

In 1852, the Wedge brothers' pastoral license for Balleymarang was cancelled and the majority of the run was divided up into smaller landholdings to cater for the rapidly increasing population of Melbourne resulting from the central Victorian goldrushes. A Government survey of numerous rural allotments, associated access roads was laid out, covering much of Lyndhurst, Langwarrin, and Frankston parishes, with allotments variously sold to existing settlers under pre-emptive rights, or offered for sale or selection at public auction. This subdivision included a main east-west access track leading from the coast inland, which also marked the boundary between Lyndhurst parish in the north and Frankston and Langwarrin parishes in the south. This track follows the current alignment of Ballarto Road – see Figure 5-4. A village reserve named "Skye" was also laid out on either side of Ballarto Road (near the current intersection with McCormicks Road), with smaller rural / town allotments offered for public sale in following years (Gunson 1968, Jones 1989). Village and parish plans of the area during the 1850s show much of the land on either side of Ballarto Road remained wooded with "heath and scrub." Interestingly, a water hole with reserved right of way is also marked on the northern side of Ballarto Road, close to Boggy Creek and the western extent of the activity area – see Figure 5-4.

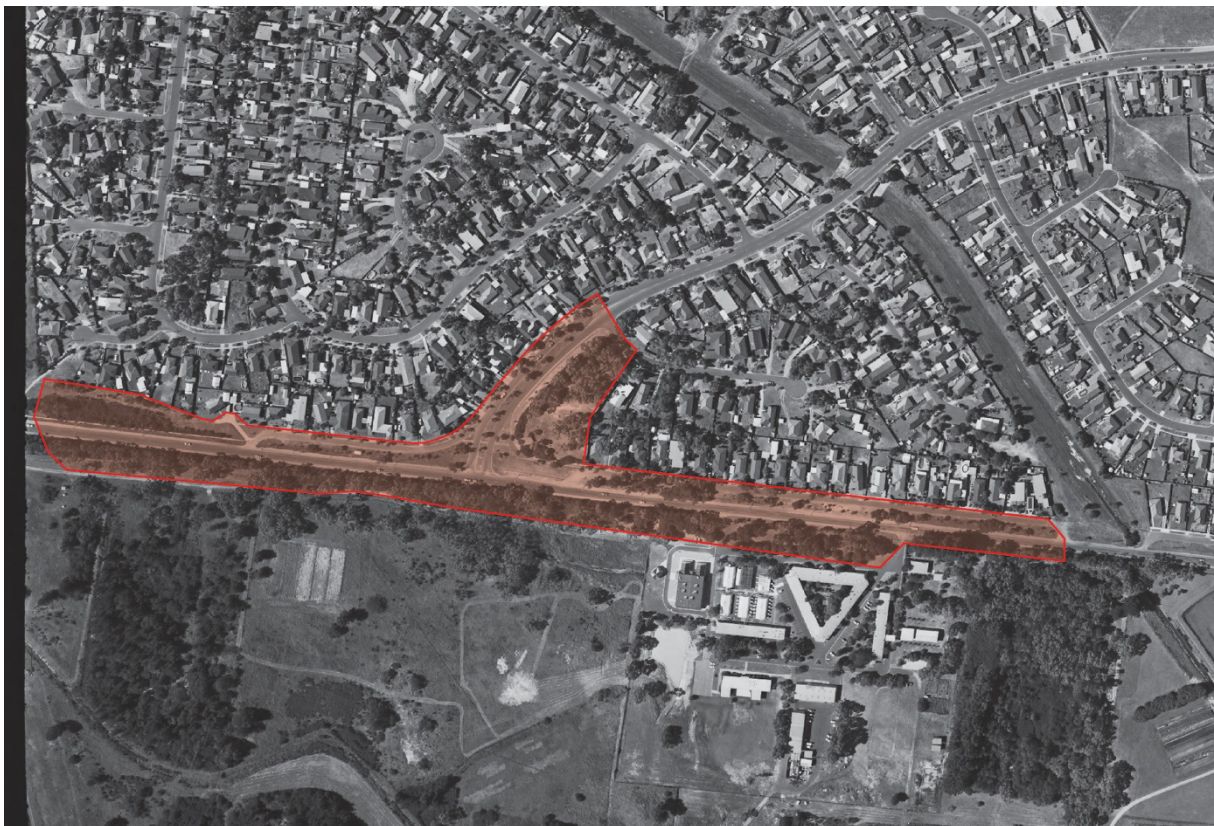
Figure 5-7 1987 aerial photograph (LANDATA) – activity area approximately marked in red.

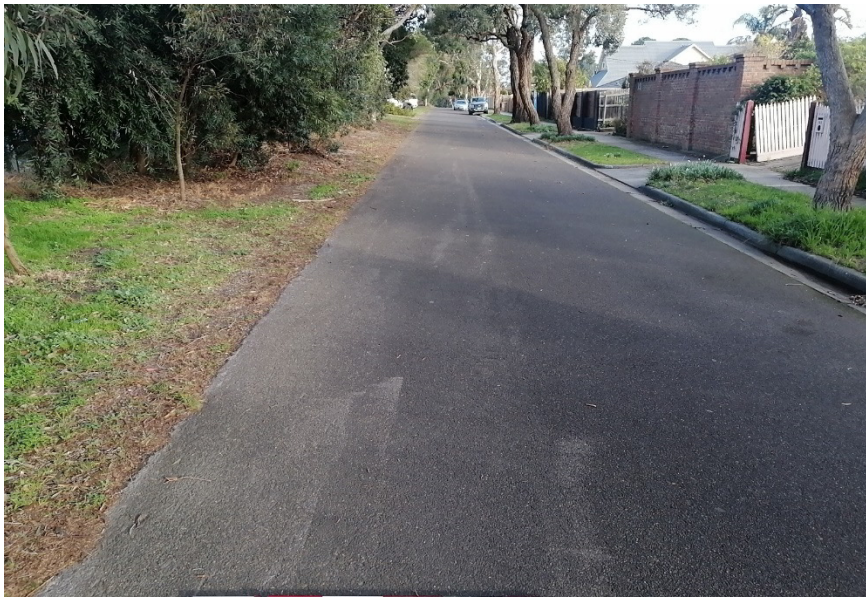
Figure 6-3 Typical roadway in the activity area facing west (Ballarto Road service road)\_T Kimber\_29 July 2021

Ground disturbance was generally as expected in a heavily urbanised roadside environment. Due to the lack of variability in landform or disturbance characteristics within the roadside environment, the activity areas were assessed as a single investigation area. The road reserves are highly disturbed from road construction including excavation adjacent to the road formation for substantial drainage and for buried services (including recycled water, telecommunications, gas, electricity and water) (see Figure 6-3 to Figure 6-6). Topography was gently undulating along the length of the alignment with gentle relief changes of approximately 1 – 2 metres across the road corridor. Due to the heavily modified nature of the area, the generally confined footprint of the activity and the extensive amount of disturbance associated with suburban development it is unlikely that *in situ* Aboriginal cultural heritage will occur within disturbed contexts.

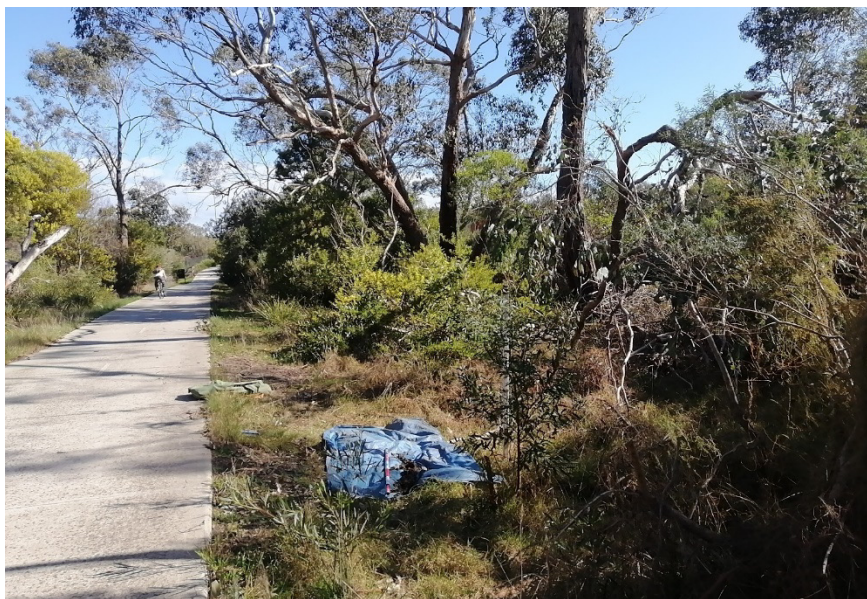
Figure 6-7 Location of Auger 2 in the activity area, facing west\_T Kimber\_30 July 2021

| ID | Context | Depth (mm) | Soil Horizon | Consistency | Texture | Munsell Colour | Soil Colour | Maximum Depth (mm) | Comments | Easting (MGA, GDA 94) | Northing (MGA, GDA 94) |
|---|---|---|---|---|---|---|---|---|--|---|---|
| Auger 2 | 1 | 0-200 | A | Firm | Silt | 10YR 5/2 | Greyish brown | 420 | Humic; disturbance present in form of soil mixing and modern waste fragments (road gravels, glass, metal, plastic), Diffuse transition | 249620.487 | 5840211.354 |
| | 2 | 200-420 | B | Firm | Clay | 10YR 4/3 | Brown | | Disturbance noted by presence of soil mixing and modern waste fragments (glass and plastic) to 300mm. | | |

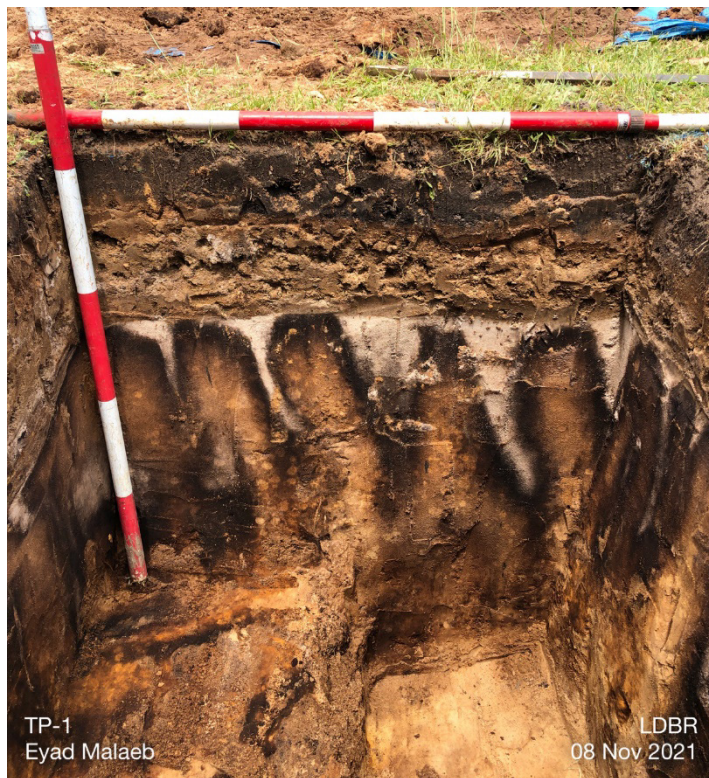
Figure 7-1 Base of TP1\_view west\_Eyad\_Malaeb\_08 Nov 2021

1. The upper c 0-100 mm comprised a humic, **redeposited/fill** friable silty sand with modern small to medium inclusions (10YR 3/1; pH 6.5) gradually transitioning to a lens deposit 2;
2. 100-150 mm firm sand **fill** (10 YR 4/4; pH 6.5) with occasional rootlets and intrusive modern material. This subtly transitioned to a continued fill deposit 3;
3. 150 – 300 firm sand **fill** (10 YR 4/3; pH 6.5) with frequent gravel inclusions throughout. This was marked with an abrupt transition to the likely truncated natural soil profile 4;
4. 300 – 1200 friable sand (10YR 7/2 pH 6.5) – A2 horizon. Sondage from 840mm to 1200mm.

No definitively sterile clay base was encountered during the excavation of TP1, though this is not unexpected in an elevated dune context within the broader sand sheet landform.

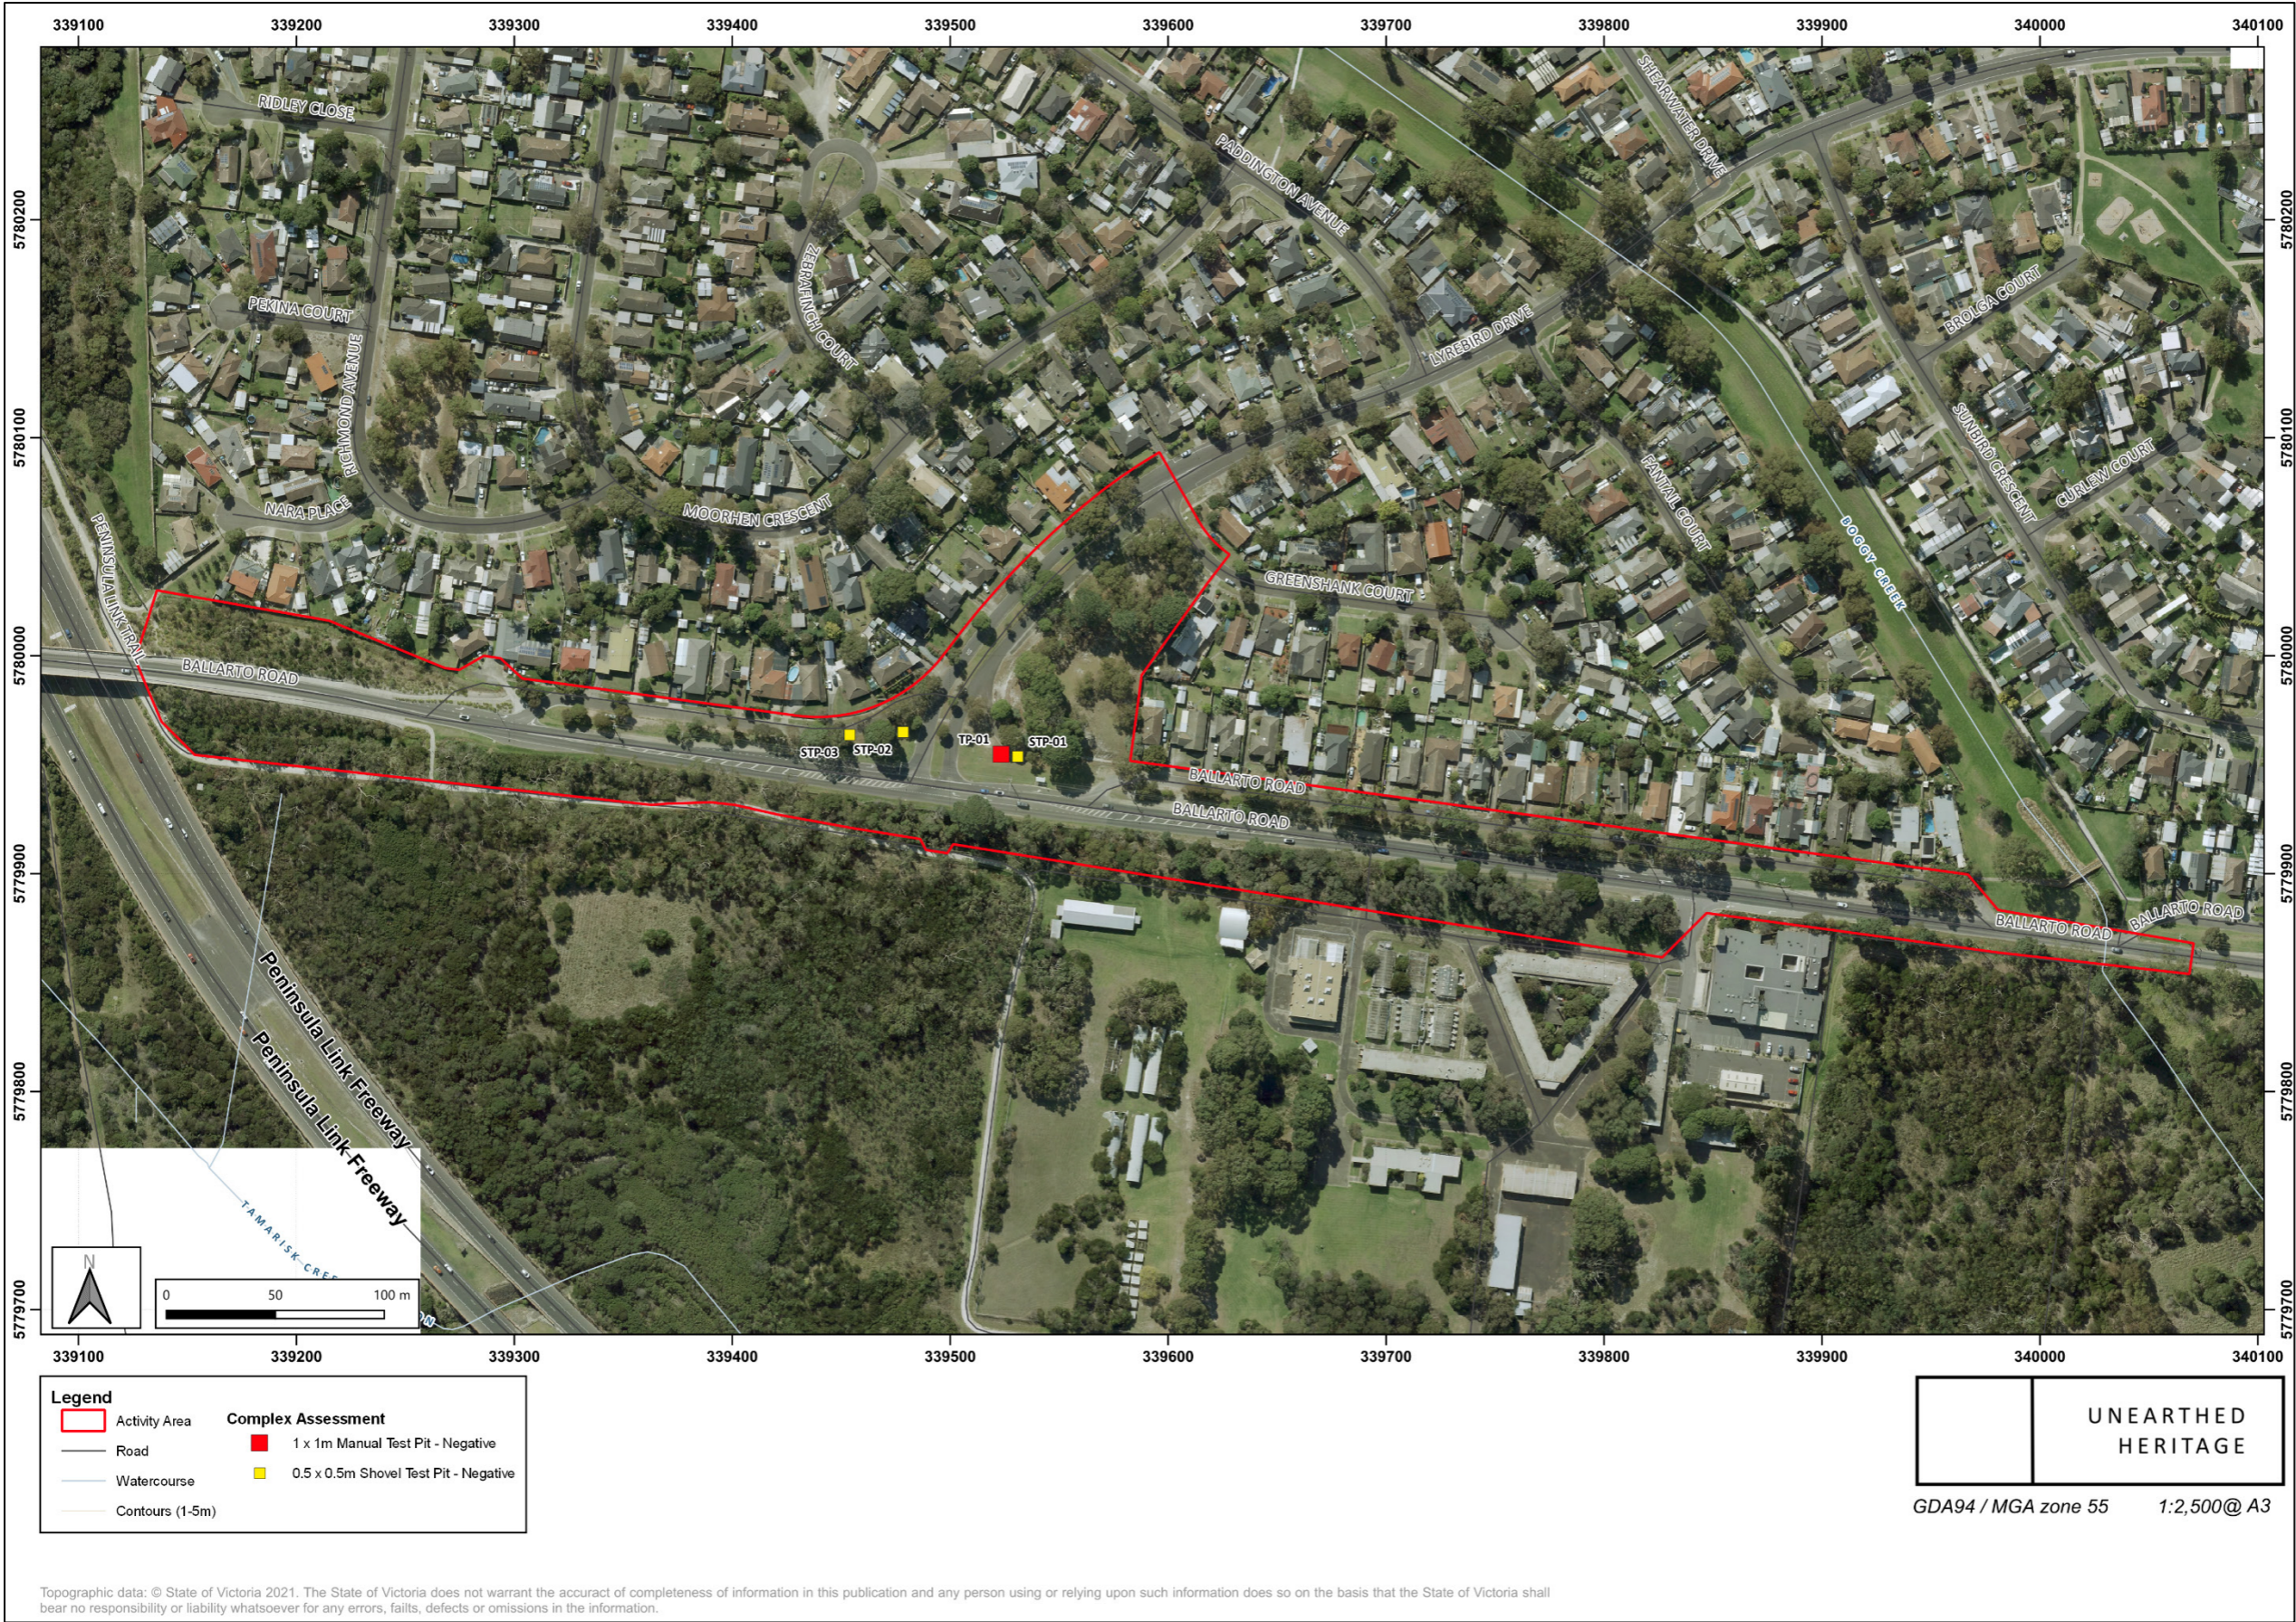
Figure 7-3 Locations and results of test excavations in the complex assessment

Test excavations confirmed the moderate to high levels of disturbance had occurred across the areas selected for subsurface testing.

The results support the predictive model developed for the geographic region indicated that the landforms of the activity had low-moderate potential for Aboriginal cultural heritage to be present (with isolated or diffuse scatters of stone artefacts the most likely site type). Heritage objects are unlikely to be present in upper contexts due to extensive disturbance associated with the land use history, however the presence of deeper sand across the area retains a likelihood that dispersed Aboriginal cultural material may be present in the landform.

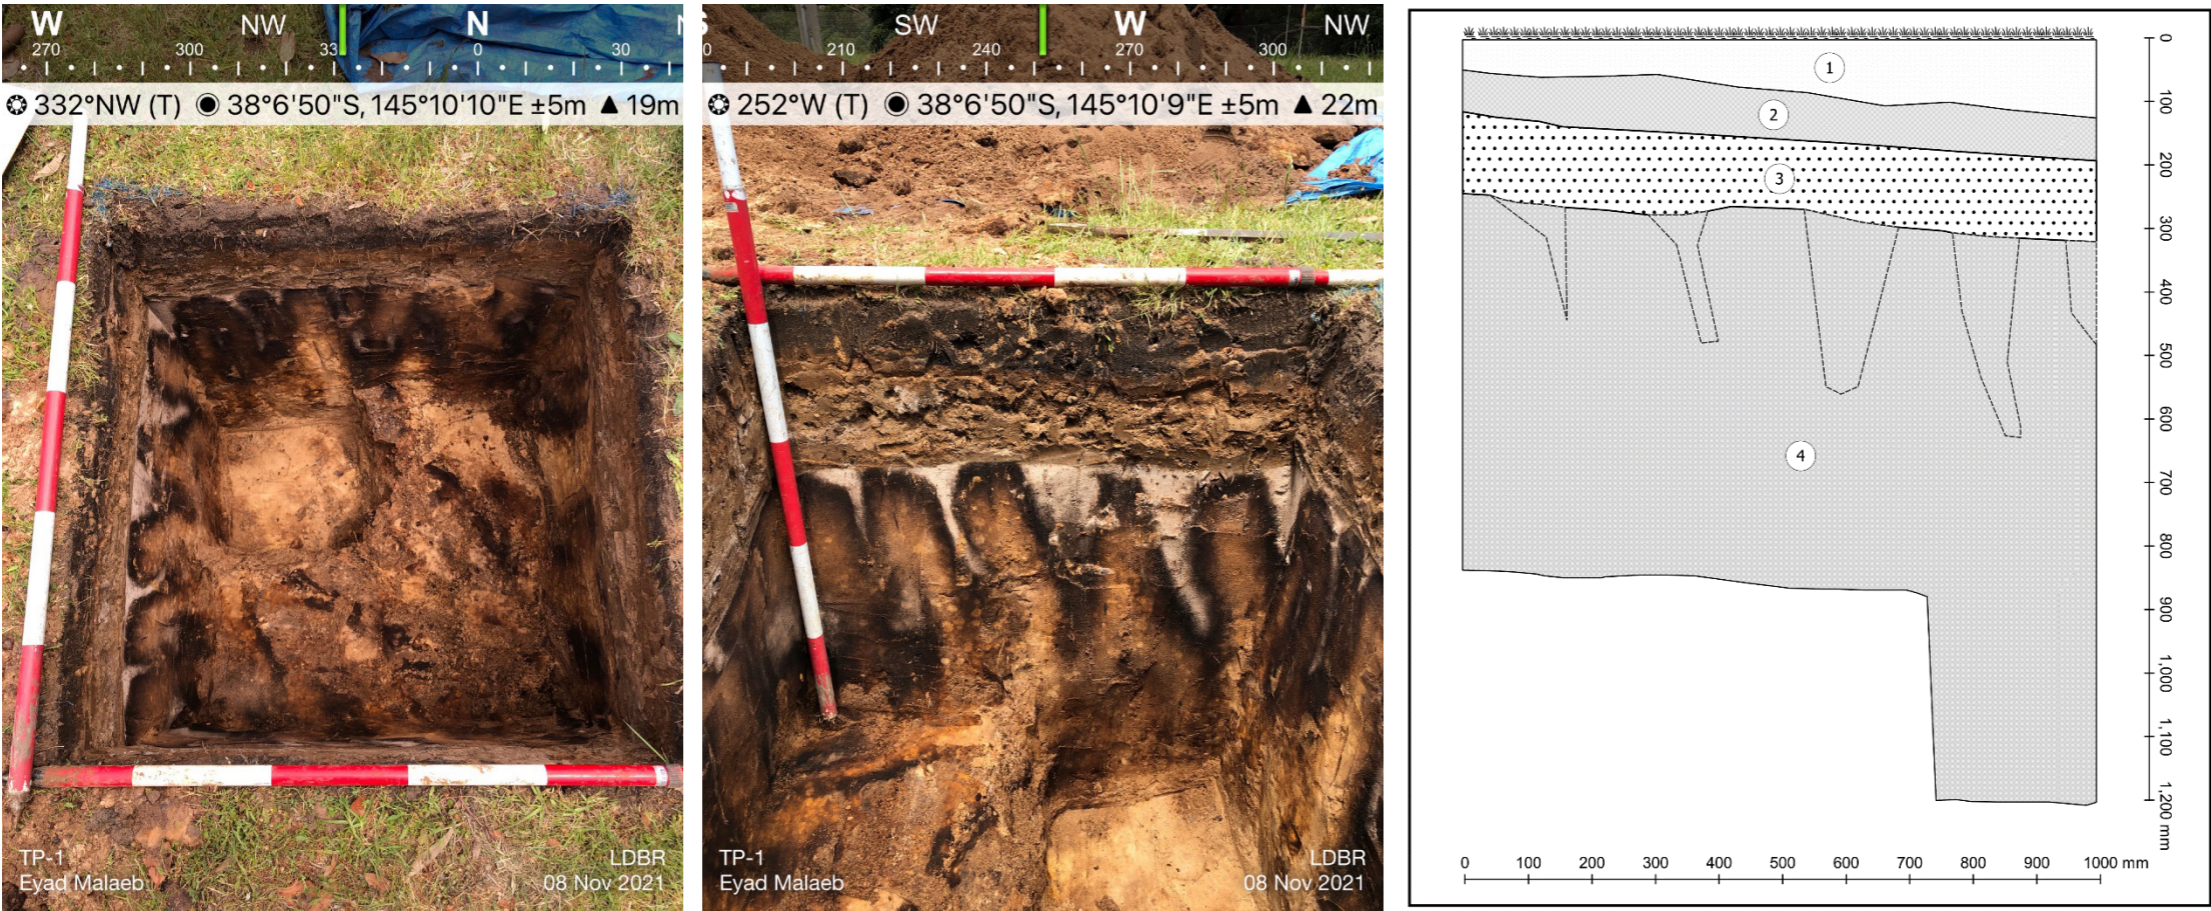
TP1

| Context | Soil horizon | Depth range (mm) | Munsell Colour | pH | Texture | Moisture | Structure | Consistency | Inclusions | Boundary | Excavation comments | Artefacts |
|---|---|---|---|---|---|---|---|---|---|---|--|---|
| 4 | B | 300-1200 | Light grey (10YR 7/2) with dark yellowish brown (10YR 4/6) and black (10YR 2/1) | 6.5 | Sand | Dry | Platy | Friable | Sandy iron nodules, mostly undulating coffee rock formation with occasional worms | -- | | |

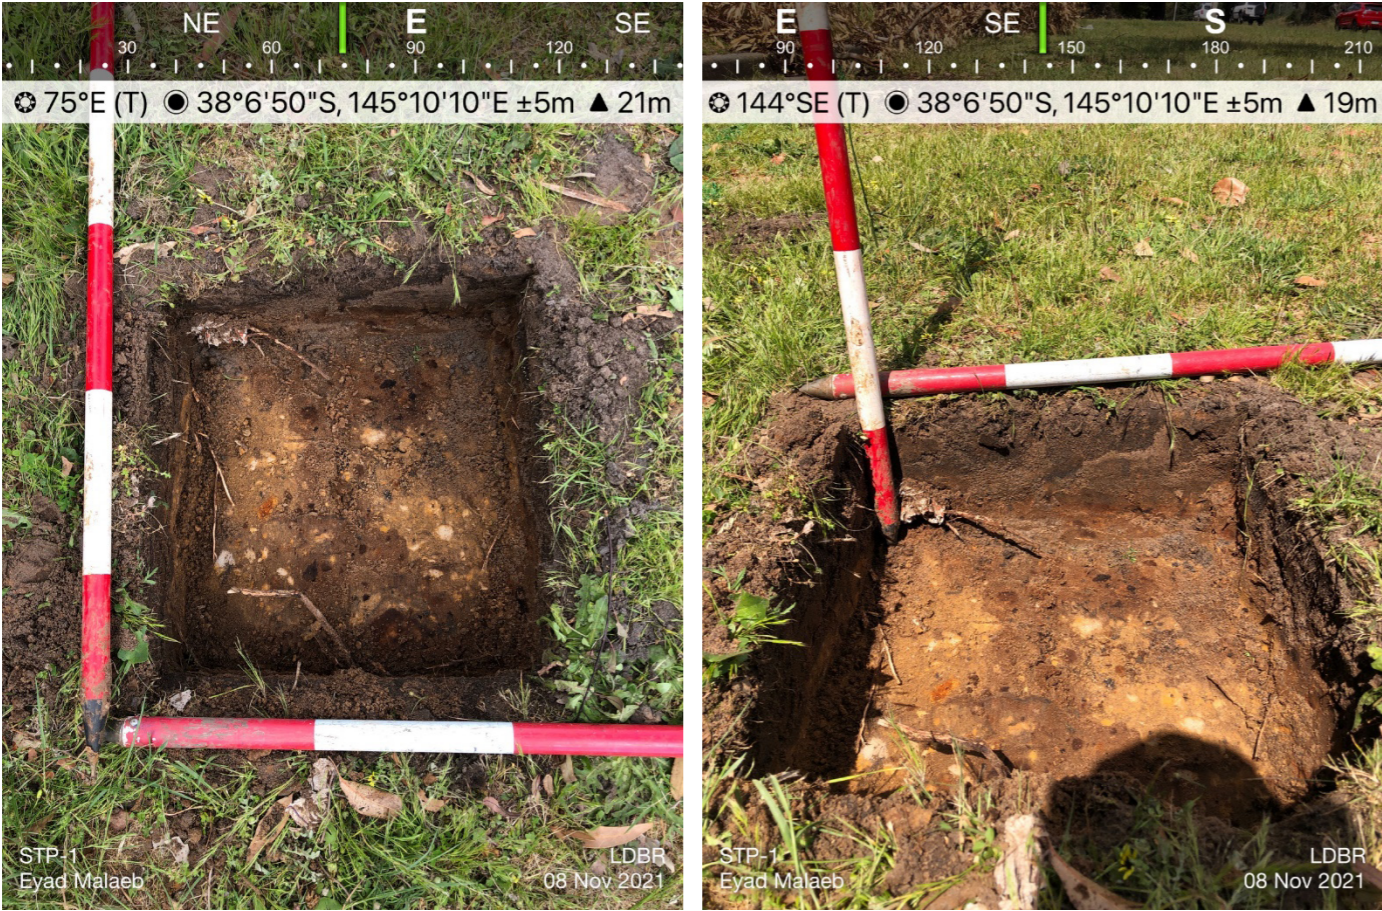
STP1

| Context | Soil horizon | Depth range (mm) | Munsell Colour | pH | Texture | Moisture | Structure | Consistency | Inclusions | Boundary | Excavation comments | Artefacts |
|---|---|---|---|---|---|---|---|---|---|---|--|---|
| 1 | N/A | 0-150 | Very dark grey (10YR 3/1) | 7 | Silty sand | Slightly moist | Granular | Firm | Plastics, rootlets and asbestos | N/A (single context) | Excavation was aborted after identification of asbestos at a depth of approximately 100mm. | No |

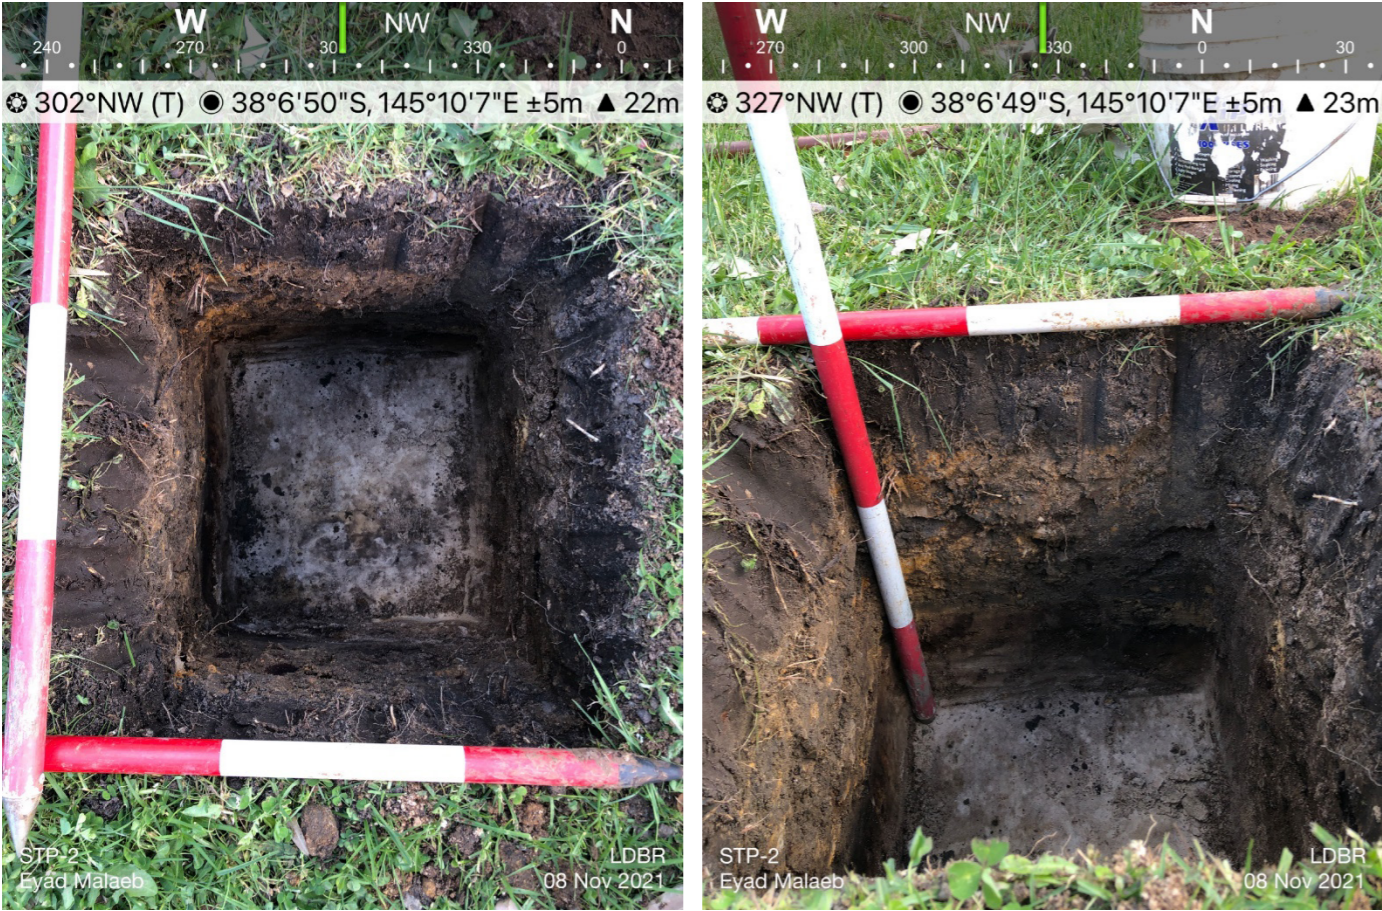
STP2

| Context | Soil horizon | Depth range (mm) | Munsell Colour | pH | Texture | Moisture | Structure | Consistency | Inclusions | Boundary | Excavation comments | Artefacts |
|---|---|---|--|---|---|---|---|---|---|---|--|---|
| 3 | A | 500-600 | Light grey (10YR 7/2) and black (10YR 2/1) | 6.5 | Sand | Dry | Single grain | Weak | Sandy layer overlaying coffee rock context | -- | | |
