# Road Intersection Upgrade: Ballarto Road and Lyrebird Drive, Carrum Downs

## Aboriginal Cultural Heritage Management Plan

**CHMP No:** 18037

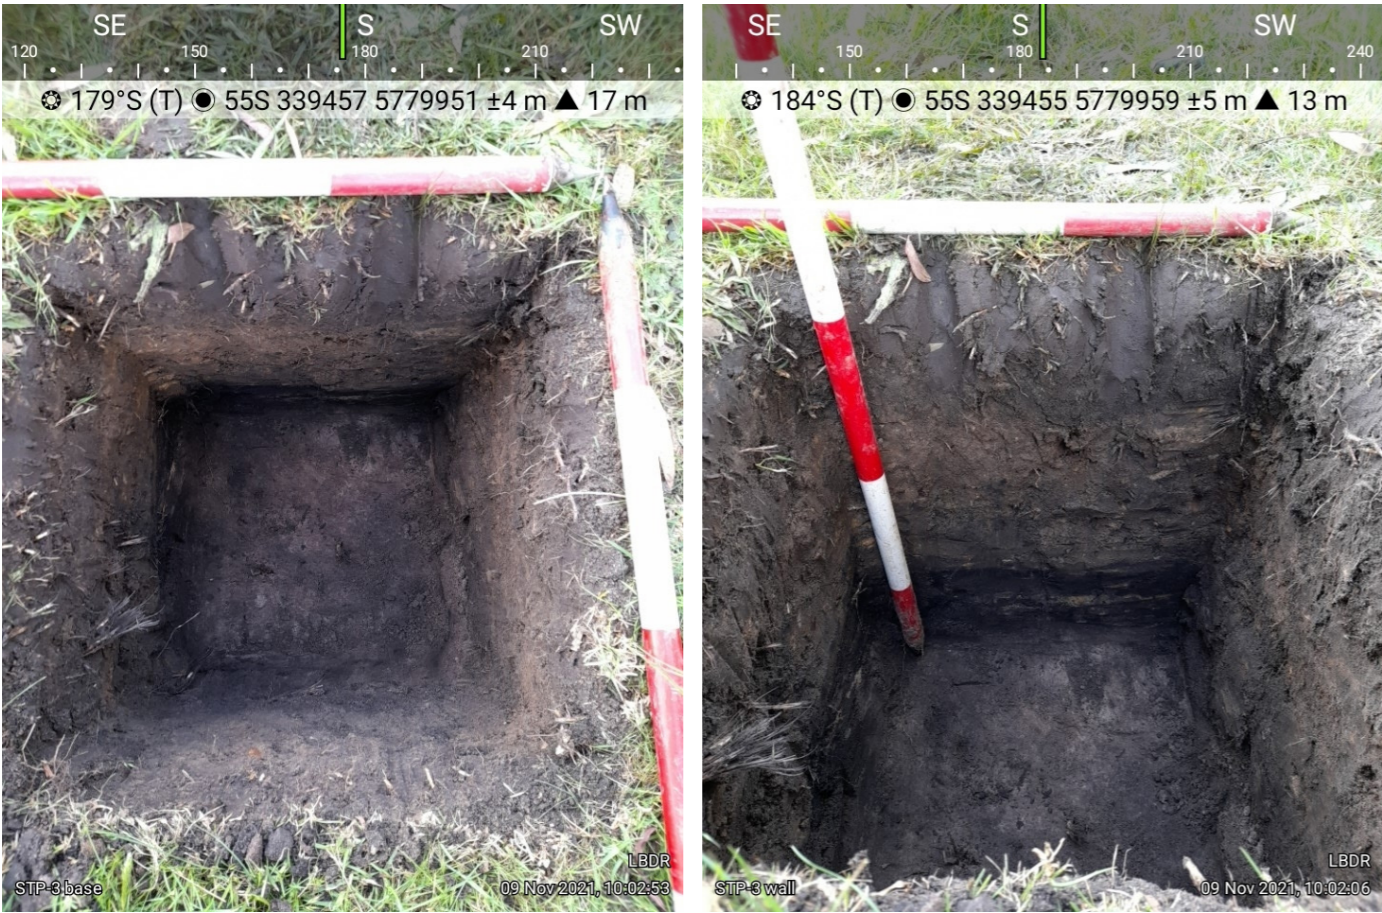
STP3

| Context | Soil horizon | Depth range (mm) | Munsell Colour | pH | Texture | Moisture | Structure | Consistency | Inclusions | Boundary | Excavation comments | Artefacts |
|---|---|---|--|---|---|---|---|---|---|---|--|---|
| 3 | A | 500-600 | Light grey (10YR 7/2) and black (10YR 2/1) | 6.5 | Sand | Dry | Single grain | Weak | Sandy layer overlaying coffee rock context | -- | | |
