# Ballarto Road and Lyrebird Drive intersection upgrade: Flora and fauna assessment

FINAL REPORT

Prepared for Department of Transport

19 July 2022

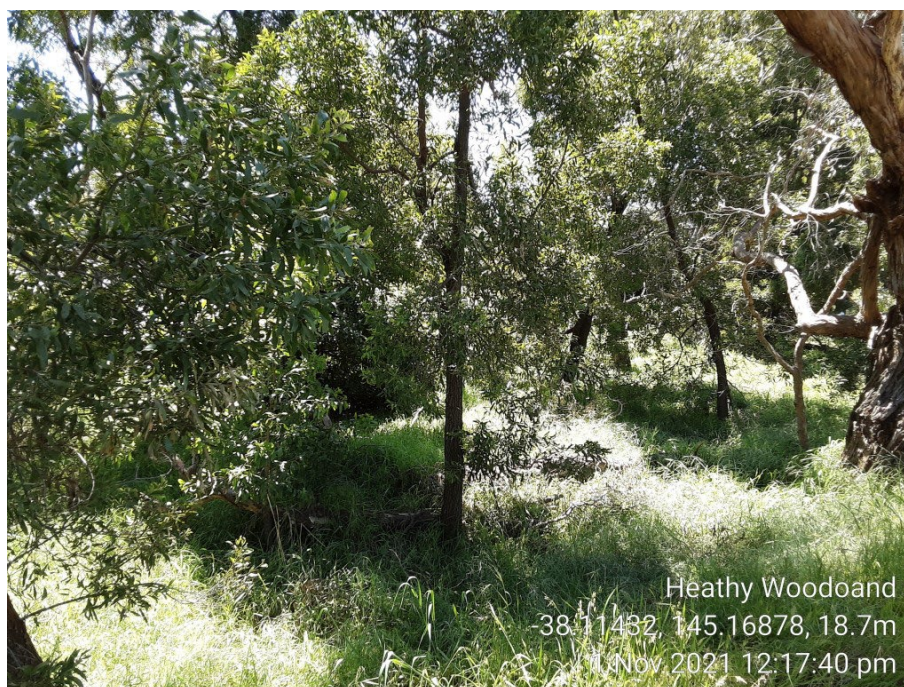
**Photo 1** Patch vegetation consisting of Heathy Woodland (EVC 48) south of Ballarto Road, opposite Lyrebird Drive in the higher quality south-western section of the study area. Photo taken 26 October 2021, looking north-east.

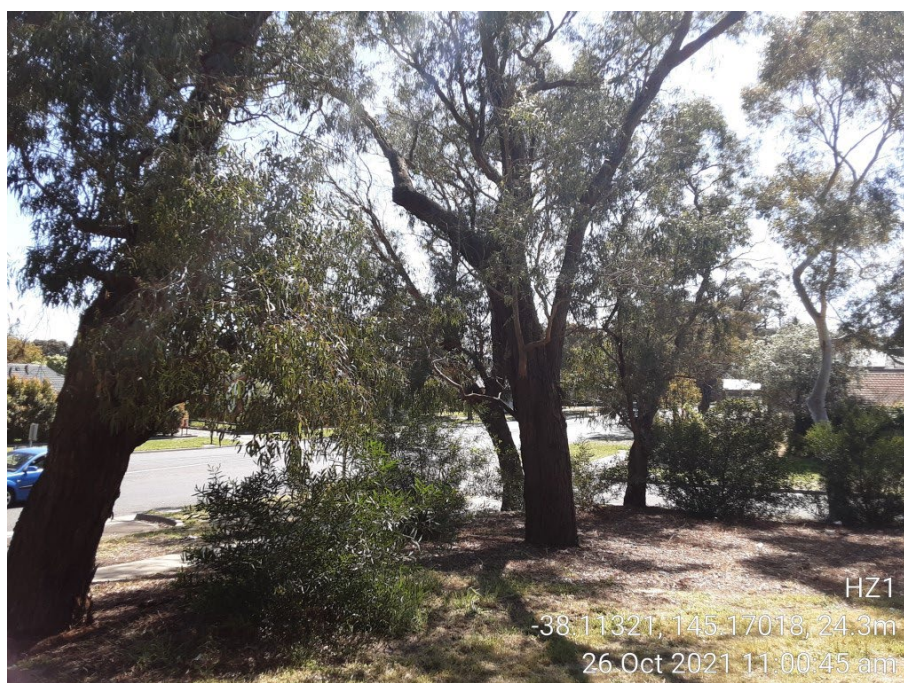
**Photo 2** Patch vegetation of Swamp Scrub EVC 53 with a predominantly introduced and landscaped understorey, in the north of the study area on Lyrebird Drive. Photo taken 26 October 2021, looking north.

<b>Swamp Scrub</b> <b>EVC 53</b>  <b>Bioregional Conservation</b> <b>status:</b> Endangered <b>(Photo 2 and 3)</b>	<p>Closed scrub to 8 metres tall dominated by Swamp Paperbark <i>Melaleuca ericifolia</i> with scattered Blackwood and the occasional Swamp Gum. This EVC had areas that were covered in water and were dominated by Narrow-leaf Cumbungi <i>Typha domingensis</i>. Drier sections were dominated by a weedy understory which included Cocksfoot <i>Dactylis glomeratus</i>, Sweet Vernal-grass and Great Brome. Some scattered Wallaby Grass <i>Rytidosperma sp.</i> and Spear Grass <i>Austrostipa sp.</i> could be found throughout.</p>	Along the majority of the southern road reserve of Ballarto Road, and two small patches north of Botany Park on Lyrebird Drive.	Includes some areas of potential habitat for Dwarf Galaxias <i>Galaxiella pusilla</i> , Lewin's Rail <i>Lewinia pectoralis</i> , Little Eagle <i>Hieraaetus morphnoides</i> , Black Falcon <i>Falco subniger</i> and Swamp Skink <i>Lissolepis coventryi</i> (threatened species).

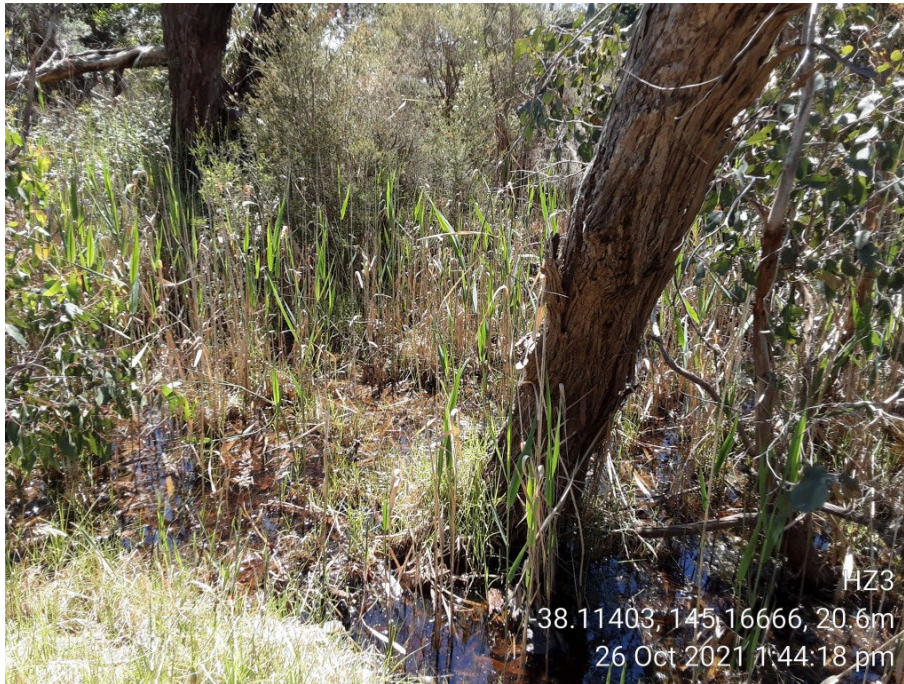
**Photo 3** Wet area in patch vegetation consisting of Swamp Scrub EVC 53 south of Ballarto Road in the western part of the study area. Photo taken 26 October 2021, looking north-west.

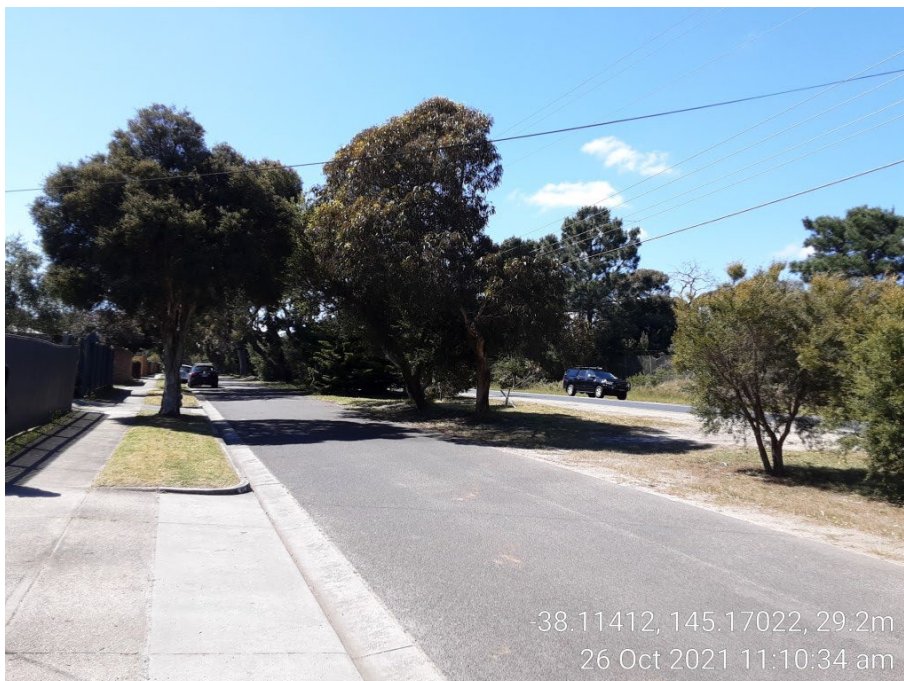
**Photo 4** Planted trees along the nature strip and northern road reserve of Ballarto Road. Photo taken 26 October 2021, looking east.

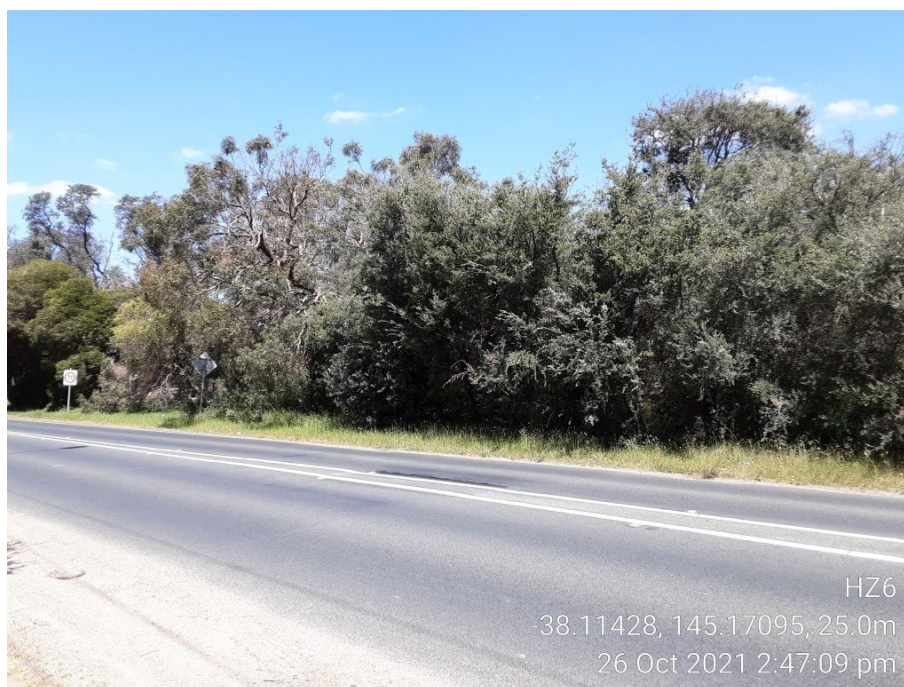
**Photo 5** Patch vegetation consisting of Heathy Woodland EVC 48 along the Ballarto Road reserve, in the eastern part of the study area near the Carrum Downs police station. Photo taken 26 October 2021, looking south-east.

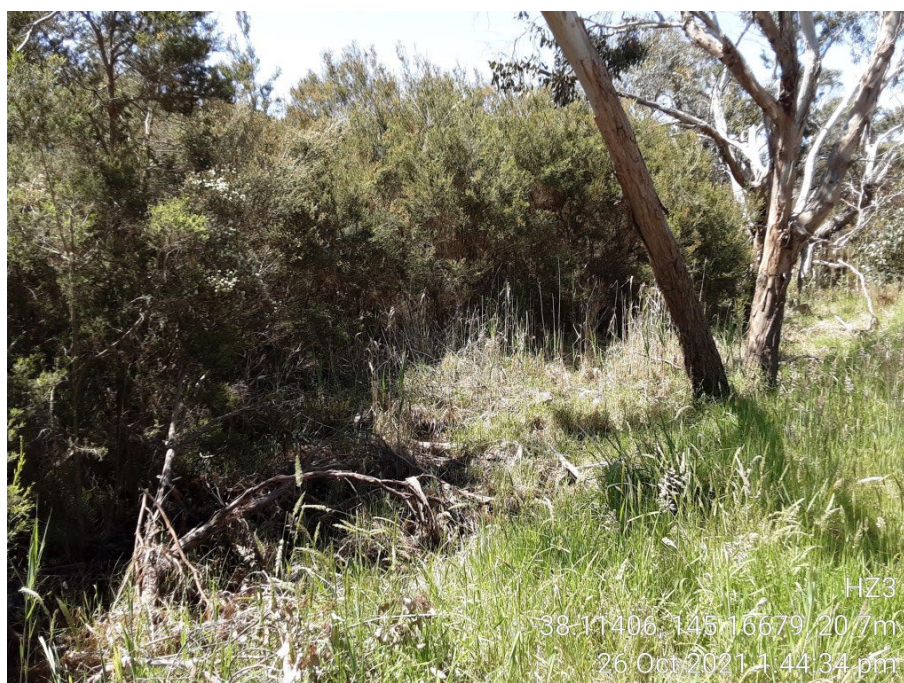
**Photo 6** Patch vegetation consisting of Swamp Scrub EVC 53 south of Ballarto Road in the western part of the study area. Photo taken 26 October 2021, looking west.

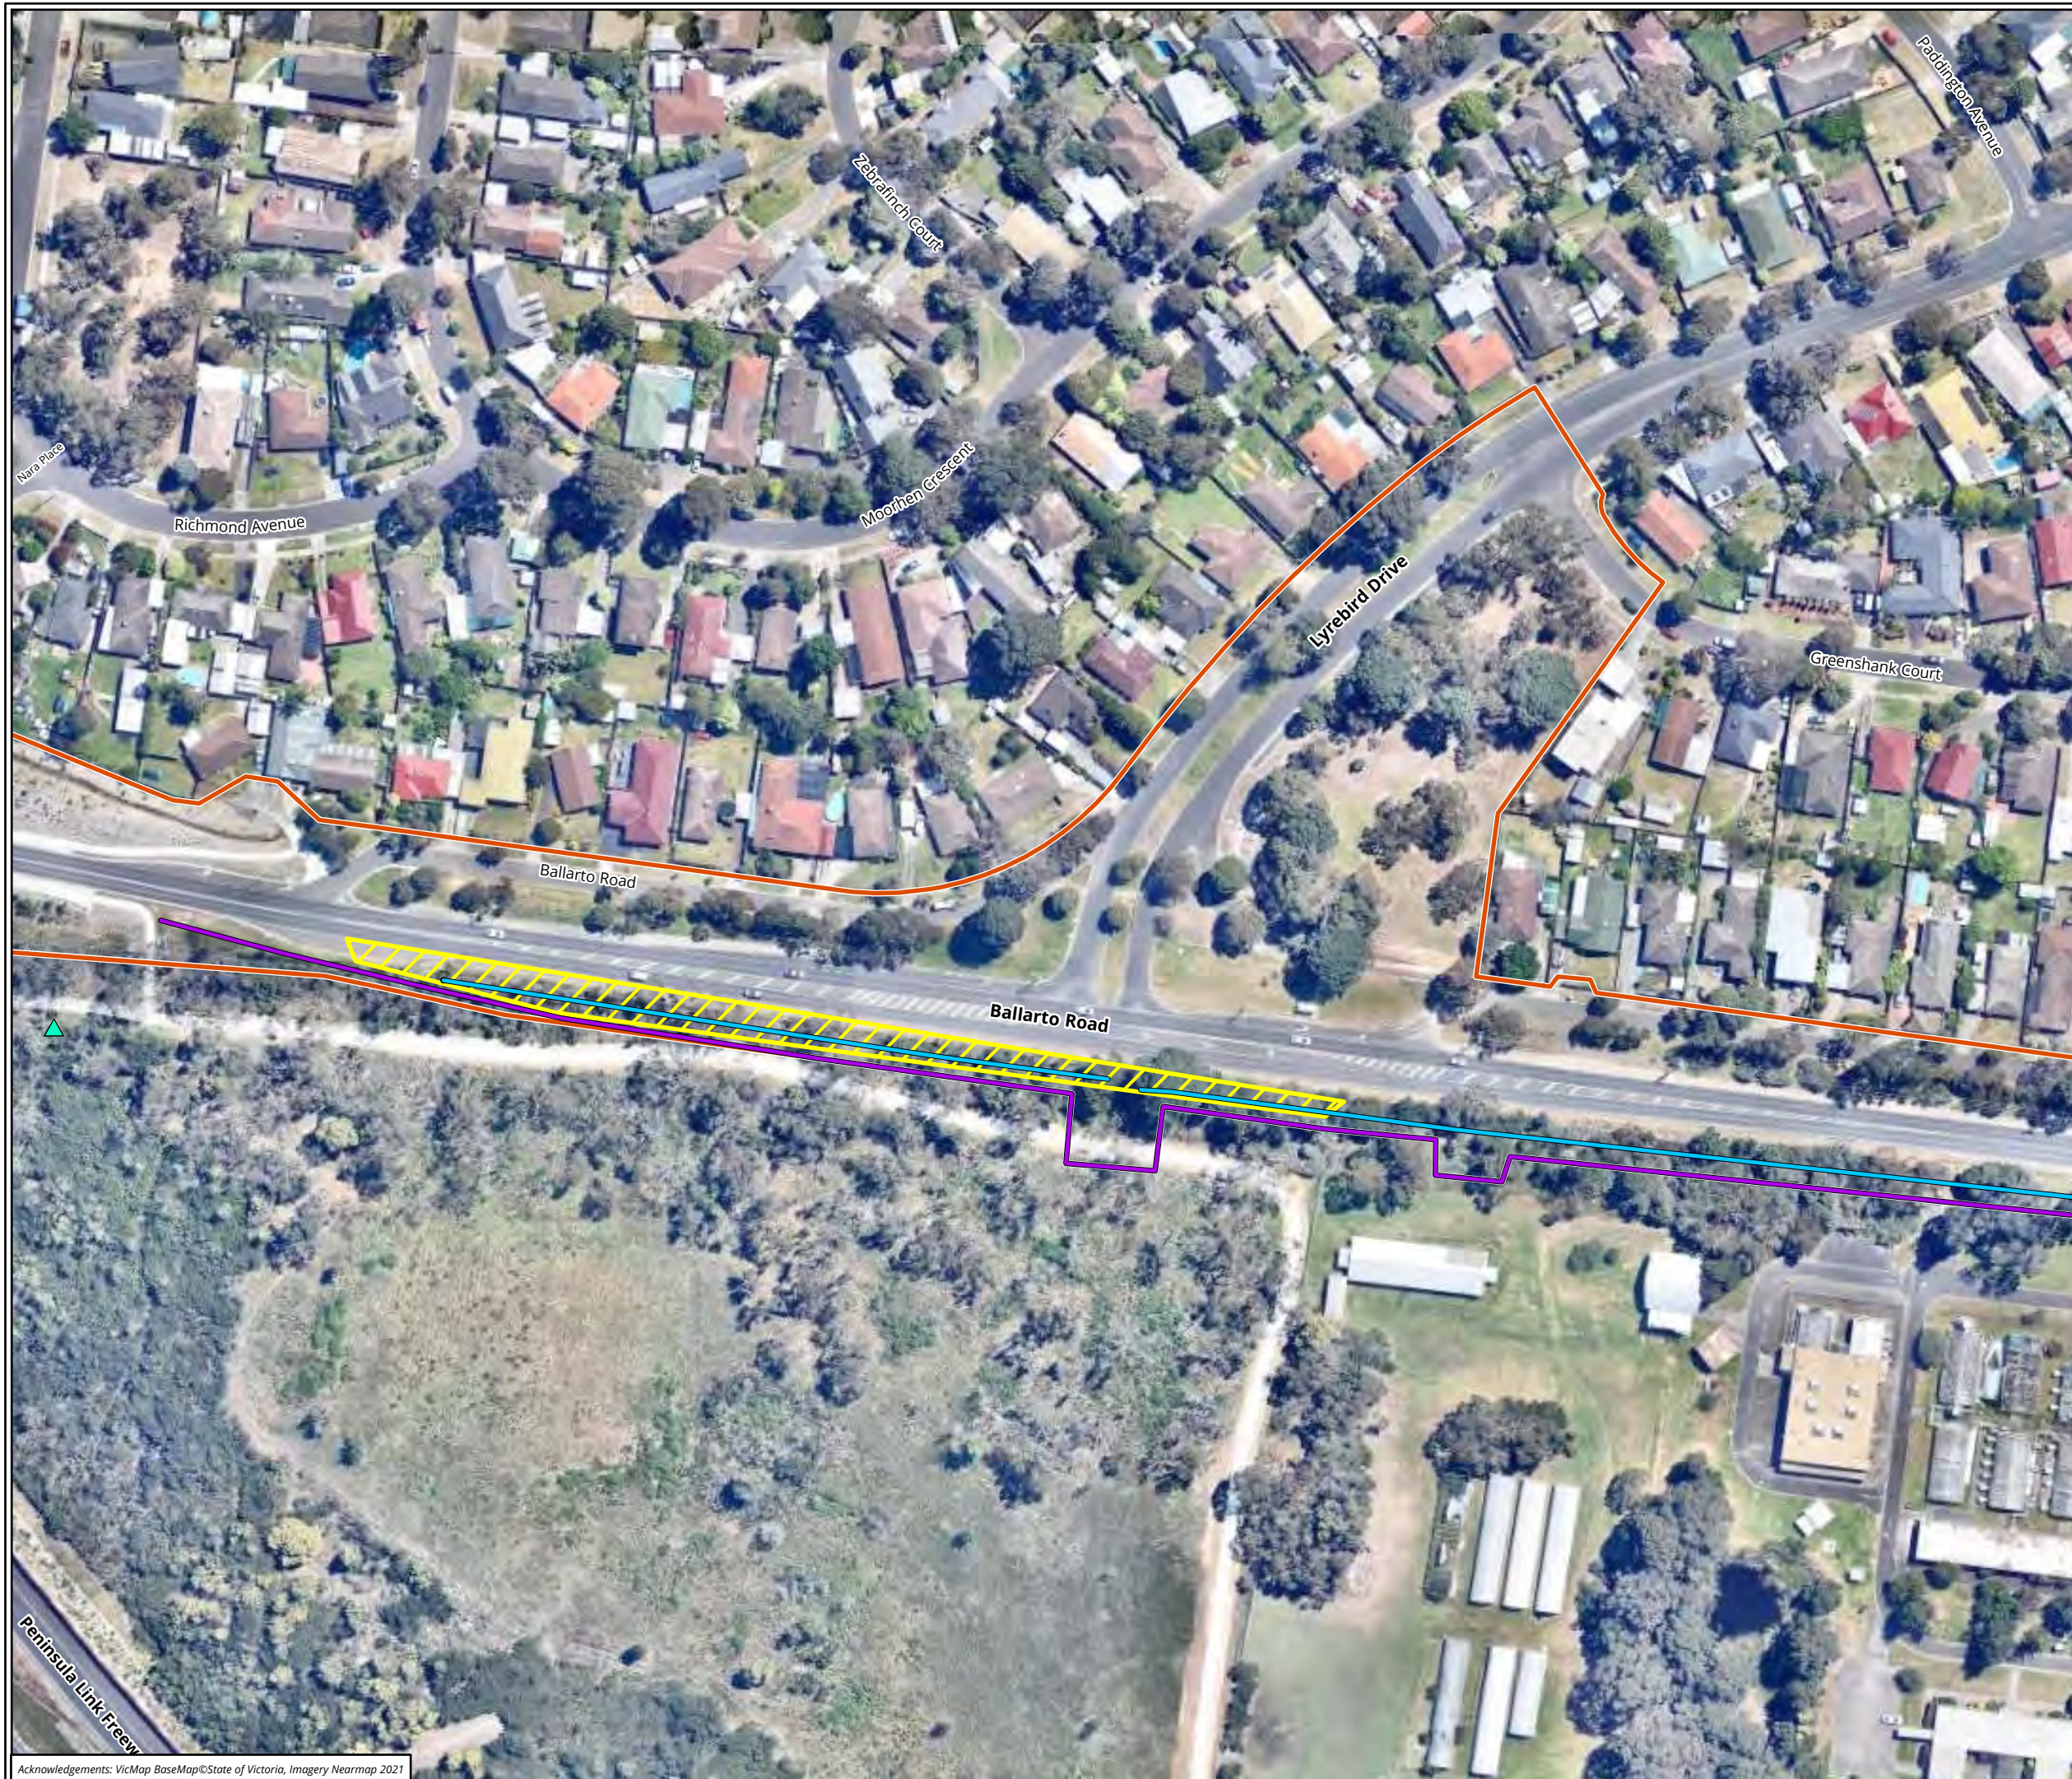
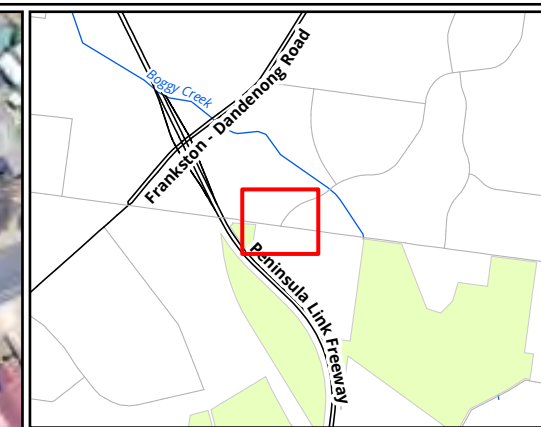
**Figure 4 Swamp Skink Mitigation Recommendations**

- Legend**
- Study area
  - Area for Artificial Refuge surveys
  - Permanent fence
  - Temporary fence with 0.6m high slit fencing
  - ▲ Swamp Skink record

In accordance with DELWP recommendations to mitigate impacts on Swamp Skink populations, a temporary fence with a 600mm high silt fence should be installed prior to works to prevent Swamp Skink from dispersing into the roadworks area. The temporary fence should start from the pathway connecting Ballarto Road to the Peninsula Link Trail and extend approximately 250 metres to join the north-south running fence to the east. The temporary fence is to be maintained and installed for the entirety of roadworks period. Additionally, artificial refuges, i.e. roof tiles, should be installed between the road and temporary fence to capture any Swamp Skink and release into habitat behind the temporary fence. Up to 50 roof tiles at intervals of 5m need to be deployed up to 4 weeks before surveys begin. Surveys should commence in Spring to early Summer (DELWP 2020). Tiles should be inspected at least three times and up to 5 times during the survey period with a week between inspections (DELWP 2020). The last check needs to coincide with the first day of vegetation removal. Upon completion of the road works, a permanent cyclone fence with an additional low barrier to prevent the dispersal of Swamp Skink should be installed and the temporary fence will be removed. These biodiversity and vegetation protection measures should be documented in a Construction Environmental Management Plan (CEMP), which should also include other measures to reduce the possible impacts of site construction works, including erosion and sedimentation management, biosecurity

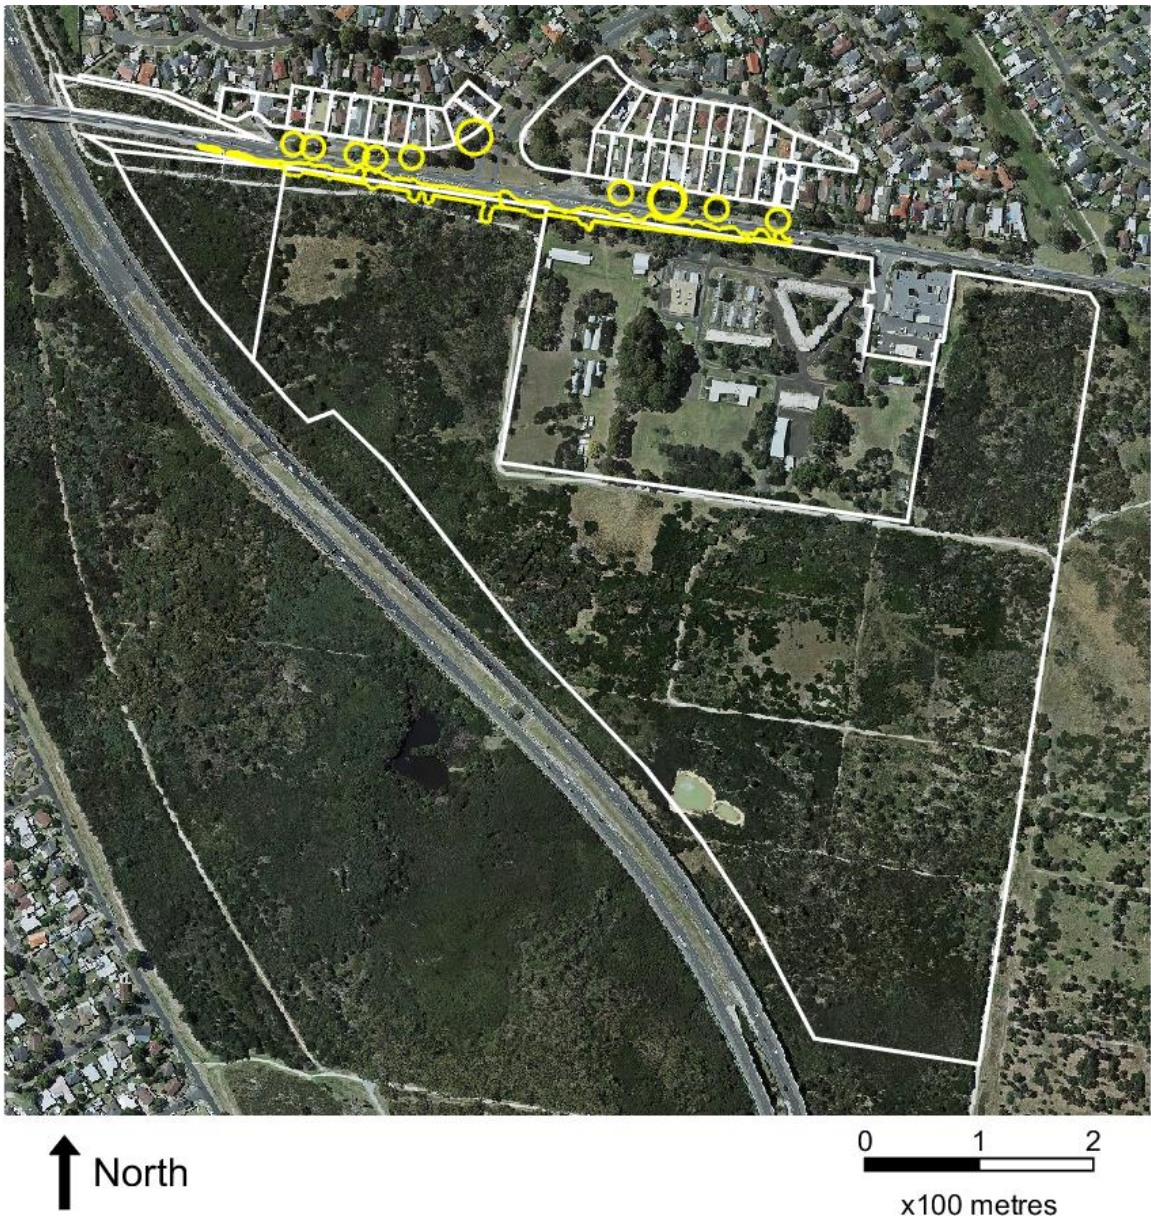
4. Map of the property in context

Yellow boundaries denote areas of proposed native vegetation removal.

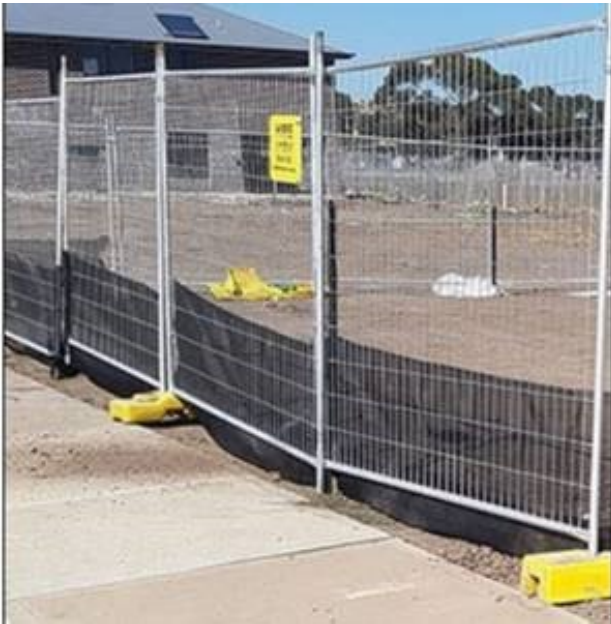
**Photo 7** Example of temporary fencing and silt fence (black material) for Swamp Skink impact mitigation.

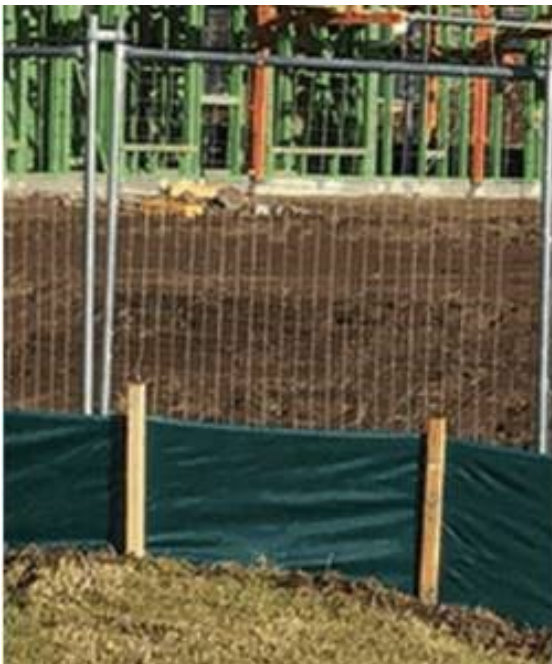
**Photo 8** Example of temporary fence with silt fence (green material) for Swamp Skink mitigation.

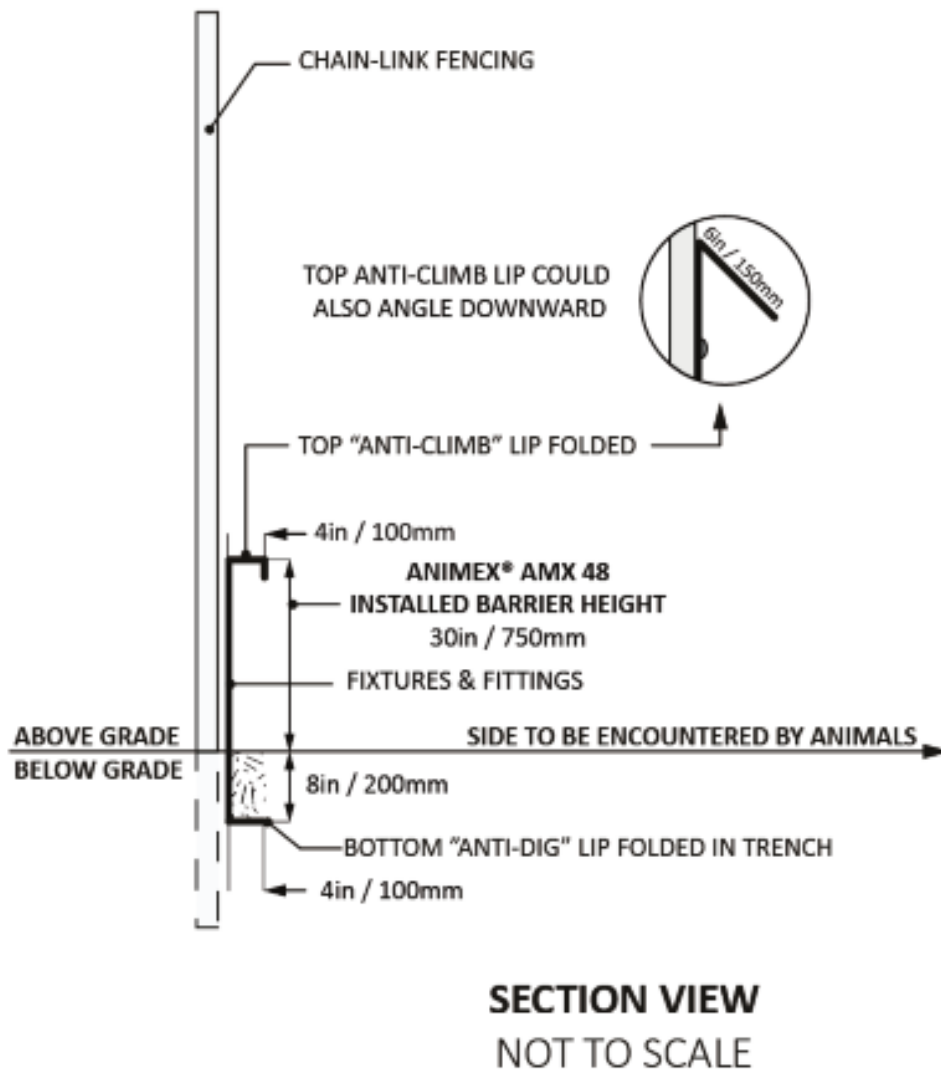
**Photo 9** Specifications for permanent cyclone fence including additional barrier for Swamp Skink as recommended in The Wildlife Fence Guide (Animex International 2021).

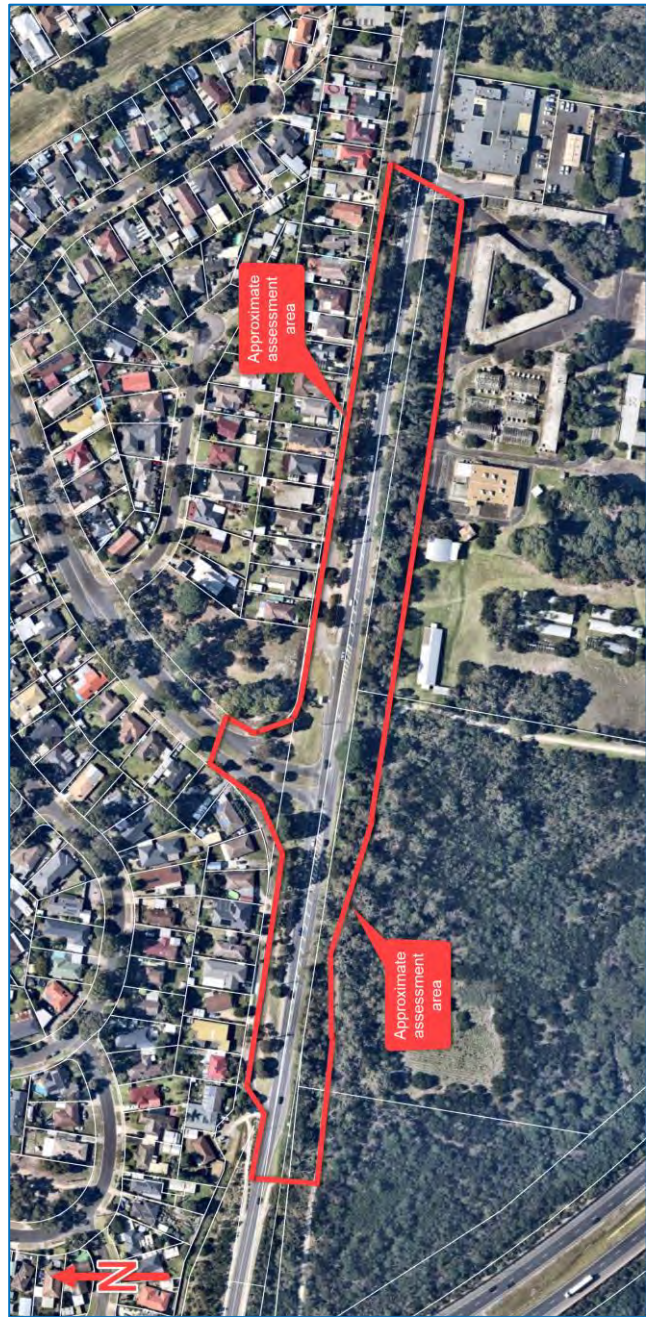
Figure 1 Site scope plan

- 4) The construction proximity for those trees that are well removed from the proposed works has been estimated rather than measured.
- 5) Tree removal and retention colour coding has not been updated in the site plans prepared for this report and colour coding in this report as per the previous report (6610 220211 CIR Biosis Ballarto Cranbourne Rd 1911).
- 6) Tree 390 is a failed tree that has been largely removed from the site.

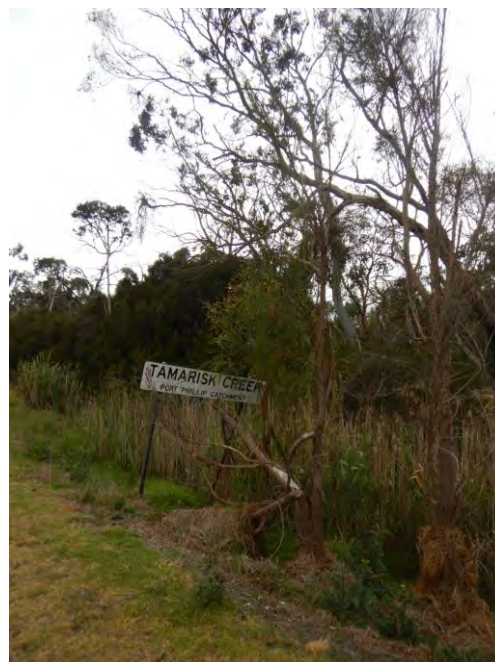
### Tree ID: 2

Genus / species: *Tamarix parviflora*

TPZ (m): 2.2 Construction Proximity: 2.4

mTPZ (m): =TPZ

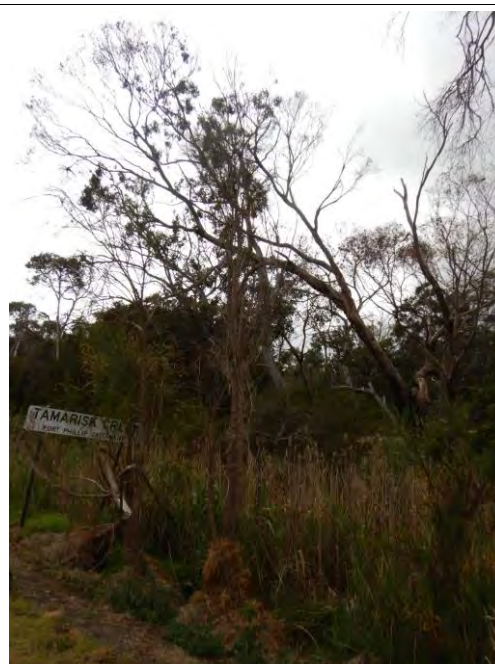
Tree ID: 3

Genus / species: *Acacia melanoxylon*

Height (m): 5 Structure: Poor  
Width (m): 2 Health: Good  
DBH (cm): 15 Measured Maturity: Immature  
Origin: Melbourne ULE (years): 1 - 5  
Retained?: Retained Form: Fair  
Retention Value: Low  
Removal / retention reason: N/A.  
Amenity value: Low  
Works Required: B Removal.

SRZ (m): 1.5 Works priority: N/A  
TPZ (m): 2.0 Construction Proximity: 9.5  
mTPZ (m): =TPZ

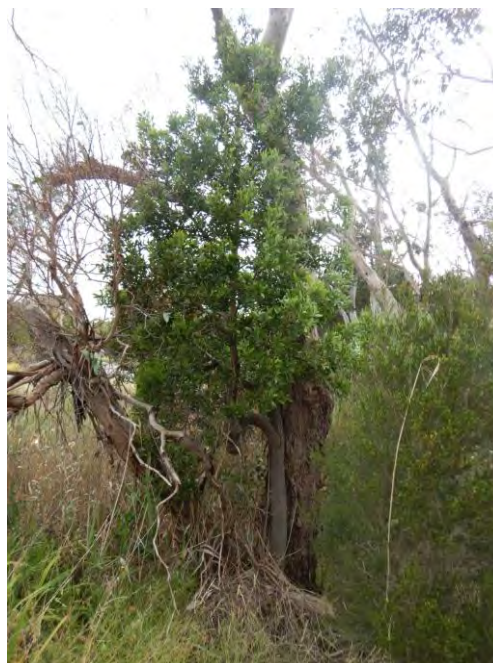
Tree ID: 4

Genus / species: *Eucalyptus ovata*

Height (m): 15 Structure: Poor  
Width (m): 10 Health: Dead  
DBH (cm): 65 Estimated Maturity: Mature  
Origin: Melbourne ULE (years): 0  
Retained?: Retained Form: Very poor  
Retention Value: Remove.  
Removal / retention reason: Health ULE.  
Amenity value: Very low  
Works Required: B Removal.

SRZ (m): 2.9 Works priority: Very low  
TPZ (m): 7.8 Construction Proximity: 13.6  
mTPZ (m): =TPZ

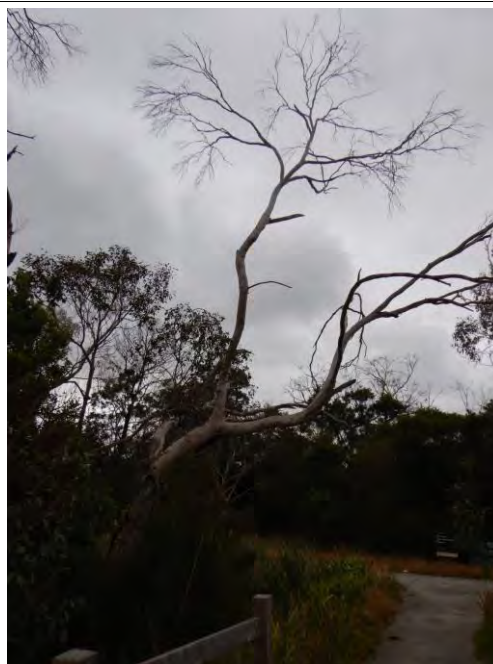
Tree ID: 6

Genus / species: *Eucalyptus ovata*

Height (m): 7 Structure: Poor  
Width (m): 2 Health: Good  
DBH (cm): 16 Measured Maturity: Immature  
Origin: Melbourne ULE (years): 5 - 15  
Retained?: Retained Form: Good  
Retention Value: Very low  
Removal / retention reason: N/A.  
Amenity value: Very low  
Works Required: J No works.

SRZ (m): 1.5 Works priority: N/A  
TPZ (m): 2.0 Construction Proximity: 13.9  
mTPZ (m): =TPZ

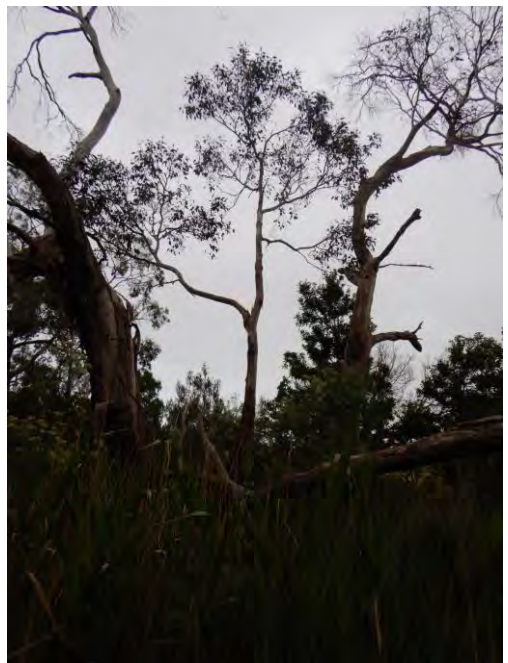
Tree ID: 7

Genus / species: *Eucalyptus ovata*

Height (m): 5 Structure: Poor  
Width (m): 2 Health: Dead  
DBH (cm): 15 Measured Maturity: Immature  
Origin: Melbourne ULE (years): 0  
Retained?: Retained Form: Fair  
Retention Value: Very low  
Removal / retention reason: N/A.  
Amenity value: Very low  
Works Required: B Removal.

SRZ (m): 1.5 Works priority: N/A  
TPZ (m): 2.0 Construction Proximity: 17.5  
mTPZ (m): =TPZ

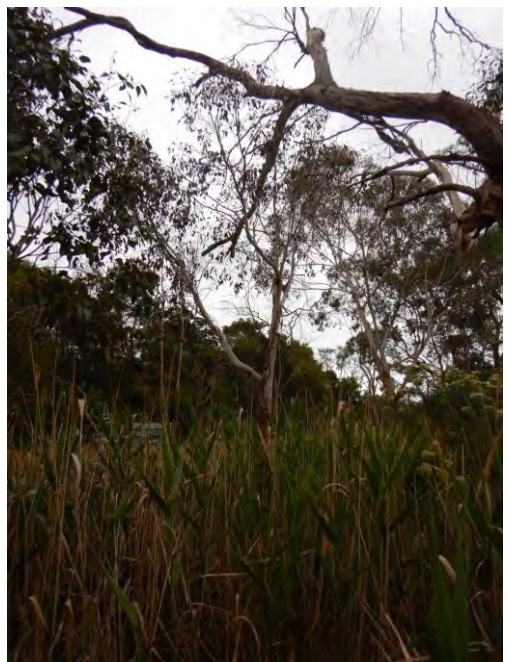
Tree ID: 8

Genus / species: *Eucalyptus ovata*

Height (m): 5 Structure: Fair  
Width (m): 1 Health: Fair  
DBH (cm): 9 Measured Maturity: Immature  
Origin: Melbourne ULE (years): 1 - 5  
Retained?: Retained Form: Fair  
Retention Value: Low  
Removal / retention reason: N/A.  
Amenity value: Low  
Works Required: J No works.

SRZ (m): 1.5 Works priority: N/A  
TPZ (m): 2.0 Construction Proximity: 19.1  
mTPZ (m): =TPZ

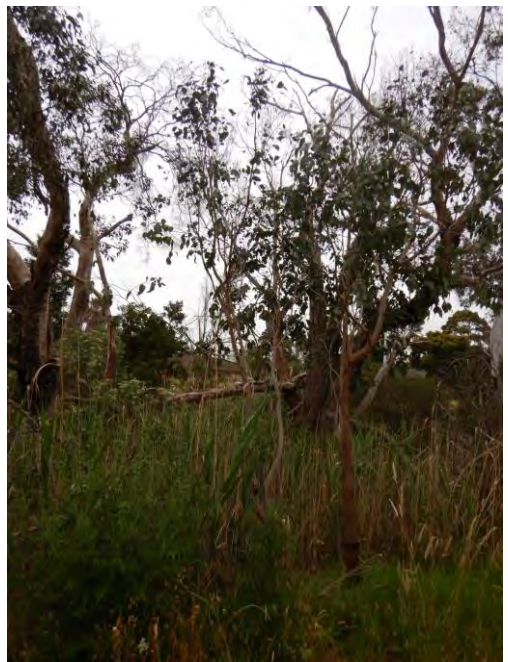
Tree ID: 9

Genus / species: *Eucalyptus ovata*

Height (m): 5 Structure: Fair  
Width (m): 2 Health: Good  
DBH (cm): 10 Measured Maturity: Immature  
Origin: Melbourne ULE (years): 5 - 15  
Retained?: Retained Form: Fair  
Retention Value: Low  
Removal / retention reason: N/A.  
Amenity value: Low  
Works Required: J No works.

SRZ (m): 1.5 Works priority: N/A  
TPZ (m): 2.0 Construction Proximity: 19.1  
mTPZ (m): =TPZ

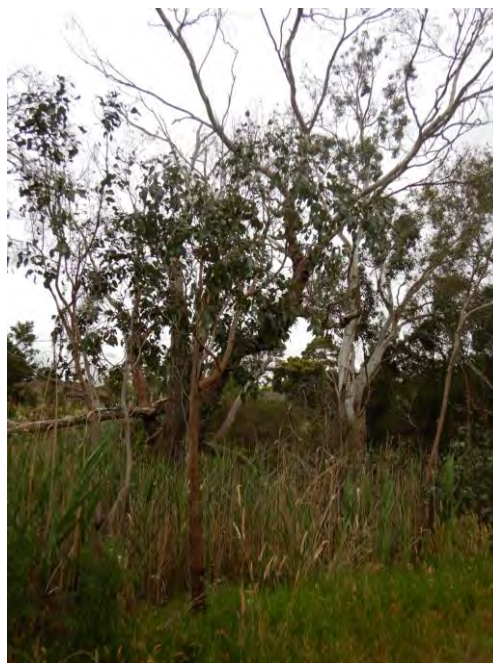
Tree ID: 10

Genus / species: *Eucalyptus ovata*

Height (m): 9 Structure: Poor  
Width (m): 11 Health: Dead  
DBH (cm): 95 Estimated Maturity: Over mature  
Origin: Melbourne ULE (years): 0  
Retained?: Retained Form: Very poor  
Retention Value: Remove.  
Removal / retention reason: Health ULE.  
Amenity value: Very low  
Works Required: B Removal.

SRZ (m): 3.2 Works priority: Very low  
TPZ (m): 11.4 Construction Proximity: 12.2  
mTPZ (m): =TPZ

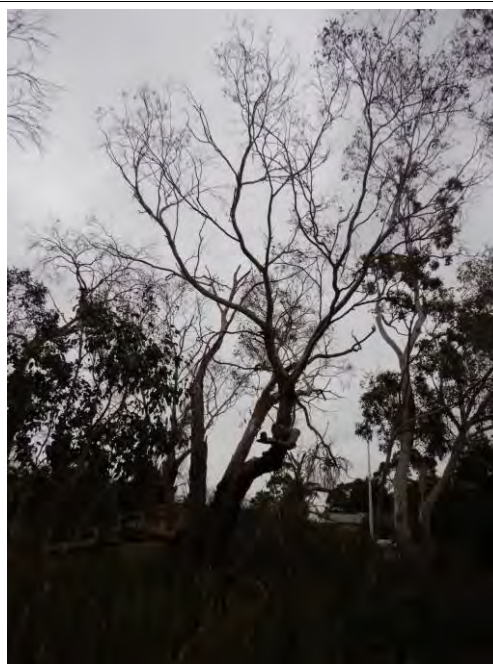
Tree ID: 11

Genus / species: *Eucalyptus ovata*

Height (m): 15 Structure: Poor  
Width (m): 8 Health: Poor  
DBH (cm): 72 Measured Maturity: Mature  
Origin: Melbourne ULE (years): 5 - 15  
Retained?: Retained Form: Fair  
Retention Value: Low  
Removal / retention reason: N/A.  
Amenity value: Moderate  
Works Required: J No works.

SRZ (m): 2.9 Works priority: N/A  
TPZ (m): 8.6 Construction Proximity: 10.2  
mTPZ (m): =TPZ

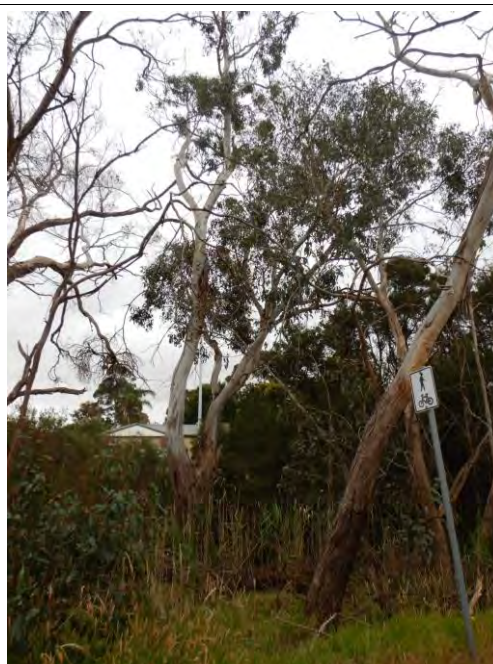
Tree ID: 12

Genus / species: *Eucalyptus ovata*

Works Required: B Removal.

SRZ (m): 2.2 Works priority: N/A  
TPZ (m): 4.2 Construction Proximity: 16.2  
mTPZ (m): =TPZ

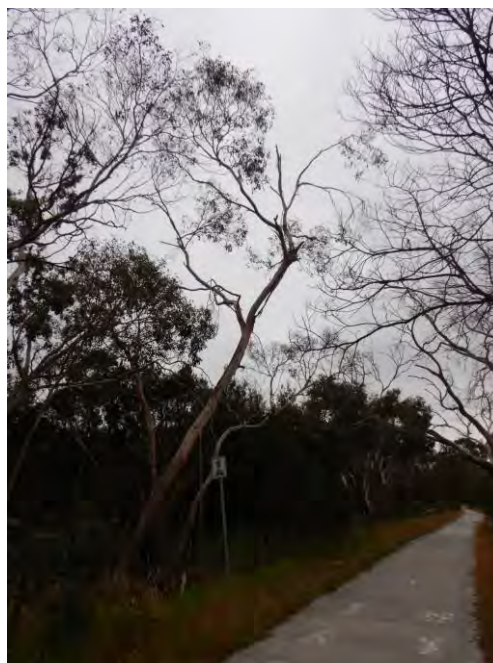
Tree ID: 13

Genus / species: *Eucalyptus ovata*

Works Required: B Removal.

SRZ (m): 1.5 Works priority: N/A  
TPZ (m): 2.0 Construction Proximity: 14.4  
mTPZ (m): =TPZ

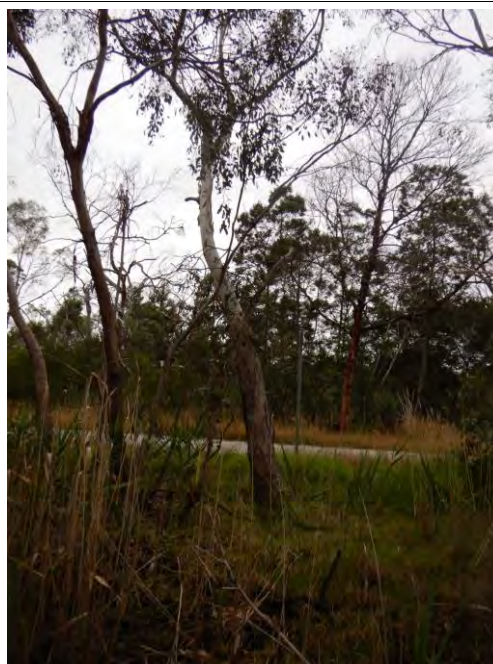
Tree ID: 14

Genus / species: *Eucalyptus ovata*

Works Required: J No works.

SRZ (m): 1.7 Works priority: N/A  
TPZ (m): 2.6 Construction Proximity: 16.1  
mTPZ (m): =TPZ

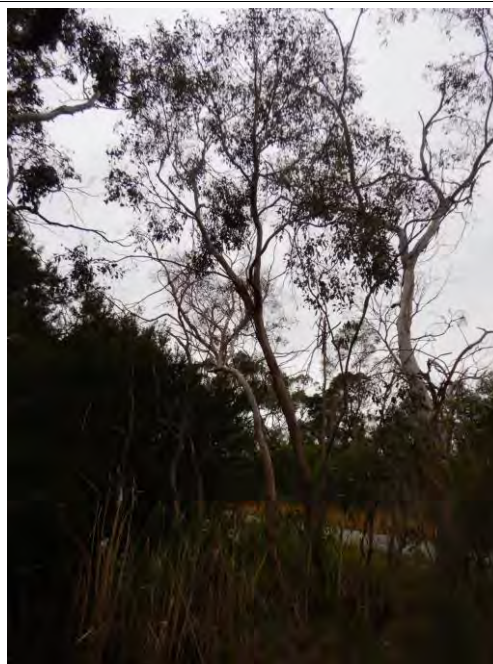
Tree ID: 15

Genus / species: *Eucalyptus ovata*

Height (m): 8 Structure: Fair  
Width (m): 6 Health: Dead  
DBH (cm): 23 Estimated Maturity: Immature  
Origin: Melbourne ULE (years): 0  
Retained?: Retained Form: Very poor  
Retention Value: Remove.  
Removal / retention reason: Health ULE.  
Amenity value: Very low  
Works Required: B Removal.

SRZ (m): 1.7 Works priority: Very low  
TPZ (m): 2.8 Construction Proximity: 15.7  
mTPZ (m): =TPZ

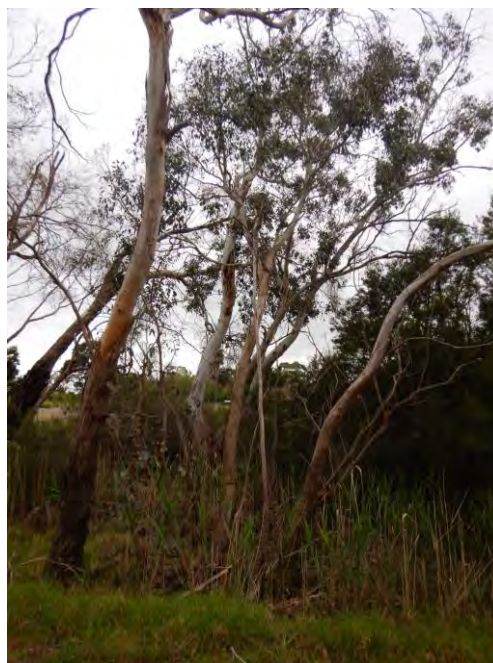
Tree ID: 16

Genus / species: *Eucalyptus ovata*

Height (m): 15 Structure: Fair  
Width (m): 14 Health: Fair  
DBH (cm): 73 Measured Maturity: Over mature  
Origin: Melbourne ULE (years): 5 - 15  
Retained?: Removed Form: Fair  
Retention Value: Moderate  
Removal / retention reason: N/A.  
Amenity value: High  
Works Required: J No works.

SRZ (m): 3 Works priority: N/A  
TPZ (m): 8.8 Construction Proximity: 1.8  
mTPZ (m): =TPZ

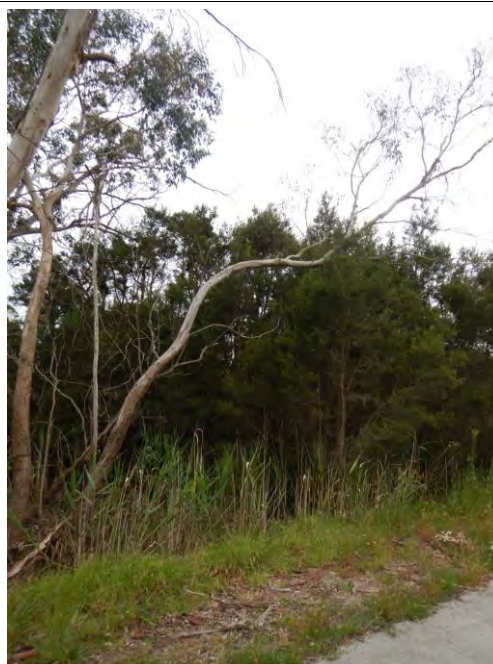
Tree ID: 17

Genus / species: *Eucalyptus ovata*

Height (m): 11 Structure: Poor  
Width (m): 8 Health: Dead  
DBH (cm): 45 Estimated Maturity: Over mature  
Origin: Melbourne ULE (years): 0  
Retained?: Retained Form: Very poor  
Retention Value: Remove.  
Removal / retention reason: Health ULE.  
Amenity value: Very low  
Works Required: B Removal.

SRZ (m): 2.5 Works priority: Very low  
TPZ (m): 5.4 Construction Proximity: 8.1  
mTPZ (m): =TPZ

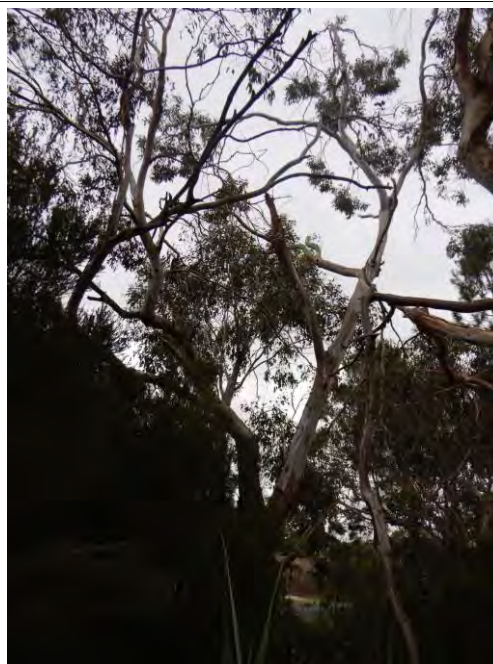
Tree ID: 18

Genus / species: *Eucalyptus ovata*

Works Required: J No works.

SRZ (m): 2.2 Works priority: N/A  
TPZ (m): 4.4 Construction Proximity: 8.4  
mTPZ (m): =TPZ

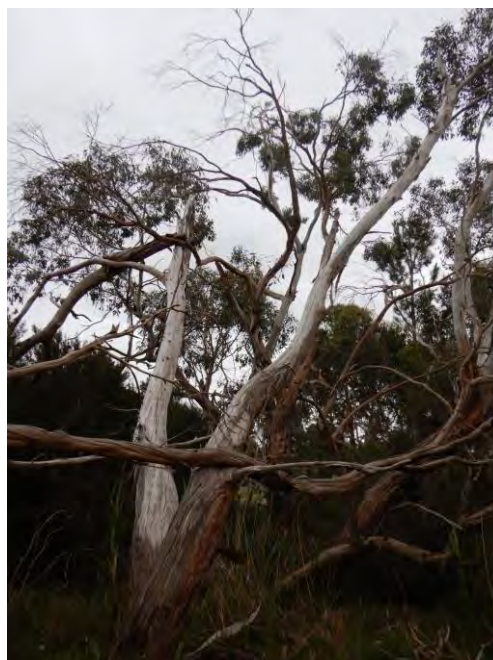
Tree ID: 19

Genus / species: *Eucalyptus ovata*

Works Required: B Removal.

SRZ (m): 2.6 Works priority: Very low  
TPZ (m): 6.0 Construction Proximity: 10.6  
mTPZ (m): =TPZ

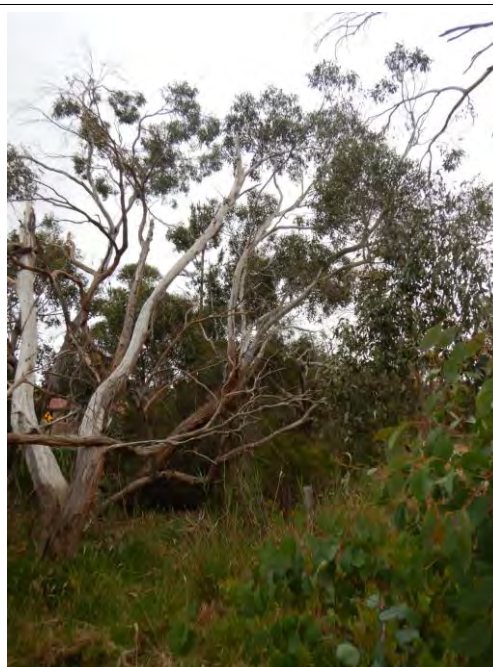
Tree ID: 20

Genus / species: *Eucalyptus ovata*

Works Required: B Removal.

SRZ (m): 2.9 Works priority: Very low  
TPZ (m): 8.4 Construction Proximity: 10  
mTPZ (m): =TPZ

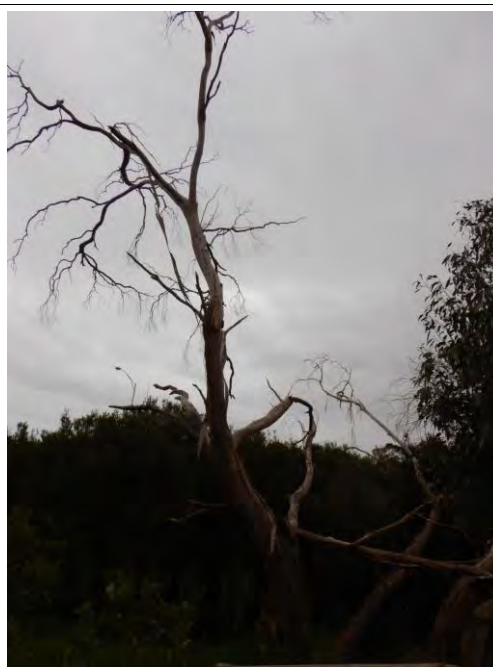
Tree ID: 21

Genus / species: *Eucalyptus ovata*

Works Required: J No works.

SRZ (m): 1.5 Works priority: N/A  
TPZ (m): 2.0 Construction Proximity: 11.7  
mTPZ (m): =TPZ

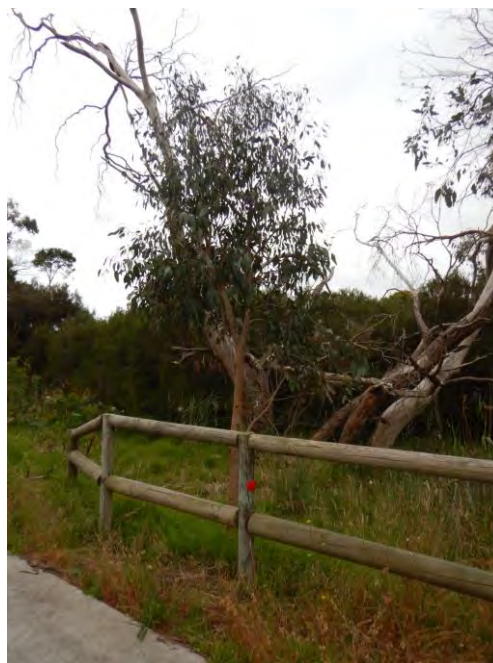
Tree ID: 22

Genus / species: *Melaleuca armillaris*

Works Required: J No works.

SRZ (m): 1.5 Works priority: N/A  
TPZ (m): 2.0 Construction Proximity: 9  
mTPZ (m): =TPZ

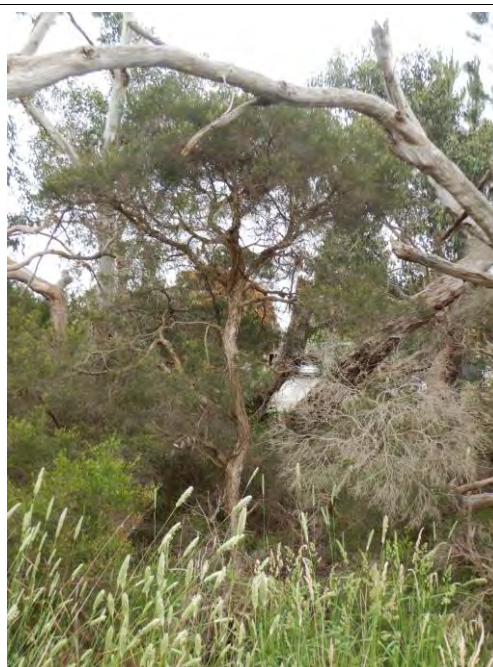
Tree ID: 23

Genus / species: *Eucalyptus ovata*

Works Required: J No works.

SRZ (m): 2.5 Works priority: N/A  
TPZ (m): 5.8 Construction Proximity: 5.1  
mTPZ (m): =TPZ

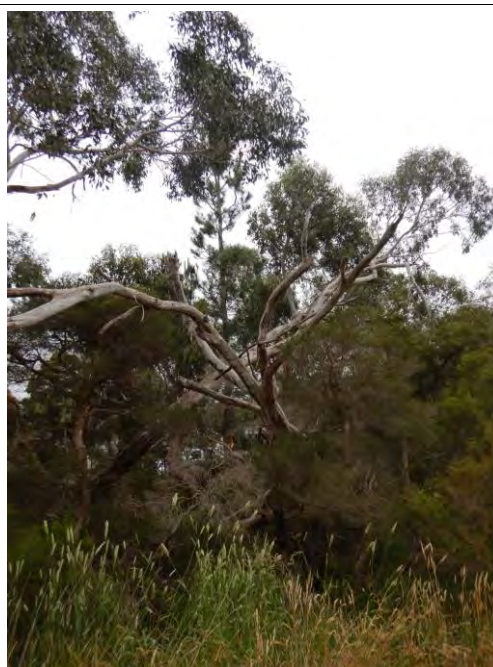
Tree ID:    24

Genus / species: *Eucalyptus ovata*

Height (m):    7                    Structure:    Poor  
Width (m):     8                    Health:       Dead  
DBH (cm):     40   Measured Maturity:   Over mature  
Origin:        Melbourne    ULE (years): 0  
Retained?:    Retained       Form:        Very poor  
Retention Value:                   Remove.  
Removal / retention reason: Health ULE.  
Amenity value:                    Very low  
Works Required: B Removal.

SRZ (m):    2.4       Works priority:           Very low  
TPZ (m):    4.8       Construction Proximity:       10  
mTPZ (m): =TPZ

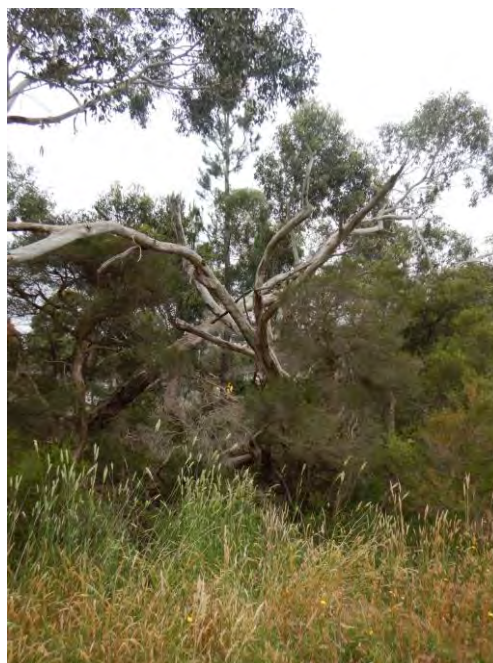
Tree ID:    25

Genus / species: *Melaleuca armillaris*

Height (m):    5                    Structure:    Good  
Width (m):     2                    Health:       Good  
DBH (cm):     10   Measured Maturity:   Mature  
Origin:        Victorian    ULE (years): 15 - 30  
Retained?:    Retained       Form:        Good  
Retention Value:                   Low  
Removal / retention reason: N/A.  
Amenity value:                    Low  
Works Required: J No works.

SRZ (m):    1.5       Works priority:           N/A  
TPZ (m):    2.0       Construction Proximity:       11  
mTPZ (m): =TPZ
