# Ballarto Road and Lyrebird Drive intersection upgrade: Flora and fauna assessment

FINAL REPORT

Prepared for Department of Transport

19 July 2022

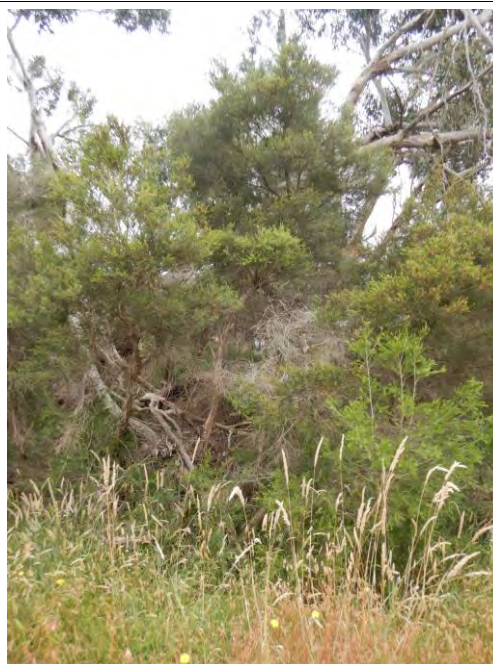
Tree ID:    26

Genus / species: *Eucalyptus ovata*

Height (m):    11                   Structure:    Poor  
Width (m):     9                    Health:       Dead  
DBH (cm):     56   Measured Maturity:   Over mature  
Origin:        Melbourne    ULE (years): 0  
Retained?:    Retained       Form:        Fair  
Retention Value:                   Low  
Removal / retention reason: N/A.  
Amenity value:                    Moderate  
Works Required: B Removal.,J No works.

SRZ (m):    2.7       Works priority:           N/A  
TPZ (m):    6.7       Construction Proximity:       6.2  
mTPZ (m): =TPZ

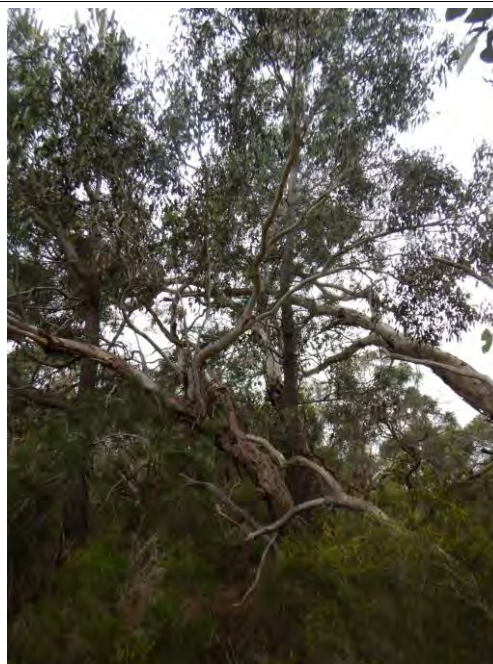
Tree ID: 27

Genus / species: *Pinus sylvestris*

Height (m): 14 Structure: Good  
Width (m): 2 Health: Fair  
DBH (cm): 26 Measured Maturity: Immature  
Origin: Exotic ULE (years): 30 - 60  
Retained?: Retained Form: Fair  
Retention Value: Moderate  
Removal / retention reason: N/A.  
Amenity value: Moderate  
Works Required: J No works.

SRZ (m): 1.8 Works priority: N/A  
TPZ (m): 3.1 Construction Proximity: 6.4  
mTPZ (m): =TPZ

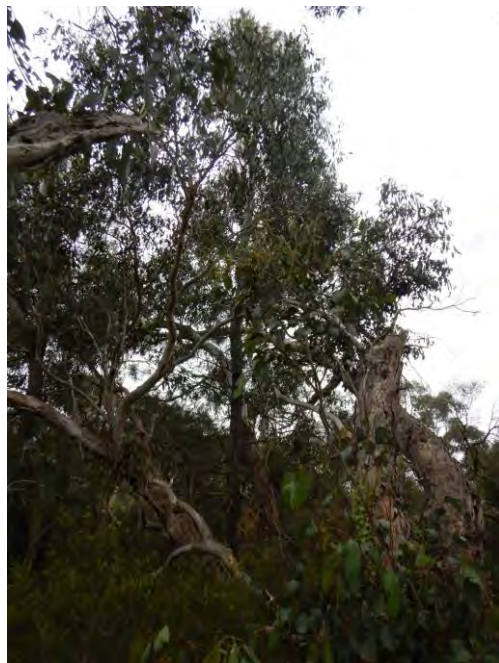
Tree ID: 28

Genus / species: *Pinus sylvestris*

Height (m): 8 Structure: Good  
Width (m): 3 Health: Fair  
DBH (cm): 29 Measured Maturity: Immature  
Origin: Exotic ULE (years): 30 - 60  
Retained?: Retained Form: Fair  
Retention Value: Low  
Removal / retention reason: N/A.  
Amenity value: Low  
Works Required: J No works.

SRZ (m): 2 Works priority: N/A  
TPZ (m): 3.5 Construction Proximity: 2.7  
mTPZ (m): =TPZ

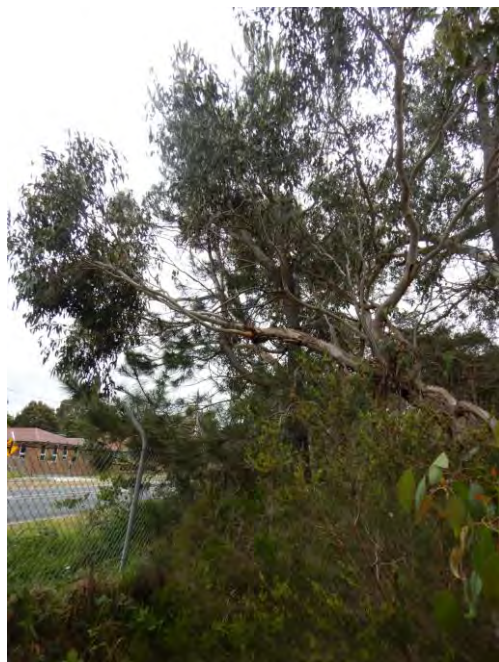
Tree ID: 29

Genus / species: *Melaleuca armillaris*

Height (m): 5 Structure: Fair  
Width (m): 2 Health: Fair  
DBH (cm): 10 Measured Maturity: Mature  
Origin: Victorian ULE (years): 5 - 15  
Retained?: Retained Form: Fair  
Retention Value: Low  
Removal / retention reason: N/A.  
Amenity value: Low  
Works Required: J No works.

SRZ (m): 1.5 Works priority: N/A  
TPZ (m): 2.0 Construction Proximity: 5.1  
mTPZ (m): =TPZ

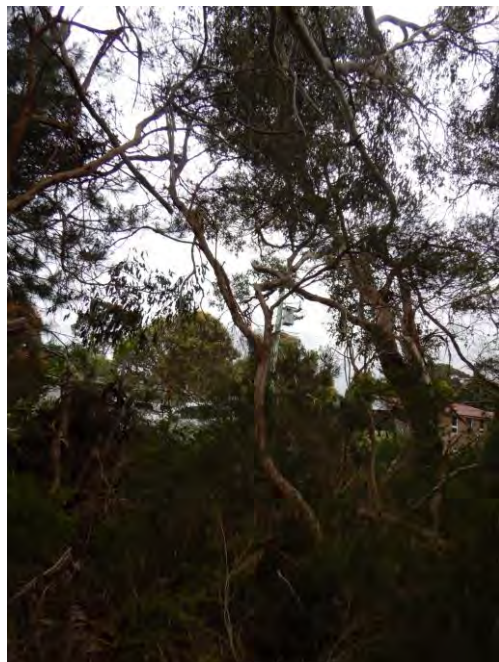
Tree ID:    30

Genus / species: *Eucalyptus ovata*

Height (m):    14                          Structure:    Fair  
Width (m):    12                          Health:       Fair  
DBH (cm):    62    Measured Maturity:    Over mature  
Origin:           Melbourne       ULE (years): 15 - 30  
Retained?:    Removed                  Form:        Fair  
Retention Value:                          Moderate  
Removal / retention reason: N/A.  
Amenity value:                          Moderate  
Works Required:    J No works.

SRZ (m):    2.8                  Works priority:                  N/A  
TPZ (m):    7.4                  Construction Proximity:       3.4  
mTPZ (m):    =TPZ

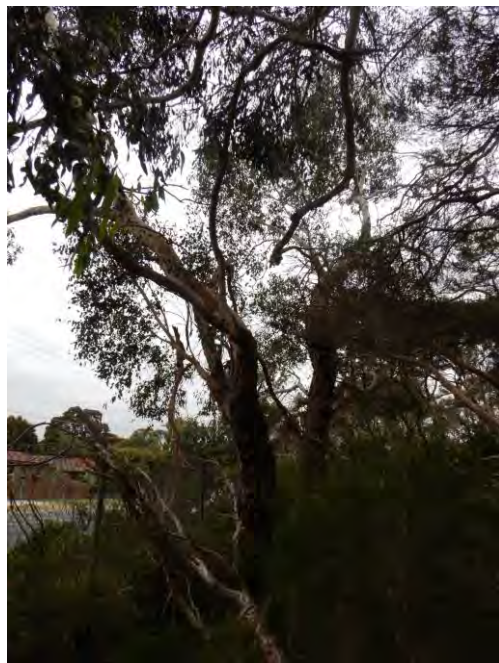
Tree ID:    31

Genus / species: *Melaleuca armillaris*

Height (m):    6                          Structure:    Good  
Width (m):    2                          Health:       Fair  
DBH (cm):    10    Measured Maturity:    Mature  
Origin:           Victorian       ULE (years): 5 - 15  
Retained?:    Retained                  Form:        Fair  
Retention Value:                          Low  
Removal / retention reason: N/A.  
Amenity value:                          Low  
Works Required:    J No works.

SRZ (m):    1.5                  Works priority:                  N/A  
TPZ (m):    2.0                  Construction Proximity:       5.1  
mTPZ (m):    =TPZ

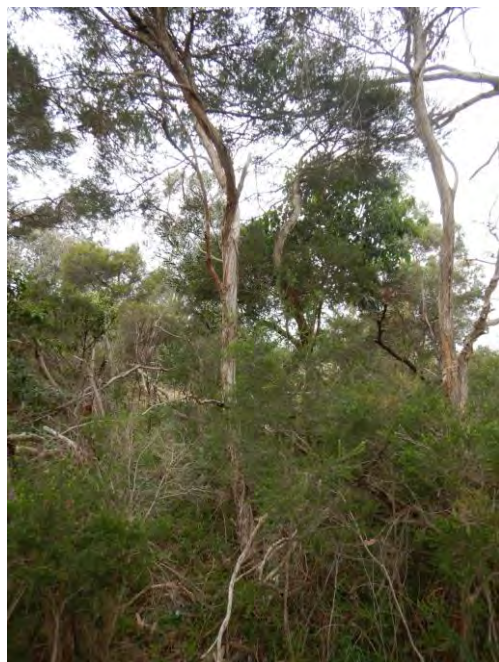
Tree ID:    32

Genus / species: *Melaleuca armillaris*

Height (m):    5                          Structure:    Good  
Width (m):    2                          Health:       Fair  
DBH (cm):    8    Measured Maturity:    Mature  
Origin:           Victorian       ULE (years): 5 - 15  
Retained?:    Retained                  Form:        Fair  
Retention Value:                          Low  
Removal / retention reason: N/A.  
Amenity value:                          Low  
Works Required:    J No works.

SRZ (m):    1.5                  Works priority:                  N/A  
TPZ (m):    2.0                  Construction Proximity:       4.4  
mTPZ (m):    =TPZ

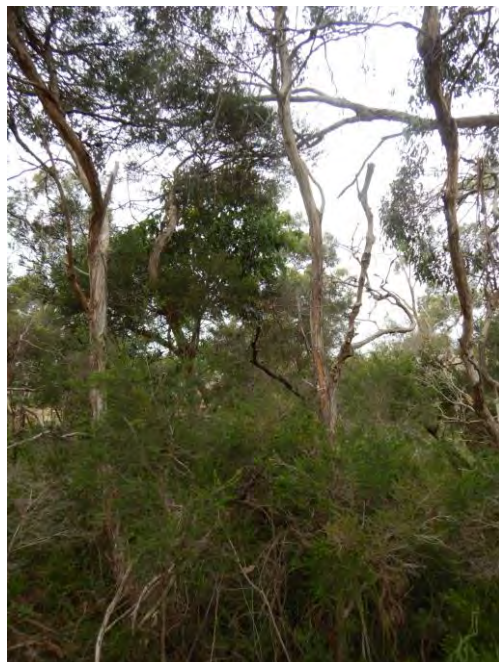
Tree ID:    33

Genus / species: *Eucalyptus botryoides*

Works Required: J No works.

SRZ (m):	1.5	Works priority:	N/A
TPZ (m):	2.0	Construction Proximity:	8
mTPZ (m):	=TPZ

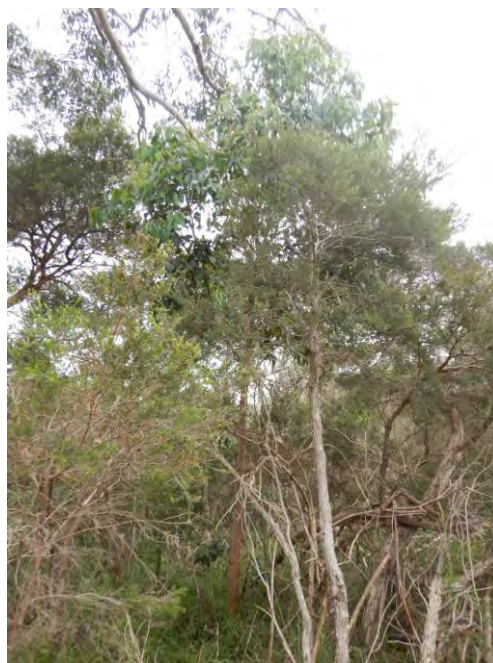
Tree ID:    34

Genus / species: *Melaleuca armillaris*

Works Required: B Removal.

SRZ (m):	1.5	Works priority:	N/A
TPZ (m):	2.0	Construction Proximity:	9
mTPZ (m):	=TPZ

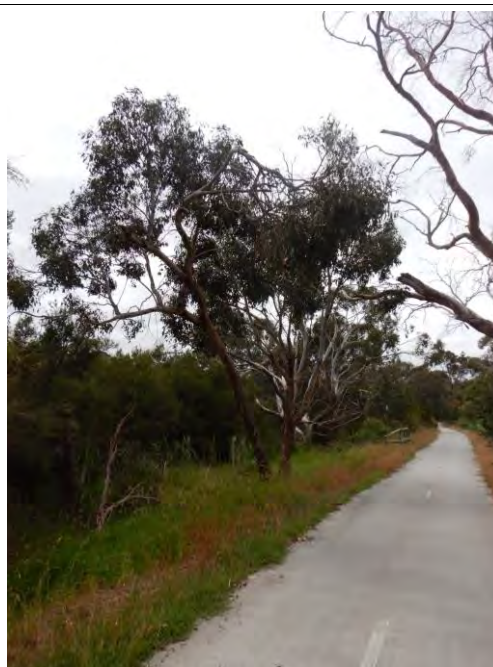
Tree ID: 36

Genus / species: *Melaleuca armillaris*

TPZ (m): 2.0 Construction Proximity: 10

mTPZ (m): =TPZ

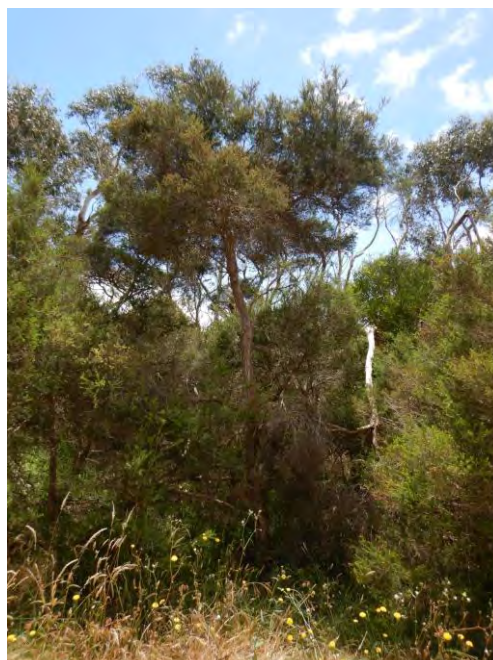
Tree ID: 37

Genus / species: *Eucalyptus ovata*

TPZ (m): 3.0 Construction Proximity: 11

mTPZ (m): =TPZ

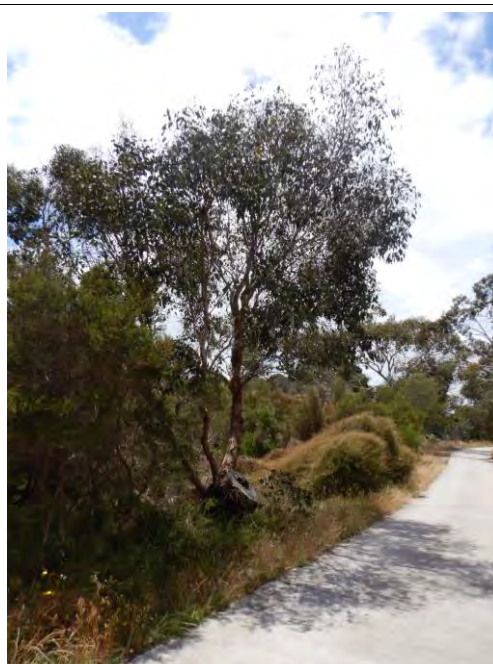
Tree ID: 38

Genus / species: *Melaleuca ericifolia*

TPZ (m): 2.0 Construction Proximity: 6.7

mTPZ (m): =TPZ

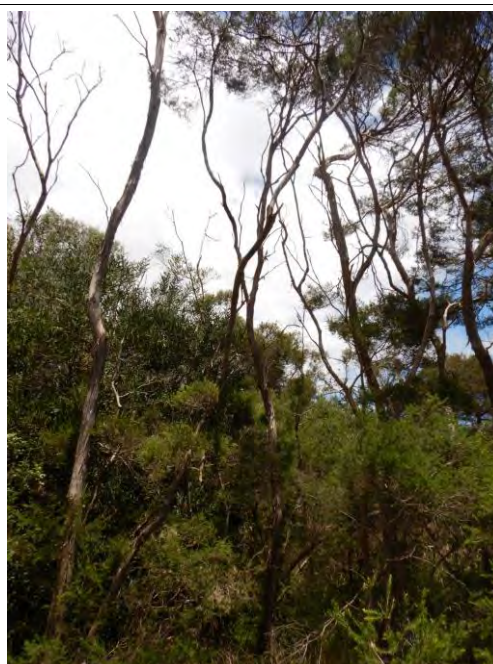
Tree ID:    39

Genus / species: *Melaleuca ericifolia*

Works Required: J No works.

SRZ (m):	1.5	Works priority:	N/A
TPZ (m):	2.0	Construction Proximity:	5.6
mTPZ (m):	=TPZ

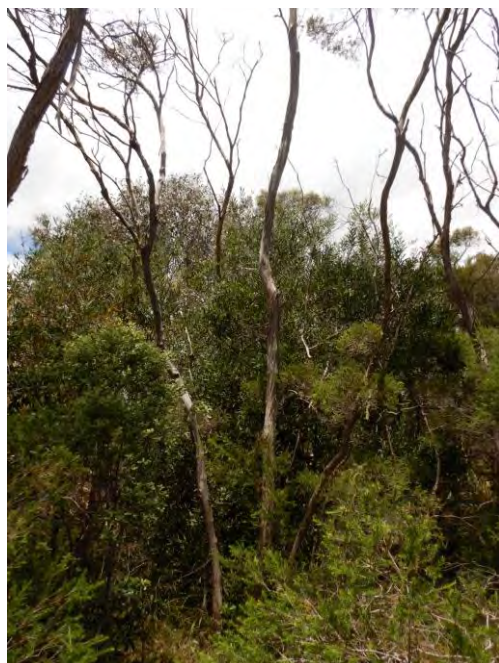
Tree ID:    40

Genus / species: *Melaleuca ericifolia*

Works Required: J No works.

SRZ (m):	1.5	Works priority:	N/A
TPZ (m):	2.0	Construction Proximity:	5.4
mTPZ (m):	=TPZ

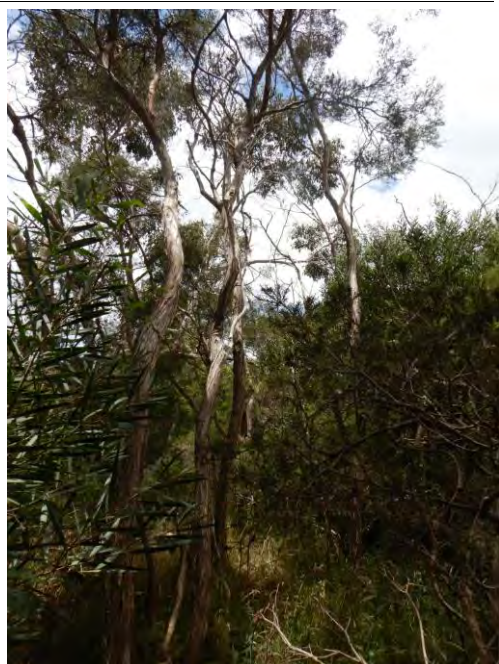
Tree ID:    41

Genus / species: *Melaleuca ericifolia*

Works Required: J No works.

SRZ (m):	1.5	Works priority:	N/A
TPZ (m):	2.0	Construction Proximity:	6.8
mTPZ (m):	=TPZ

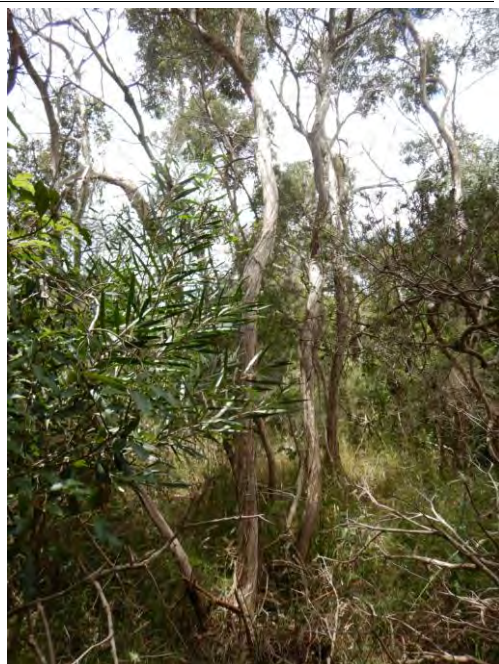
Tree ID: 42

Genus / species: *Melaleuca ericifolia*

Height (m): 6 Structure: Poor  
Width (m): 1 Health: Fair  
DBH (cm): 10 Measured Maturity: Over mature  
Origin: Melbourne ULE (years): 15 - 30  
Retained?: Retained Form: Poor  
Retention Value: Low  
Removal / retention reason: N/A.  
Amenity value: Low  
Works Required: J No works.

SRZ (m): 1.5 Works priority: N/A  
TPZ (m): 2.0 Construction Proximity: 5.6  
mTPZ (m): =TPZ

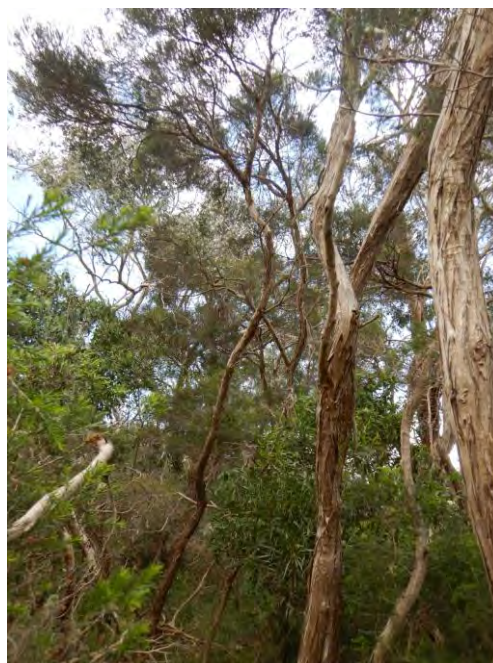
Tree ID: 43

Genus / species: *Melaleuca ericifolia*

Height (m): 5 Structure: Poor  
Width (m): 2 Health: Fair  
DBH (cm): 10 Measured Maturity: Over mature  
Origin: Melbourne ULE (years): 15 - 30  
Retained?: Removed Form: Poor  
Retention Value: Low  
Removal / retention reason: N/A.  
Amenity value: Low  
Works Required: J No works.

SRZ (m): 1.5 Works priority: N/A  
TPZ (m): 2.0 Construction Proximity: 2.9  
mTPZ (m): =TPZ

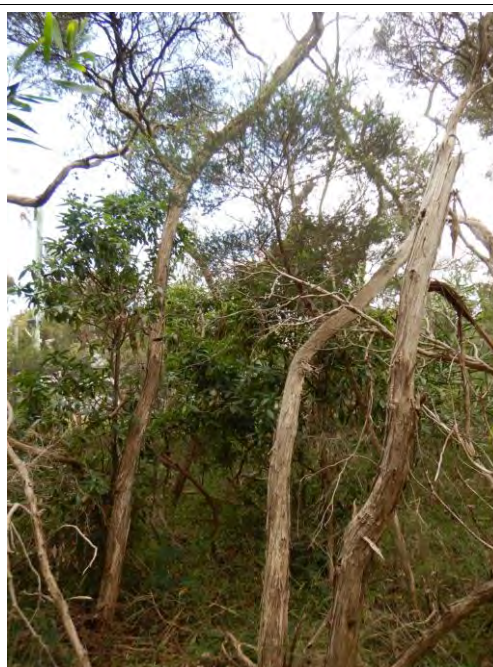
Tree ID: 44

Genus / species: *Acacia sophorae*

Height (m): 5 Structure: Good  
Width (m): 4 Health: Good  
DBH (cm): 10 Measured Maturity: Immature  
Origin: Melbourne ULE (years): 15 - 30  
Retained?: Retained Form: Good  
Retention Value: Low  
Removal / retention reason: N/A.  
Amenity value: Low  
Works Required: J No works.

SRZ (m): 1.5 Works priority: N/A  
TPZ (m): 2.0 Construction Proximity: 6.4  
mTPZ (m): =TPZ

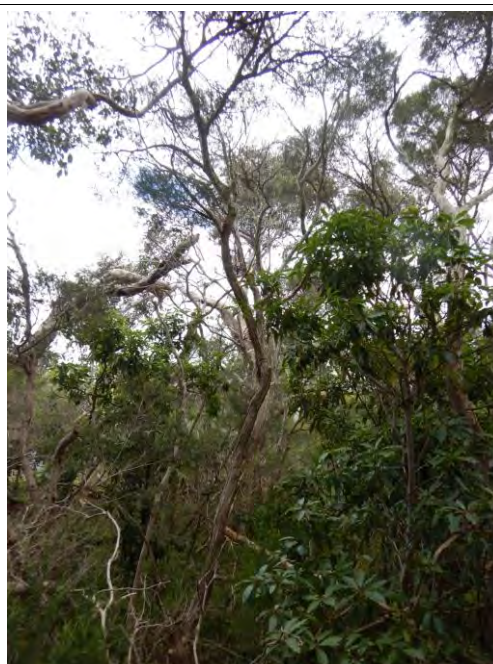
Tree ID: 45

Genus / species: *Melaleuca ericifolia*

Height (m): 5 Structure: Poor  
Width (m): 2 Health: Poor  
DBH (cm): 10 Measured Maturity: Over mature  
Origin: Melbourne ULE (years): 5 - 15  
Retained?: Retained Form: Poor  
Retention Value: Low  
Removal / retention reason: N/A.  
Amenity value: Low  
Works Required: J No works.

SRZ (m): 1.5 Works priority: N/A  
TPZ (m): 2.0 Construction Proximity: 4.3  
mTPZ (m): =TPZ

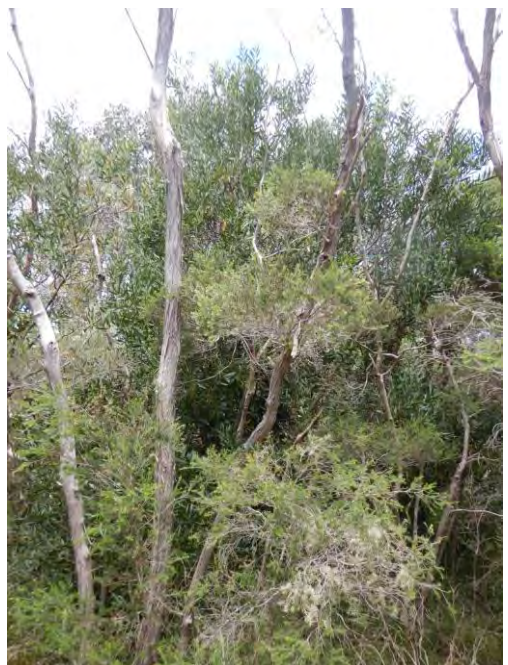
Tree ID: 46

Genus / species: *Eucalyptus ovata*

Height (m): 12 Structure: Fair  
Width (m): 9 Health: Fair  
DBH (cm): 49 Measured Maturity: Over mature  
Origin: Melbourne ULE (years): 15 - 30  
Retained?: Removed Form: Fair  
Retention Value: Moderate  
Removal / retention reason: N/A.  
Amenity value: Moderate  
Works Required: J No works.

SRZ (m): 2.6 Works priority: N/A  
TPZ (m): 5.9 Construction Proximity: 2.7  
mTPZ (m): =TPZ

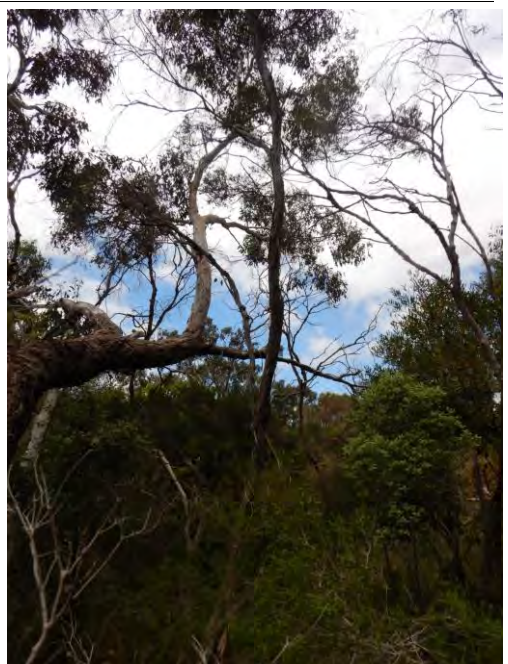
Tree ID: 47

Genus / species: *Eucalyptus ovata*

Height (m): 9 Structure: Fair  
Width (m): 5 Health: Fair  
DBH (cm): 35 Measured Maturity: Mature  
Origin: Melbourne ULE (years): 15 - 30  
Retained?: Removed Form: Fair  
Retention Value: Low  
Removal / retention reason: N/A.  
Amenity value: Low  
Works Required: J No works.

SRZ (m): 2.2 Works priority: N/A  
TPZ (m): 4.2 Construction Proximity: 0.5  
mTPZ (m): =TPZ

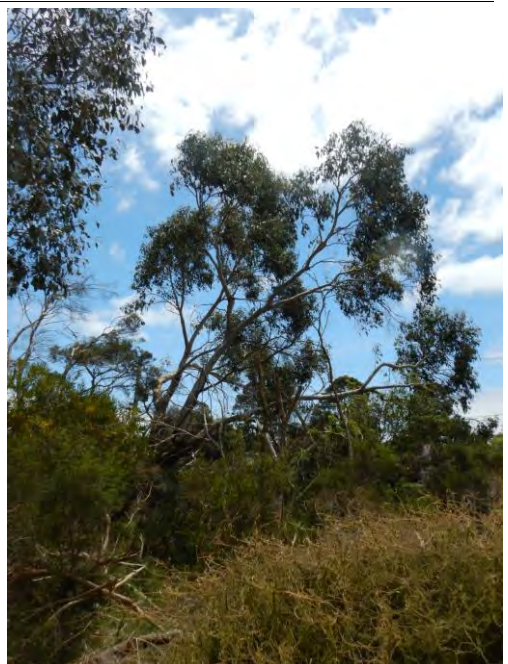
Tree ID: 48

Genus / species: *Acacia melanoxylon*

Works Required: J No works.

SRZ (m): 1.5 Works priority: N/A  
TPZ (m): 2.0 Construction Proximity: 0.7  
mTPZ (m): =TPZ

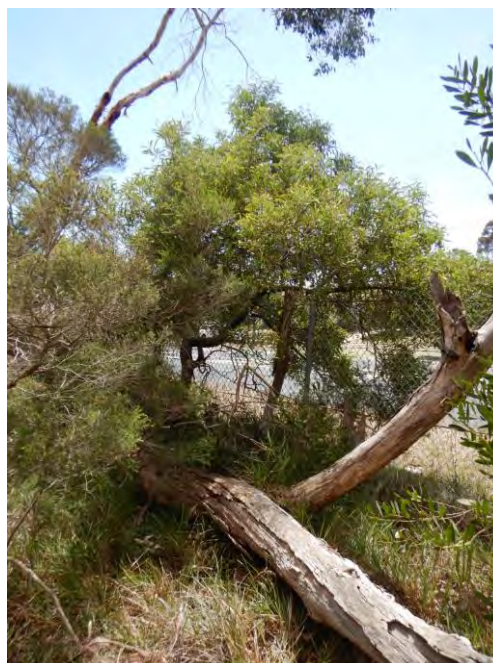
Tree ID: 49

Genus / species: *Acacia sophorae*

Works Required: J No works.

SRZ (m): 1.5 Works priority: N/A  
TPZ (m): 2.0 Construction Proximity: 0.8  
mTPZ (m): =TPZ

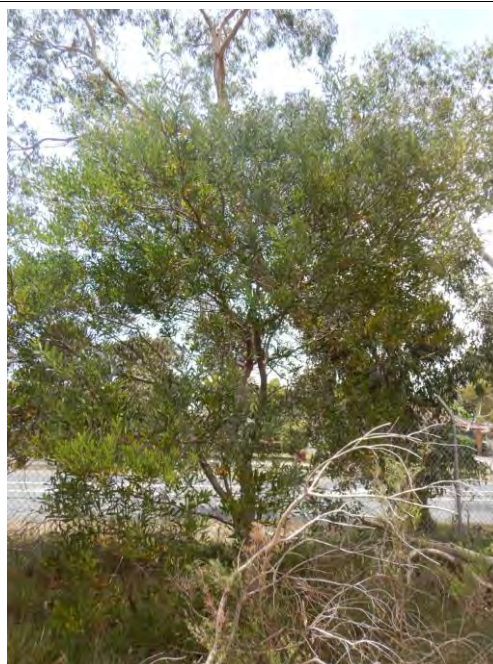
Tree ID: 50

Genus / species: *Eucalyptus ovata*

Works Required: J No works.

SRZ (m): 2.4 Works priority: N/A  
TPZ (m): 4.9 Construction Proximity: 0.1  
mTPZ (m): =TPZ

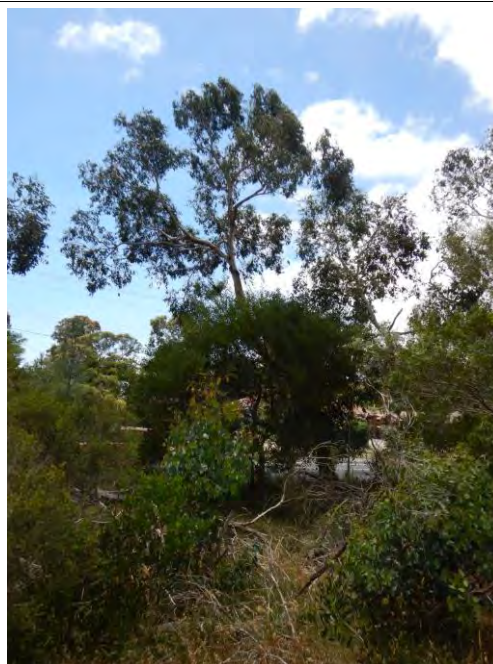
Tree ID: 51

Genus / species: *Acacia sophorae*

Height (m): 6 Structure: Poor  
Width (m): 4 Health: Fair  
DBH (cm): 14 Measured Maturity: Over mature  
Origin: Melbourne ULE (years): 5 - 15  
Retained?: Retained Form: Fair  
Retention Value: Low  
Removal / retention reason: N/A.  
Amenity value: Moderate  
Works Required: J No works.

SRZ (m): 1.5 Works priority: N/A  
TPZ (m): 2.0 Construction Proximity: 5.8  
mTPZ (m): =TPZ

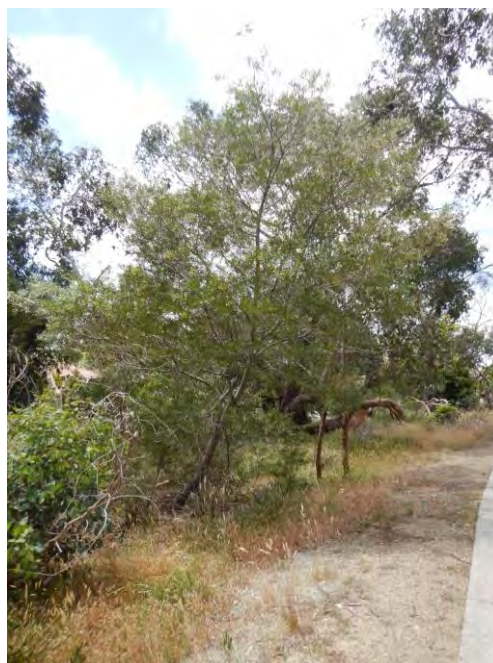
Tree ID: 52

Genus / species: *Eucalyptus ovata*

Height (m): 6 Structure: Fair  
Width (m): 2 Health: Good  
DBH (cm): 10 Measured Maturity: Immature  
Origin: Melbourne ULE (years): 30 - 60  
Retained?: Retained Form: Good  
Retention Value: Low  
Removal / retention reason: N/A.  
Amenity value: Low  
Works Required: J No works.

SRZ (m): 1.5 Works priority: N/A  
TPZ (m): 2.0 Construction Proximity: 6.7  
mTPZ (m): =TPZ

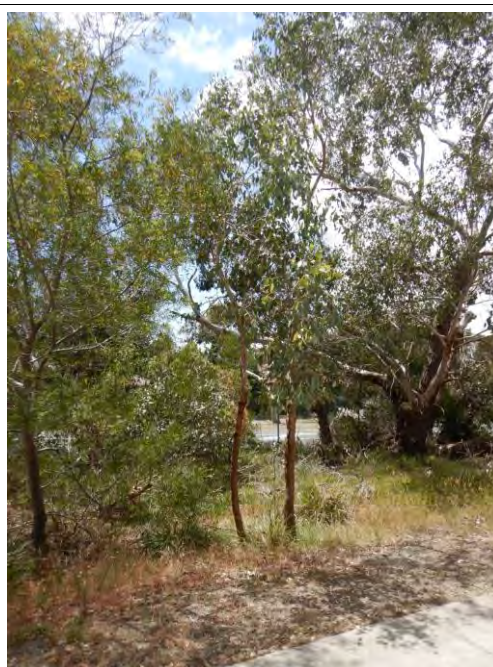
Tree ID: 53

Genus / species: *Eucalyptus ovata*

Height (m): 7 Structure: Fair  
Width (m): 2 Health: Good  
DBH (cm): 12 Measured Maturity: Immature  
Origin: Melbourne ULE (years): 30 - 60  
Retained?: Retained Form: Good  
Retention Value: Low  
Removal / retention reason: N/A.  
Amenity value: Low  
Works Required: J No works.

SRZ (m): 1.5 Works priority: N/A  
TPZ (m): 2.0 Construction Proximity: 6.7  
mTPZ (m): =TPZ

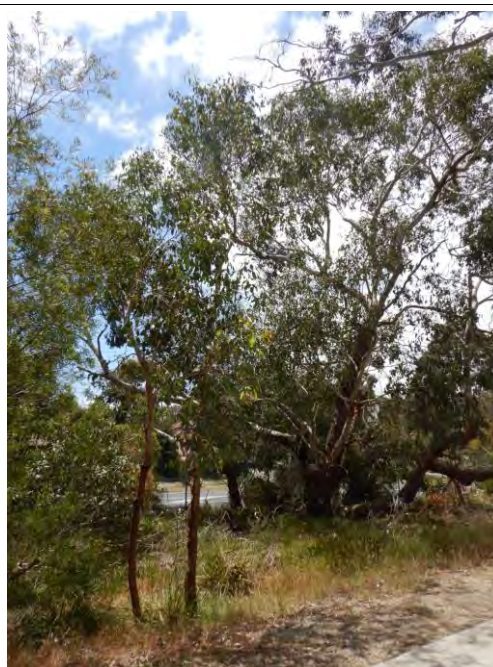
Tree ID: 54

Genus / species: *Eucalyptus ovata*

Height (m): 14 Structure: Fair  
Width (m): 16 Health: Good  
DBH (cm): 99 Measured Maturity: Over mature  
Origin: Melbourne ULE (years): 15 - 30  
Retained?: Removed Form: Good  
Retention Value: High  
Removal / retention reason: N/A.  
Amenity value: High  
Works Required: J No works.

SRZ (m): 3.3 Works priority: N/A  
TPZ (m): 11.9 Construction Proximity: 0.1  
mTPZ (m): =TPZ

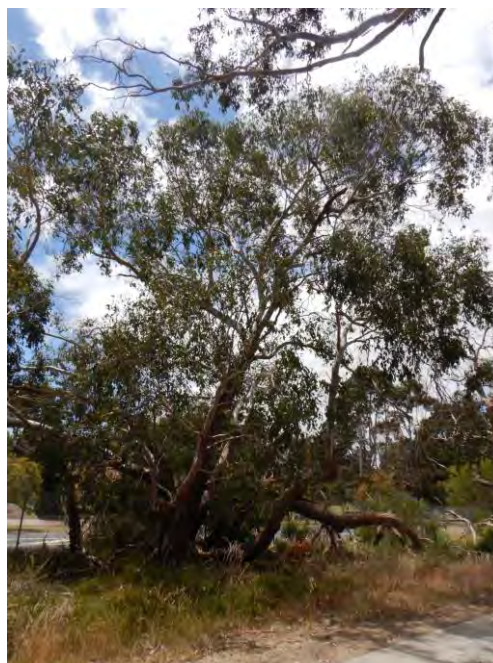
Tree ID: 55

Genus / species: *Eucalyptus ovata*

Height (m): 14 Structure: Poor  
Width (m): 12 Health: Dead  
DBH (cm): 85 Estimated Maturity: Over mature  
Origin: Melbourne ULE (years): 0  
Retained?: Removed Form: Very poor  
Retention Value: Remove.  
Removal / retention reason: Health ULE.  
Amenity value: Very low  
Works Required: B Removal.

SRZ (m): 3.1 Works priority: Very low  
TPZ (m): 10.2 Construction Proximity: 0.1  
mTPZ (m): =TPZ

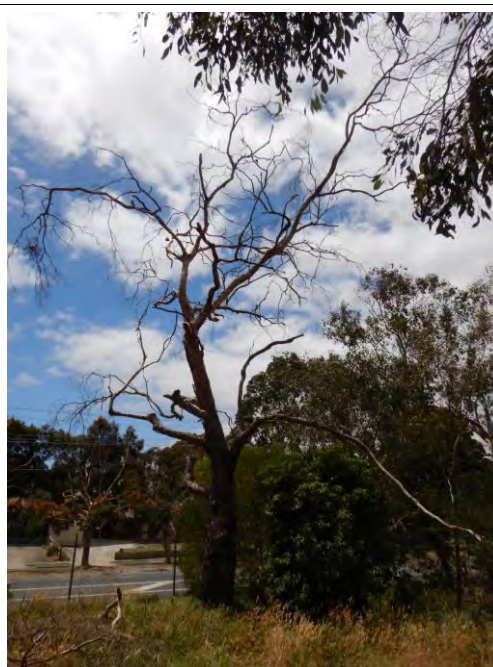
Tree ID: 56

Genus / species: *Pittosporum undulatum*

Height (m): 5 Structure: Good  
Width (m): 3 Health: Good  
DBH (cm): 10 Measured Maturity: Immature  
Origin: Victorian ULE (years): 15 - 30  
Retained?: Removed Form: Good  
Retention Value: Low  
Removal / retention reason: N/A.  
Amenity value: Low  
Works Required: J No works.

SRZ (m): 1.5 Works priority: N/A  
TPZ (m): 2.0 Construction Proximity: 2.2  
mTPZ (m): =TPZ

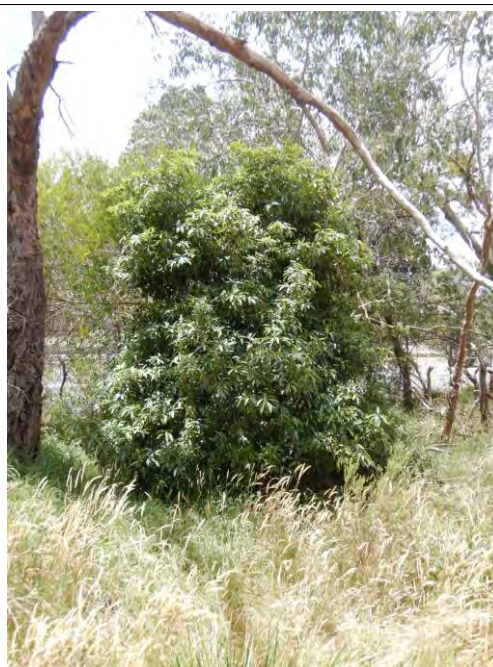
Tree ID: 57

Genus / species: *Acacia sophorae*

Height (m): 4 Structure: Fair  
Width (m): 5 Health: Poor  
DBH (cm): 16 Measured Maturity: Over mature  
Origin: Melbourne ULE (years): 5 - 15  
Retained?: Removed Form: Fair  
Retention Value: Low  
Removal / retention reason: N/A.  
Amenity value: Low  
Works Required: J No works.

SRZ (m): 1.5 Works priority: N/A  
TPZ (m): 2.0 Construction Proximity: 0.1  
mTPZ (m): =TPZ

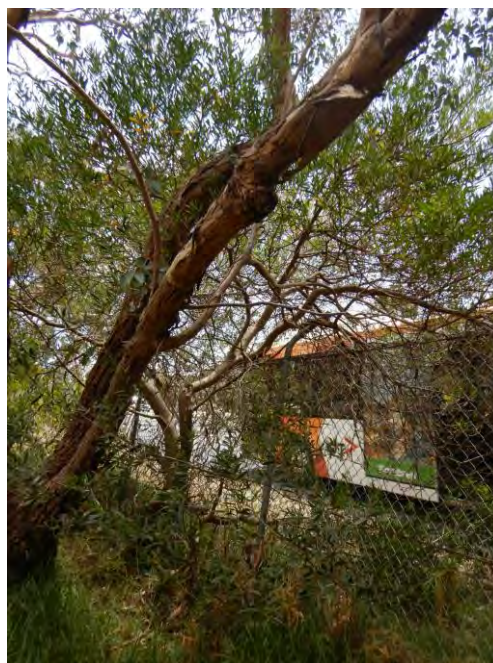
Tree ID: 58

Genus / species: *Eucalyptus ovata*

Height (m): 10 Structure: Poor  
Width (m): 7 Health: Poor  
DBH (cm): 49 Measured Maturity: Over mature  
Origin: Melbourne ULE (years): 5 - 15  
Retained?: Removed Form: Fair  
Retention Value: Low  
Removal / retention reason: N/A.  
Amenity value: Low  
Works Required: J No works.

SRZ (m): 2.6 Works priority: N/A  
TPZ (m): 5.9 Construction Proximity: 0.1  
mTPZ (m): =TPZ

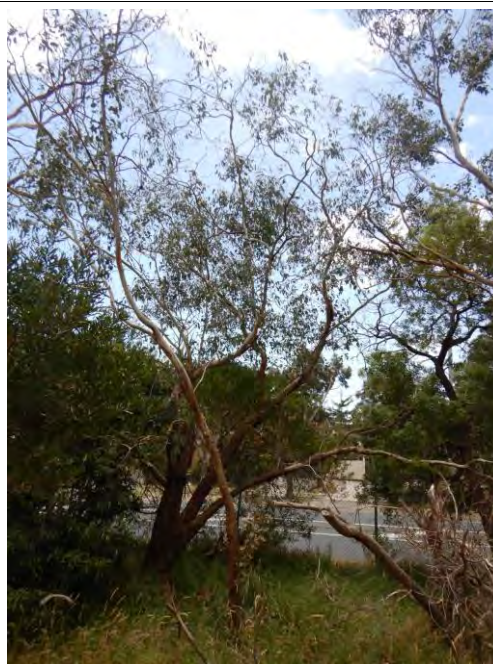
Tree ID: 59

Genus / species: *Eucalyptus ovata*

Height (m): 7 Structure: Fair  
Width (m): 2 Health: Poor  
DBH (cm): 14 Measured Maturity: Immature  
Origin: Melbourne ULE (years): 5 - 15  
Retained?: Removed Form: Fair  
Retention Value: Low  
Removal / retention reason: N/A.  
Amenity value: Low  
Works Required: J No works.

SRZ (m): 1.5 Works priority: N/A  
TPZ (m): 2.0 Construction Proximity: 0.9  
mTPZ (m): =TPZ

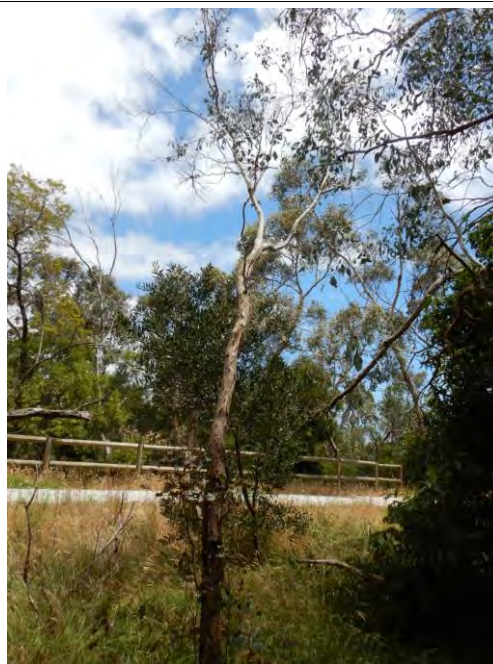
Tree ID: 60

Genus / species: *Acacia melanoxylon*

Height (m): 7 Structure: Fair  
Width (m): 3 Health: Poor  
DBH (cm): 19 Measured Maturity: Immature  
Origin: Melbourne ULE (years): 5 - 15  
Retained?: Removed Form: Fair  
Retention Value: Low  
Removal / retention reason: N/A.  
Amenity value: Low  
Works Required: J No works.

SRZ (m): 1.5 Works priority: N/A  
TPZ (m): 2.3 Construction Proximity: 0.1  
mTPZ (m): =TPZ

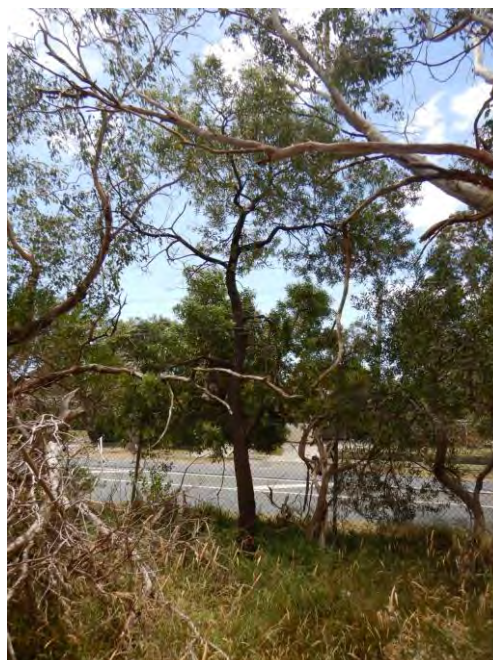
Tree ID: 61

Genus / species: *Eucalyptus ovata*

Height (m): 9 Structure: Fair  
Width (m): 3 Health: Fair  
DBH (cm): 14 Measured Maturity: Immature  
Origin: Melbourne ULE (years): 15 - 30  
Retained?: Removed Form: Fair  
Retention Value: Low  
Removal / retention reason: N/A.  
Amenity value: Low  
Works Required: J No works.

SRZ (m): 1.5 Works priority: N/A  
TPZ (m): 2.0 Construction Proximity: 1.4  
mTPZ (m): =TPZ

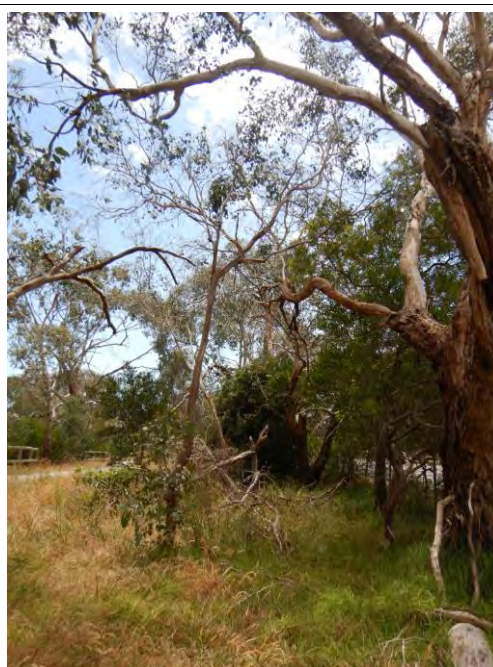
Tree ID: 62

Genus / species: *Eucalyptus ovata*

Height (m): 12 Structure: Poor  
Width (m): 9 Health: Poor  
DBH (cm): 71 Measured Maturity: Over mature  
Origin: Melbourne ULE (years): 5 - 15  
Retained?: Removed Form: Fair  
Retention Value: Low  
Removal / retention reason: N/A.  
Amenity value: Moderate  
Works Required: J No works.

SRZ (m): 2.9 Works priority: N/A  
TPZ (m): 8.5 Construction Proximity: 0.1  
mTPZ (m): =TPZ

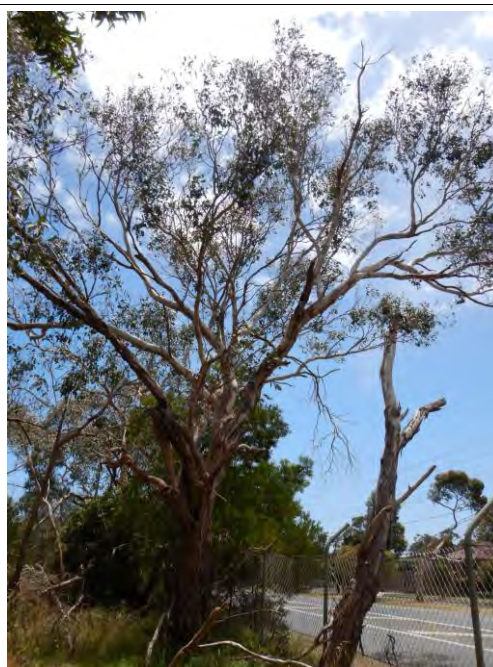
Tree ID: 63

Genus / species: *Eucalyptus ovata*

Height (m): 16 Structure: Fair  
Width (m): 13 Health: Good  
DBH (cm): 85 Measured Maturity: Over mature  
Origin: Melbourne ULE (years): 15 - 30  
Retained?: Retained Form: Good  
Retention Value: High  
Removal / retention reason: N/A.  
Amenity value: High  
Works Required: J No works.

SRZ (m): 3.1 Works priority: N/A  
TPZ (m): 10.2 Construction Proximity: 6.1  
mTPZ (m): =TPZ

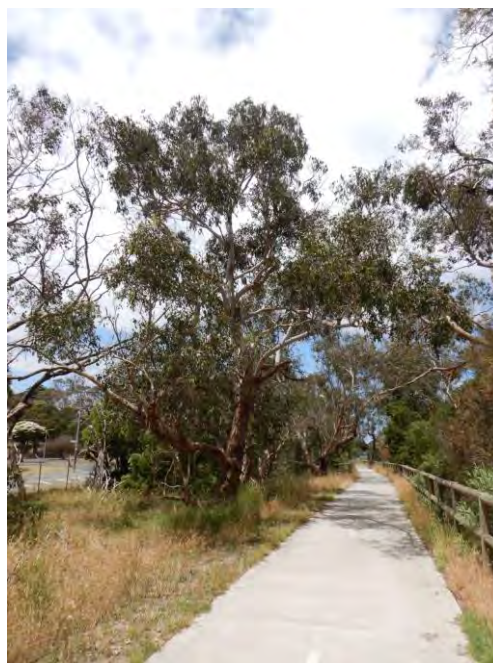
Tree ID: 64

Genus / species: *Acacia melanoxylon*

Height (m): 6 Structure: Good  
Width (m): 2 Health: Good  
DBH (cm): 9 Measured Maturity: Immature  
Origin: Melbourne ULE (years): 15 - 30  
Retained?: Retained Form: Good  
Retention Value: Low  
Removal / retention reason: N/A.  
Amenity value: Low  
Works Required: J No works.

SRZ (m): 1.5 Works priority: N/A  
TPZ (m): 2.0 Construction Proximity: 2.8  
mTPZ (m): =TPZ

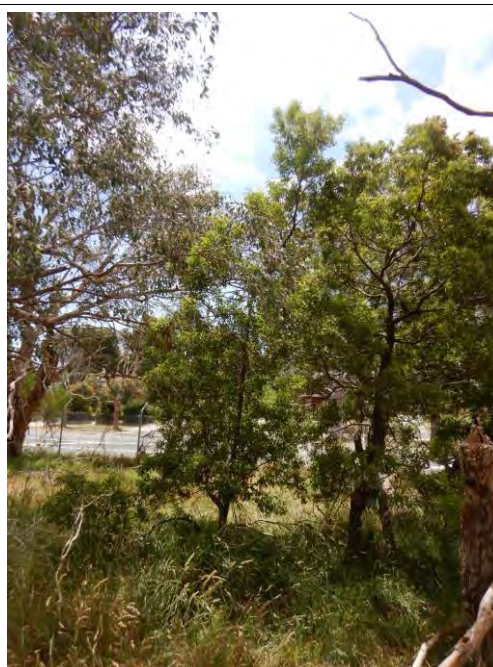
Tree ID: 65

Genus / species: *Acacia melanoxylon*

Height (m): 6 Structure: Poor  
Width (m): 3 Health: Fair  
DBH (cm): 19 Measured Maturity: Immature  
Origin: Melbourne ULE (years): 5 - 15  
Retained?: Retained Form: Fair  
Retention Value: Low  
Removal / retention reason: N/A.  
Amenity value: Low  
Works Required: J No works.

SRZ (m): 1.5 Works priority: N/A  
TPZ (m): 2.3 Construction Proximity: 2.4  
mTPZ (m): =TPZ

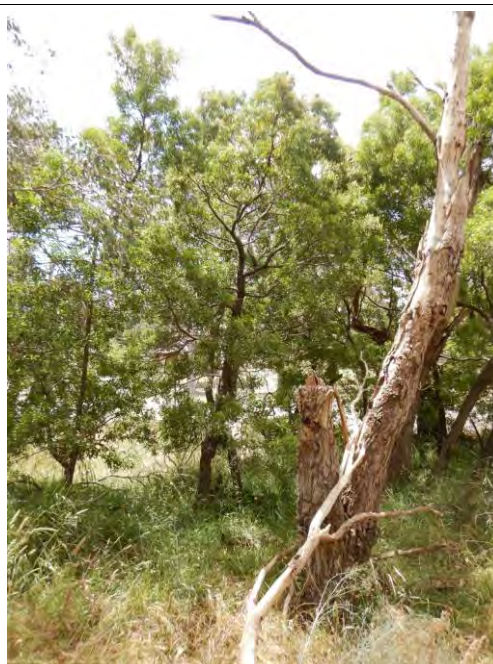
Tree ID: 66

Genus / species: *Acacia melanoxylon*

Height (m): 5 Structure: Good  
Width (m): 2 Health: Fair  
DBH (cm): 15 Measured Maturity: Immature  
Origin: Melbourne ULE (years): 15 - 30  
Retained?: Removed Form: Good  
Retention Value: Low  
Removal / retention reason: N/A.  
Amenity value: Low  
Works Required: J No works.

SRZ (m): 1.5 Works priority: N/A  
TPZ (m): 2.0 Construction Proximity: 1.8  
mTPZ (m): =TPZ

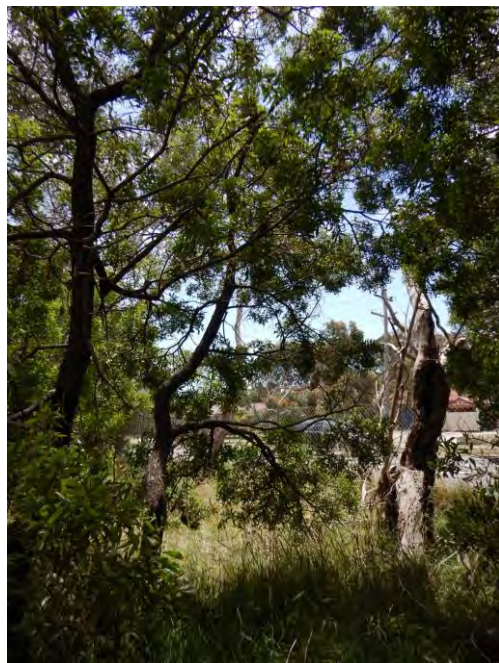
Tree ID: 67

Genus / species: *Eucalyptus ovata*

Height (m): 6 Structure: Poor  
Width (m): 4 Health: Poor  
DBH (cm): 30 Measured Maturity: Mature  
Origin: Melbourne ULE (years): 1 - 5  
Retained?: Removed Form: Poor  
Retention Value: Remove.  
Removal / retention reason: Health ULE.  
Amenity value: Low  
Works Required: B Removal.

SRZ (m): 2 Works priority: Very low  
TPZ (m): 3.6 Construction Proximity: 0.1  
mTPZ (m): =TPZ

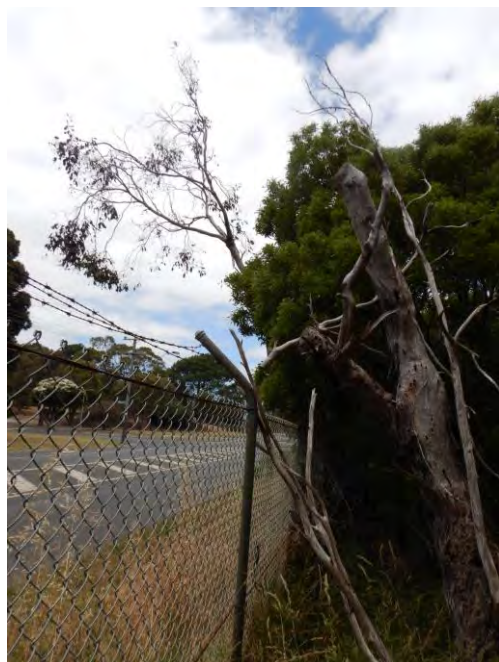
Tree ID: 68

Genus / species: *Acacia melanoxylon*

Height (m): 5 Structure: Good  
Width (m): 1 Health: Good  
DBH (cm): 10 Measured Maturity: Immature  
Origin: Melbourne ULE (years): 15 - 30  
Retained?: Removed Form: Good  
Retention Value: Low  
Removal / retention reason: N/A.  
Amenity value: Low  
Works Required: J No works.

SRZ (m): 1.5 Works priority: N/A  
TPZ (m): 2.0 Construction Proximity: 0.1  
mTPZ (m): =TPZ

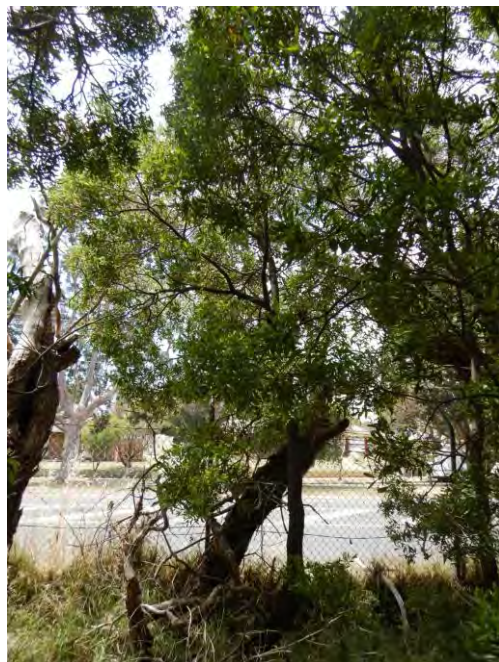
Tree ID: 69

Genus / species: *Acacia melanoxylon*

Height (m): 5 Structure: Good  
Width (m): 1 Health: Good  
DBH (cm): 8 Measured Maturity: Immature  
Origin: Melbourne ULE (years): 15 - 30  
Retained?: Removed Form: Good  
Retention Value: Low  
Removal / retention reason: N/A.  
Amenity value: Low  
Works Required: J No works.

SRZ (m): 1.5 Works priority: N/A  
TPZ (m): 2.0 Construction Proximity: 0.1  
mTPZ (m): =TPZ

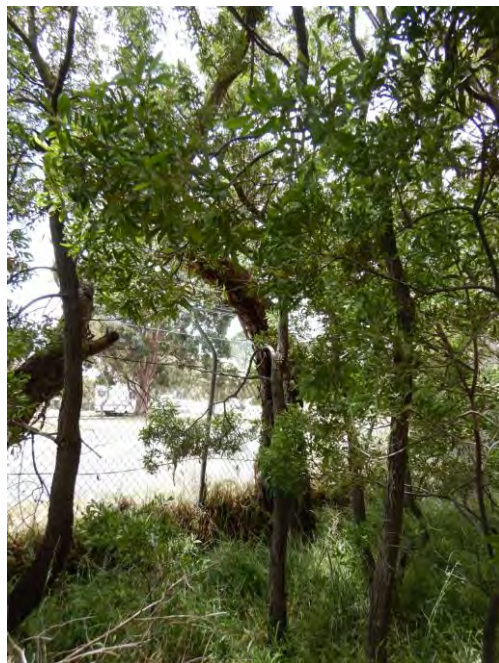
Tree ID: 70

Genus / species: *Acacia melanoxylon*

Height (m): 5 Structure: Good  
Width (m): 1 Health: Good  
DBH (cm): 8 Measured Maturity: Immature  
Origin: Melbourne ULE (years): 15 - 30  
Retained?: Removed Form: Good  
Retention Value: Low  
Removal / retention reason: N/A.  
Amenity value: Low  
Works Required: J No works.

SRZ (m): 1.5 Works priority: N/A  
TPZ (m): 2.0 Construction Proximity: 0.1  
mTPZ (m): =TPZ

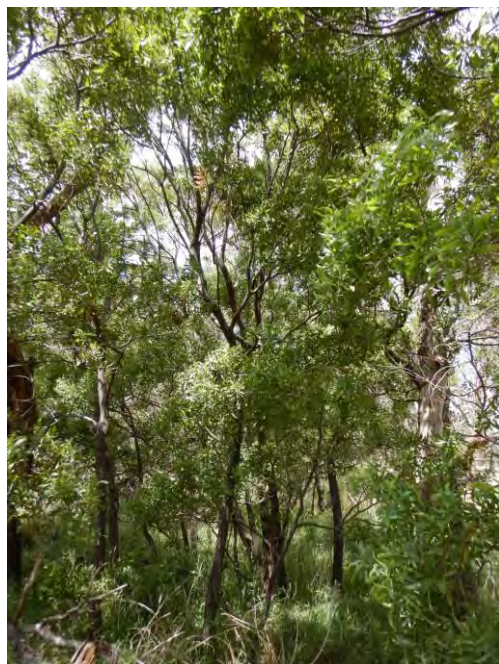
Tree ID: 71

Genus / species: *Acacia melanoxylon*

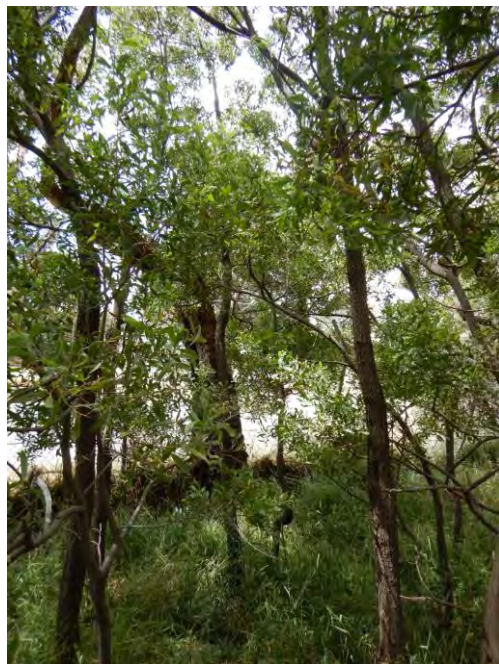
Height (m): 5 Structure: Poor  
Width (m): 1 Health: Good  
DBH (cm): 9 Measured Maturity: Immature  
Origin: Melbourne ULE (years): 5 - 15  
Retained?: Removed Form: Fair  
Retention Value: Low  
Removal / retention reason: N/A.  
Amenity value: Low  
Works Required: J No works.

SRZ (m): 1.5 Works priority: N/A  
TPZ (m): 2.0 Construction Proximity: 0.1  
mTPZ (m): =TPZ

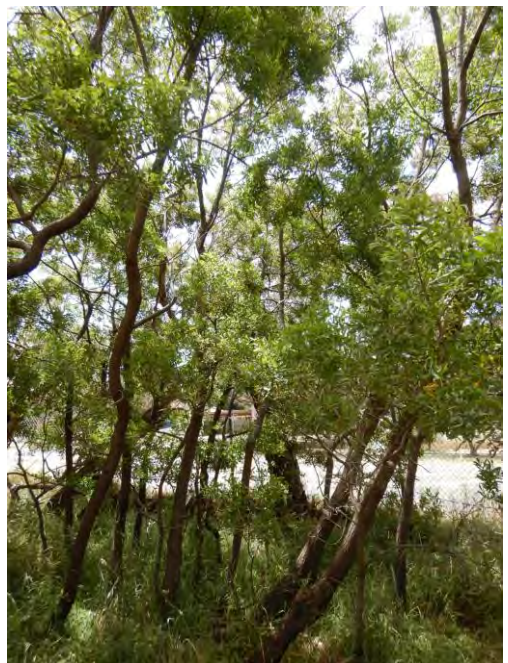
Tree ID: 72

Height (m): 6 Structure: Poor  
Width (m): 2 Health: Good  
DBH (cm): 12 Measured Maturity: Immature  
Origin: Melbourne ULE (years): 5 - 15  
Retained?: Removed Form: Fair  
Retention Value: Low  
Removal / retention reason: N/A.  
Amenity value: Low  
Works Required: J No works.

SRZ (m): 1.5 Works priority: N/A  
TPZ (m): 2.0 Construction Proximity: 0.1  
mTPZ (m): =TPZ

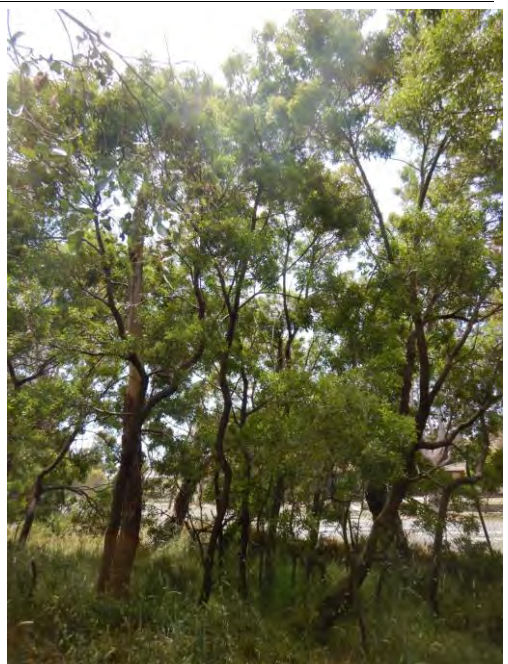
Tree ID: 73

Height (m): 7 Structure: Fair  
Width (m): 2 Health: Good  
DBH (cm): 12 Measured Maturity: Immature  
Origin: Melbourne ULE (years): 15 - 30  
Retained?: Retained Form: Fair  
Retention Value: Low  
Removal / retention reason: N/A.  
Amenity value: Low  
Works Required: J No works.

SRZ (m): 1.5 Works priority: N/A  
TPZ (m): 2.0 Construction Proximity: 1.1  
mTPZ (m): =TPZ

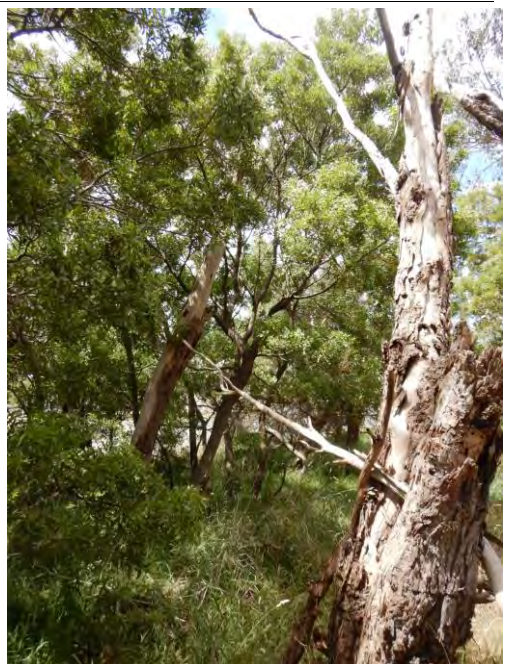
Tree ID: 74

Height (m): 6 Structure: Fair  
Width (m): 2 Health: Good  
DBH (cm): 18 Measured Maturity: Immature  
Origin: Melbourne ULE (years): 15 - 30  
Retained?: Retained Form: Fair  
Retention Value: Low  
Removal / retention reason: N/A.  
Amenity value: Low  
Works Required: J No works.

SRZ (m): 1.5 Works priority: N/A  
TPZ (m): 2.2 Construction Proximity: 1.6  
mTPZ (m): =TPZ

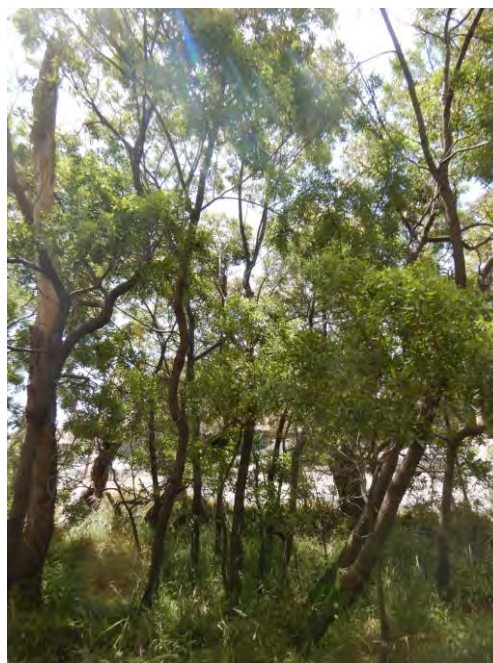
Tree ID: 75

Height (m): 7 Structure: Fair  
Width (m): 2 Health: Good  
DBH (cm): 10 Measured Maturity: Immature  
Origin: Melbourne ULE (years): 15 - 30  
Retained?: Retained Form: Fair  
Retention Value: Low  
Removal / retention reason: N/A.  
Amenity value: Low  
Works Required: J No works.

SRZ (m): 1.5 Works priority: N/A  
TPZ (m): 2.0 Construction Proximity: 1.1  
mTPZ (m): =TPZ

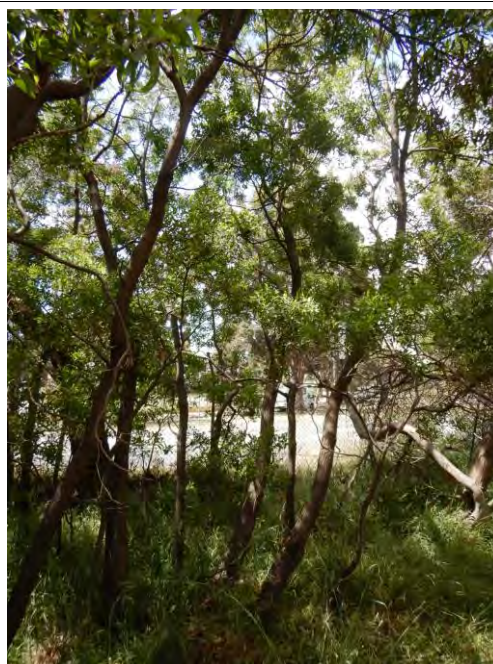
Tree ID: 76

Height (m): 6 Structure: Fair  
Width (m): 2 Health: Good  
DBH (cm): 14 Measured Maturity: Immature  
Origin: Melbourne ULE (years): 15 - 30  
Retained?: Retained Form: Fair  
Retention Value: Low  
Removal / retention reason: N/A.  
Amenity value: Low  
Works Required: J No works.

SRZ (m): 1.5 Works priority: N/A  
TPZ (m): 2.0 Construction Proximity: 1.7  
mTPZ (m): =TPZ

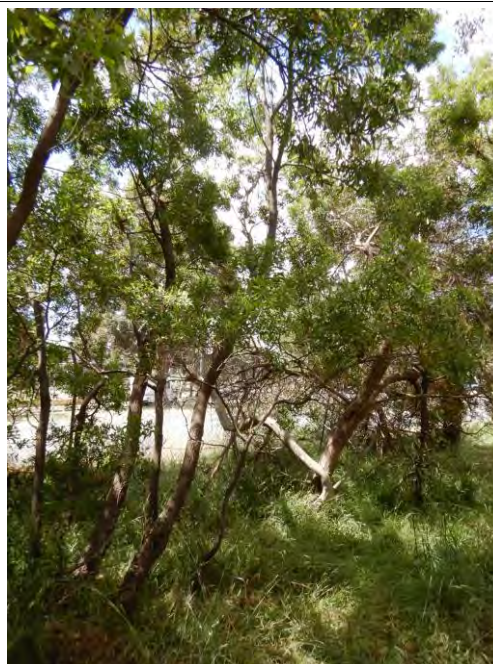
Tree ID: 77

Height (m): 6 Structure: Fair  
Width (m): 3 Health: Good  
DBH (cm): 14 Measured Maturity: Immature  
Origin: Melbourne ULE (years): 15 - 30  
Retained?: Retained Form: Fair  
Retention Value: Low  
Removal / retention reason: N/A.  
Amenity value: Low  
Works Required: J No works.

SRZ (m): 1.5 Works priority: N/A  
TPZ (m): 2.0 Construction Proximity: 0.1  
mTPZ (m): =TPZ
