# Ballarto Road and Lyrebird Drive intersection upgrade: Flora and fauna assessment

FINAL REPORT

Prepared for Department of Transport

19 July 2022

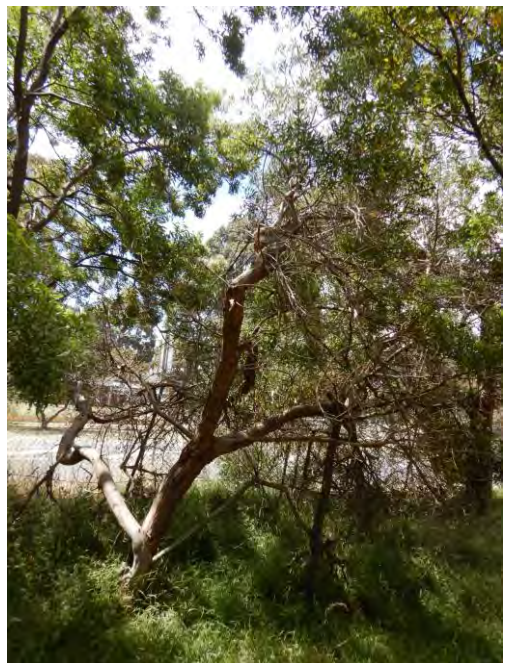
Tree ID: 78

Height (m): 5 Structure: Poor  
Width (m): 4 Health: Poor  
DBH (cm): 23 Measured Maturity: Over mature  
Origin: Melbourne ULE (years): 1 - 5  
Retained?: Removed Form: Fair  
Retention Value: Remove.  
Removal / retention reason: Health ULE.  
Amenity value: Low  
Works Required: B Removal.

SRZ (m): 1.7 Works priority: Very low  
TPZ (m): 2.8 Construction Proximity: 0.1  
mTPZ (m): =TPZ

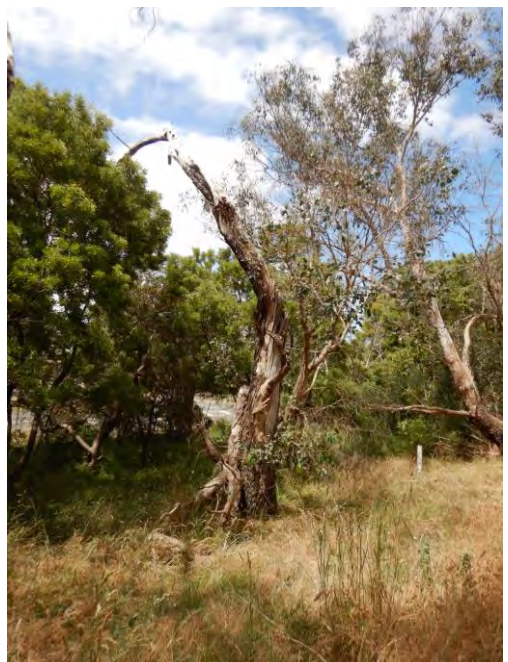
Tree ID: 79

Height (m): 8 Structure: Very poor  
Width (m): 7 Health: Very poor  
DBH (cm): 80 Estimated Maturity: Over mature  
Origin: Melbourne ULE (years): 0  
Retained?: Retained Form: Very poor  
Retention Value: Remove.  
Removal / retention reason: Health ULE.  
Amenity value: Very low  
Works Required: B Removal.

SRZ (m): 3 Works priority: Very low  
TPZ (m): 9.6 Construction Proximity: 4.4  
mTPZ (m): =TPZ

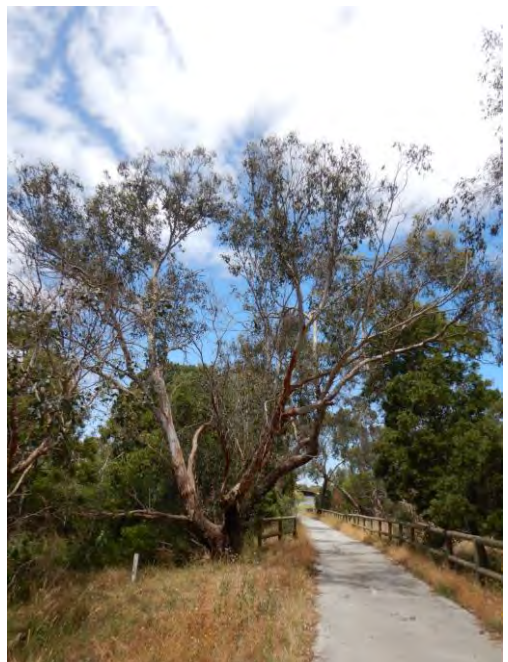
Tree ID: 80

Height (m): 14 Structure: Poor  
Width (m): 13 Health: Fair  
DBH (cm): 71 Measured Maturity: Over mature  
Origin: Melbourne ULE (years): 15 - 30  
Retained?: Retained Form: Fair  
Retention Value: Low  
Removal / retention reason: N/A.  
Amenity value: Moderate  
Works Required: J No works.

SRZ (m): 2.9 Works priority: N/A  
TPZ (m): 8.5 Construction Proximity: 9  
mTPZ (m): =TPZ

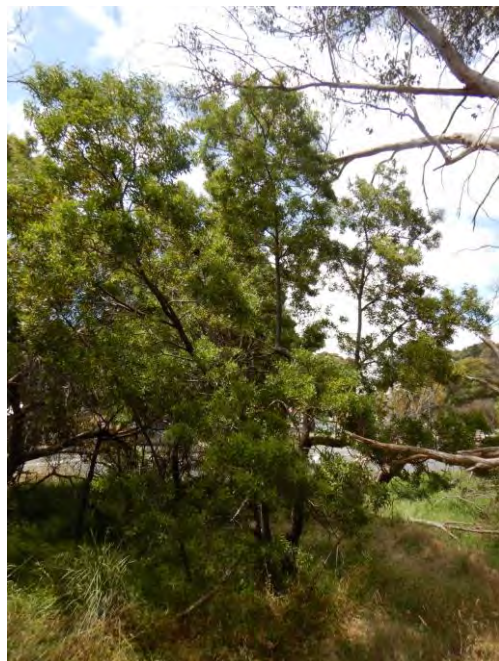
Tree ID: 81

Works Required: J No works.

SRZ (m): 1.7 Works priority: N/A  
TPZ (m): 2.8 Construction Proximity: 2.7  
mTPZ (m): =TPZ

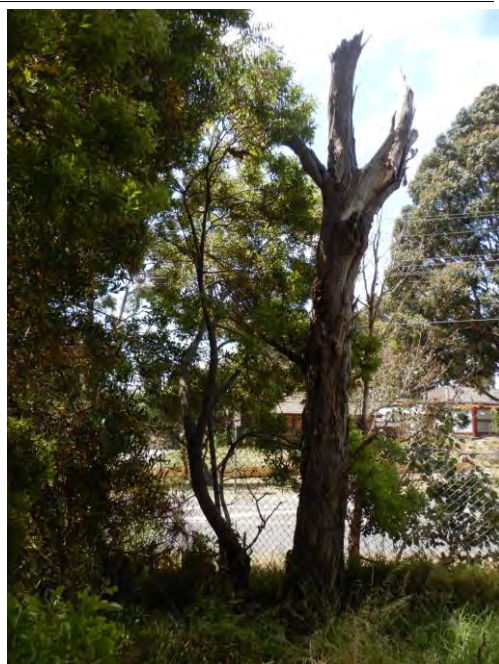
Tree ID: 82

Works Required: J No works.

SRZ (m): 1.5 Works priority: N/A  
TPZ (m): 2.0 Construction Proximity: 0.1  
mTPZ (m): =TPZ

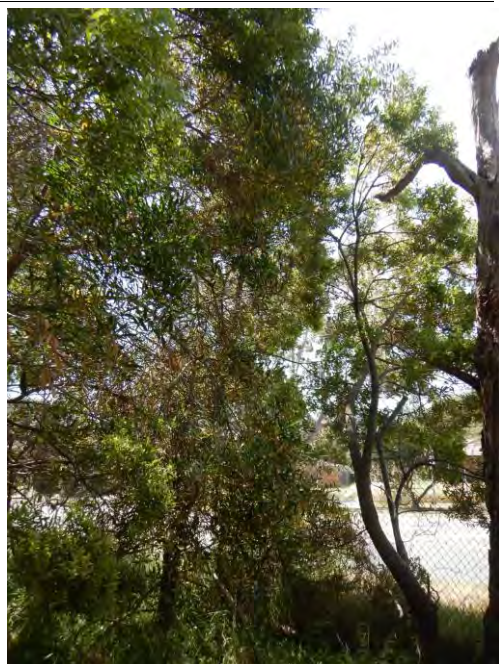
Tree ID: 83

Works Required: J No works.

SRZ (m): 1.5 Works priority: N/A  
TPZ (m): 2.0 Construction Proximity: 0.1  
mTPZ (m): =TPZ

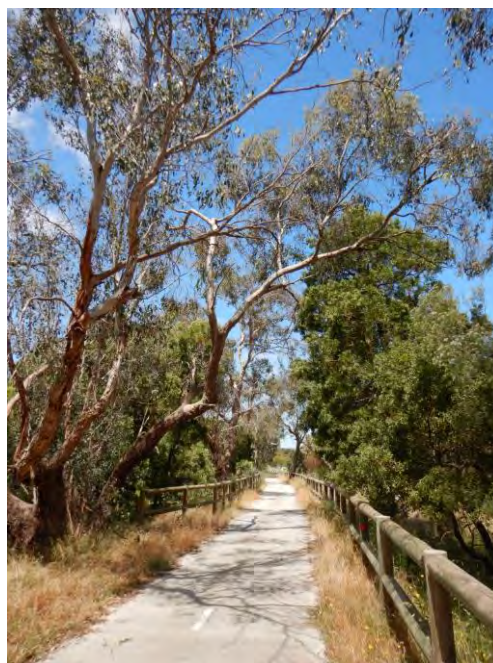
Tree ID: 84

Height (m): 12 Structure: Poor  
Width (m): 11 Health: Poor  
DBH (cm): 58 Measured Maturity: Over mature  
Origin: Melbourne ULE (years): 5 - 15  
Retained?: Retained Form: Fair  
Retention Value: Low  
Removal / retention reason: N/A.  
Amenity value: Moderate  
Works Required: J No works.

SRZ (m): 2.7 Works priority: N/A  
TPZ (m): 7.0 Construction Proximity: 8.6  
mTPZ (m): =TPZ

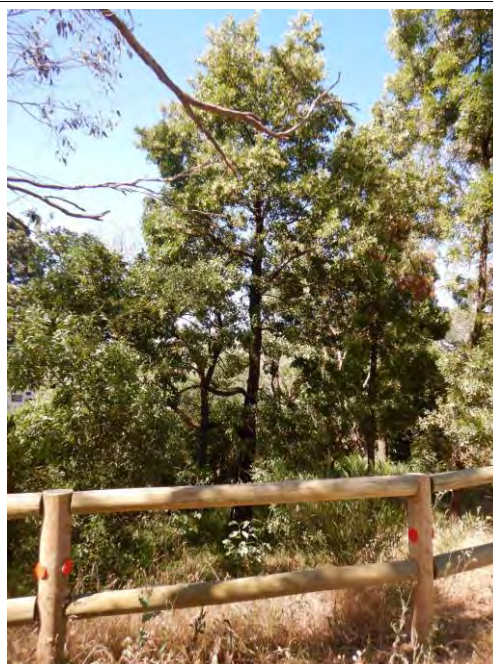
Tree ID: 85

Height (m): 10 Structure: Fair  
Width (m): 4 Health: Good  
DBH (cm): 30 Measured Maturity: Mature  
Origin: Melbourne ULE (years): 15 - 30  
Retained?: Retained Form: Good  
Retention Value: Low  
Removal / retention reason: N/A.  
Amenity value: Low  
Works Required: J No works.

SRZ (m): 2 Works priority: N/A  
TPZ (m): 3.6 Construction Proximity: 4.4  
mTPZ (m): =TPZ

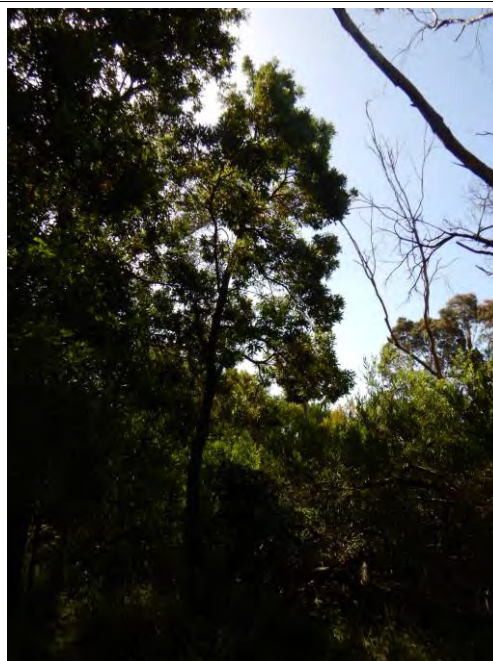
Tree ID: 86

Height (m): 9 Structure: Fair  
Width (m): 3 Health: Good  
DBH (cm): 16 Measured Maturity: Mature  
Origin: Melbourne ULE (years): 15 - 30  
Retained?: Retained Form: Fair  
Retention Value: Low  
Removal / retention reason: N/A.  
Amenity value: Low  
Works Required: J No works.

SRZ (m): 1.5 Works priority: N/A  
TPZ (m): 2.0 Construction Proximity: 3.2  
mTPZ (m): =TPZ

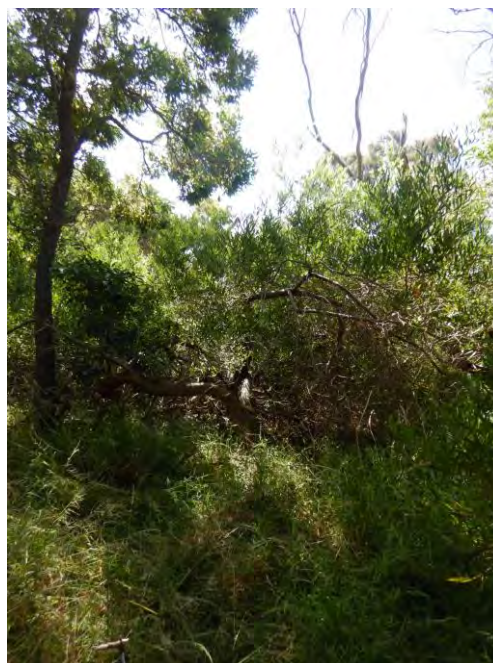
Tree ID: 87

Height (m): 4 Structure: Poor  
Width (m): 6 Health: Fair  
DBH (cm): 20 Measured Maturity: Over mature  
Origin: Melbourne ULE (years): 1 - 5  
Retained?: Removed Form: Poor  
Retention Value: Remove.  
Removal / retention reason: Health ULE.  
Amenity value: Low  
Works Required: B Removal.

SRZ (m): 1.6 Works priority: Very low  
TPZ (m): 2.4 Construction Proximity: 1  
mTPZ (m): =TPZ

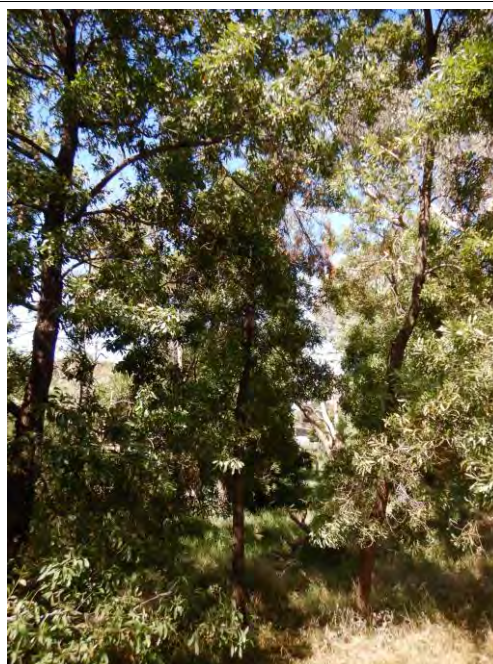
Tree ID: 88

Height (m): 8 Structure: Good  
Width (m): 2 Health: Good  
DBH (cm): 16 Measured Maturity: Mature  
Origin: Melbourne ULE (years): 15 - 30  
Retained?: Retained Form: Good  
Retention Value: Low  
Removal / retention reason: N/A.  
Amenity value: Low  
Works Required: J No works.

SRZ (m): 1.5 Works priority: N/A  
TPZ (m): 2.0 Construction Proximity: 5  
mTPZ (m): =TPZ

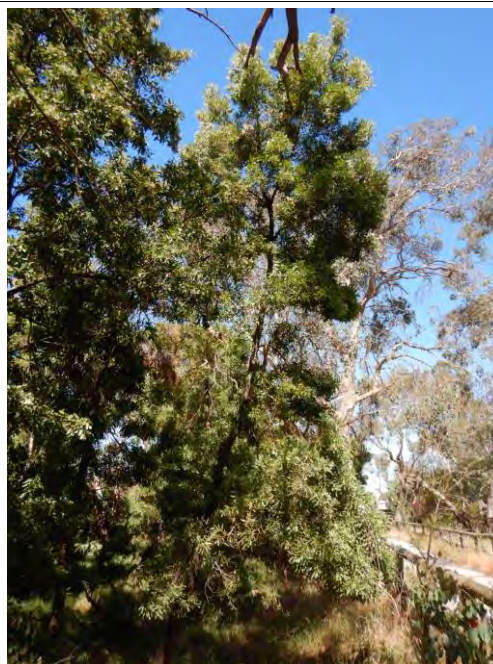
Tree ID: 89

Height (m): 10 Structure: Fair  
Width (m): 3 Health: Good  
DBH (cm): 17 Measured Maturity: Mature  
Origin: Melbourne ULE (years): 5 - 15  
Retained?: Retained Form: Fair  
Retention Value: Low  
Removal / retention reason: N/A.  
Amenity value: Low  
Works Required: J No works.

SRZ (m): 1.5 Works priority: N/A  
TPZ (m): 2.0 Construction Proximity: 7  
mTPZ (m): =TPZ

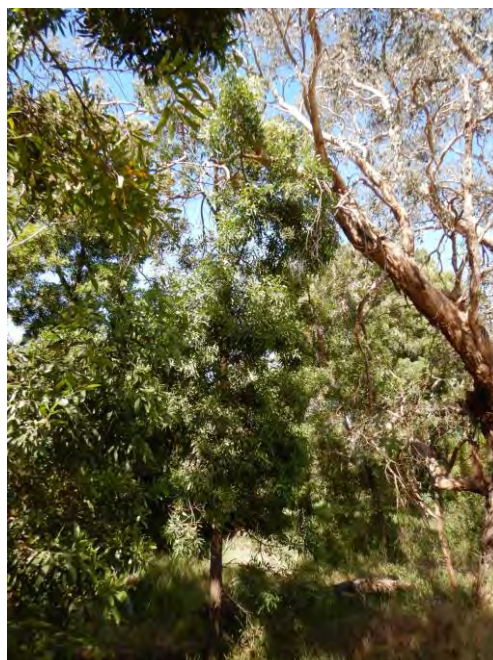
Tree ID: 90

TPZ (m): 2.0 Construction Proximity: 7

mTPZ (m): =TPZ

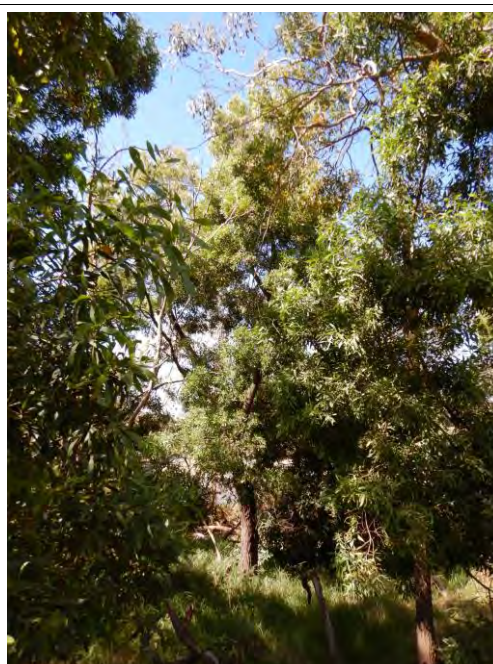
Tree ID: 91

TPZ (m): 3.6 Construction Proximity: 1.3

mTPZ (m): =TPZ

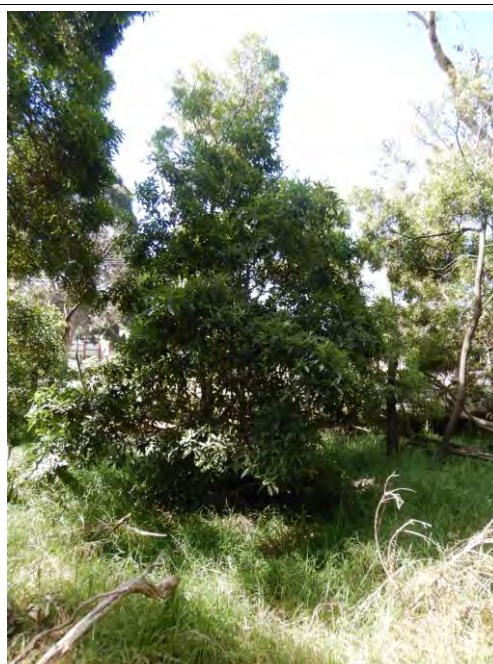
Tree ID: 92

TPZ (m): 2.0 Construction Proximity: 1

mTPZ (m): =TPZ

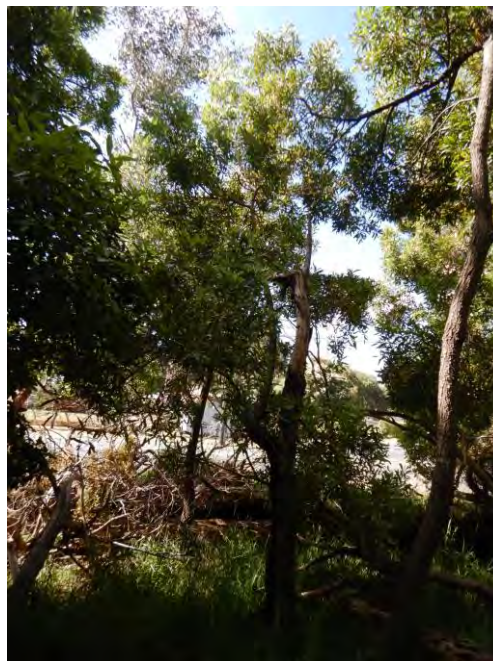
Tree ID: 93

Works Required: J No works.

SRZ (m): 1.5 Works priority: N/A  
TPZ (m): 2.0 Construction Proximity: 0.1  
mTPZ (m): =TPZ

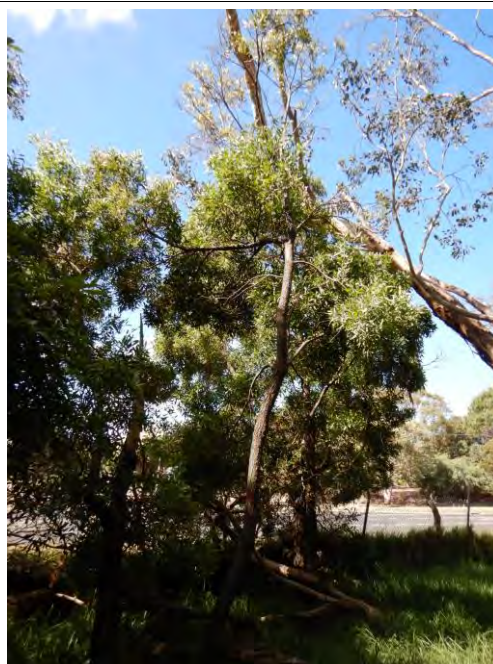
Tree ID: 94

Works Required: J No works.

SRZ (m): 1.5 Works priority: N/A  
TPZ (m): 2.0 Construction Proximity: 0.1  
mTPZ (m): =TPZ

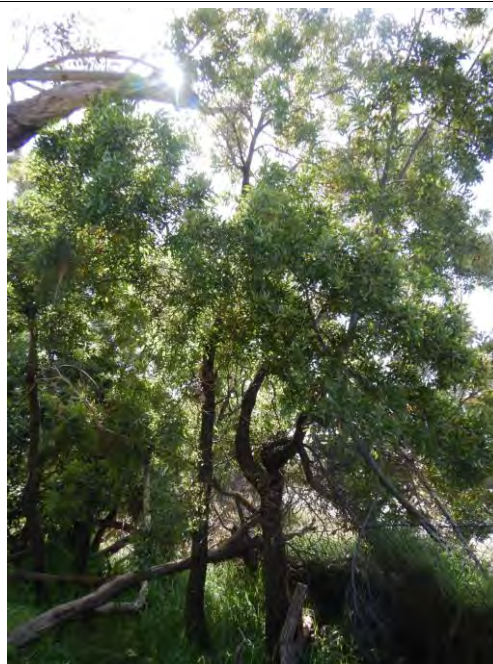
Tree ID: 95

Works Required: J No works.

SRZ (m): 1.5 Works priority: N/A  
TPZ (m): 2.0 Construction Proximity: 0.1  
mTPZ (m): =TPZ

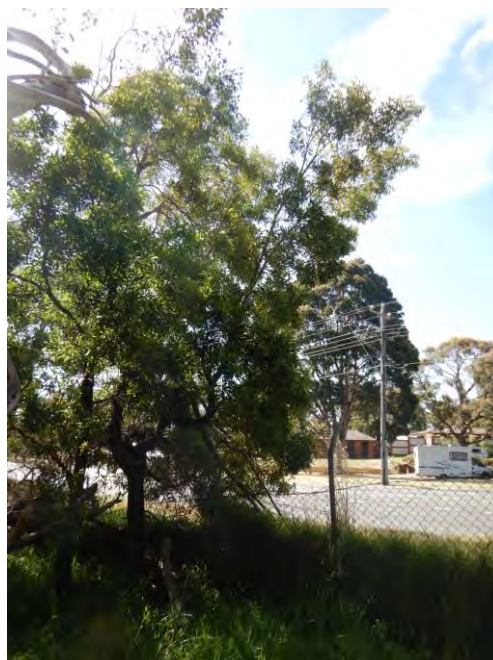
Tree ID: 96

Works Required: J No works.

SRZ (m): 1.5 Works priority: N/A  
TPZ (m): 2.2 Construction Proximity: 0.1  
mTPZ (m): =TPZ

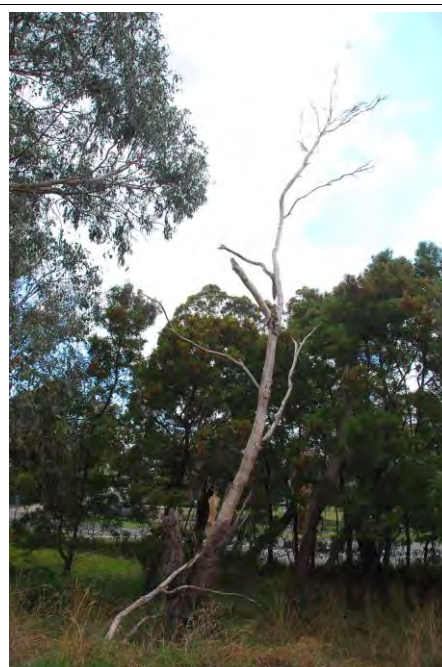
Tree ID: 97

Works Required: B Removal.

SRZ (m): 2.4 Works priority: Very low  
TPZ (m): 4.8 Construction Proximity: 0.1  
mTPZ (m): =TPZ

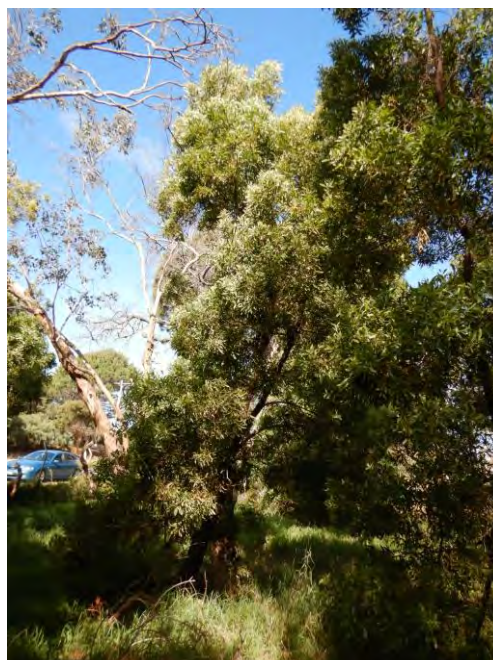
Tree ID: 98

Works Required: J No works.

SRZ (m): 1.8 Works priority: N/A  
TPZ (m): 3.0 Construction Proximity: 3.6  
mTPZ (m): =TPZ

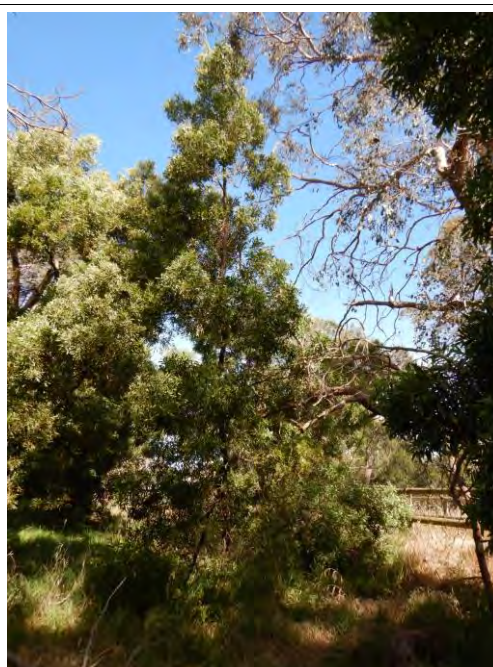
Tree ID: 100

Works Required: J No works.

SRZ (m): 1.5 Works priority: N/A  
TPZ (m): 2.0 Construction Proximity: 6  
mTPZ (m): =TPZ

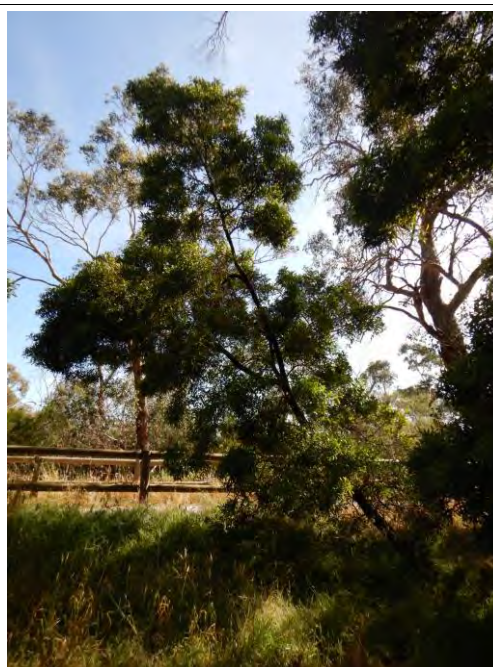
Tree ID: 101

Works Required: J No works.

SRZ (m): 1.5 Works priority: N/A  
TPZ (m): 2.0 Construction Proximity: 8  
mTPZ (m): =TPZ

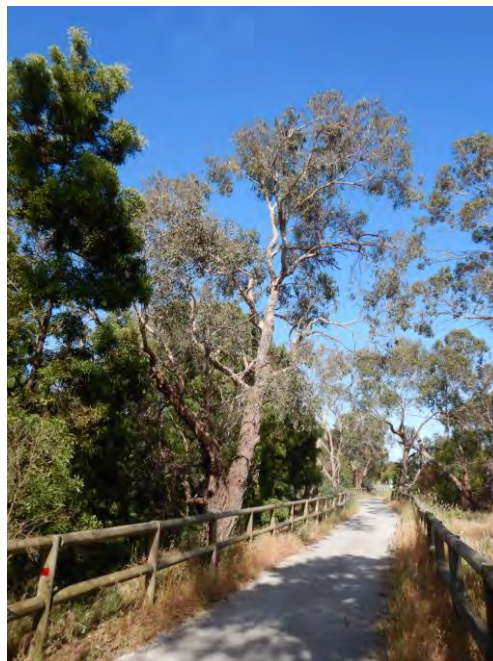
Tree ID: 102

Height (m): 15 Structure: Fair  
Width (m): 13 Health: Fair  
DBH (cm): 89 Measured Maturity: Over mature  
Origin: Melbourne ULE (years): 15 - 30  
Retained?: Retained Form: Fair  
Retention Value: Low  
Removal / retention reason: N/A.  
Amenity value: Low  
Works Required: J No works.

SRZ (m): 3.1 Works priority: N/A  
TPZ (m): 10.7 Construction Proximity: 7  
mTPZ (m): =TPZ

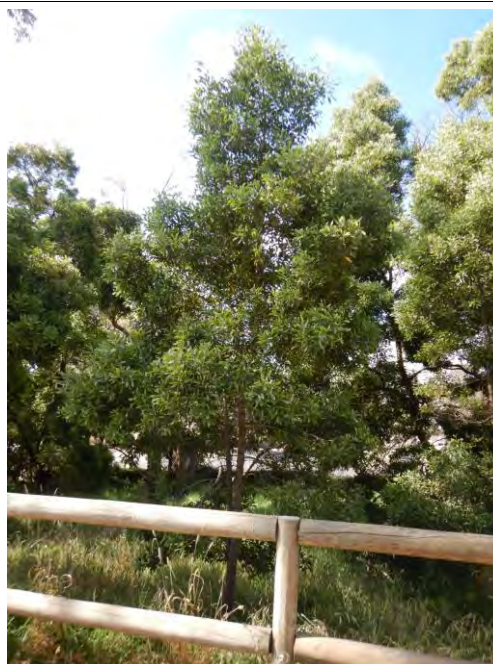
Tree ID: 103

Height (m): 6 Structure: Poor  
Width (m): 3 Health: Good  
DBH (cm): 11 Measured Maturity: Immature  
Origin: Melbourne ULE (years): 5 - 15  
Retained?: Retained Form: Good  
Retention Value: Low  
Removal / retention reason: N/A.  
Amenity value: Low  
Works Required: J No works.

SRZ (m): 1.5 Works priority: N/A  
TPZ (m): 2.0 Construction Proximity: 4.6  
mTPZ (m): =TPZ

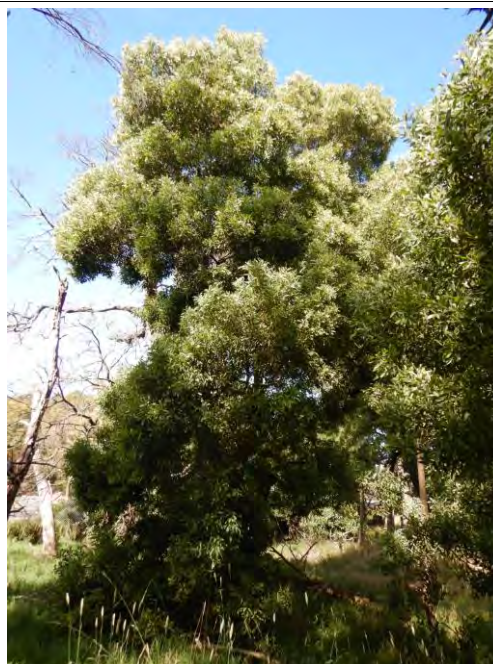
Tree ID: 104

Height (m): 9 Structure: Fair  
Width (m): 5 Health: Good  
DBH (cm): 19 Measured Maturity: Mature  
Origin: Melbourne ULE (years): 15 - 30  
Retained?: Retained Form: Poor  
Retention Value: Low  
Removal / retention reason: N/A.  
Amenity value: Low  
Works Required: J No works.

SRZ (m): 1.5 Works priority: N/A  
TPZ (m): 2.3 Construction Proximity: 1.4  
mTPZ (m): =TPZ

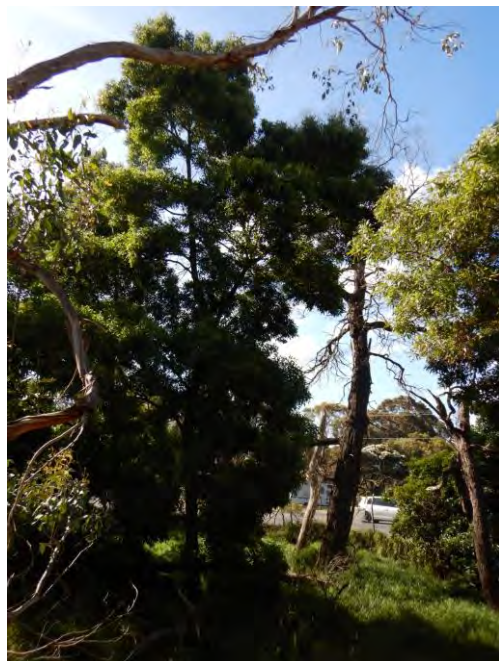
Tree ID: 105

Works Required: J No works.

SRZ (m): 1.8 Works priority: N/A  
TPZ (m): 3.1 Construction Proximity: 0.4  
mTPZ (m): =TPZ

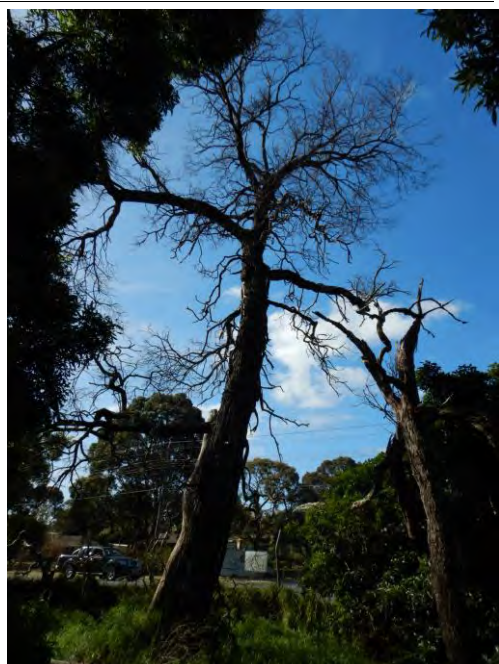
Tree ID: 106

Works Required: B Removal.

SRZ (m): 2.9 Works priority: Very low  
TPZ (m): 8.4 Construction Proximity: 0.1  
mTPZ (m): =TPZ

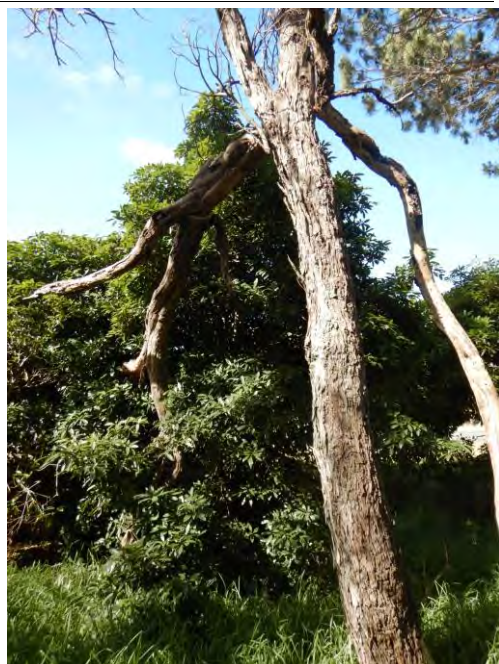
Tree ID: 107

Works Required: J No works.

SRZ (m): 1.5 Works priority: N/A  
TPZ (m): 2.0 Construction Proximity: 0.1  
mTPZ (m): =TPZ

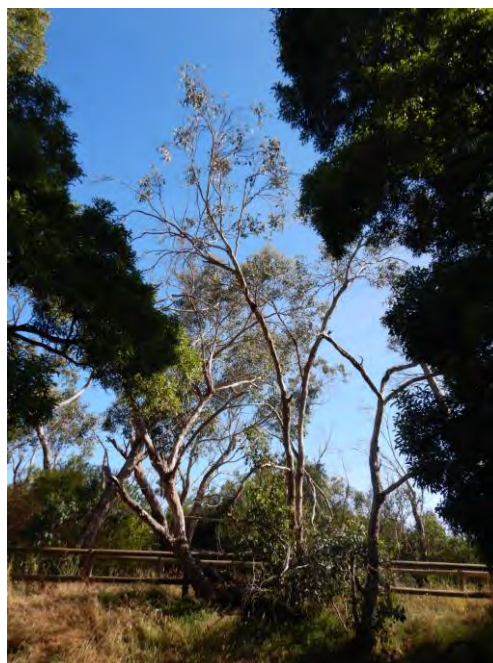
Tree ID:    108

Height (m):   11                   Structure:   Poor  
Width (m):    9                   Health:      Poor  
DBH (cm):    44   Measured Maturity:   Over mature  
Origin:       Melbourne    ULE (years): 1 - 5  
Retained?:   Removed       Form:        Poor  
Retention Value:               Remove.  
Removal / retention reason: Health ULE.  
Amenity value:               Low  
Works Required: B Removal.

SRZ (m):    2.5           Works priority:           Very low  
TPZ (m):    5.3           Construction Proximity:   0.1  
mTPZ (m):  =TPZ

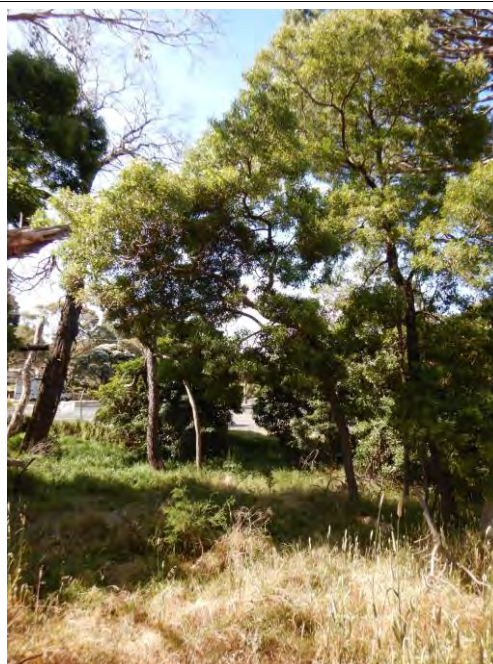
Tree ID:    109

Height (m):   6                   Structure:   Fair  
Width (m):    5                   Health:      Good  
DBH (cm):    19   Measured Maturity:   Mature  
Origin:       Melbourne    ULE (years): 5 - 15  
Retained?:   Removed       Form:        Poor  
Retention Value:               Low  
Removal / retention reason: N/A.  
Amenity value:               Low  
Works Required: J No works.

SRZ (m):    1.5           Works priority:           N/A  
TPZ (m):    2.3           Construction Proximity:   0.6  
mTPZ (m):  =TPZ

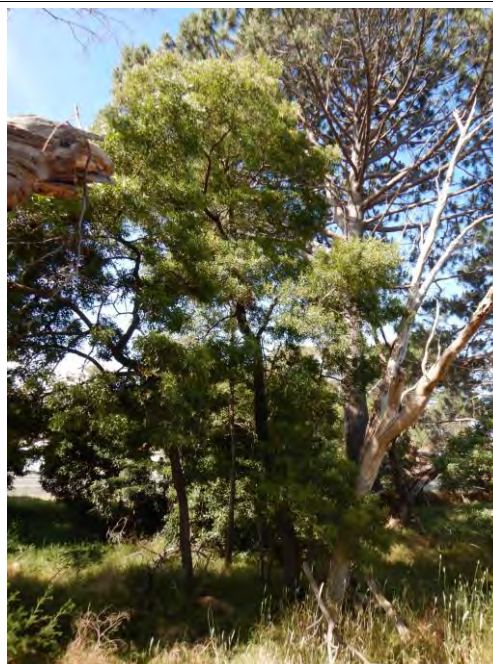
Tree ID:    110

Height (m):   11                   Structure:   Good  
Width (m):    6                   Health:      Good  
DBH (cm):    27   Measured Maturity:   Mature  
Origin:       Melbourne    ULE (years): 15 - 30  
Retained?:   Retained       Form:        Good  
Retention Value:               Moderate  
Removal / retention reason: N/A.  
Amenity value:               Moderate  
Works Required: J No works.

SRZ (m):    1.9           Works priority:           N/A  
TPZ (m):    3.2           Construction Proximity:   2.4  
mTPZ (m):  =TPZ

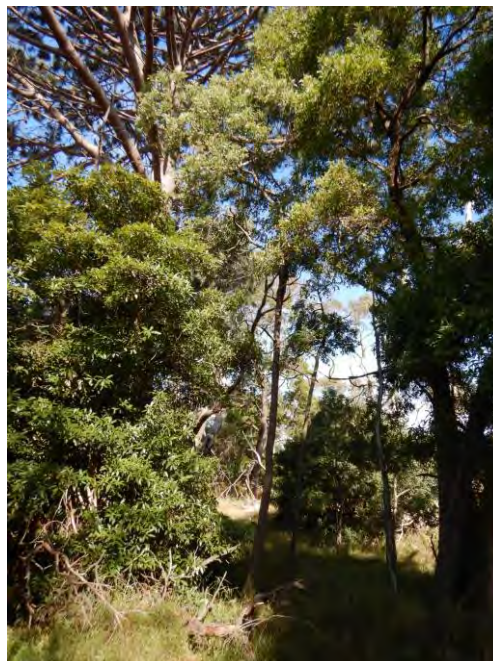
Tree ID: 111

Height (m): 8 Structure: Poor  
Width (m): 2 Health: Fair  
DBH (cm): 13 Measured Maturity: Immature  
Origin: Melbourne ULE (years): 5 - 15  
Retained?: Retained Form: Poor  
Retention Value: Low  
Removal / retention reason: N/A.  
Amenity value: Moderate  
Works Required: J No works.

SRZ (m): 1.5 Works priority: N/A  
TPZ (m): 2.0 Construction Proximity: 1  
mTPZ (m): =TPZ

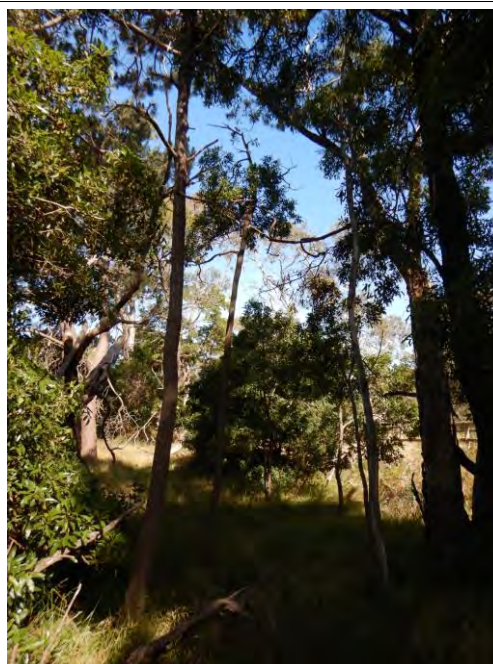
Tree ID: 113

Height (m): 5 Structure: Good  
Width (m): 4 Health: Good  
DBH (cm): 10 Measured Maturity: Immature  
Origin: Victorian ULE (years): 15 - 30  
Retained?: Removed Form: Good  
Retention Value: Moderate  
Removal / retention reason: N/A.  
Amenity value: Moderate  
Works Required: J No works.

SRZ (m): 1.5 Works priority: N/A  
TPZ (m): 2.0 Construction Proximity: 0.1  
mTPZ (m): =TPZ

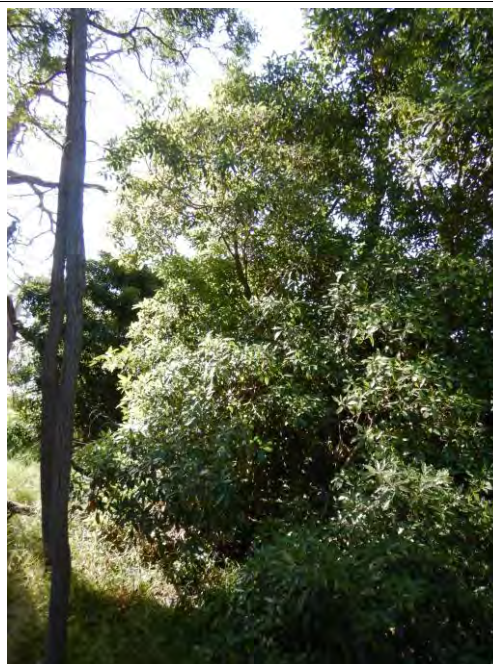
Tree ID: 114

Height (m): 5 Structure: Good  
Width (m): 4 Health: Good  
DBH (cm): 10 Measured Maturity: Immature  
Origin: Victorian ULE (years): 15 - 30  
Retained?: Removed Form: Good  
Retention Value: Moderate  
Removal / retention reason: N/A.  
Amenity value: Moderate  
Works Required: J No works.

SRZ (m): 1.5 Works priority: N/A  
TPZ (m): 2.0 Construction Proximity: 0.1  
mTPZ (m): =TPZ

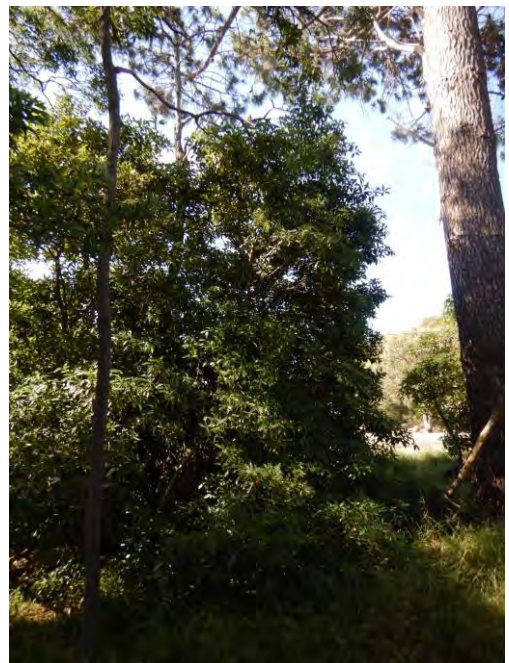
Tree ID: 115

Height (m): 24 Structure: Good  
Width (m): 18 Health: Good  
DBH (cm): 98 Measured Maturity: Mature  
Origin: Exotic ULE (years): 30 - 60  
Retained?: Removed Form: Good  
Retention Value: High  
Removal / retention reason: N/A.  
Amenity value: High  
Works Required: I 50mm dead wood

SRZ (m): 3.3 Works priority: Very low  
TPZ (m): 11.8 Construction Proximity: 0.1  
mTPZ (m): =TPZ

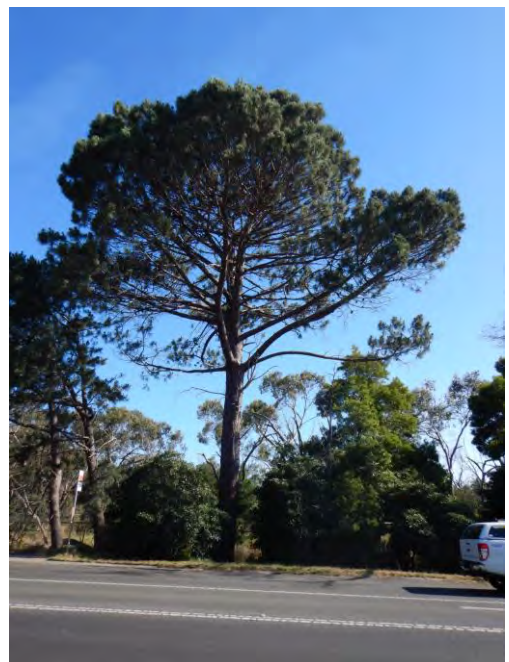
Tree ID: 116

Height (m): 5 Structure: Good  
Width (m): 4 Health: Fair  
DBH (cm): 10 Measured Maturity: Mature  
Origin: Victorian ULE (years): 5 - 15  
Retained?: Removed Form: Fair  
Retention Value: Low  
Removal / retention reason: N/A.  
Amenity value: Low  
Works Required: J No works.

SRZ (m): 1.5 Works priority: N/A  
TPZ (m): 2.0 Construction Proximity: 0.1  
mTPZ (m): =TPZ

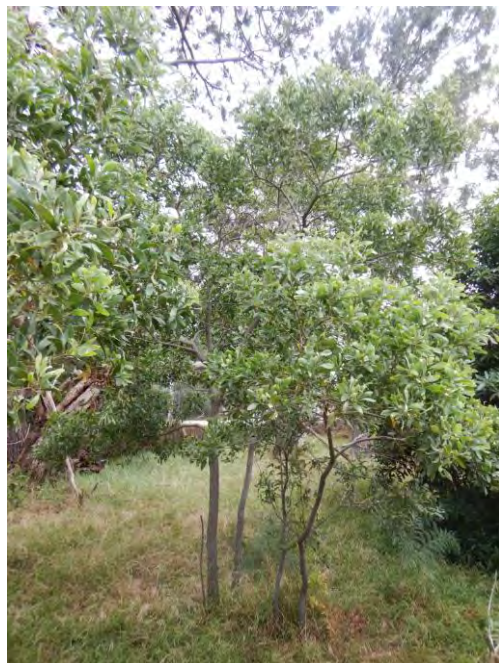
Tree ID: 121

Height (m): 5 Structure: Fair  
Width (m): 2 Health: Poor  
DBH (cm): 8 Measured Maturity: Immature  
Origin: Melbourne ULE (years): 1 - 5  
Retained?: Retained Form: Fair  
Retention Value: Remove.  
Removal / retention reason: Health ULE.  
Amenity value: Low  
Works Required: B Removal.

SRZ (m): 1.5 Works priority: Very low  
TPZ (m): 2.0 Construction Proximity: 5.3  
mTPZ (m): =TPZ

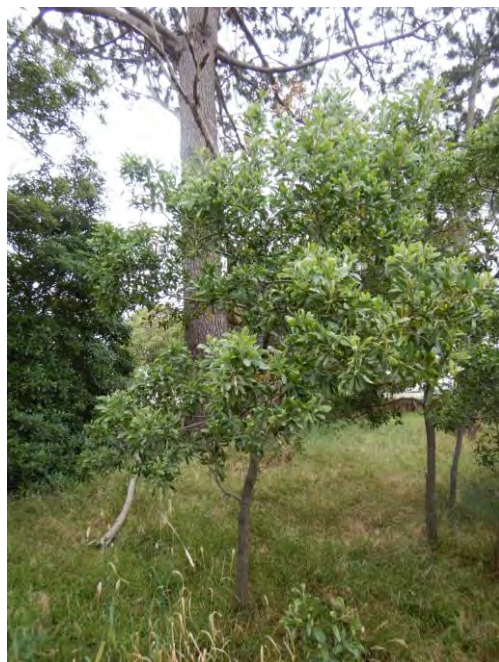
Tree ID: 122

Height (m): 12 Structure: Poor  
Width (m): 7 Health: Dead  
DBH (cm): 48 Estimated Maturity: Mature  
Origin: Australian ULE (years): 0  
Retained?: Retained Form: Very poor  
Retention Value: Remove.  
Removal / retention reason: Health ULE.  
Amenity value: Very low  
Works Required: B Removal.

SRZ (m): 2.5 Works priority: Very low  
TPZ (m): 5.8 Construction Proximity: 3.2  
mTPZ (m): =TPZ

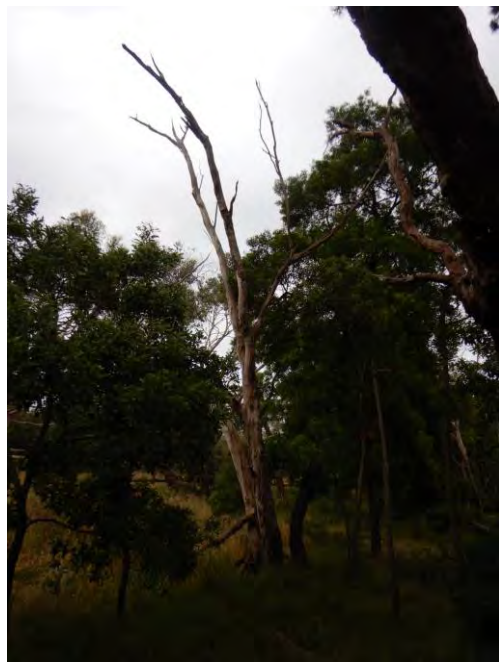
Tree ID: 123

Height (m): 15 Structure: Poor  
Width (m): 12 Health: Fair  
DBH (cm): 123 Measured Maturity: Over mature  
Origin: Melbourne ULE (years): 5 - 15  
Retained?: Retained Form: Fair  
Retention Value: Moderate  
Removal / retention reason: N/A.  
Amenity value: High  
Works Required: I 50mm dead wood

SRZ (m): 3.6 Works priority: Very low  
TPZ (m): 14.8 Construction Proximity: 15  
mTPZ (m): =TPZ

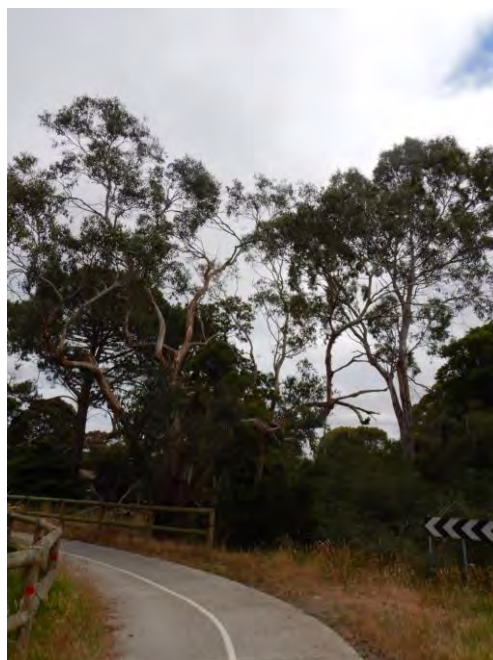
Tree ID: 124

Height (m): 6 Structure: Poor  
Width (m): 5 Health: Very poor  
DBH (cm): 30 Estimated Maturity: Over mature  
Origin: Melbourne ULE (years): 0  
Retained?: Retained Form: Very poor  
Retention Value: Remove.  
Removal / retention reason: Health ULE.  
Amenity value: Very low  
Works Required: B Removal.

SRZ (m): 2 Works priority: Very low  
TPZ (m): 3.6 Construction Proximity: 12  
mTPZ (m): =TPZ

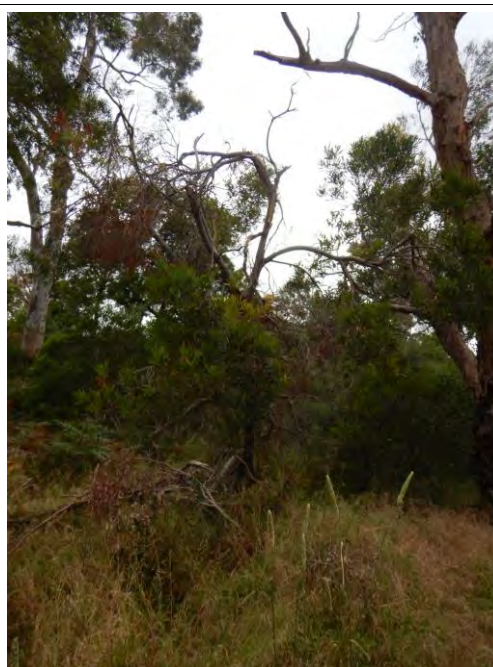
Tree ID: 125

Height (m): 13 Structure: Poor  
Width (m): 9 Health: Poor  
DBH (cm): 50 Measured Maturity: Over mature  
Origin: Melbourne ULE (years): 1 - 5  
Retained?: Retained Form: Poor  
Retention Value: Remove.  
Removal / retention reason: Health ULE.  
Amenity value: Moderate  
Works Required: B Removal.

SRZ (m): 2.6 Works priority: Very low  
TPZ (m): 6.0 Construction Proximity: 5.5  
mTPZ (m): =TPZ

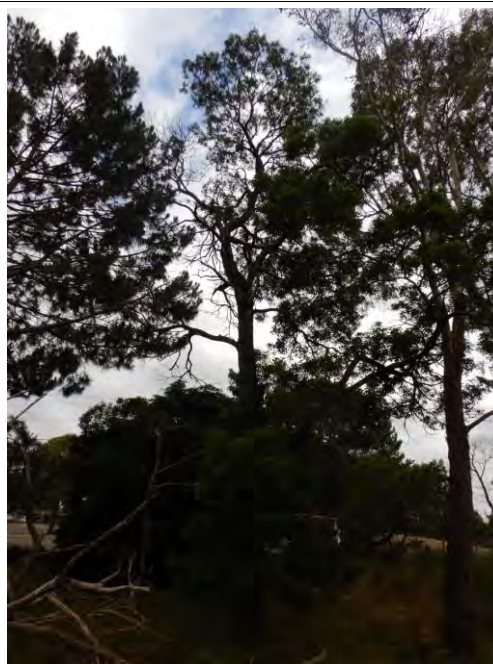
Tree ID: 126

Height (m): 17 Structure: Good  
Width (m): 7 Health: Fair  
DBH (cm): 46 Measured Maturity: Mature  
Origin: Melbourne ULE (years): 15 - 30  
Retained?: Retained Form: Fair  
Retention Value: High  
Removal / retention reason: N/A.  
Amenity value: High  
Works Required: J No works.

SRZ (m): 2.5 Works priority: N/A  
TPZ (m): 5.5 Construction Proximity: 6.9  
mTPZ (m): =TPZ

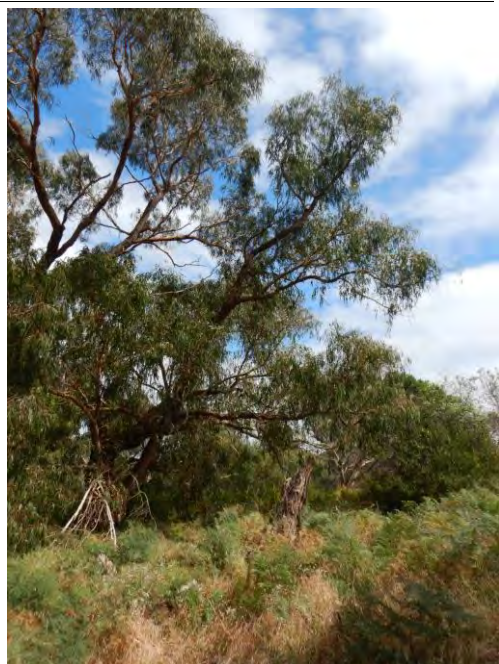
Tree ID: 141

Genus / species: *Eucalyptus pryoriana*  
Evergreen Gippsland Manna Gum  
Height (m): 9 Structure: Very poor  
Width (m): 10 Health: Fair  
DBH (cm): 80 Measured Maturity: Over mature  
Origin: Melbourne ULE (years): 1 - 5  
Retained?: Removed Form: Poor  
Retention Value: Remove.  
Removal / retention reason: Health ULE.  
Amenity value: Low  
Works Required: B Removal.

SRZ (m): 3 Works priority: Very low  
TPZ (m): 9.6 Construction Proximity: 2.6  
mTPZ (m): =TPZ

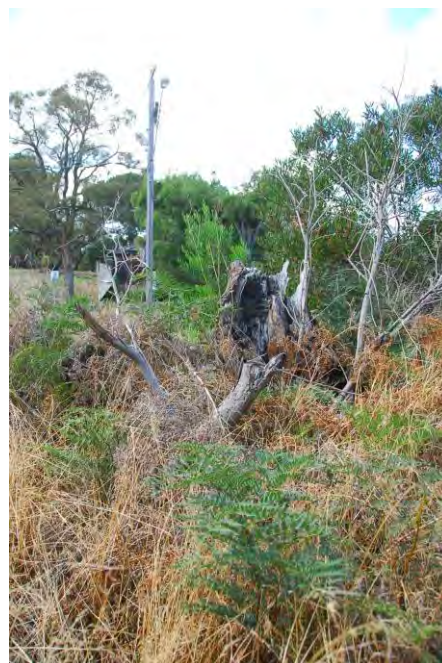
Tree ID: 142

Genus / species: *Acacia sophorae*  
Evergreen Coast Wattle  
Height (m): 6 Structure: Poor  
Width (m): 4 Health: Dead  
DBH (cm): 20 Estimated Maturity: Over mature  
Origin: Melbourne ULE (years): 0  
Retained?: Removed Form: Poor  
Retention Value: Remove.  
Removal / retention reason: Health ULE.  
Amenity value: Very low  
Works Required: B Removal.

SRZ (m): 1.6 Works priority: Very low  
TPZ (m): 2.4 Construction Proximity: 1.7  
mTPZ (m): =TPZ

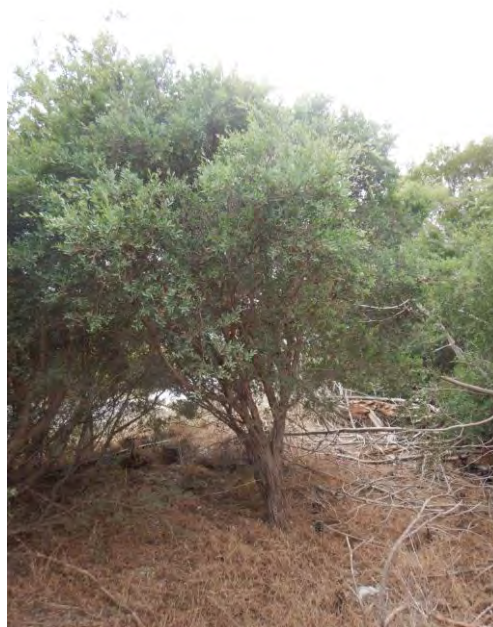
Tree ID: 149

Height (m): 5 Structure: Poor  
Width (m): 4 Health: Dead  
DBH (cm): 15 Estimated Maturity: Over mature  
Origin: Melbourne ULE (years): 0  
Retained?: Retained Form: Very poor  
Retention Value: Remove.  
Removal / retention reason: Health ULE.  
Amenity value: Very low  
Works Required: B Removal.

SRZ (m): 1.5 Works priority: Very low  
TPZ (m): 2.0 Construction Proximity: 9  
mTPZ (m): =TPZ

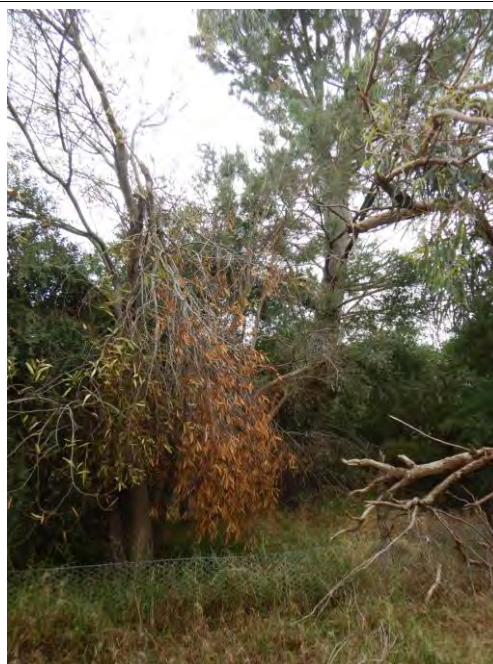
Tree ID: 152

SRZ (m): 1.5 Works priority: N/A  
TPZ (m): 2.0 Construction Proximity: 6.3  
mTPZ (m): =TPZ

Works Required: J No works.

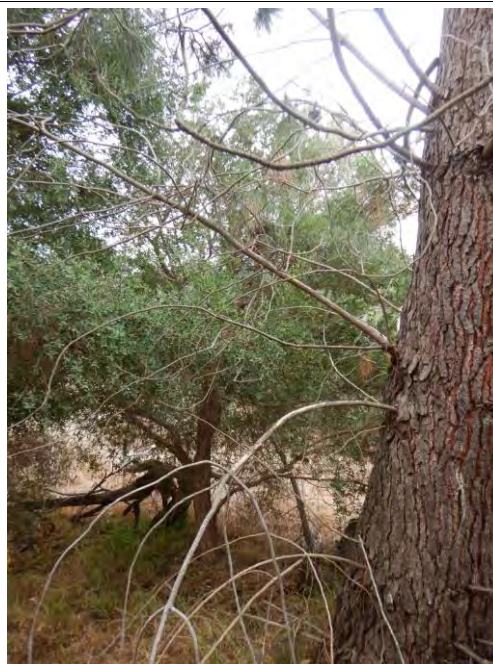
Tree ID:    153

SRZ (m):	2.7	Works priority:	N/A
TPZ (m):	6.7	Construction Proximity:	5
mTPZ (m):	=TPZ

Works Required: J No works.

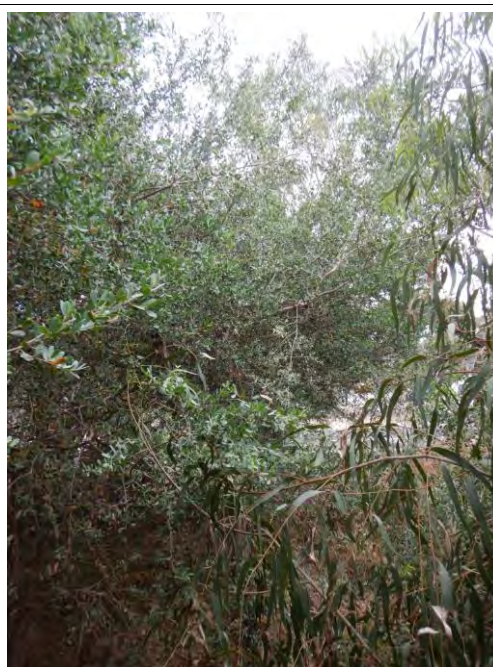
Tree ID: 164

SRZ (m): 2.4 Works priority: Very low  
TPZ (m): 4.8 Construction Proximity: 0.1  
mTPZ (m): =TPZ

Works Required: B Removal.

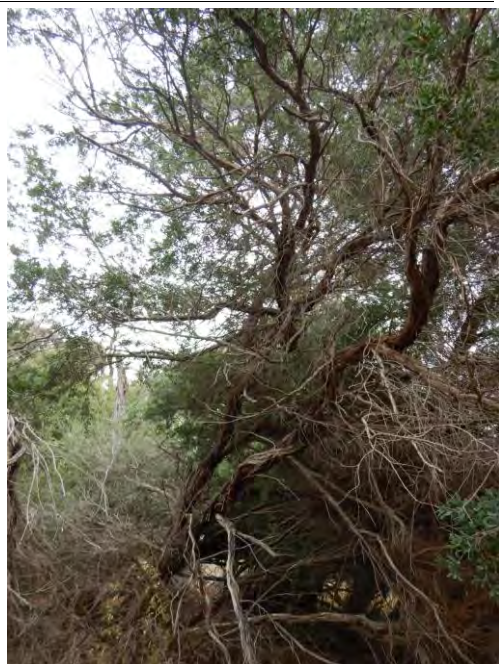
Tree ID: 174

Height (m): 4 Structure: Fair  
Width (m): 8 Health: Fair  
DBH (cm): 34 Measured Maturity: Over mature  
Origin: Victorian ULE (years): 5 - 15  
Retained?: Retained Form: Poor  
Retention Value: Low  
Removal / retention reason: N/A.  
Amenity value: Low  
Works Required: J No works.

SRZ (m): 2.2 Works priority: N/A  
TPZ (m): 4.1 Construction Proximity: 5.3  
mTPZ (m): =TPZ

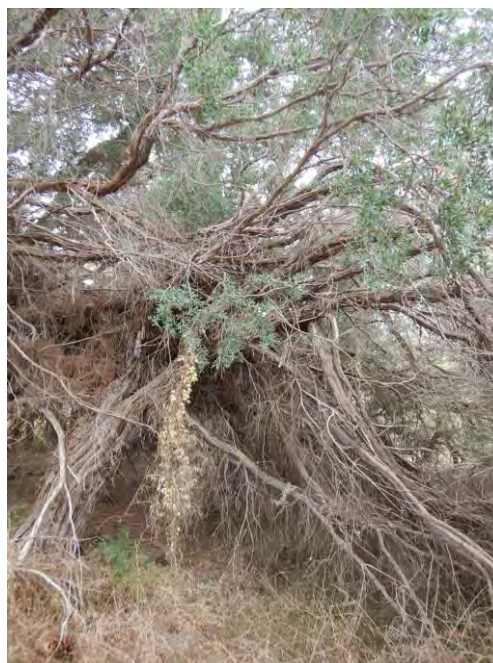
Tree ID: 175

Height (m): 4 Structure: Fair  
Width (m): 6 Health: Poor  
DBH (cm): 30 Measured Maturity: Over mature  
Origin: Victorian ULE (years): 5 - 15  
Retained?: Retained Form: Fair  
Retention Value: Low  
Removal / retention reason: N/A.  
Amenity value: Low  
Works Required: J No works.

SRZ (m): 2 Works priority: N/A  
TPZ (m): 3.6 Construction Proximity: 3.5  
mTPZ (m): =TPZ

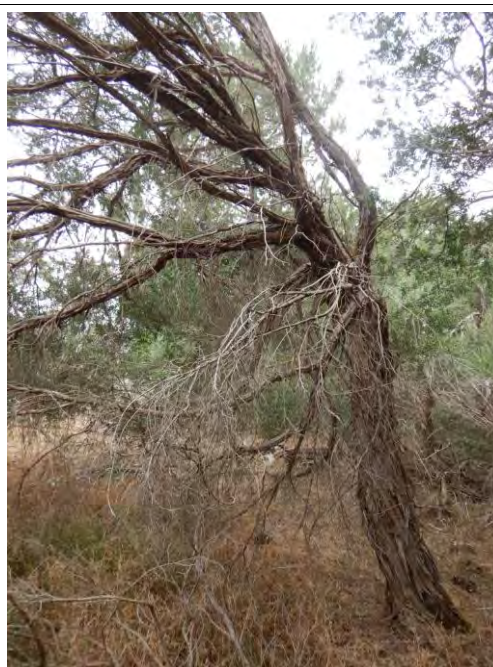
Tree ID: 176

Height (m): 6 Structure: Poor  
Width (m): 9 Health: Fair  
DBH (cm): 40 Measured Maturity: Over mature  
Origin: Victorian ULE (years): 5 - 15  
Retained?: Retained Form: Fair  
Retention Value: Low  
Removal / retention reason: N/A.  
Amenity value: Low  
Works Required: J No works.

SRZ (m): 2.4 Works priority: N/A  
TPZ (m): 4.8 Construction Proximity: 2.7  
mTPZ (m): =TPZ

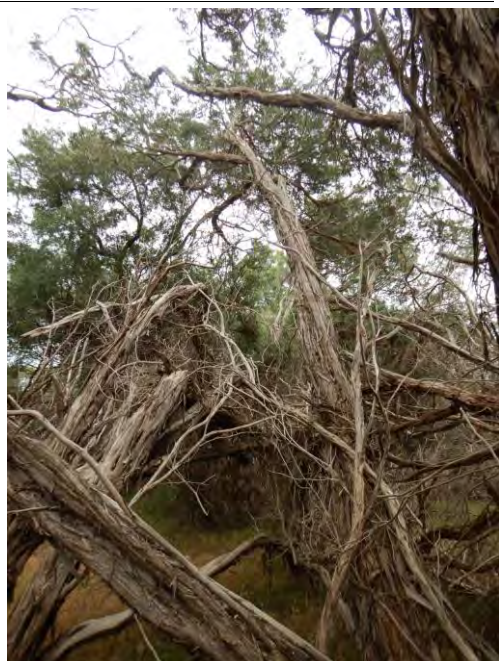
Tree ID: 186

Height (m): 7 Structure: Fair  
Width (m): 6 Health: Poor  
DBH (cm): 35 Measured Maturity: Over mature  
Origin: Victorian ULE (years): 1 - 5  
Retained?: Retained Form: Poor  
Retention Value: Remove.  
Removal / retention reason: Health ULE.  
Amenity value: Low  
Works Required: J No works.

SRZ (m): 2.2 Works priority: N/A  
TPZ (m): 4.2 Construction Proximity: 4.5  
mTPZ (m): =TPZ

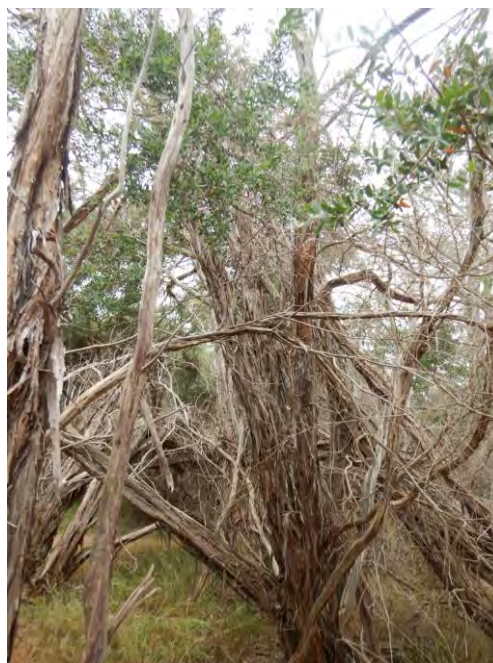
Tree ID: 187

Height (m): 5 Structure: Poor  
Width (m): 4 Health: Poor  
DBH (cm): 25 Measured Maturity: Over mature  
Origin: Victorian ULE (years): 1 - 5  
Retained?: Retained Form: Poor  
Retention Value: Remove.  
Removal / retention reason: Health ULE.  
Amenity value: Very low  
Works Required: B Removal.

SRZ (m): 1.8 Works priority: Very low  
TPZ (m): 3.0 Construction Proximity: 2.2  
mTPZ (m): =TPZ

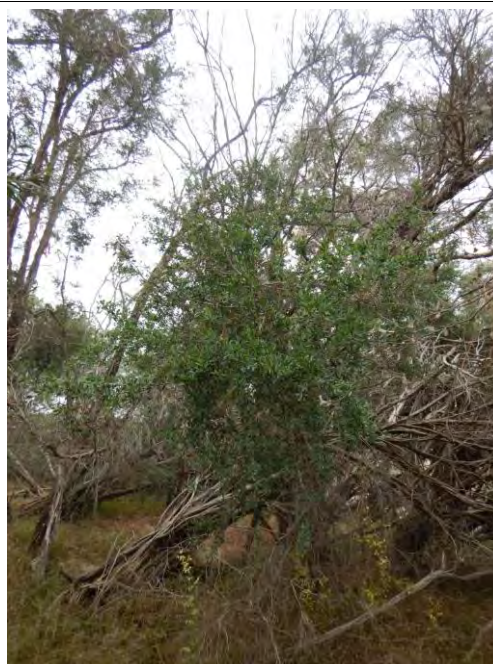
Tree ID: 188

Height (m): 14 Structure: Good  
Width (m): 8 Health: Fair  
DBH (cm): 50 Measured Maturity: Mature  
Origin: Exotic ULE (years): 15 - 30  
Retained?: Removed Form: Good  
Retention Value: Moderate  
Removal / retention reason: N/A.  
Amenity value: Moderate  
Works Required: J No works.

SRZ (m): 2.6 Works priority: N/A  
TPZ (m): 6.0 Construction Proximity: 0.1  
mTPZ (m): =TPZ
