# Ballarto Road and Lyrebird Drive intersection upgrade: Flora and fauna assessment

FINAL REPORT

Prepared for Department of Transport

19 July 2022

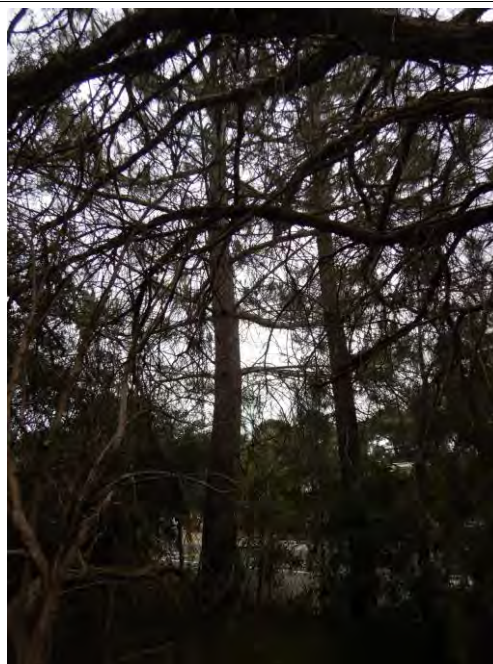
Tree ID: 189

Height (m): 11 Structure: Good  
Width (m): 3 Health: Fair  
DBH (cm): 25 Measured Maturity: Immature  
Origin: Exotic ULE (years): 15 - 30  
Retained?: Removed Form: Fair  
Retention Value: Low  
Removal / retention reason: N/A.  
Amenity value: Low  
Works Required: J No works.

SRZ (m): 1.8 Works priority: N/A  
TPZ (m): 3.0 Construction Proximity: 0.1  
mTPZ (m): =TPZ

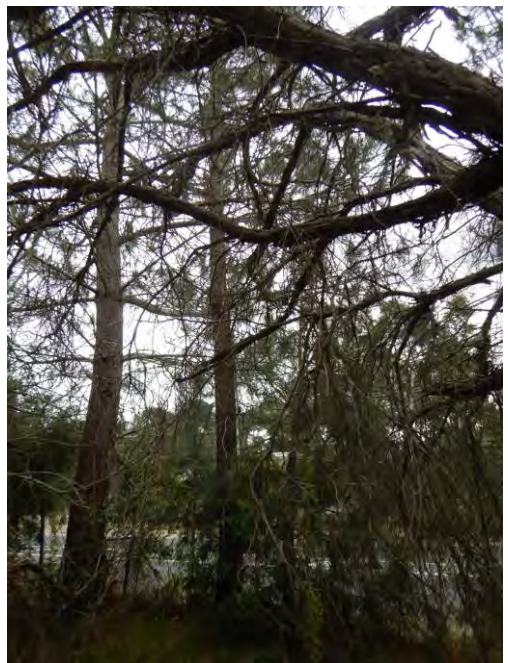
Tree ID: 190

Height (m): 11 Structure: Good  
Width (m): 4 Health: Fair  
DBH (cm): 25 Measured Maturity: Immature  
Origin: Exotic ULE (years): 15 - 30  
Retained?: Removed Form: Good  
Retention Value: Low  
Removal / retention reason: N/A.  
Amenity value: Low  
Works Required: J No works.

SRZ (m): 1.8 Works priority: N/A  
TPZ (m): 3.0 Construction Proximity: 0.1  
mTPZ (m): =TPZ

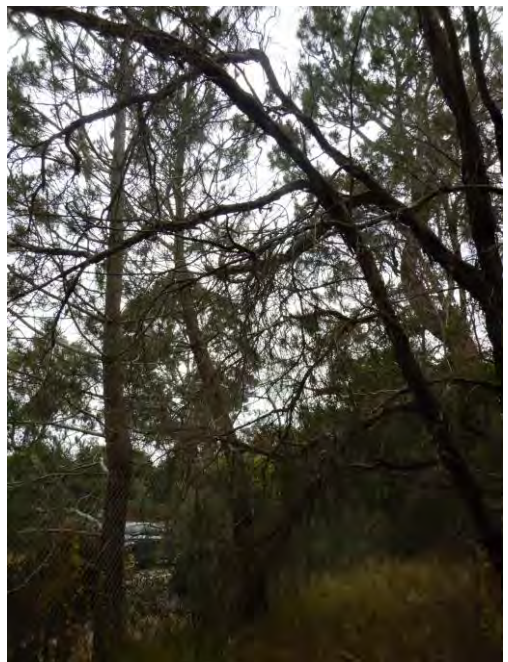
Tree ID: 192

Height (m): 8 Structure: Fair  
Width (m): 5 Health: Dead  
DBH (cm): 40 Measured Maturity: Over mature  
Origin: Victorian ULE (years): 5 - 15  
Retained?: Removed Form: Fair  
Retention Value: Low  
Removal / retention reason: N/A.  
Amenity value: Low  
Works Required: J No works.

SRZ (m): 2.4 Works priority: N/A  
TPZ (m): 4.8 Construction Proximity: 1  
mTPZ (m): =TPZ

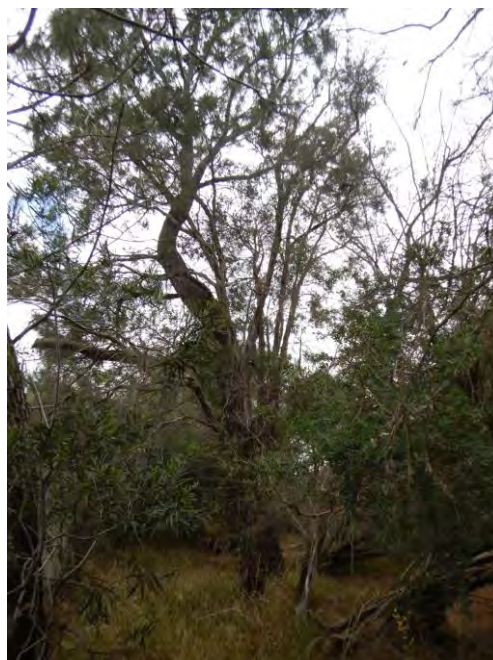
Tree ID: 193

Height (m): 14 Structure: Good  
Width (m): 7 Health: Good  
DBH (cm): 50 Measured Maturity: Mature  
Origin: Exotic ULE (years): 30 - 60  
Retained?: Retained Form: Good  
Retention Value: Moderate  
Removal / retention reason: N/A.  
Amenity value: Moderate  
Works Required: J No works.

SRZ (m): 2.6 Works priority: N/A  
TPZ (m): 6.0 Construction Proximity: 1.8  
mTPZ (m): =TPZ

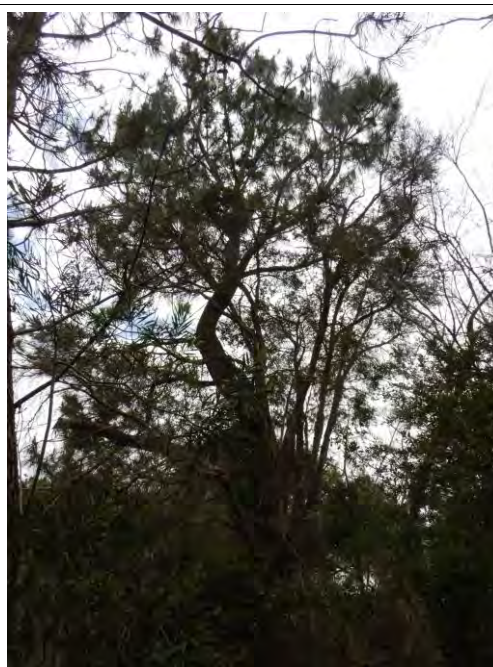
Tree ID: 194

Height (m): 11 Structure: Fair  
Width (m): 7 Health: Poor  
DBH (cm): 40 Measured Maturity: Over mature  
Origin: Victorian ULE (years): 5 - 15  
Retained?: Retained Form: Fair  
Retention Value: Low  
Removal / retention reason: N/A.  
Amenity value: Low  
Works Required: J No works.

SRZ (m): 2.4 Works priority: N/A  
TPZ (m): 4.8 Construction Proximity: 1.9  
mTPZ (m): =TPZ

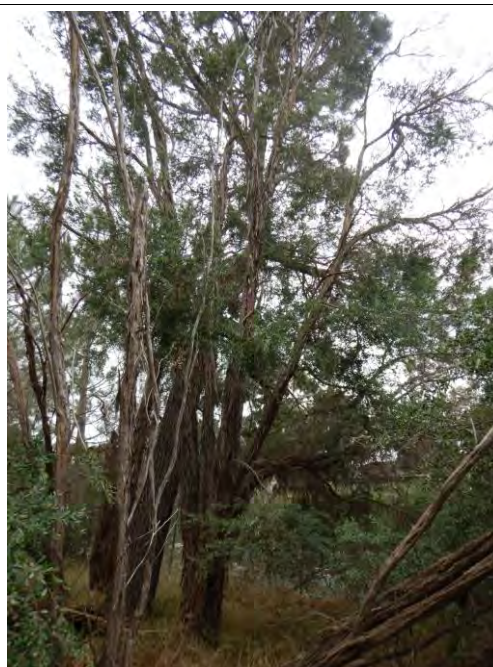
Tree ID: 195

Height (m): 4 Structure: Very poor  
Width (m): 9 Health: Fair  
DBH (cm): 30 Measured Maturity: Over mature  
Origin: Victorian ULE (years): 5 - 15  
Retained?: Retained Form: Poor  
Retention Value: Very low  
Removal / retention reason: N/A.  
Amenity value: Very low  
Works Required: J No works.

SRZ (m): 2 Works priority: N/A  
TPZ (m): 3.6 Construction Proximity: 1.2  
mTPZ (m): =TPZ

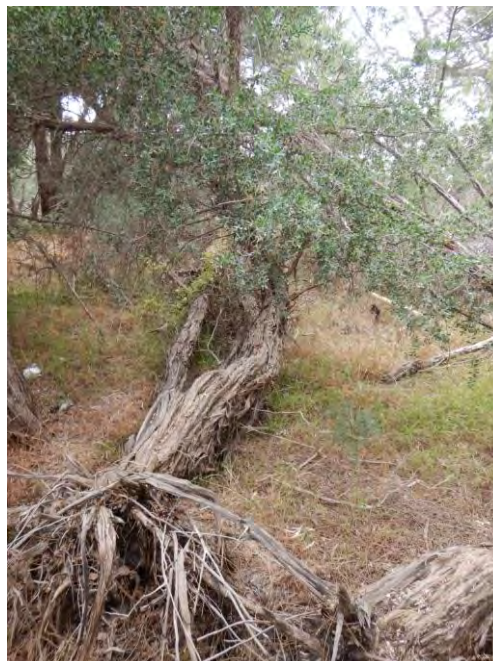
Tree ID: 196

Height (m): 4 Structure: Fair  
Width (m): 4 Health: Good  
DBH (cm): 15 Measured Maturity: Mature  
Origin: Victorian ULE (years): 15 - 30  
Retained?: Removed Form: Good  
Retention Value: Low  
Removal / retention reason: N/A.  
Amenity value: Low  
Works Required: J No works.

SRZ (m): 1.5 Works priority: N/A  
TPZ (m): 2.0 Construction Proximity: 0.1  
mTPZ (m): =TPZ

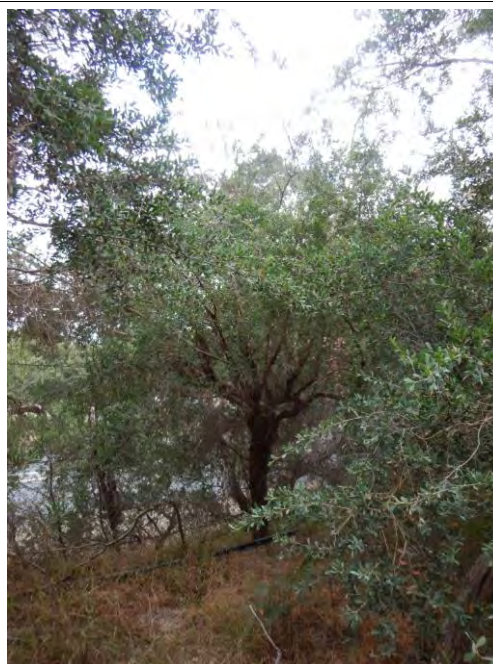
Tree ID: 197

Height (m): 4 Structure: Fair  
Width (m): 4 Health: Good  
DBH (cm): 15 Measured Maturity: Mature  
Origin: Victorian ULE (years): 5 - 15  
Retained?: Removed Form: Poor  
Retention Value: Very low  
Removal / retention reason: N/A.  
Amenity value: Very low  
Works Required: J No works.

SRZ (m): 1.5 Works priority: N/A  
TPZ (m): 2.0 Construction Proximity: 0.6  
mTPZ (m): =TPZ

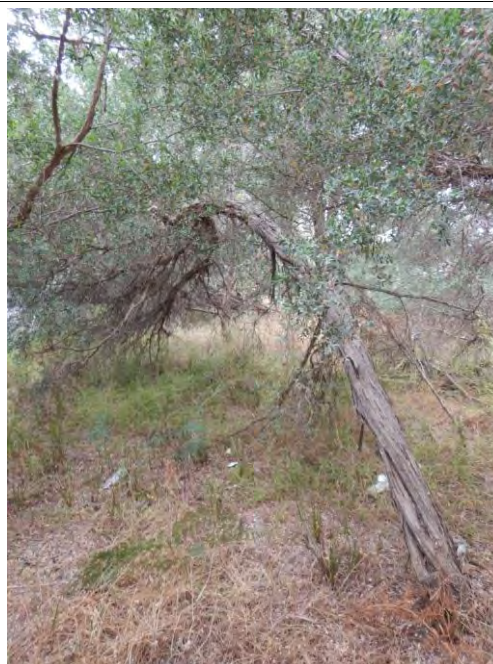
Tree ID: 198

Height (m): 6 Structure: Poor  
Width (m): 7 Health: Poor  
DBH (cm): 40 Measured Maturity: Over mature  
Origin: Victorian ULE (years): 1 - 5  
Retained?: Retained Form: Poor  
Retention Value: Remove.  
Removal / retention reason: Health ULE.  
Amenity value: Very low  
Works Required: B Removal.

SRZ (m): 2.4 Works priority: Very low  
TPZ (m): 4.8 Construction Proximity: 8.5  
mTPZ (m): =TPZ

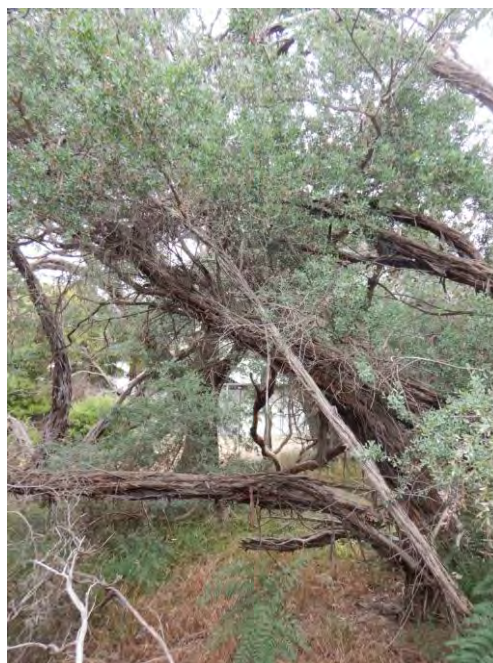
Tree ID: 199

Height (m): 5 Structure: Poor  
Width (m): 4 Health: Poor  
DBH (cm): 25 Measured Maturity: Over mature  
Origin: Victorian ULE (years): 1 - 5  
Retained?: Retained Form: Poor  
Retention Value: Remove.  
Removal / retention reason: Health ULE.  
Amenity value: Very low  
Works Required: B Removal.

SRZ (m): 1.8 Works priority: Very low  
TPZ (m): 3.0 Construction Proximity: 2.4  
mTPZ (m): =TPZ

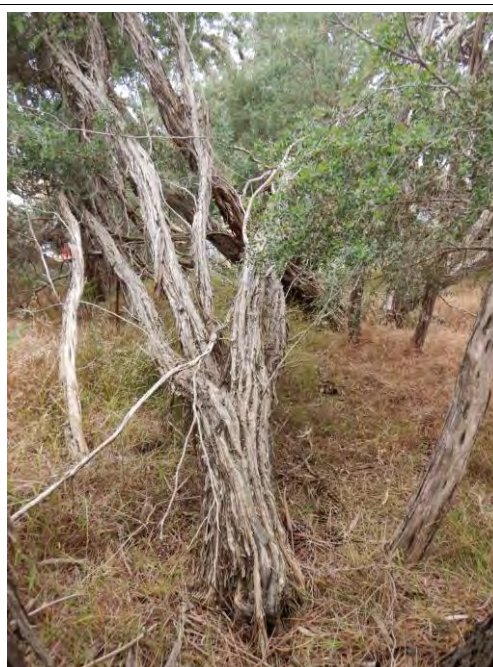
Tree ID: 200

Height (m): 5 Structure: Poor  
Width (m): 7 Health: Poor  
DBH (cm): 20 Measured Maturity: Over mature  
Origin: Victorian ULE (years): 1 - 5  
Retained?: Retained Form: Poor  
Retention Value: Remove.  
Removal / retention reason: Health ULE.  
Amenity value: Very low  
Works Required: B Removal.

SRZ (m): 1.6 Works priority: Very low  
TPZ (m): 2.4 Construction Proximity: 5.5  
mTPZ (m): =TPZ

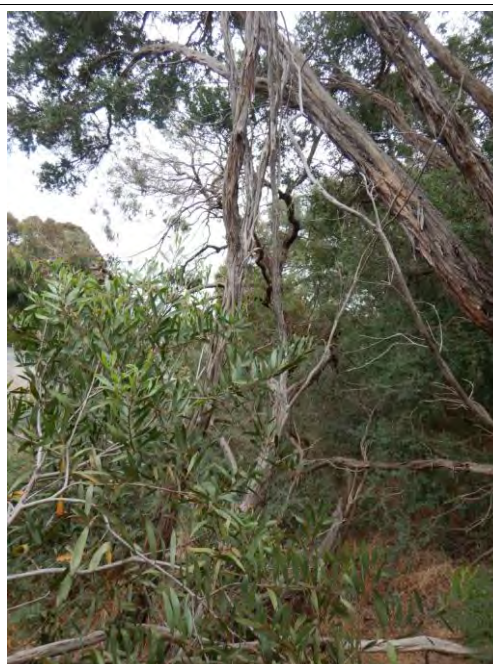
Tree ID: 207

Height (m): 2 Structure: Very poor  
Width (m): 10 Health: Poor  
DBH (cm): 45 Measured Maturity: Over mature  
Origin: Victorian ULE (years): 0  
Retained?: Retained Form: Very poor  
Retention Value: Remove.  
Removal / retention reason: Health ULE.  
Amenity value: Very low  
Works Required: B Removal.

SRZ (m): 2.5 Works priority: Very low  
TPZ (m): 5.4 Construction Proximity: 6.3  
mTPZ (m): =TPZ

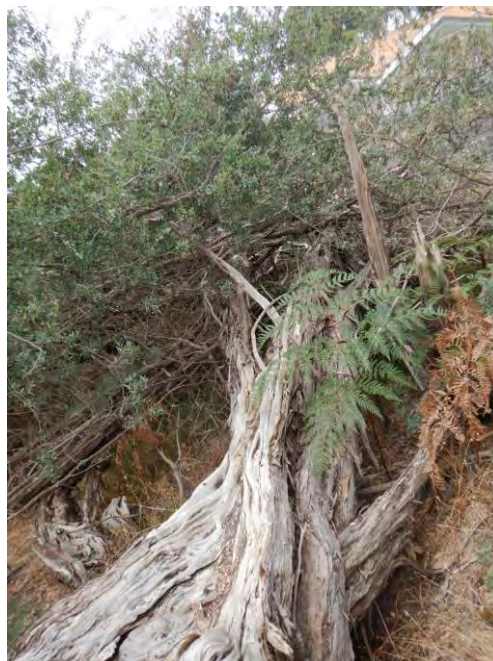
Tree ID: 208

Height (m): 3 Structure: Very poor  
Width (m): 10 Health: Poor  
DBH (cm): 45 Measured Maturity: Over mature  
Origin: Victorian ULE (years): 0  
Retained?: Retained Form: Very poor  
Retention Value: Remove.  
Removal / retention reason: Health ULE.  
Amenity value: Very low  
Works Required: B Removal.

SRZ (m): 2.5 Works priority: Very low  
TPZ (m): 5.4 Construction Proximity: 5.6  
mTPZ (m): =TPZ

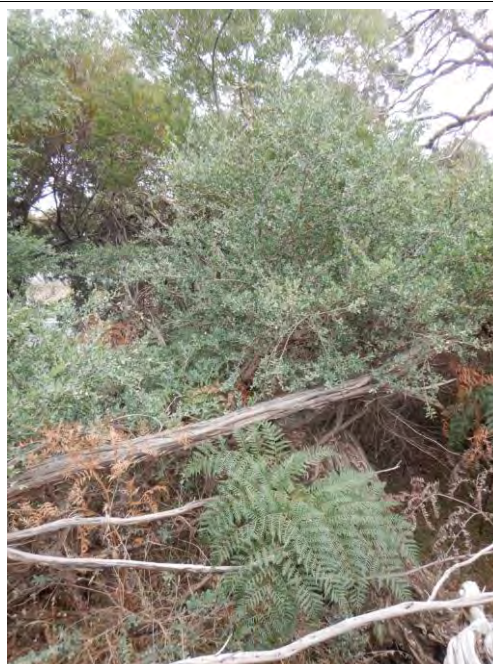
Tree ID: 209

Height (m): 5 Structure: Poor  
Width (m): 7 Health: Good  
DBH (cm): 25 Measured Maturity: Over mature  
Origin: Victorian ULE (years): 5 - 15  
Retained?: Retained Form: Fair  
Retention Value: Low  
Removal / retention reason: N/A.  
Amenity value: Low  
Works Required: J No works.

SRZ (m): 1.8 Works priority: N/A  
TPZ (m): 3.0 Construction Proximity: 4  
mTPZ (m): =TPZ

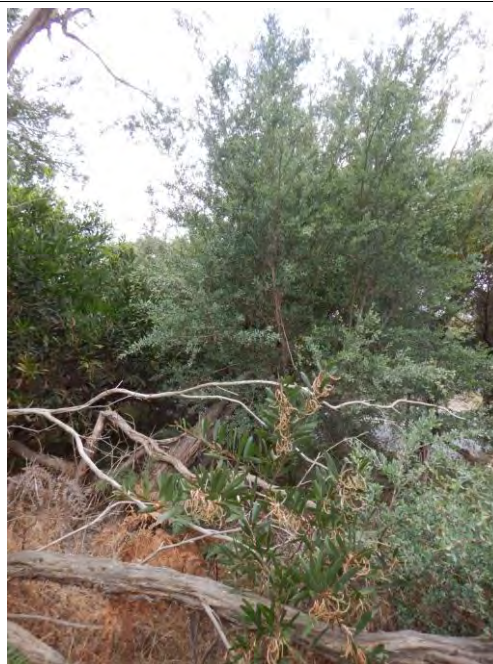
Tree ID: 210

Height (m): 4 Structure: Poor  
Width (m): 7 Health: Good  
DBH (cm): 25 Measured Maturity: Over mature  
Origin: Victorian ULE (years): 5 - 15  
Retained?: Retained Form: Fair  
Retention Value: Very low  
Removal / retention reason: N/A.  
Amenity value: Very low  
Works Required: J No works.

SRZ (m): 1.8 Works priority: N/A  
TPZ (m): 3.0 Construction Proximity: 5.9  
mTPZ (m): =TPZ

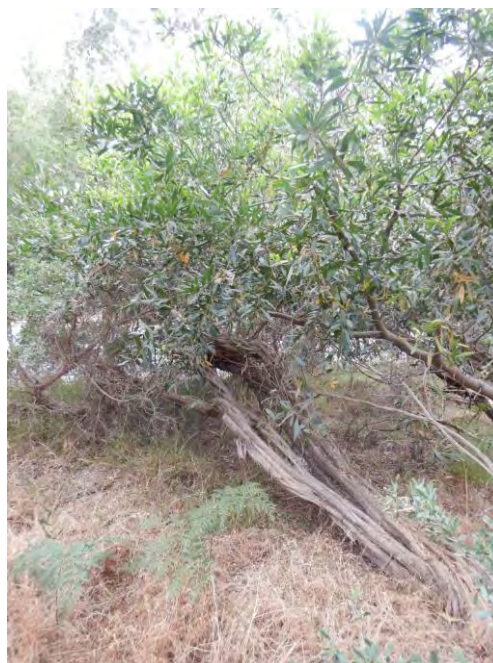
Tree ID: 211

Height (m): 3 Structure: Poor  
Width (m): 6 Health: Fair  
DBH (cm): 30 Measured Maturity: Over mature  
Origin: Victorian ULE (years): 1 - 5  
Retained?: Retained Form: Very poor  
Retention Value: Remove.  
Removal / retention reason: Health ULE.  
Amenity value: Very low  
Works Required: B Removal.

SRZ (m): 2 Works priority: Very low  
TPZ (m): 3.6 Construction Proximity: 7.1  
mTPZ (m): =TPZ

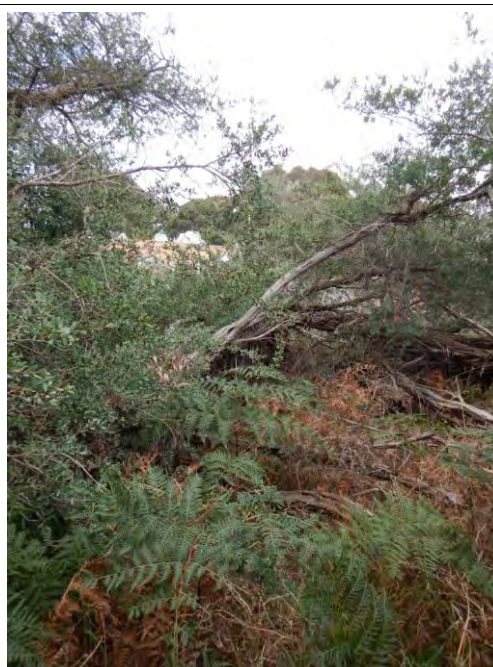
Tree ID: 212

Height (m): 5 Structure: Poor  
Width (m): 6 Health: Fair  
DBH (cm): 25 Measured Maturity: Over mature  
Origin: Victorian ULE (years): 5 - 15  
Retained?: Retained Form: Poor  
Retention Value: Low  
Removal / retention reason: N/A.  
Amenity value: Low  
Works Required: J No works.

SRZ (m): 1.8 Works priority: N/A  
TPZ (m): 3.0 Construction Proximity: 6.9  
mTPZ (m): =TPZ

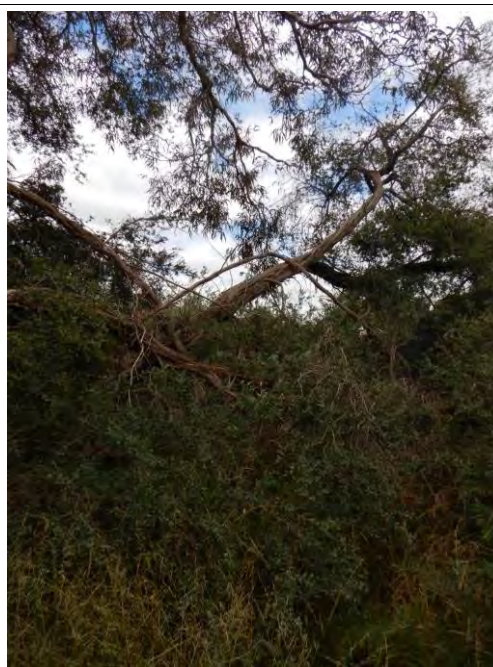
Tree ID: 213

Height (m): 7 Structure: Poor  
Width (m): 6 Health: Poor  
DBH (cm): 26 Measured Maturity: Over mature  
Origin: Victorian ULE (years): 1 - 5  
Retained?: Retained Form: Fair  
Retention Value: Remove.  
Removal / retention reason: Health ULE.  
Amenity value: Low  
Works Required: B Removal.

SRZ (m): 1.8 Works priority: Very low  
TPZ (m): 3.1 Construction Proximity: 6.5  
mTPZ (m): =TPZ

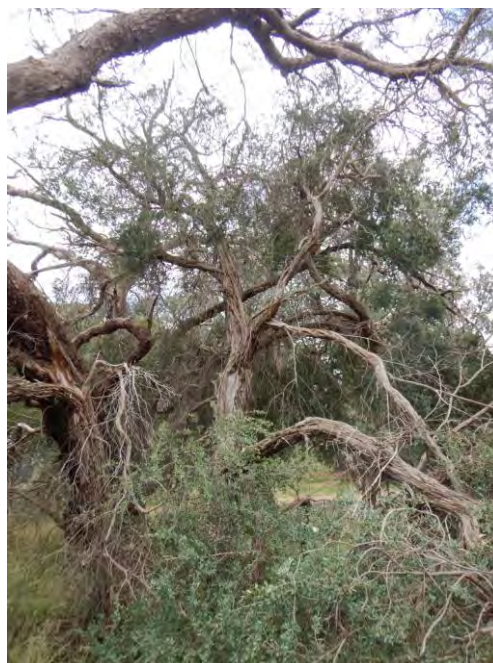
Tree ID: 214

Height (m): 4 Structure: Poor  
Width (m): 6 Health: Very poor  
DBH (cm): 25 Estimated Maturity: Over mature  
Origin: Victorian ULE (years): 1 - 5  
Retained?: Retained Form: Poor  
Retention Value: Remove.  
Removal / retention reason: Health ULE.  
Amenity value: Very low  
Works Required: B Removal.

SRZ (m): 1.8 Works priority: Very low  
TPZ (m): 3.0 Construction Proximity: 5.7  
mTPZ (m): =TPZ

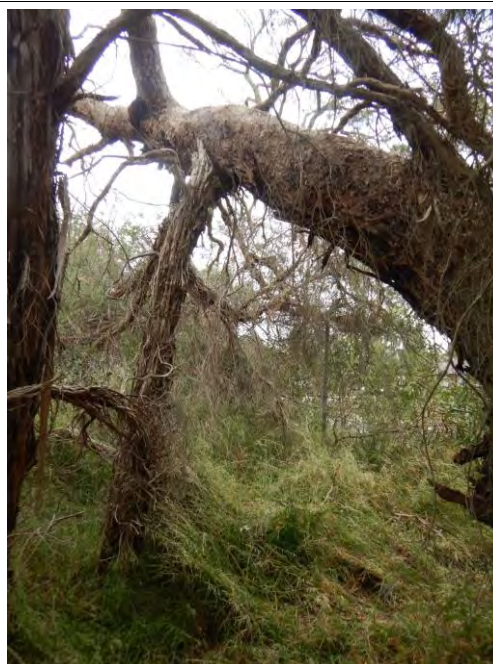
Tree ID: 215

Height (m): 6 Structure: Fair  
Width (m): 5 Health: Fair  
DBH (cm): 25 Measured Maturity: Over mature  
Origin: Victorian ULE (years): 5 - 15  
Retained?: Retained Form: Fair  
Retention Value: Low  
Removal / retention reason: N/A.  
Amenity value: Low  
Works Required: J No works.

SRZ (m): 1.8 Works priority: N/A  
TPZ (m): 3.0 Construction Proximity: 7.5  
mTPZ (m): =TPZ

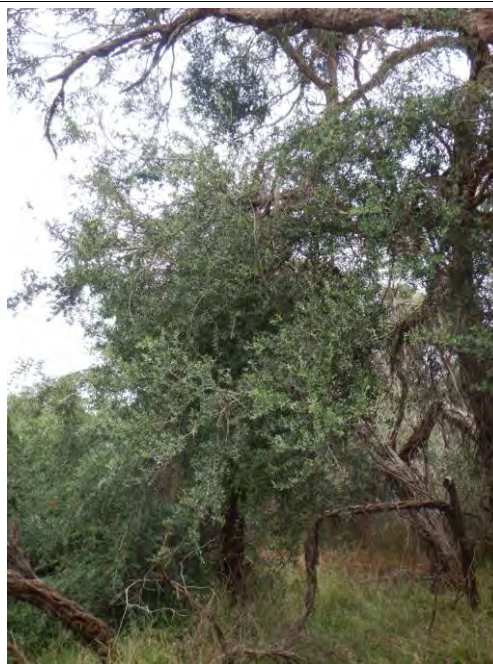
Tree ID: 216

Height (m): 5 Structure: Very poor  
Width (m): 10 Health: Fair  
DBH (cm): 40 Measured Maturity: Over mature  
Origin: Victorian ULE (years): 5 - 15  
Retained?: Retained Form: Poor  
Retention Value: Low  
Removal / retention reason: N/A.  
Amenity value: Low  
Works Required: J No works.

SRZ (m): 2.4 Works priority: N/A  
TPZ (m): 4.8 Construction Proximity: 9  
mTPZ (m): =TPZ

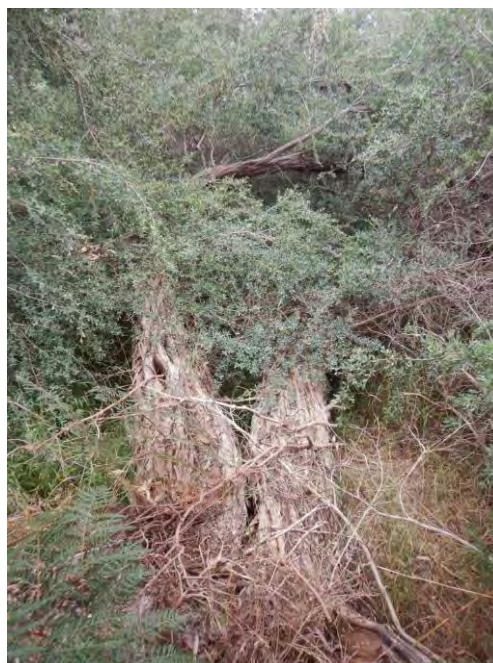
Tree ID: 217

Height (m): 4 Structure: Very poor  
Width (m): 6 Health: Fair  
DBH (cm): 25 Measured Maturity: Over mature  
Origin: Victorian ULE (years): 5 - 15  
Retained?: Retained Form: Poor  
Retention Value: Very low  
Removal / retention reason: N/A.  
Amenity value: Very low  
Works Required: J No works.

SRZ (m): 1.8 Works priority: N/A  
TPZ (m): 3.0 Construction Proximity: 8  
mTPZ (m): =TPZ

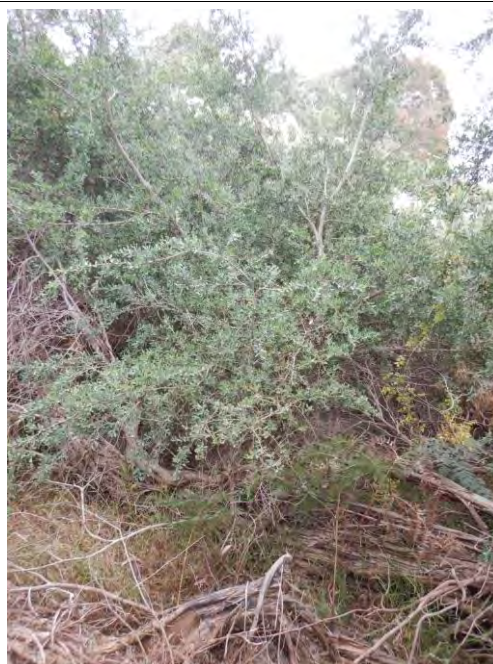
Tree ID: 218

Height (m): 9 Structure: Fair  
Width (m): 12 Health: Poor  
DBH (cm): 62 Measured Maturity: Over mature  
Origin: Melbourne ULE (years): 1 - 5  
Retained?: Retained Form: Poor  
Retention Value: Remove.  
Removal / retention reason: Health ULE.  
Amenity value: Low  
Works Required: B Removal.

SRZ (m): 2.8 Works priority: Very low  
TPZ (m): 7.4 Construction Proximity: 5.3  
mTPZ (m): =TPZ

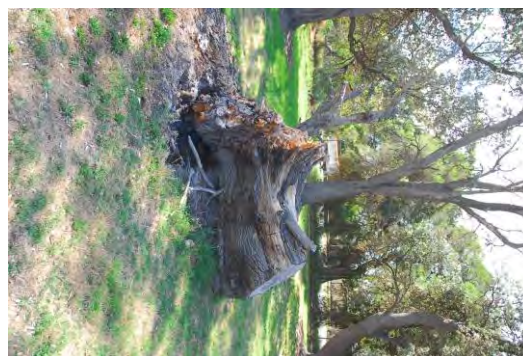
Tree ID: 222

Height (m): 15 Structure: Very poor  
Width (m): 8 Health: Dead  
DBH (cm): 92 Estimated Maturity: Over mature  
Origin: Melbourne ULE (years): 0  
Retained?: Retained Form: Poor  
Retention Value: Remove.  
Removal / retention reason: Health ULE.  
Amenity value: Very low  
Works Required: B Removal.

SRZ (m): 3.2 Works priority: Very low  
TPZ (m): 11.0 Construction Proximity: 15  
mTPZ (m): =TPZ

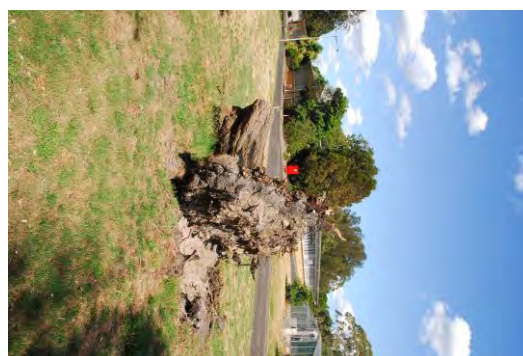
Tree ID: 223

Height (m): 17 Structure: Very poor  
Width (m): 9 Health: Dead  
DBH (cm): 86 Measured Maturity: Over mature  
Origin: Melbourne ULE (years): 0  
Retained?: Retained Form: Fair  
Retention Value: Moderate  
Removal / retention reason: N/A.  
Amenity value: Very low  
Works Required: J No works.

SRZ (m): 3.1 Works priority: N/A  
TPZ (m): 10.3 Construction Proximity: 20  
mTPZ (m): =TPZ

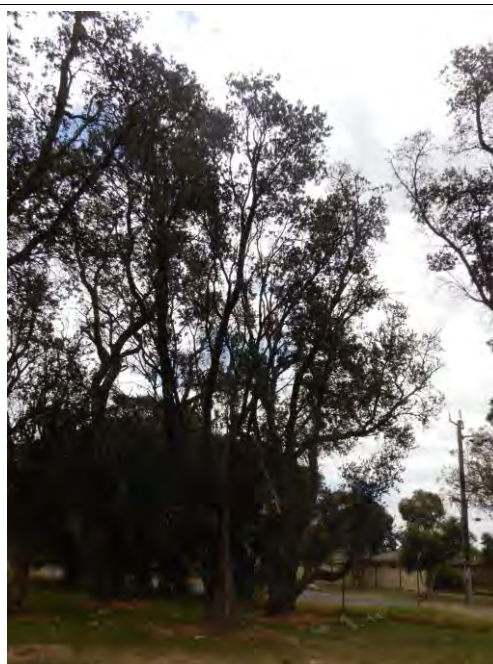
Tree ID: 224

Height (m): 17 Structure: Fair  
Width (m): 8 Health: Fair  
DBH (cm): 65 Measured Maturity: Over mature  
Origin: Melbourne ULE (years): 15 - 30  
Retained?: Retained Form: Fair  
Retention Value: High  
Removal / retention reason: N/A.  
Amenity value: High  
Works Required: I 50mm dead wood

SRZ (m): 2.9 Works priority: Very low  
TPZ (m): 7.8 Construction Proximity: 11.2  
mTPZ (m): =TPZ

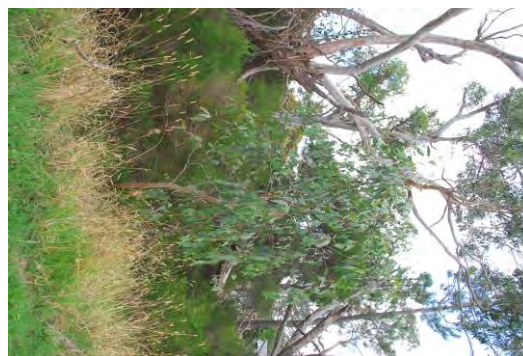
**Tree ID: 288**Genus / species: *Eucalyptus ovata*

Evergreen Swamp Gum

Height (m): 4 Structure: Good  
 Width (m): 2 Health: Good  
 DBH (cm): 7 Estimated Maturity: Immature  
 Origin: Melbourne ULE (years): > 60  
 Retained?: Retained Form: Good  
 Retention Value: Low  
 Removal / retention reason: N/A.  
 Amenity value: Very low  
 Works Required: J No works.

SRZ (m): 1.5 Works priority: N/A  
 TPZ (m): 2.0 Construction Proximity: 11  
 mTPZ (m): =TPZ

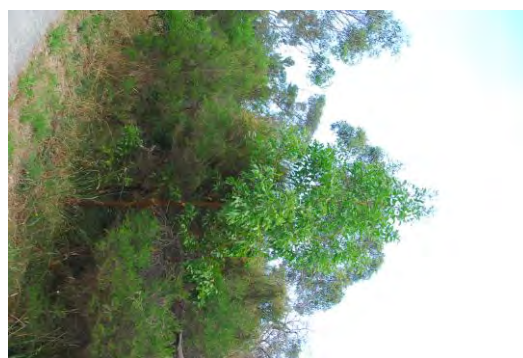
**Tree ID: 289**Genus / species: *Acacia melanoxylon*

Evergreen Blackwood

Height (m): 5 Structure: Good  
 Width (m): 2 Health: Good  
 DBH (cm): 7 Estimated Maturity: Immature  
 Origin: Melbourne ULE (years): > 60  
 Retained?: Retained Form: Good  
 Retention Value: Moderate  
 Removal / retention reason: N/A.  
 Amenity value: Low  
 Works Required: J No works.

SRZ (m): 1.5 Works priority: N/A  
 TPZ (m): 2.0 Construction Proximity: 11  
 mTPZ (m): =TPZ

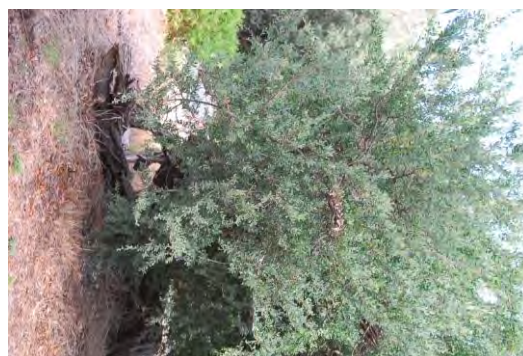
**Tree ID: 290**Genus / species: *Leptospermum laevigatum*

Evergreen Coast Tea Tree

Height (m): 4 Structure: Poor  
 Width (m): 7 Health: Dead  
 DBH (cm): 45 Estimated Maturity: Over mature  
 Origin: Victorian ULE (years): 0  
 Retained?: Removed Form: Fair  
 Retention Value: Low  
 Removal / retention reason: N/A.  
 Amenity value: Very low  
 Works Required: B Removal.

SRZ (m): 2.5 Works priority: N/A  
 TPZ (m): 5.4 Construction Proximity: 0.1  
 mTPZ (m): =TPZ
