Preliminary Geotechnical Assessment
Proposed ramp and snow fence, Rocky Valley Ski Club, Falls Creek

754-MELGE268821AB Rev1

13 May 2020

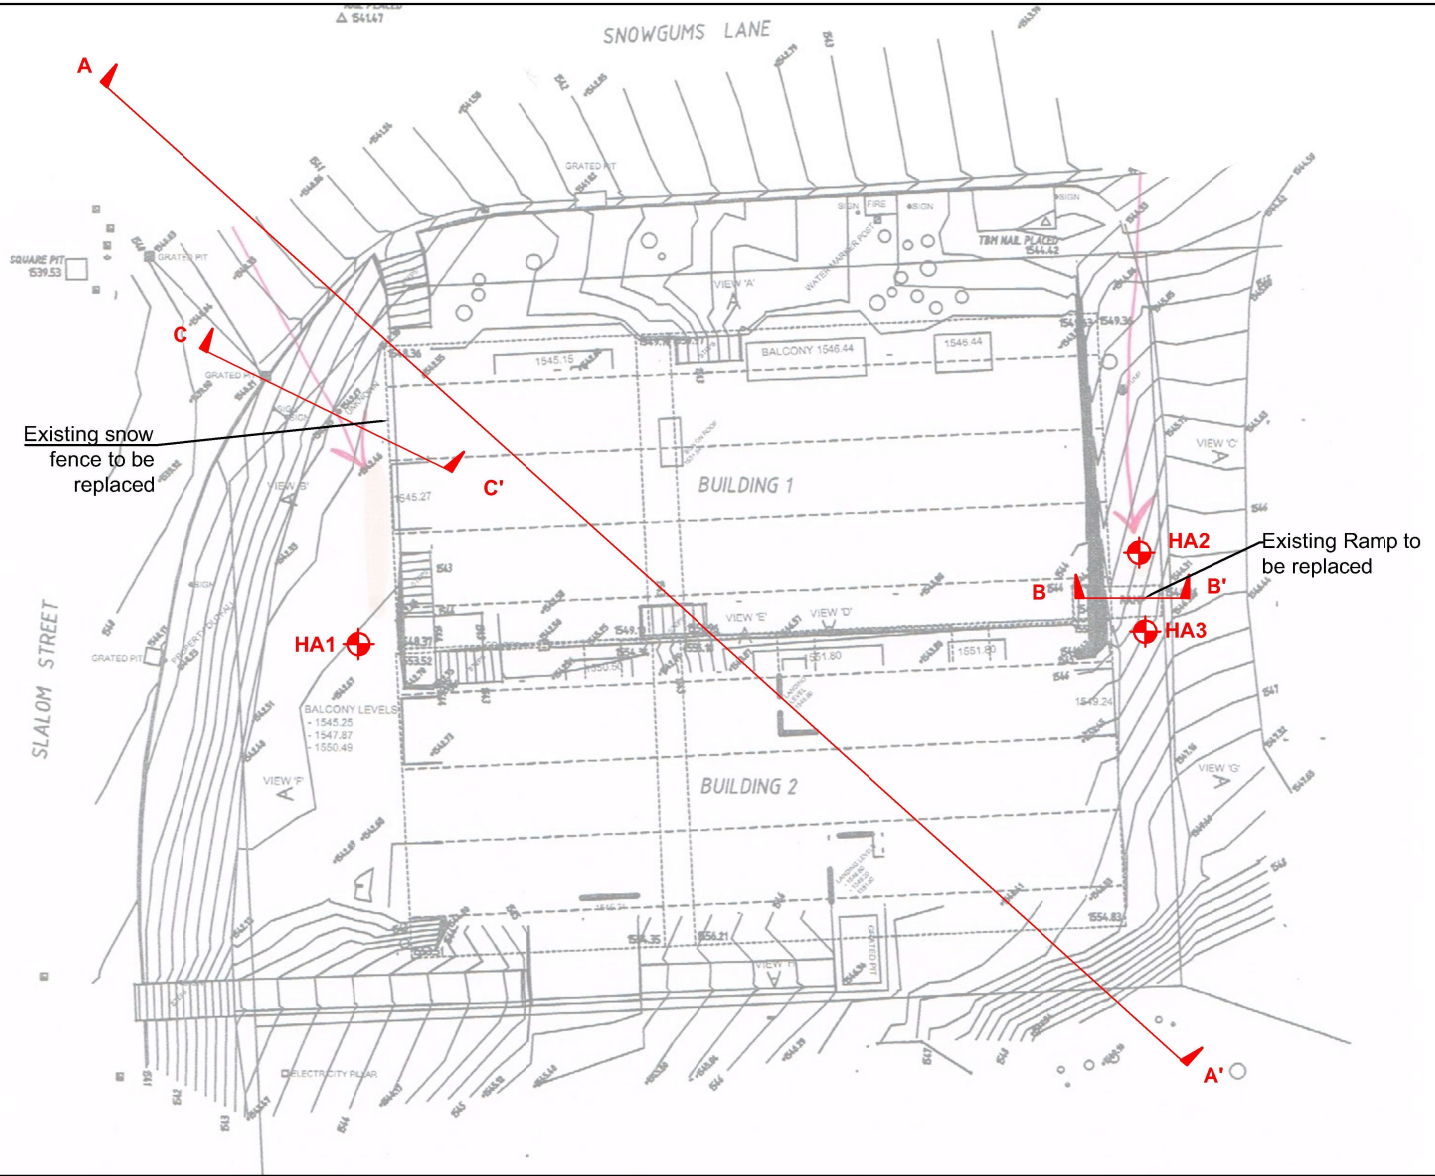
project no: 754-MELGE268821 Figure no: Figure 1 rev: 0

- Excavation and engineering logging of three hand auger boreholes and Dynamic Cone Penetrometer (DCP) tests at the site. The locations of the boreholes are shown in Figure 1. Engineering logs of the boreholes are presented in Appendix A, preceded by sheets summarising the terms and symbols used in their preparation. The results of the DCP tests are presented on the engineering logs.

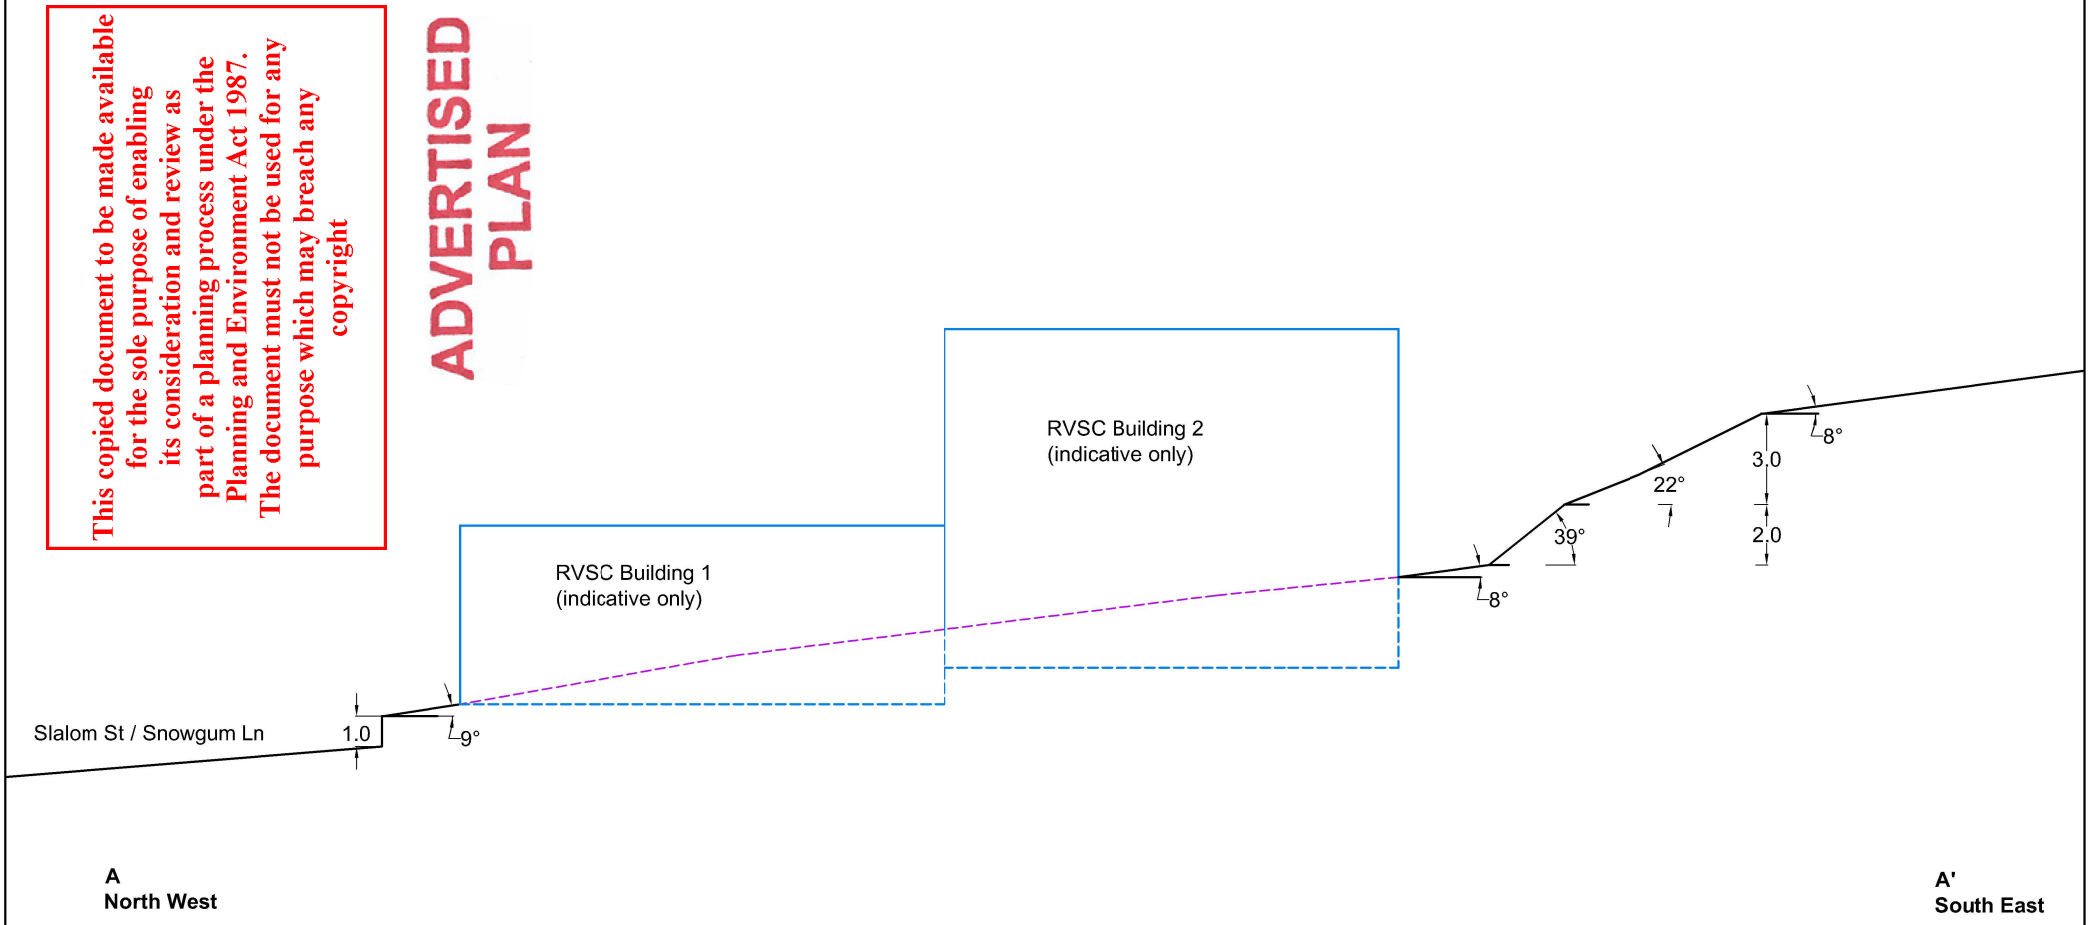
The Rocky Valley site lies on the south east corner of Slalom Street and Snowgums Lane in Falls Creek. The ski club comprises two buildings of 2 and 4 storeys. Figure 1 presents a plan of the site and Figure 2 presents a section through the site. Site photographs presented in Figures 4 to 6 show typical conditions on and adjacent to the site.

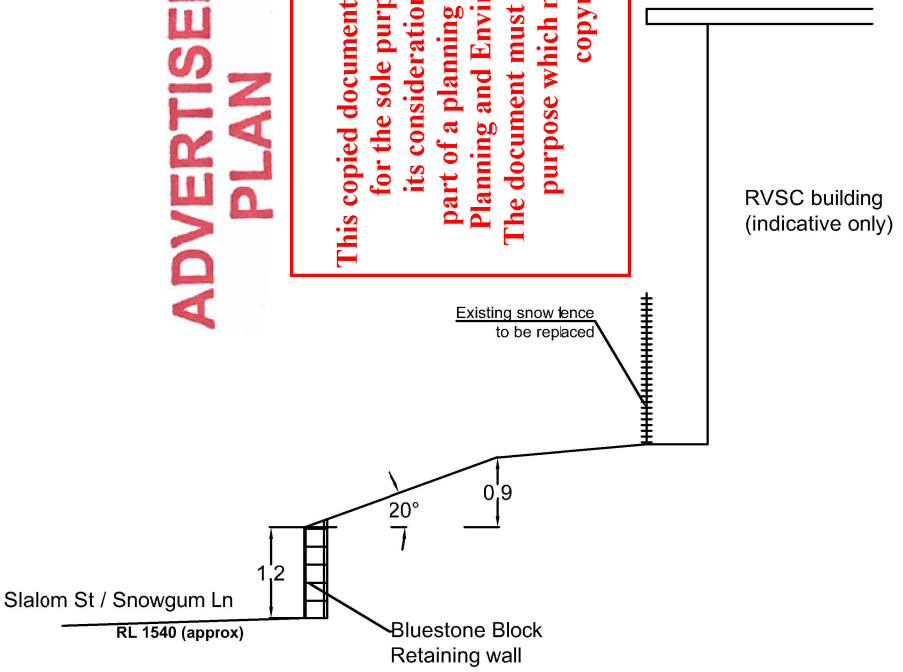
The cutting is at an angle of 68° and falls to the west. The toe of the cutting is offset 0.5m from the edge of the building. The face of the cutting is protected by a bluestone block wall with cement mortar. The mortar appeared to be intact without cracks. Drainage holes were not observed in the bluestone block wall.

The cutting at the ramp site is about 2.1m high and battered at 68°. It is protected by a bluestone block wall. We recommend the structural designer of the ramp review the nature of this block wall and consider its retention capacity in the context of the proposed new ramp.

It is recommended that no surcharge loadings be placed or located above the plane projected up at 45° from the toe of the cutting or batter. This line is presented on Figure 3 for the proposed ramp location. Surface water should be diverted away from the crests of batter slopes.

It is noted that the ramp footings will lie close to the existing cutting at the eastern side of the building. At this location the footings should be installed below any fill and below the plane projected up at 45° from the toe of the existing cutting. This line is presented on Figure 3.

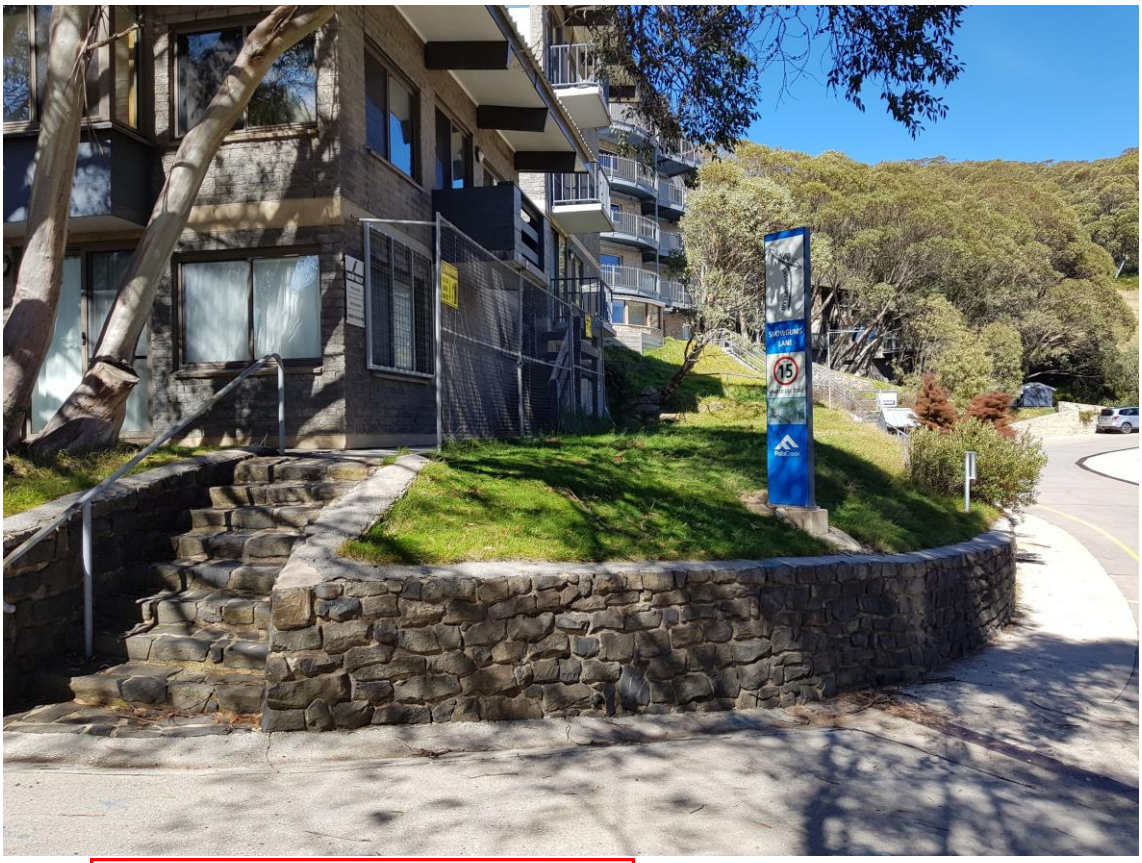
It is noted that drainage holes were not observed in the bluestone block wall on the eastern side of the building at the ramp location. The covered slope may prevent the dissipation of water behind the wall and cause temporary build-up of groundwater behind the wall. This can reduce the bearing capacity of the foundations behind the wall, as well as leading to instability of the slope.

For the advice in Section 6.3 to apply it is recommended that drainage holes are installed in the bluestone block wall. These drainage holes may comprise small diameter holes (say 20mm diameter) drilled through the wall at staggered 1m horizontal and 1m vertical intervals.
