28 April 2022

Arboricultural Impact Assessment Report regarding seventeen (17) trees located within the vicinity of the proposed Star Centre at Star of the Sea College, 80 Martin Street, Brighton

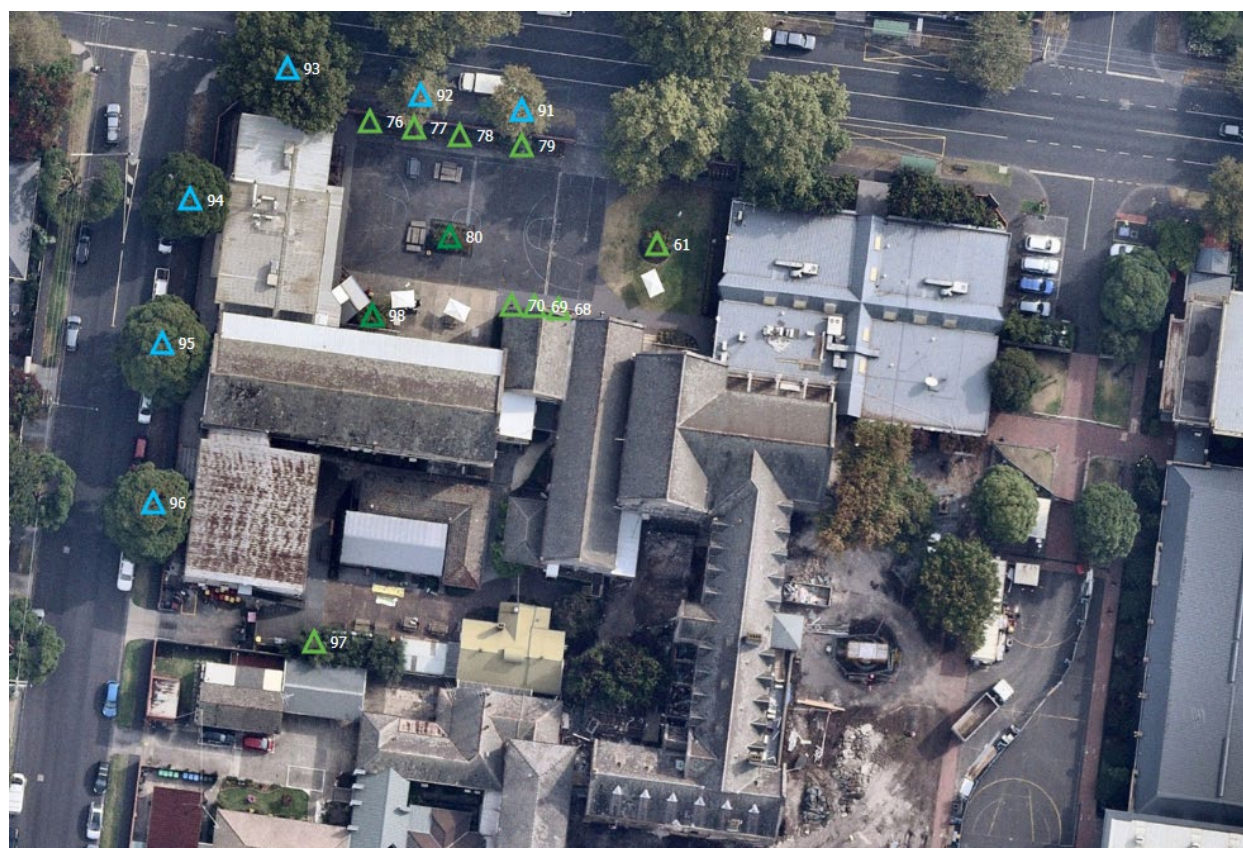
Figure 3. Site map showing subject trees. Note that icon colour indicates trees current risk rating (not Retention Value). Tree attributes are to be obtained from Appendix E – Tree Assessment Data. (ArborPlan, April 2022).

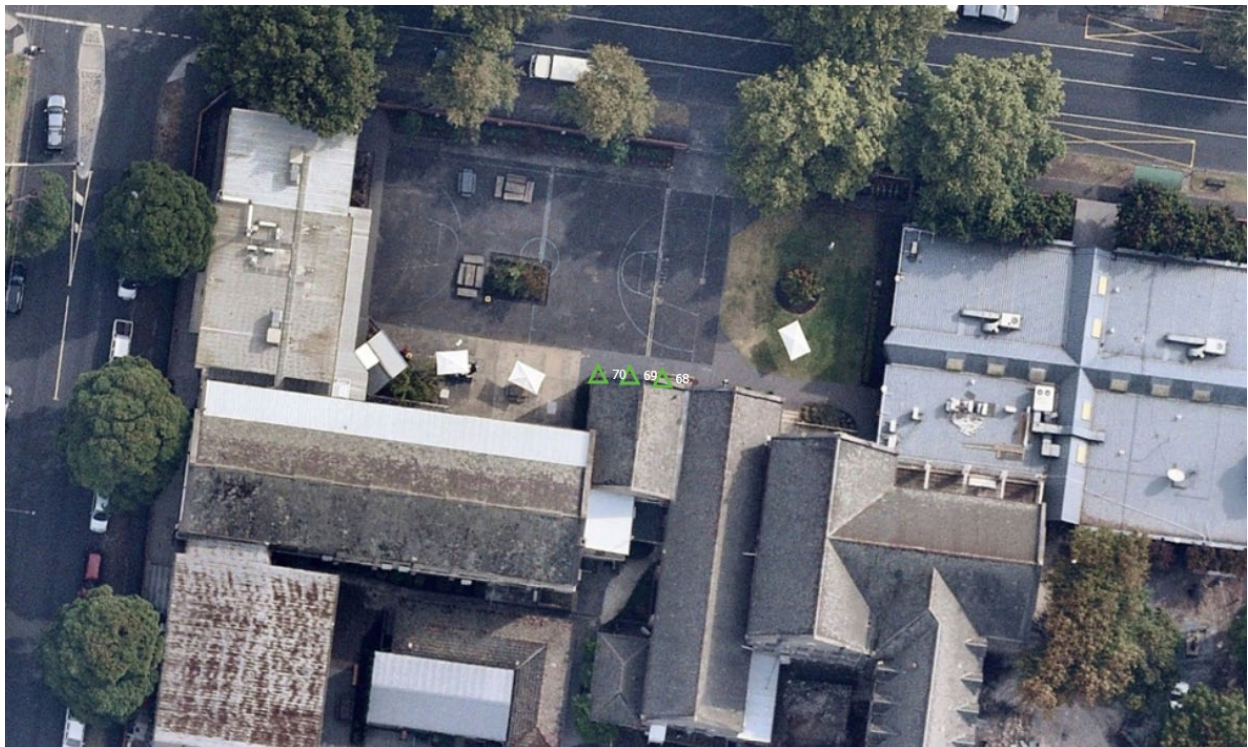
Figure 10. Site map showing tree requiring generic protection measures. (ArborPlan, April 2022).

7.6.1 All retained trees require generic protection measure (Figure 10). Refer to Section 7.5–7.8 for further detail.
